GeoSolve Ref: 170845  
1 December 2017

## Geotechnical Assessment Leaning Lodge Hut, Rock and Pillar Range, Otago

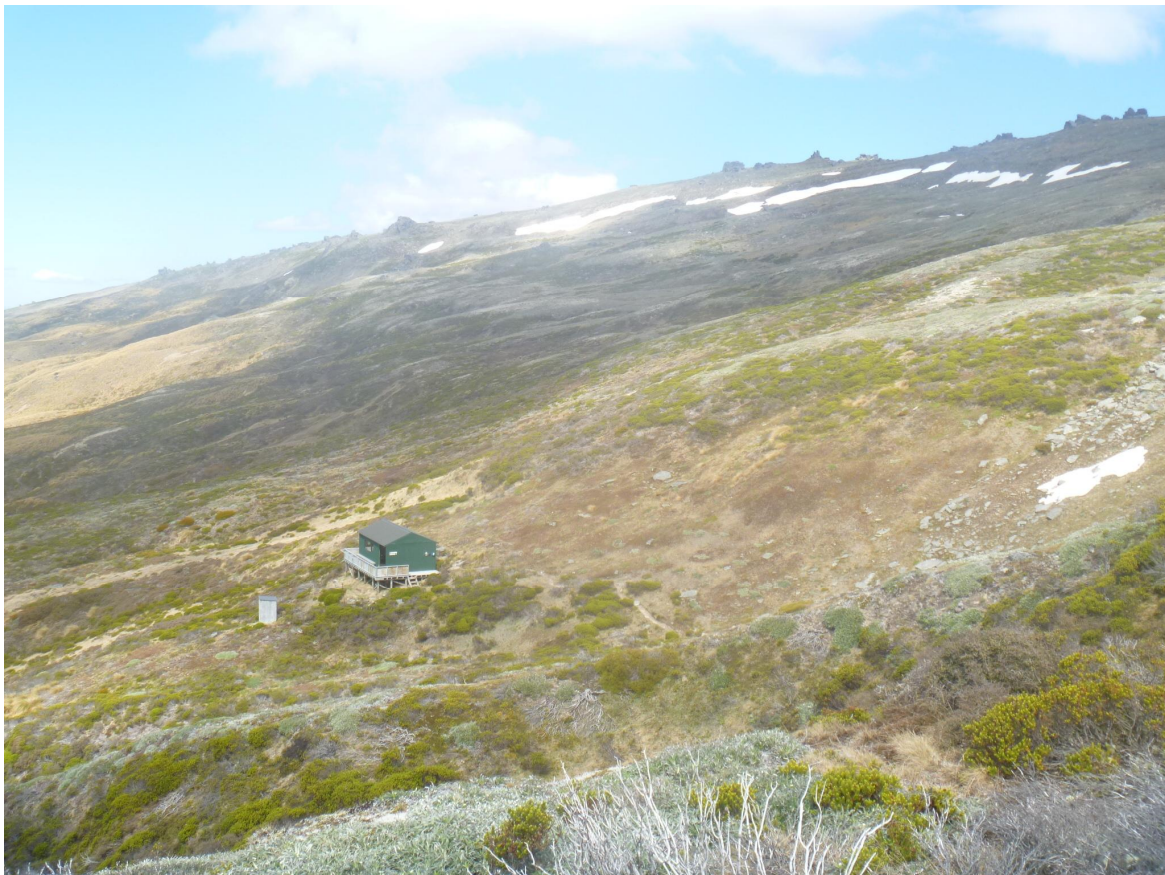
*Photo 1 – Leaning Lodge Hut site.*

The hut is located on a slope of approximately 20 degrees. The land upslope of the hut begins to steepen approximately 30 m from the hut and slopes at up to 30 degrees before cresting to gentle slopes approximately 50 m upslope (see Photo 1 & 2).

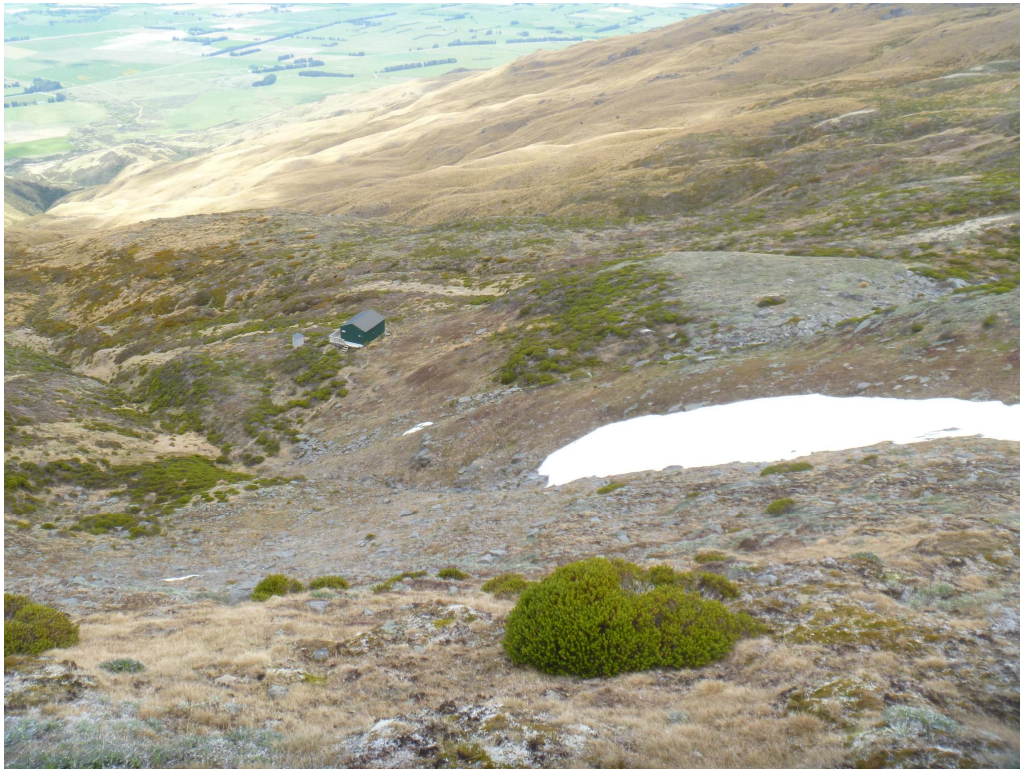
*Photo 2 – View of the hut from upslope areas above ancient headscarp. Note hummocky ancient landslide topography of the range below the hut.*

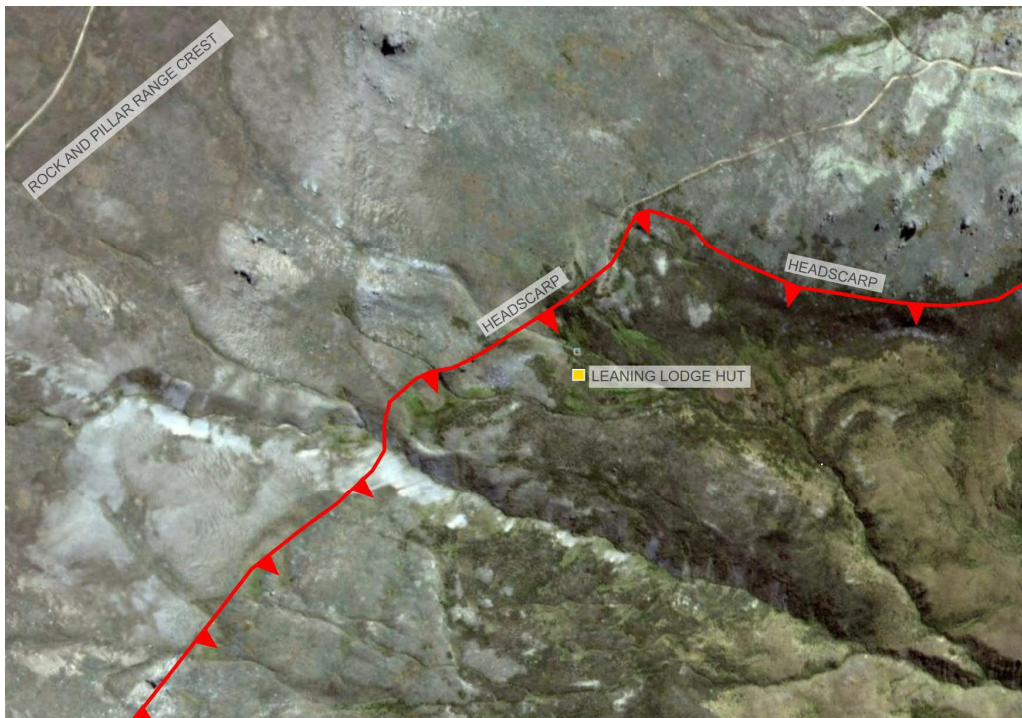
A pronounced steepening of slopes is noted approximately 120 m upslope of the hut and this is interpreted to be part of the headscarp area of an ancient large-scale schist landslide feature that affects most of the range-front (Photo 3).

*Photo 3– Aerial photo (source Google Earth) showing inferred position of ancient schist landslide headscarp with respect to Leaning Lodge Hut (within ancient landslide terrain).*

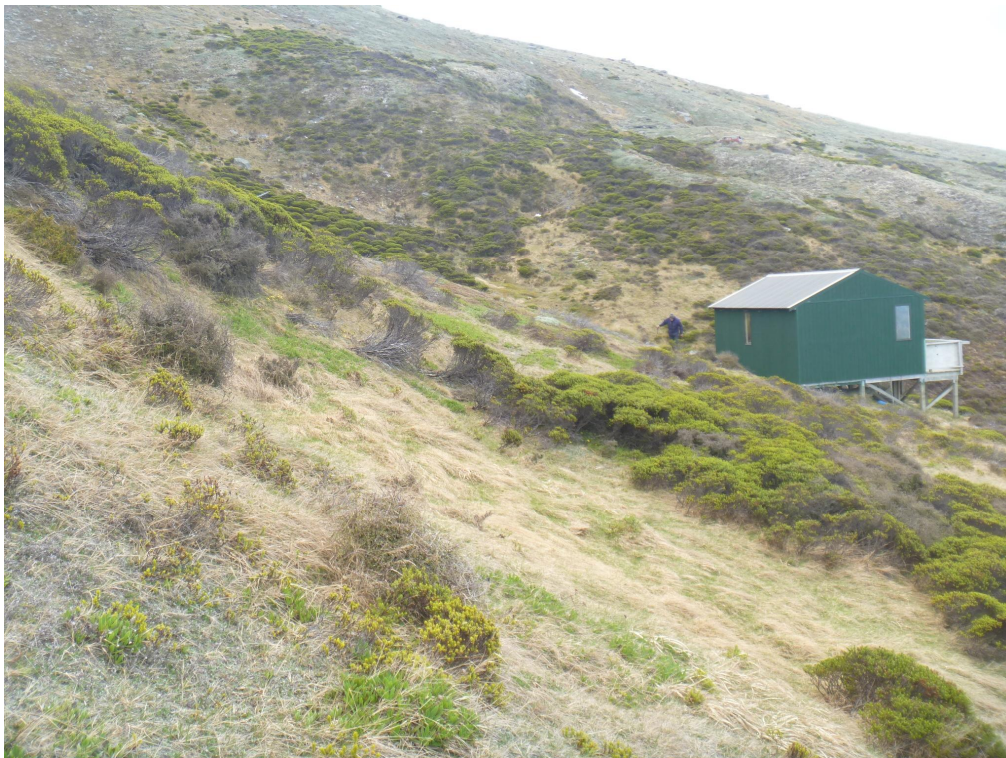
We have carried out an engineering geological appraisal of the hut site and surrounding land to check for indicators of recent landslide activity. The area of the hut shows no evidence of significant recent landslide activity. No scarps or tension cracks were observed and we note that vegetation is well established on the slopes above the hut (Photo 4) In addition, no tension cracking or other signs of recent landslide reactivation were apparent in the steeper headscarp area (Photo 5), apart from superficial near surface slip within the topsoils on the steep slope. Some accumulation of rock fragments from rockfall or rock-roll was noted below the headscarp slope.

*Photo 4– Subdued vegetated slopes behind hut, with no evidence of tension cracking or scarps.*

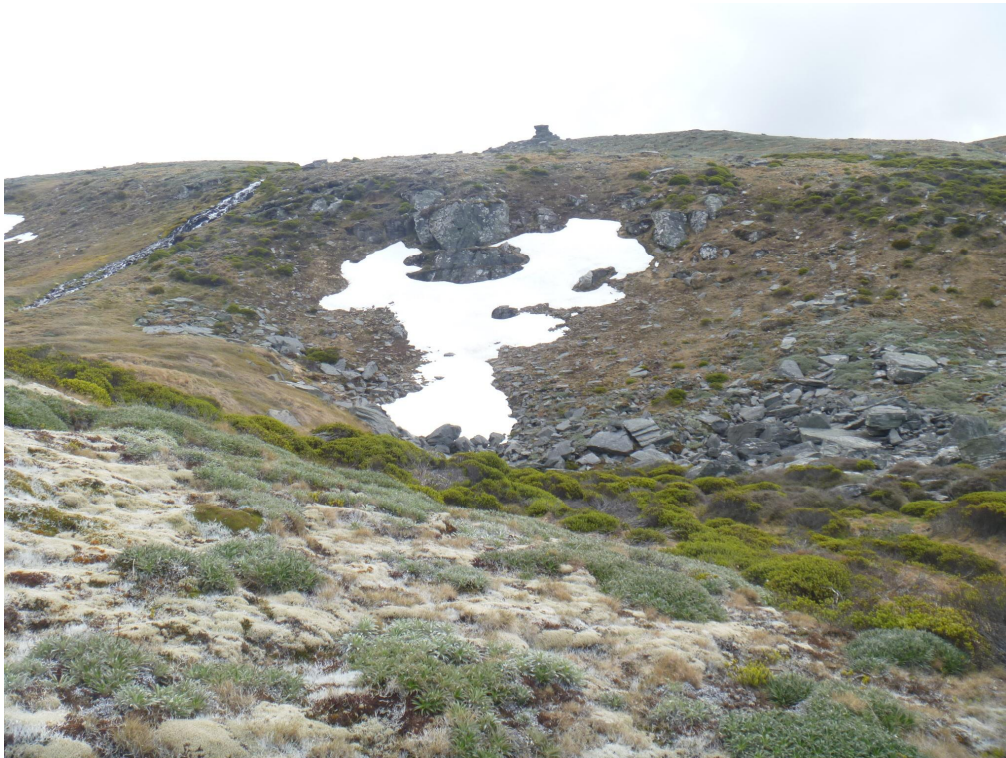
*Photo 5– Steeper ancient headscarp areas well upslope of the hut.*

Some areas of rock fragment accumulation was noted in ephemeral swales at higher elevation than the hut, however these areas are not directly upslope of the hut. Some occasional boulders are evident on the surface upslope, however these are generally angular fragments of tabular shape with minimal potential to present rock fall or rock-roll hazard to the hut.

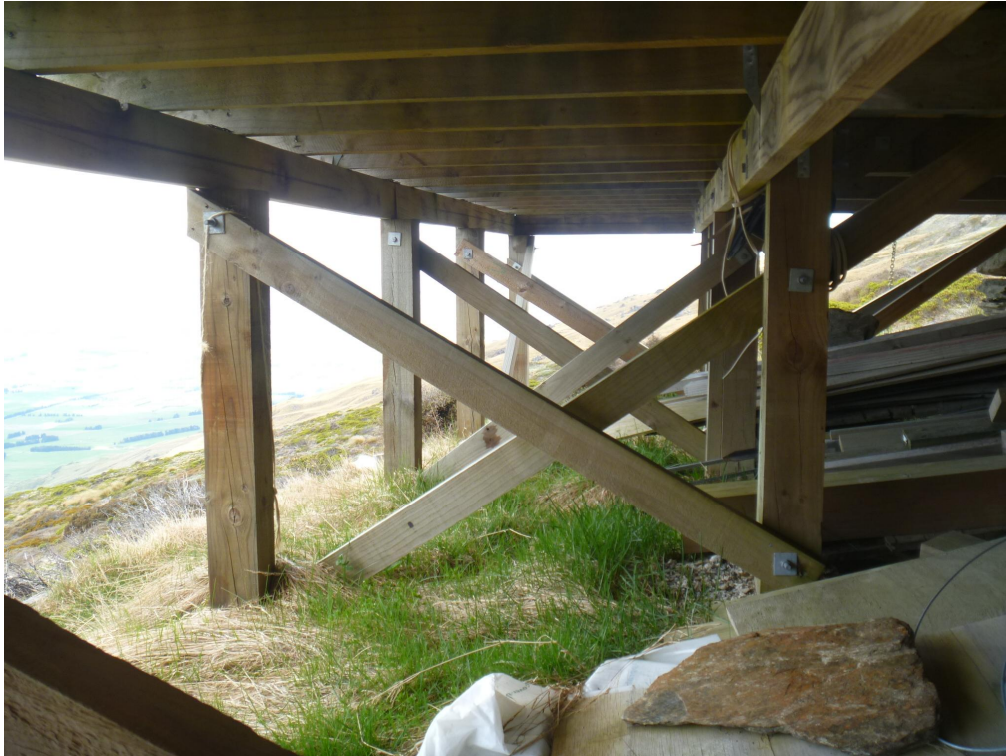
We have carried out a condition assessment of the hut with emphasis on the subfloor area. The hut appears to be in excellent structural condition, however we understand that some replacement of cladding is planned and that a structural engineer will carry out more detailed assessment. We noted no evidence of sloping floors, racking damage, foundation distress or other indicators that could be related to settlement or landslide movement within the subgrade soils. We noted no significant construction issues with the piles and no significant rotation of piles (Photo 6). We understand that piles are well embedded (at least 600 mm) into the subgrade soils (inferred ancient landslide debris). Some packers (piles without embedment) are evident under the structure, however we understand that these are not formally required for structural performance of the bearers (to be confirmed by

structural inspection). We note that the piles are well braced. We note that the subfloor is anchored to the ground using chains embedded into concrete casts (to assist performance during extreme wind conditions).

*Photo 6 – Undeformed and well braced piles.*

- Some cumulative structural distress could occur over the medium to long-term.
- We recommend that regular monitoring of floor levels and condition assessment of the hut should be carried out to identify if any releveling work is required in response to potential landslide creep movement. Inspection every 2 years is recommended initially, however this could be reduced if no issues are evident over several inspections.
