**CAMPBELL ISLAND**  
**meteorological station**  
BUILDINGS, CONDITION & PLANS

MEASURED FEBRUARY 2017

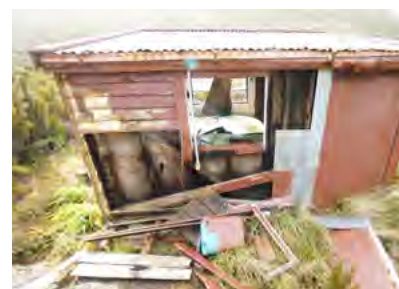
Figure 1-1  
ABOVE The very historic Tucker Hut, near to demolished by neglect.

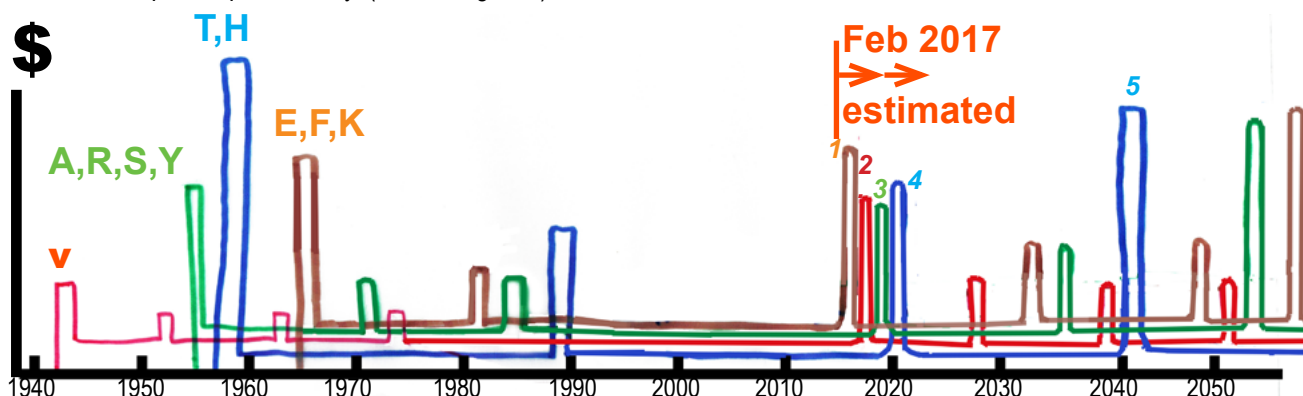
In the future [1] replace perforated zinc cladding, [2] repair Tucker Hut, [3] repair and repaint timber framed buildings, or re-clad, since painting in a damp environment is time consuming, [4] replace Technical building roof and cladding under copper treated window shutters. [5] re-clad rest of aluminium on Hostel and Technical building. The estimated dates further out from Feb. 2017 are VERY approximate.

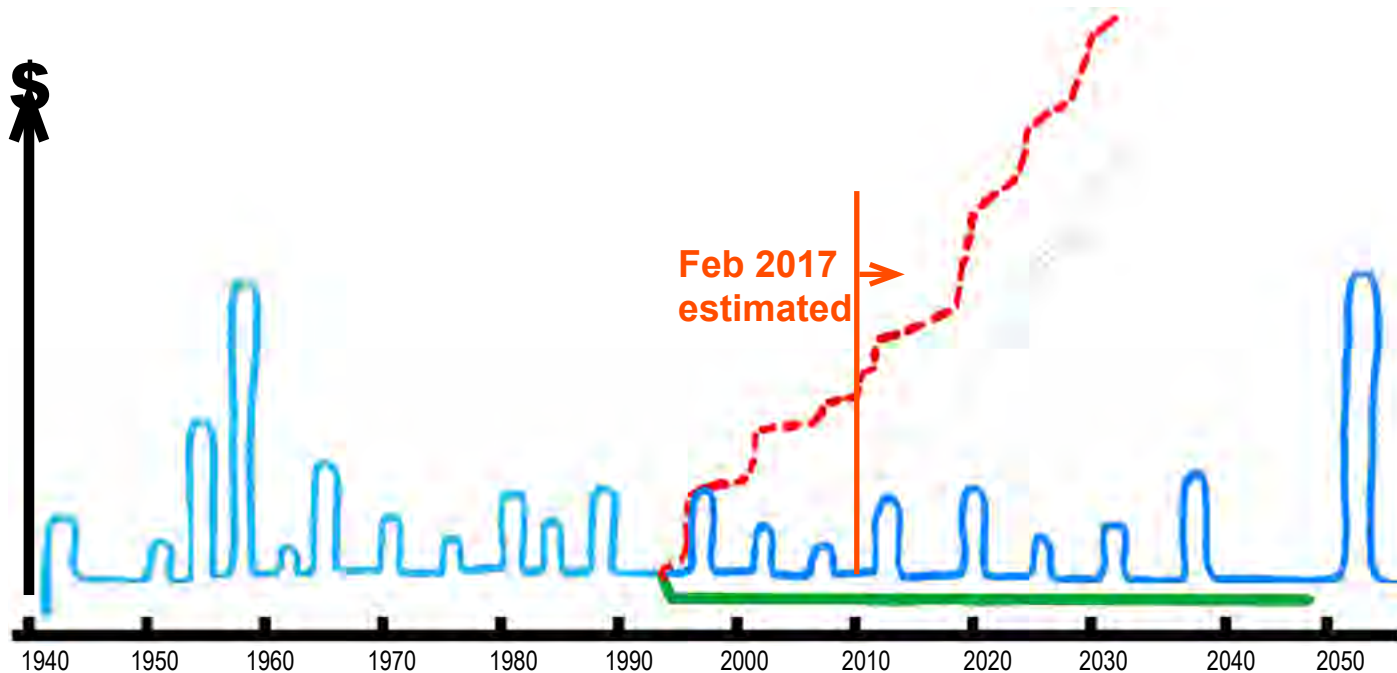
Figure 1-3 ABOVE Accumulated costs, generalised & anecdotal shown with the blue line. Expenditure on larger maintenance items stopped between around 1995 and 2017 and the green line shows the reduction in costs at this time. If maintenance is not completed in a timely manner, then there are secondary maintenance costs that must be added. For instance, a cladding that has already perforated will rot out the structure underneath, hence, the recovery costs of re-establishing a periodic maintenance programme, (the red dotted line) is exponential. The costs start at the vertical red line, then drops down to the blue line after an initial high expenditure.

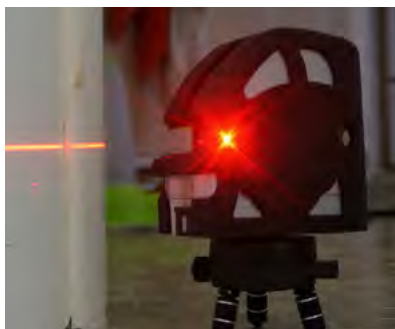
Figure 1-4  
ABOVE An industrial laser was used to check the condition of the foundations, these measurements are on the plans, eg FFL +10.

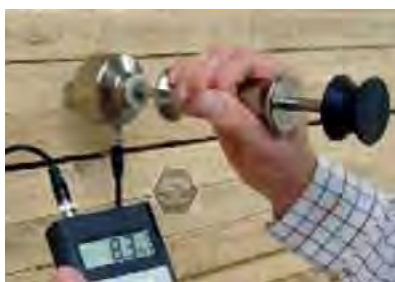
**Acknowledgments.** I would like to thank all the staff from D.o.C. and Met service, photographed in figure 0-2 & 0-3, for their passionate and committed help with the preparation of this report, especially on site.

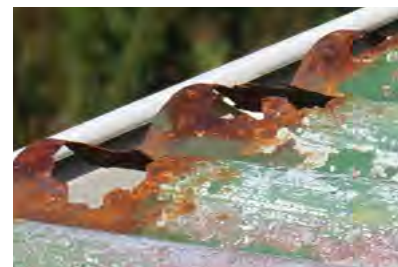
*Figure 1-6*  
**ABOVE** A lot of the cladding around Beeman Base is ending its natural life. In this case the roofing has perforated.

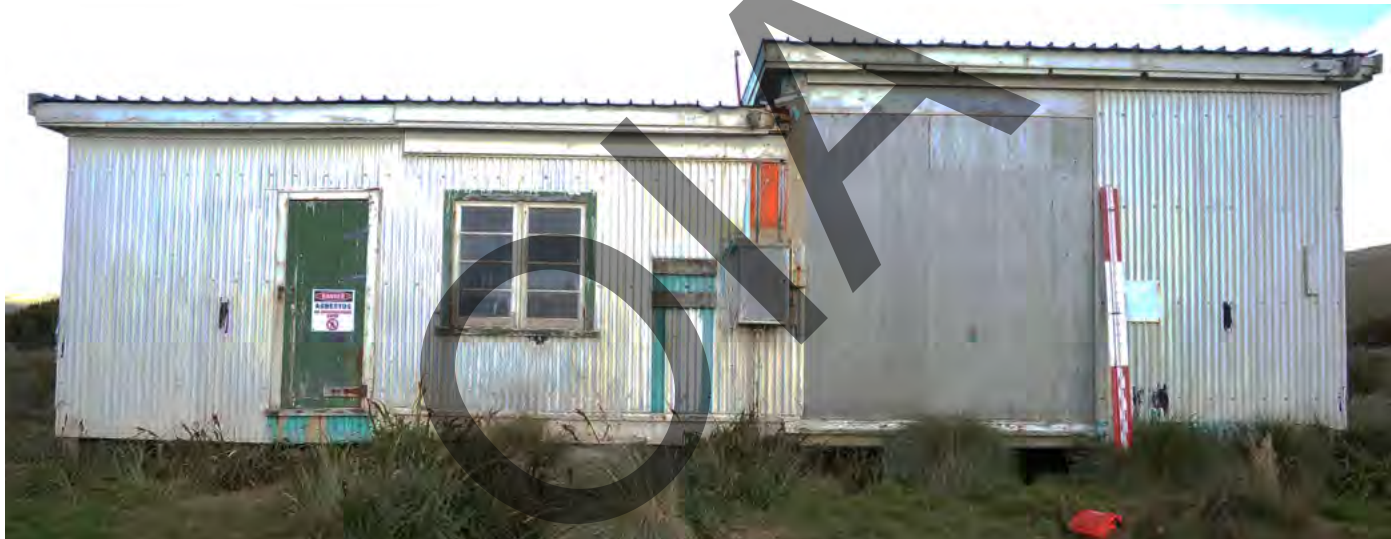
*Figure 1-7*  
**ABOVE** The historic hydrogen building, near to demolished by neglect

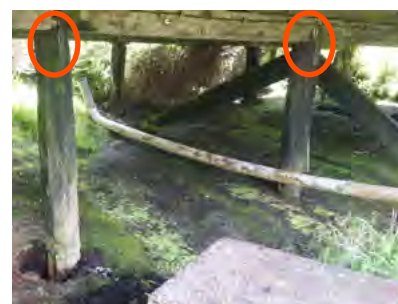
*Figure 1-8*  
**BELOW** The typical structure, minor modifications required to add connections to limit earthquake damage are missing, red circle.

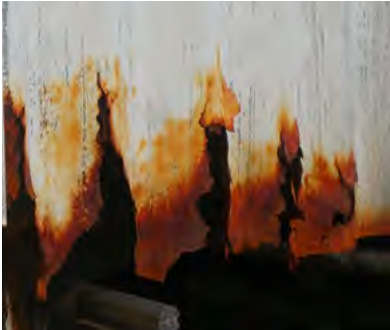
Figure 1-9  
ABOVE Corrosion on ferrous cladding material, installed post 1960,

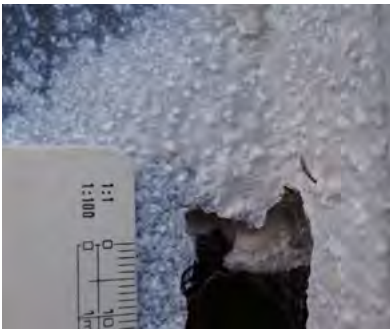
Figure 1-11  
BELOW Pre 1955 cladding is generally in good order, for instance on these wharf buildings. However repaints may be slow in an area of high rainfall.

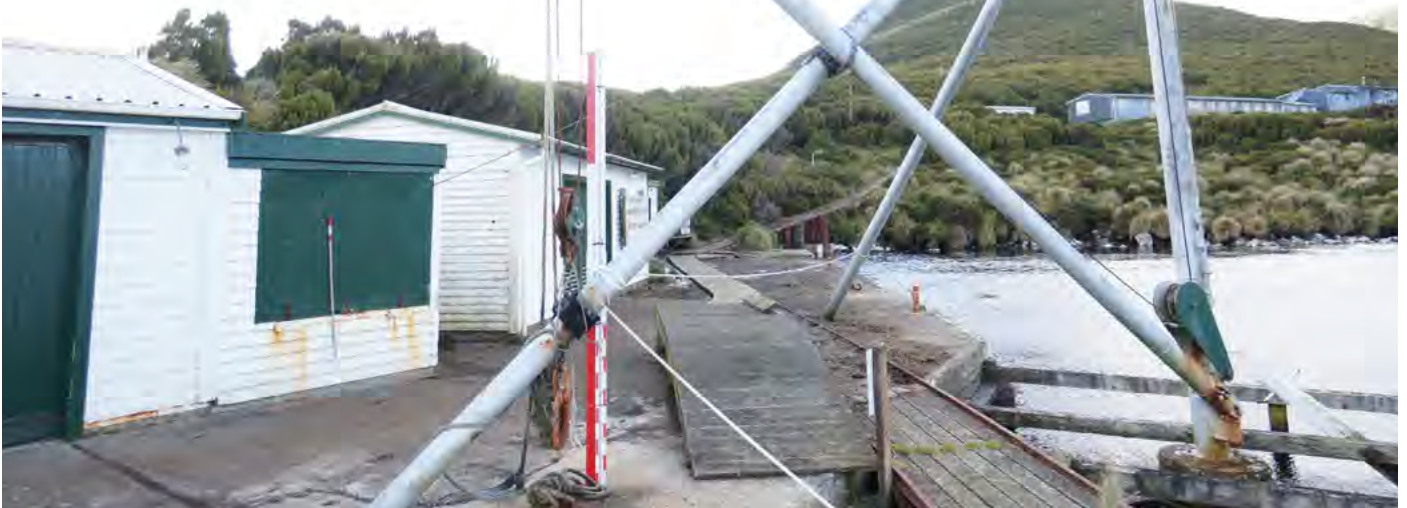
**1d - Post 1960 cladding.** This cladding together with recent materials used for maintenance, in most cases is in very poor condition. The lack of durability reflects the fact that a more economical material has been chosen. These areas need replacing in less than one decade on nearly all buildings built after 1960. In a lot of cases perforation has already occurred in one location and more, and holes that allow water into the structure are both enlarging and multiplying. With this perforation the likelihood of structural damage from rot of the timber framing inside the wall will increase exponentially.

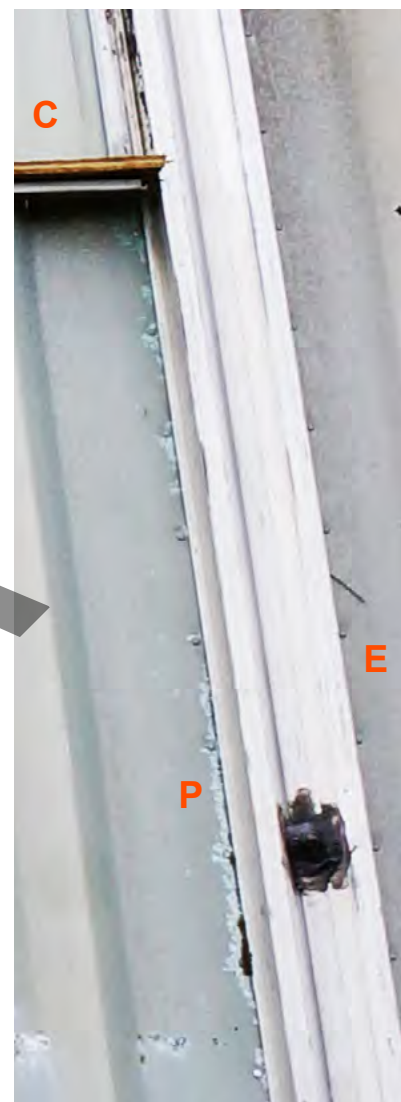
Figure 1-12  
Corrosion evident on the left hand side, where the copper treated shutters have been added above. The aluminium is in pristine condition for its age on the right hand side where there was no treated copper shutters added above.

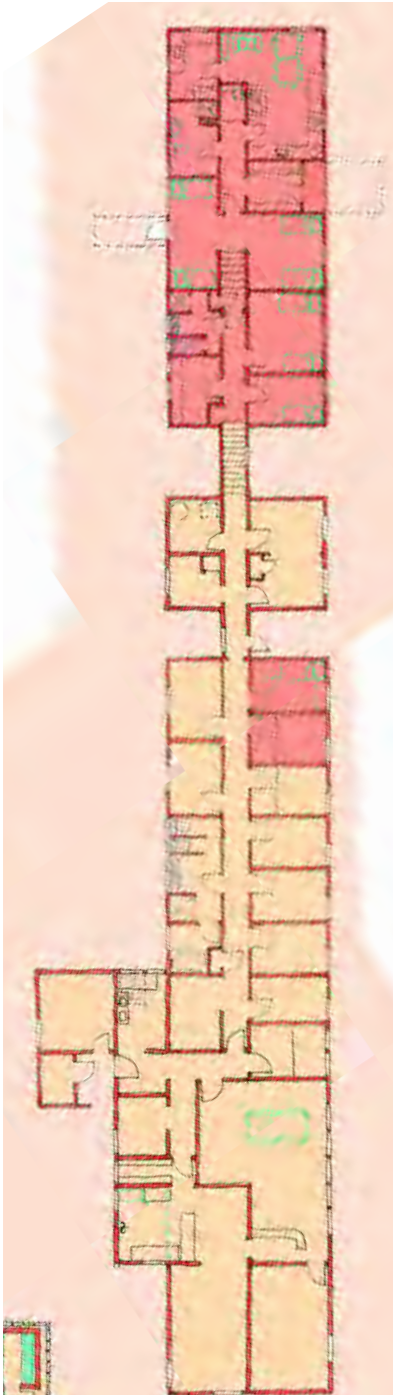
Figure 1-13  
ABOVE Parts of the accommodation used are shown in red, for a full plan refer section "Use - Feb. 2017"

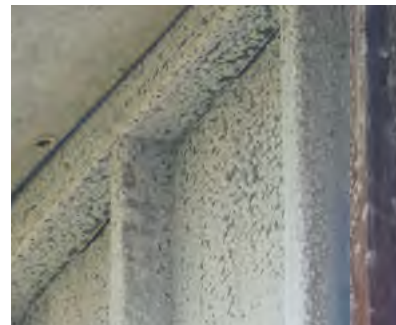
Figure 1-14  
ABOVE The upper area of the cladding on the accommodation buildings, where zinc has extensively oxidised. The next stage of the corrosion cycle is perforation.

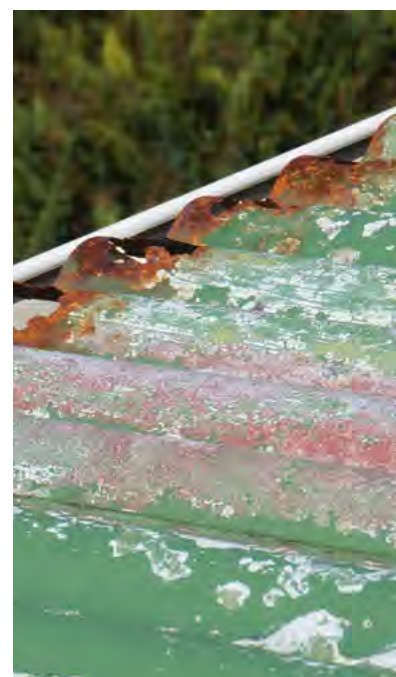
**1m - Immediate Use:** I have only had one trip to Campbell island. However the contents of the buildings, on my review of every accessible room, give a good indication of use. From this observation a minimum requirement to provide facilities could be the:- jetty structures (Q,R,S and U) ; part of the hostel (H) ; some ancillary food, vege, and water structures (J,L) ; and parts of the Technical building required to service the aerals and climate enclosure(T).

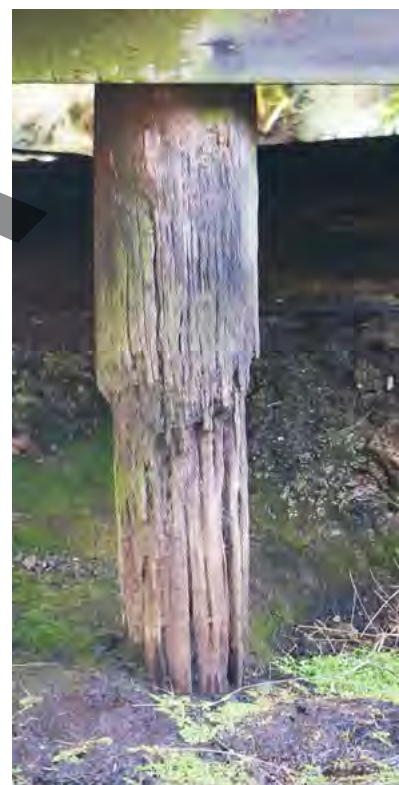
Figure 1-17  
ABOVE A silver pine pile, expected durability, 90 years, with 60 years gone. Refer also section 2H in the condition report.

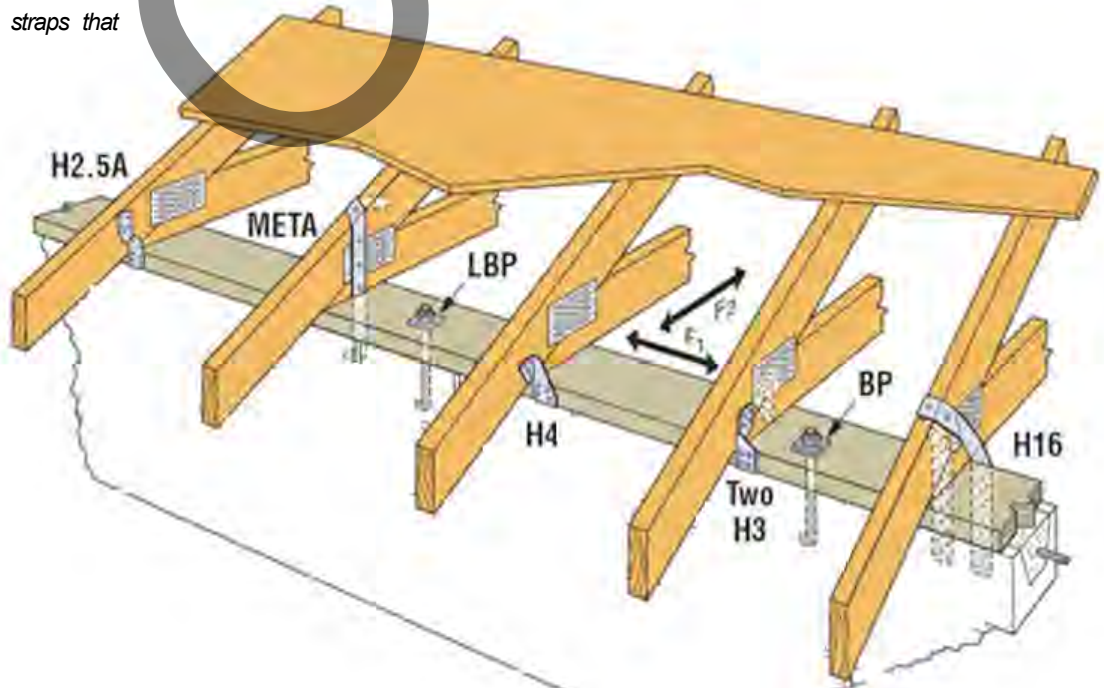
**1q – Wall Cladding - Details** Tucker Hut has deteriorated to such an extent that a complete rebuild is required. Refer section 2V.

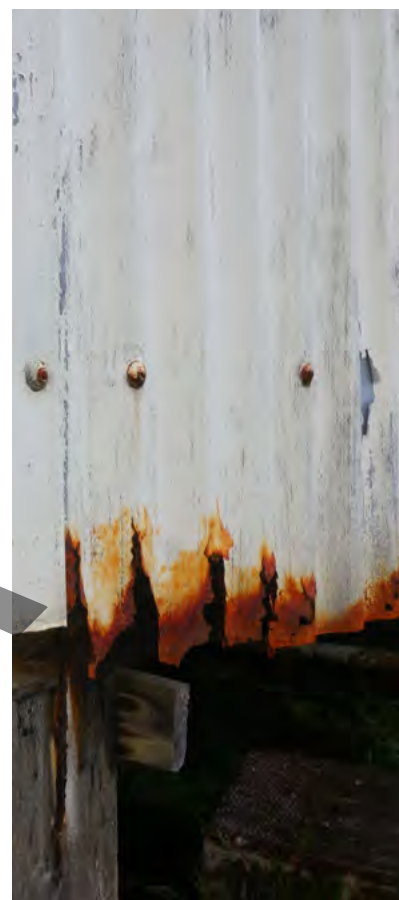
Figure 1-19  
ABOVE Cladding corrosion at the base of a wall.

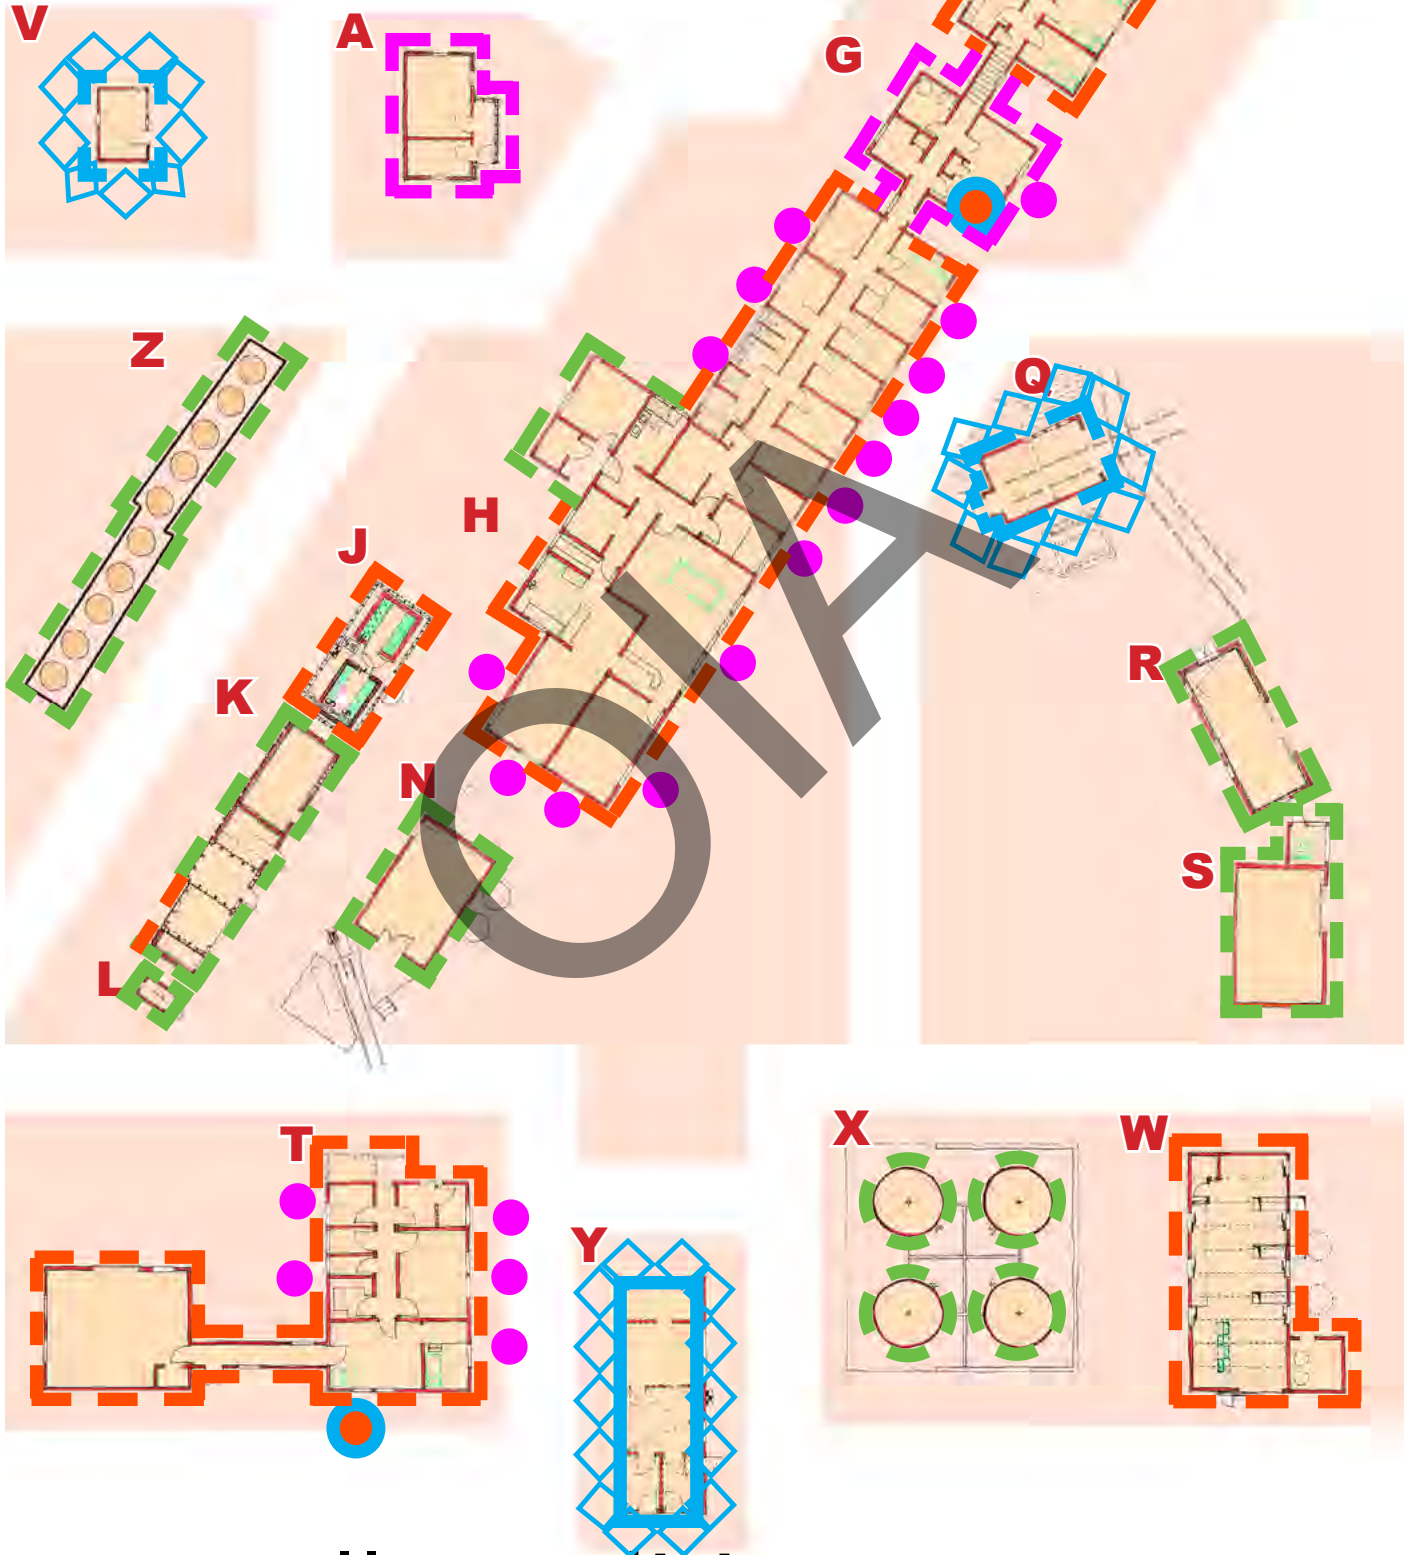
Visual check showed area of building failure, structural decay highly probably.

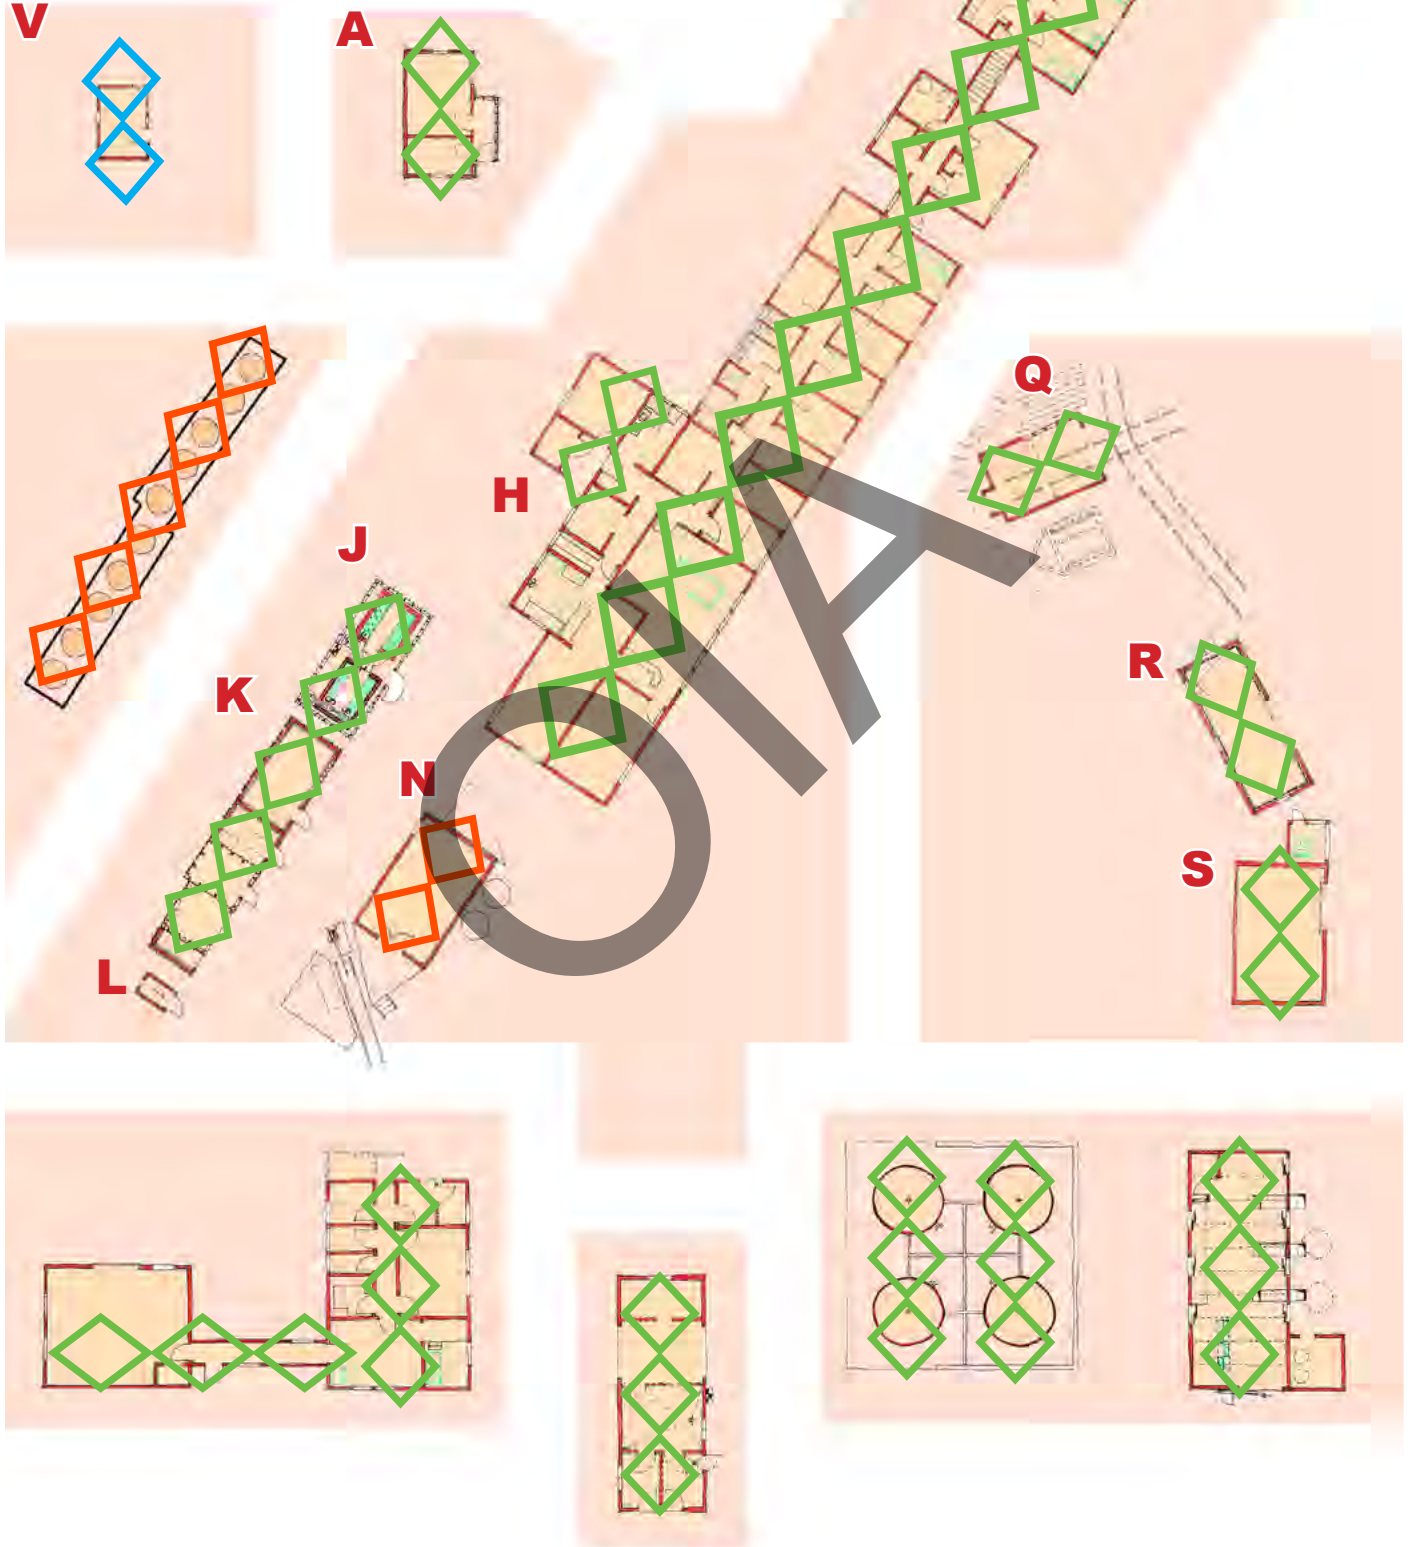
# foundation condition

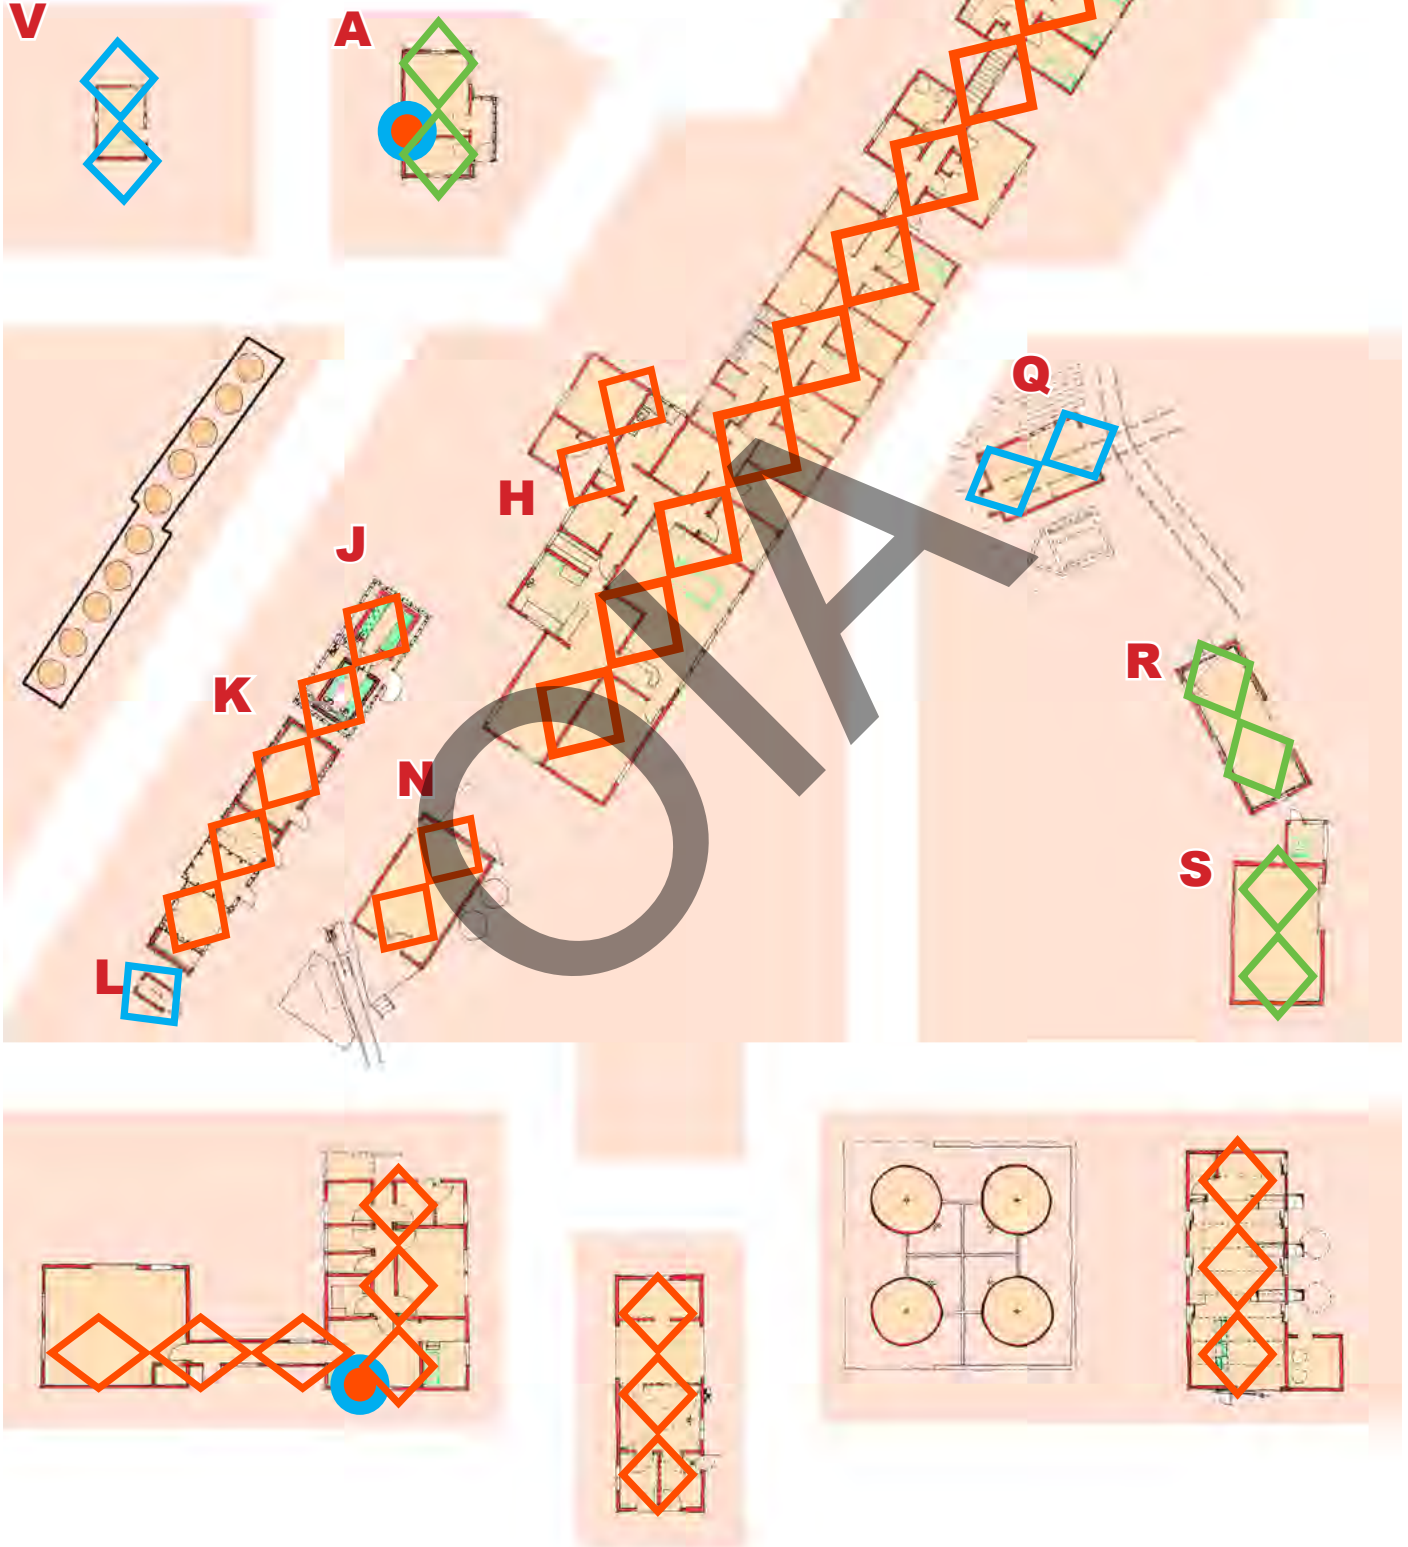
Small area picked for a detailed spot check. Showed roofing has already failed in this spot or is likely to fail.

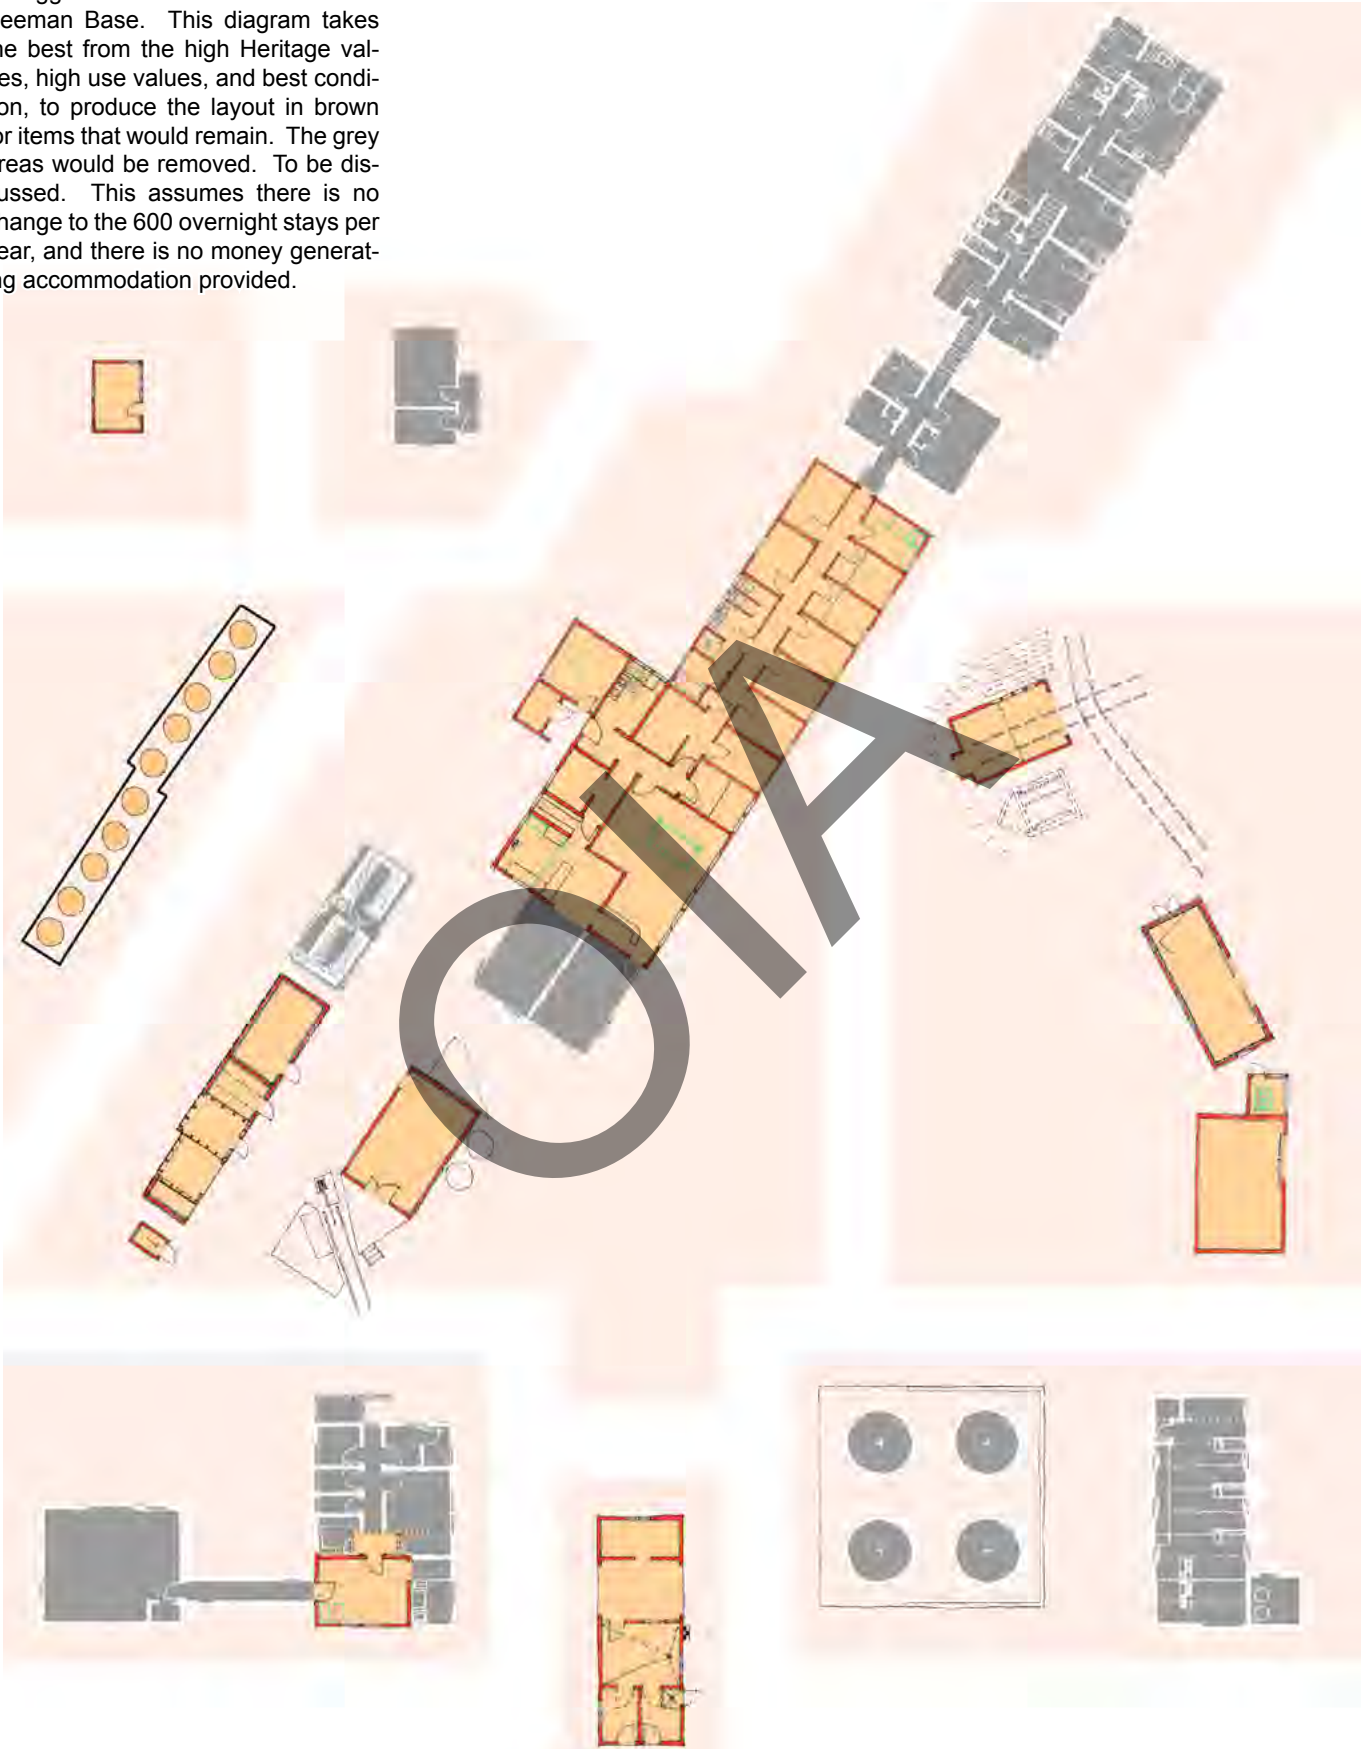
SUGGESTED USE. For discussion.  
A suggestion to reduce the area of Beeman Base. This diagram takes the best from the high Heritage values, high use values, and best condition, to produce the layout in brown for items that would remain. The grey areas would be removed. To be discussed. This assumes there is no change to the 600 overnight stays per year, and there is no money generating accommodation provided.

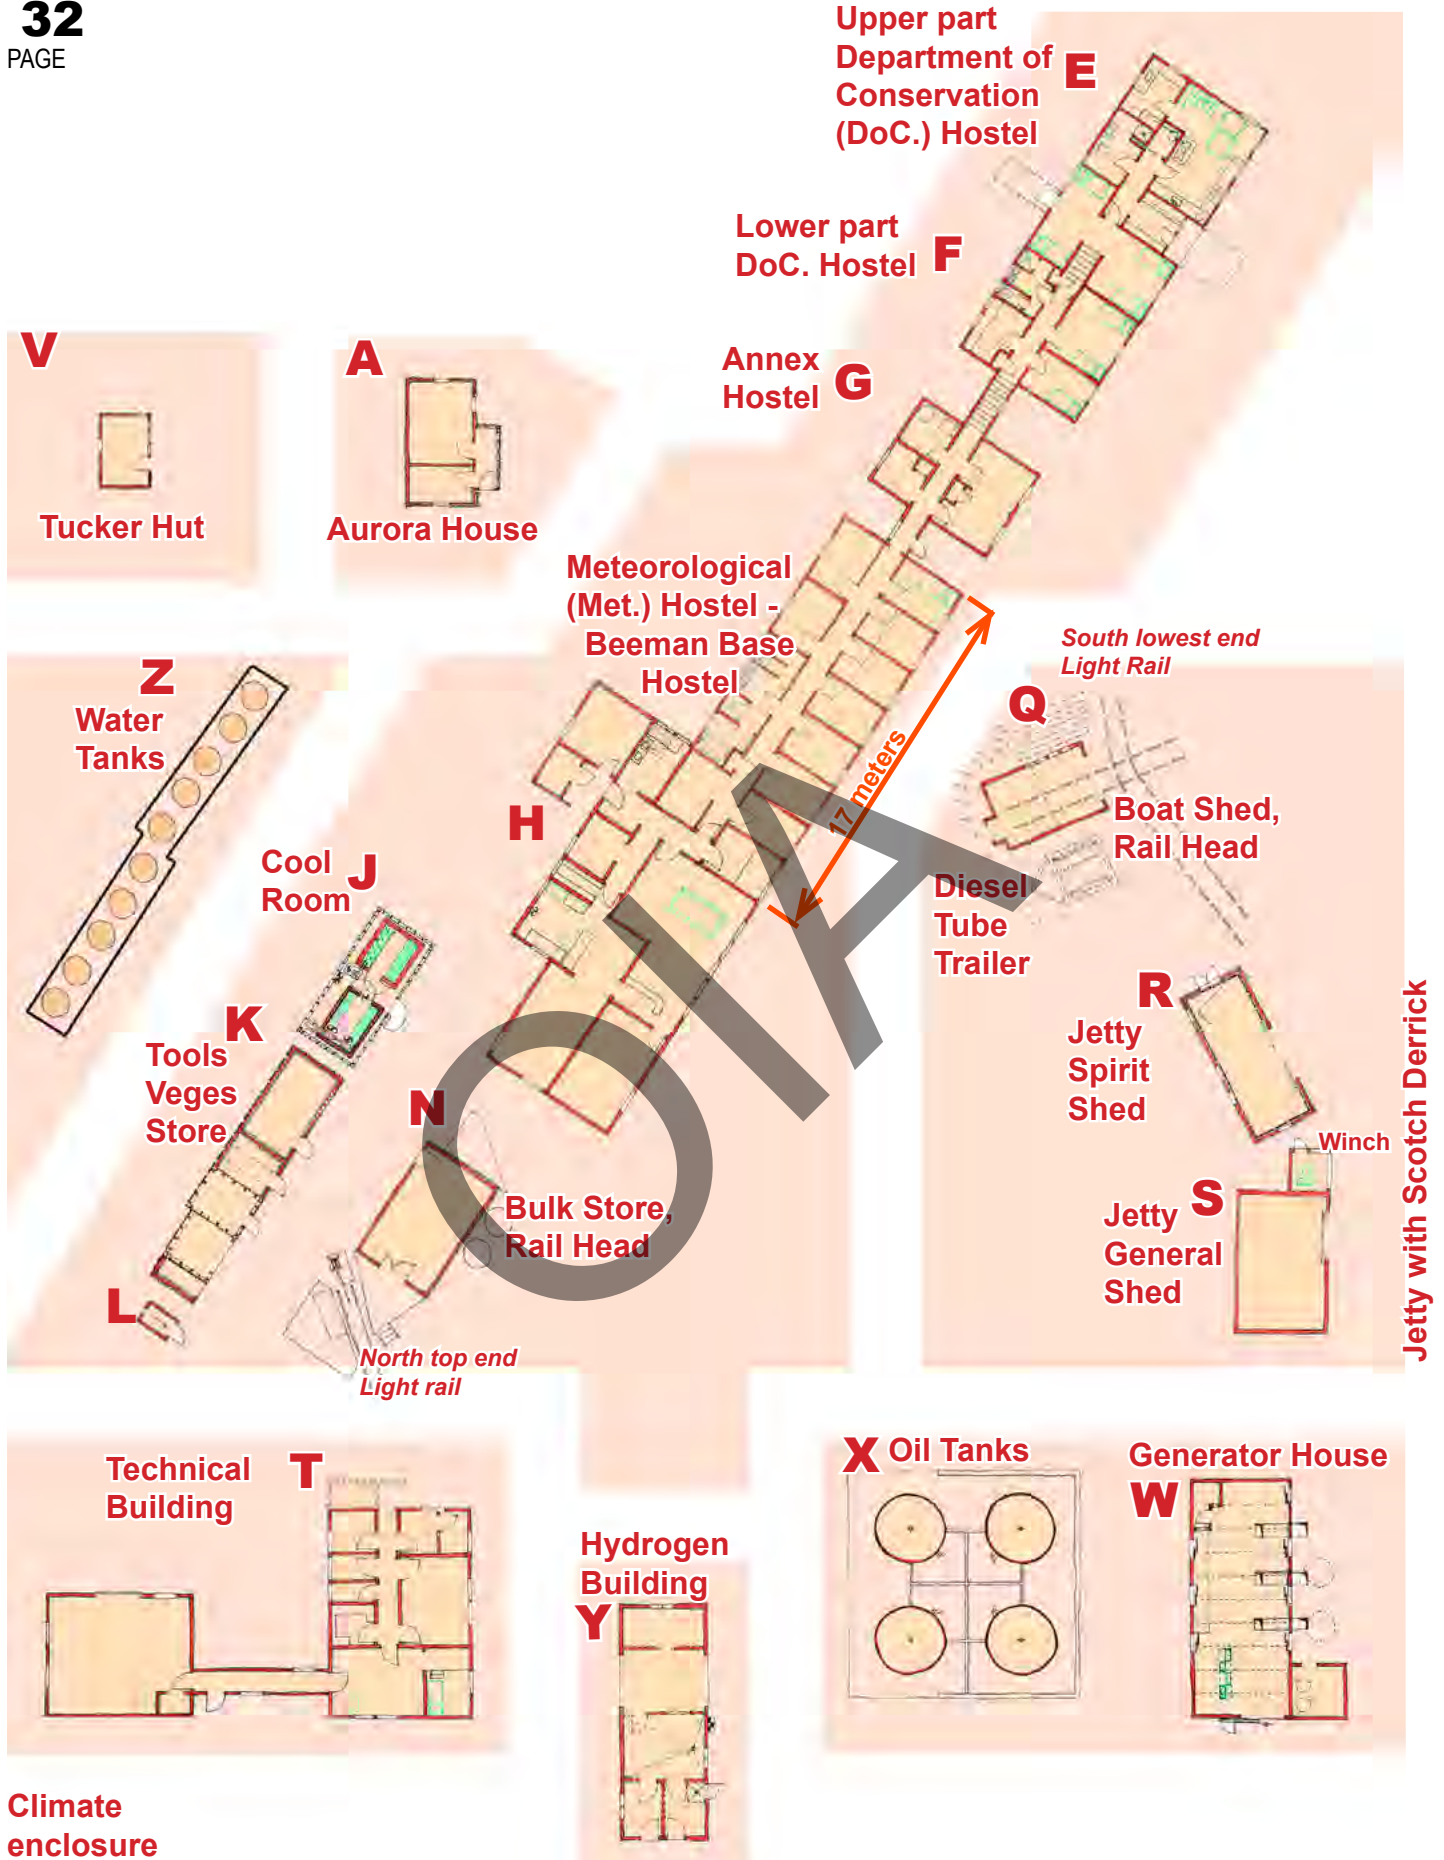
Figure 2-2  
LEFT Condition of the historically and most highly significant building, the Tucker Hut.

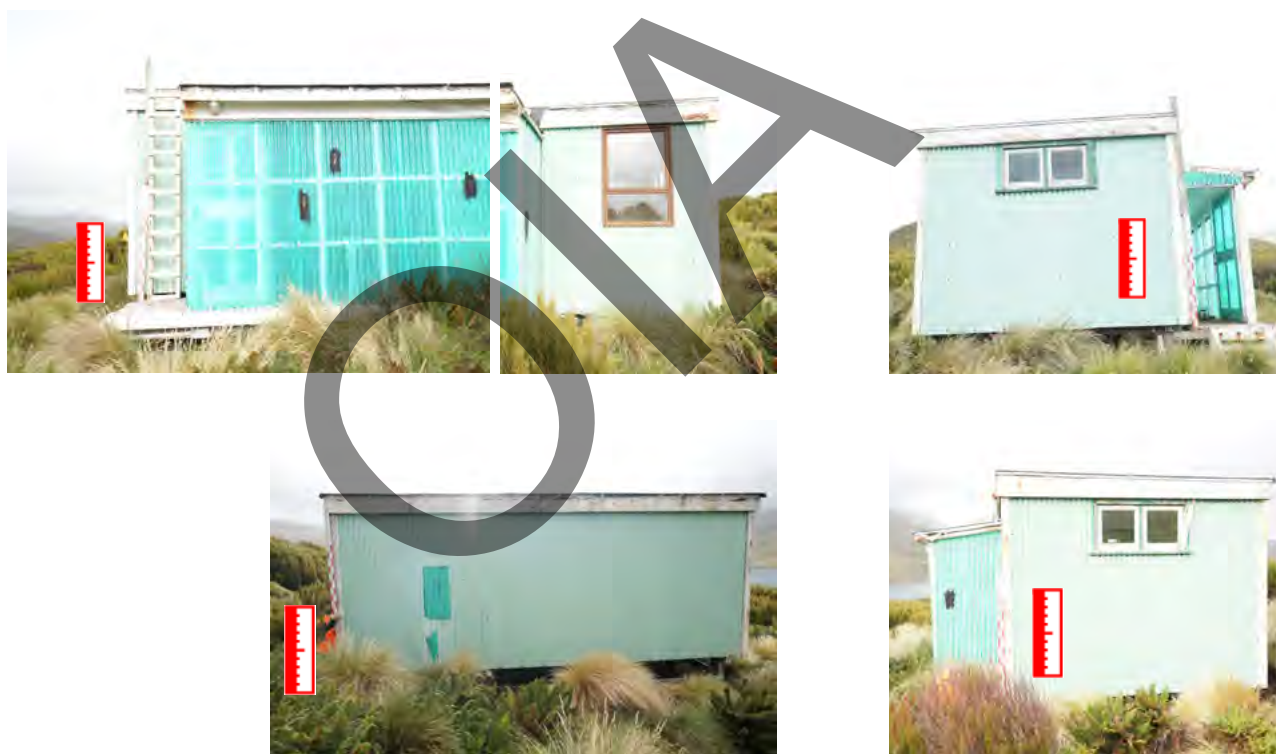
Figure A1 ; A2 ; A3 ; A4  
The four elevations of Aurora Hut.  
The patches are where the plastic cladding, added over the previous, have cracked and deteriorating.  
The timber cladding below was leaking before the plastic over-clad.

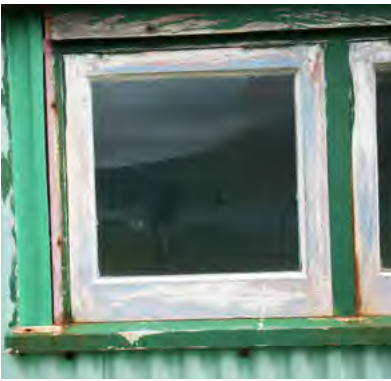
Figure A5  
ABOVE -The south window, in poor condition. This will be leading to leaks and the high moisture content (27%) below this window.

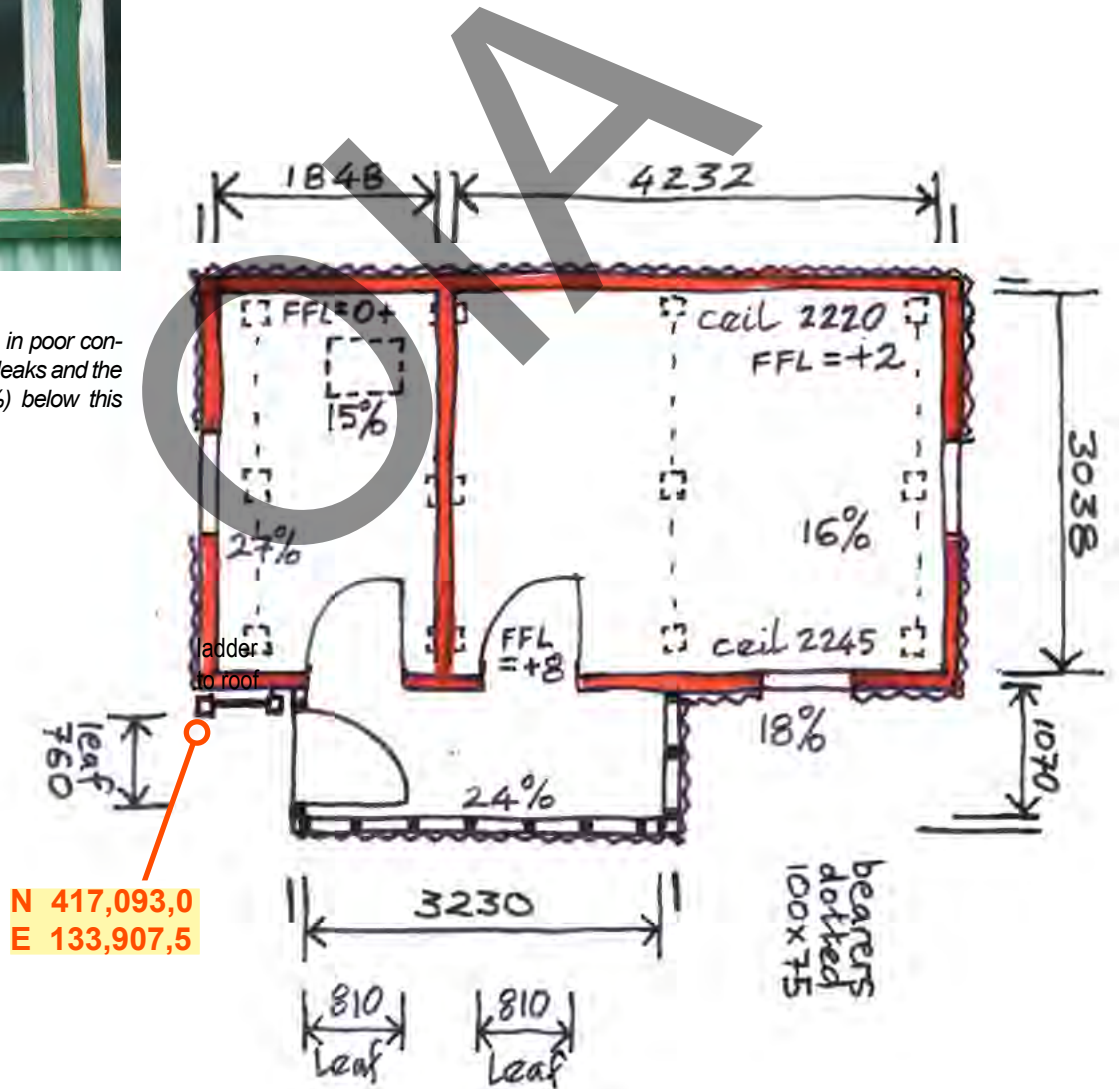
Figure A6  
RIGHT -Aurora Floor Plan

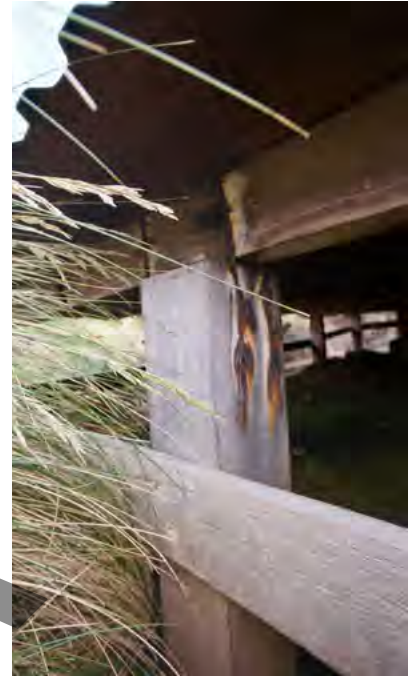
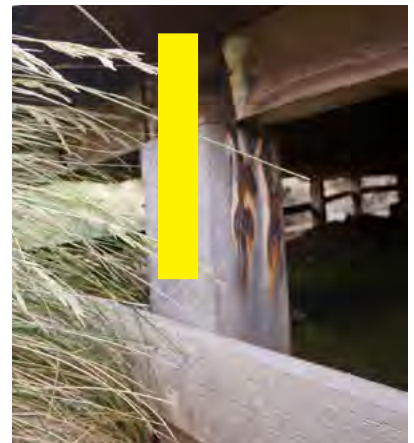
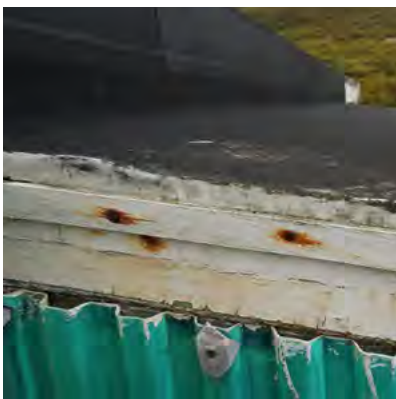
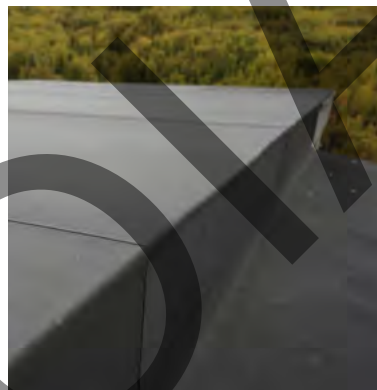
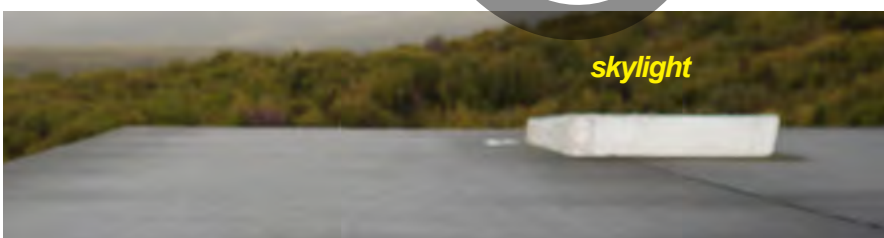
Figure A8 ; A9 ; A10  
The roof membrane is in good condition, but very poor detailing around all the edges means that the roof will leak &/or peel off in high winds.  
The skylight has no upstand and this will lead to inevitable decay if no corrective action is completed.

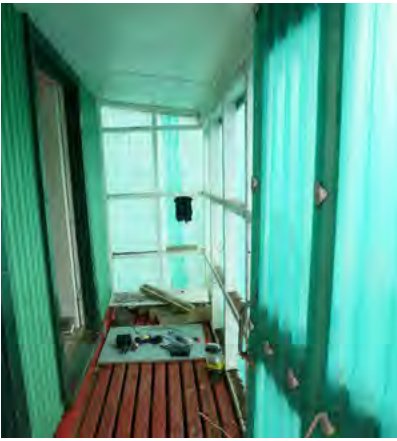
Figure A11  
ABOVE The open porch
