**CAMPBELL ISLAND**  
**meteorological station**  
BUILDINGS, CONDITION & PLANS

MEASURED FEBRUARY 2017

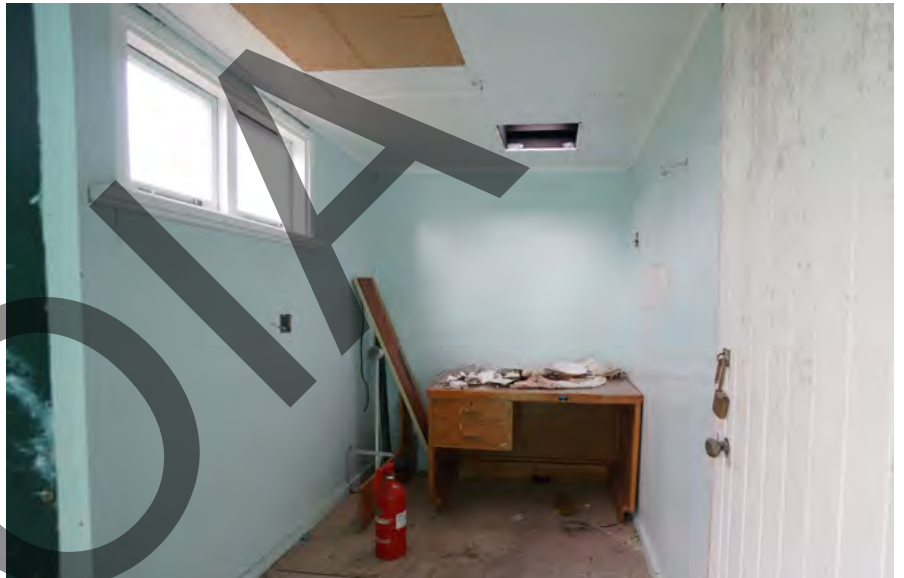
Figure A12  
ABOVE RIGHT - The smaller room, with  
the leaking window to the left. The skylight  
is above the desk.

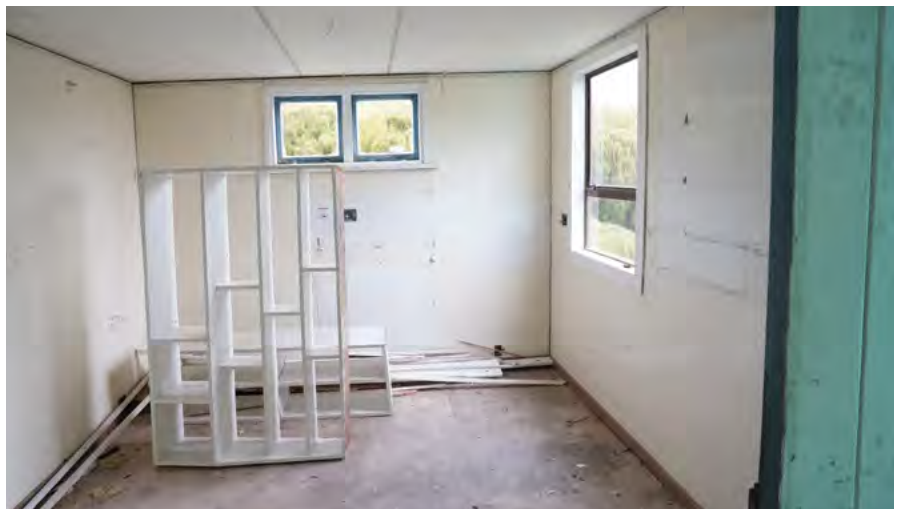
Historic significance      Average significance.  
Foundation condition      Regular mowing would assist with interpretation

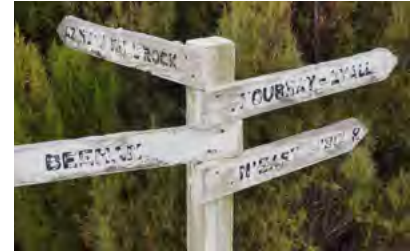
Figure B1  
AZIMUTH HILL ROCK  
MOUBRAY - LYALL  
BEEMAN  
N'EAST H'BOUR

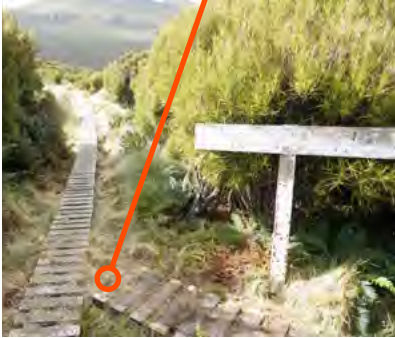
Historic significance  
Foundation condition

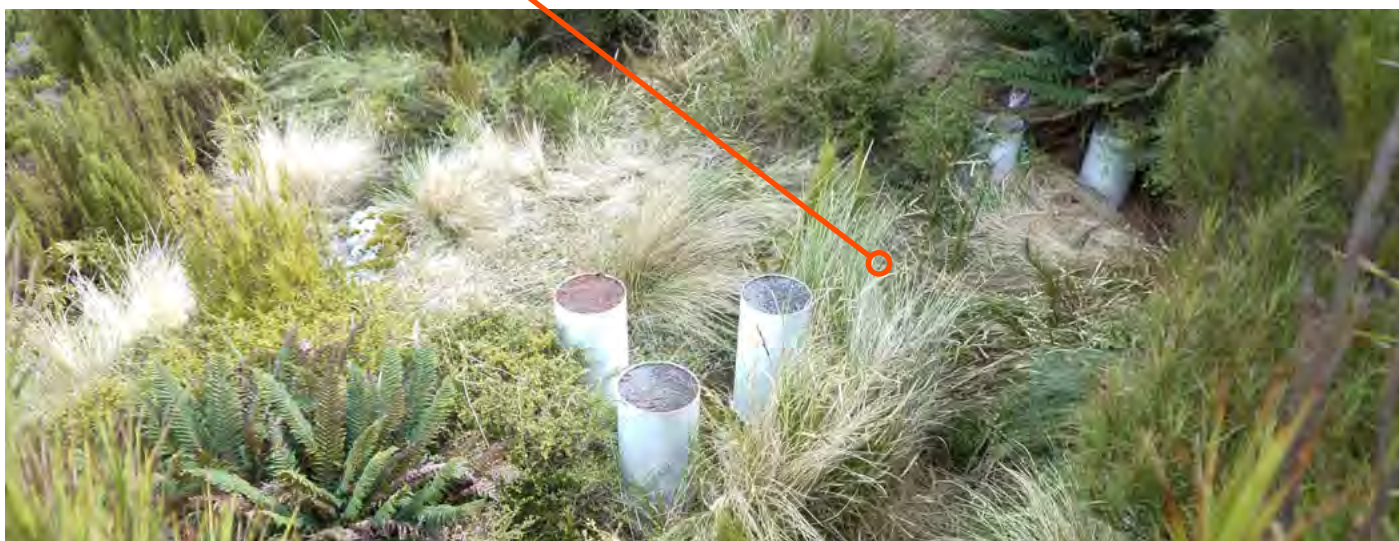
# geomagnetic observ.

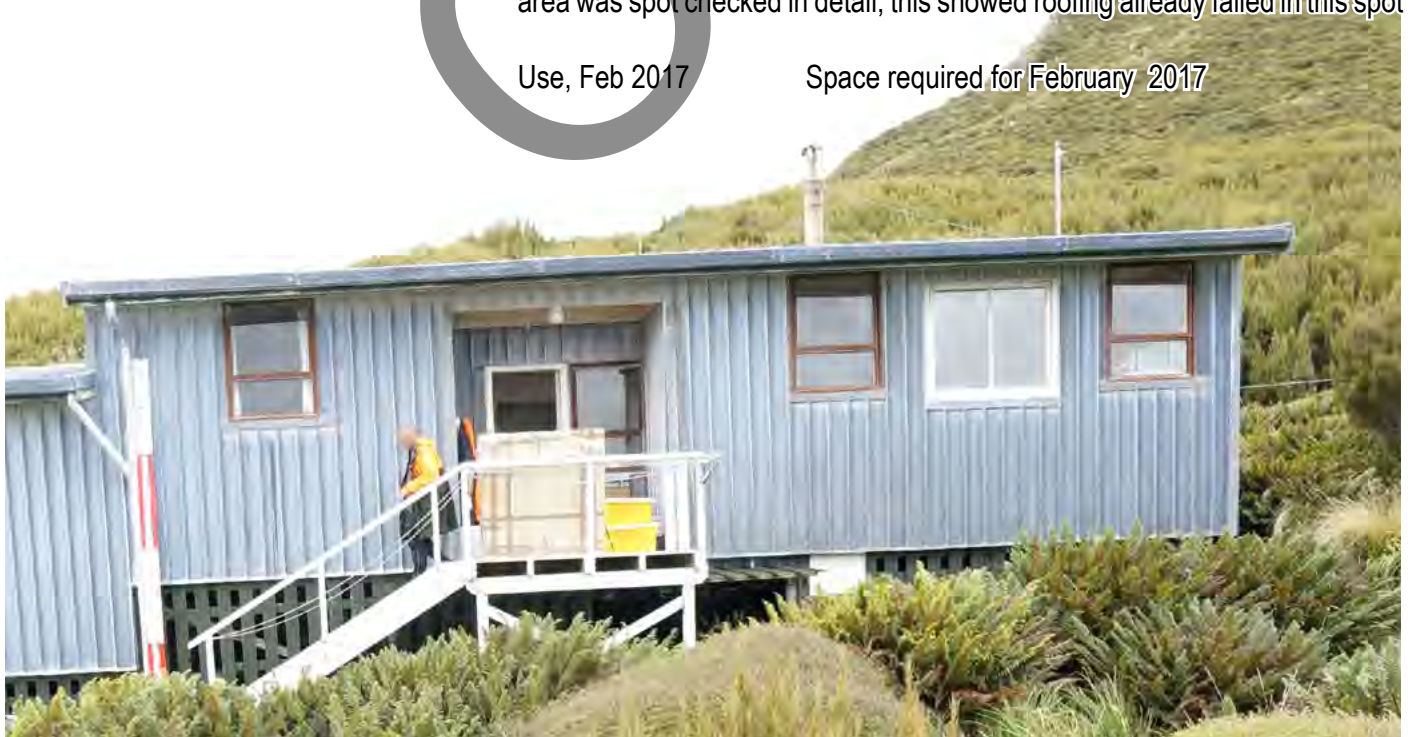
Figure E1  
Hostel, DoC end. The original alum windows are brown, and the assumption is that the recently added timber windows, (which are leaking) are white

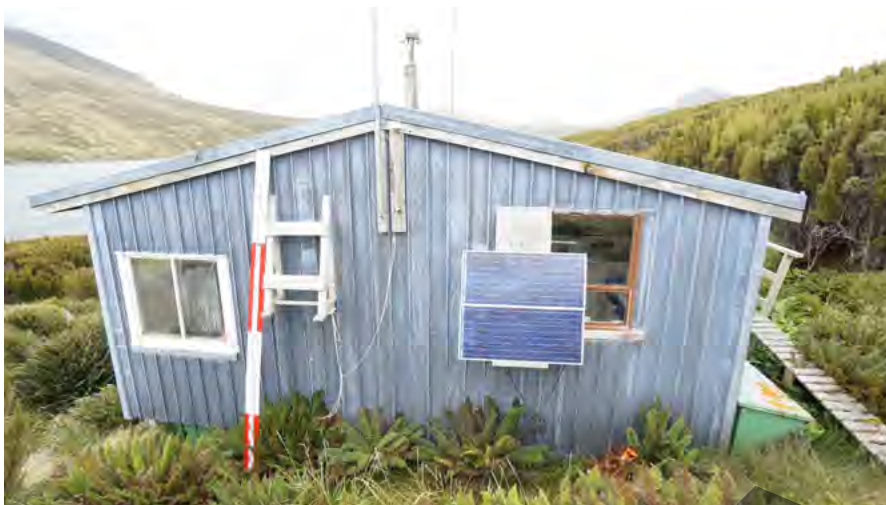
Figure E2  
LEFT TOP. Hostel, DoC end. The recently added timber window which is leaking is white

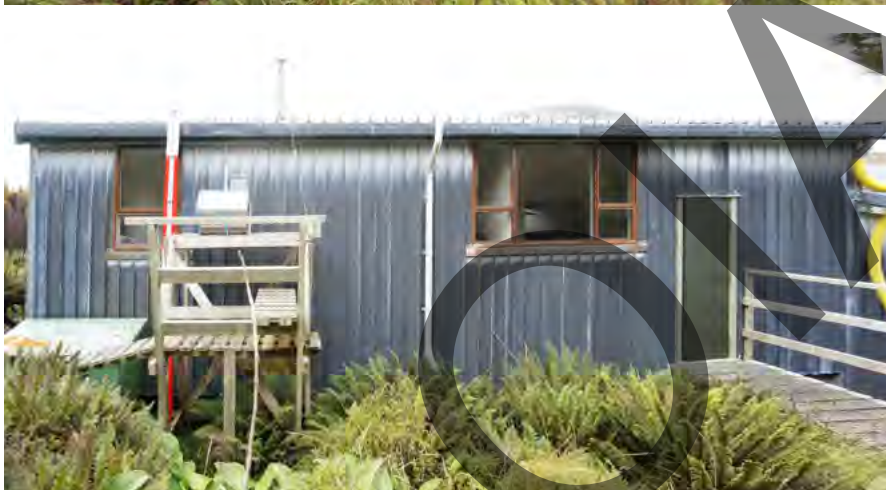
Figure E3  
LEFT MID. Diesel fire equipment on the left.

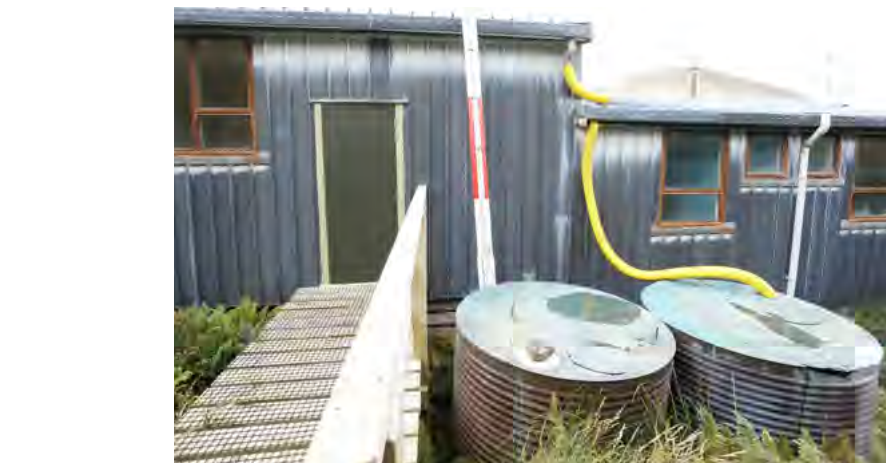
Figure E4  
LEFT BELOW. Water tanks and feed.

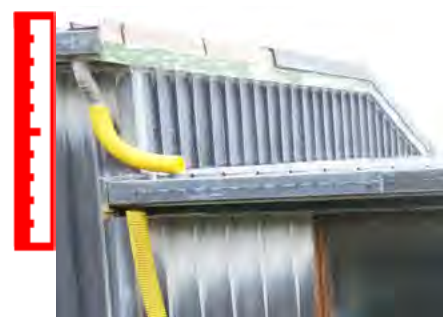
# dept. conserv. hut

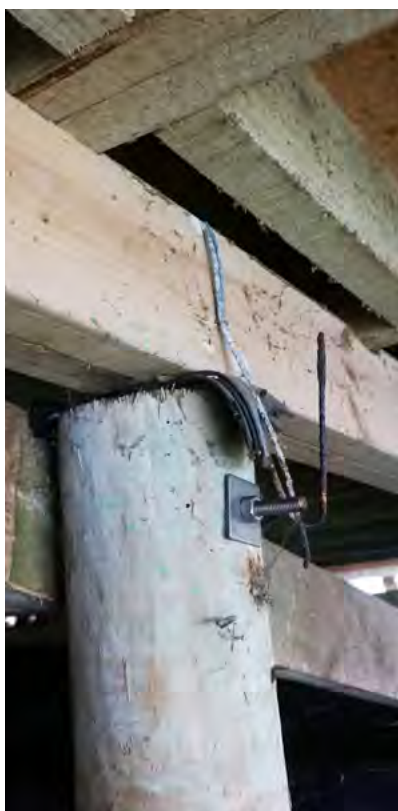
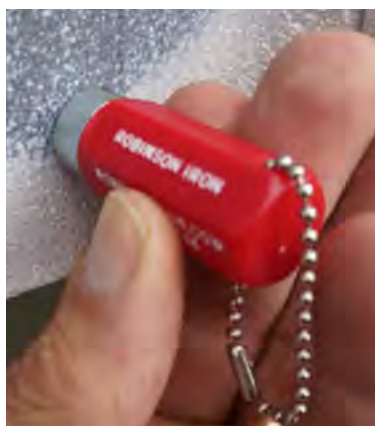
Figure E7  
LEFT TOP. Foundations of all Hostel Huts, showing requirement for earthquake strengthening in red, where a stub stud is required.

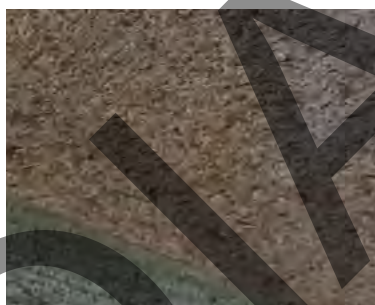
Figure E9  
LEFT. Condition of underside of particle board flooring

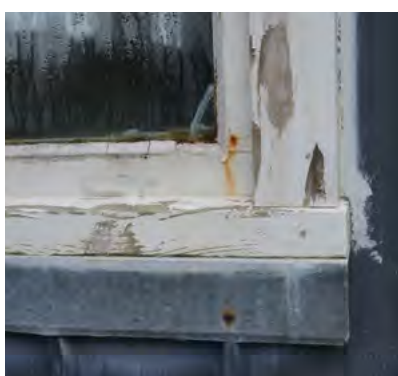
Figure E10  
LEFT BELOW. Timber window, sill, where leaks will be testing the durability of the framing .

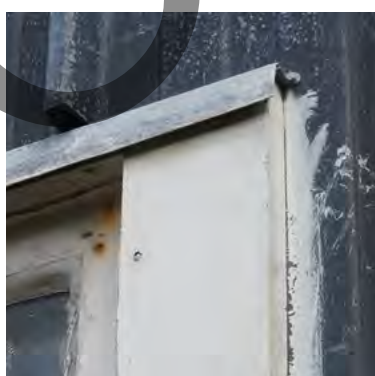
Figure E11  
LEFT BELOW. Same window showing the window head

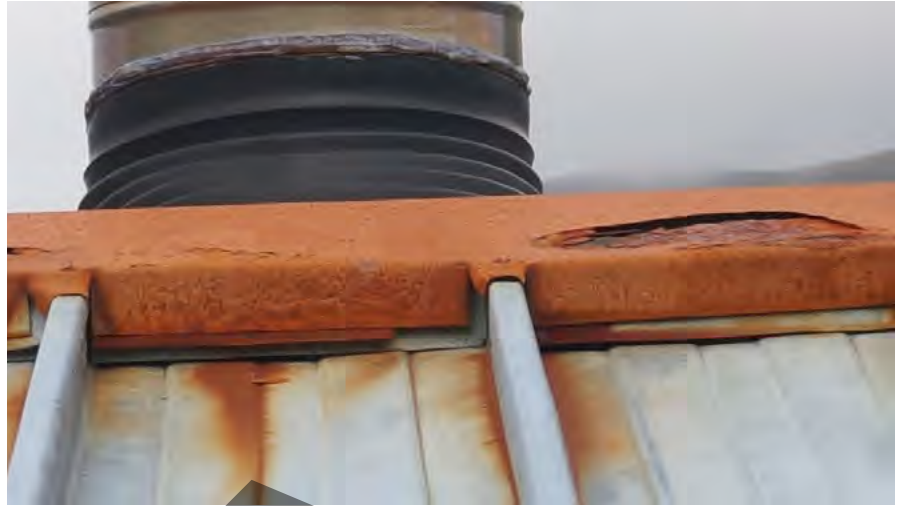
Figure E13  
RIGHT BELOW. Condition of cladding, where the white areas are white rust, or Zinc oxidation. This is the start of a process that leads to cladding perforation

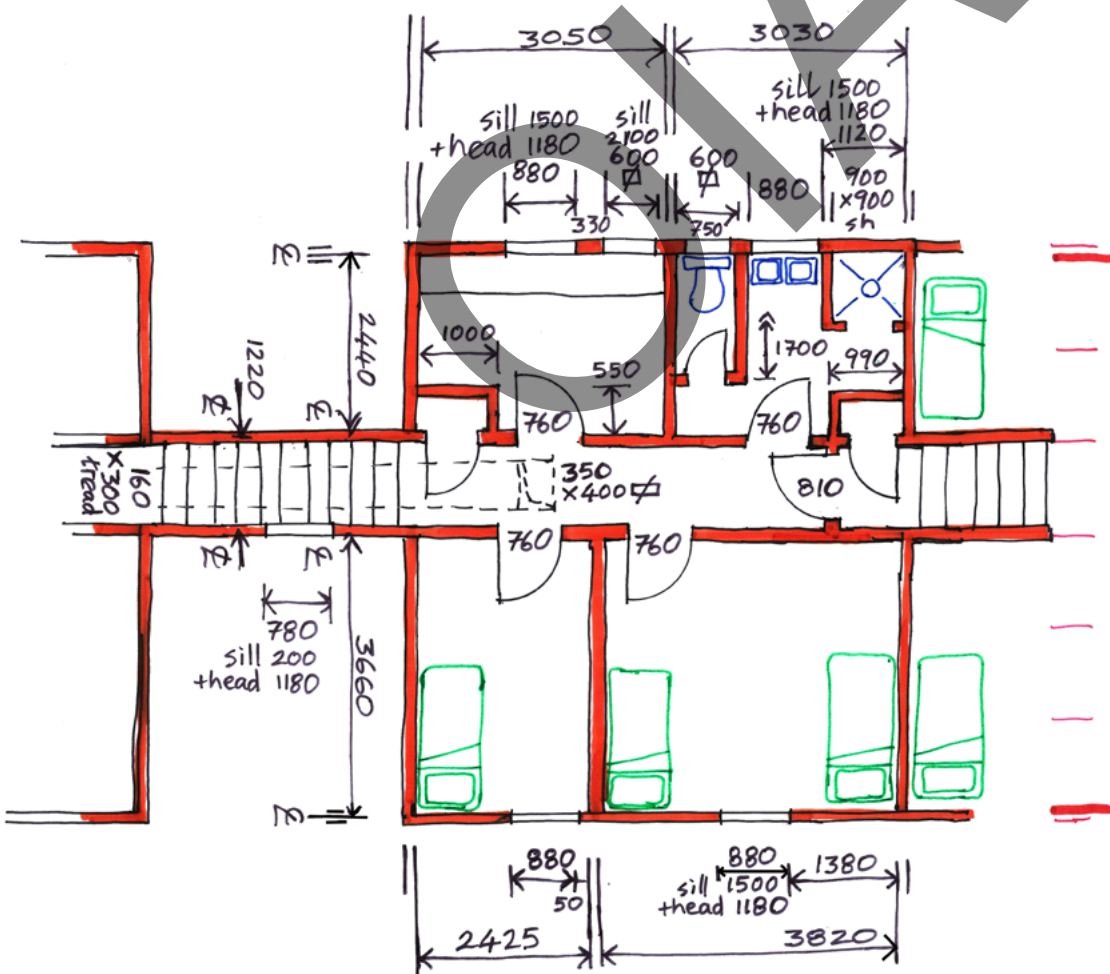
Figure F2  
BELOW. Floor Plan, with items drawn in green being removable furniture.

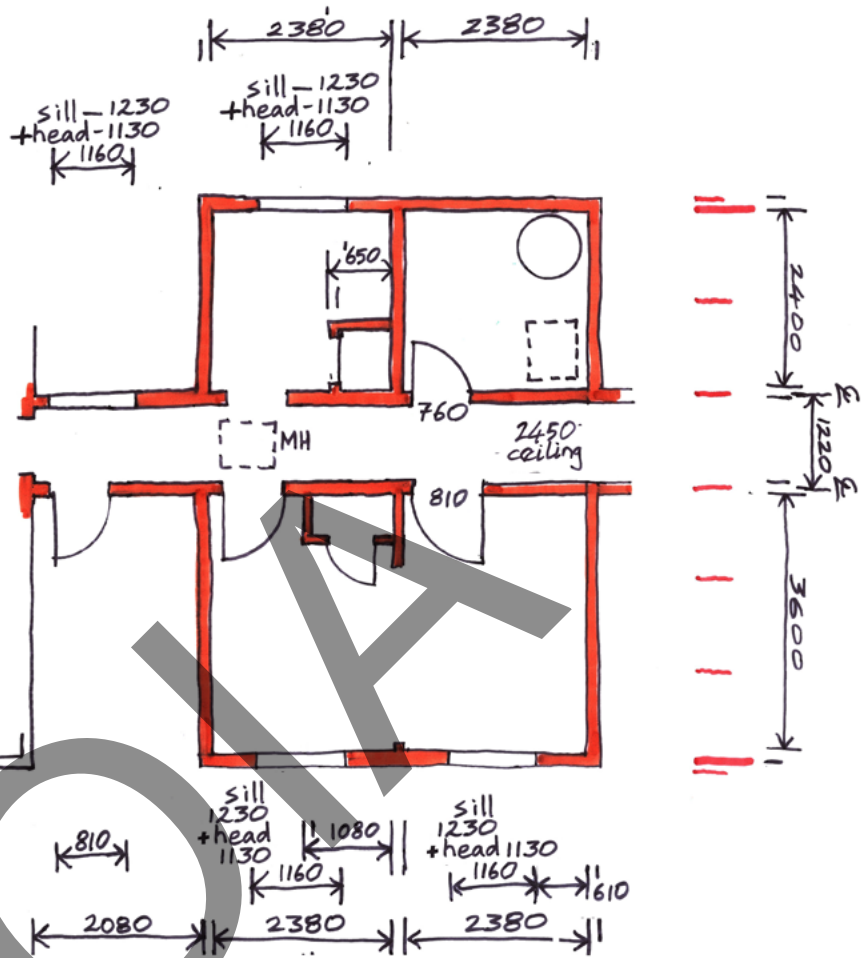
Figure G3  
RIGHT -Hostel sleeping annex plan.

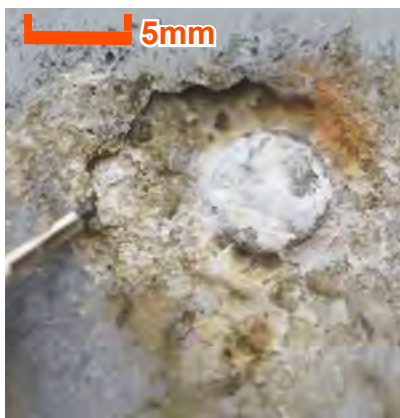
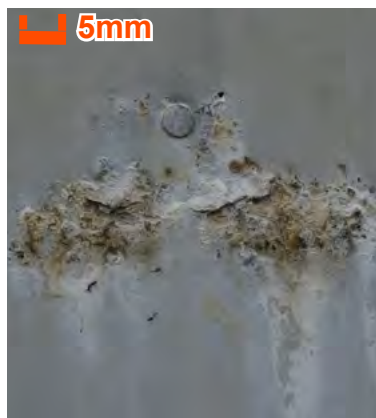
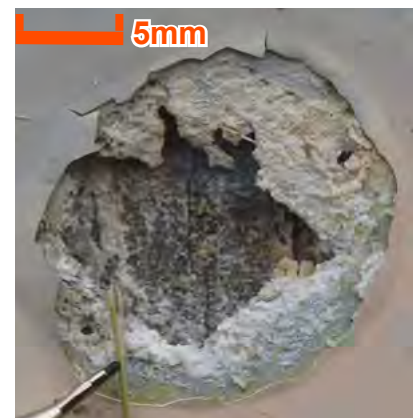
Historic significance      High historically significant.  
Construction                Techniques historically significant and unique.

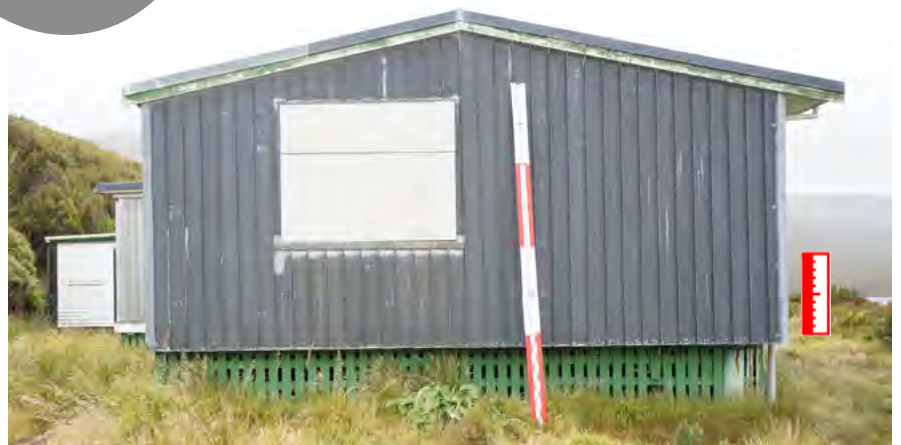
Figure H3  
 ABOVE The recent zinc clad addition at the south end of the Hostel. The copper treated shutter installed over the window shown in this photo is corroding the zinc.

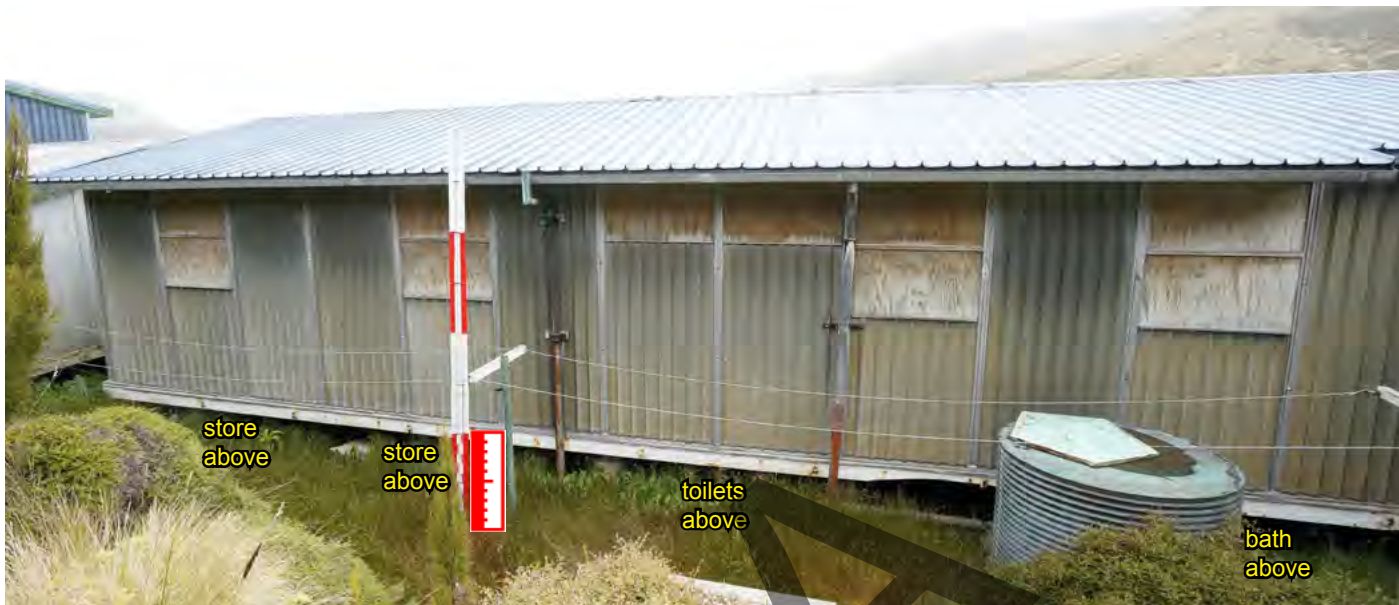
Figure H4  
ABOVE The west elevation of the Hostel,  
the north end.

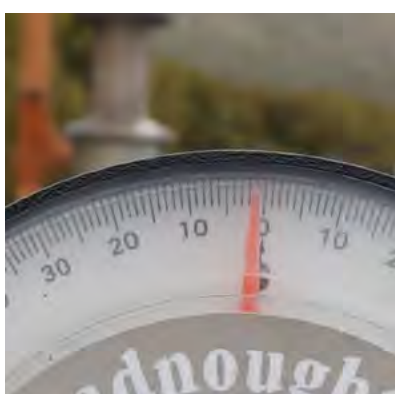
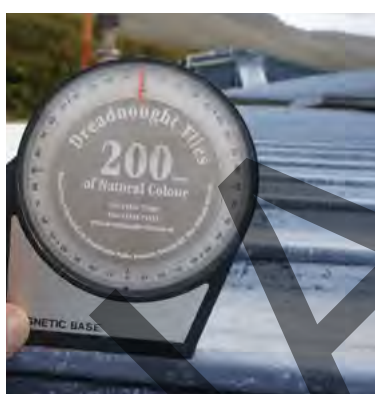
*Figure H13 & H14  
LEFT The roof above the kitchen and laundry has a negative slope, and relies on wind and evaporation to clear water. From the original plans, the elevation drawings could indicate that the roof was originally clad with a membrane, as the barge boards are horizontal. This membrane roof cladding is not noted. The recent zinc roof cladding will suffice in the short term but does not meet any building standard or manufacturer's recommendations.*

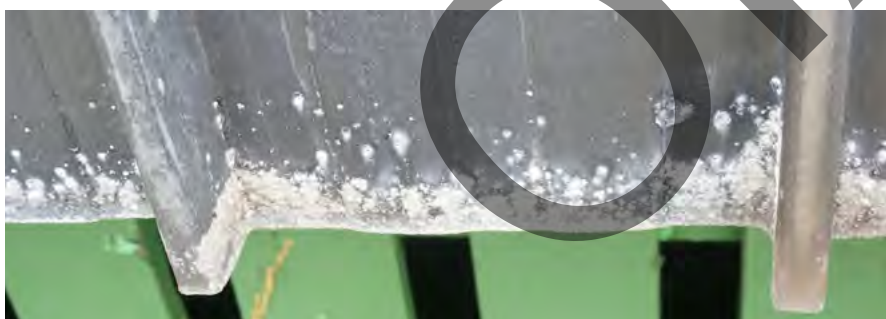
*Figure H15  
LEFT The zinc on the extension has started to corrode, white rust, or oxidation, is prevalent at the base of the recent zinc clad Hostel extension.*

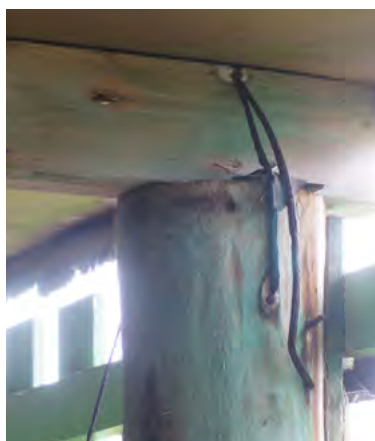
*Figure H16  
LEFT Loose number 8 wire connections, between the floor bearers and piles, were shown to provide little resistance to damage in an earthquake.*

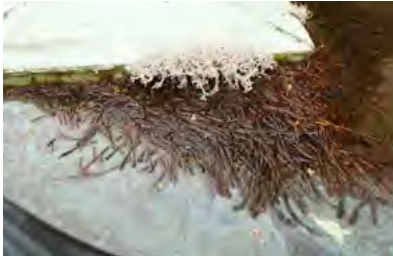
Figure J1  
 ABOVE Growth in and extending out of a water tank.

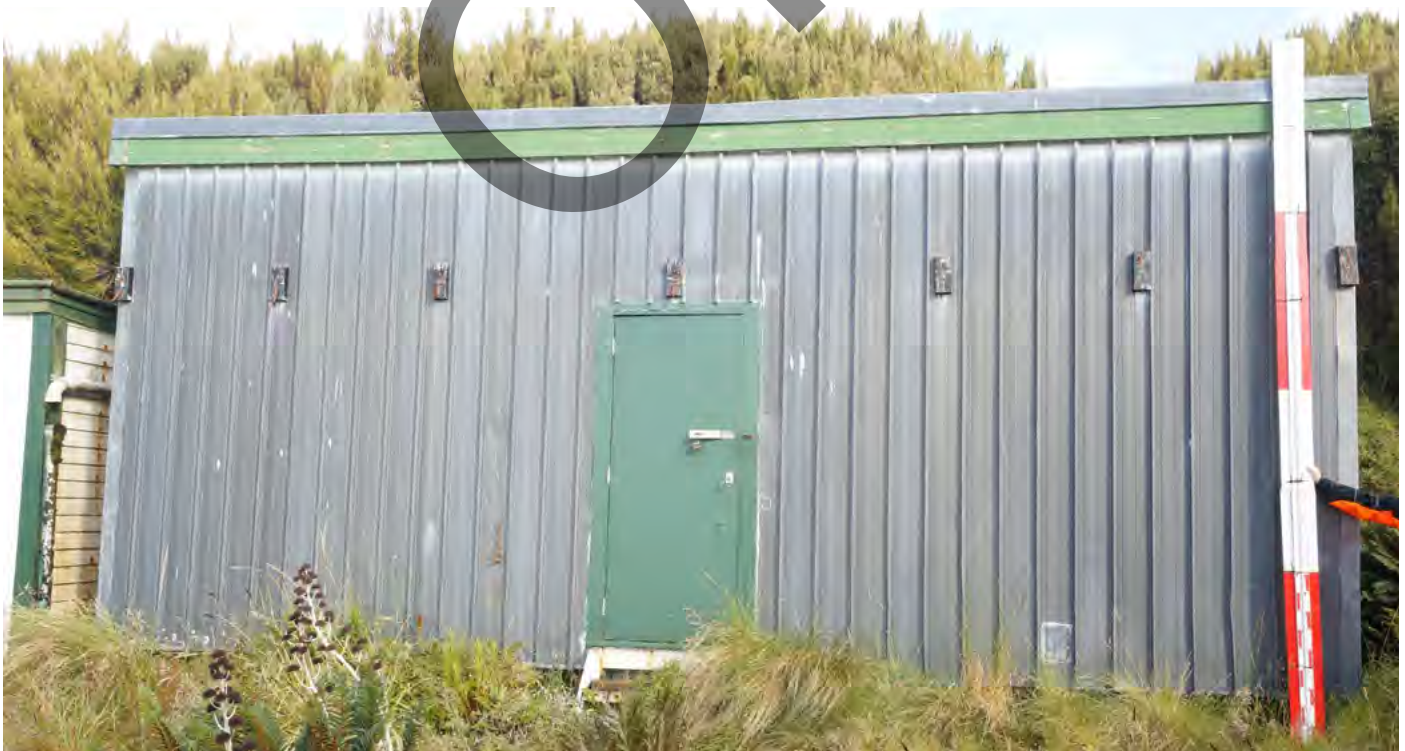
Figure J1  
BELOW The east elevation of the Cool Store.

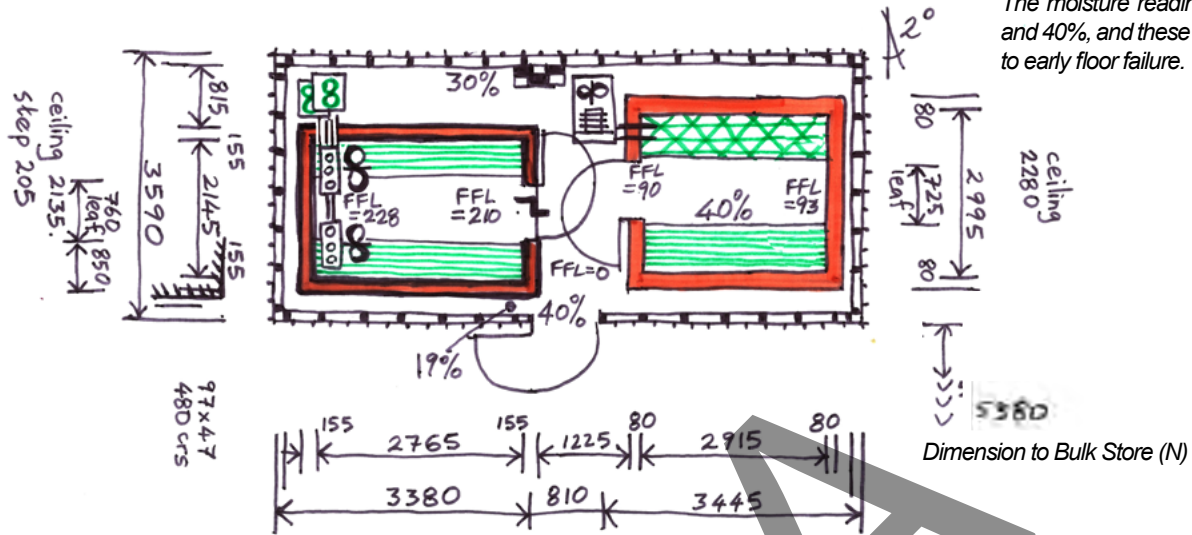
Figure J2  
The dimensioned plan of the cool store. The moisture readings are high, at 30% and 40%, and these percentages will lead to early floor failure.

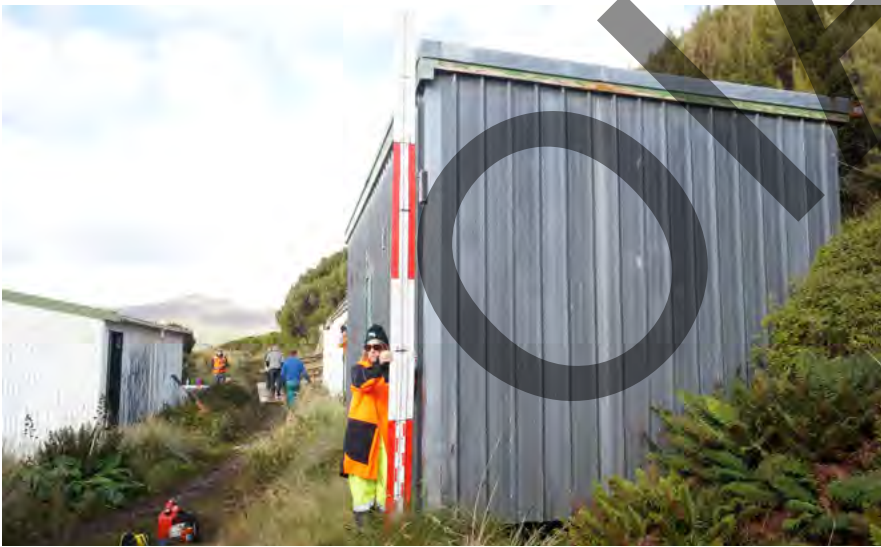
Figure J3  
The north elevation of the Cool Store. Compare the condition of the Marsden matting as Michael Kelly, in his historic report, August 2017, took a photo from a similar angle.

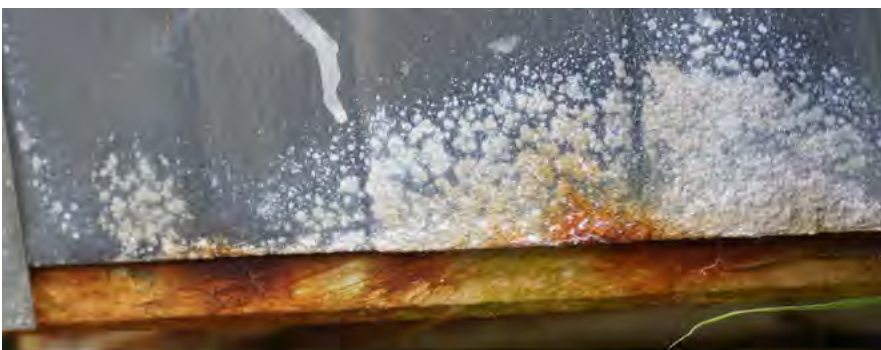
Figure J4  
The bottom edge of the cladding of the Cool Store. The bottom plate is visible. Water runs down the cladding, and then over the bottom plate, where the timber will absorb this moisture. This is transferred to the floor where high moisture levels are recorded. This will lead to early floor failure.

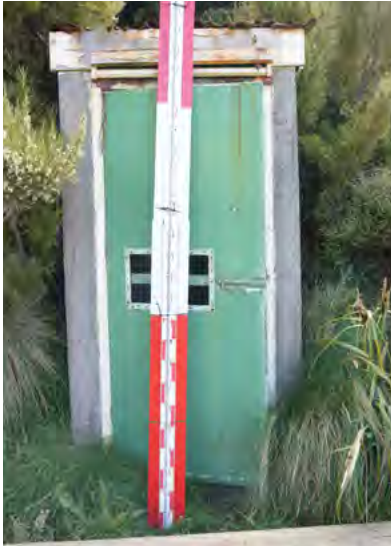
Figure L1  
 ABOVE The Meat hanging and butchery hanging room. The roof and walls are in very poor condition.

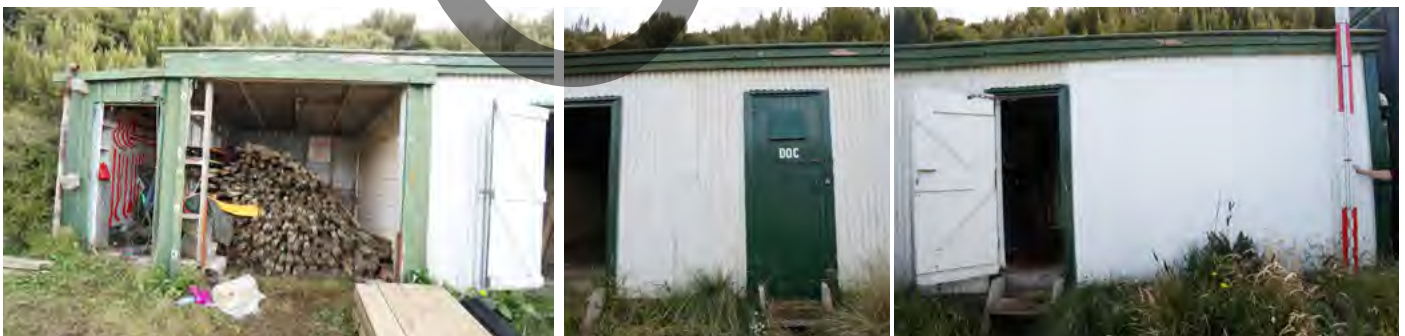
Historic significance  
 Construction

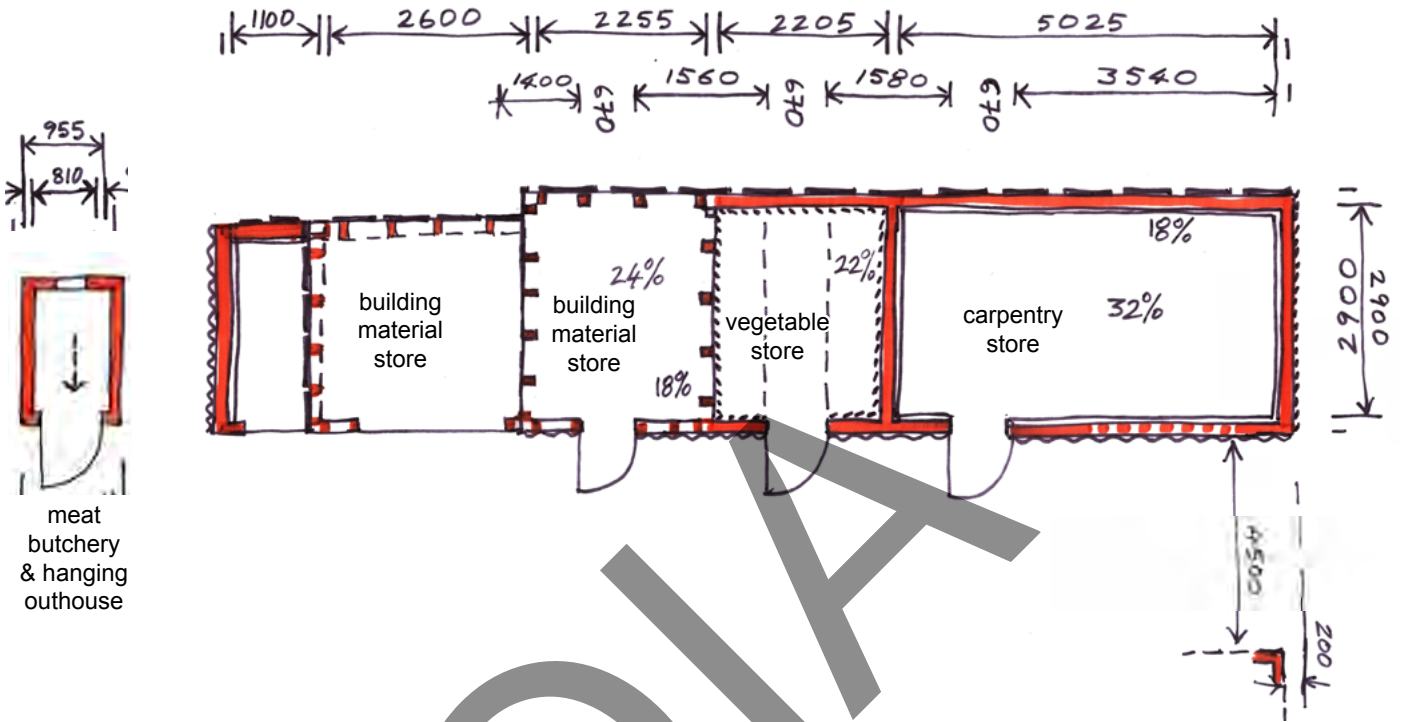
Figure L5  
 ABOVE The Meat hanging or butchery room is on the far left. The plan indicates the wall materials, with a long dash being a possible asbestos based material, the wavy line is vertical corrugated steel, and the short dots are plywood. A dashed red line indicates a possible window. The percentages indicate moisture content; any figure that is over 20%; will lead to decay. The rate of this decay depends on the durability of the timber

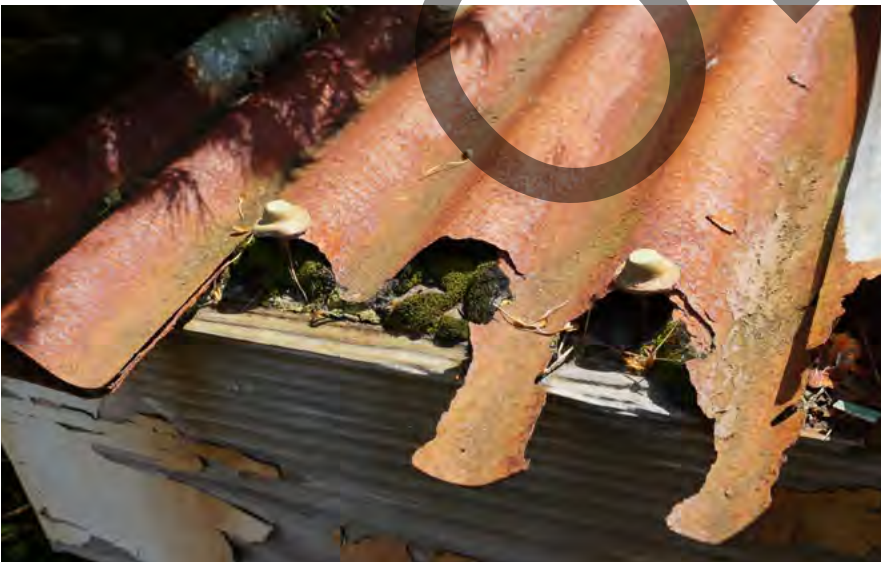
# carpentry, vegetable & meat store

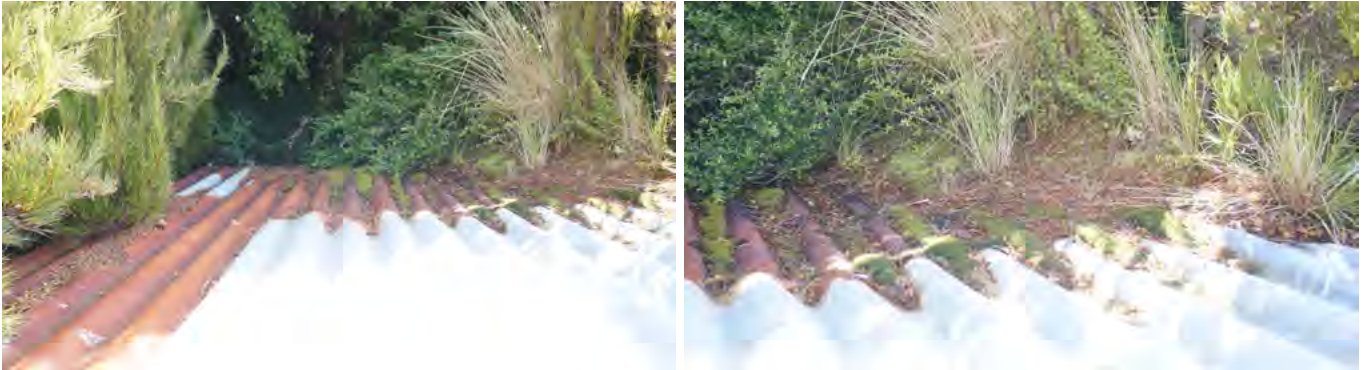
Figure L7 ; L8 ;  
ABOVE. Simple house keeping measures, which involves the removal of moss and forest litter from the roof, would allow the roofing to dry and would remarkably extend the durability of the roofing.

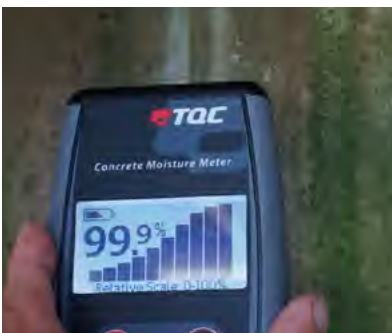
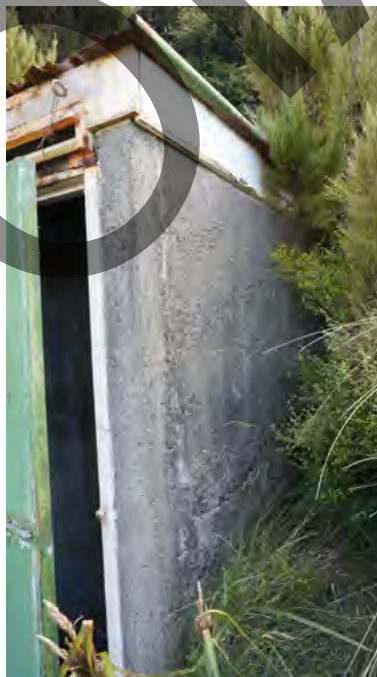
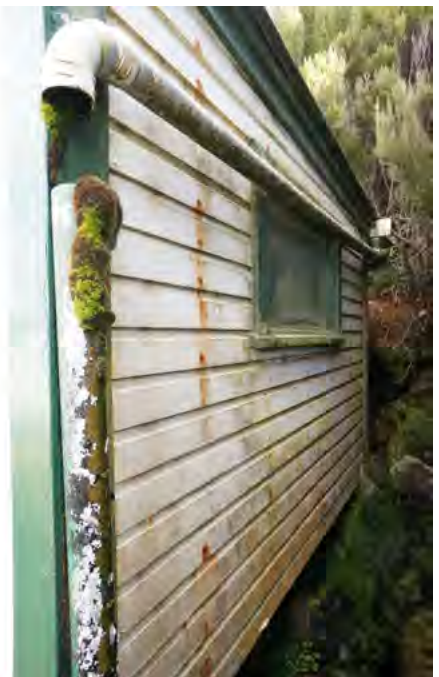
# carpentry, meat & vegetable store

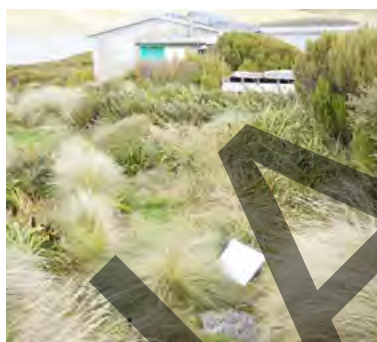
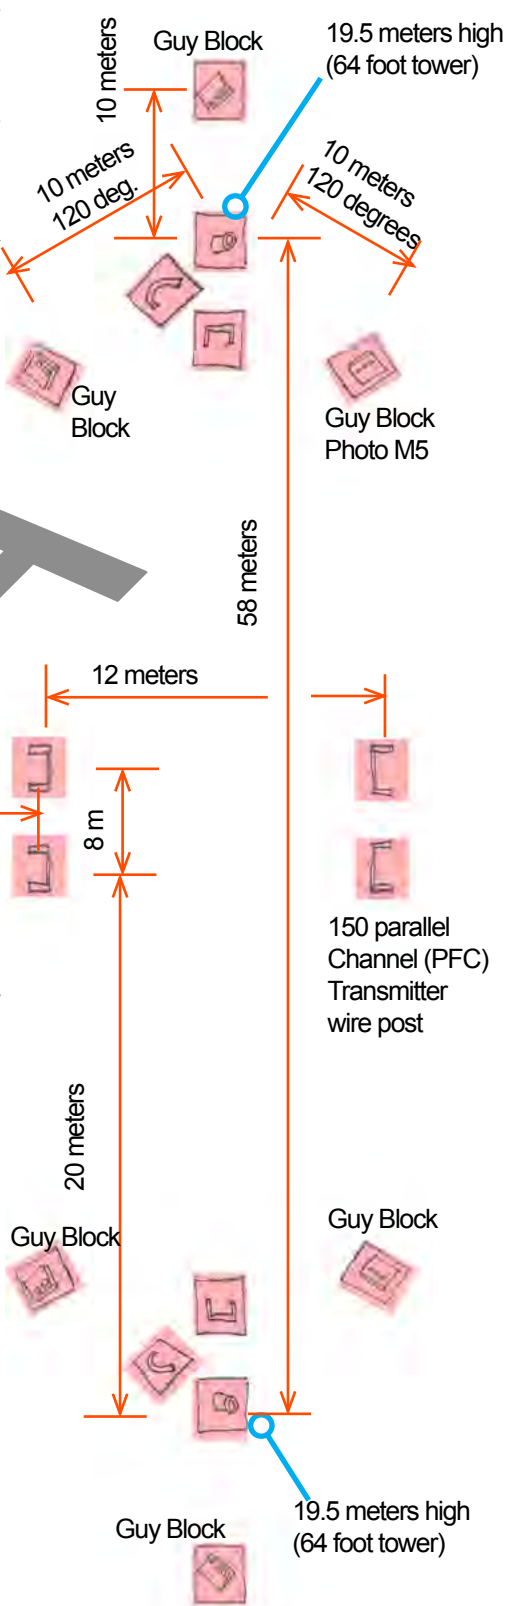
VERY APPROXIMATELY  
30 meters to next mast, for comms  
to NZ

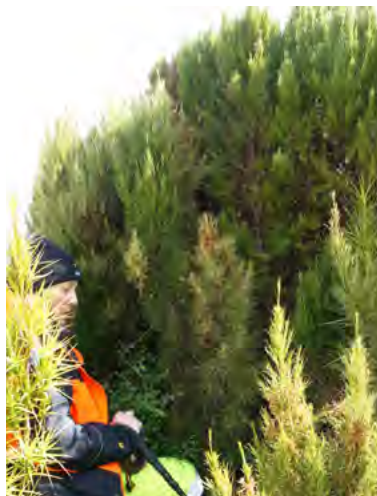
Figure M6  
BELOW. Height of bush in area of second mast

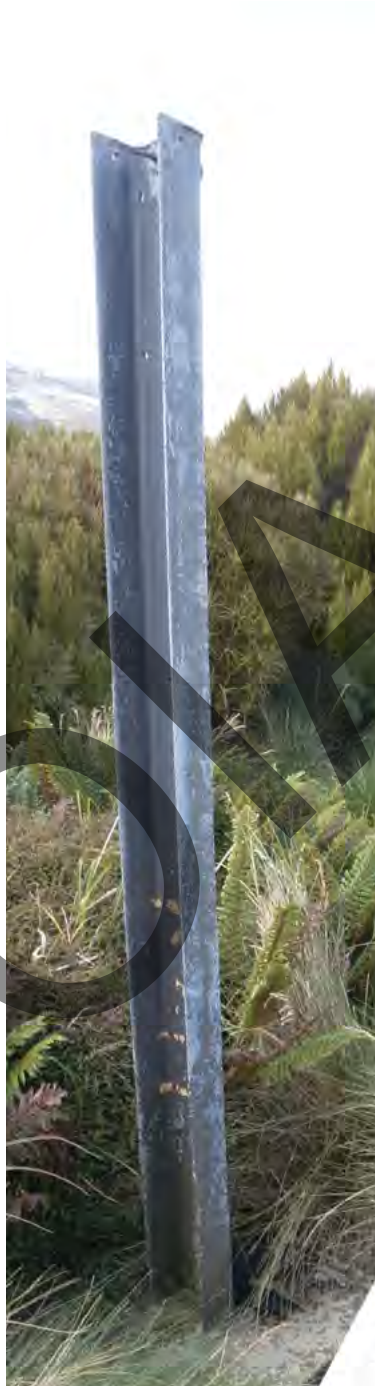
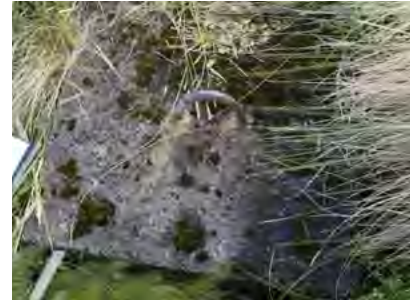
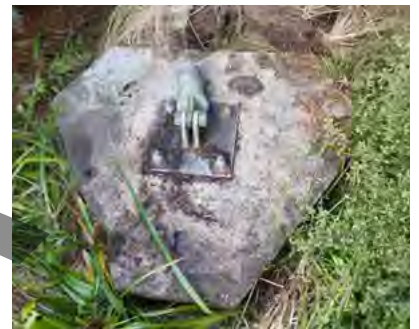
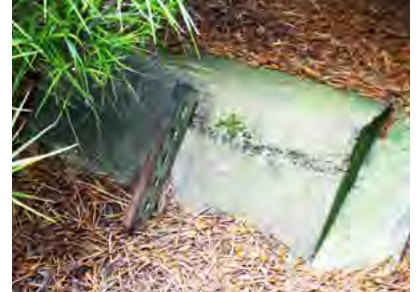
Figure M10  
FAR BOTTOM RIGHT Guy rod block, at  
120 degree intervals.

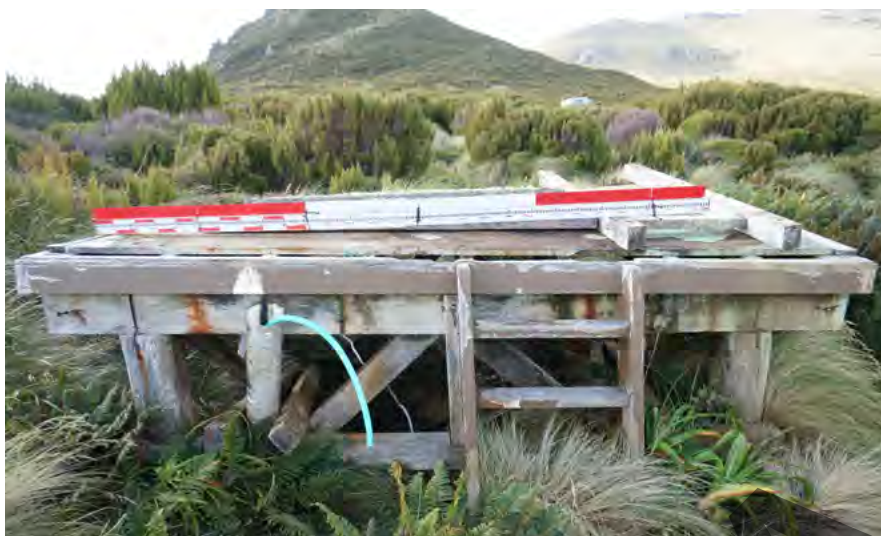
Figure M11  
LEFT. All sky camera building, the walls have been demolished and the foundations only remain. The area for the first aerial to NZ is in the background.

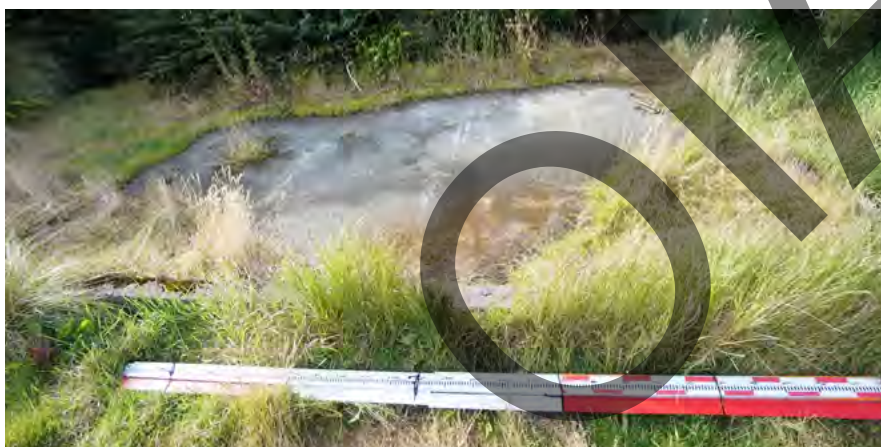
Figure M8  
BELOW. The chook shed slab remains. This is below the south east corner of the Technical Building.

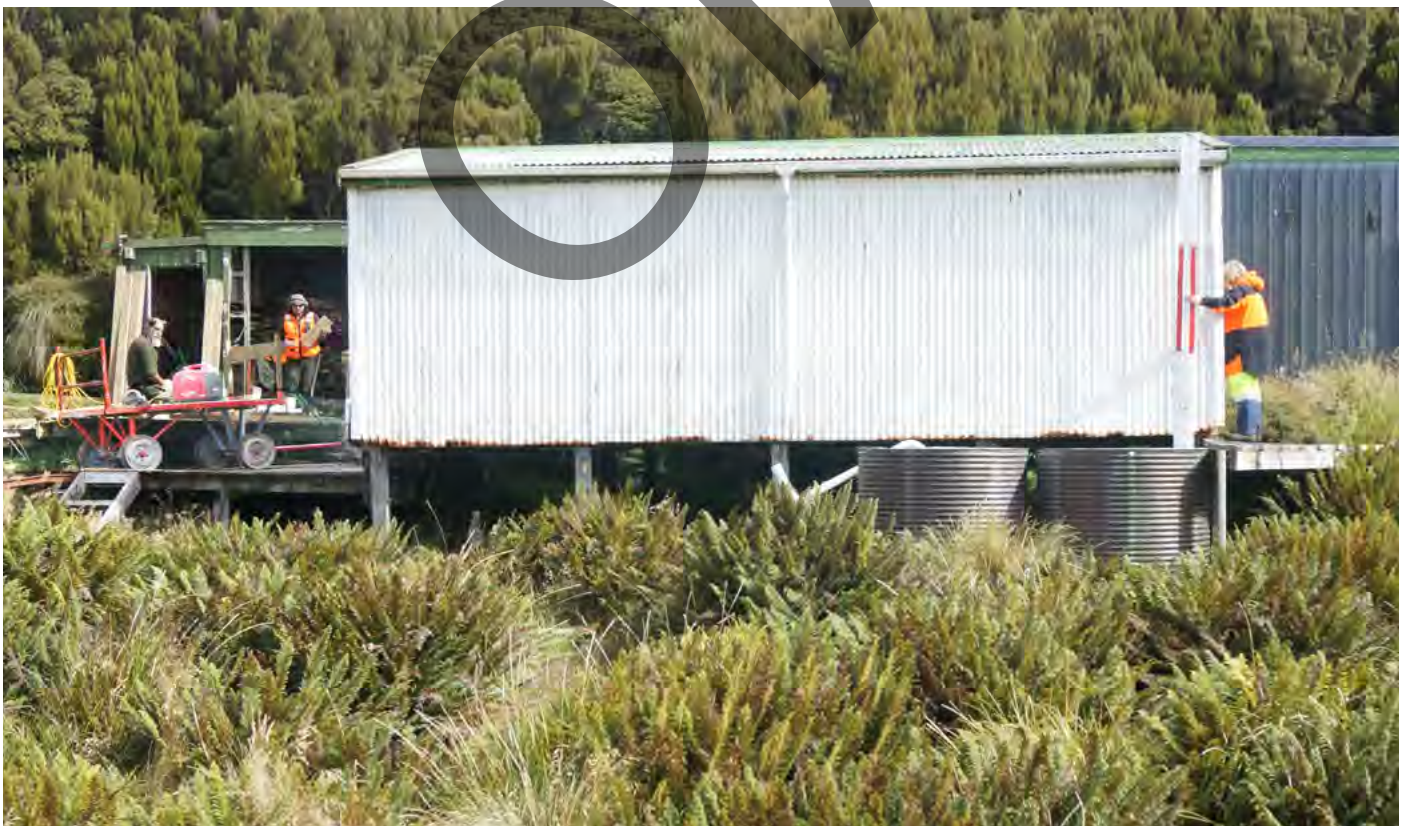
BELOW East elevation, showing cantilevered piles, and little diagonal bracing. The winch to the jetty is on the left. This elevation has the original cladding, however rust stains and perforations exist at the base.

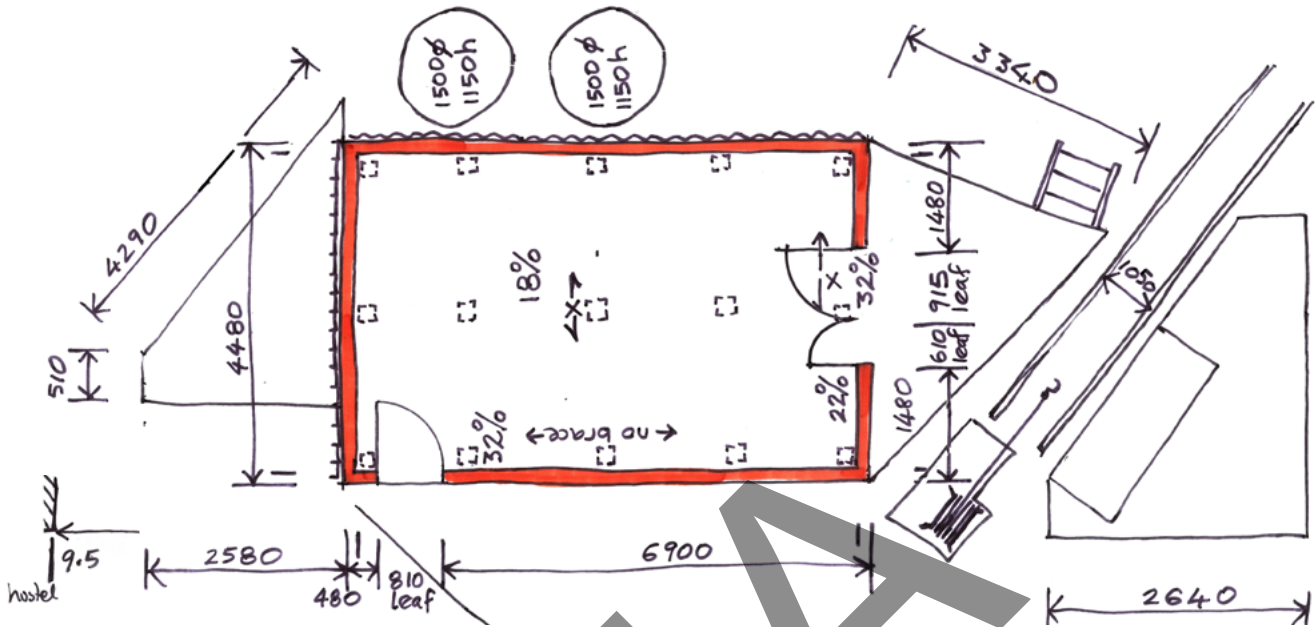
Figure N2  
ABOVE Plan, with winch to the jetty on the left.
