**CAMPBELL ISLAND**  
**meteorological station**  
BUILDINGS, CONDITION & PLANS

MEASURED FEBRUARY 2017

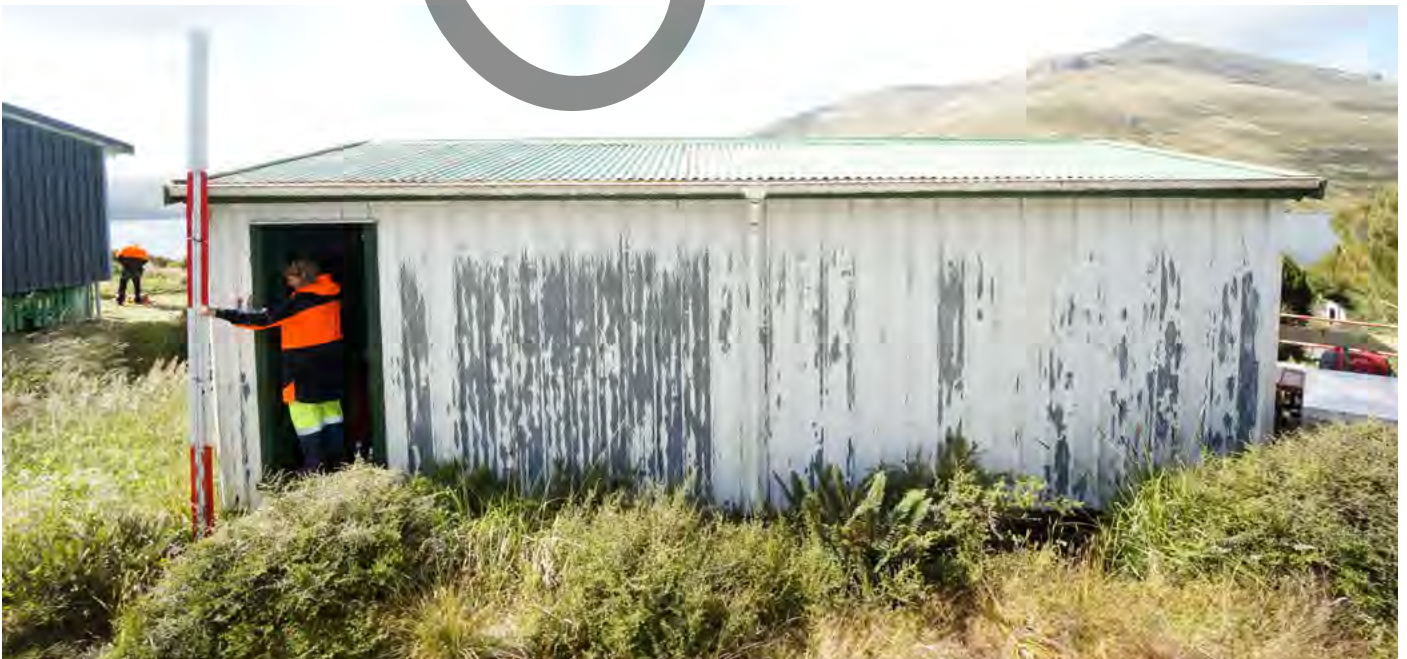
Figure N3  
BELOW Elevation to the west, from the main walkway. The cladding to this elevation has been replaced,

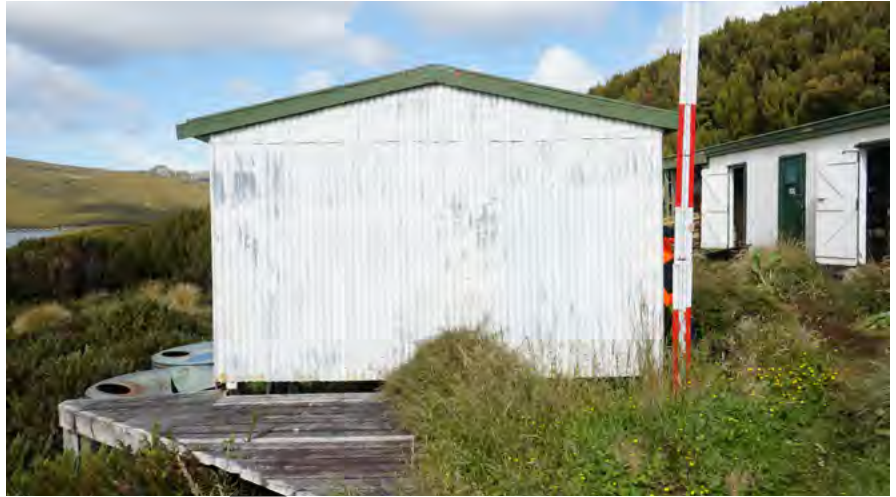
Figure N5  
LEFT Elevation to the south. The cladding to this elevation has been replaced.

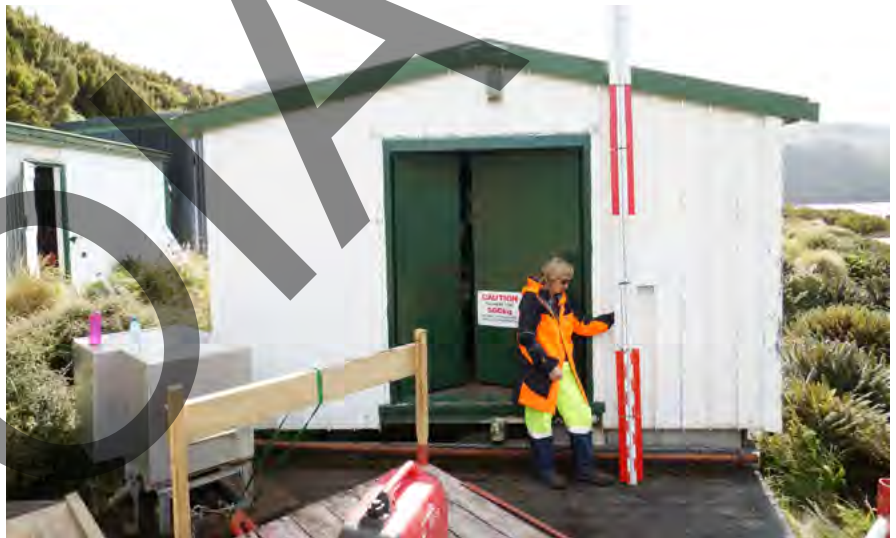
Figure N6  
BOTTOM LEFT Roof condition showing perforation.

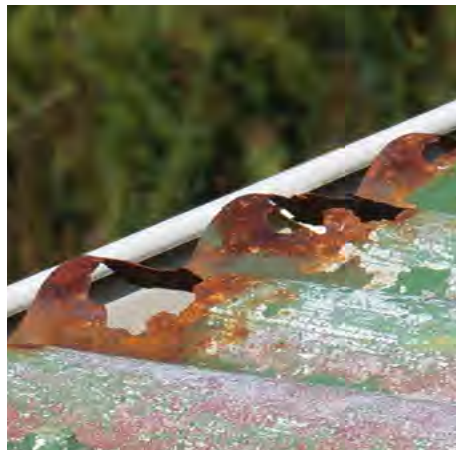
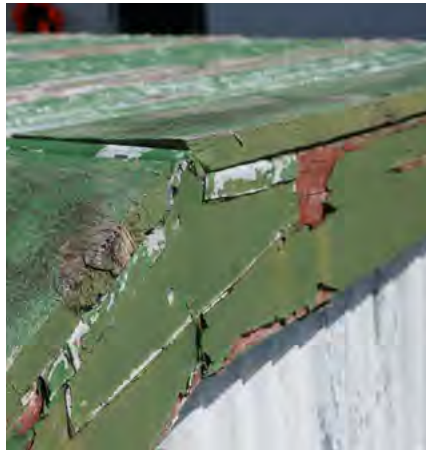
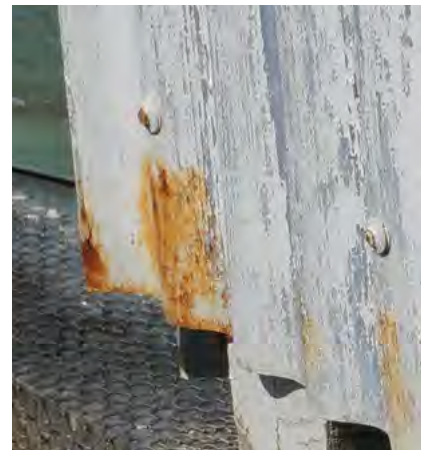
Figure N8  
BOTTOM RIGHT Rust starting in areas of the original cladding not replaced.

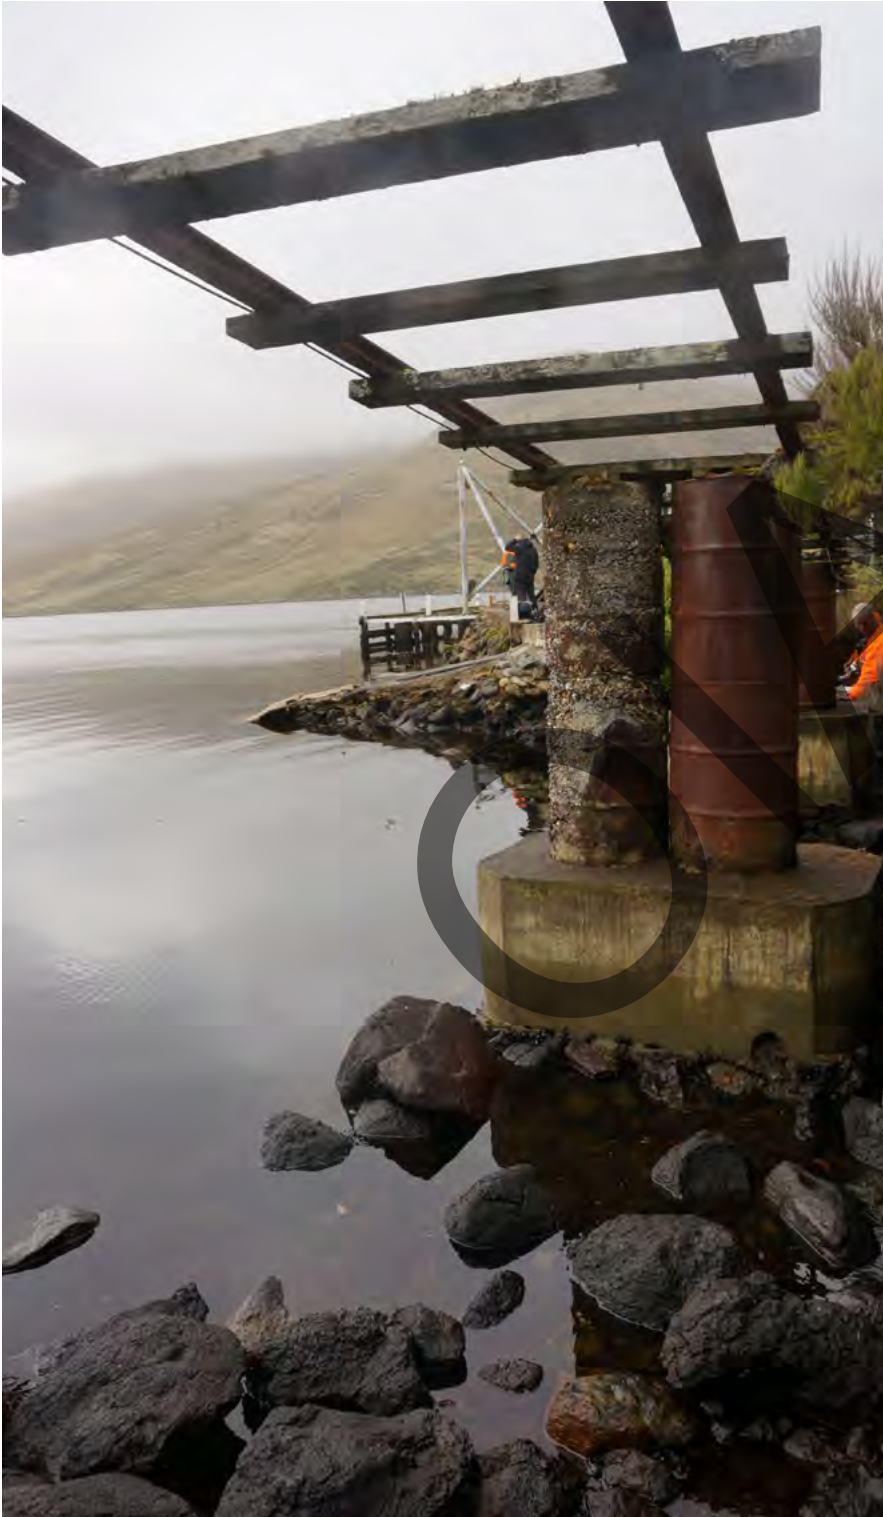
Figure 01  
LEFT Photo of the trolley track from  
below.

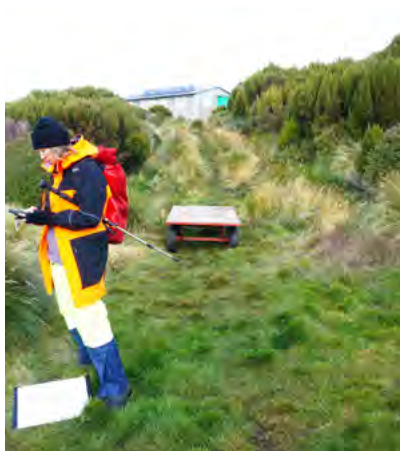
Figure N4  
ABOVE Typical path condition

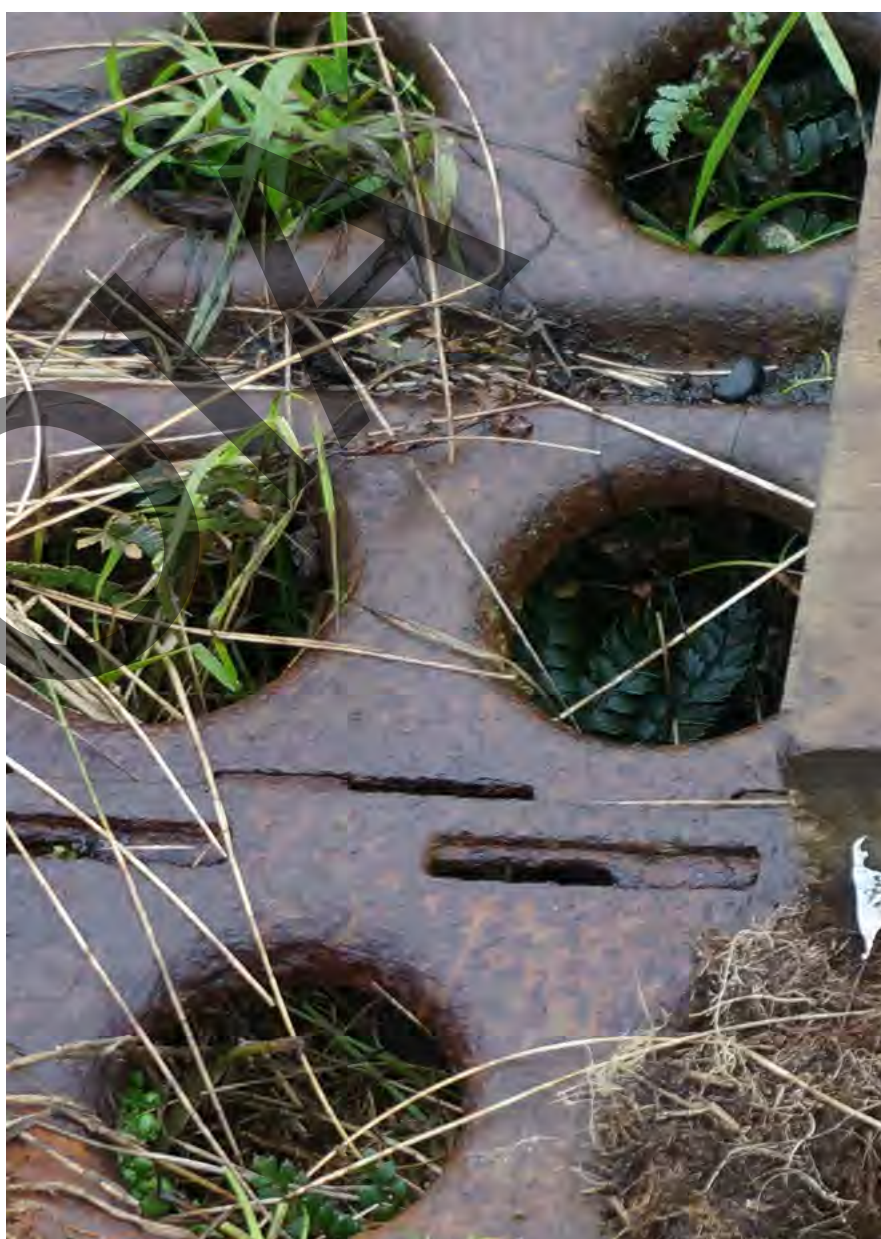
Figure N5  
LEFT Detail of Marsden matting, one of the few areas where the matting is exposed. There has been a complete change in undergrowth around the matting, refer Michael Kelly's report.

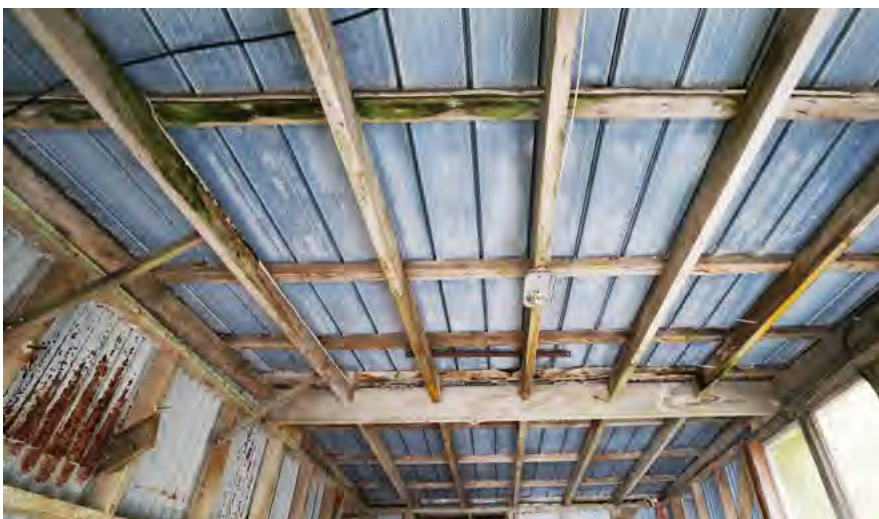
Figure Q2  
ABOVE Plan of Jetty Boat Shed, with the approximate mean high water springs shown in blue. Any timber readings of 40% indicate complete water saturation of the timber, and decay is inevitable, depending on the durability of the timber purlins.

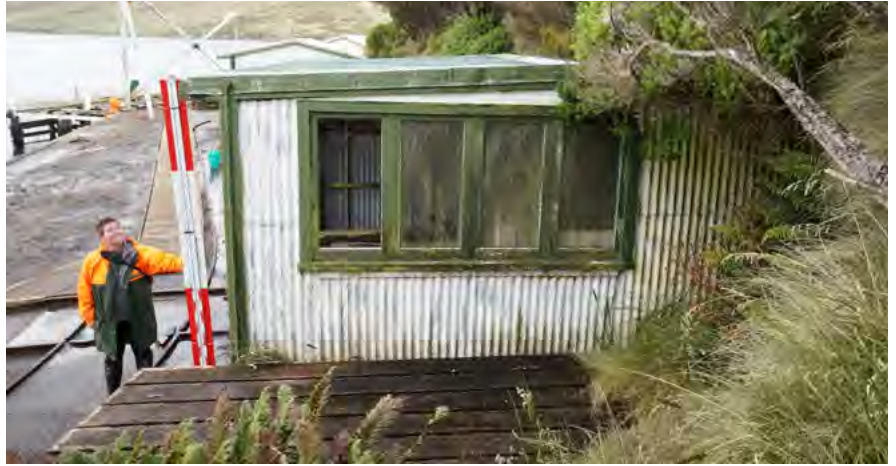
**RIGHT TOP** North Elevation, with DoC ranger operations Kathryn Pemberton holding the measuring staff. The far left pane of glass is missing, and the bank to the right has slipped and is resting against the right (west) wall. The wall still has the original corrugated cladding.

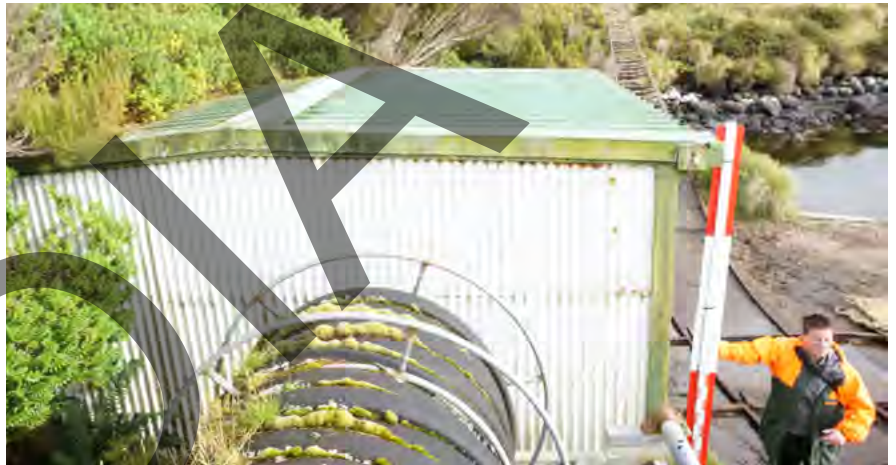
**RIGHT MIDDLE** South wall, showing original cladding, and more recently replaced roof. The west wall (left) where the bank has slipped now has vegetation growing from the slipped soil, and over the roof. Encouraging roof structural decay.

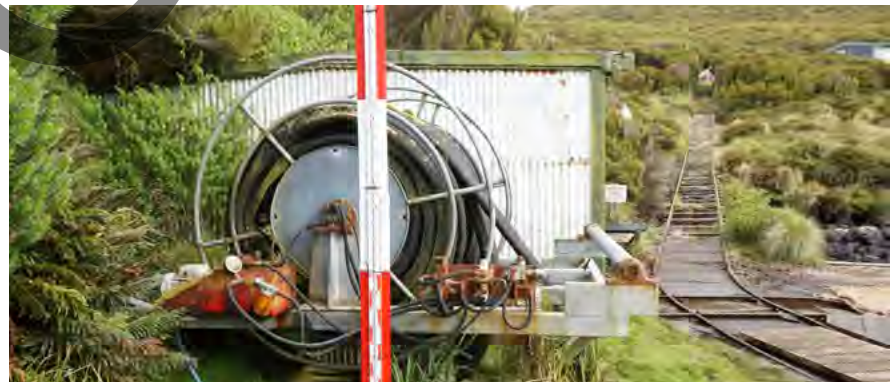
**RIGHT LOWER MIDDLE** South wall, with Diesel hose, for filling the land based tanks from tanker ships. The railway and winch is to the right, with a small corner of the Hostel visible to the far right.

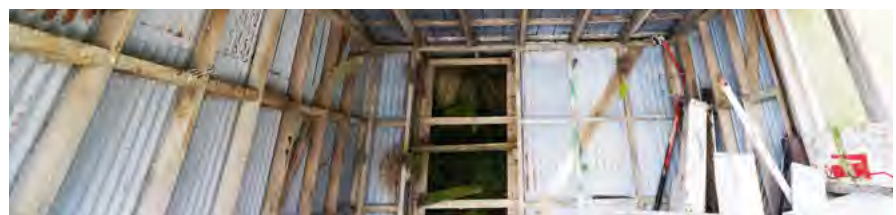
Historic significance  
Construction

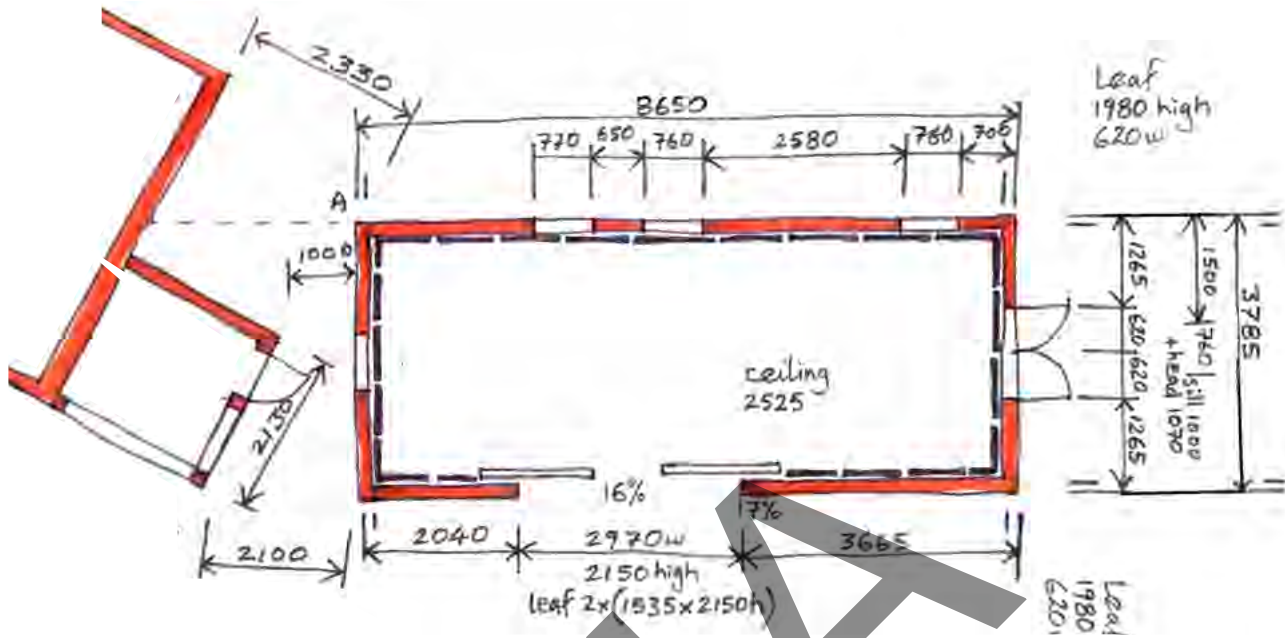
Figure R2  
TOP Floor Plan

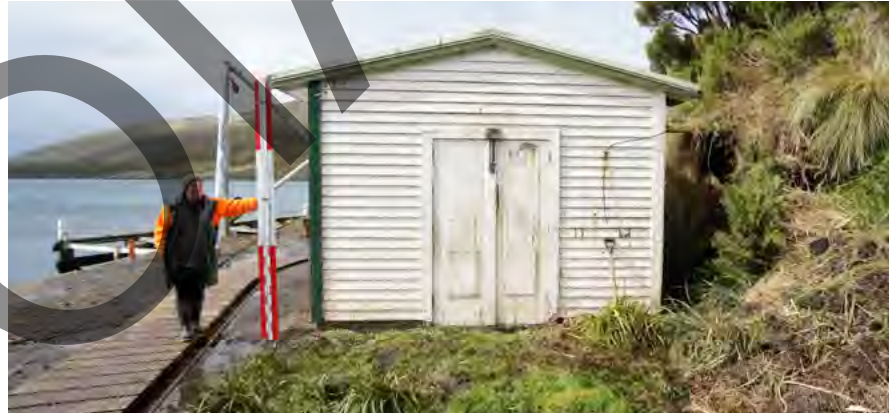
Figure R4  
RIGHT LOWER South wall, with interior  
cladding clad directly behind the windows.

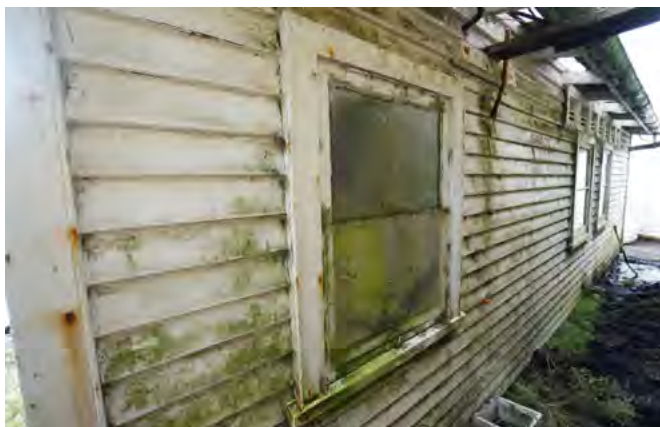
Figure R5  
LEFT TOP Wall closest to the bank, moss and mould will speed up decay and needs to be removed.

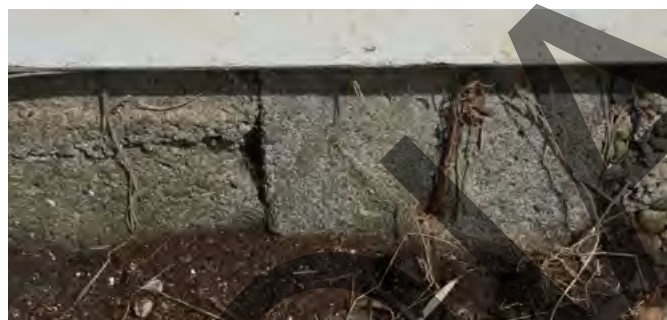
Figure R6  
LEFT MIDDLE Concrete foundations, with evidence of creepers entering the wall through the bottom plate.

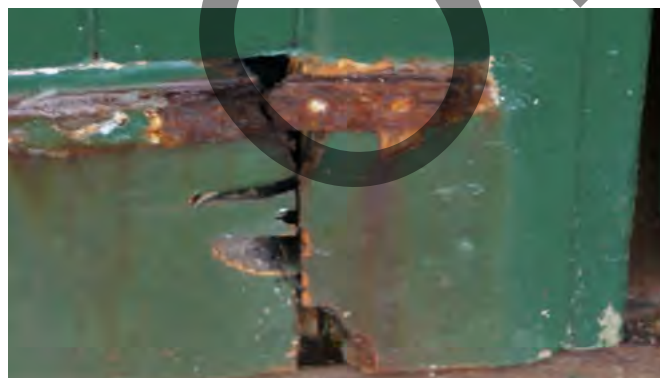
Figure R7  
LEFT LOWER MIDDLE The corner of the doors, where the door style meets the bottom rail. This, as well as other style / bottom rails, are rotten.

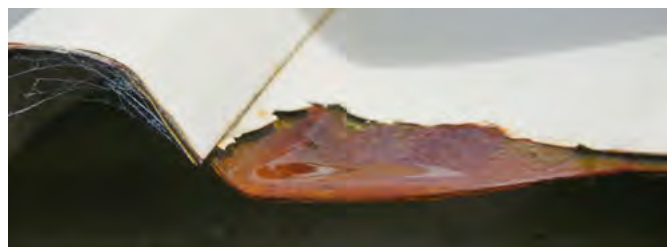
Figure R8  
LEFT LOWEST Roof where edge has lost the protective coating, and the substrate is rusting .

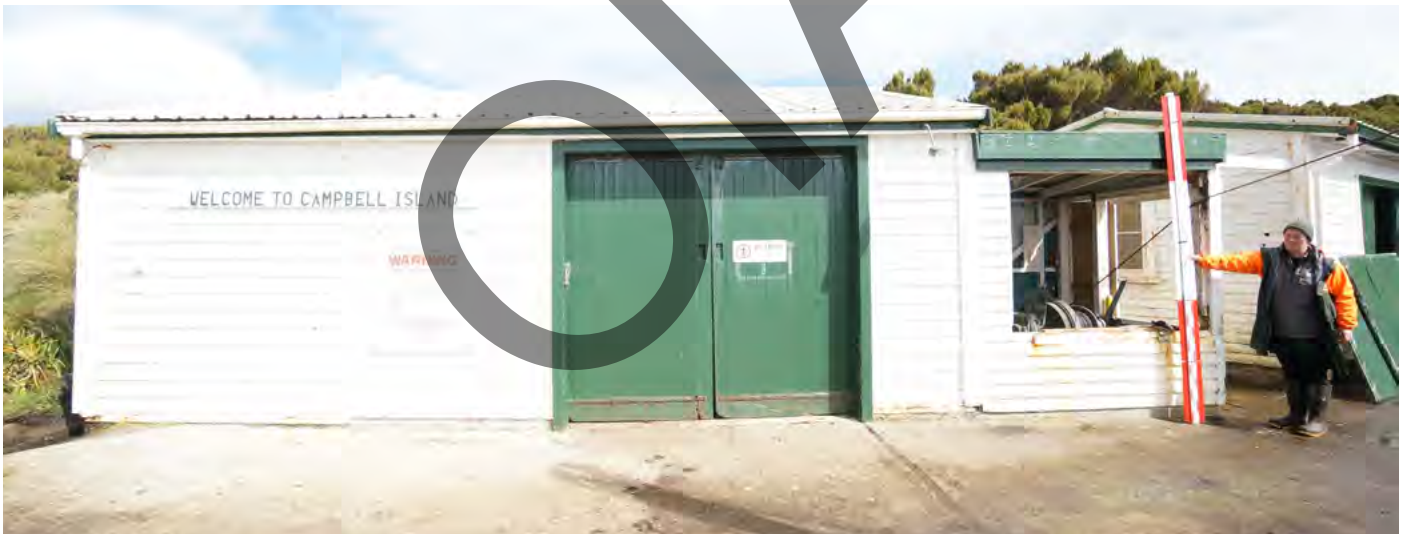
Figure S1  
BELOW East elevation of Jetty Store with winch alcove, with window openings removed and on the ground leaning against the Spirits / Paint store.

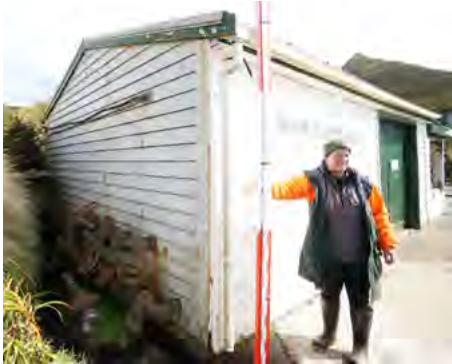
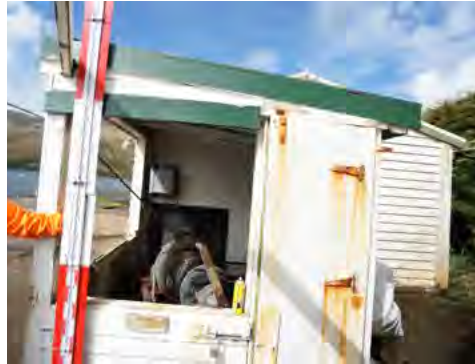
Figure S4  
LEFT TOP South wall of the Jetty Store,

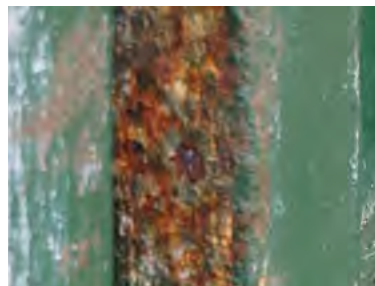
Figure S9  
RIGHT BOTTOM Rusting strap on door.  
The door styles / bottom rails are also rotten

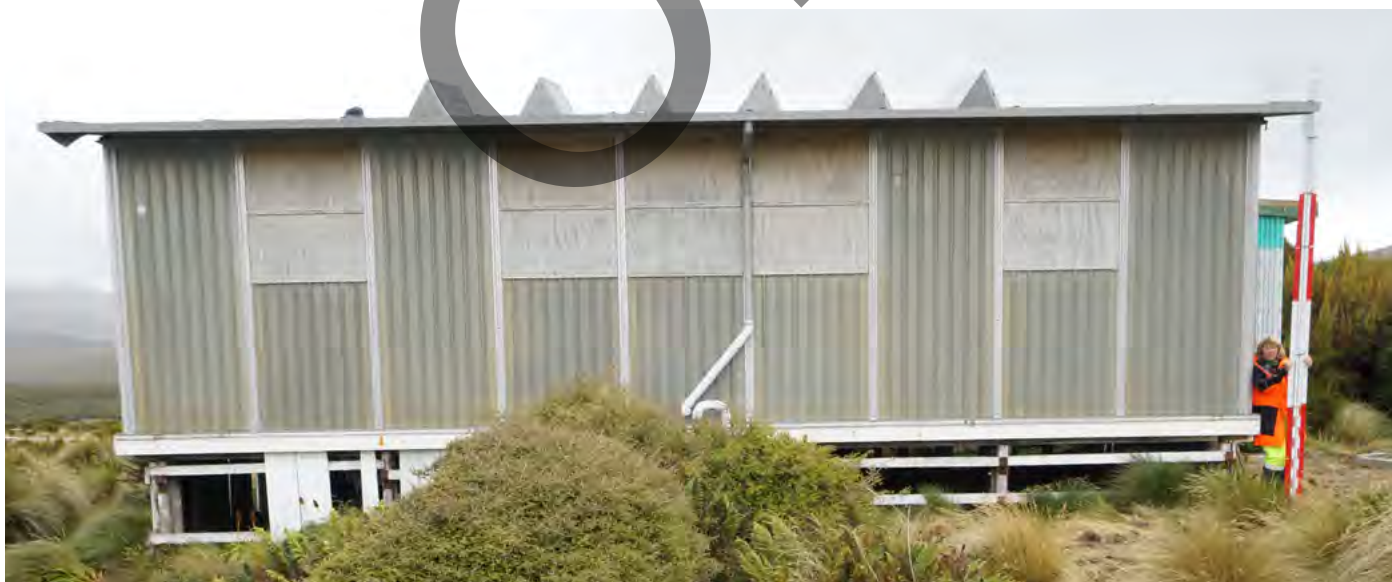
# technical building

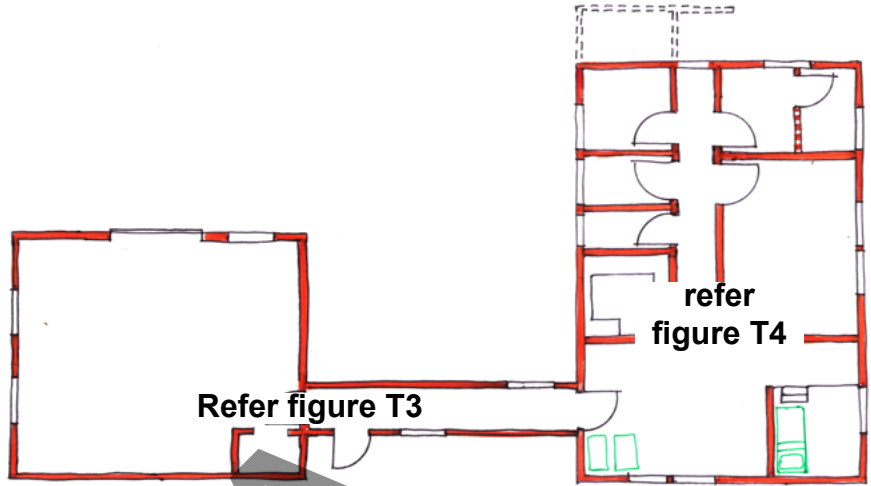
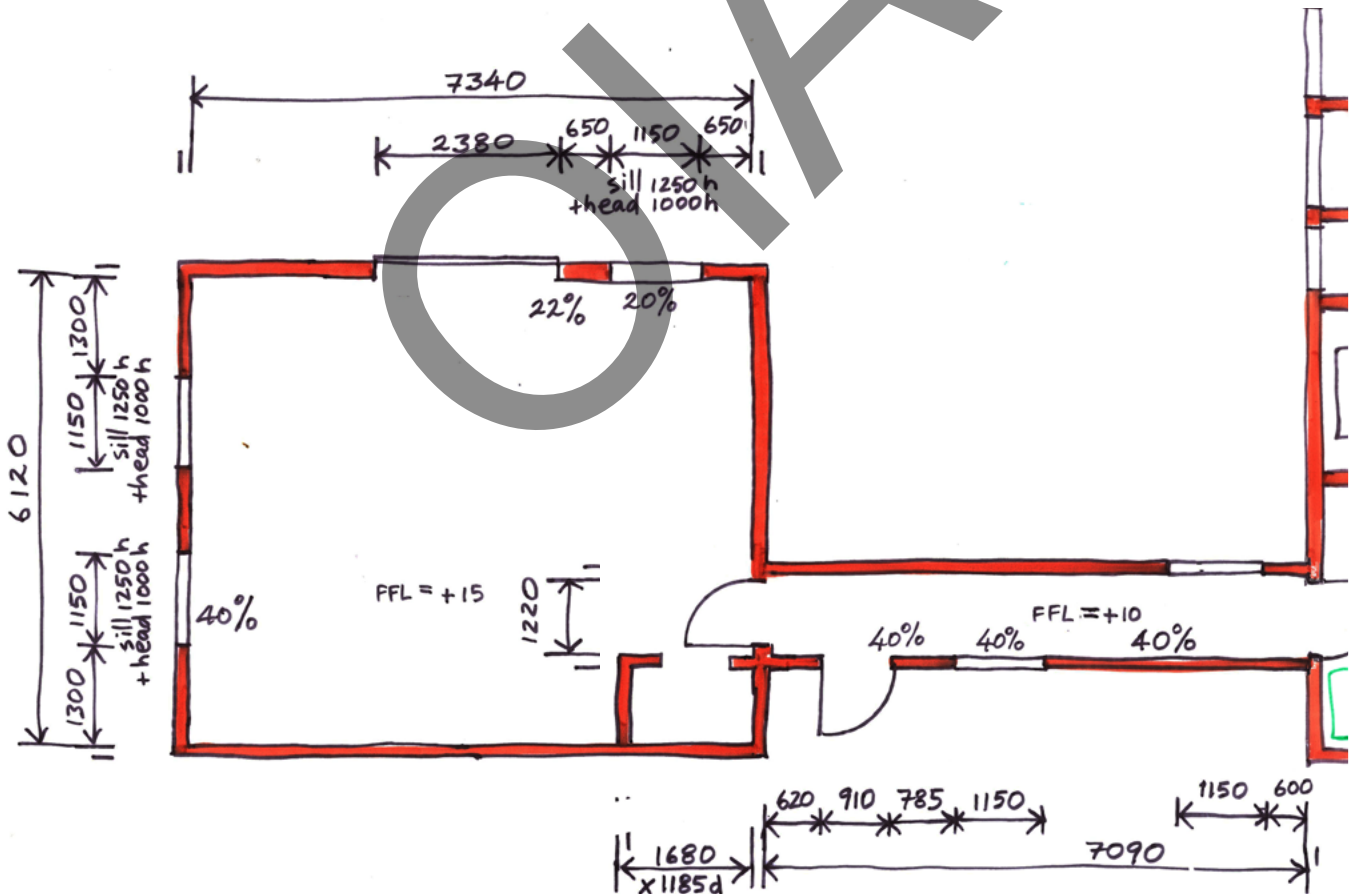
# technical building

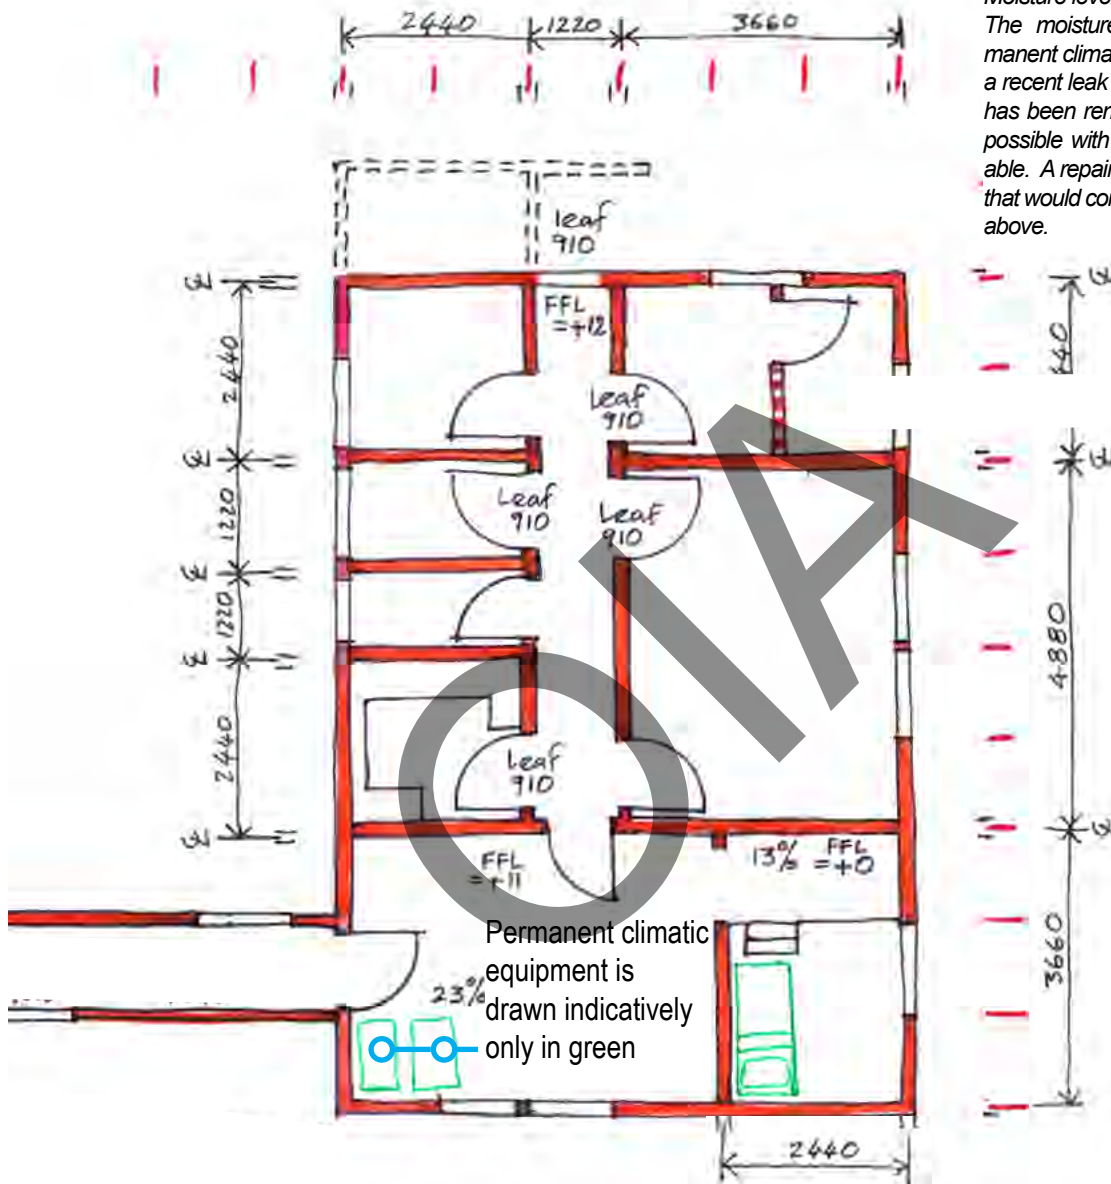
Figure T4  
BELOW The original Technical Building. Moisture levels of 13% are excellent. The moisture level of 23% near the permanent climatic equipment is indicative of a recent leak in the roof above. This leak has been remedied to the best standard possible with the ad hoc materials available. A repair of this sort has a limited life, that would correspond to the life of the roof above.

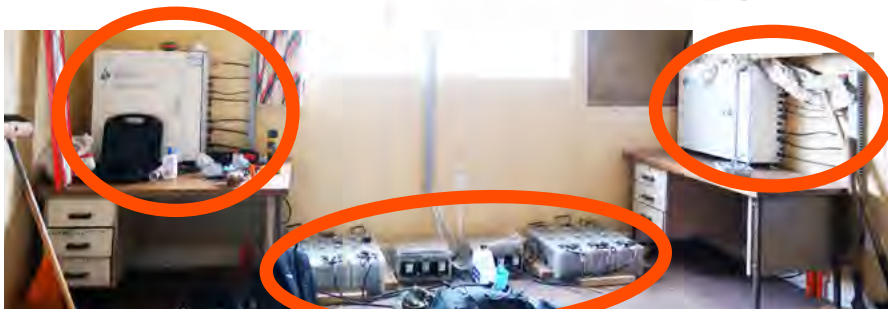
Figure T5  
LEFT The permanent climatic equipment is circled in red, generally on the old desks. The moisture reading, 23%, was completed in front of the battery pack, under an existing roof leak partially fixed. This reading indicates inevitable decay, with the rate of decay dependent on the durability of the timber. The flooring would have the least durability.

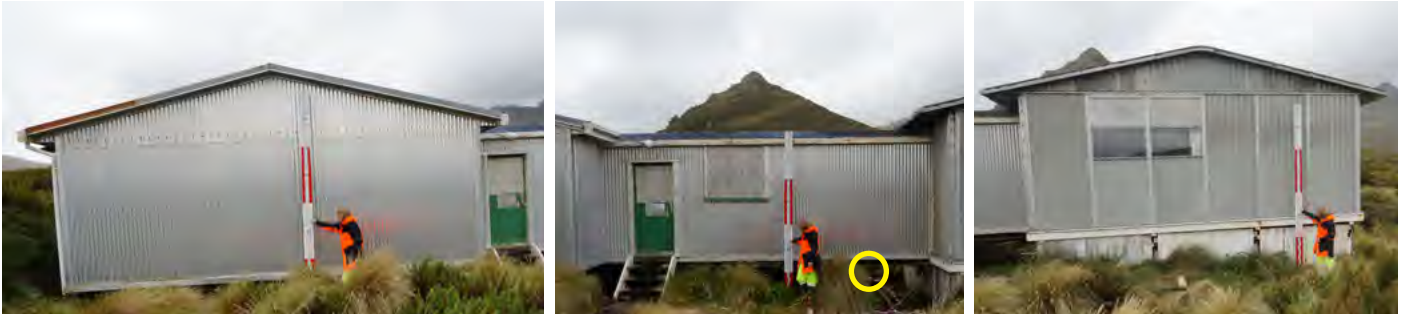
Figure T6 , T7 , T8  
 ABOVE The south elevation of the Technical Building.  
 The foundation timber sample was taken where the yellow circle is on fig T7. This was taken to prove equivalence to other timber samples taken on other historic buildings, to estimate durability of Silver Pine. A note in the 1950's in the George Poppleton's book on "Campbell Island 1955-56 - 1958 - 60" was that this timber in the 1950's was a 'supply problem'

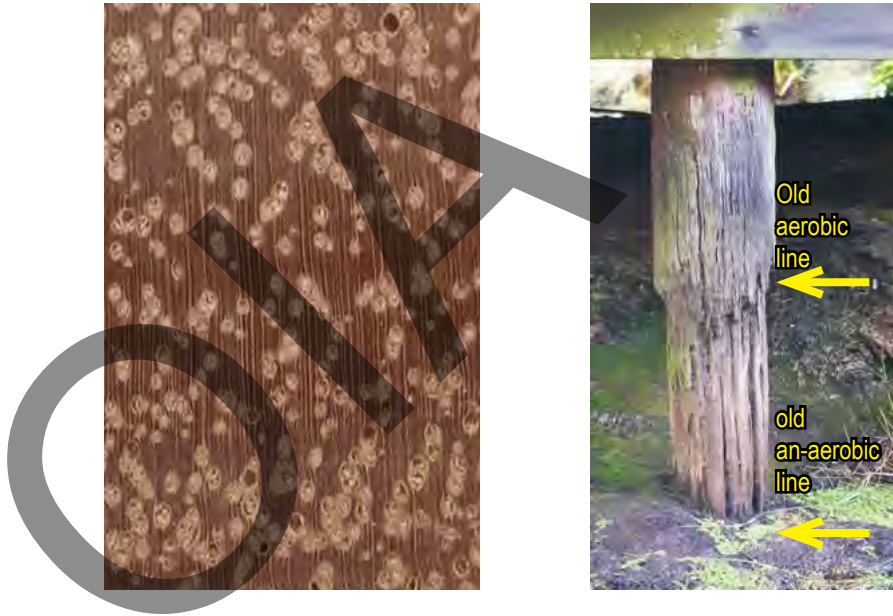
Figure T10  
 ABOVE RIGHT Microscopic view of the timber species. Both Ormondville and Campbell Island piles have similar cell structure. Also the specific gravity of both timbers was measured by coating samples in water and measuring in a test tube. Both are above a specific gravity of 1, an unusual non typical reading.

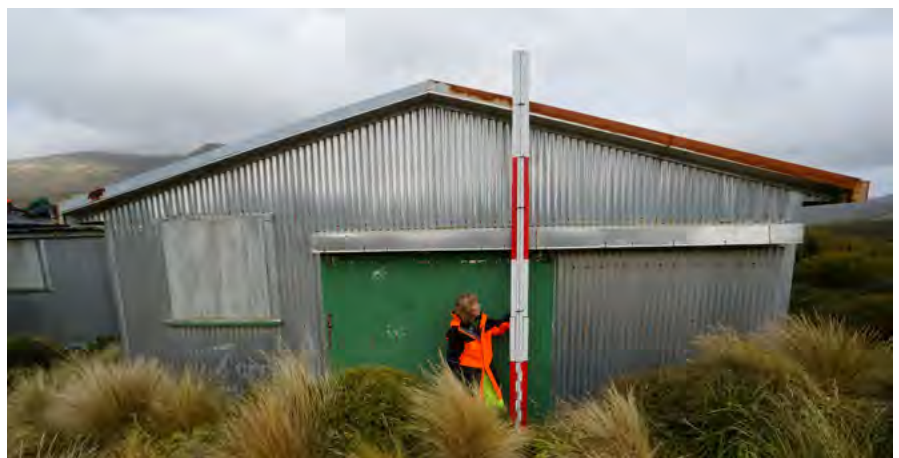
Figure T11  
 RIGHT The north elevation of the Technical Building, with the garage door (2380mm wide) in green. The photo to the left was not taken owing to a particularly aggressive seal (Sammy) taking up residence in the scrub to the left of where I was standing when taking this photo.

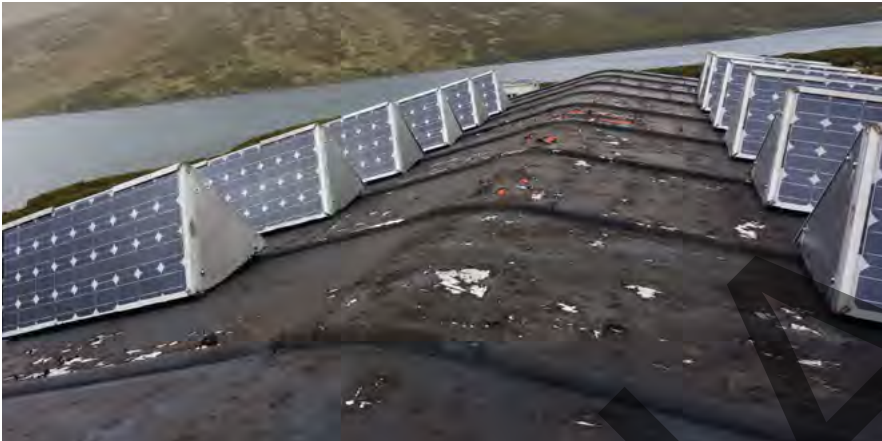
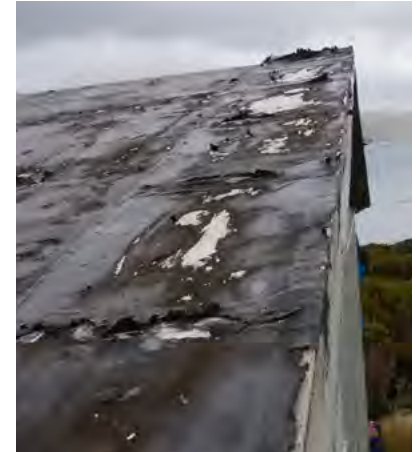
Figure T12  
ABOVE The original aluminium clad roof, with a membrane over, an economical possible solution to remedy the roof leaks. This membrane is now ending its effective life.

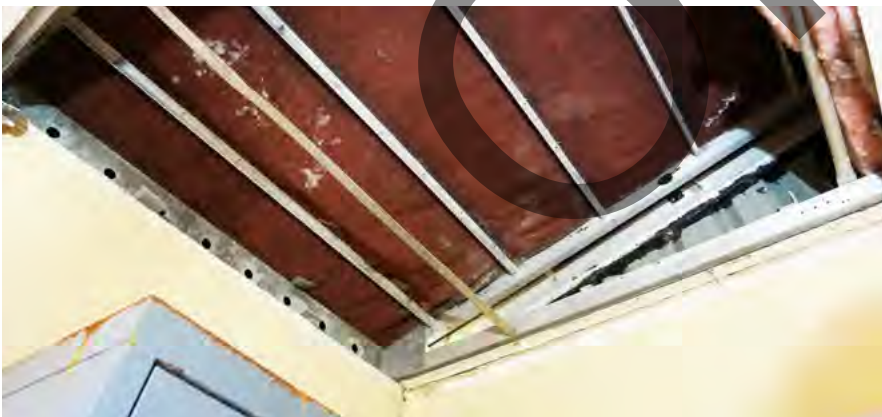
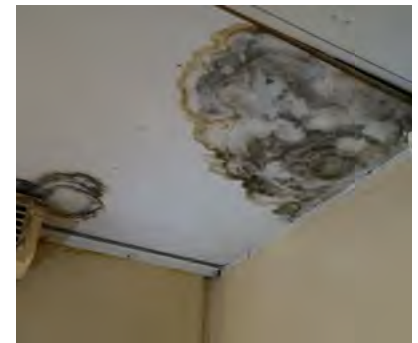
Figure T14  
ABOVE RIGHT The original aluminium roof panels viewed a missing ceiling panel.

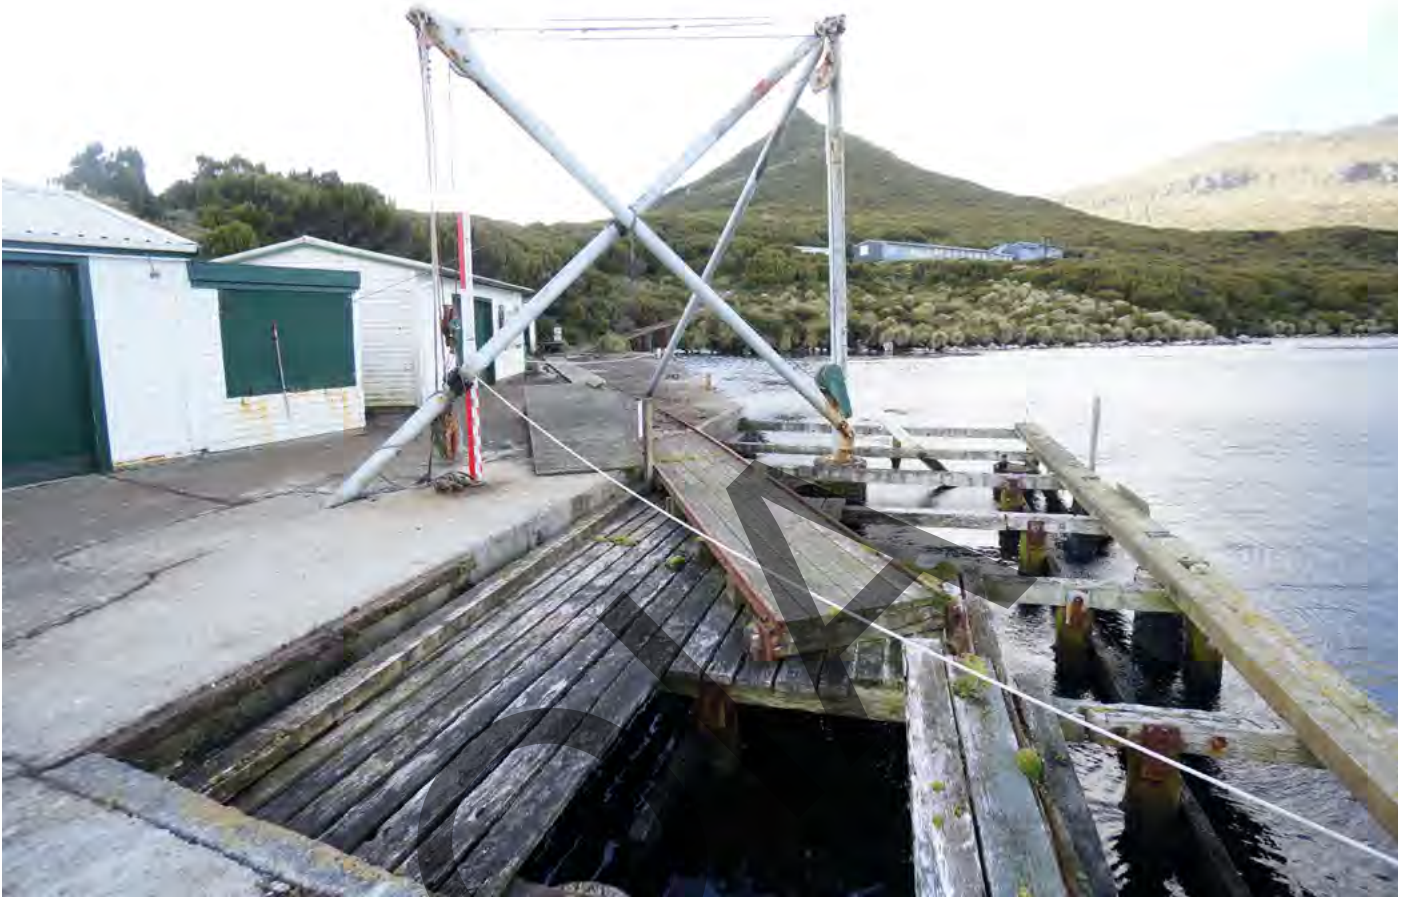
Figure U1  
ABOVE The Jetty, just before being  
roped off.

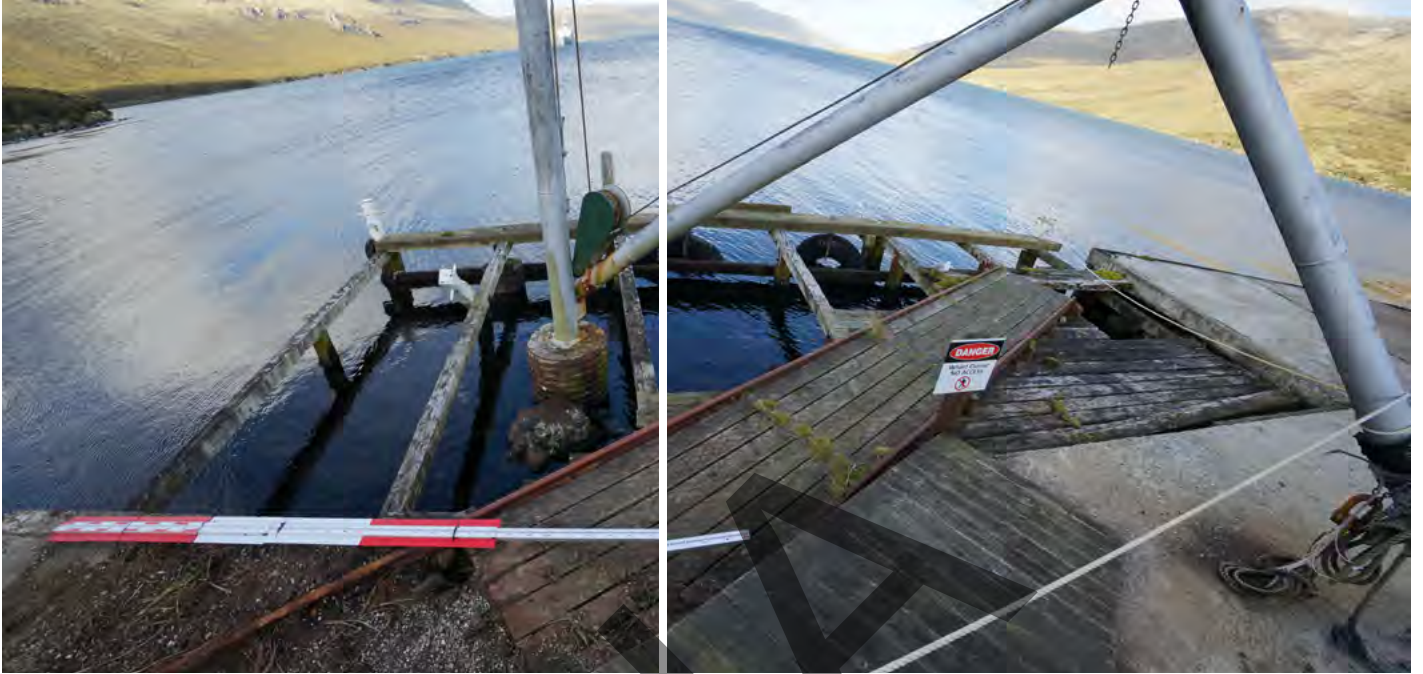
Figure U5 , U6  
ABOVE Extent of timbers removed from  
the jetty from the winch room, (S)

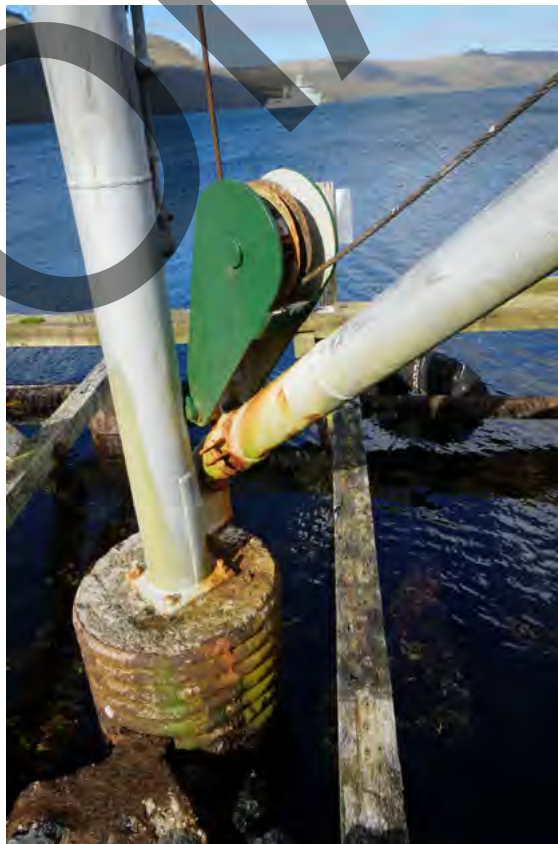
Historic significance	Highest category, historically significant.
Construction	Standard New Zealand wide common construction techniques
Wall condition	Near to demolished by neglect, structural timbers are mostly sound, where test drilling was possible .
Foundation condition	Near to demolished by neglect, sunk 300mm.
Roof condition	Near to demolished by neglect
Use, Feb. 2017	Use impossible, close to demolished.

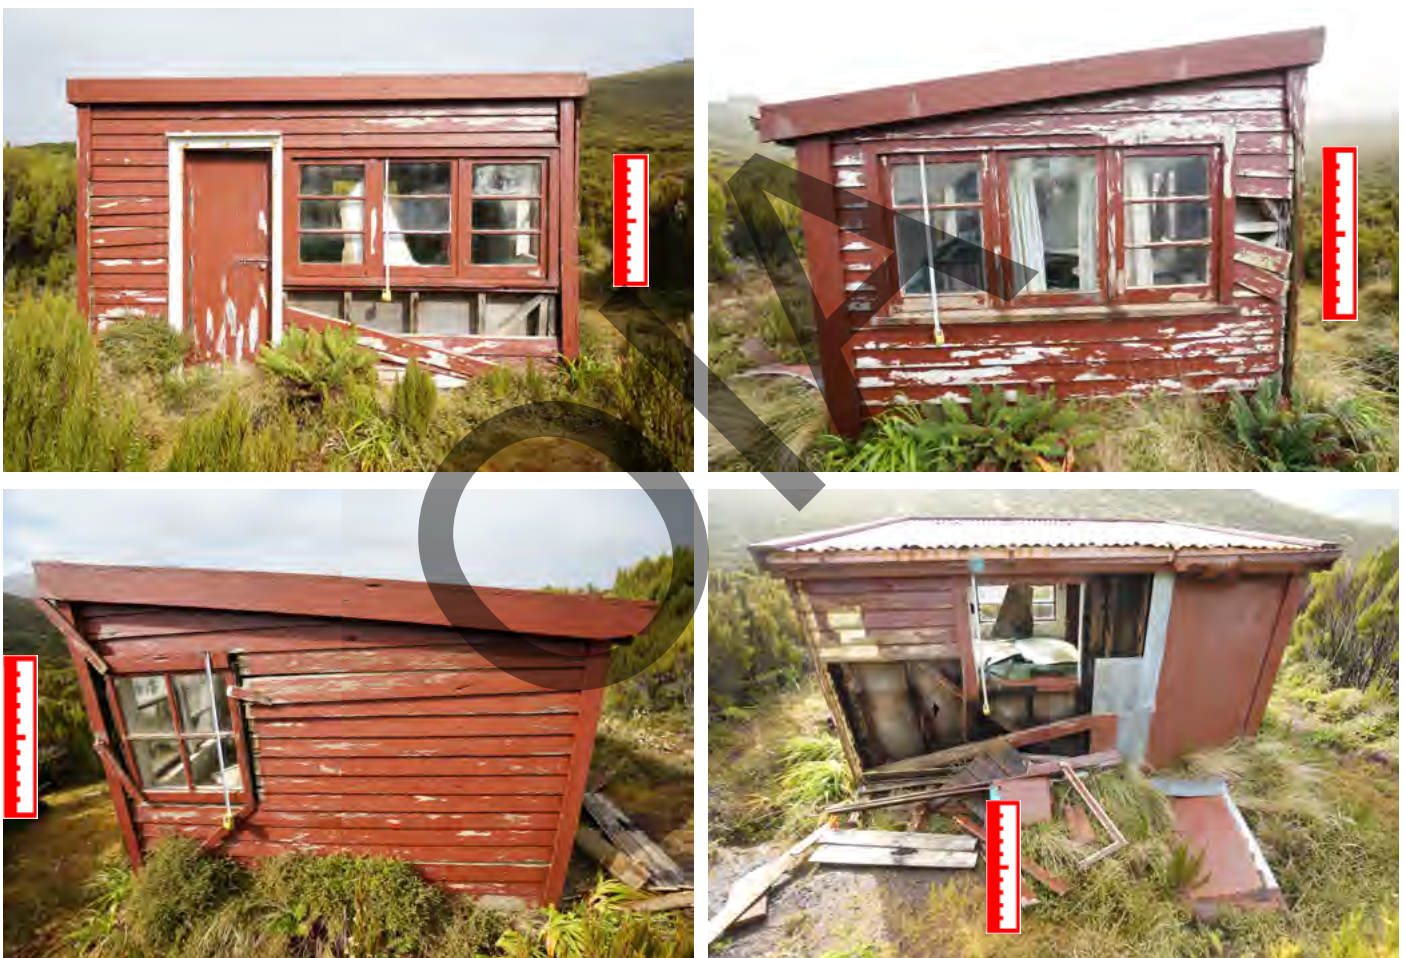
Figure V1 , V2 , V3 , V4  
CLOCKWISE FROM TOP LEFT The east, north, south, and west elevations of the Tucker Hut
