**CAMPBELL ISLAND**  
**meteorological station**  
BUILDINGS, CONDITION & PLANS

MEASURED FEBRUARY 2017

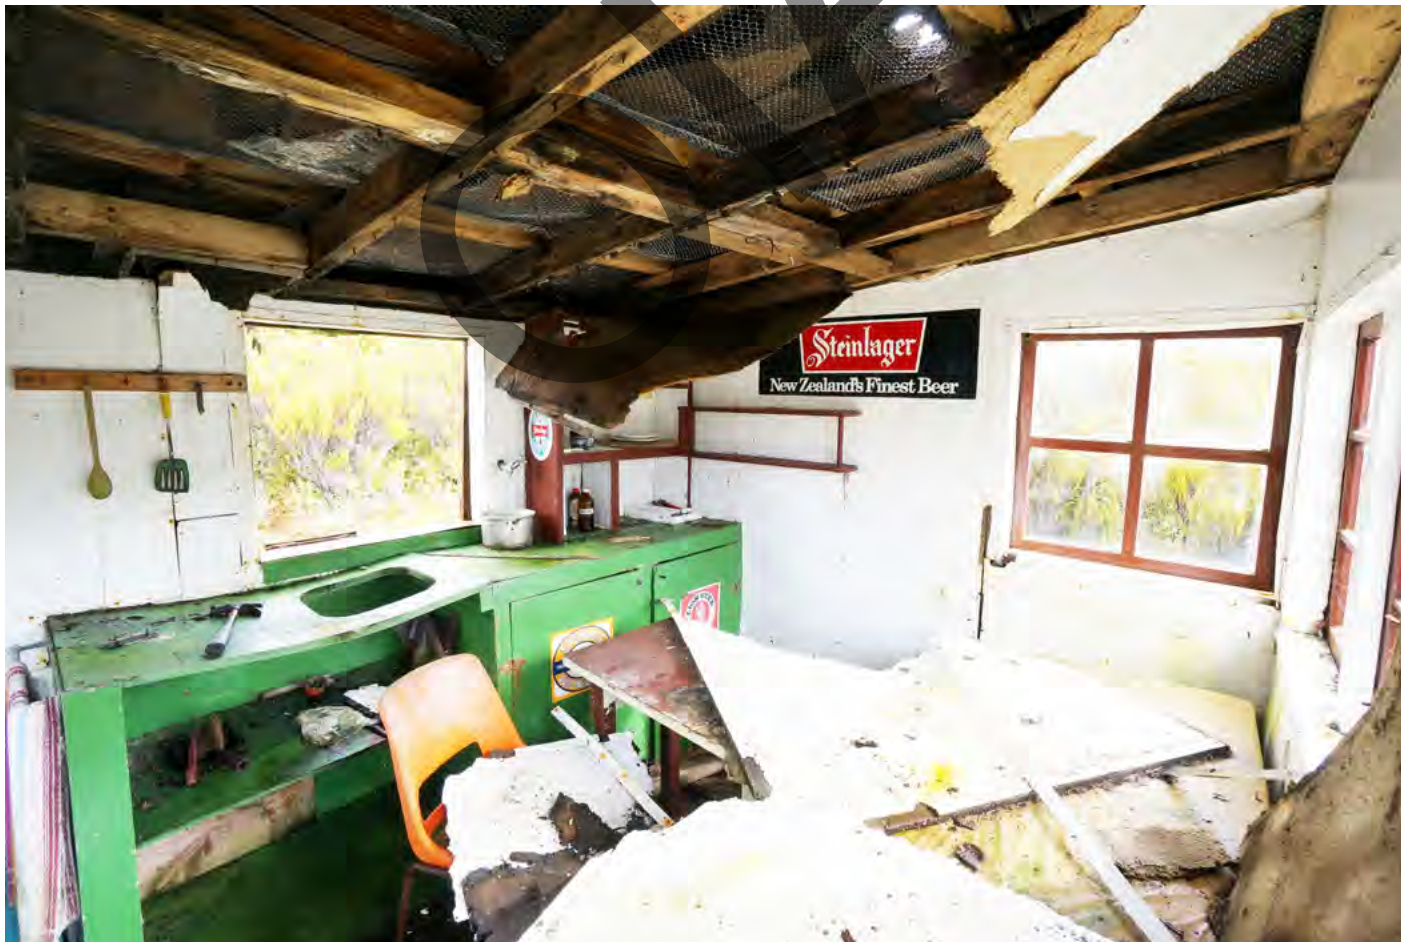
*BELOW* The ceiling has collapsed onto the furniture below. Holes in the roof are visible as light patches. The window is missing. The towel in the far left bottom corner has remained relatively clean with all the internal moisture.

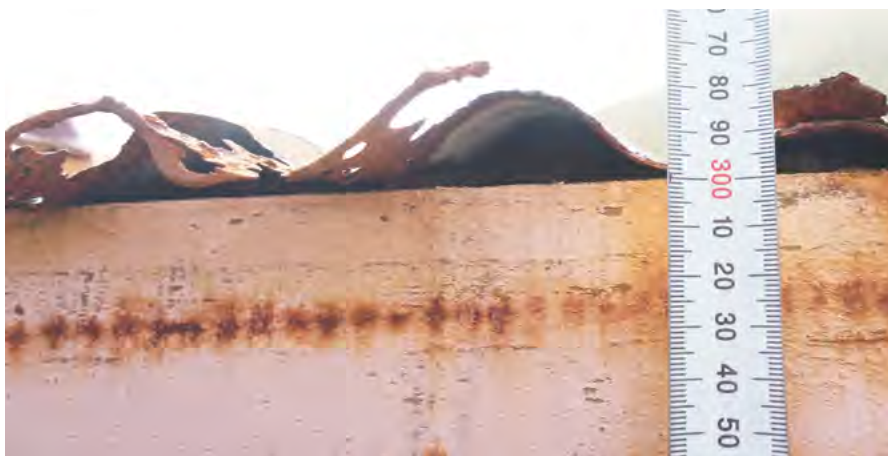
Figure V8  
LEFT Condition of the edge of the roofing,  
showing extensive perforation.

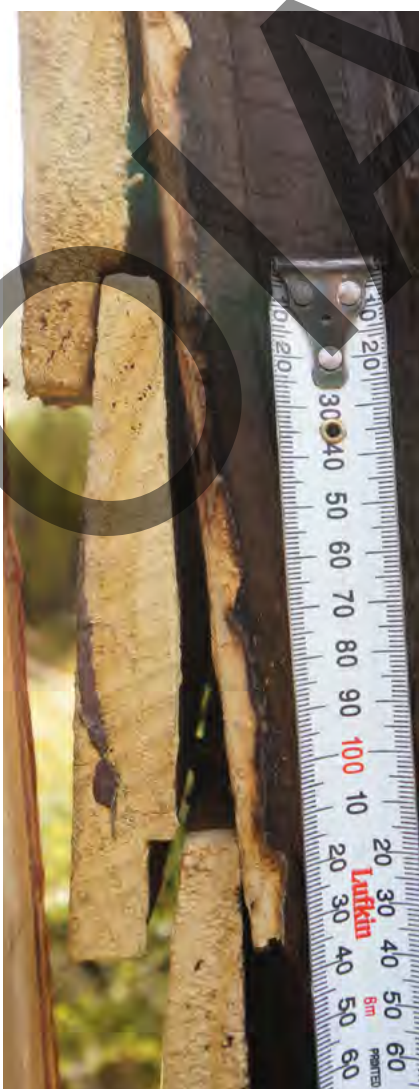
Figure V6  
LEFT Record of the size and profile of the  
weatherboards.

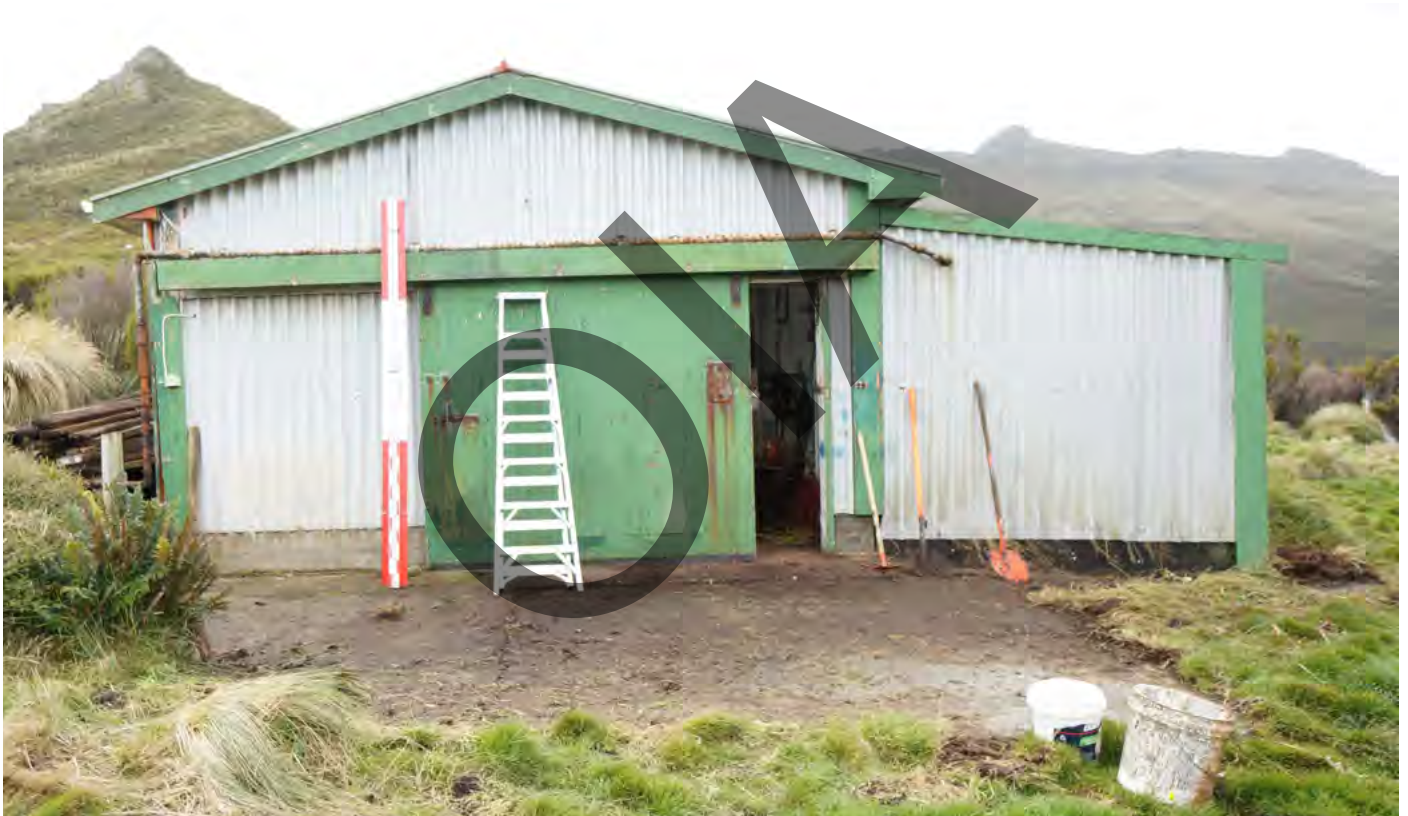
Historic significance	Low significance.
Construction	Standard New Zealand wide common construction techniques
Wall condition	Minor repairs only required.
Foundation condition	Foundations could last up to 30 to 50 years
Roof condition	Minor repairs required, however roof replacement is due within one decade, as areas rusting.
Use, Feb. 2017	No use during February 2017.

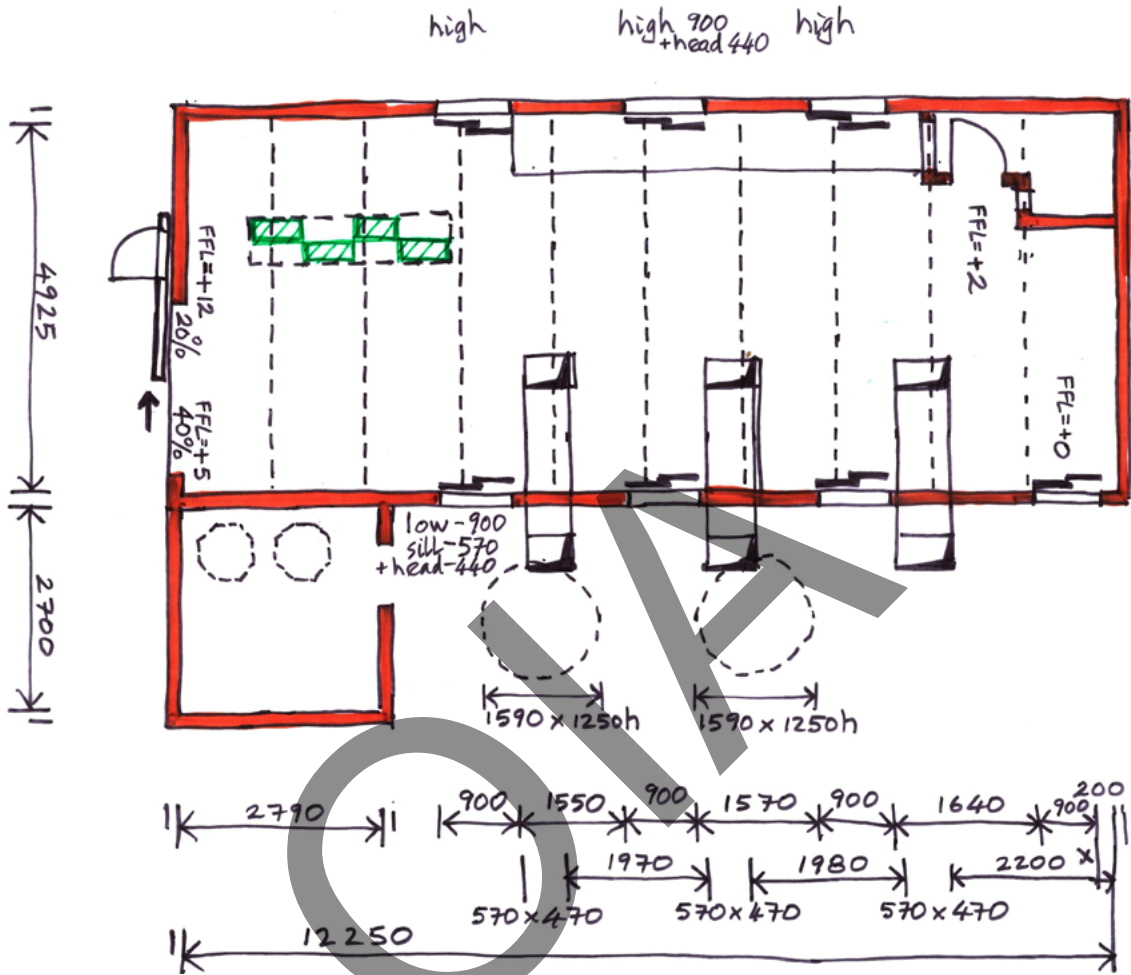
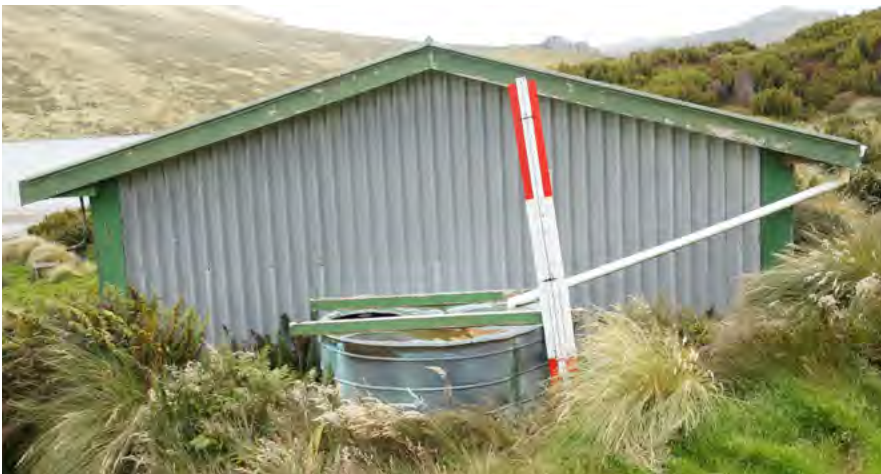
Figure W2  
ABOVE Floor plan of generator garage.

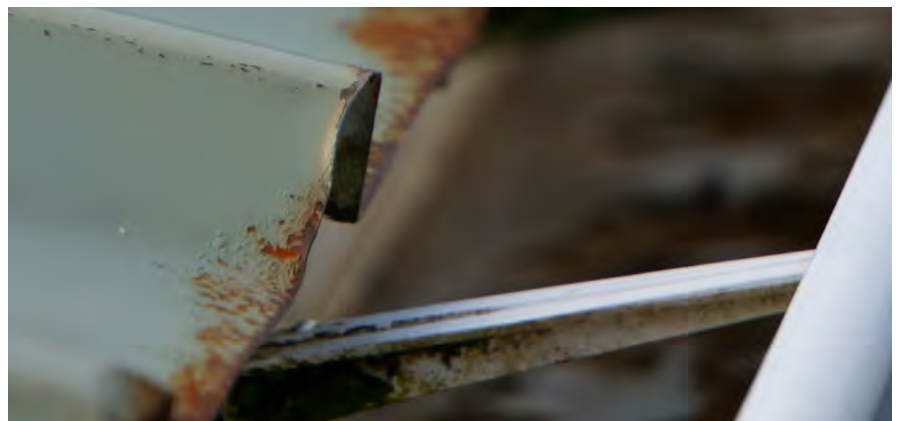
Figure W6  
RIGHT Rust developing at the edge of the roofing.

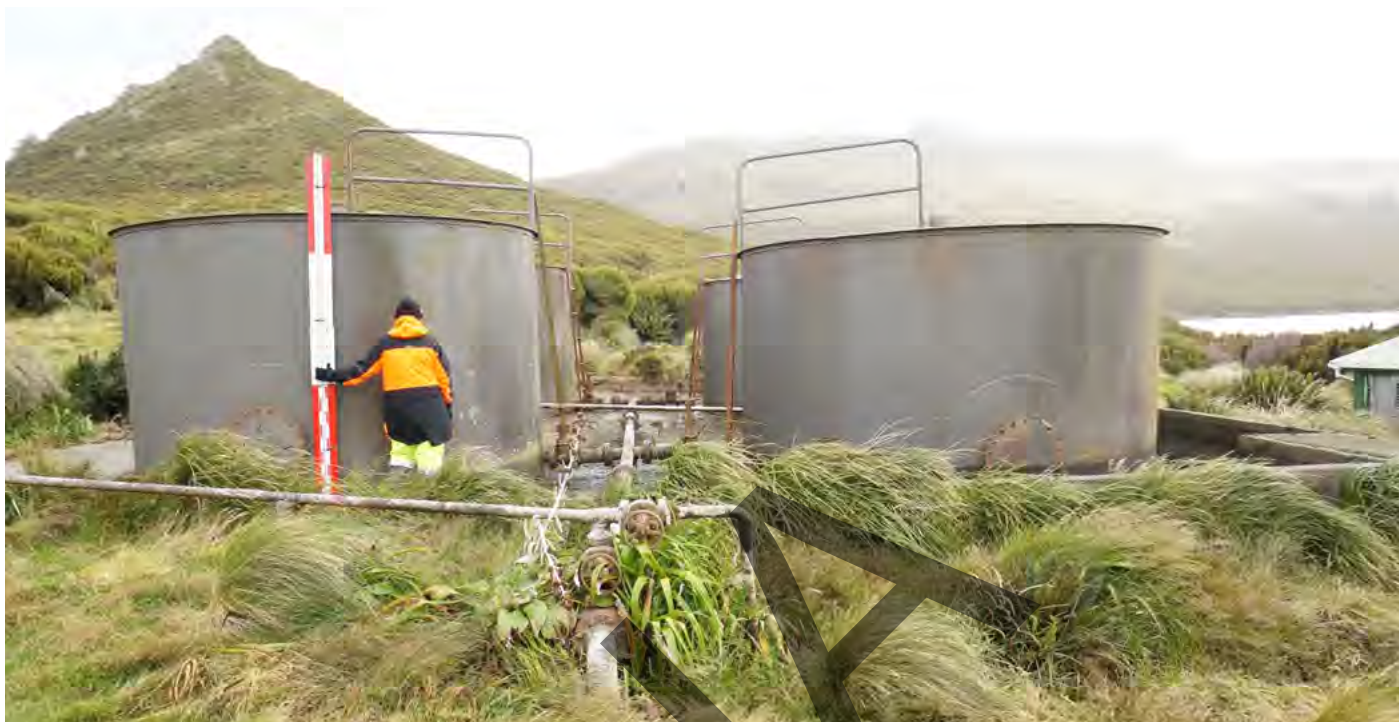
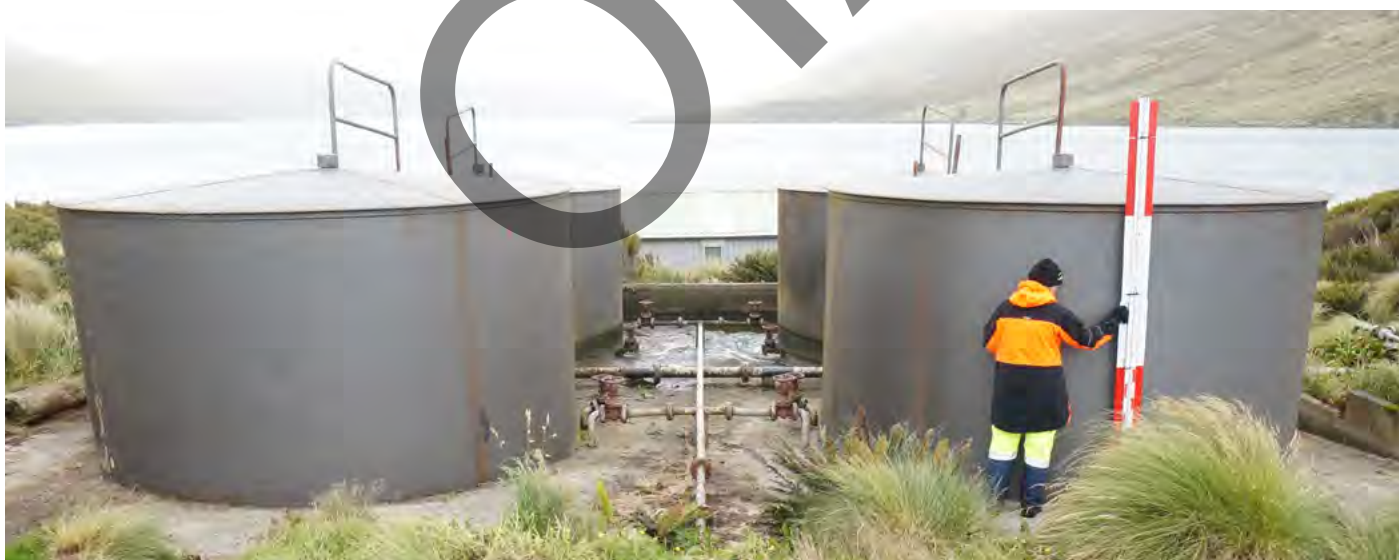
Figure X1  
FAR TOP South elevation of the water tanks.

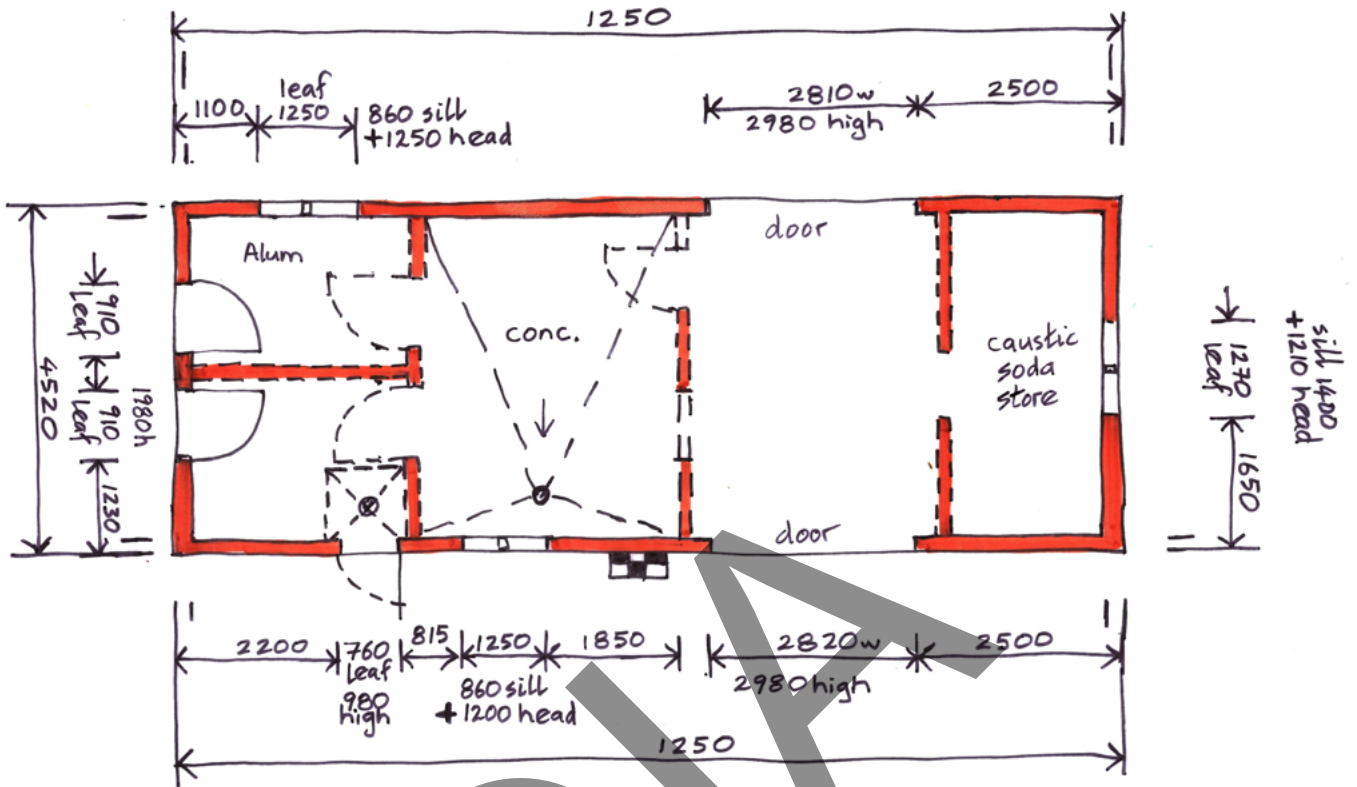
Figure Y5  
 ABOVE Plan of hydrogen building, dotted outlines are estimated.

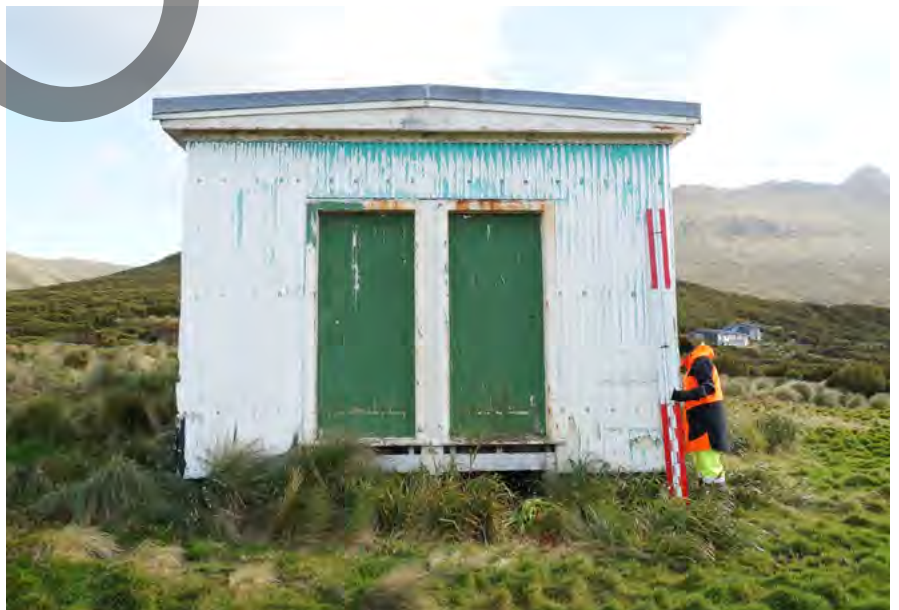
Figure Y6  
 RIGHT South elevation

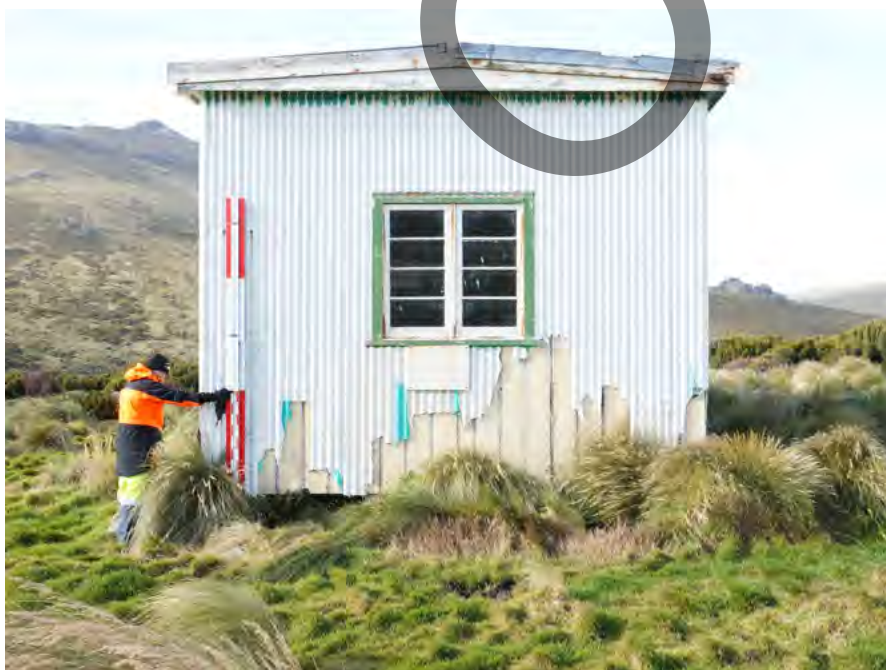
Figure Y8  
LEFT North elevation, like Aurora House, the plastic overcladding that was to keep the building waterproof, (instead of painting), has become brittle and in-effective, and has been broken by sea lions.

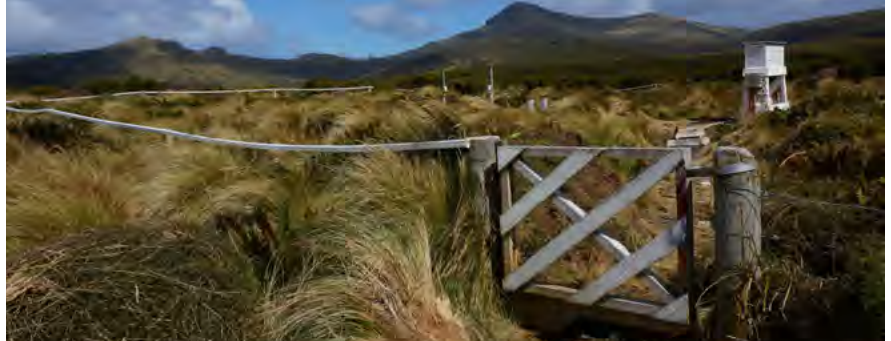
Figure Z1  
ABOVE Climatic Enclosure, from east edge, looking west.

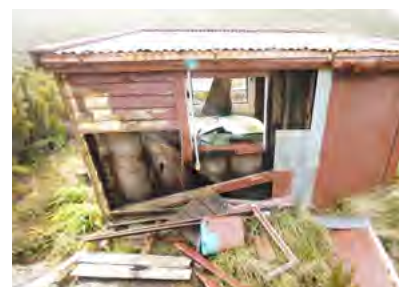
Figure 1-1  
ABOVE The very historic Tucker Hut, near to demolished by neglect.

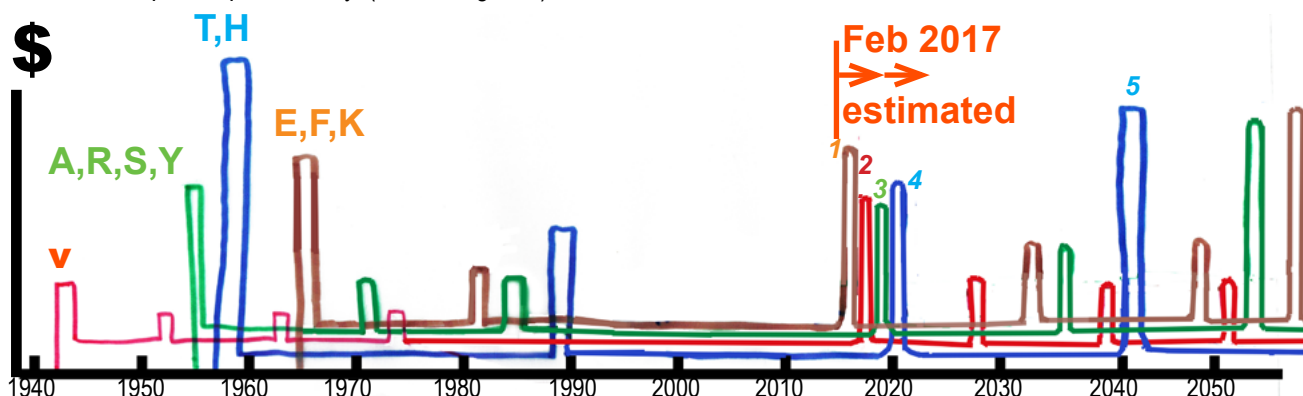
Figure 1-2  
BELOW A generalised (anecdotal) indication of costs. Tucker hut (V) [red] with initial cost for building, then every 10 years cost for re-painting. Zinc clad buildings (E,F,K) [brown] the initial cost is more, and the gap between maintenance is longer. The Technical building (T) and Hostel (H) [blue] the initial cost is higher again and the gap between maintenance is even longer. Between 1995 and 2017 there is a gap where periodic maintenance has not been completed. In the future [1] replace perforated zinc cladding, [2] repair Tucker Hut, [3] repair and repaint timber framed buildings, or re-clad, since painting in a damp environment is time consuming, [4] replace Technical building roof and cladding under copper treated window shutters. [5] re-clad rest of aluminium on Hostel and Technical building. The estimated dates further out from Feb. 2017 are VERY approximate.

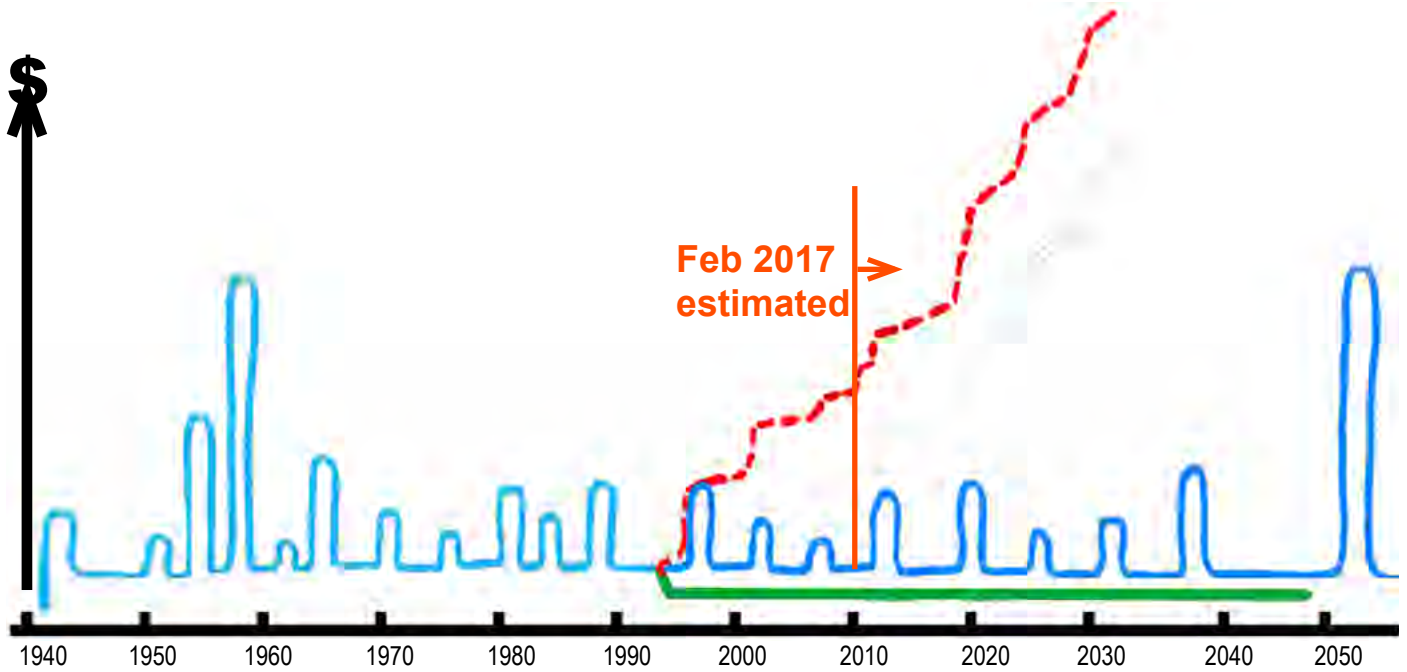
Figure 1-3 ABOVE Accumulated costs, generalised & anecdotal shown with the blue line. Expenditure on larger maintenance items stopped between around 1995 and 2017 and the green line shows the reduction in costs at this time. If maintenance is not completed in a timely manner, then there are secondary maintenance costs that must be added. For instance, a cladding that has already perforated will rot out the structure underneath, hence, the recovery costs of re-establishing a periodic maintenance programme, (the red dotted line) is exponential. The costs start at the vertical red line, then drops down to the blue line after an initial high expenditure.

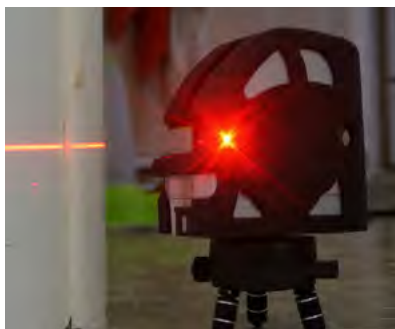
Figure 1-4 ABOVE An industrial laser was used to check the condition of the foundations, these measurements are on the plans, eg FFL +10.

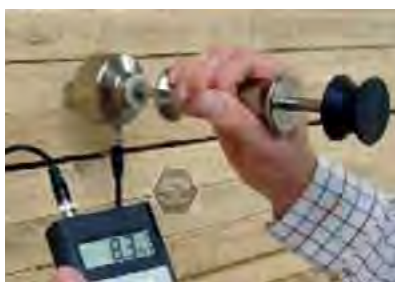
**Acknowledgments.** I would like to thank all the staff from D.o.C. and Met service, photographed in figure 0-2 & 0-3, for their passionate and committed help with the preparation of this report, especially on site.

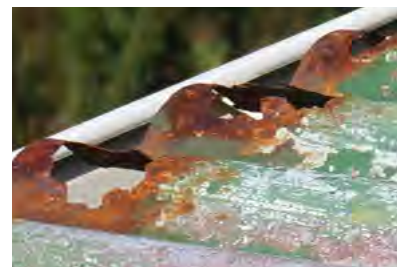
Figure 1-6  
ABOVE A lot of the cladding around Beeman Base is ending its natural life. In this case the roofing has perforated.

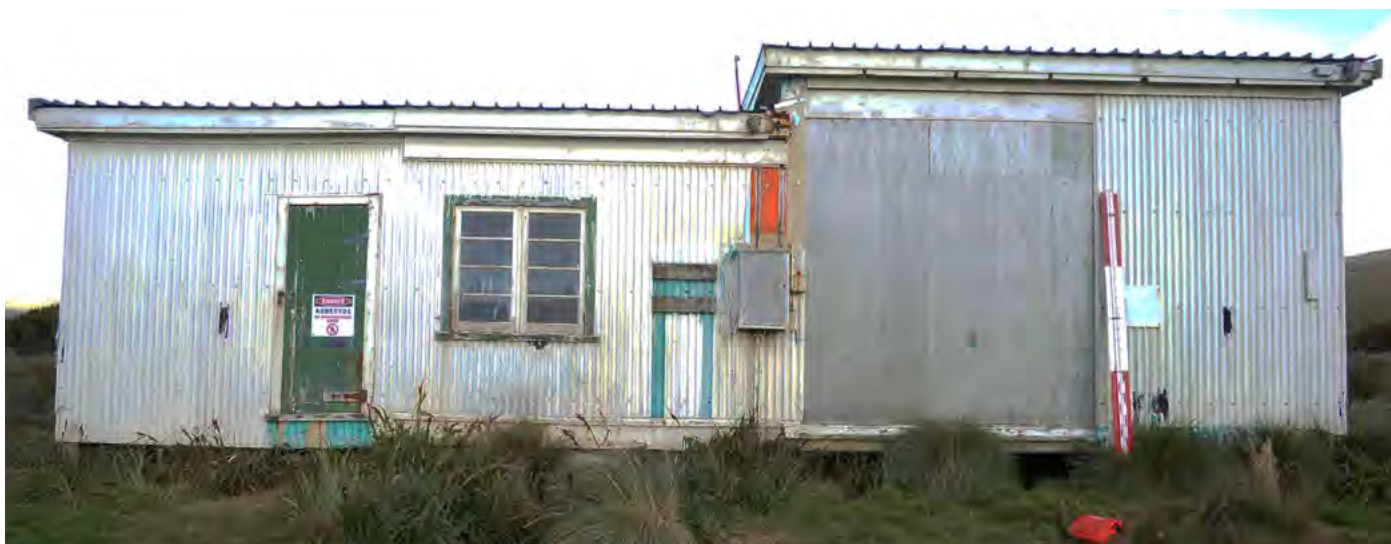
Figure 1-7  
ABOVE The historic hydrogen building, near to demolished by neglect

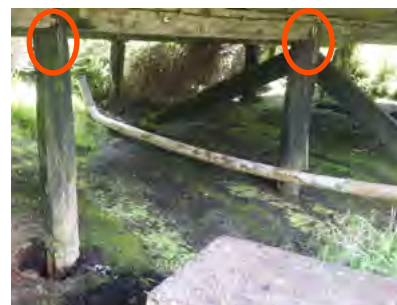
Figure 1-8  
BELOW The typical structure, minor modifications required to add connections to limit earthquake damage are missing, red circle.

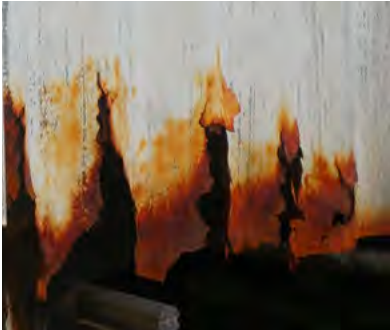
Figure 1-9  
ABOVE Corrosion on ferrous cladding material, installed post 1960,

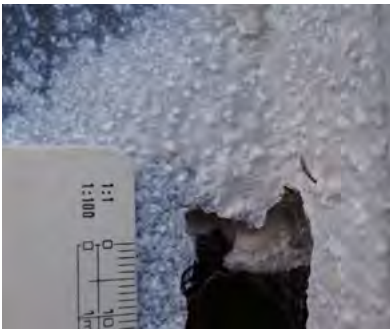
Figure 1-11  
BELOW Pre 1955 cladding is generally in good order, for instance on these wharf buildings. However repaints may be slow in an area of high rainfall.

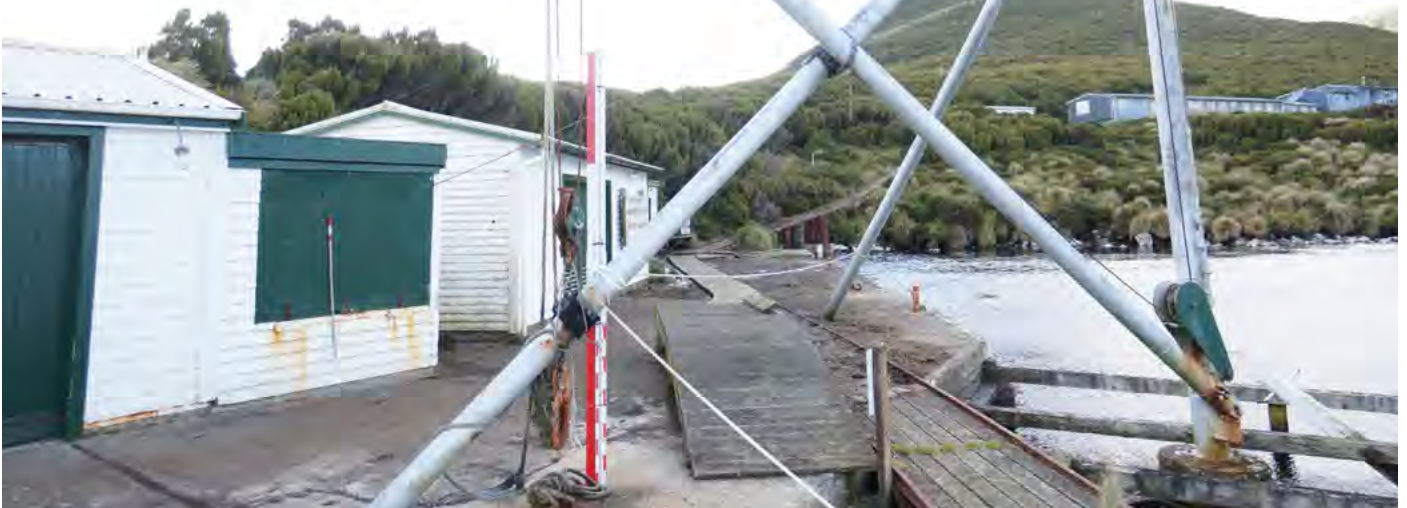
**1d - Post 1960 cladding.** This cladding together with recent materials used for maintenance, in most cases is in very poor condition. The lack of durability reflects the fact that a more economical material has been chosen. These areas need replacing in less than one decade on nearly all buildings built after 1960. In a lot of cases perforation has already occurred in one location and more, and holes that allow water into the structure are both enlarging and multiplying. With this perforation the likelihood of structural damage from rot of the timber framing inside the wall will increase exponentially.

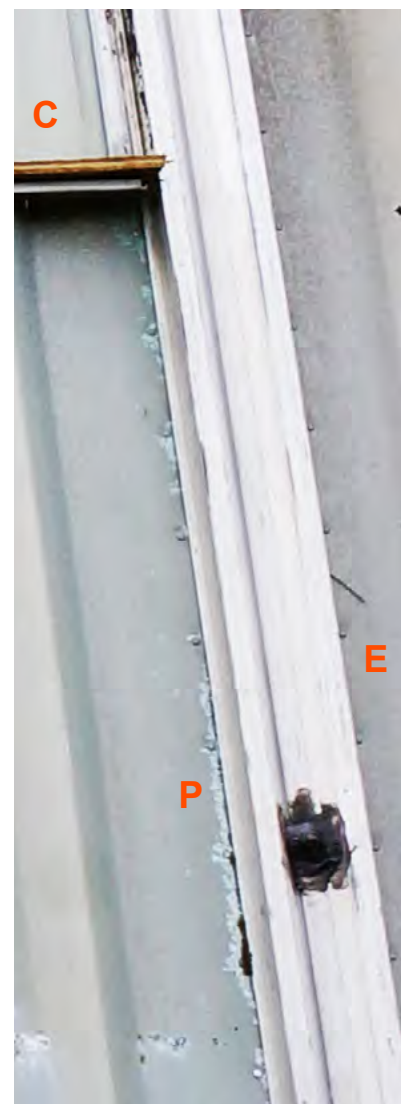
*Figure 1-12  
Corrosion evident on the left hand side, where the copper treated shutters have been added above. The aluminium is in pristine condition for its age on the right hand side where there was no treated copper shutters added above.*

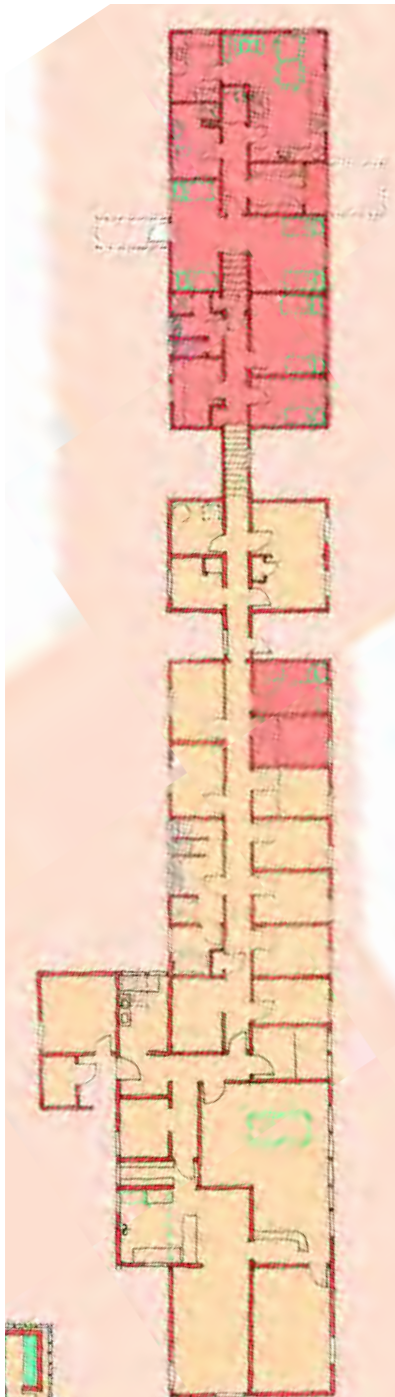
Figure 1-13  
ABOVE Parts of the accommodation used are shown in red, for a full plan refer section "Use - Feb. 2017"

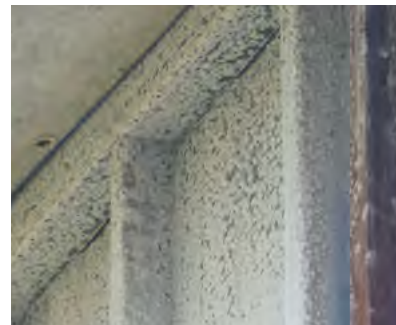
Figure 1-14  
ABOVE The upper area of the cladding on the accommodation buildings, where zinc has extensively oxidised. The next stage of the corrosion cycle is perforation.

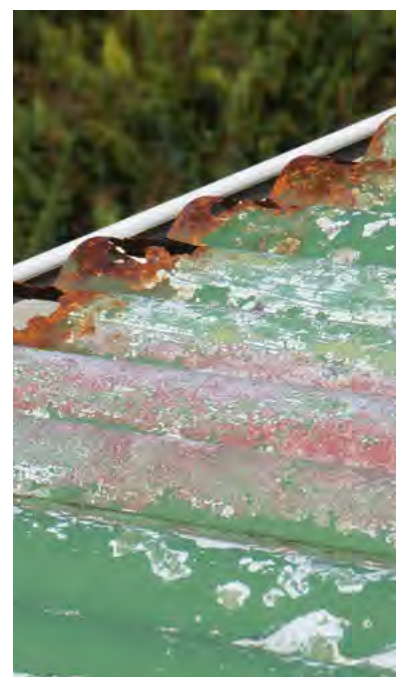
**1m - Immediate Use:** I have only had one trip to Campbell island. However the contents of the buildings, on my review of every accessible room, give a good indication of use. From this observation a minimum requirement to provide facilities could be the:- jetty structures (Q,R,S and U) ; part of the hostel (H) ; some ancillary food, vege, and water structures (J,L) ; and parts of the Technical building required to service the aerals and climate enclosure(T).

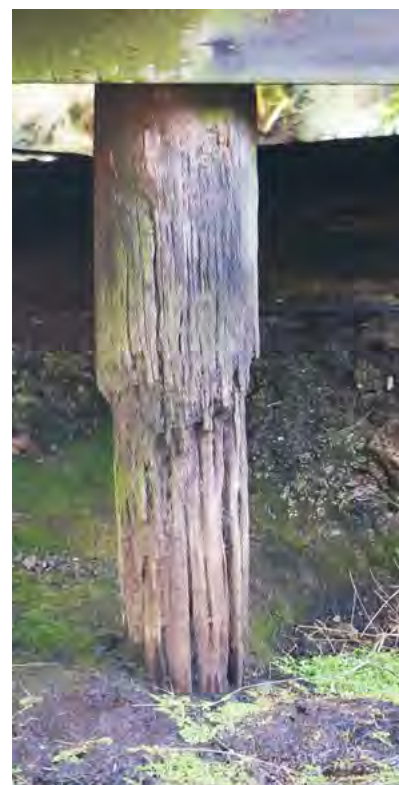
Figure 1-17  
ABOVE A silver pine pile, expected durability, 90 years, with 60 years gone. Refer also section 2H in the condition report.

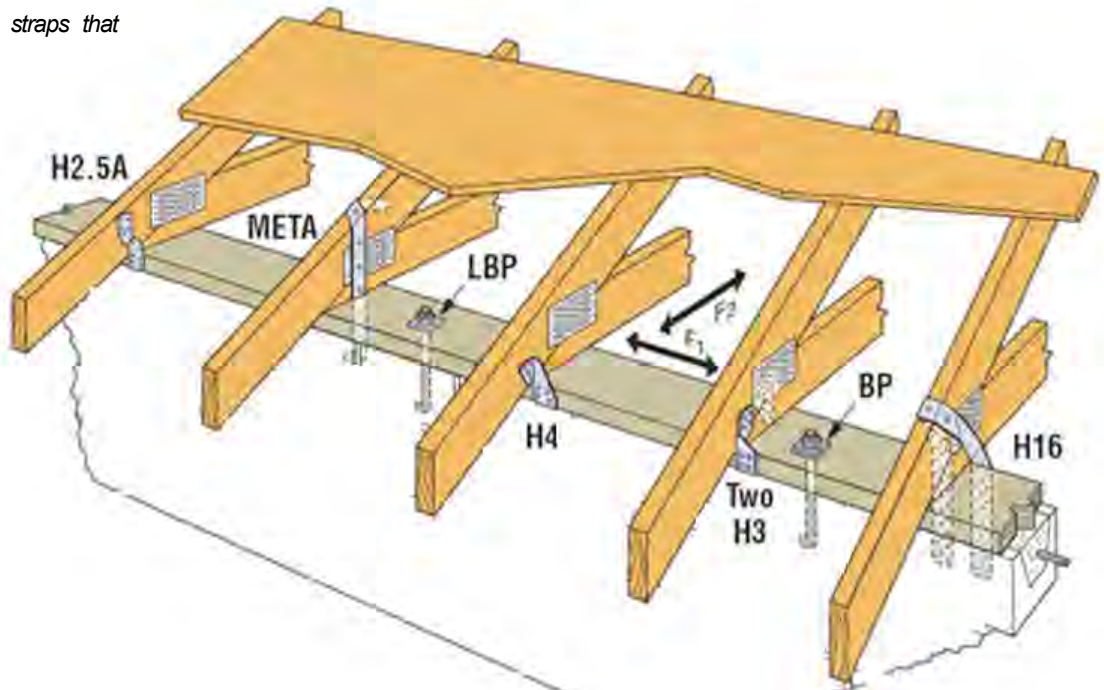
**1q – Wall Cladding - Details** Tucker Hut has deteriorated to such an extent that a complete rebuild is required. Refer section 2V.

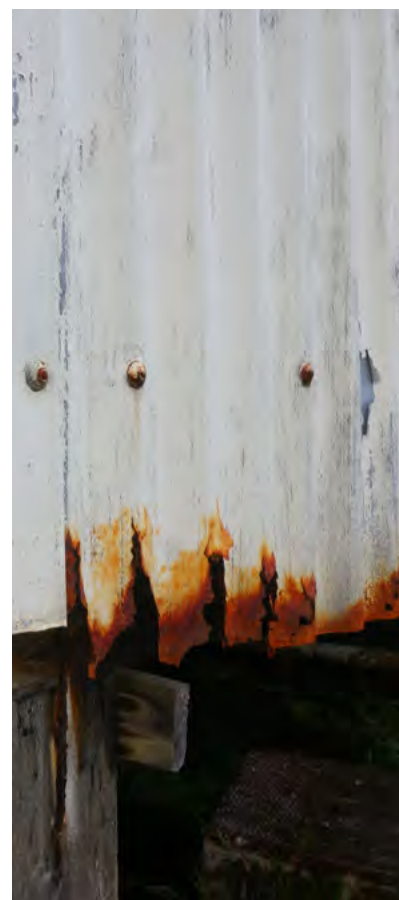
Figure 1-19  
ABOVE Cladding corrosion at the base of a wall.

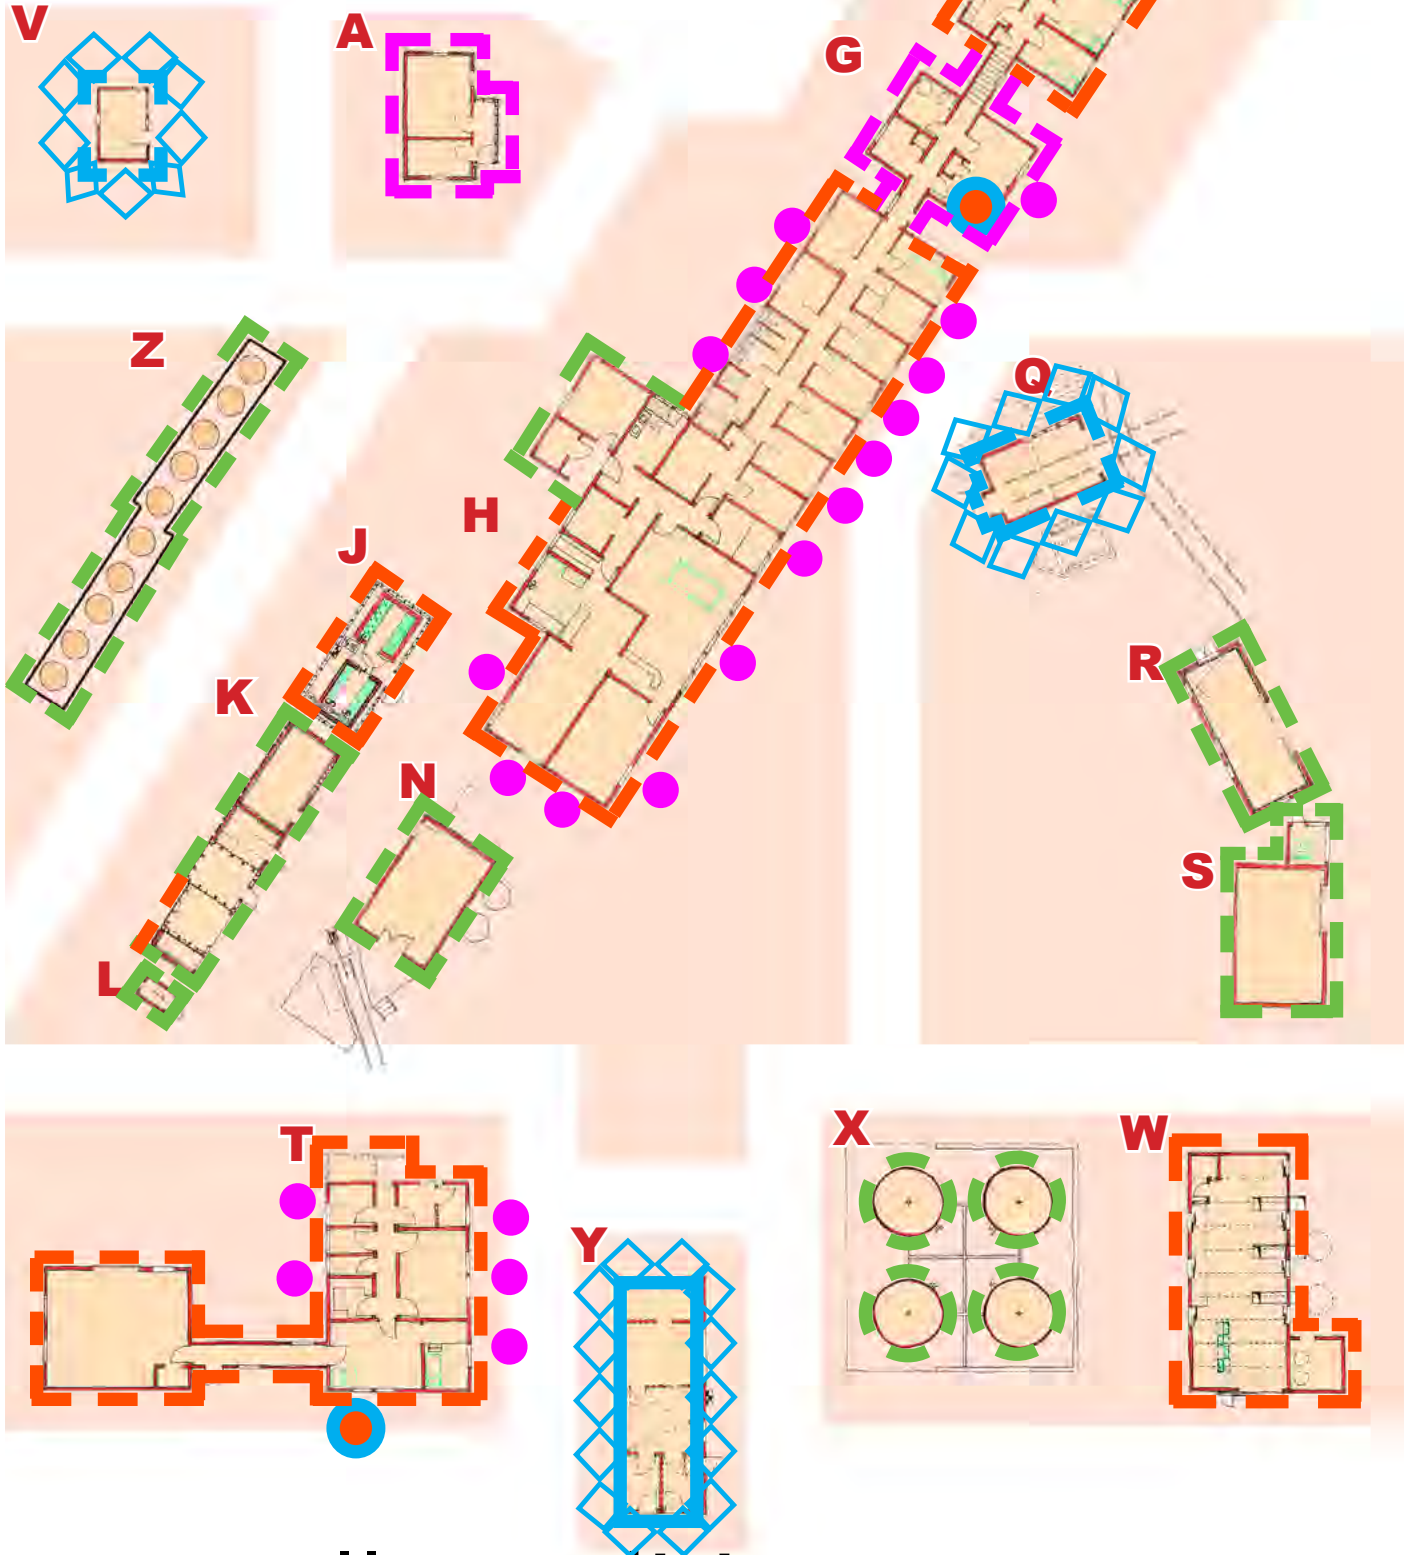
Visual check showed area of building failure, structural decay highly probably.

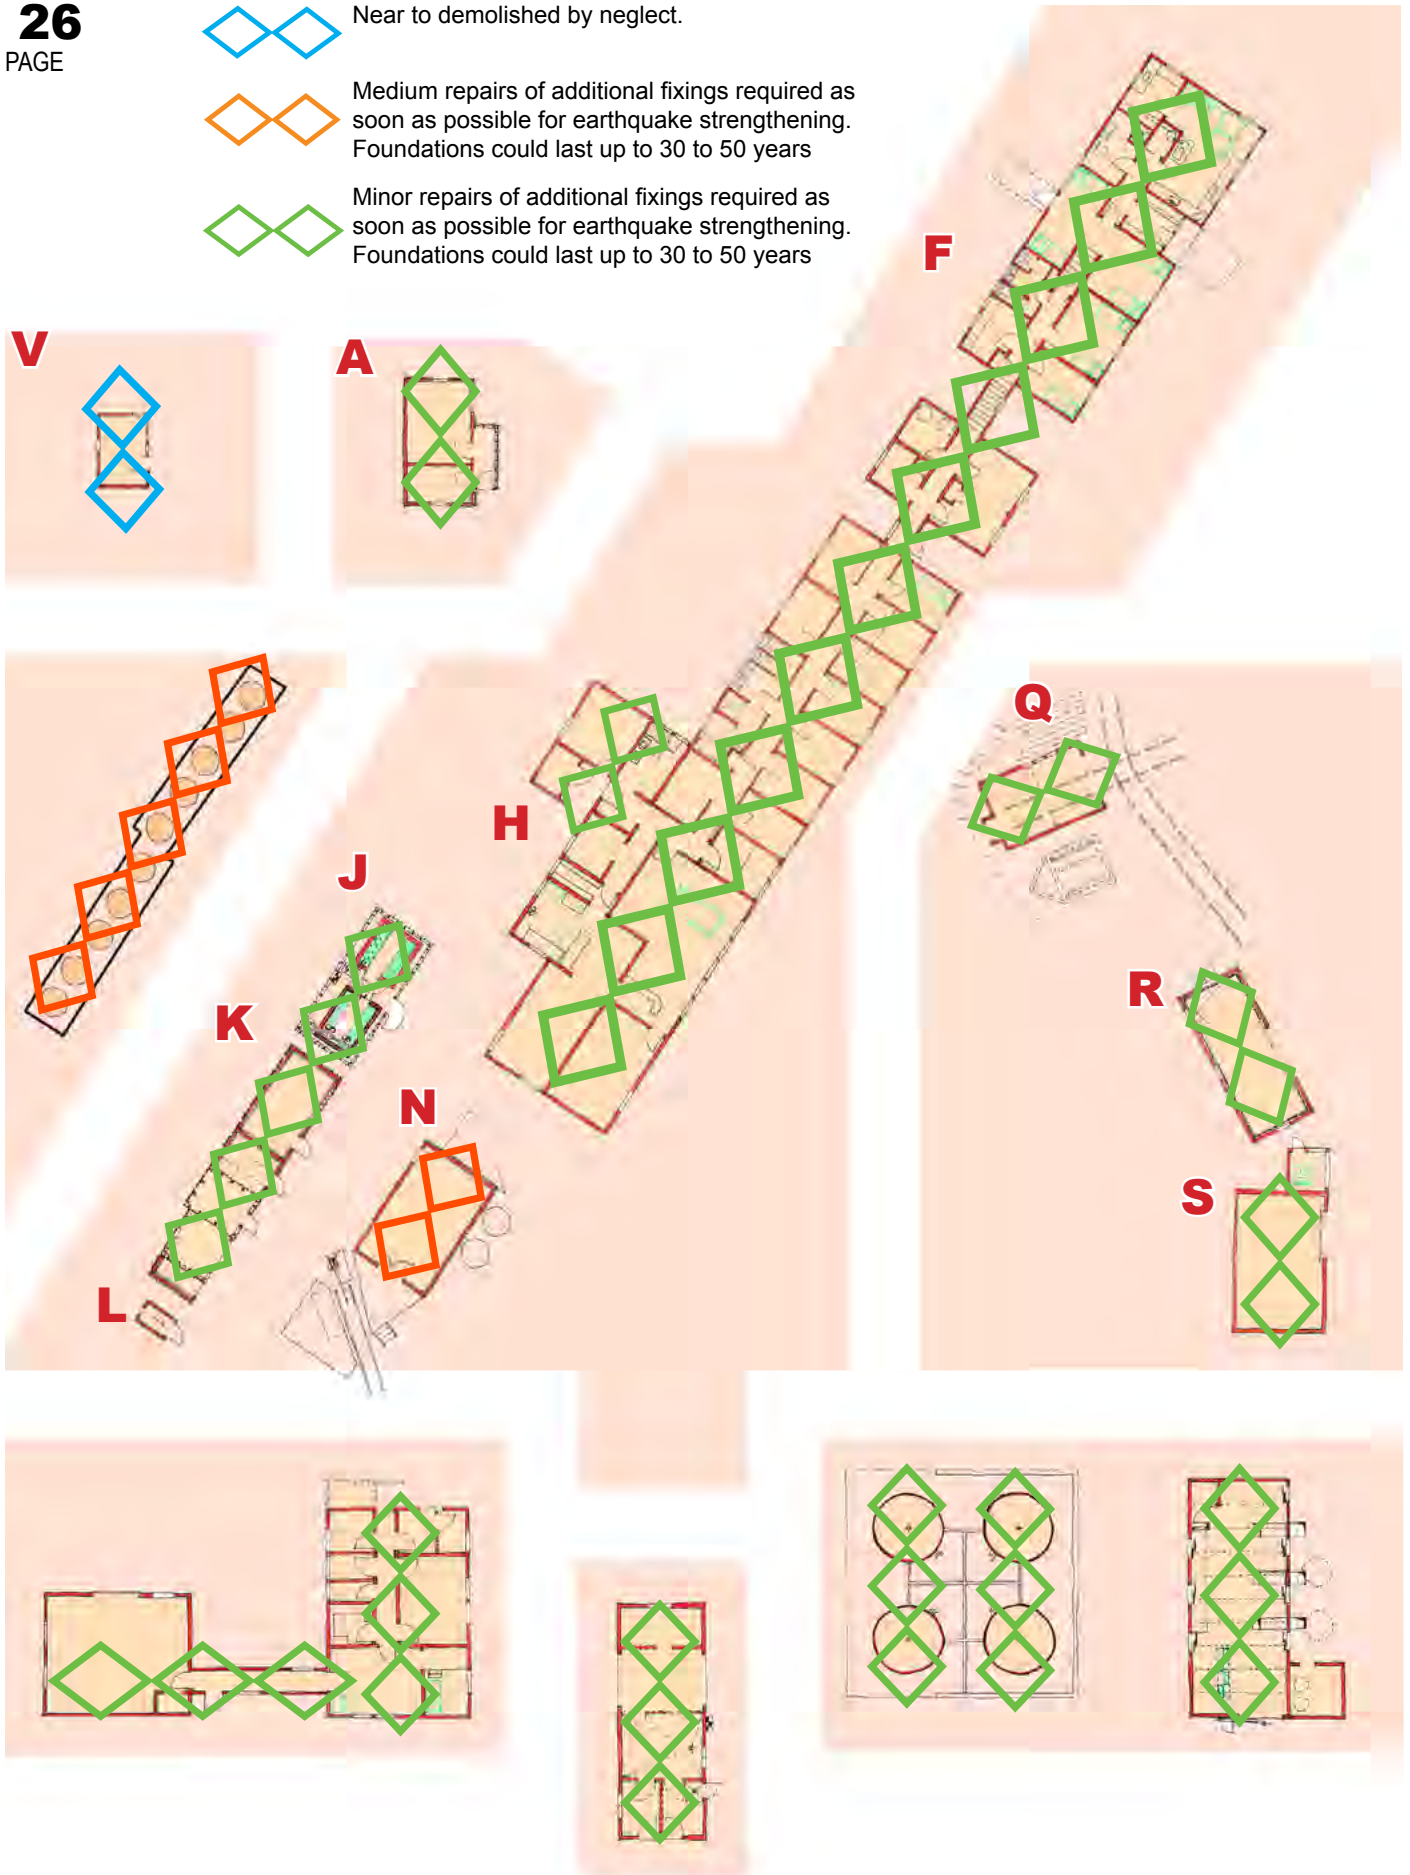
# foundation condition
