**CAMPBELL ISLAND**  
**meteorological station**  
BUILDINGS, CONDITION & PLANS

MEASURED FEBRUARY 2017

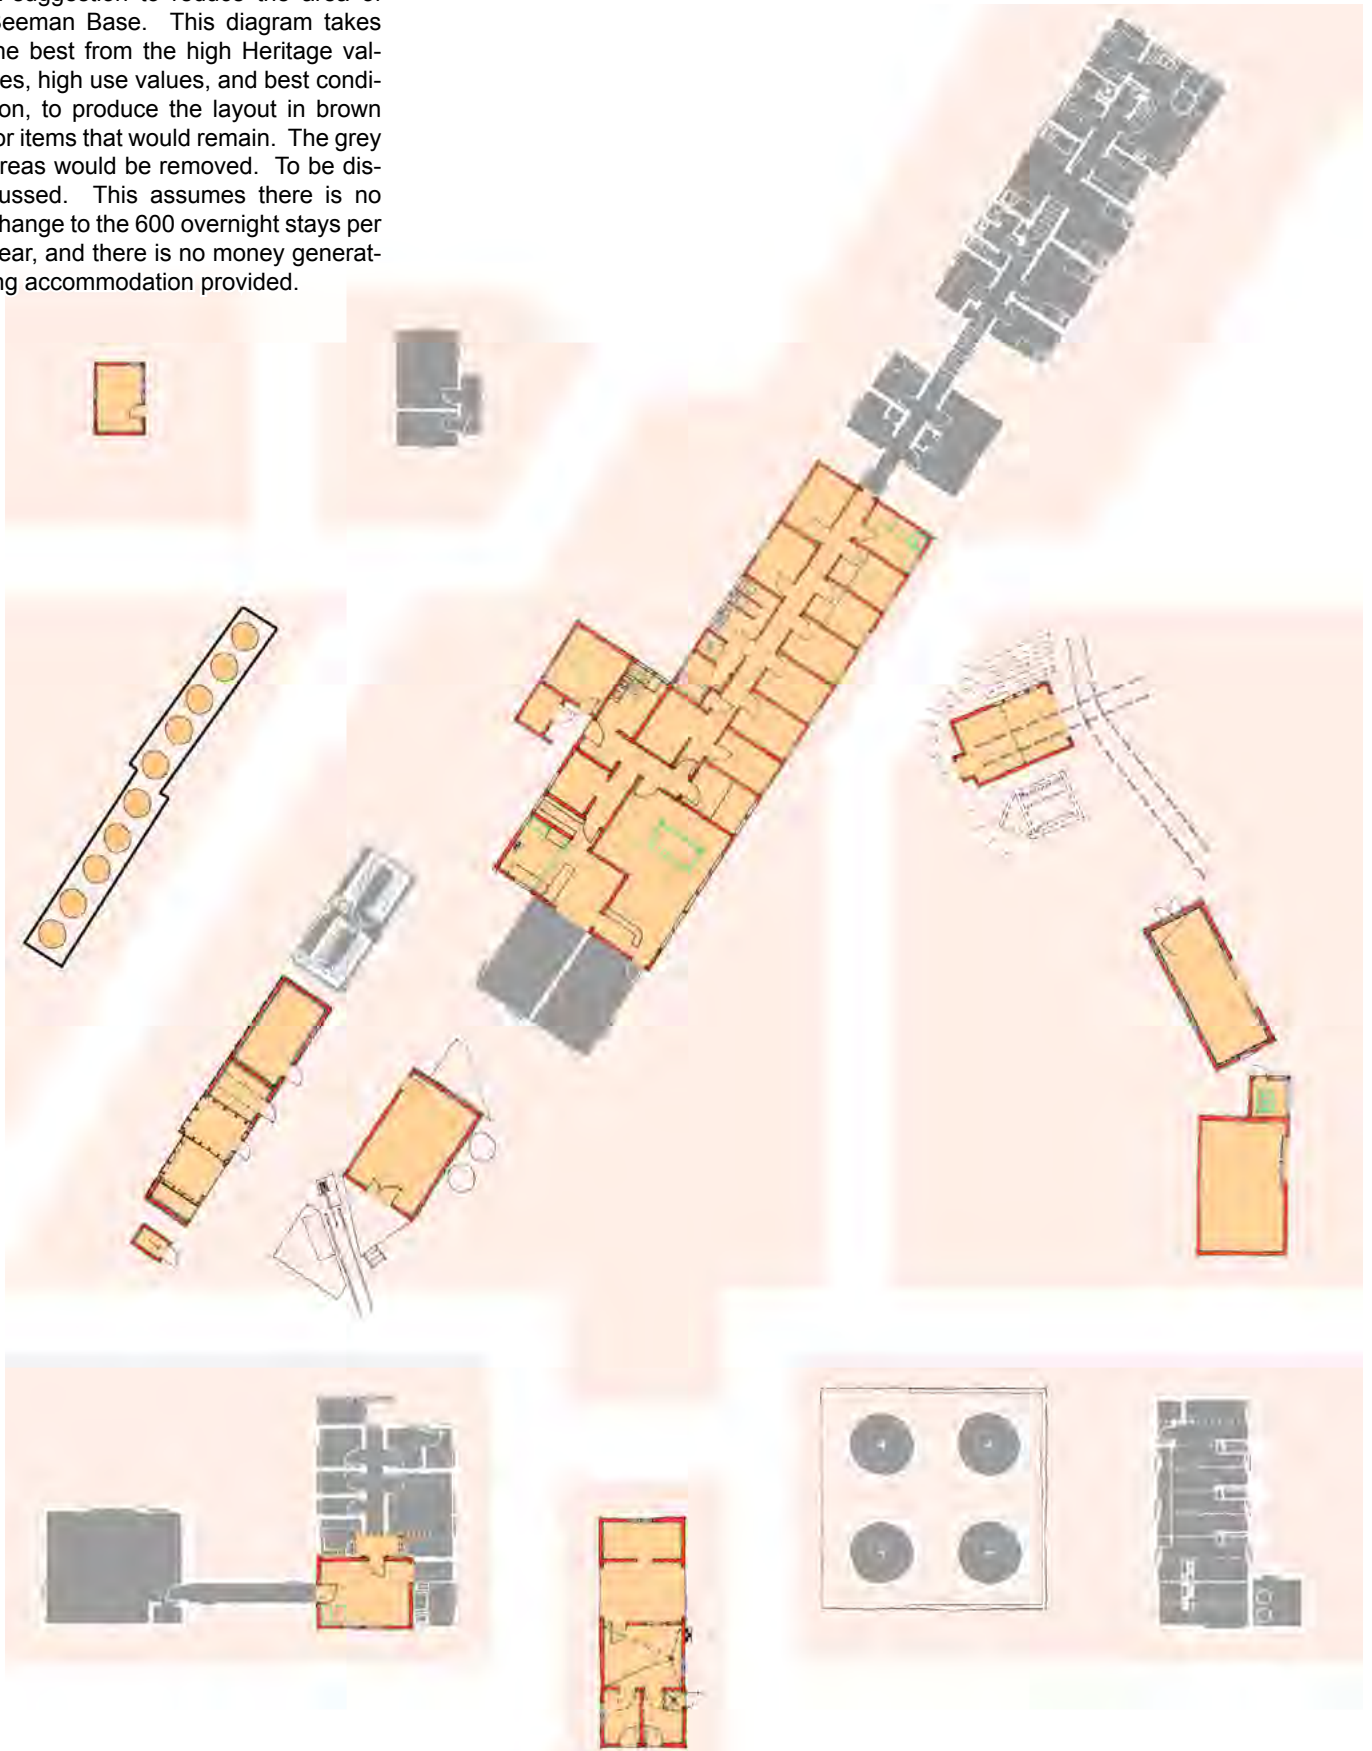
SUGGESTED USE. For discussion.  
A suggestion to reduce the area of Beeman Base. This diagram takes the best from the high Heritage values, high use values, and best condition, to produce the layout in brown for items that would remain. The grey areas would be removed. To be discussed. This assumes there is no change to the 600 overnight stays per year, and there is no money generating accommodation provided.

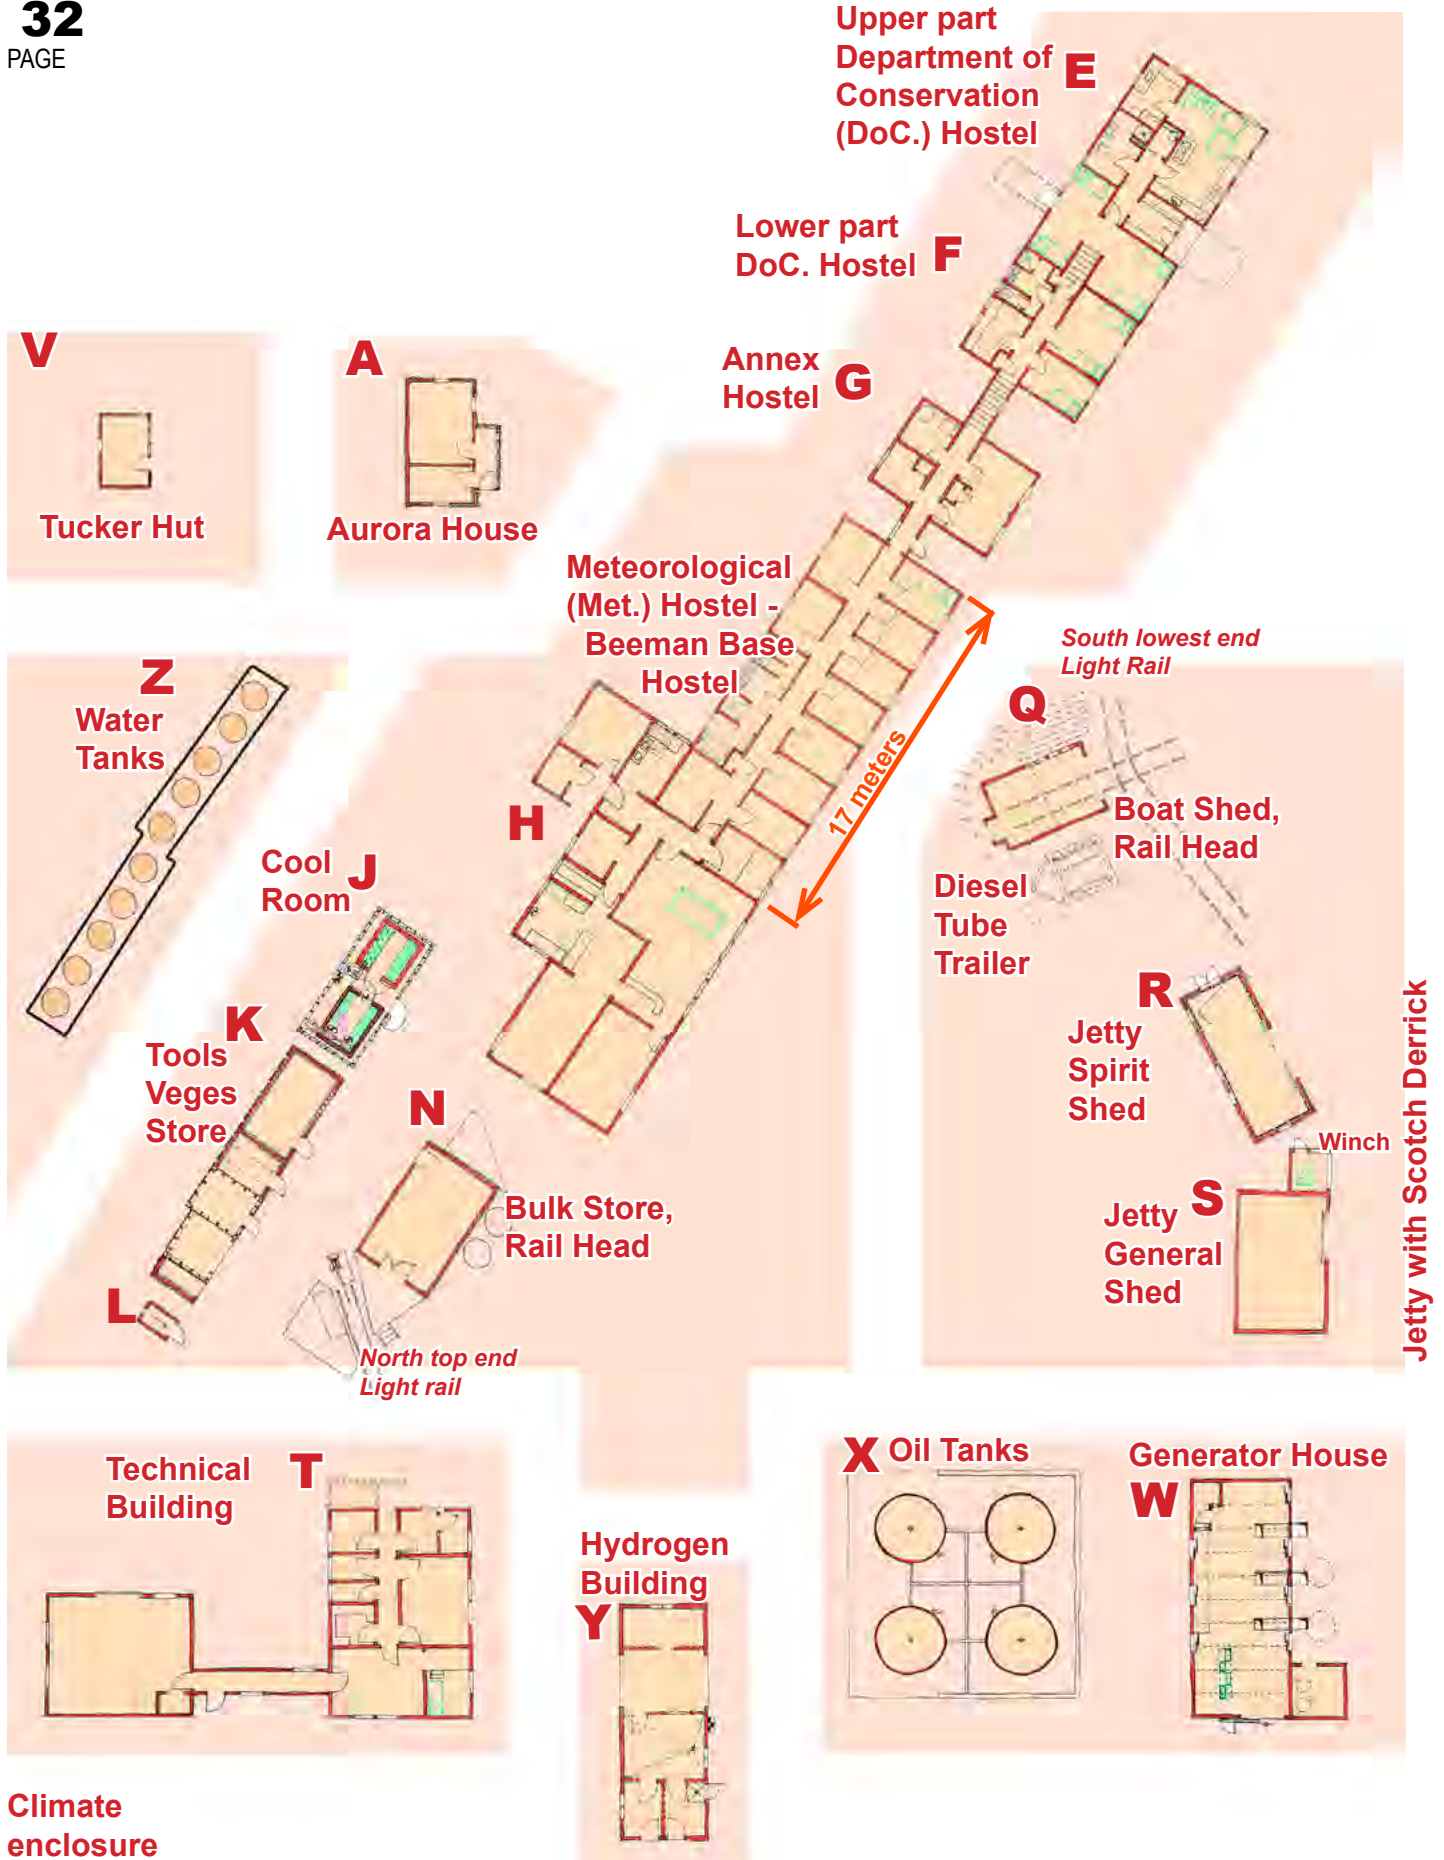
Figure 2-2  
LEFT Condition of the historically and most highly significant building, the Tucker Hut.

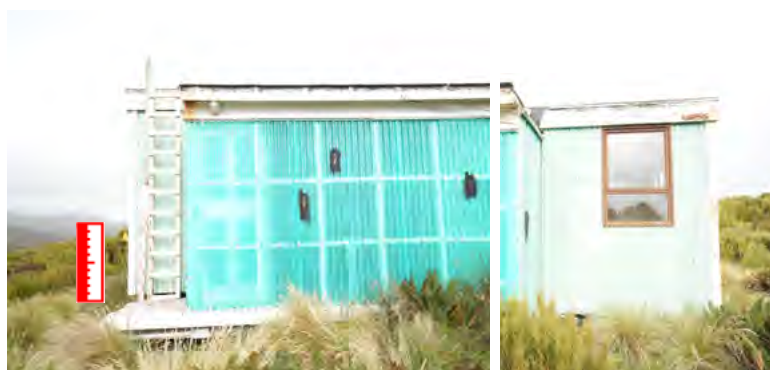
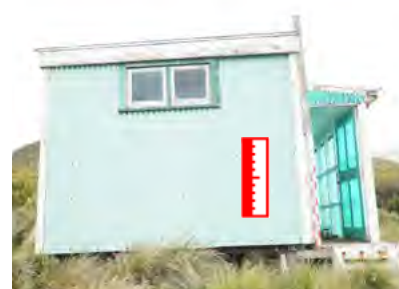
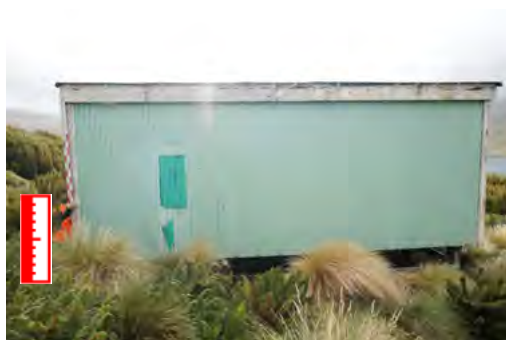
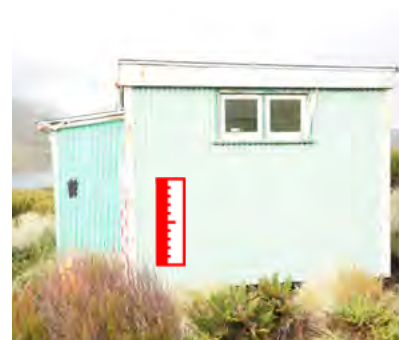
Figure A1 ; A2 ; A3 ; A4  
The four elevations of Aurora Hut.  
The patches are where the plastic cladding, added over the previous, have cracked and deteriorating.  
The timber cladding below was leaking before the plastic over-clad.

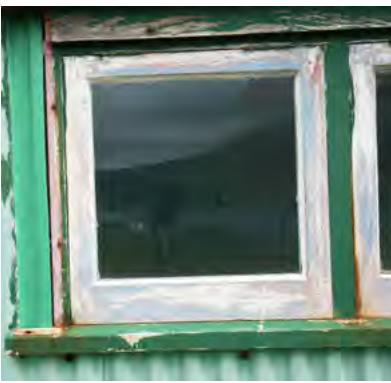
Figure A5  
 ABOVE -The south window, in poor condition. This will be leading to leaks and the high moisture content (27%) below this window.

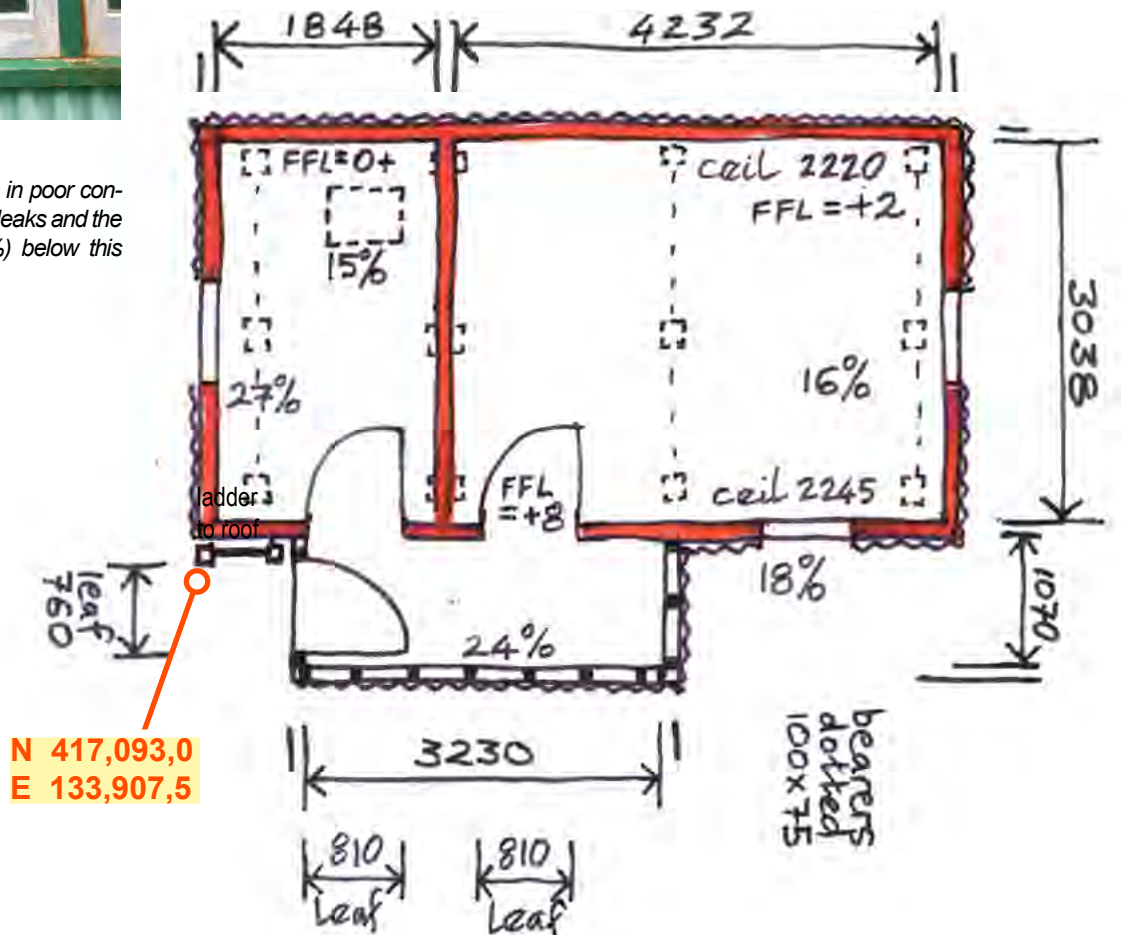
Figure A6  
 RIGHT -Aurora Floor Plan

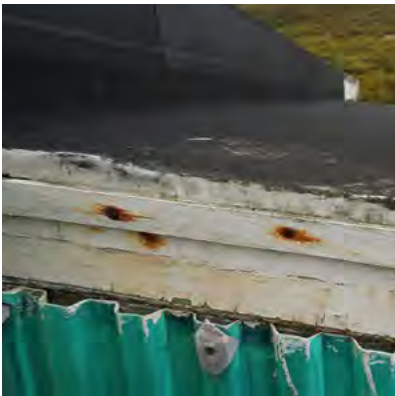
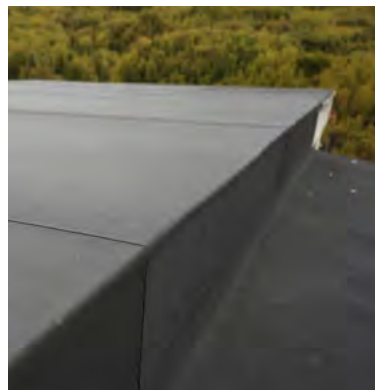
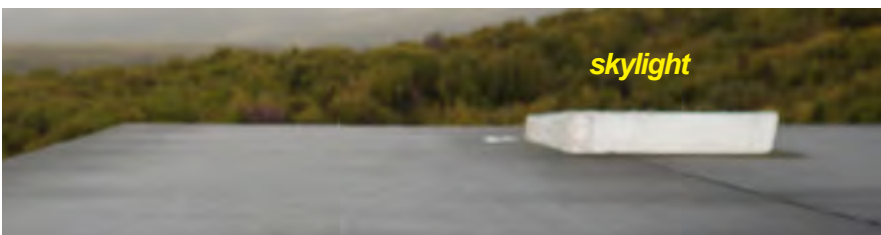
Figure A8 ; A9 ; A10  
The roof membrane is in good condition, but very poor detailing around all the edges means that the roof will leak &/or peel off in high winds.  
The skylight has no upstand and this will lead to inevitable decay if no corrective action is completed.

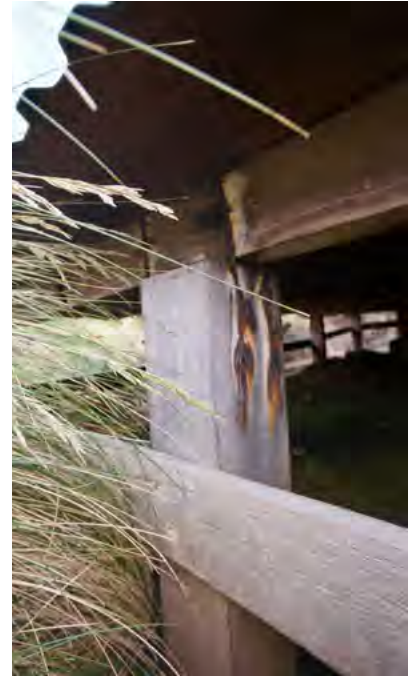
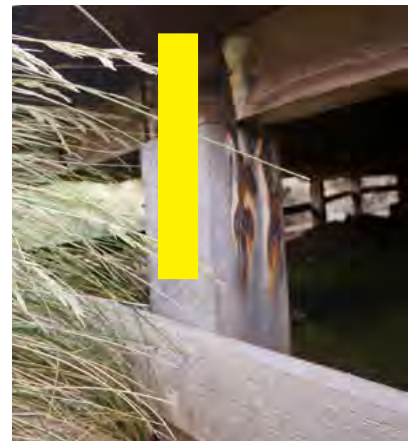
Figure A7  
TOP The foundations "as is" and BOTTOM the position of the additional stub stud required is drawn in yellow below. This will assist in earthquake resilience.

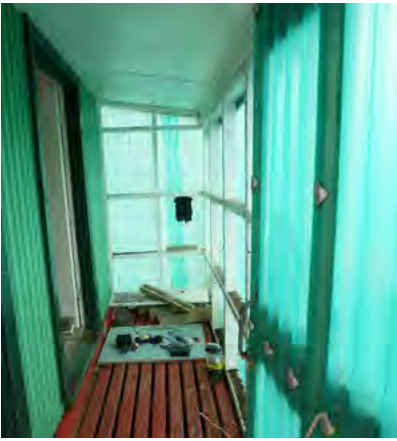
Figure A11  
ABOVE The open porch

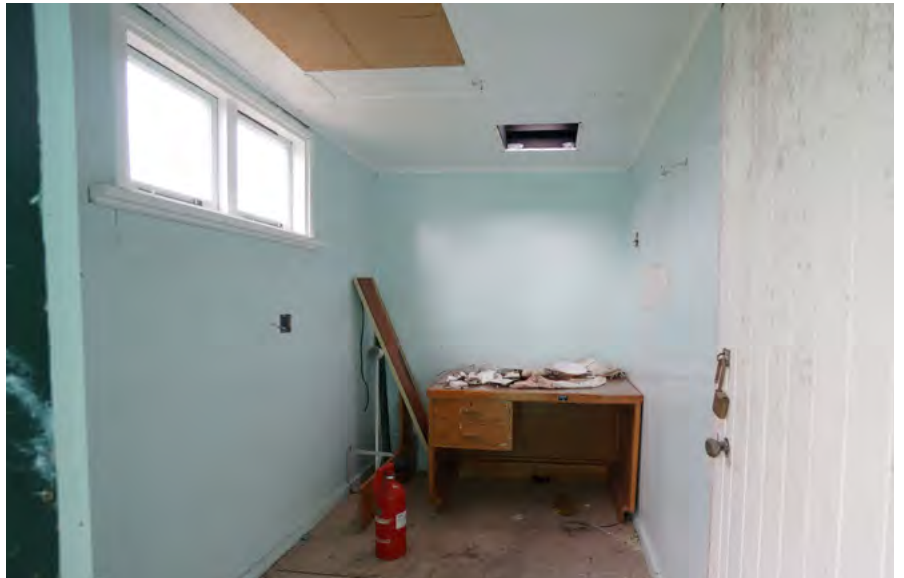
Figure A12  
ABOVE RIGHT - The smaller room, with  
the leaking window to the left. The skylight  
is above the desk.

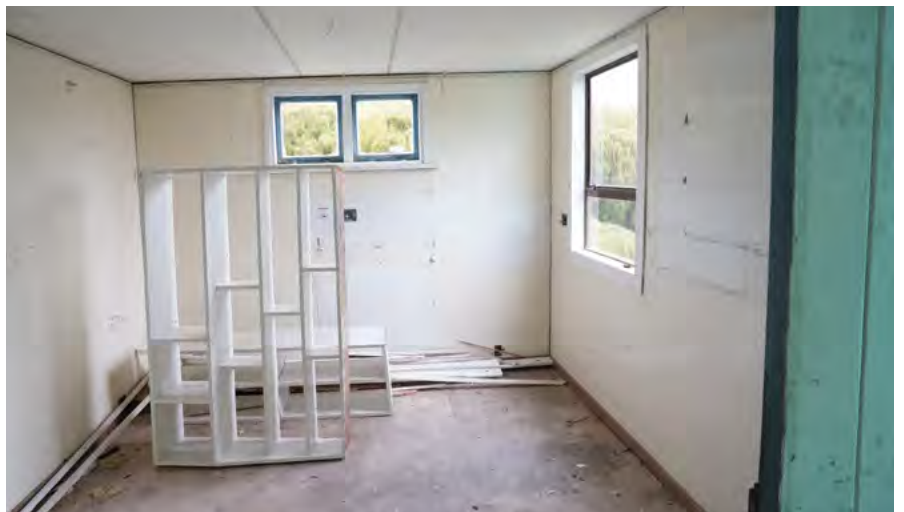
Figure A13  
RIGHT -The larger room

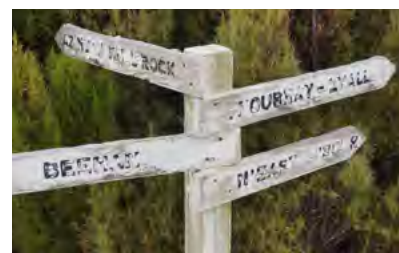
Figure B1  
AZIMUTH HILL ROCK  
MOUBRAY - LYALL  
BEEMAN  
N'EAST H'BOUR

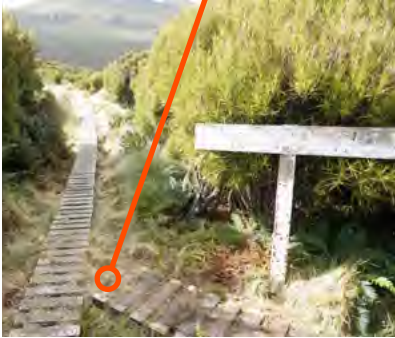
Historic significance  
Foundation condition

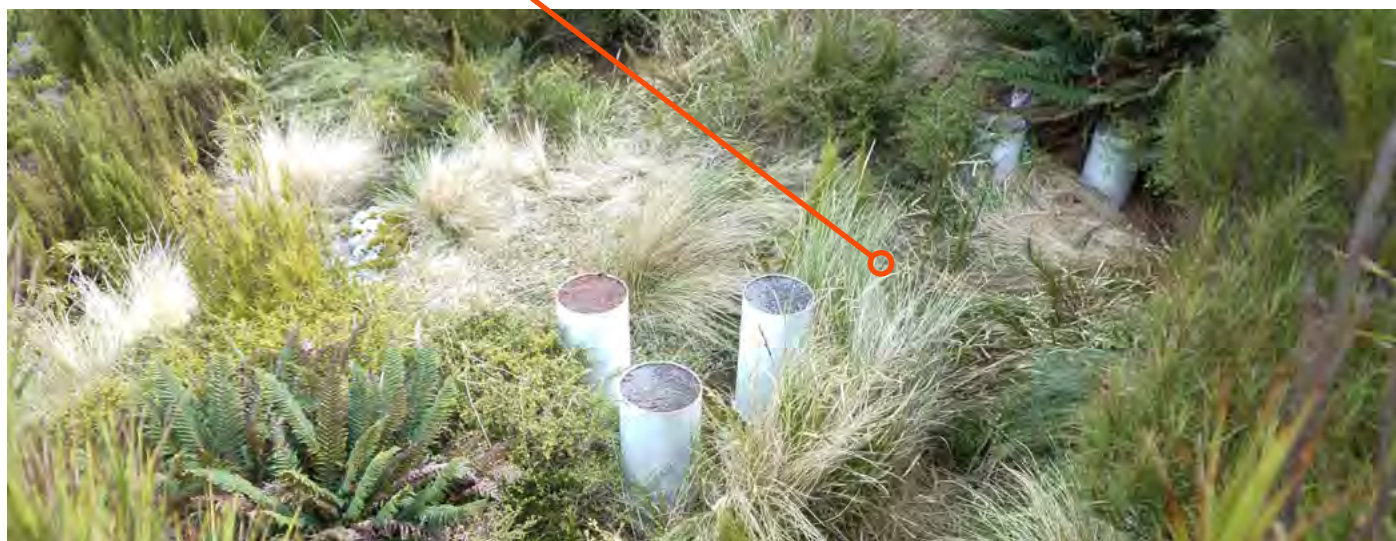
# geomagnetic observ.

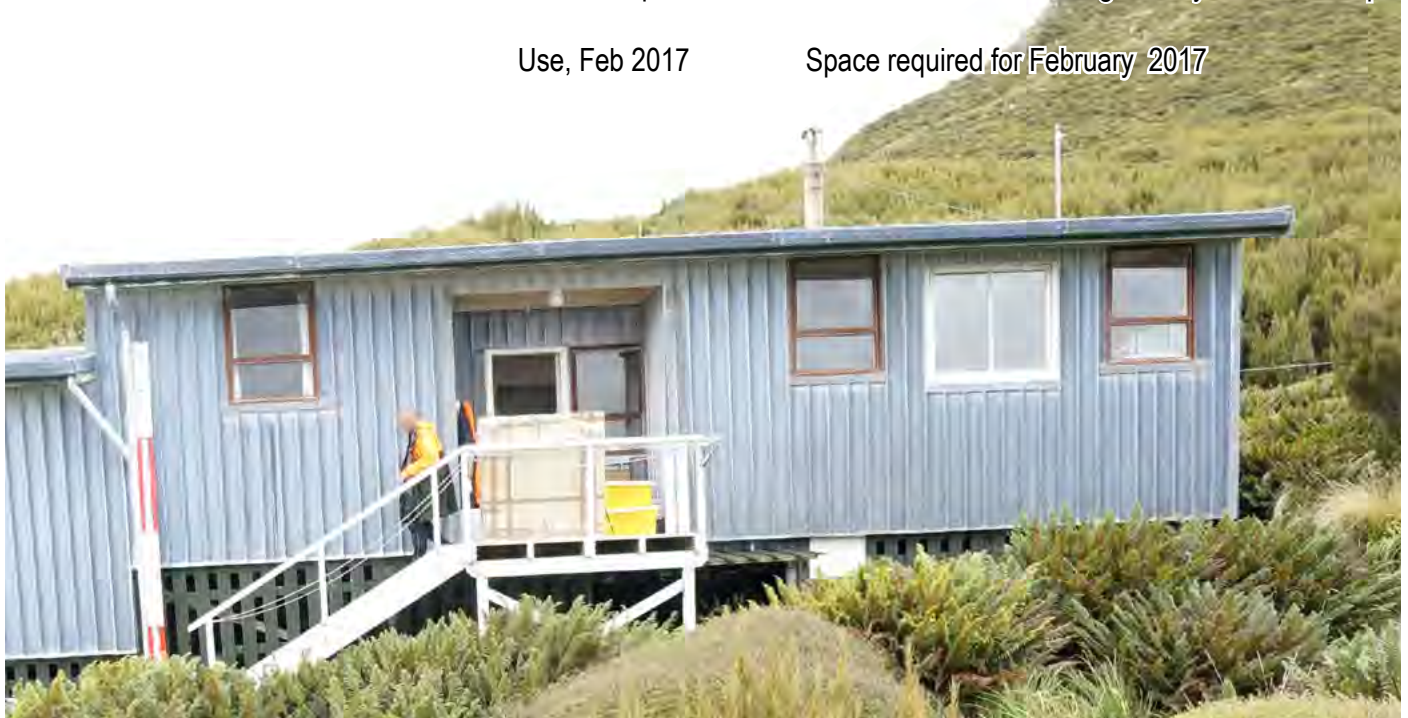
*Figure E1  
 Hostel, DoC end. The original alum windows are brown, and the assumption is that the recently added timber windows, (which are leaking) are white*

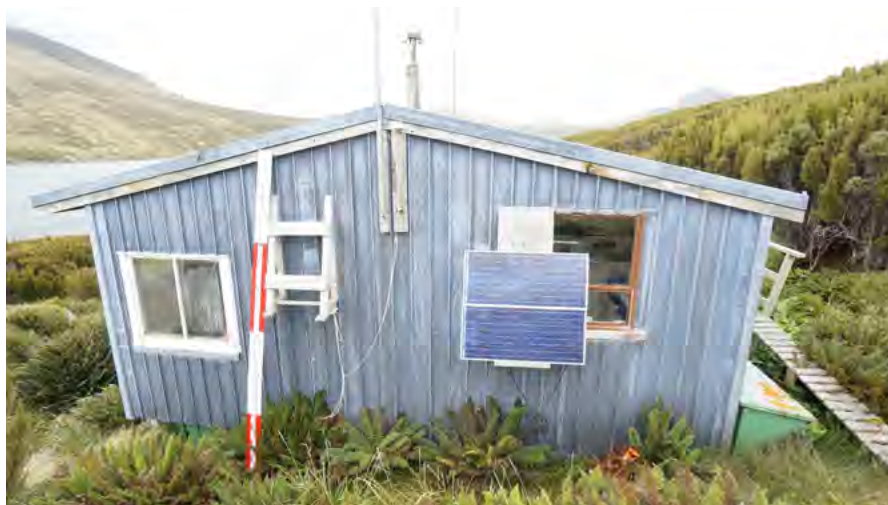
Figure E2  
LEFT TOP. Hostel, DoC end. The recently added timber window which is leaking is white

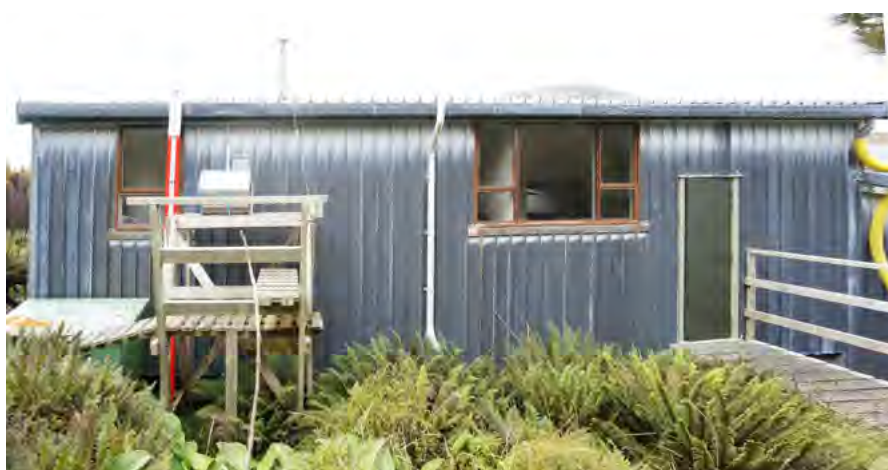
Figure E3  
LEFT MID. Diesel fire equipment on the left.

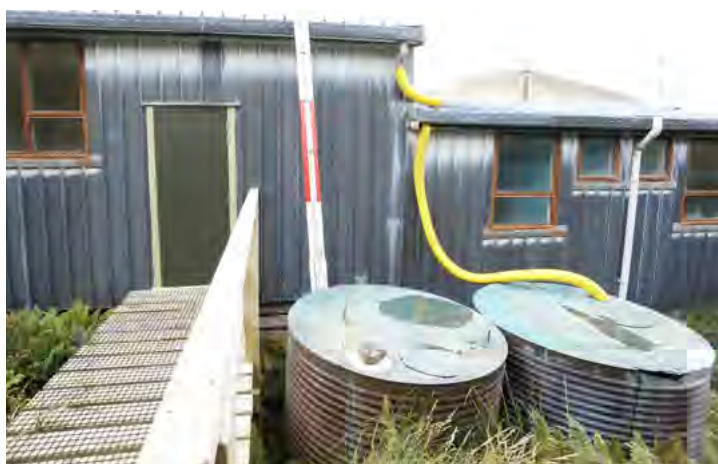
Figure E5  
BELOW. Connection to space F, with barge boards missing. This will lead to decay.

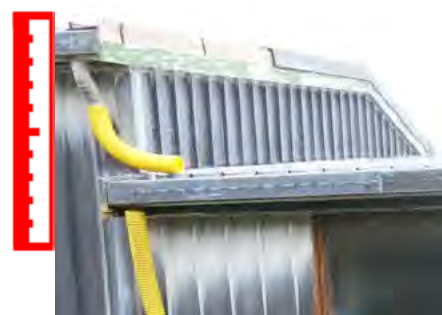
# dept. conserv. hut

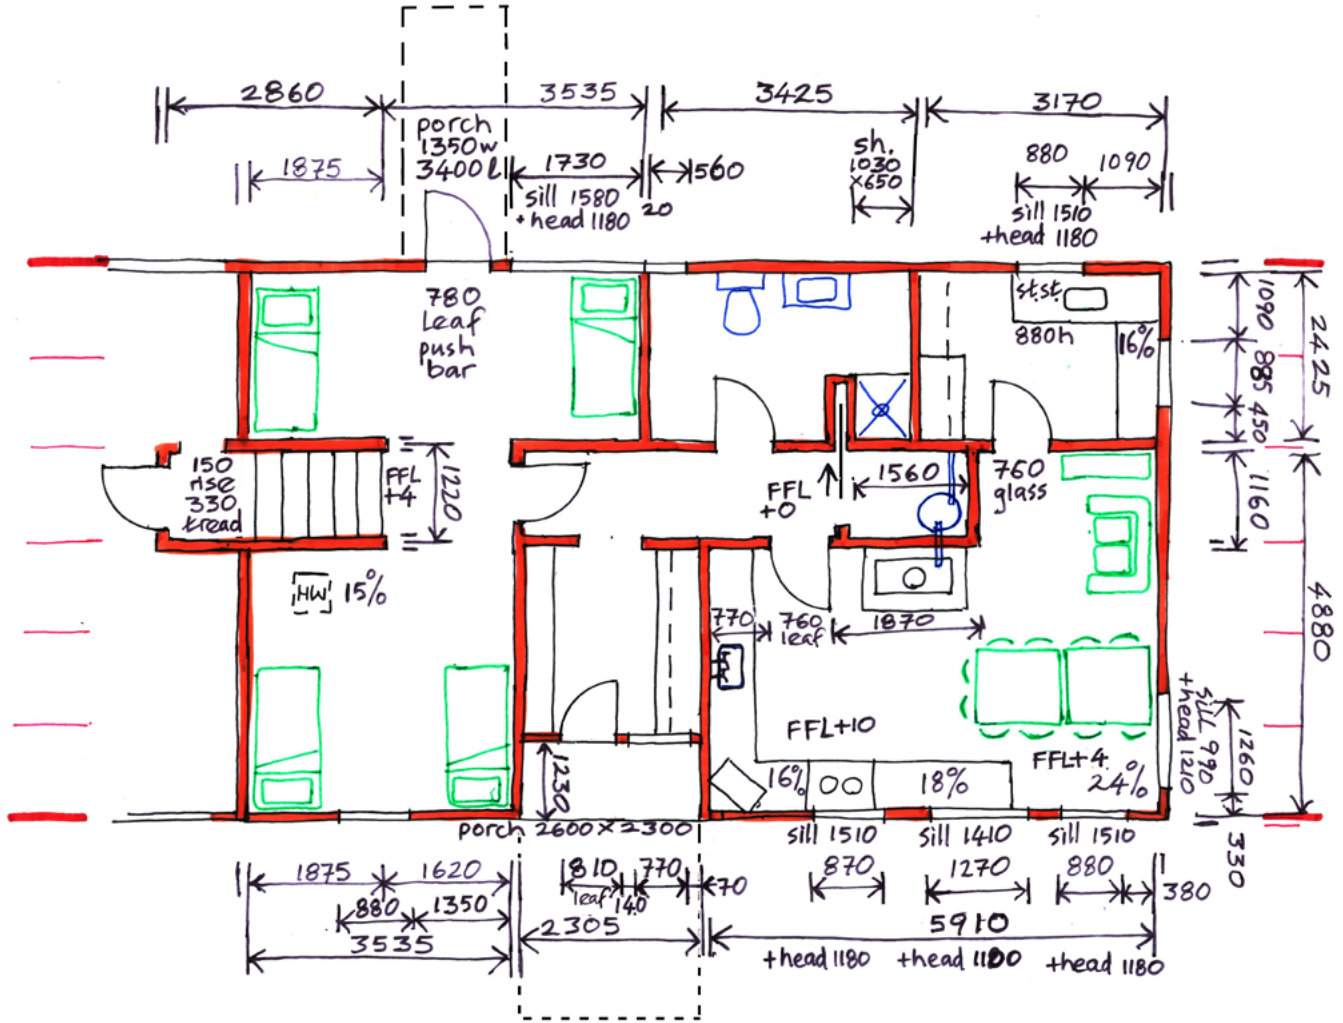
Figure E6  
 Hostel, DoC end. The leaking window is in the bottom right hand side of the plan, where internal framing moisture content was recorded at 24%. Readings for dry construction in the Campbell Island environment should be 15% to 16%.

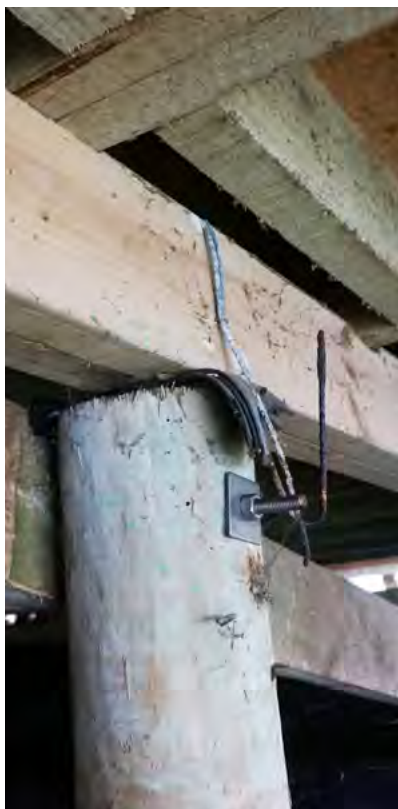
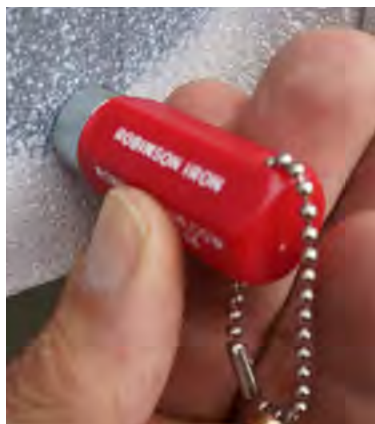
Figure E7  
LEFT TOP. Foundations of all Hostel Huts, showing requirement for earthquake strengthening in red, where a stub stud is required.

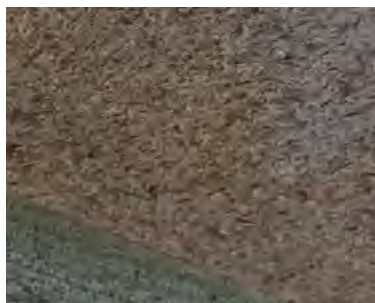
Figure E9  
LEFT. Condition of underside of particle board flooring

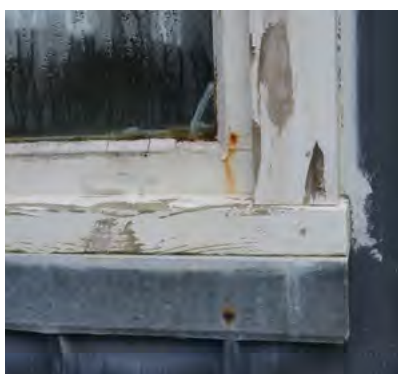
Figure E10  
LEFT BELOW. Timber window, sill, where leaks will be testing the durability of the framing .

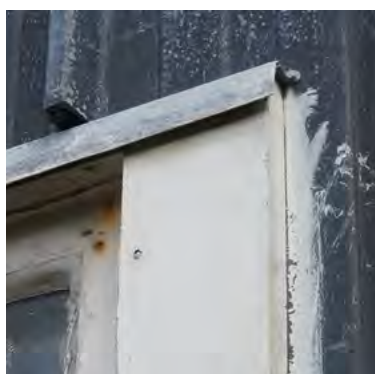
Figure E11  
LEFT BELOW. Same window showing the window head

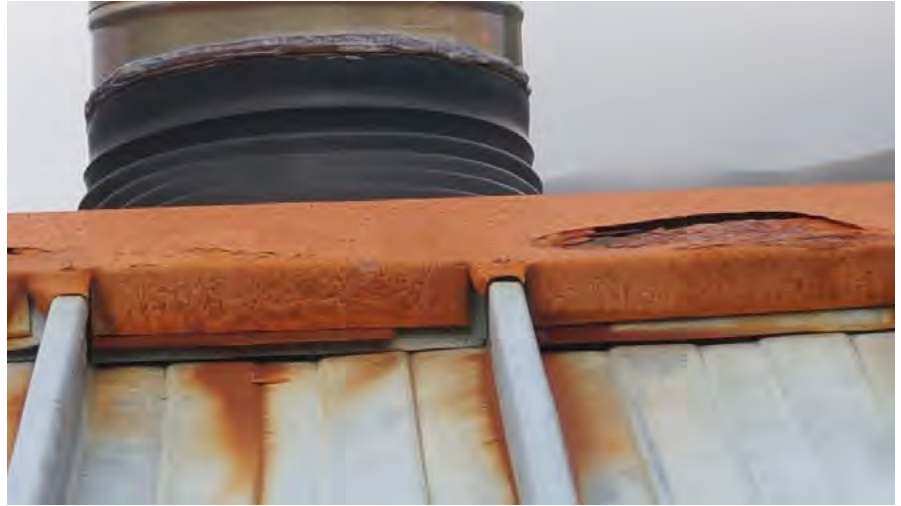
Figure E13  
RIGHT BELOW. Condition of cladding, where the white areas are white rust, or Zinc oxidation. This is the start of a process that leads to cladding perforation

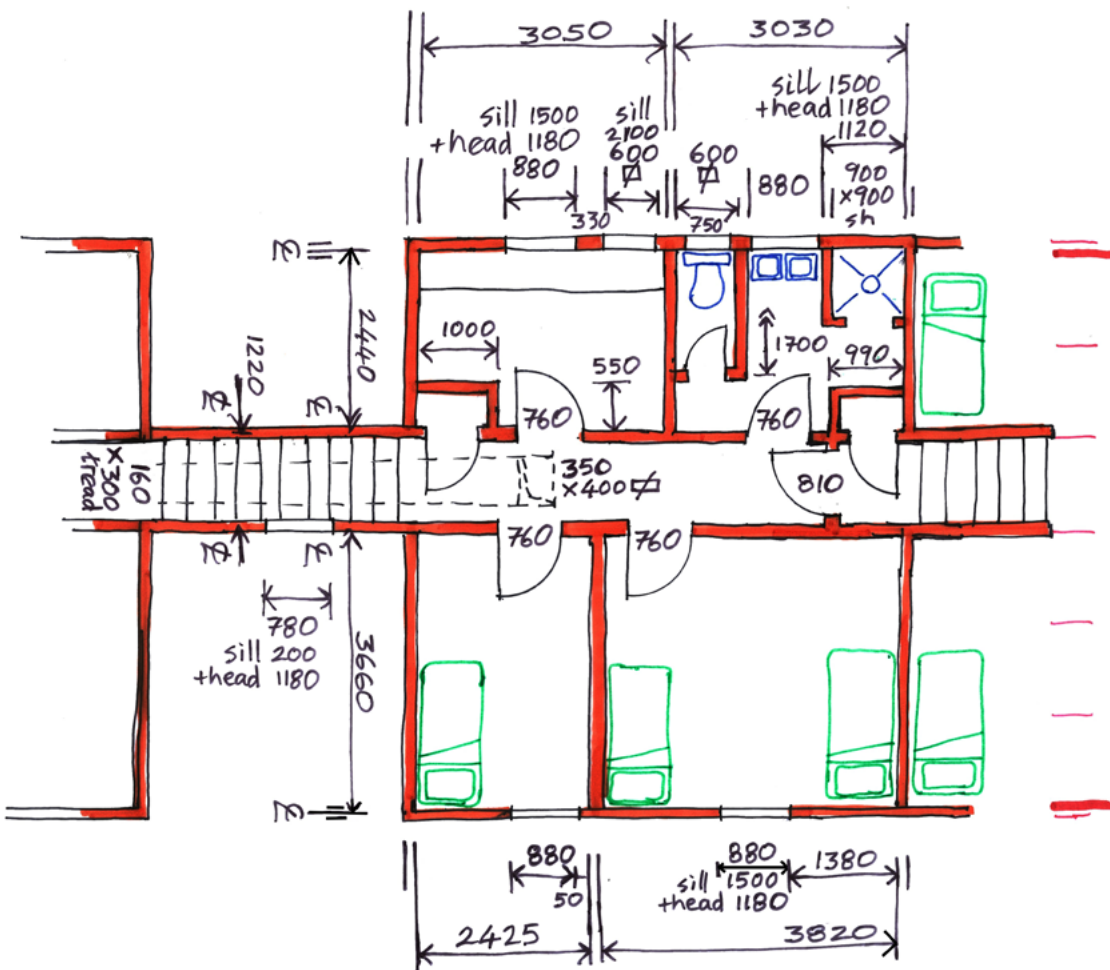
Figure F2  
BELOW. Floor Plan, with items drawn in green being removable furniture.

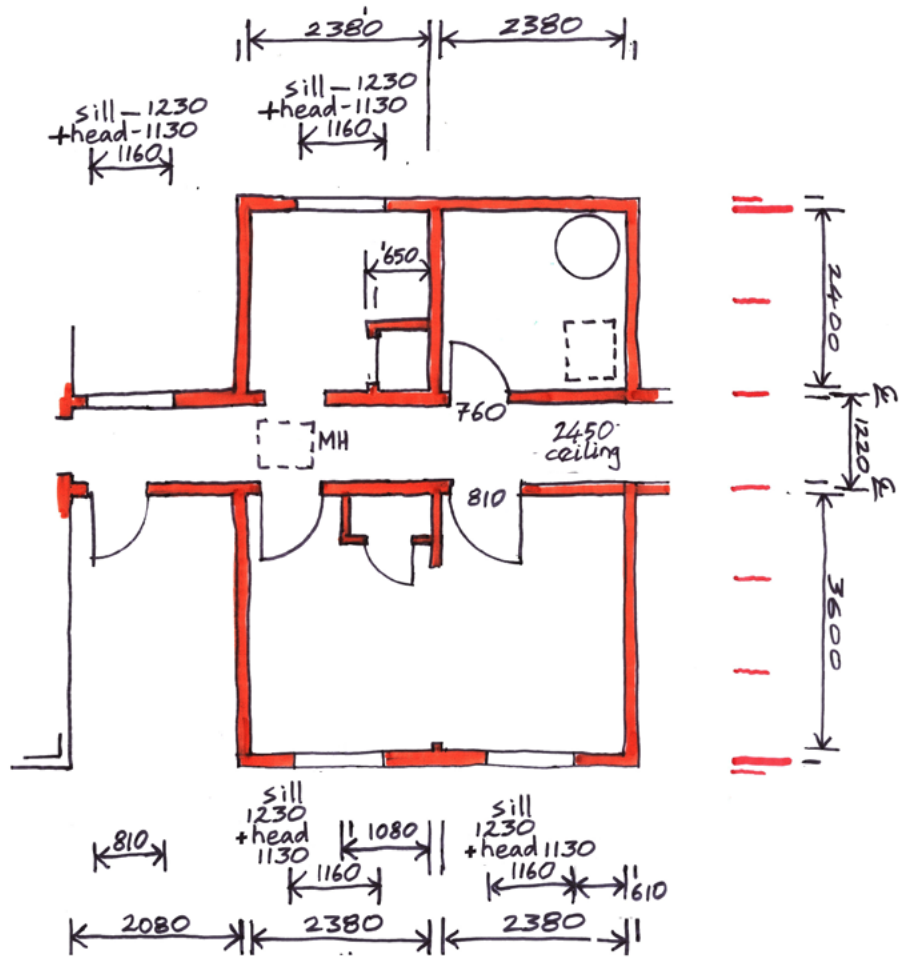
Figure G3  
RIGHT -Hostel sleeping annex plan.

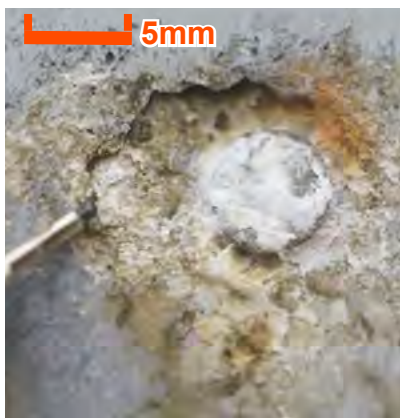
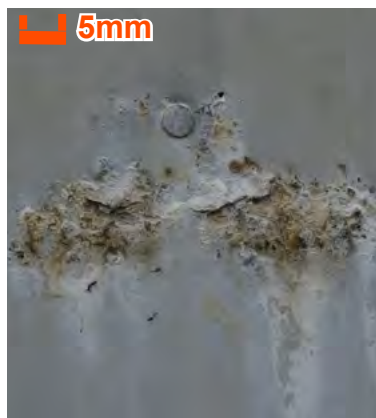
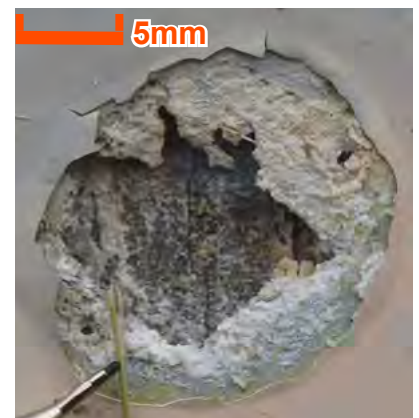
Historic significance      High historically significant.  
Construction                Techniques historically significant and unique.

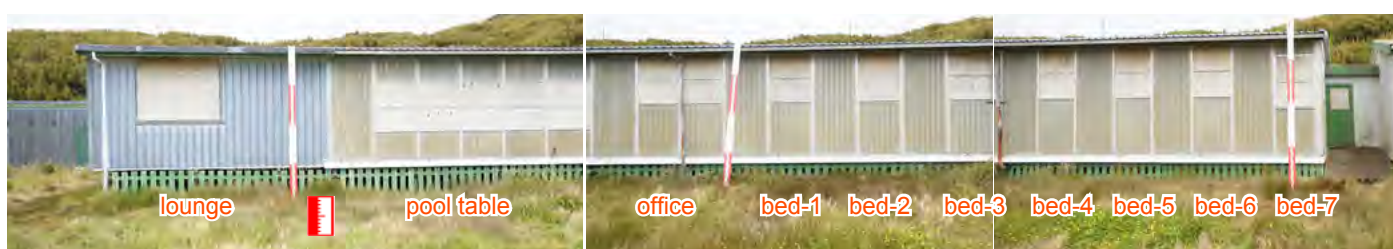
Figure H1  
Hostel, east elevation, with plywood shutters installed. The aluminium has a slight green tinge and was the original building installed on white pine piles. The recent lounge addition, installed on treated pine piles, with zinc cladding, is a blue grey on the left.

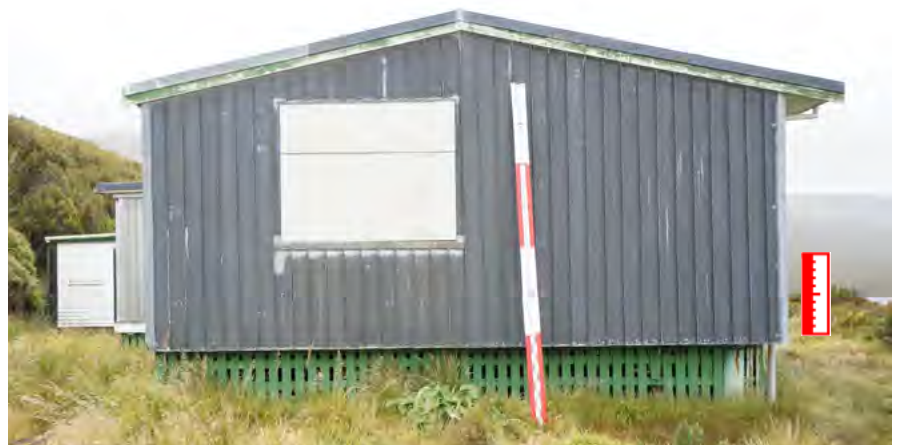
Figure H3  
 ABOVE The recent zinc clad addition at the south end of the Hostel. The copper treated shutter installed over the window shown in this photo is corroding the zinc.

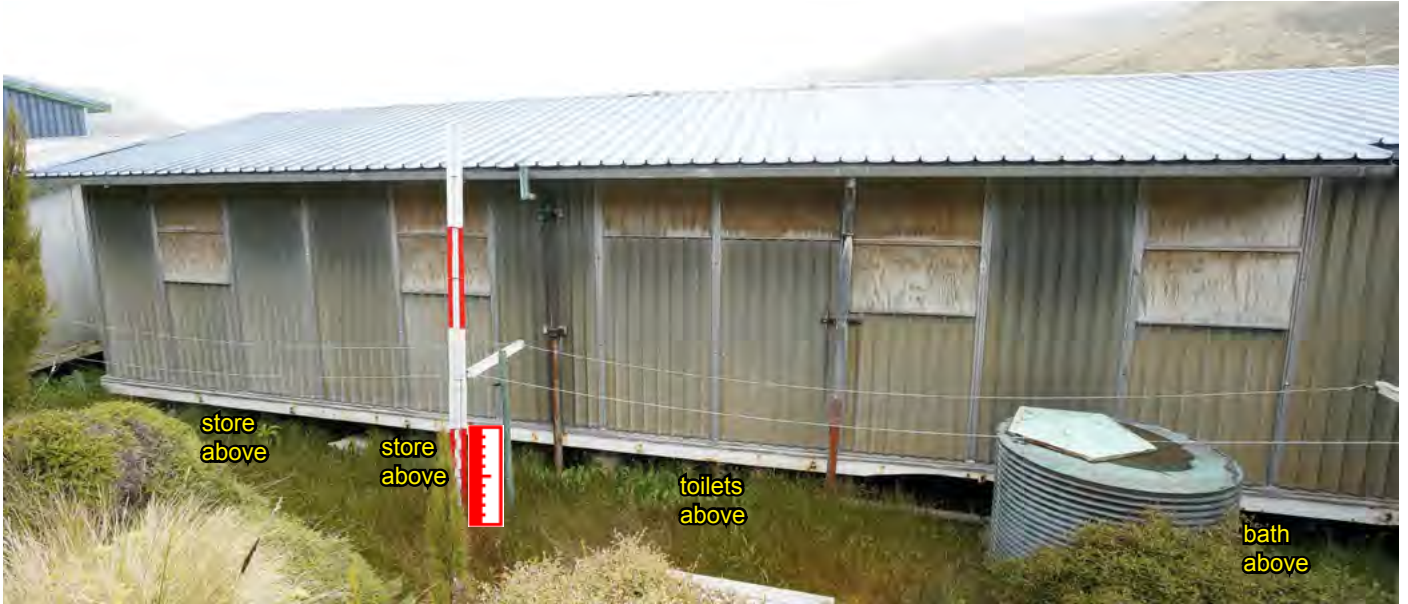
Figure H4  
ABOVE The west elevation of the Hostel,  
the north end.

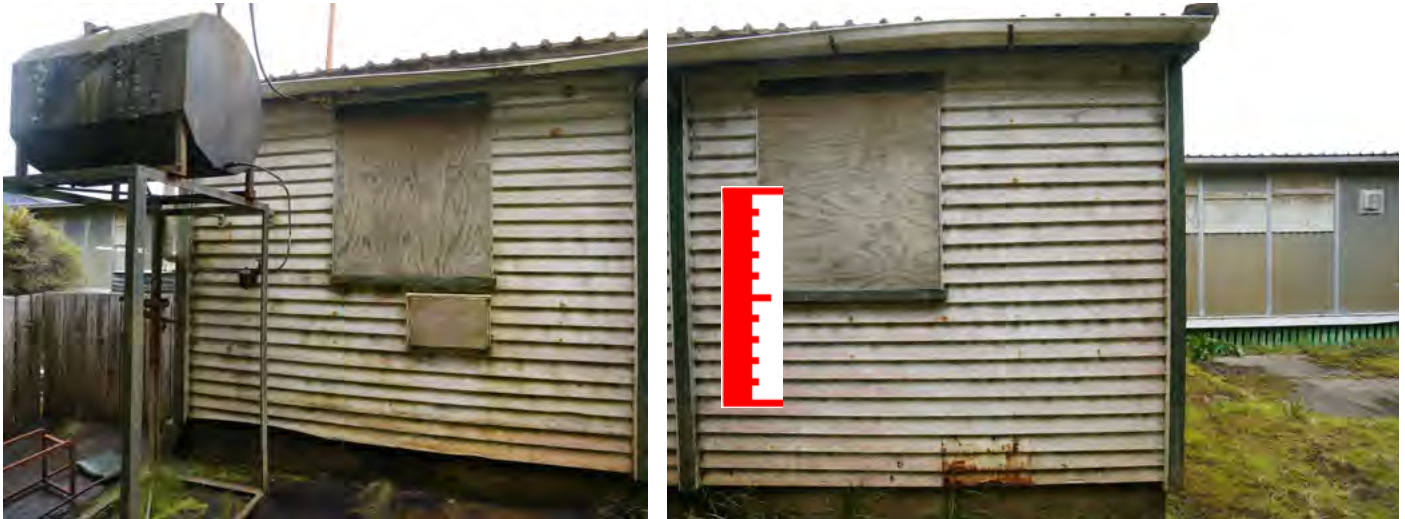
Figure H6 & H7  
ABOVE The west elevation of the Hostel,  
the west wall of the store.

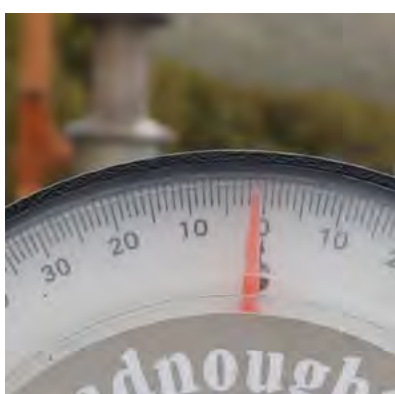
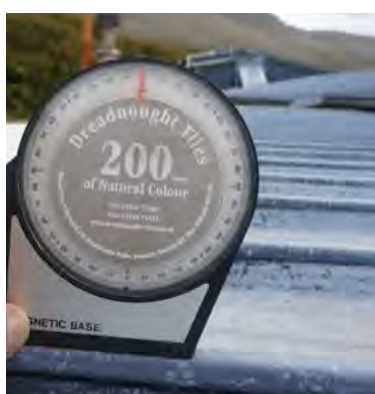
*Figure H13 & H14  
LEFT The roof above the kitchen and laundry has a negative slope, and relies on wind and evaporation to clear water. From the original plans, the elevation drawings could indicate that the roof was originally clad with a membrane, as the barge boards are horizontal. This membrane roof cladding is not noted. The recent zinc roof cladding will suffice in the short term but does not meet any building standard or manufacturer's recommendations.*

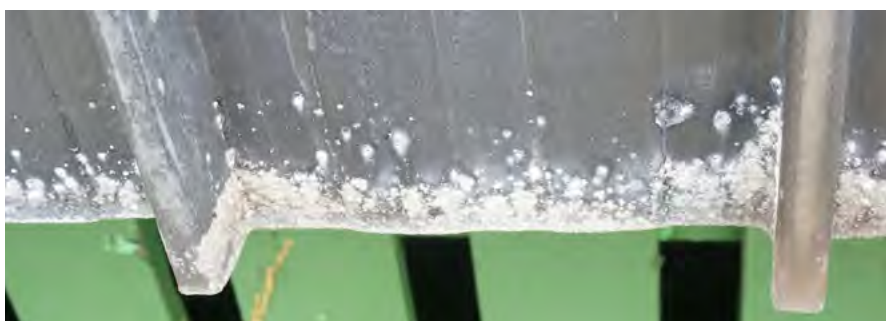
*Figure H15  
LEFT The zinc on the extension has started to corrode, white rust, or oxidation, is prevalent at the base of the recent zinc clad Hostel extension.*

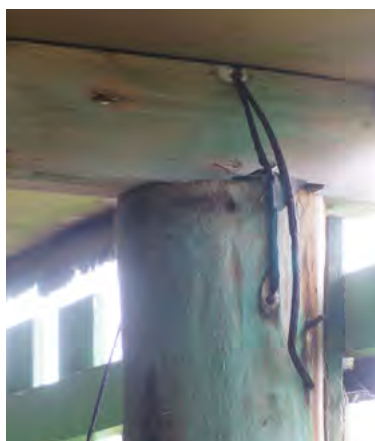
*Figure H16  
LEFT Loose number 8 wire connections, between the floor bearers and piles, were shown to provide little resistance to damage in an earthquake.*

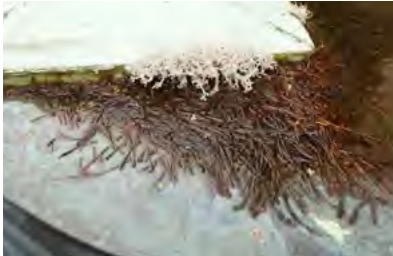
Figure J1  
 ABOVE Growth in and extending out of a water tank.

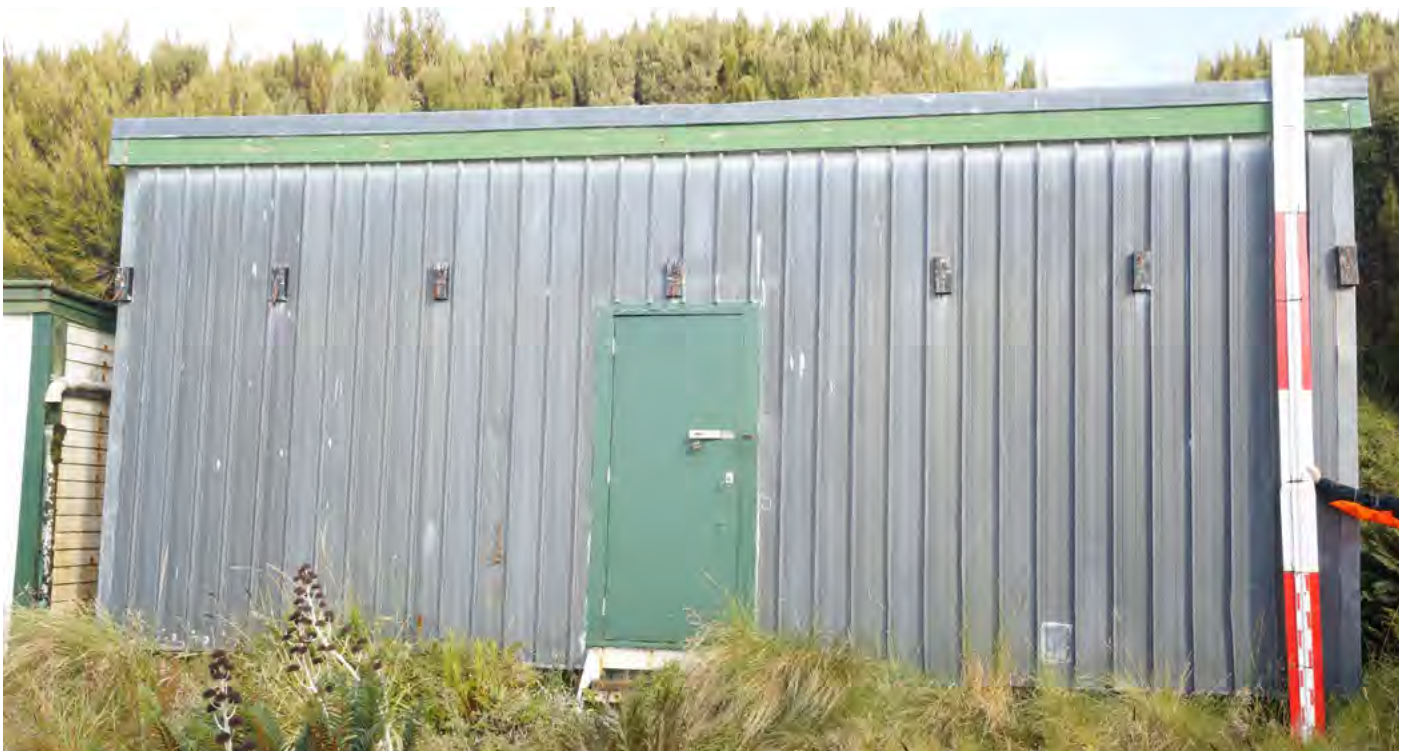
Figure J1  
BELOW The east elevation of the Cool Store.
