**CAMPBELL ISLAND**  
**meteorological station**  
BUILDINGS, CONDITION & PLANS

MEASURED FEBRUARY 2017

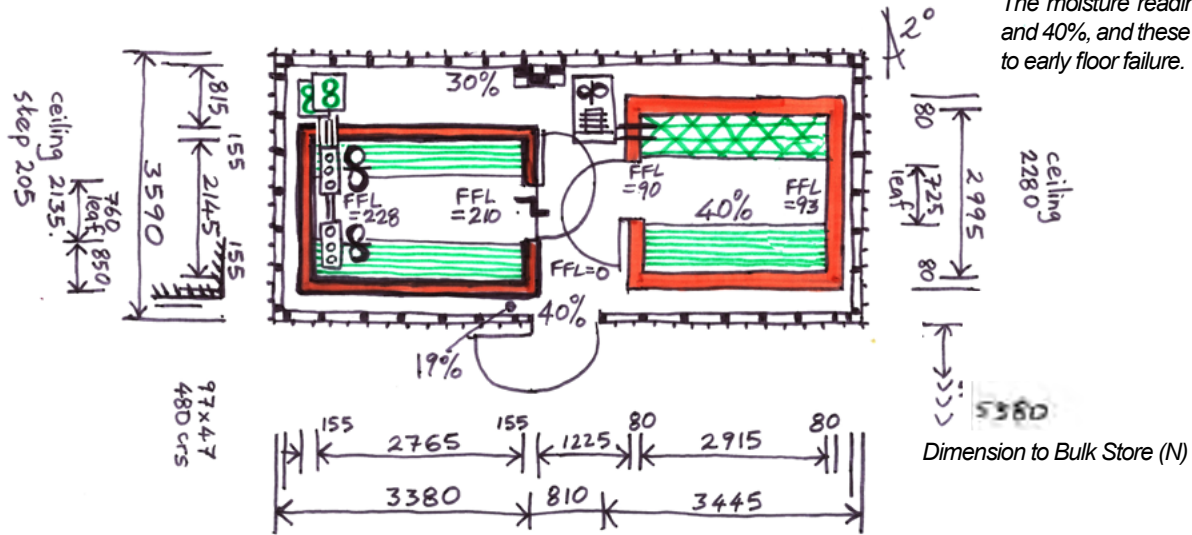
Figure J2  
The dimensioned plan of the cool store. The moisture readings are high, at 30% and 40%, and these percentages will lead to early floor failure.

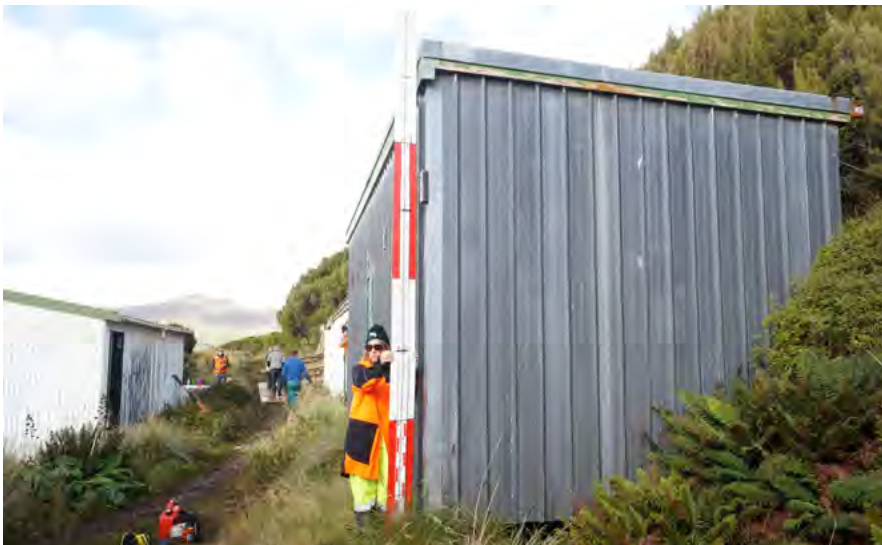
Figure J3  
The north elevation of the Cool Store. Compare the condition of the Marsden matting as Michael Kelly, in his historic report, August 2017, took a photo from a similar angle.

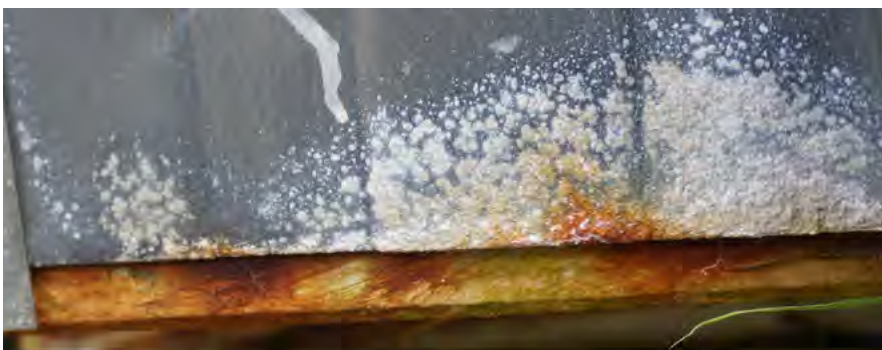
Figure J4  
The bottom edge of the cladding of the Cool Store. The bottom plate is visible. Water runs down the cladding, and then over the bottom plate, where the timber will absorb this moisture. This is transferred to the floor where high moisture levels are recorded. This will lead to early floor failure.

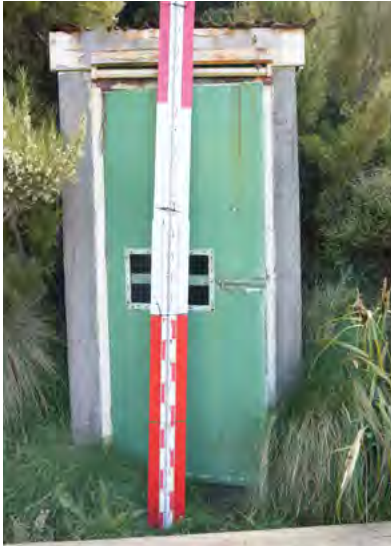
Figure L1  
ABOVE The Meat hanging and butchery hanging room. The roof and walls are in very poor condition.

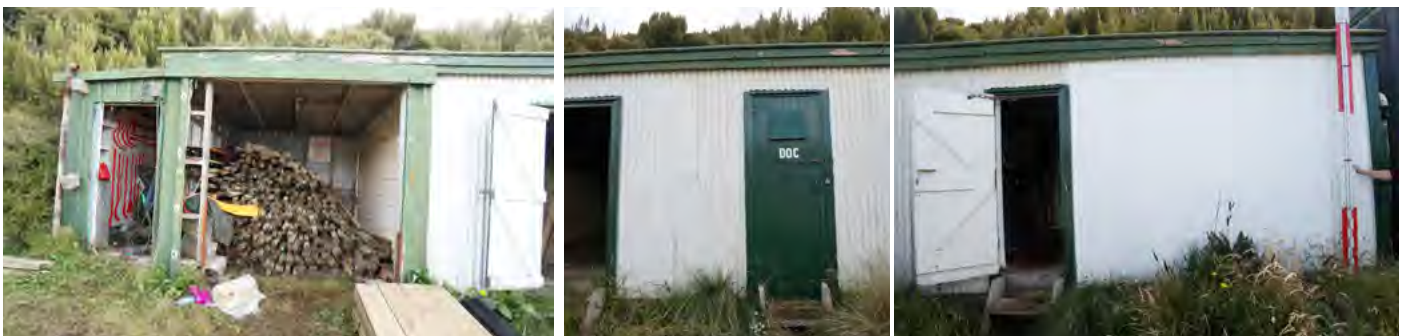
Historic significance  
Construction

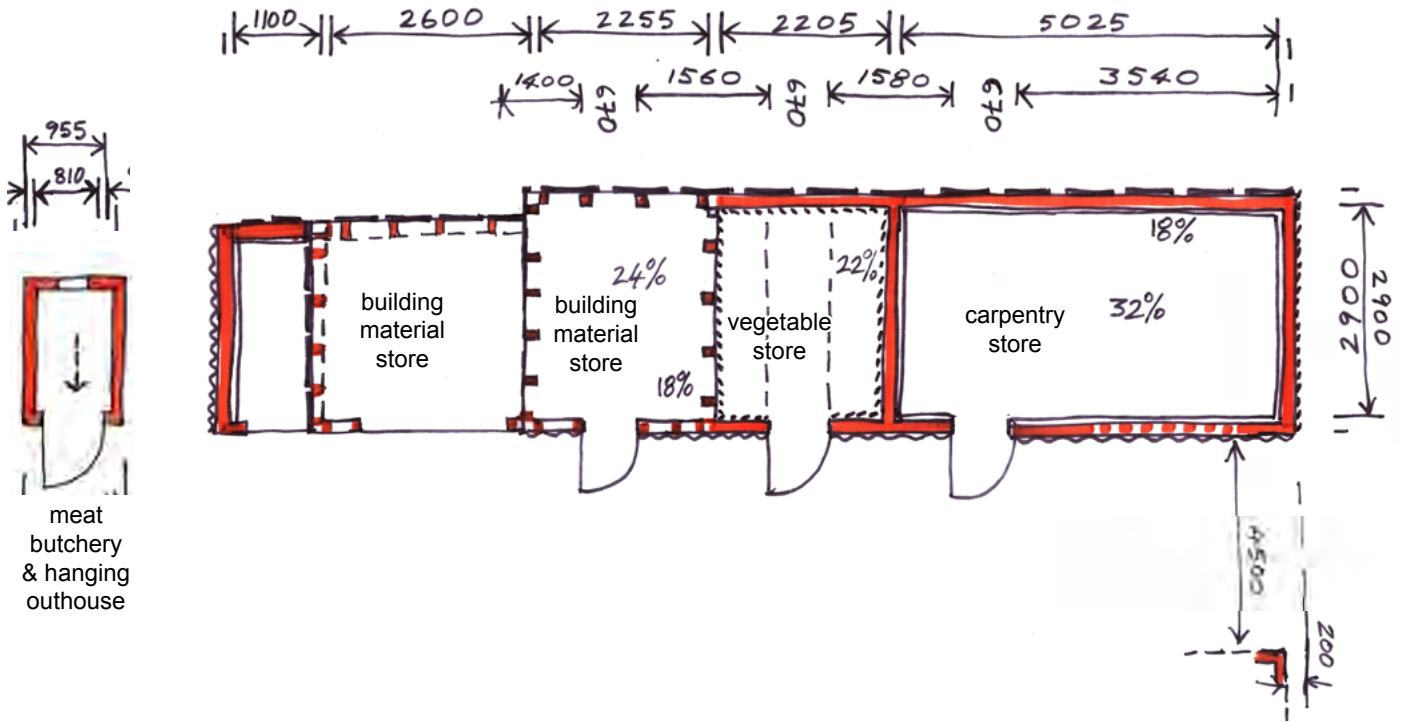
Figure L5  
 ABOVE The Meat hanging or butchery room is on the far left. The plan indicates the wall materials, with a long dash being a possible asbestos based material, the wavy line is vertical corrugated steel, and the short dots are plywood. A dashed red line indicates a possible window. The percentages indicate moisture content; any figure that is over 20%; will lead to decay. The rate of this decay depends on the durability of the timber

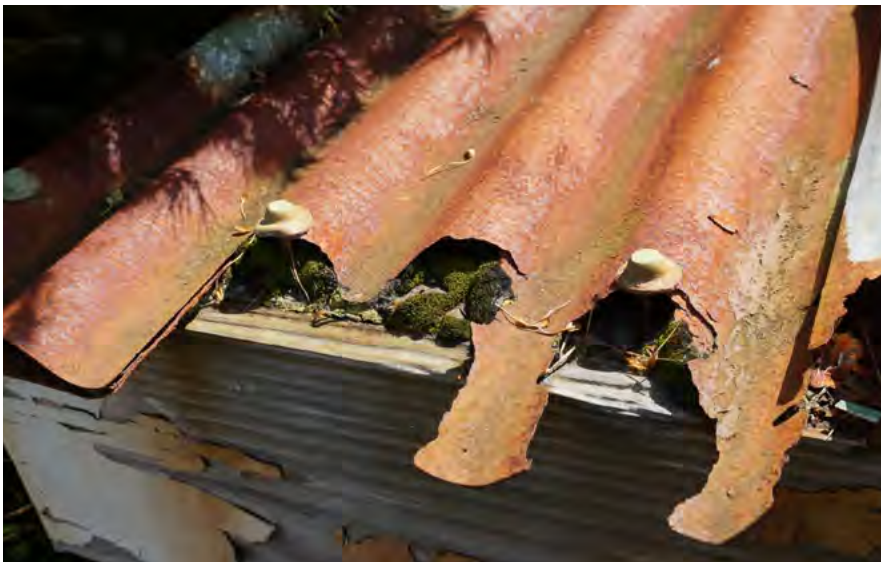
# carpentry, vegetable & meat store

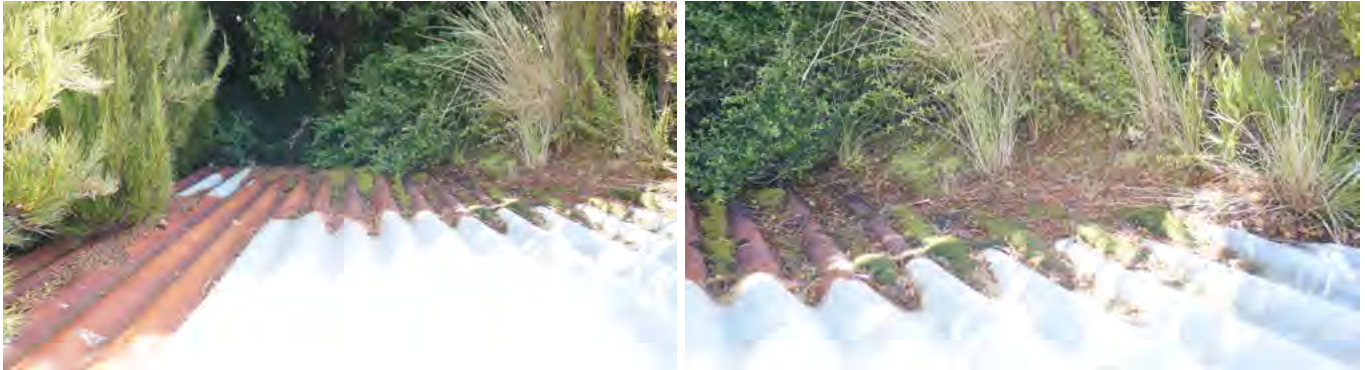
Figure L7 ; L8 ;  
ABOVE. Simple house keeping measures, which involves the removal of moss and forest litter from the roof, would allow the roofing to dry and would remarkably extend the durability of the roofing.

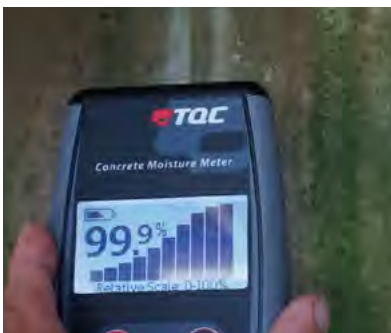
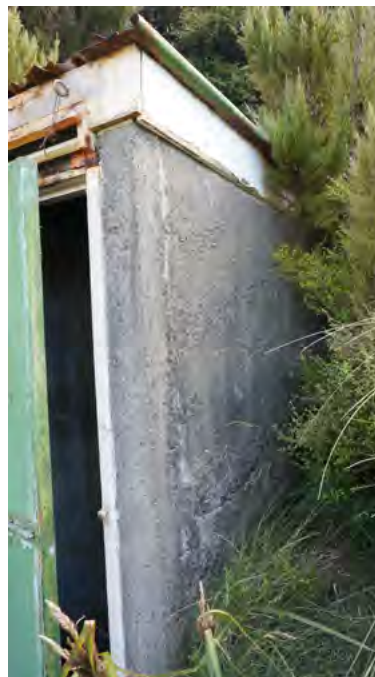
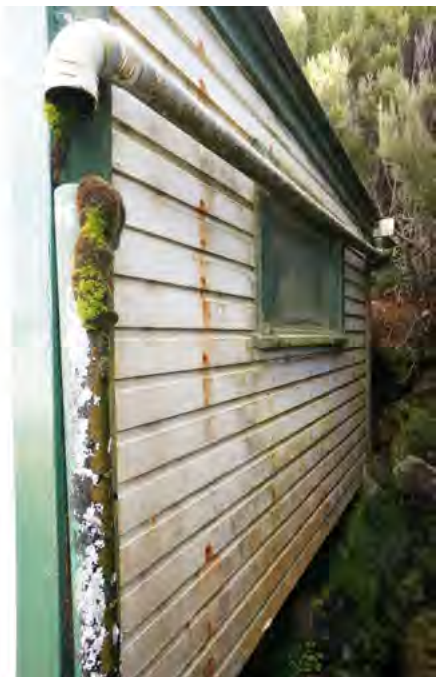
# carpentry, meat & vegetable store

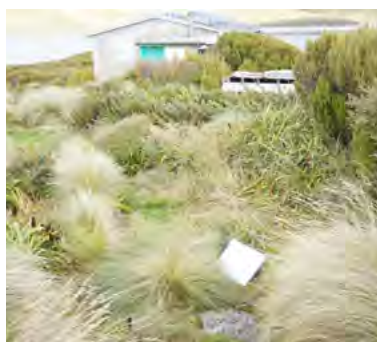
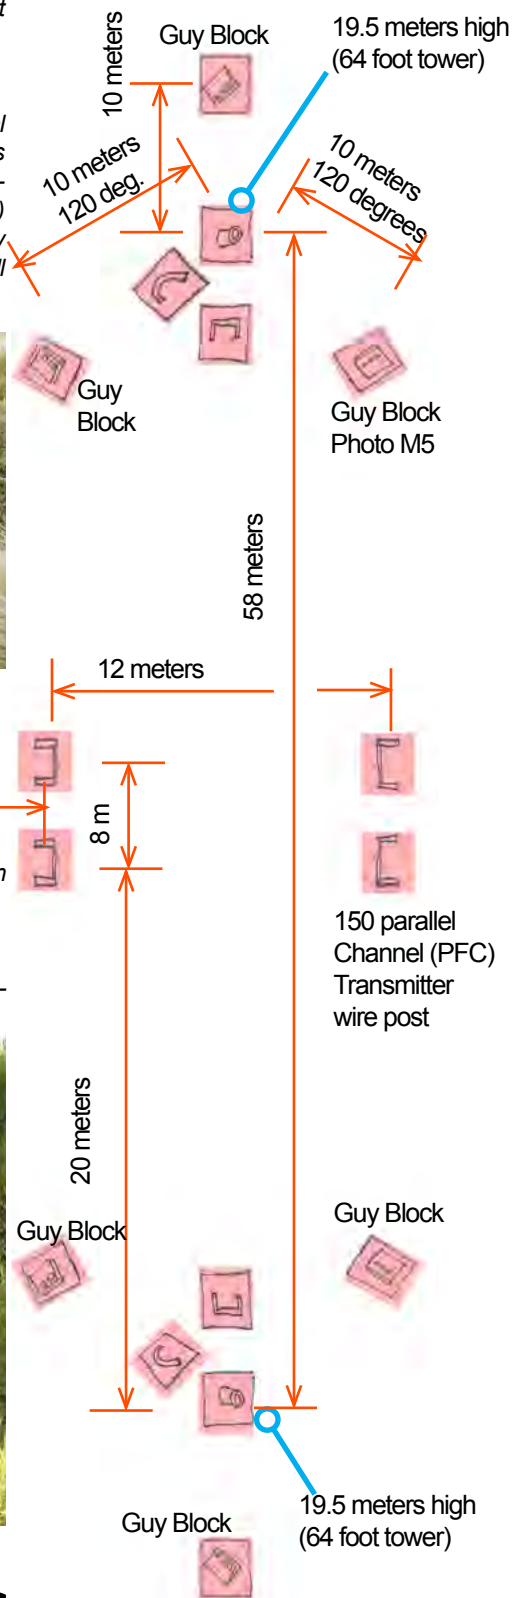
VERY APPROXIMATELY  
30 meters to next mast, for comms  
to NZ

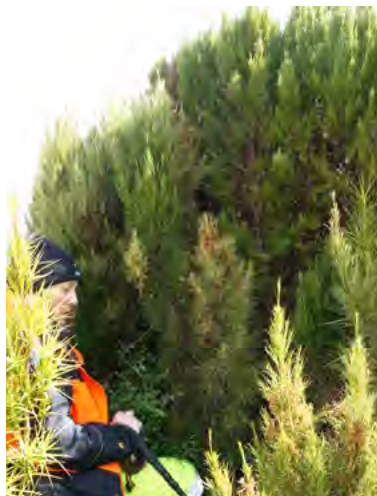
Figure M6  
BELOW. Height of bush in area of second mast

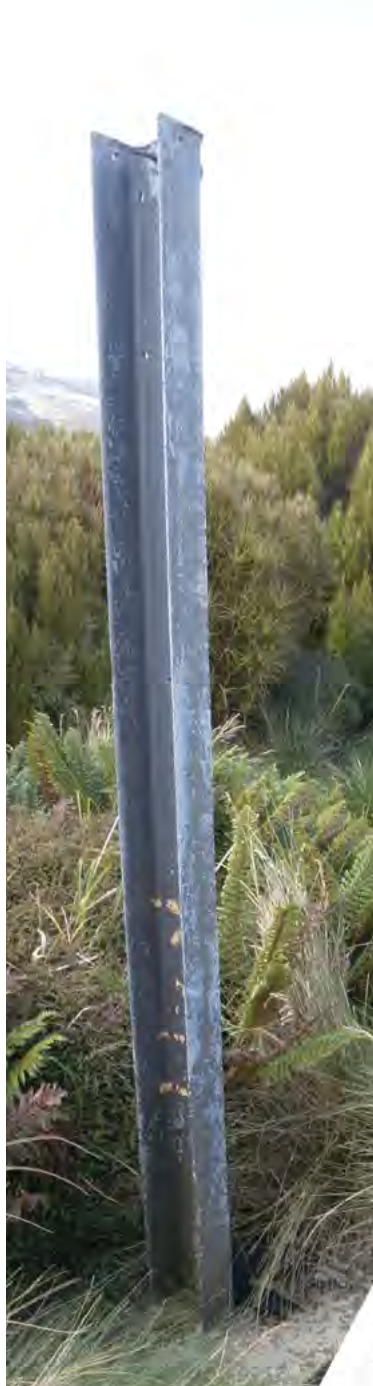
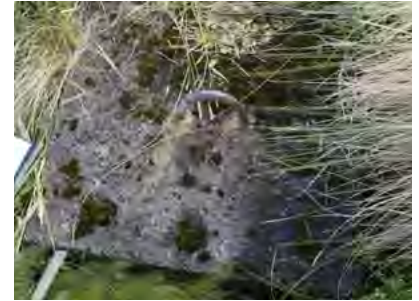
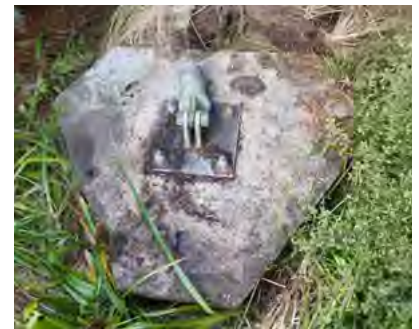
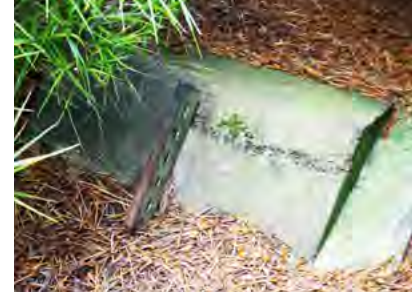
Figure M10  
FAR BOTTOM RIGHT Guy rod block, at  
120 degree intervals.

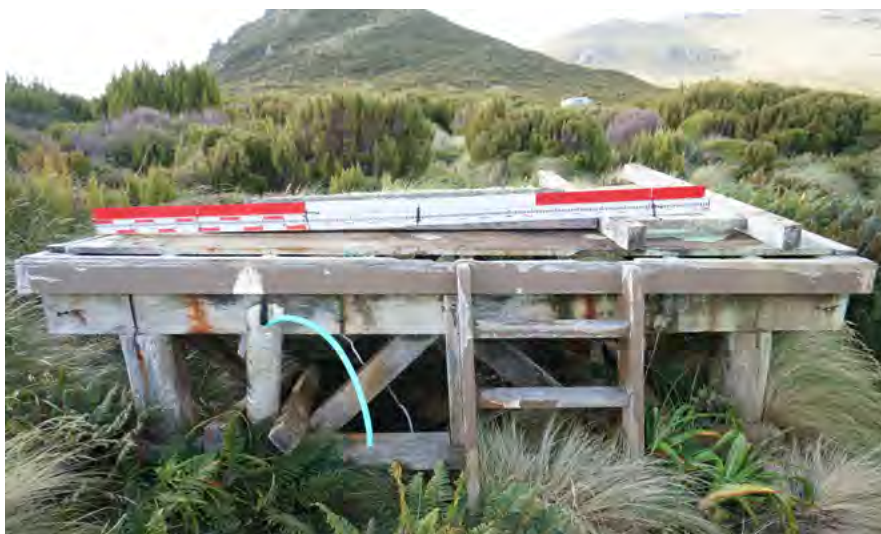
*Figure M11  
LEFT. All sky camera building, the walls  
have been demolished and the founda-  
tions only remain. The area for the first  
aerial to NZ is in the background.*

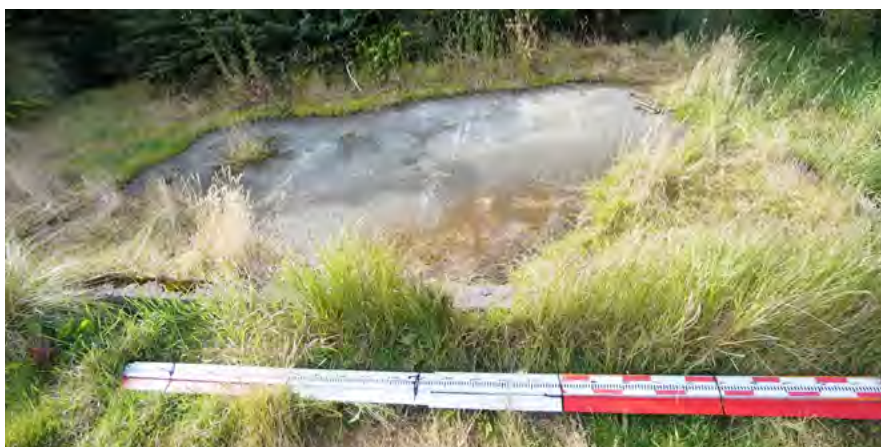
*Figure M8  
BELOW. The chook shed slab remains.  
This is below the south east corner of the  
Technical Building.*

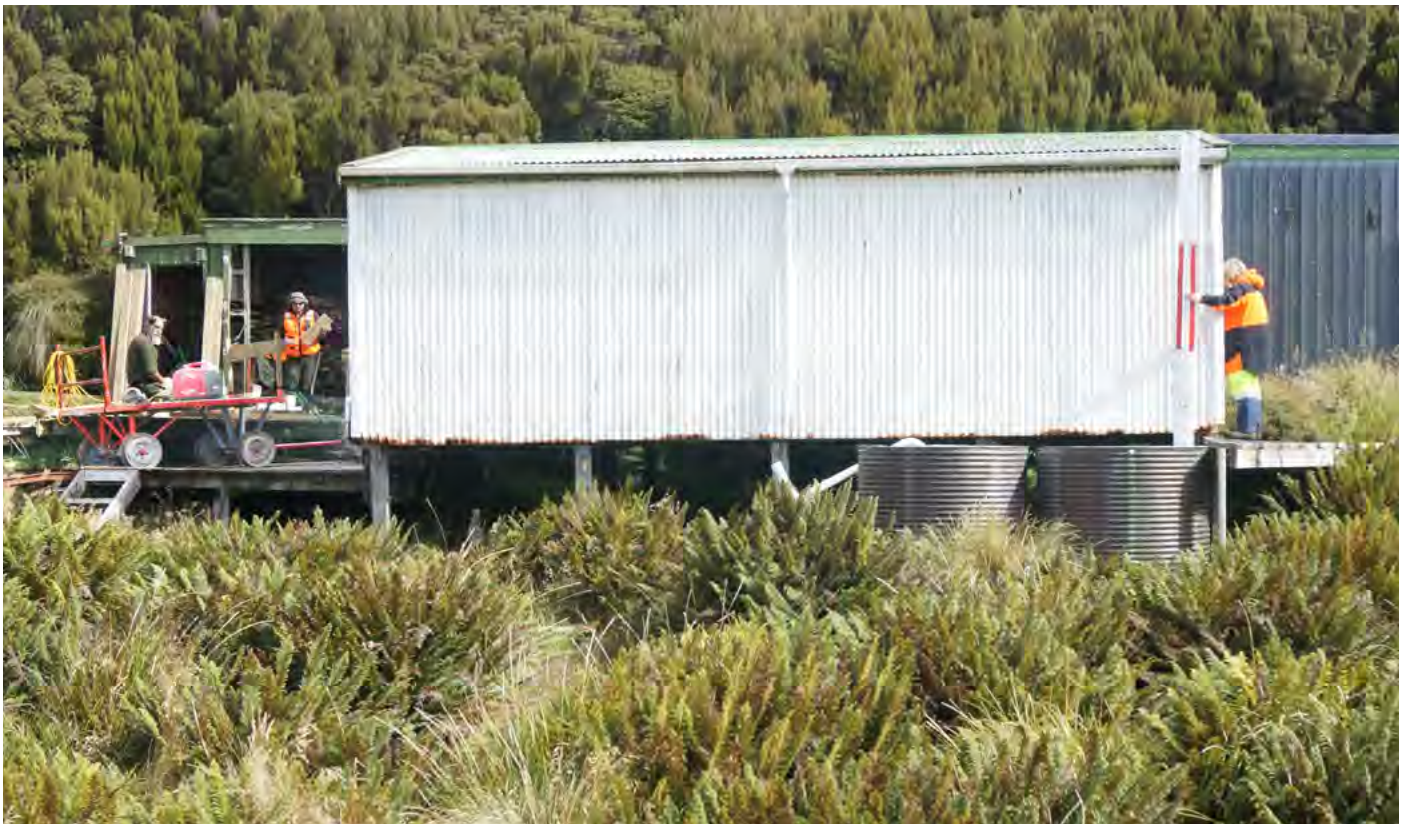
BELOW East elevation, showing cantilevered piles, and little diagonal bracing. The winch to the jetty is on the left. This elevation has the original cladding, however rust stains and perforations exist at the base.

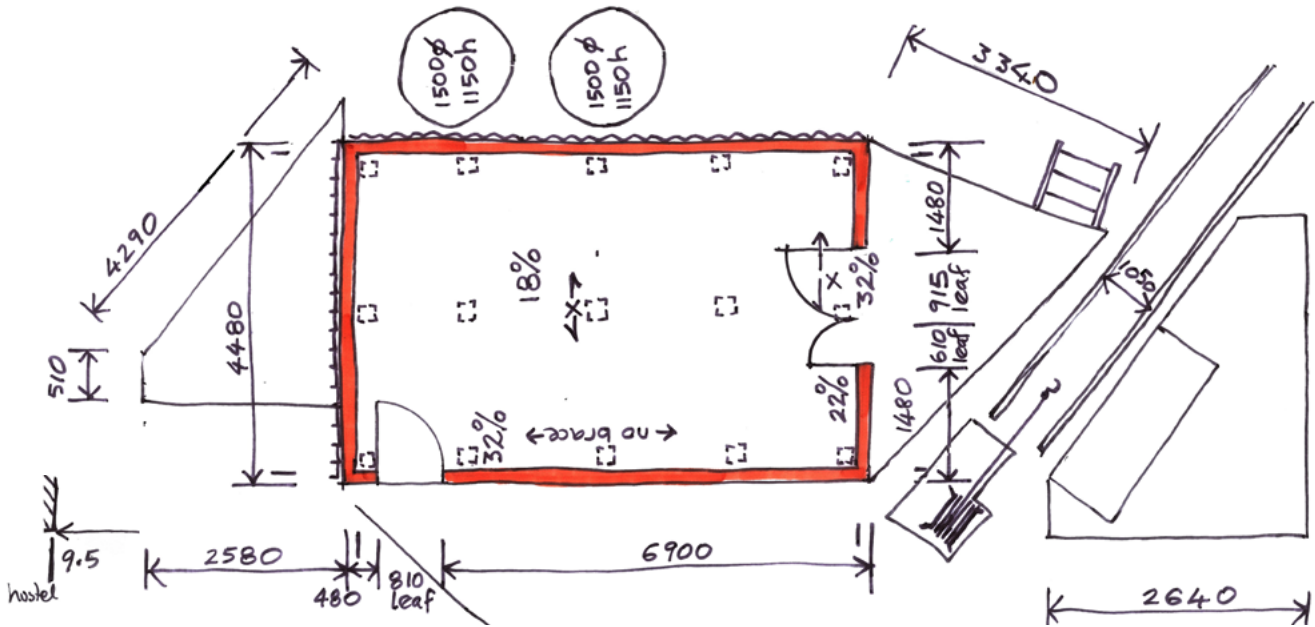
Figure N2  
ABOVE Plan, with winch to the jetty on the left.

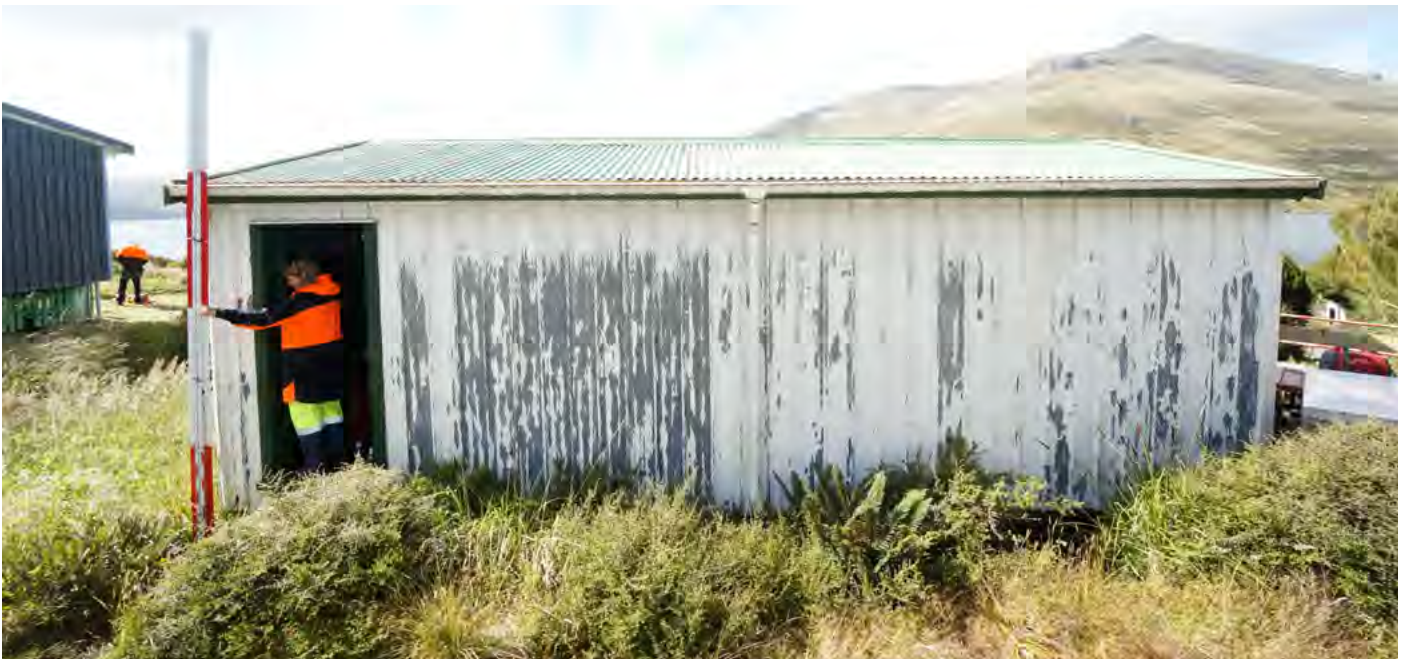
Figure N3  
BELOW Elevation to the west, from the main walkway. The cladding to this elevation has been replaced,

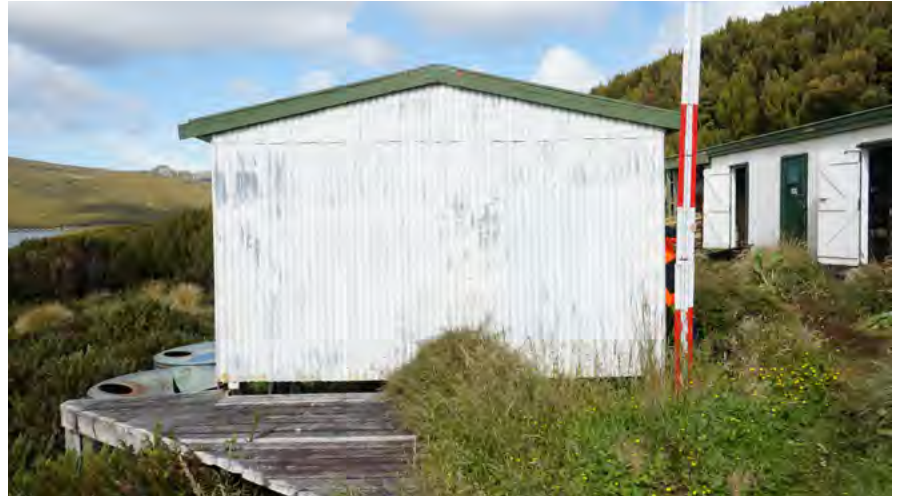
Figure N5  
LEFT Elevation to the south. The cladding to this elevation has been replaced.

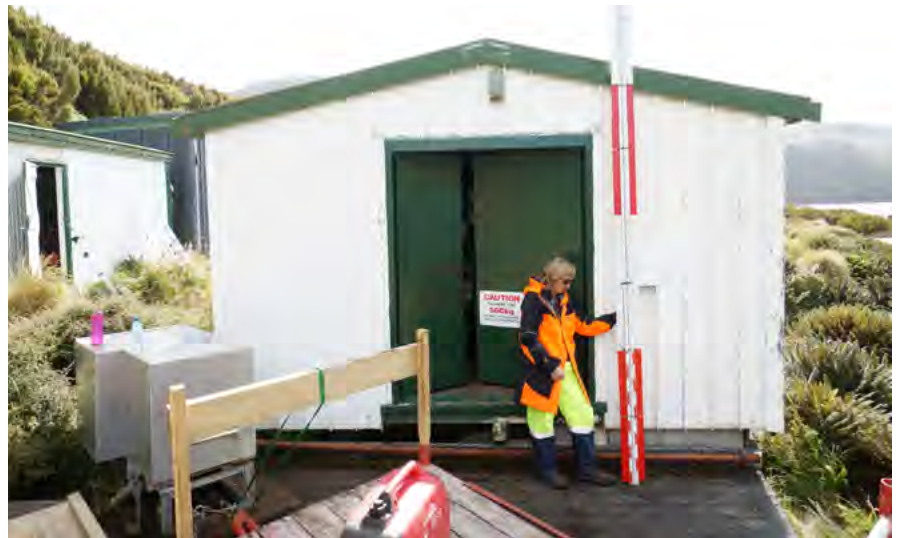
Figure N6  
BOTTOM LEFT Roof condition showing perforation.

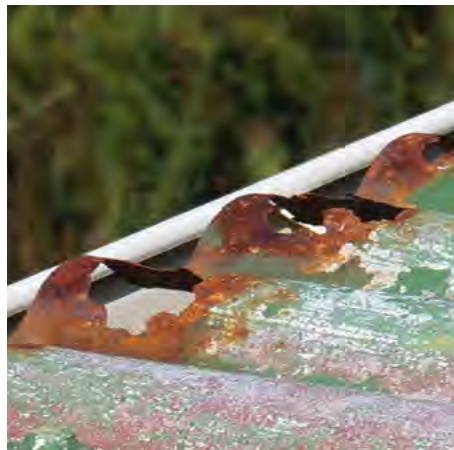
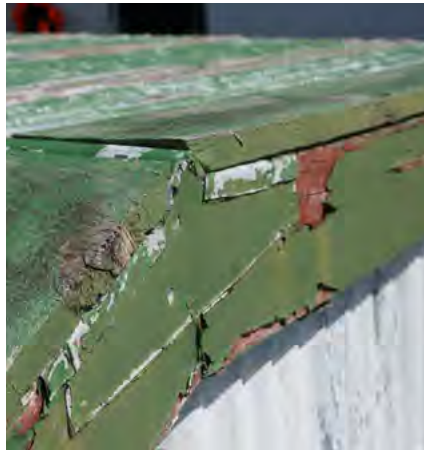
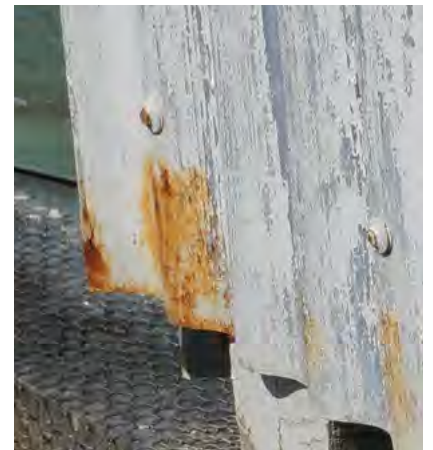
Figure N8  
BOTTOM RIGHT Rust starting in areas of the original cladding not replaced.

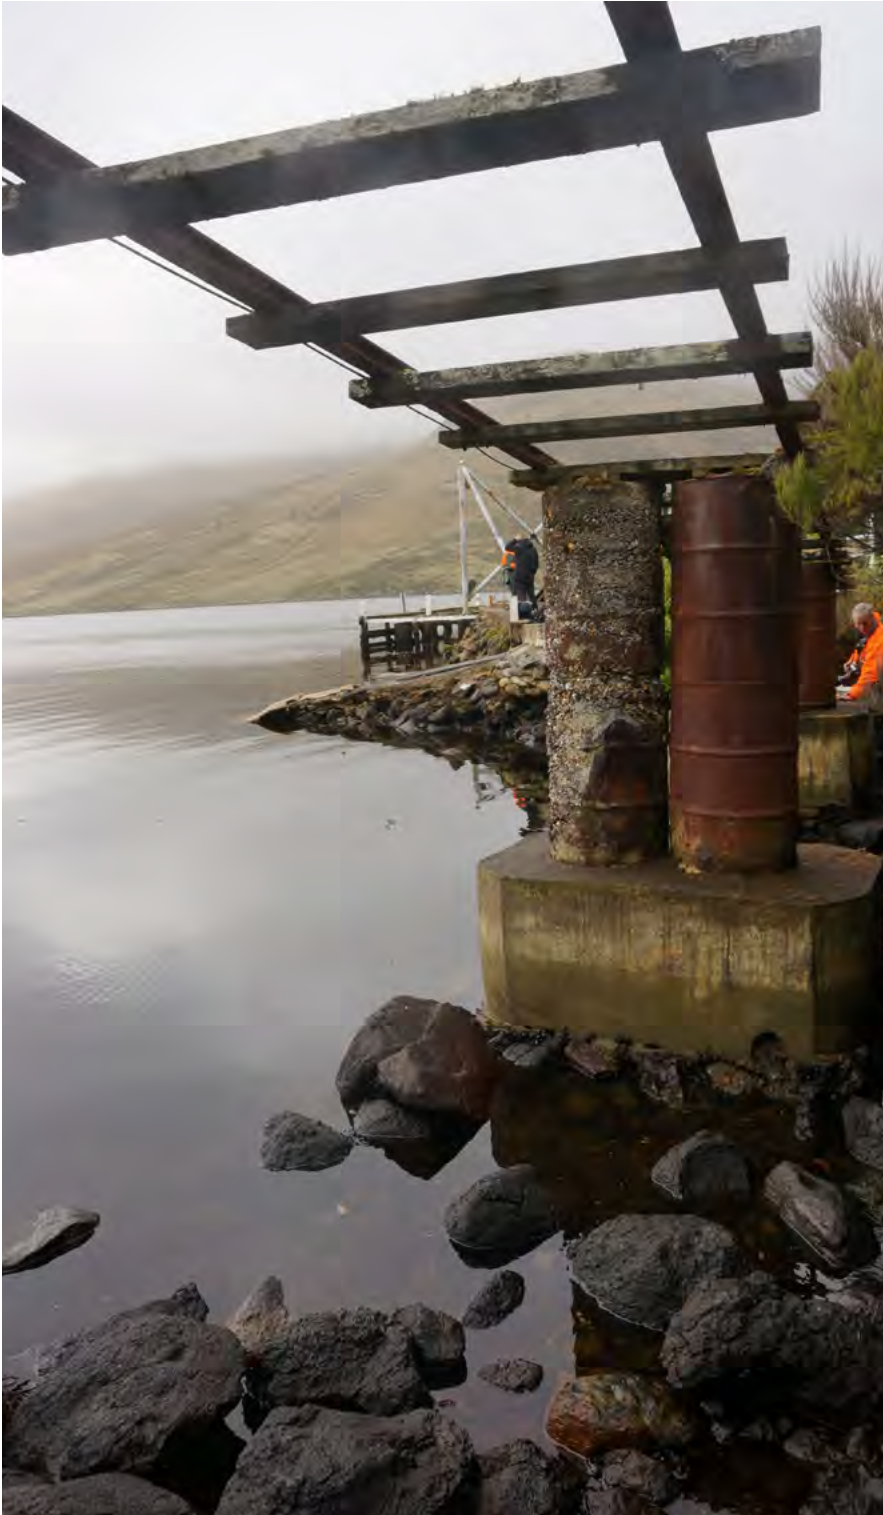
*Figure 01*  
*LEFT* Photo of the trolley track from  
*below.*

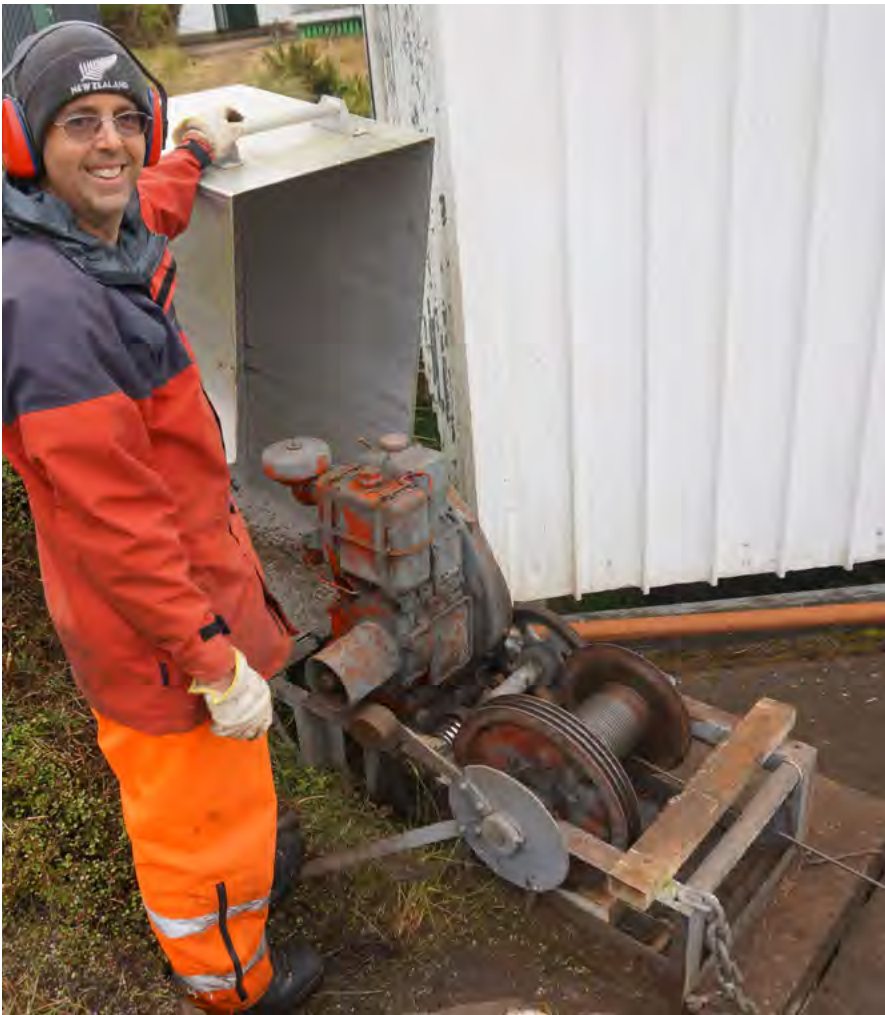
Figure o5  
LEFT Photo of the trolley track winch engine and winch, being run by Rossco, Met service.

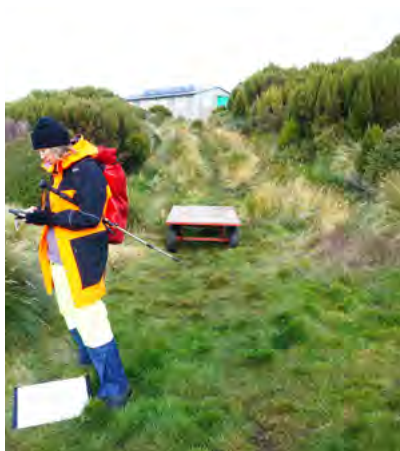
Figure N4  
ABOVE Typical path condition

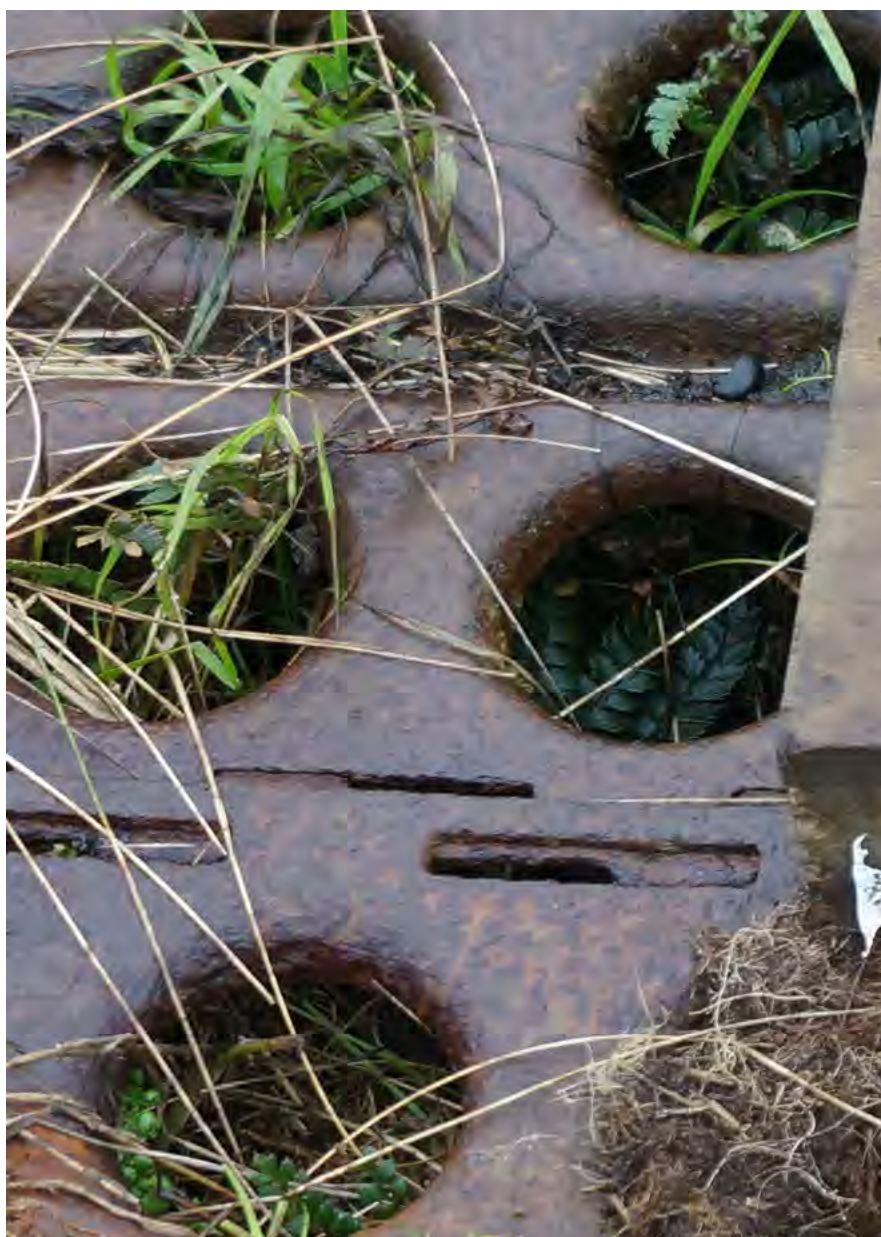
Figure N5  
LEFT Detail of Marsden matting, one of the few areas where the matting is exposed. There has been a complete change in undergrowth around the matting, refer Michael Kelly's report.

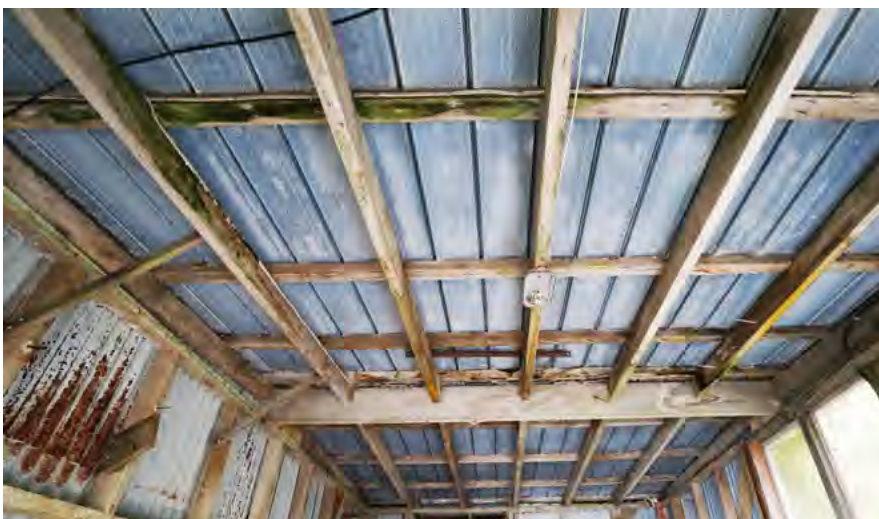
Figure Q2  
ABOVE Plan of Jetty Boat Shed, with the approximate mean high water springs shown in blue. Any timber readings of 40% indicate complete water saturation of the timber, and decay is inevitable, depending on the durability of the timber purlins.

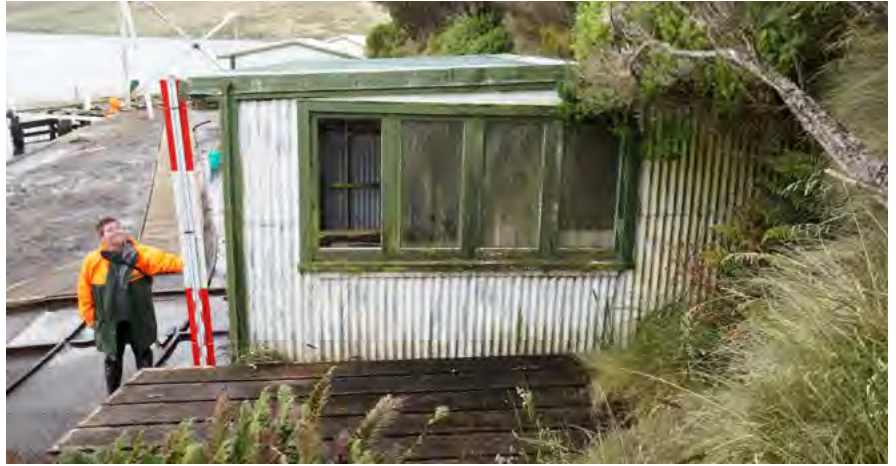
**RIGHT TOP** North Elevation, with DoC ranger operations Kathryn Pemberton holding the measuring staff. The far left pane of glass is missing, and the bank to the right has slipped and is resting against the right (west) wall. The wall still has the original corrugated cladding.

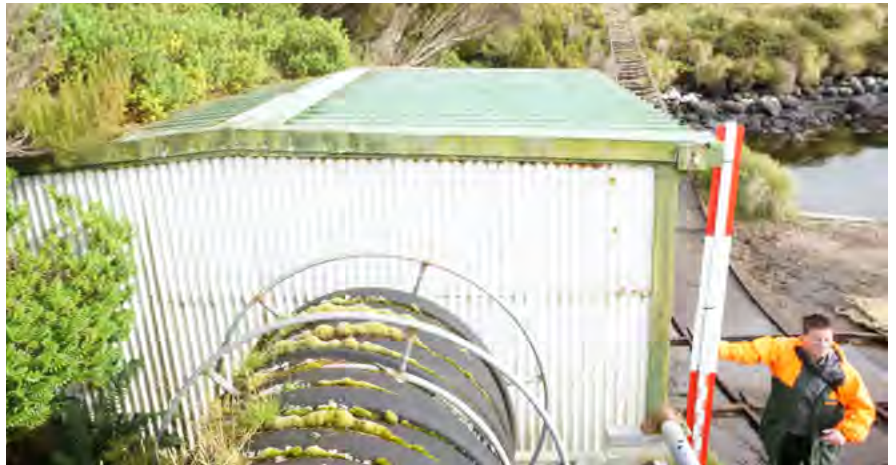
**RIGHT MIDDLE** South wall, showing original cladding, and more recently replaced roof. The west wall (left) where the bank has slipped now has vegetation growing from the slipped soil, and over the roof. Encouraging roof structural decay.

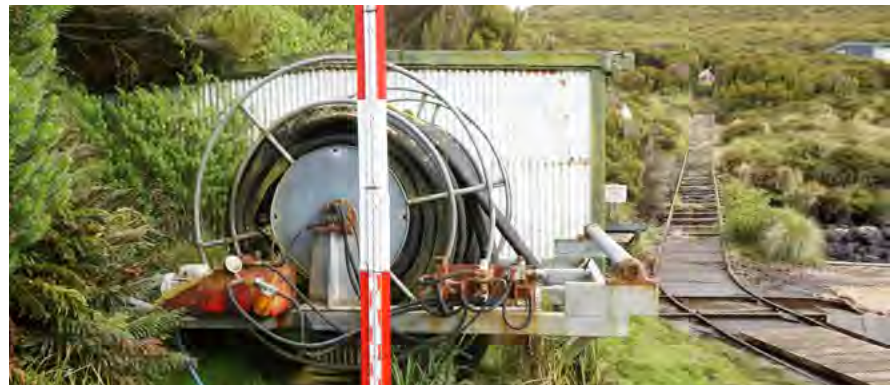
**RIGHT LOWER MIDDLE** South wall, with Diesel hose, for filling the land based tanks from tanker ships. The railway and winch is to the right, with a small corner of the Hostel visible to the far right.

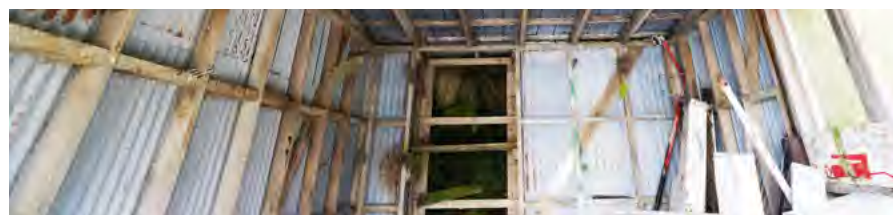
**RIGHT BOTTOM** Inside, with the earth against the west wall, visible through the far door, where I assume the door has decayed.

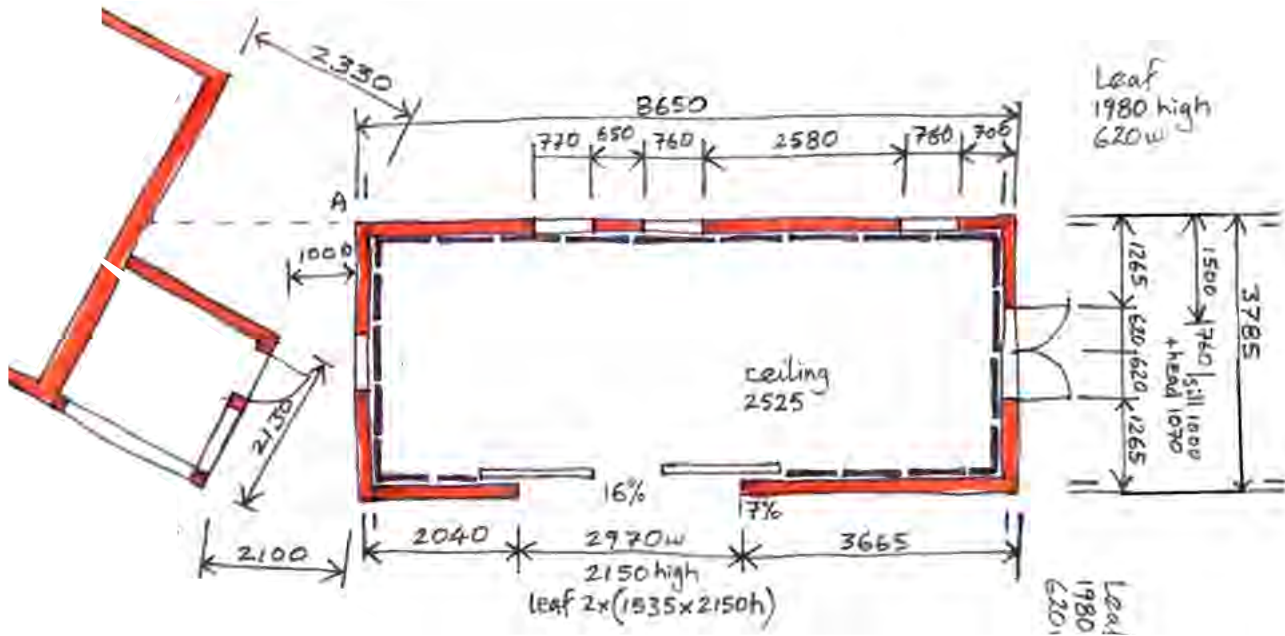
Figure R2  
TOP Floor Plan

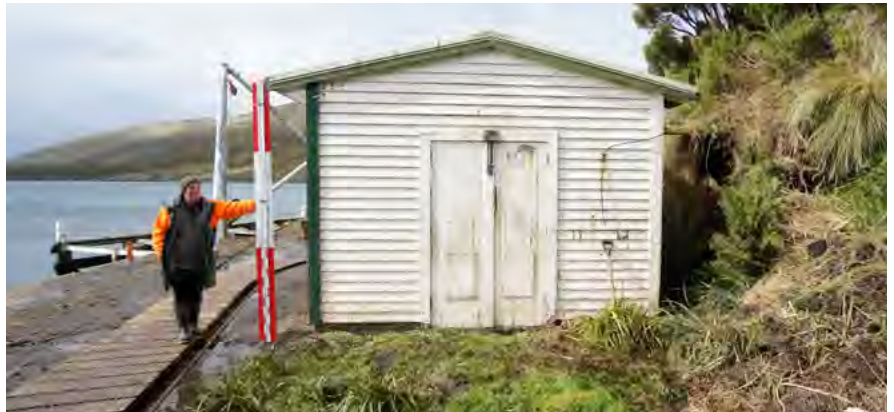
Figure R4  
RIGHT LOWER South wall, with interior  
cladding clad directly behind the windows.

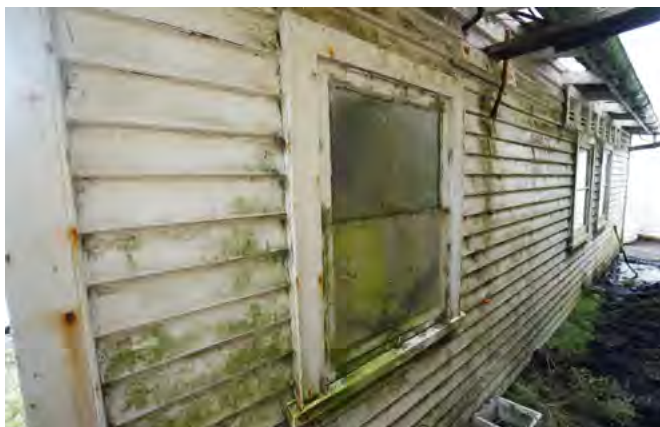
*Figure R5*  
**LEFT TOP** Wall closest to the bank, moss and mould will speed up decay and needs to be removed.

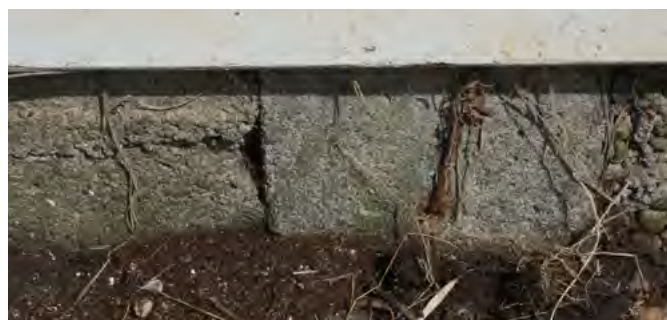
*Figure R6*  
**LEFT MIDDLE** Concrete foundations, with evidence of creepers entering the wall through the bottom plate.

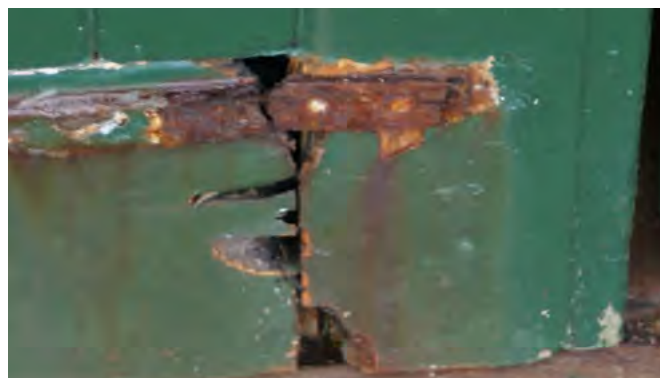
*Figure R7*  
**LEFT LOWER MIDDLE** The corner of the doors, where the door style meets the bottom rail. This, as well as other style / bottom rails, are rotten.

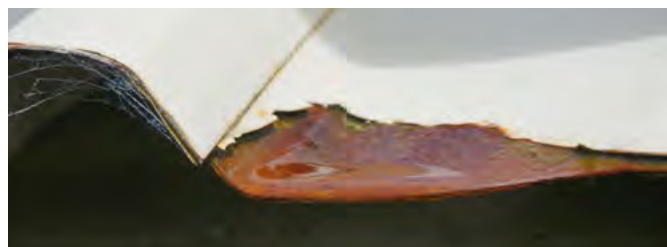
*Figure R8*  
**LEFT LOWEST** Roof where edge has lost the protective coating, and the substrate is rusting .

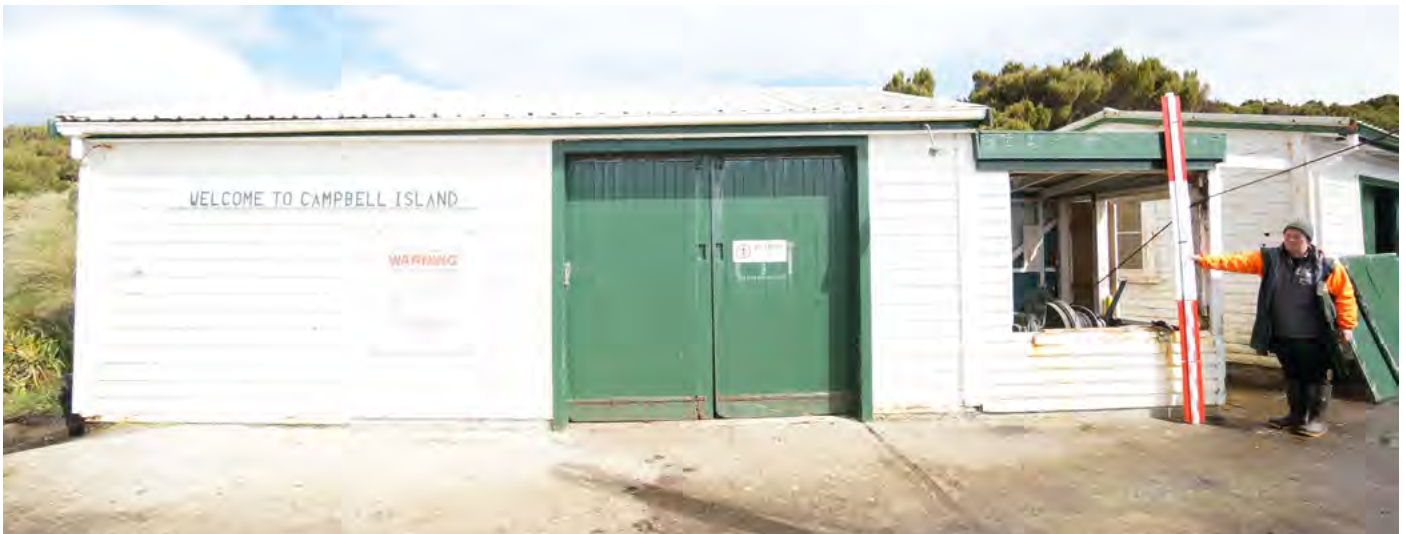
Figure S1  
BELOW East elevation of Jetty Store with winch alcove, with window openings removed and on the ground leaning against the Spirits / Paint store.

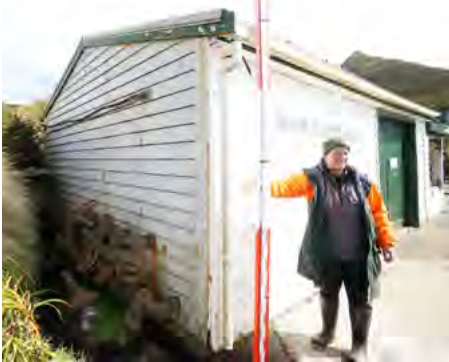
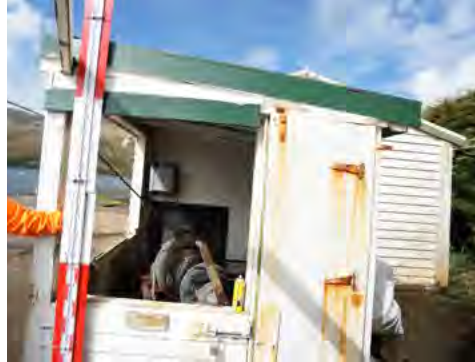
Figure S4  
LEFT TOP South wall of the Jetty Store,

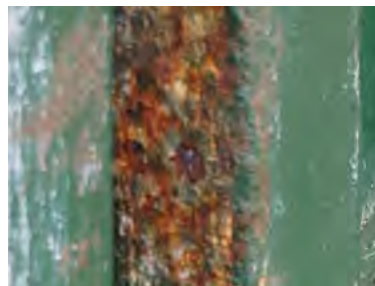
Figure S9  
RIGHT BOTTOM Rusting strap on door.  
The door styles / bottom rails are also rotten

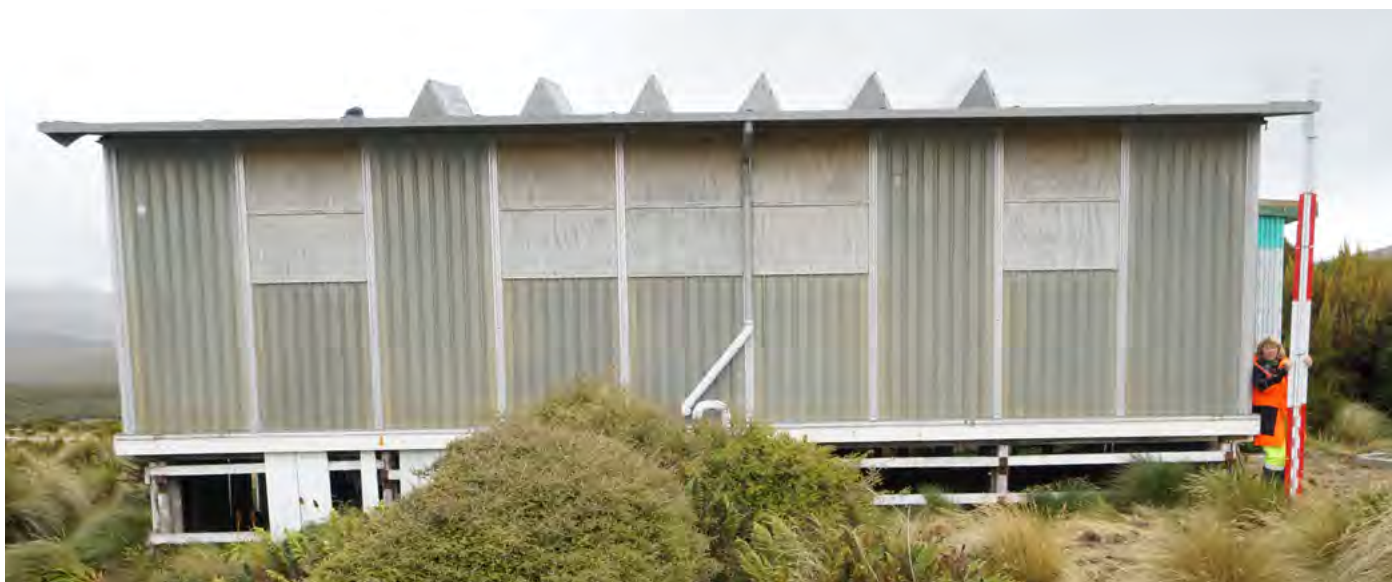
# technical building
