**CAMPBELL ISLAND**  
**meteorological station**  
BUILDINGS, CONDITION & PLANS

MEASURED FEBRUARY 2017

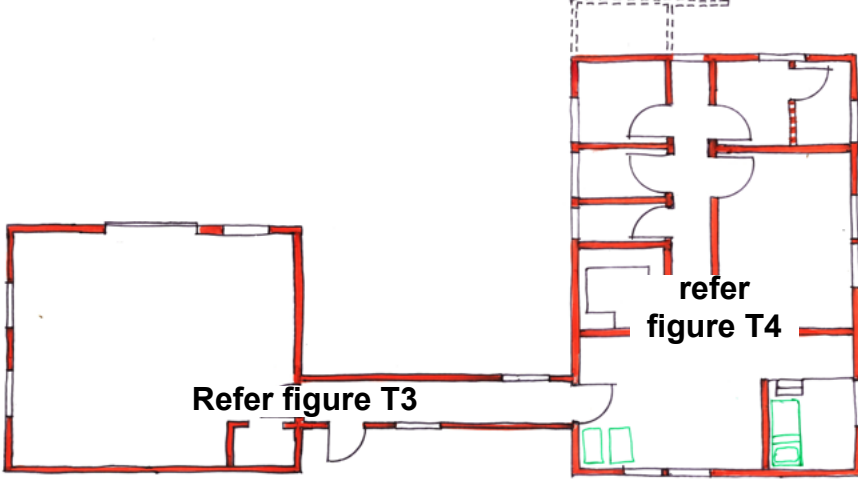
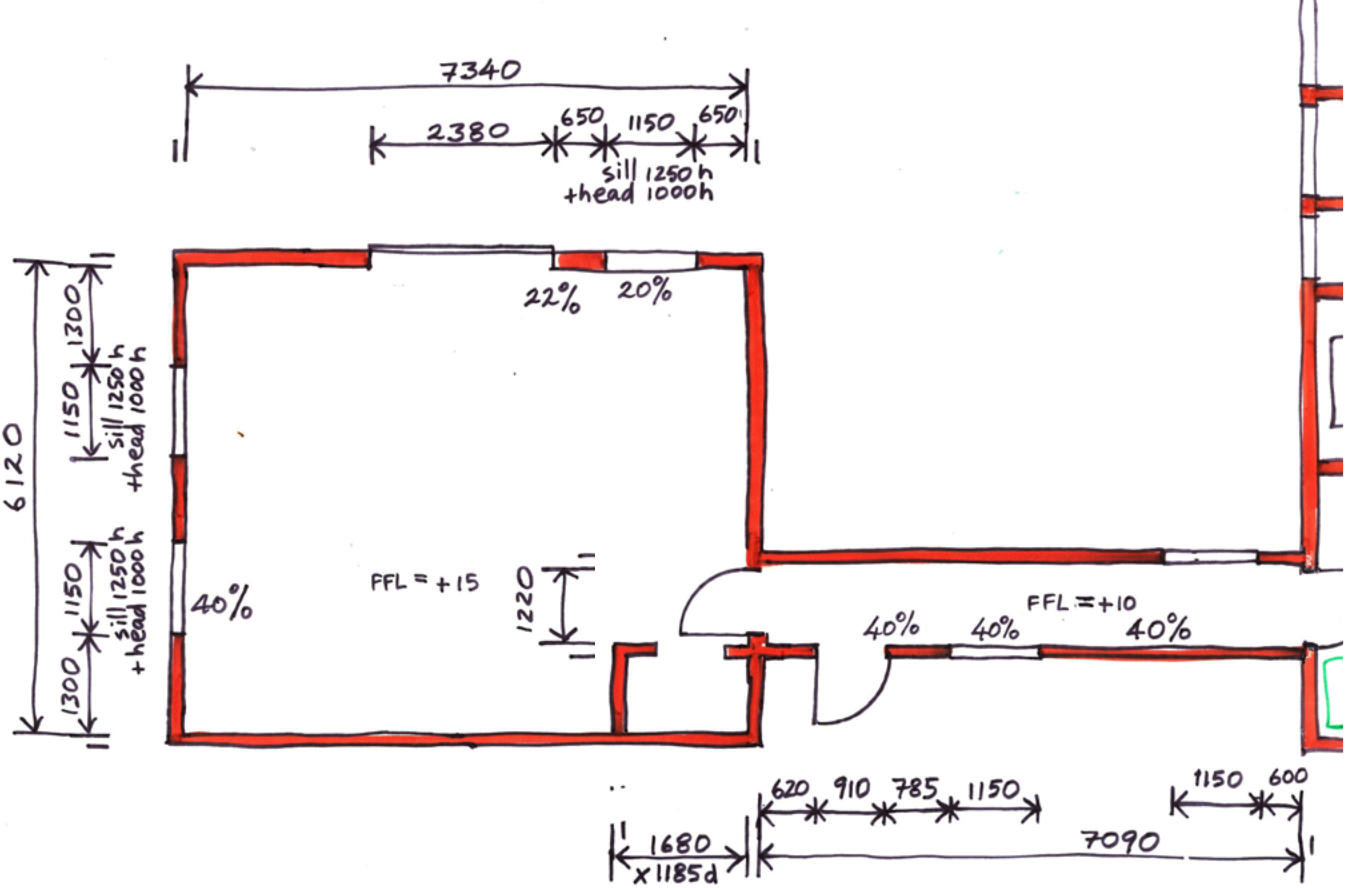
Figure T3  
 BELOW The recent extension of the Technical Building, a garage door 2380mm wide, and corridor to the Technical Building. Moisture levels of 40% are of concern and show complete water saturation inside the wall. Moisture readings in the Campbell Island climate should be around 15%

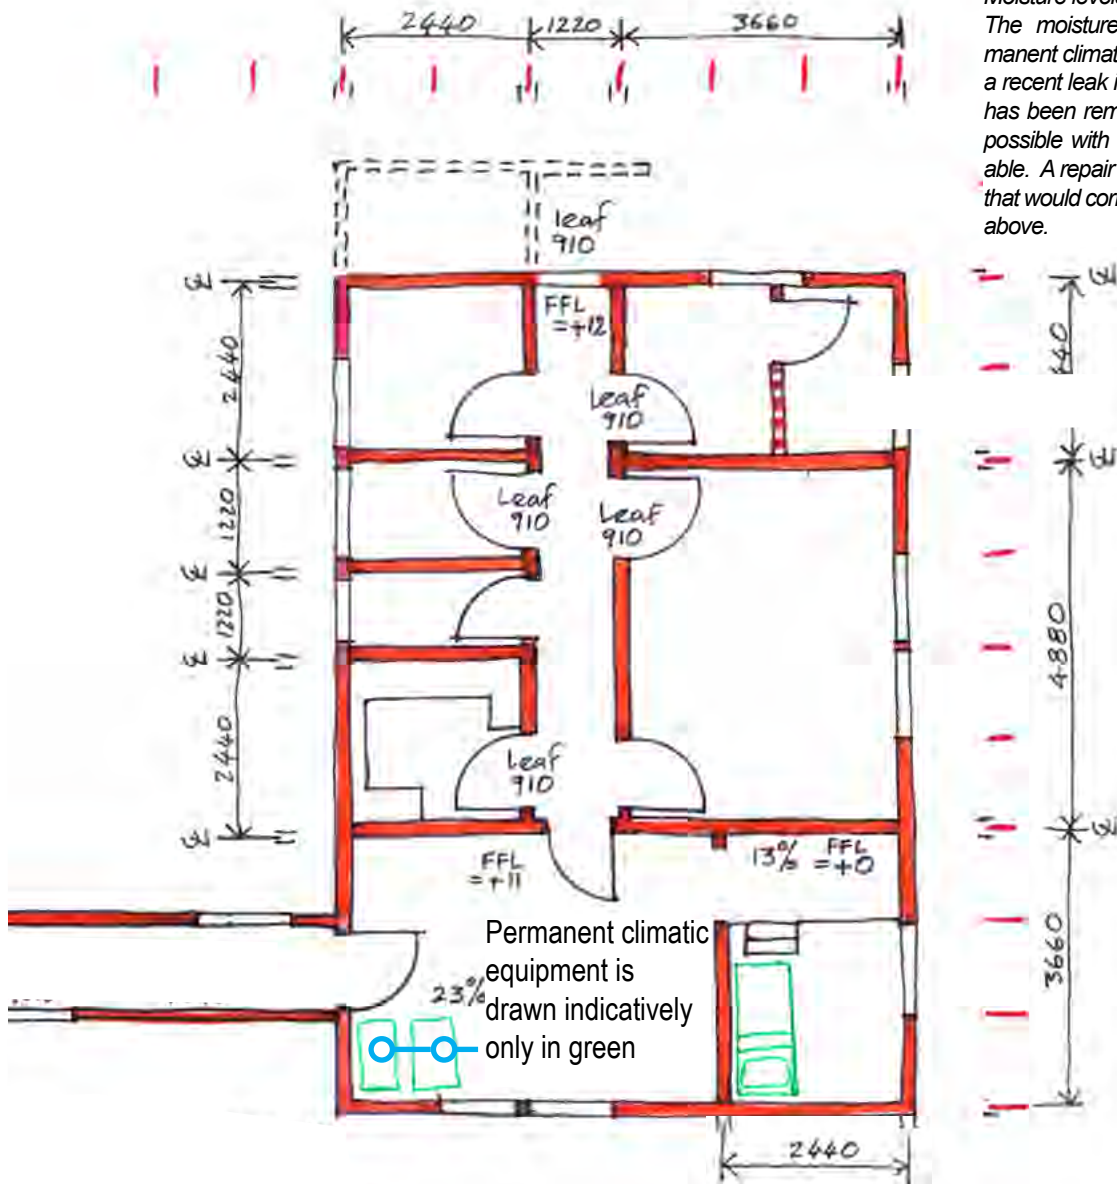
Figure T4  
BELOW The original Technical Building. Moisture levels of 13% are excellent. The moisture level of 23% near the permanent climatic equipment is indicative of a recent leak in the roof above. This leak has been remedied to the best standard possible with the ad hoc materials available. A repair of this sort has a limited life, that would correspond to the life of the roof above.

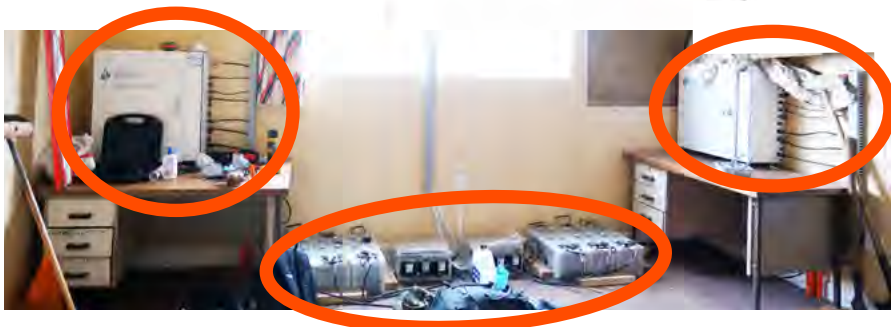
Figure T5  
LEFT The permanent climatic equipment is circled in red, generally on the old desks. The moisture reading, 23%, was completed in front of the battery pack, under an existing roof leak partially fixed. This reading indicates inevitable decay, with the rate of decay dependent on the durability of the timber. The flooring would have the least durability.

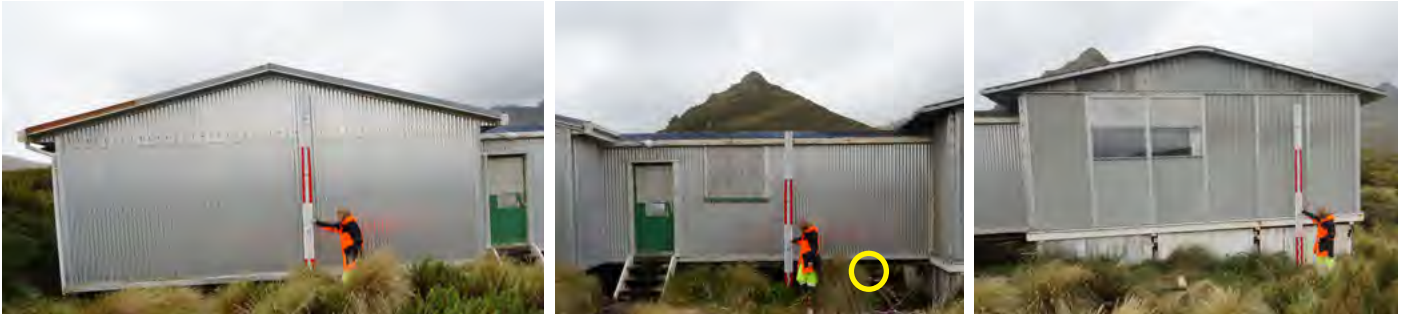
Figure T6 , T7 , T8  
 ABOVE The south elevation of the Technical Building.

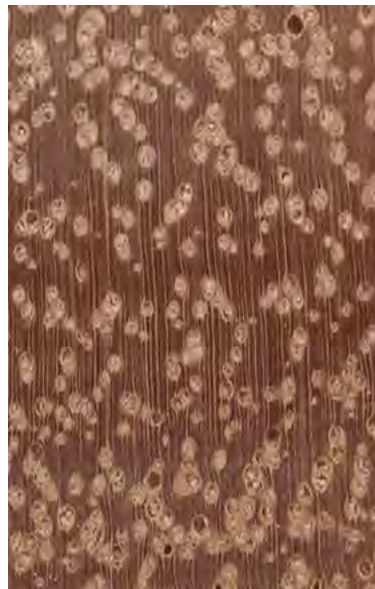
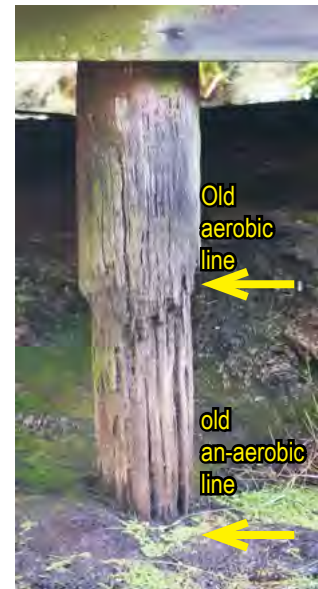
Figure T10  
 ABOVE RIGHT Microscopic view of the timber species. Both Ormondville and Campbell Island piles have similar cell structure. Also the specific gravity of both timbers was measured by coating samples in water and measuring in a test tube. Both are above a specific gravity of 1, an unusual non typical reading.

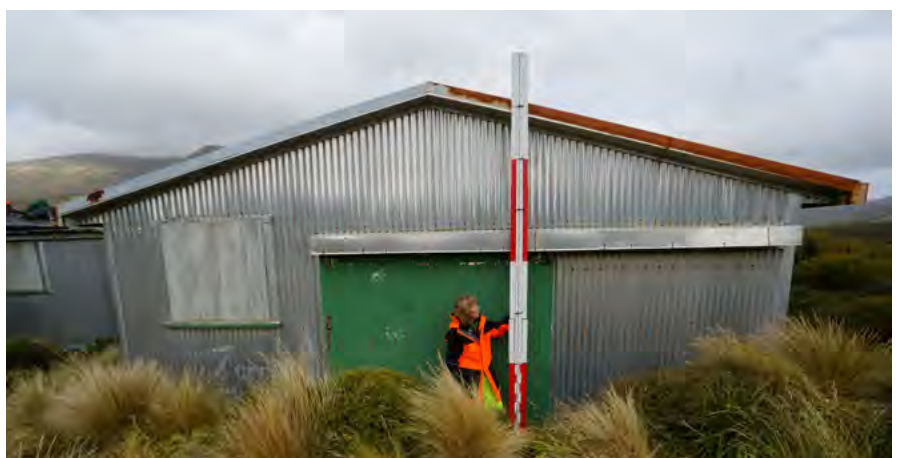
Figure T11  
 RIGHT The north elevation of the Technical Building, with the garage door (2380mm wide) in green. The photo to the left was not taken owing to a particularly aggressive seal (Sammy) taking up residence in the scrub to the left of where I was standing when taking this photo.

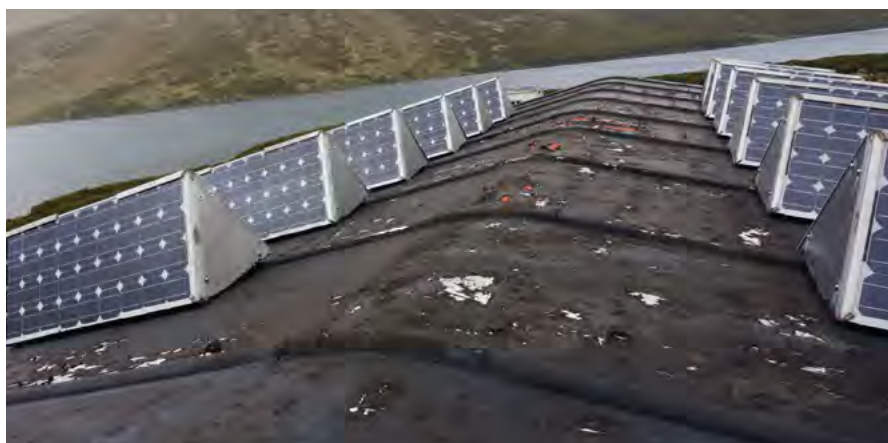
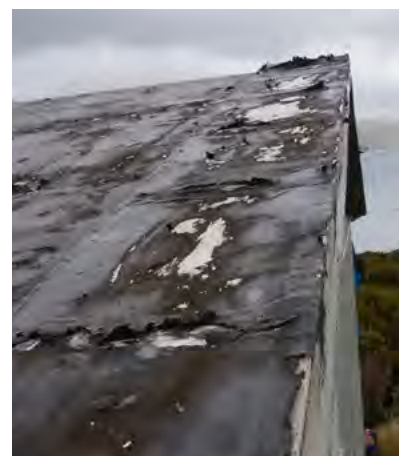
Figure T12  
ABOVE The original aluminium clad roof, with a membrane over, an economical possible solution to remedy the roof leaks. This membrane is now ending its effective life.

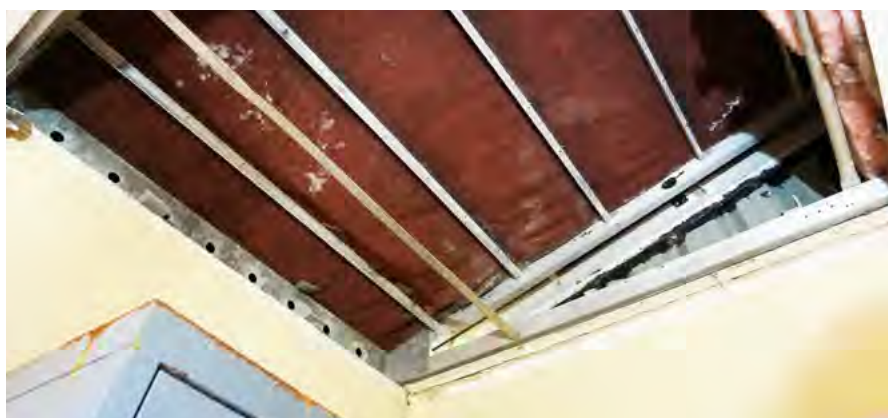
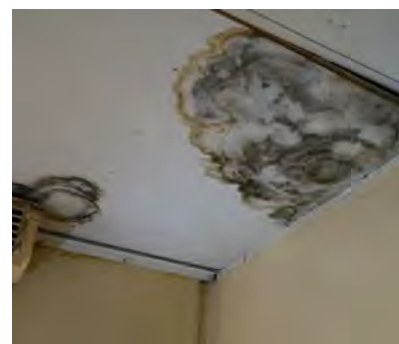
Figure T14  
ABOVE RIGHT The original aluminium roof panels viewed a missing ceiling panel.

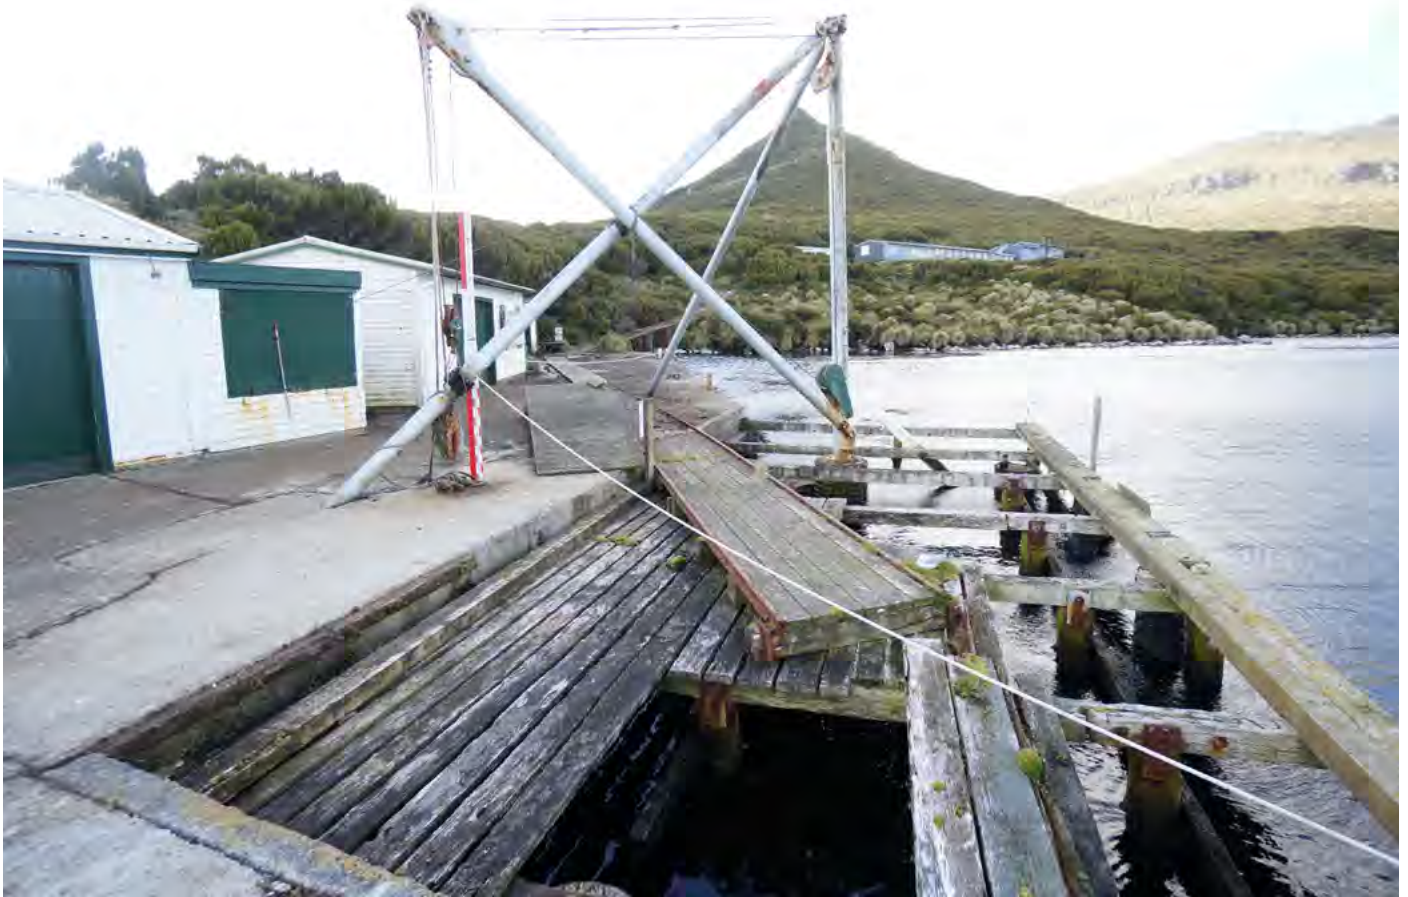
*Figure U1  
ABOVE The Jetty, just before being  
roped off.*

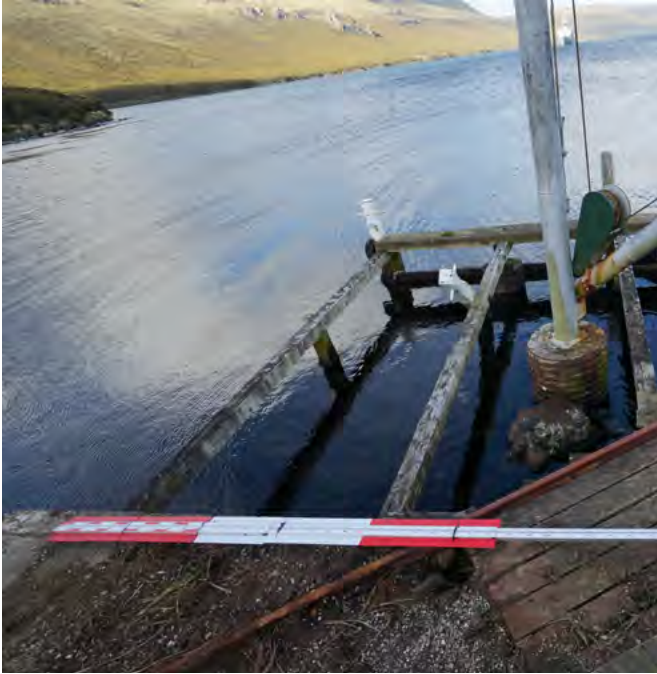
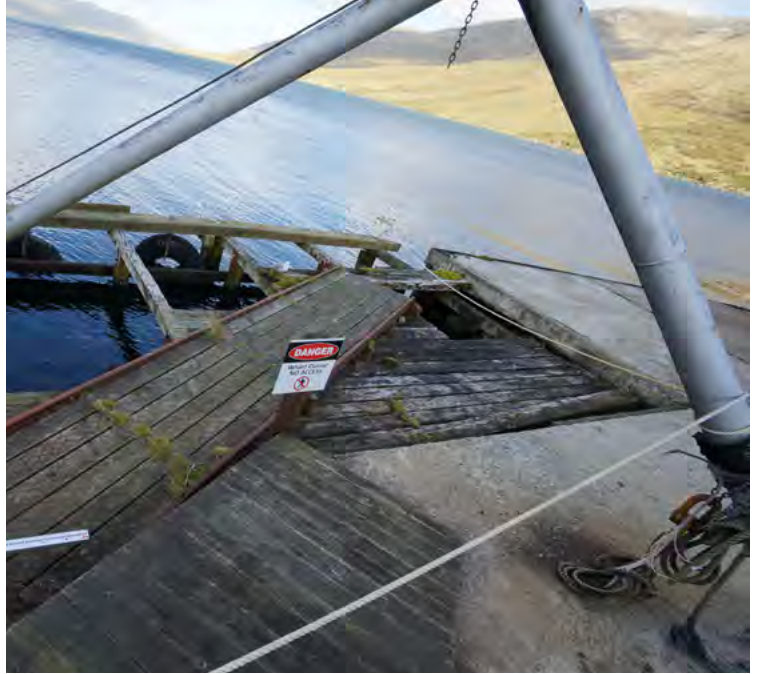
Figure U5 , U6  
ABOVE Extent of timbers removed from  
the jetty from the winch room, (S)

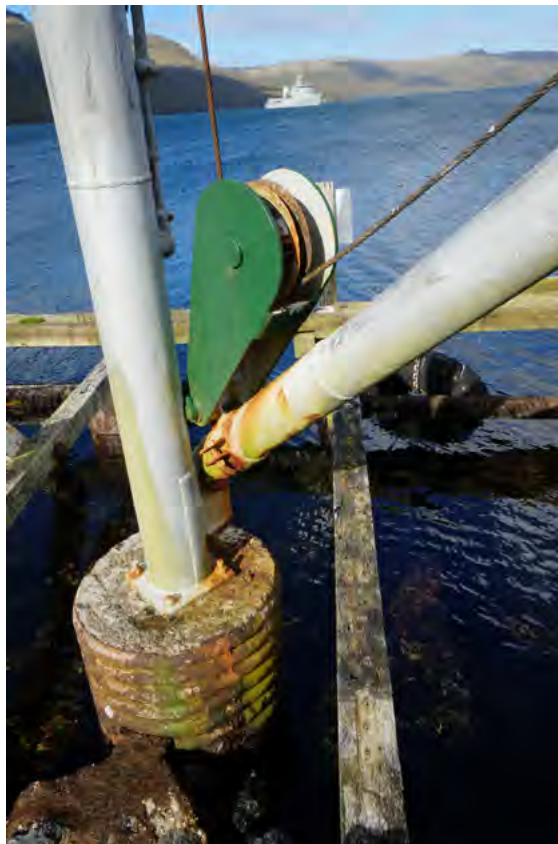
Historic significance	Highest category, historically significant.
Construction	Standard New Zealand wide common construction techniques
Wall condition	Near to demolished by neglect, structural timbers are mostly sound, where test drilling was possible .
Foundation condition	Near to demolished by neglect, sunk 300mm.
Roof condition	Near to demolished by neglect
Use, Feb. 2017	Use impossible, close to demolished.

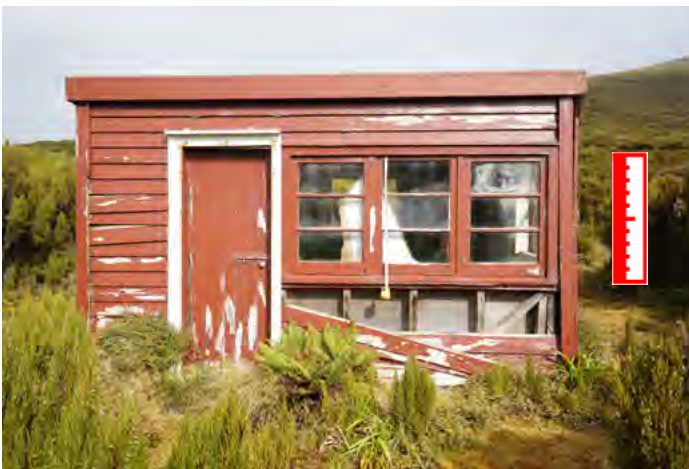
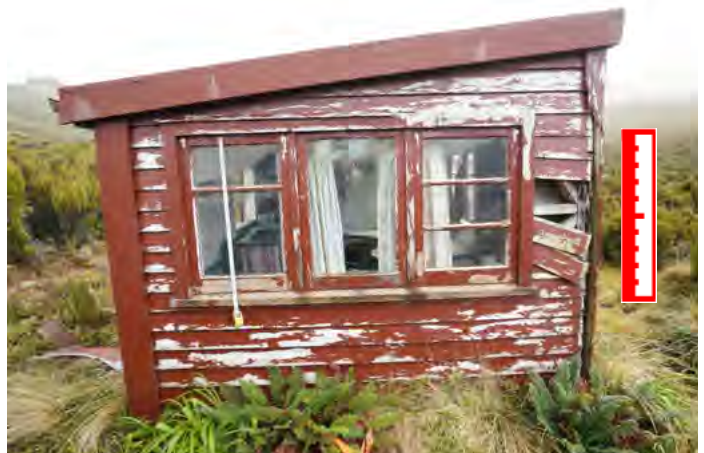
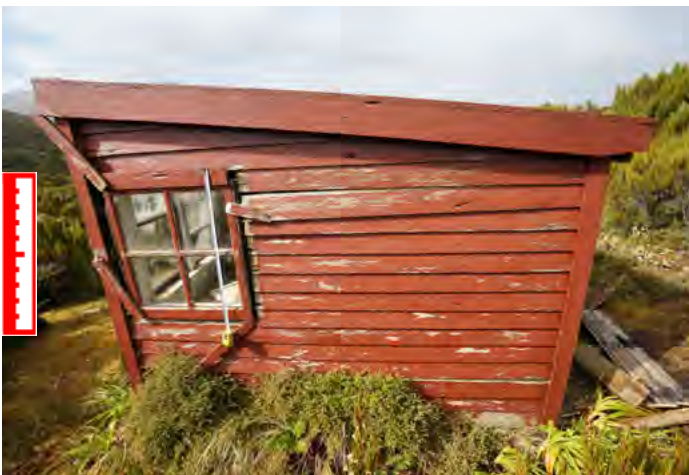
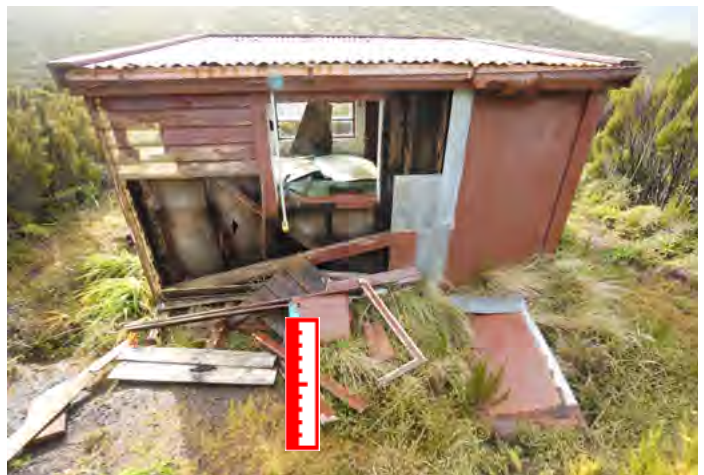
Figure V1 , V2 , V3 , V4  
CLOCKWISE FROM TOP LEFT The  
east, north, south, and west elevations of  
the Tucker Hut

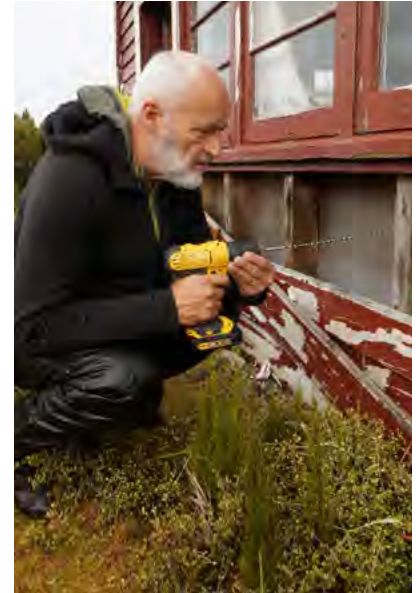
Figure V7  
BELOW The ceiling has collapsed onto the furniture below. Holes in the roof are visible as light patches. The window is missing. The towel in the far left bottom corner has remained relatively clean with all the internal moisture.

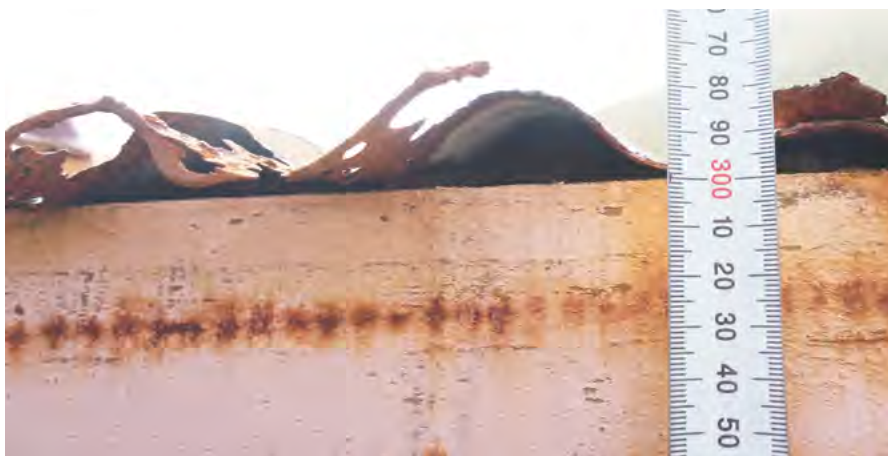
Figure V8  
LEFT Condition of the edge of the roofing,  
showing extensive perforation.

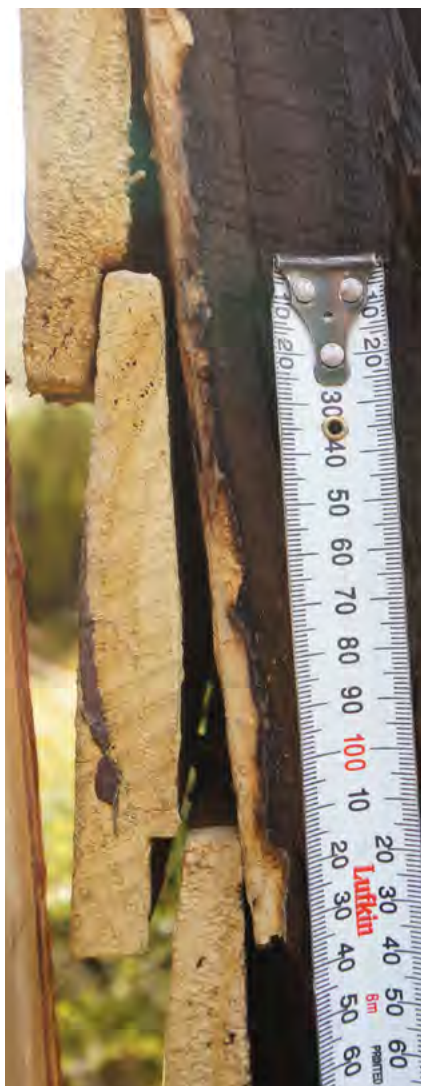
Figure V6  
LEFT Record of the size and profile of the  
weatherboards.

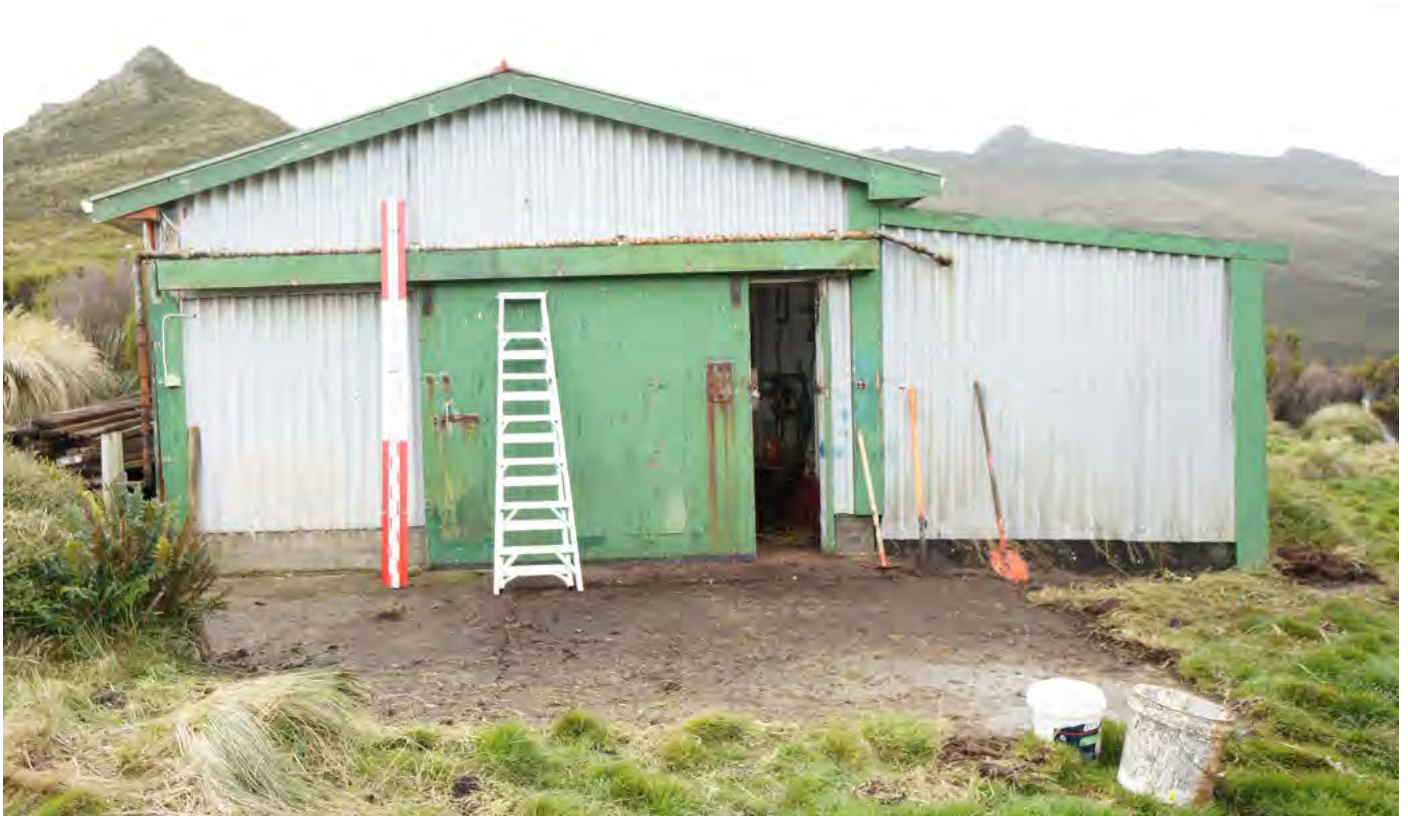
Figure W1  
BELOW South elevation of the generator garage.

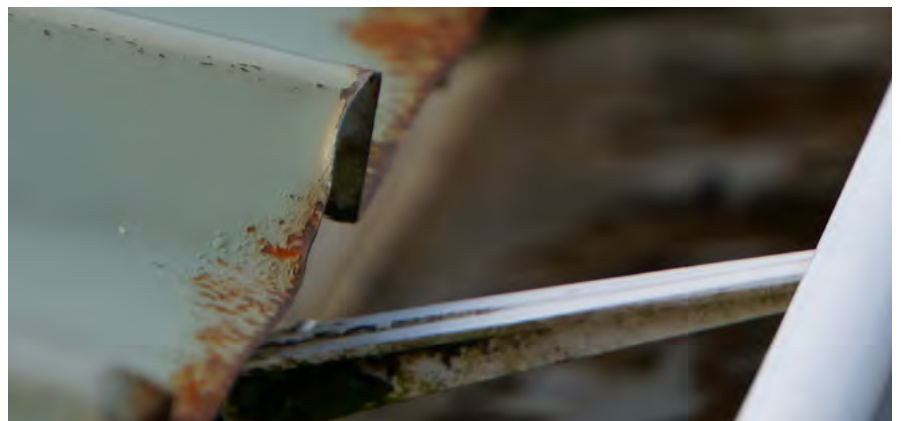
Figure W6  
RIGHT Rust developing at the edge of the roofing.

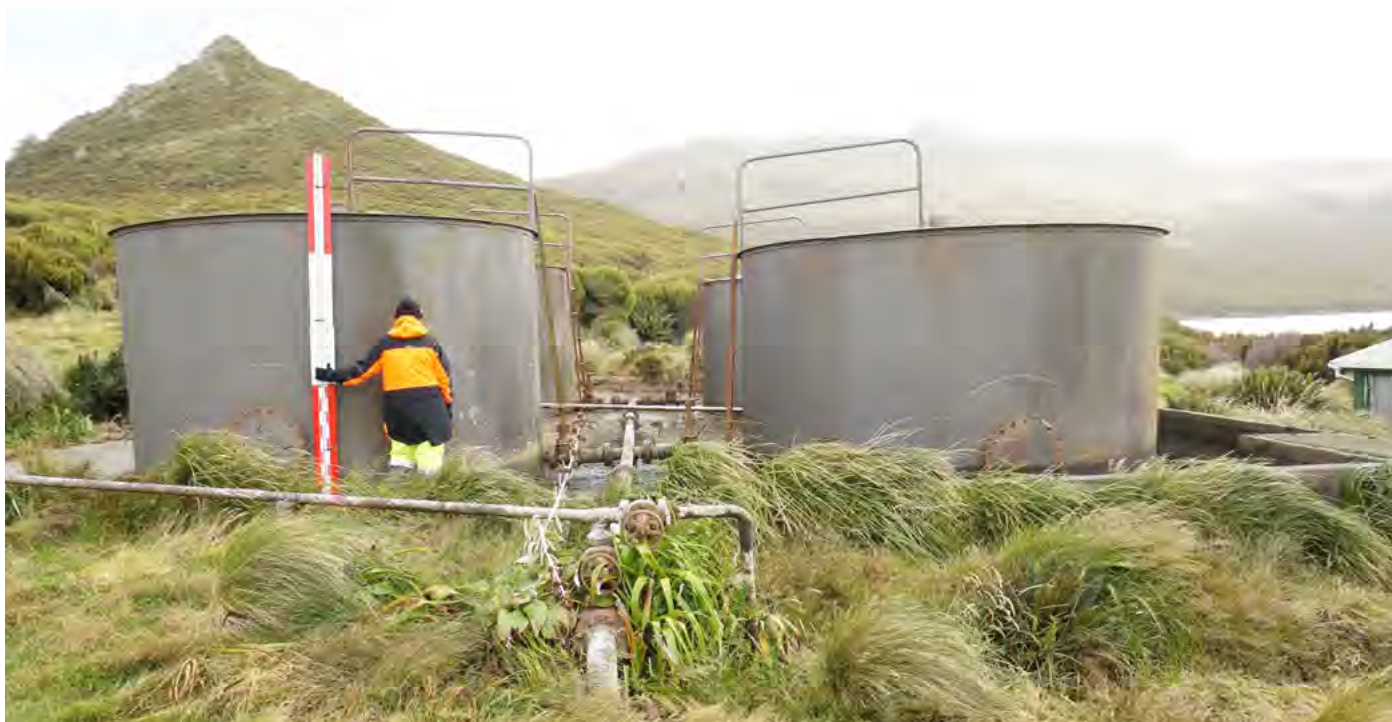
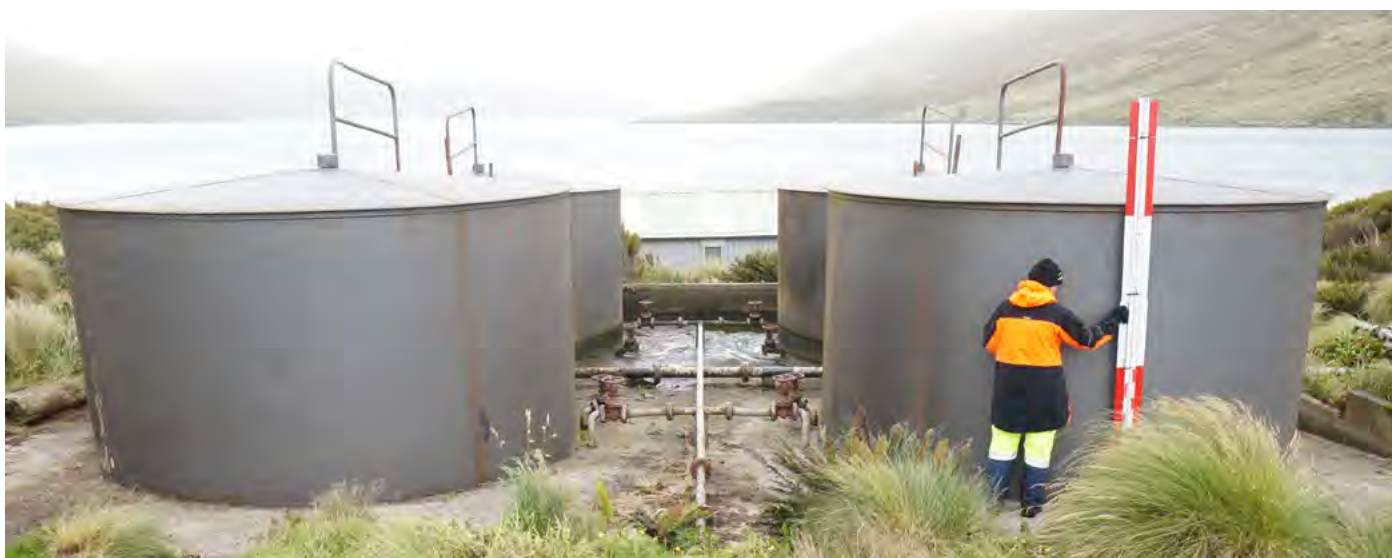
Figure X1  
FAR TOP South elevation of the water tanks.

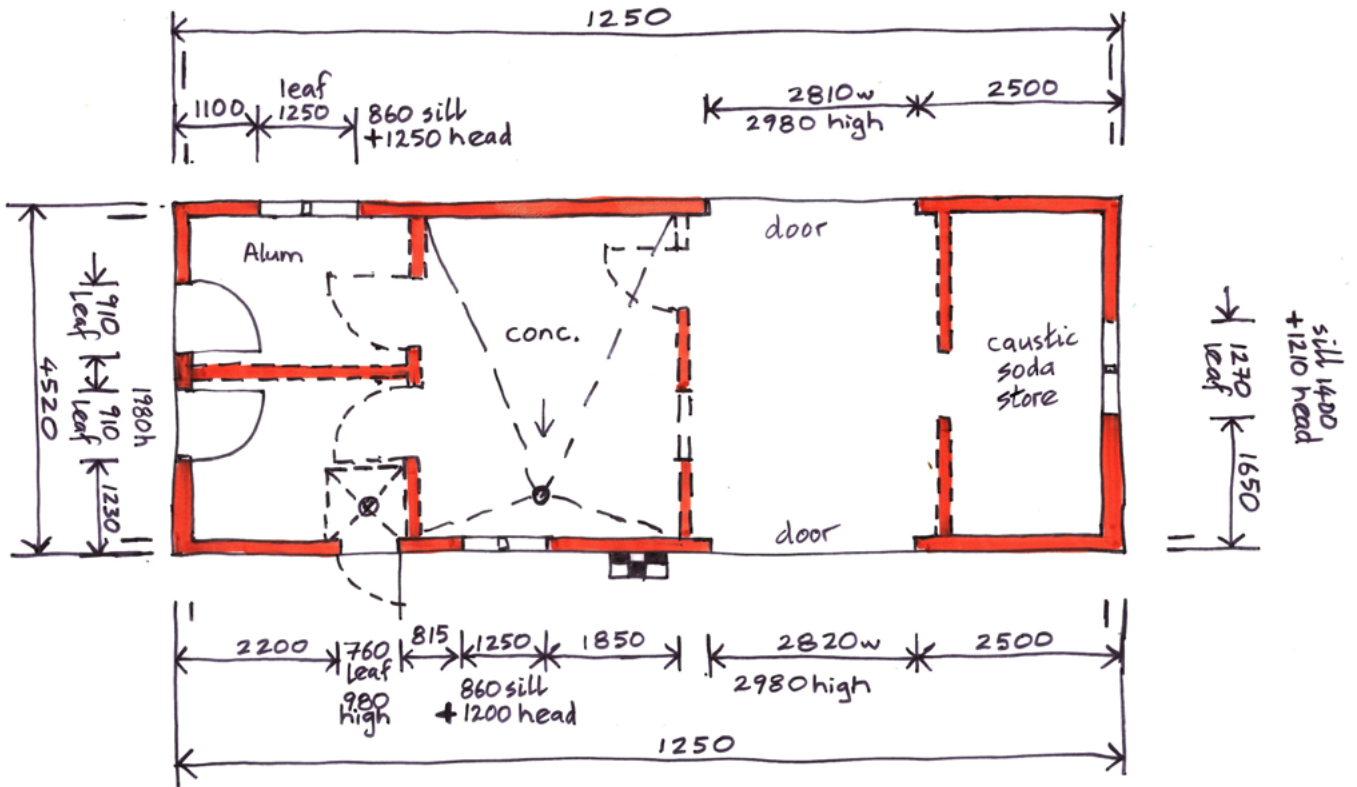
Figure Y5  
 ABOVE Plan of hydrogen building, dotted outlines are estimated.

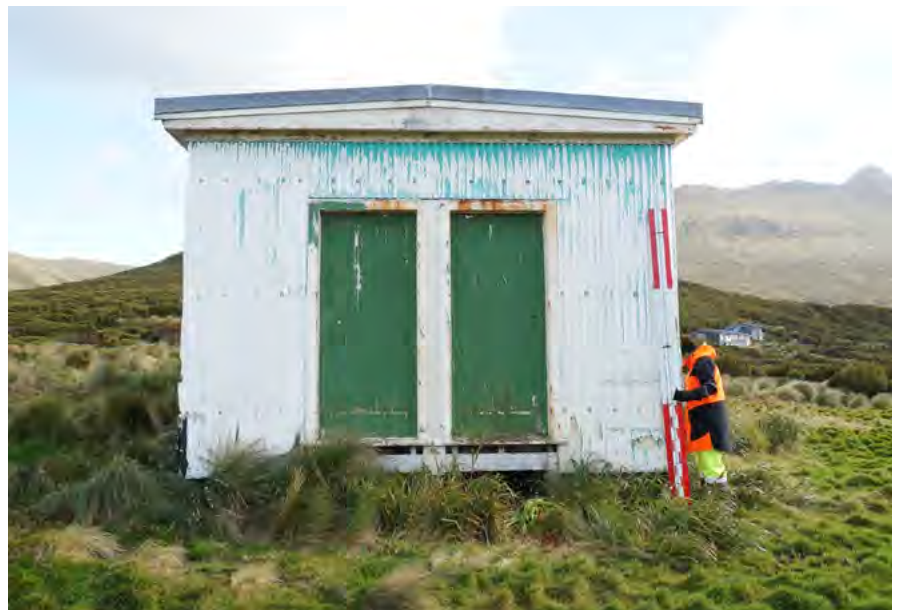
Figure Y6  
 RIGHT South elevation

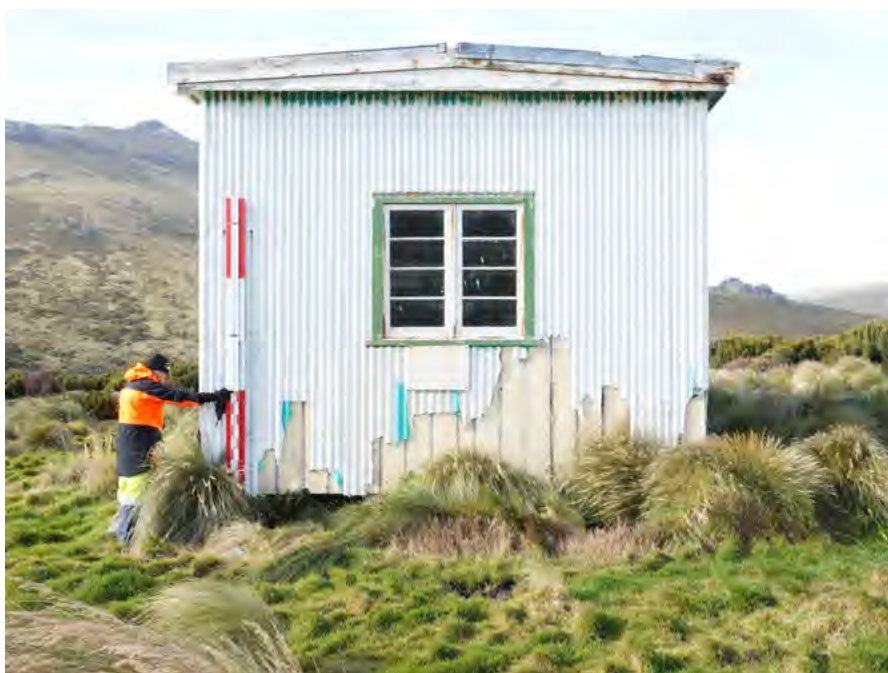
Figure Y8  
LEFT North elevation, like Aurora House, the plastic overcladding that was to keep the building waterproof, (instead of painting), has become brittle and in-effective, and has been broken by sea lions.

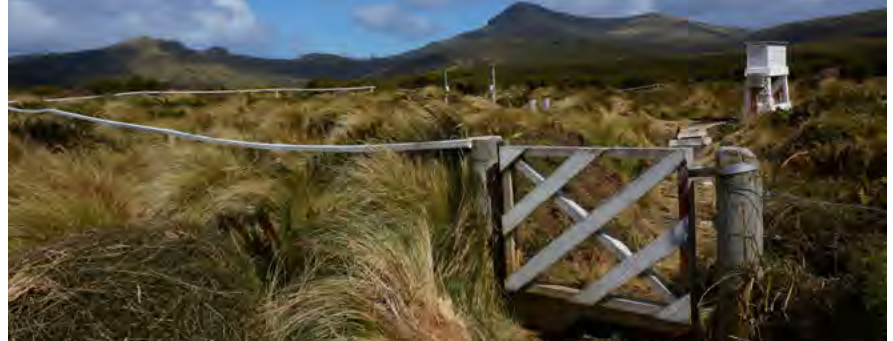
Figure Z1  
ABOVE Climatic Enclosure, from east edge, looking west.
