Blackball Coal Mine

Historic Site Assessment and Workplan

Jim Staton | West Coast *Tai Poutini* Conservancy

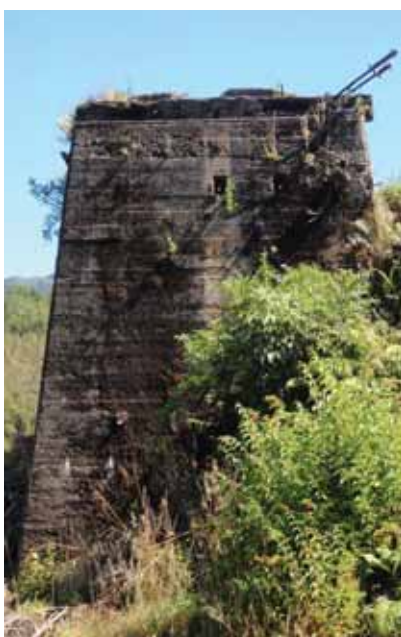
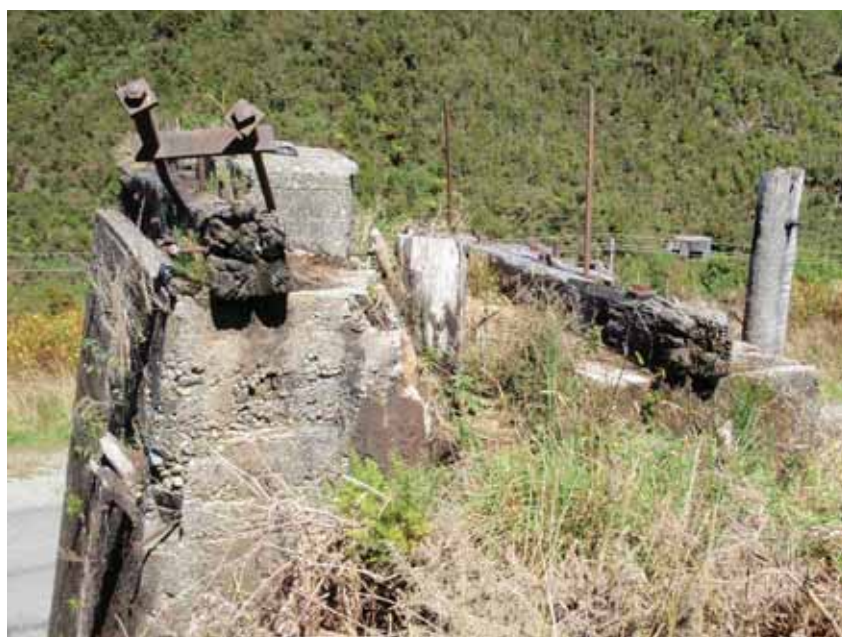
The main physical feature is the conveyor foundation located close to the edge of Roa Road. The foundation has been backfilled with overburden from the quarry and only the front face is totally visible. The foundation supported the conveyor drive mechanism and gantry that transported coal from the mine to the bins situated in the Blackball railway yards. Measuring 3.73 m across the face, 4.04 m deep across the top and 5.9 m high on the front face, the structure is tapered and the base and has been calculated to be 4.85 m across and the face is 5160 m deep at the base. Built in 1909 in conjunction with the storage bins this structure is in good condition, there are three beams and parts of two posts intact and several holding down bolts set into the top of the structure.

Left: Conveyor foundation, Blackball side view.
 Right: Rear view, Roa Road below, overburden from the quarry operation piled up behind the structure.
 JIM STATON, MARCH 2009

SITE INSPECTION — CONVEYOR FOUNDATION	WORK RECOMMENDATION Items marked * will require a work specification before work proceeds	HERITAGE IMPACT OF WORK Is this project complex ... and is a conservation plan required?
<p>Condition diagnosis</p> <ul style="list-style-type: none"> ▪ The existing concrete work is inherently sound ▪ It is not in any danger of collapse ▪ Visitors who venture onto this structure could easily injure themselves from falling off ▪ Iron strapping and timber remnants require treatment for long term viability ▪ Overburden and vegetation surround three sides of the structure 	<p>Remedial work</p> <ul style="list-style-type: none"> ▪ Top cleared of detritus <p>Upgrade work</p> <ul style="list-style-type: none"> ▪ Make workplace safe* ▪ Maintain iron and timber remnants* ▪ Remove up to two metres of overburden from rear of structure to stop the public from climbing over the top of this structure ▪ Weeds sprayed on a regular basis 	<p>Positive</p> <ul style="list-style-type: none"> ▪ Involves no loss of heritage fabric ▪ Adds another 1 to 200 years to the life of the foundation ▪ Removes a public safety hazard ▪ Well within DOC Area Office capability to complete this project ▪ Conservation plan for whole site will include this feature. <p>Negative</p> <ul style="list-style-type: none"> ▪ Nil

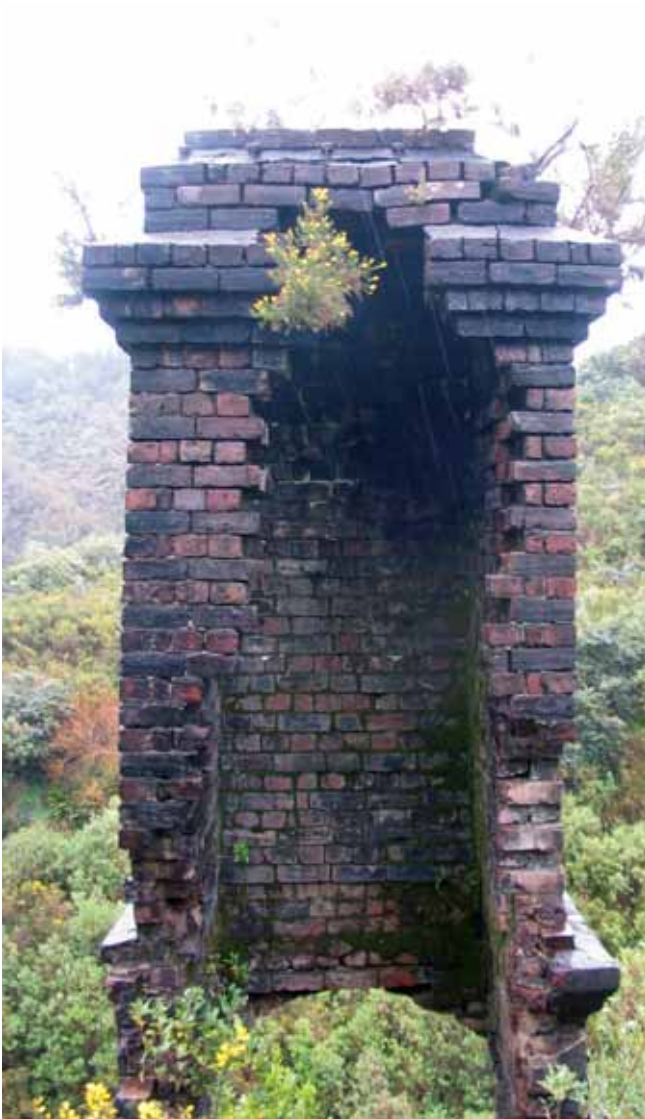
Left: Rear of the smaller chimney, showing extent of repairs required to stabilize the structure. JIM STATON APRIL 2006

The small red brick chimney is in poor condition, with 90% of the rear brickwork non-existent. There is a 300 x 400 mm hole under the cap on the east face as well as a slight twist in the top third of the structure. The cap is progressively collapsing into the centre of the hole, and gorse is growing out the top of the capping. The chimney is standing quite solidly on the ridge and is supported by wrought iron bands; one around the base above the incline flue line, and the other 300 mm below the cap.

The front of the base of the chimney requires repair work to the top of the arch to support the arch shape. If a new section of flue was built between the two chimneys then a secure grill would need to be placed in the front of the base. This grill could also be part of the strengthening support for the chimney; the wrought iron bands are in good condition and do not require immediate attention. Several railway irons and seven concrete flue support pillars line the flue location up to the chimneys; these are in good condition. At the bottom of the ridge there is one cast frame boiler setting still in place; it is the rear boiler flue outlet, approximately 50 cm square. On the south side of the frame there are the remnants of the lower end of the brick inclined flue, and part of the original drainage tunnel.

SITE INSPECTION	WORK RECOMMENDATION Items marked * will require a work specification before work proceeds	HERITAGE IMPACT OF WORK Is this project complex ... and is a conservation plan required?
<p>CHIMNEY 1 - SMALL CHIMNEY Condition diagnosis</p> <ul style="list-style-type: none"> ▪ Many bricks have been removed from rear of chimney making it structurally unstable ▪ The upper portion of the chimney is in imminent danger of collapse so this work is urgent ▪ Visitors who stray from the path below could damage the chimney and injure themselves ▪ The remaining bricks are susceptible to theft ▪ Iron strapping requires treatment for long term viability ▪ The lower brickwork is inherently sound 	<p>Remedial work</p> <ul style="list-style-type: none"> ▪ None is proposed <p>Upgrade work</p> <ul style="list-style-type: none"> ▪ Obtain matching bricks* ▪ Recruit traditional bricklayer with strong work record ▪ Make workplace safe* ▪ Use lime mortar* ▪ Restore chimney to original form, based on what is seen, and copy the original style* ▪ Reconstruct the incline portion of the chimney flue between the two chimneys, this includes placing a grill in the base of the chimney* ▪ Create a file record of old & new brick work 	<p>Positive</p> <ul style="list-style-type: none"> ▪ Work involves no loss of heritage fabric ▪ Chimney is made structurally stable ▪ Adds up to 200 years to the life of the chimney ▪ Inserting a portion of inclined flue will greatly enhance visitor experience of the site ▪ Well within DOC Area Office capability to complete this project. <p>Negative</p> <ul style="list-style-type: none"> ▪ A complex project with major scaffolding required, logistical difficulties in transporting bricks, mortar and water to a tough site. ▪ Positive and in depth planning will negate much of the complexity. ▪ Placing a grill in the base of the small chimney could look out of character, however if painted black may not be all that noticeable from the track below.

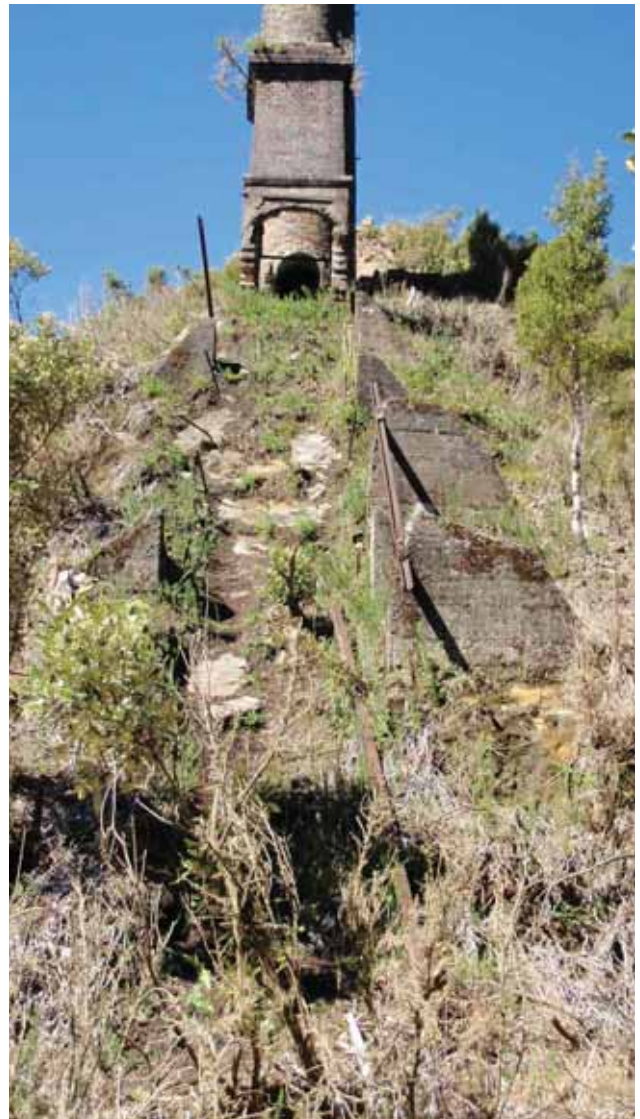
Right: View up the ridge to the two chimneys showing the line of the inclined flue. JIM STATON, MARCH 2009

The tall chimney is in sound condition at the base and appears so to the cap. The whole east side of the chimney can be easily viewed for nearly its total height from the clear ridge that rises steeply beside it a short distance away. The rungs that run up inside the chimney are in place and appear to be sound (but haven't been tested). The cap has one brick missing; it probably fell into the gully to the north and it is unlikely to have survived. It is not envisaged that the cap of the tall chimney will be repaired due to site difficulty for scaffolding and cost. The copper lightning rod is missing – presumed scrapped. It is not known where the bricks to build this chimney were sourced, although it is reasonable to assume they came from the Brunner brick kilns 24 km down the road.

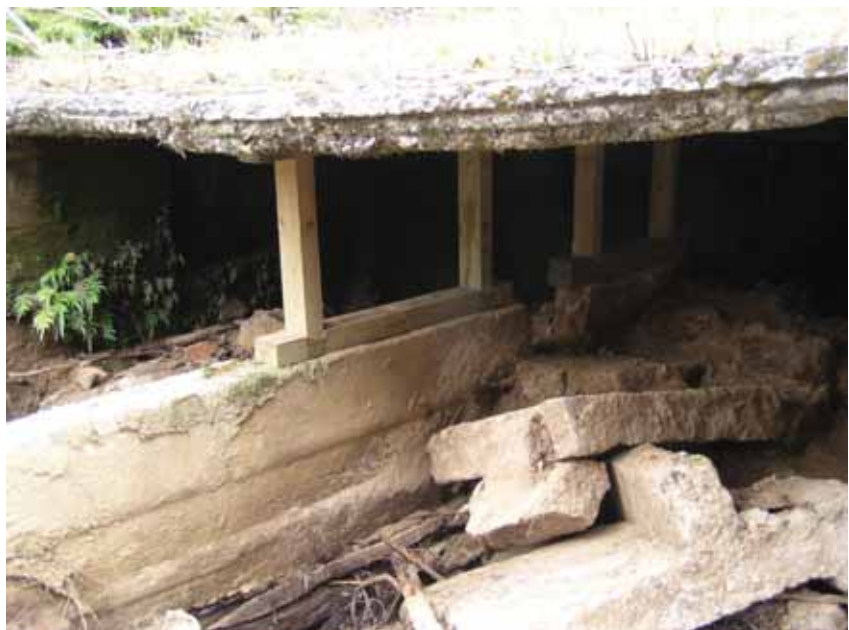
1904 Capel fan return airway opening, the fan itself was sited centrally in front of the opening, with air doors both sides of the fan. JIM STATON, MARCH 2008

SITE INSPECTION – CAPELL FANHOUSE	WORK RECOMMENDATION Items marked * will require a work specification before work proceeds	HERITAGE IMPACT OF WORK Is this project complex ... and is a conservation plan required?
<p>Condition diagnosis</p> <ul style="list-style-type: none"> ▪ The remains are three low walls and the return airway opening, other remains consist of broken blocks of concrete that have been discarded or used in the drainage system as wall packing. ▪ The iron relics, which may be from the Capell fan, laying in the drainage channel do not require treatment for long term viability 	<p>Remedial work</p> <ul style="list-style-type: none"> ▪ Inspect the foundations for stability <p>Upgrade work</p> <ul style="list-style-type: none"> ▪ Nil 	<p>Positive</p> <ul style="list-style-type: none"> ▪ The work involves no loss of heritage fabric ▪ Well within DOC Area Office capability to manage this project. ▪ Ensures safety of the structure <p>Negative</p> <ul style="list-style-type: none"> ▪ Nil

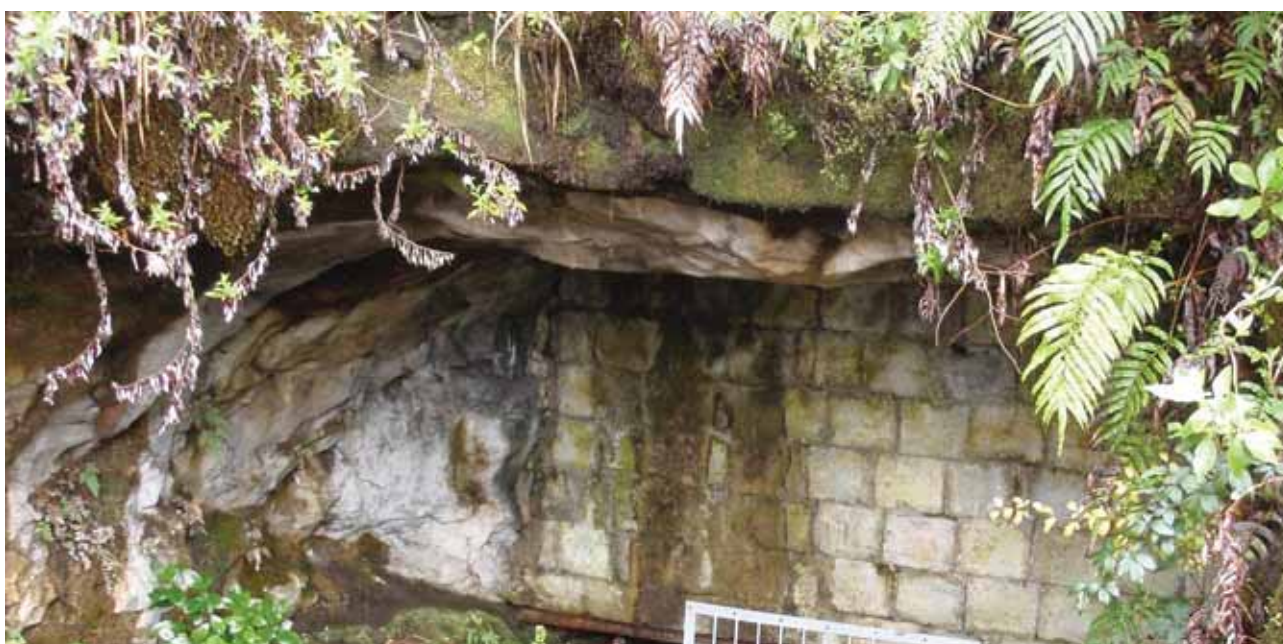
Mine entrance. JIM STATON, AUGUST 2008

SITE INSPECTION – MINE ENTRANCE	WORK RECOMMENDATION Items marked * will require a work specification before work proceeds	HERITAGE IMPACT OF WORK Is this project complex ... and is a conservation plan required?
<p>Condition diagnosis</p> <ul style="list-style-type: none"> ▪ The mine walls and roof are sound, as is the concrete block wall that seals the entrance ▪ A new grill has been placed by DOC to stop public from entering via a low gap at the base of the block wall ▪ There is no danger of collapse ▪ Visitors who stray from the path could injure themselves ▪ The iron remnants are susceptible to theft ▪ Iron remnants require treatment for long term viability. 	<p>Remedial work</p> <ul style="list-style-type: none"> ▪ Stabilise the boiler end plate and pump remains <p>Upgrade work</p> <ul style="list-style-type: none"> ▪ Maintain the track* ▪ Make workplace safe* ▪ Create a file record of work undertaken.. 	<p>Positive</p> <ul style="list-style-type: none"> ▪ The work involves no loss of heritage fabric ▪ Adds many years to the life of the iron relics ▪ Well within DOC Area Office capability to complete this project. <p>Negative</p> <ul style="list-style-type: none"> ▪ Nil

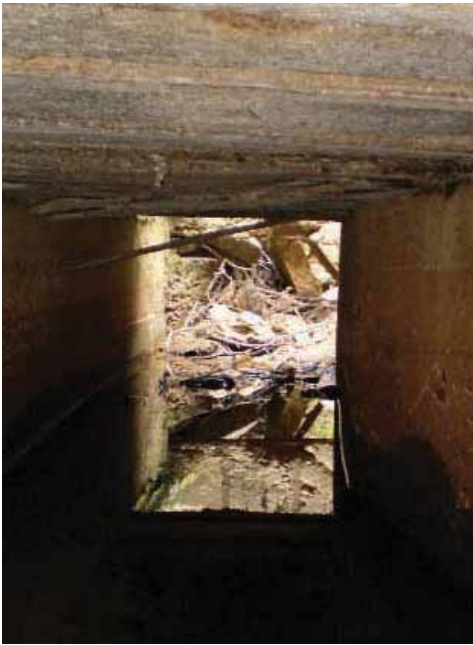
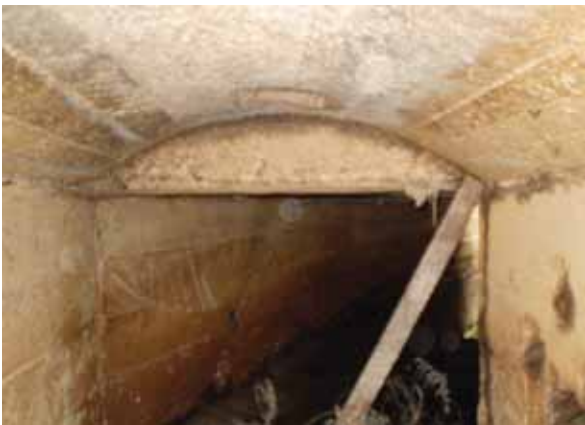
Inside the fanhouse drainage tunnel. Top: looking towards the Capell fan foundations. Below: showing the diagonal brace that impedes some material. JOHN OLIVER

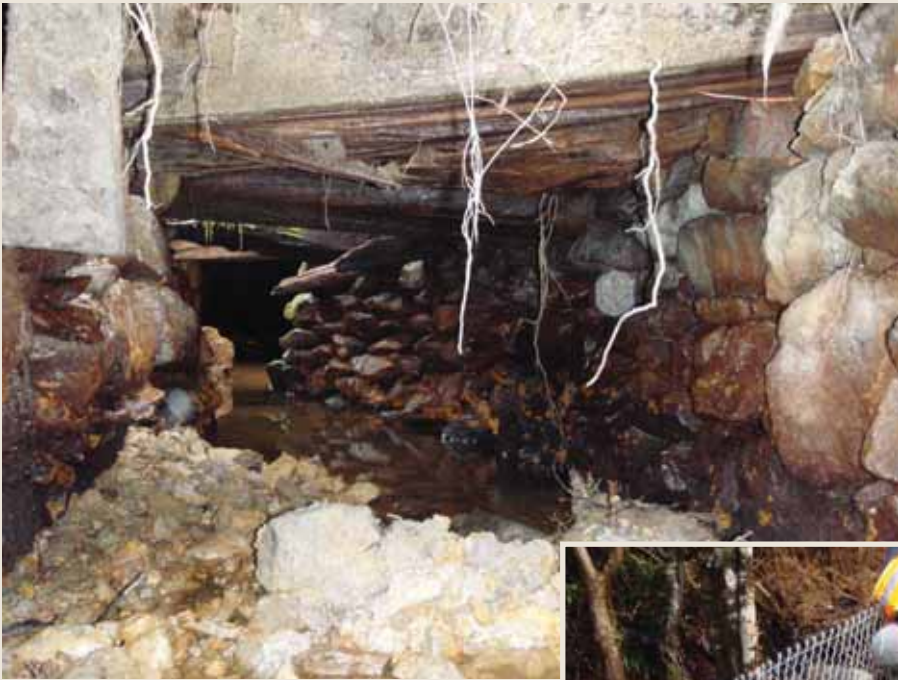
Left: The diverted drainage culvert, view back towards the main tunnel. Built on stacked stone (RH side) then broken blocks of concrete (LH side) overlaid with 8x4" (100x200mm) beams, back-filled to ground level. (Washed out by severe flooding in December 2009). It is assumed that the concrete blocks came from the Capell fanhouse building as there is a lot of broken wall concrete in the immediate area.

SITE INSPECTION – DRAINAGE CHANNEL AND TUNNELS	WORK RECOMMENDATION Items marked * will require a work specification before work proceeds	HERITAGE IMPACT OF WORK Is this project complex, and is a conservation plan required?
<p>Condition diagnosis</p> <ul style="list-style-type: none"> ▪ The existing brick and concrete tunnels are inherently sound ▪ The in-fill between the later tunnel and the return airway was washed away by flooding and remains open. and in danger of collapse, monitoring is required ▪ The section across the front of the return airway is prone to subsidence, monitoring required ▪ Beams from the dam have become lodged in the tunnels ▪ Visitors could injure themselves 	<p>Remedial work</p> <ul style="list-style-type: none"> ▪ None is proposed <p>Upgrade work</p> <ul style="list-style-type: none"> ▪ Monitor the drainage system after each major rain event ▪ Make workplace safe* ▪ Clear drains and tunnels as required ▪ Create a file record of old & new work 	<p>Positive</p> <ul style="list-style-type: none"> ▪ The work involves no loss of heritage fabric ▪ Drains and tunnels monitored ▪ Adds up to 200 years to the life of the site ▪ Well within DOC Area Office capability to complete this project. <p>Negative</p> <ul style="list-style-type: none"> ▪ Nil

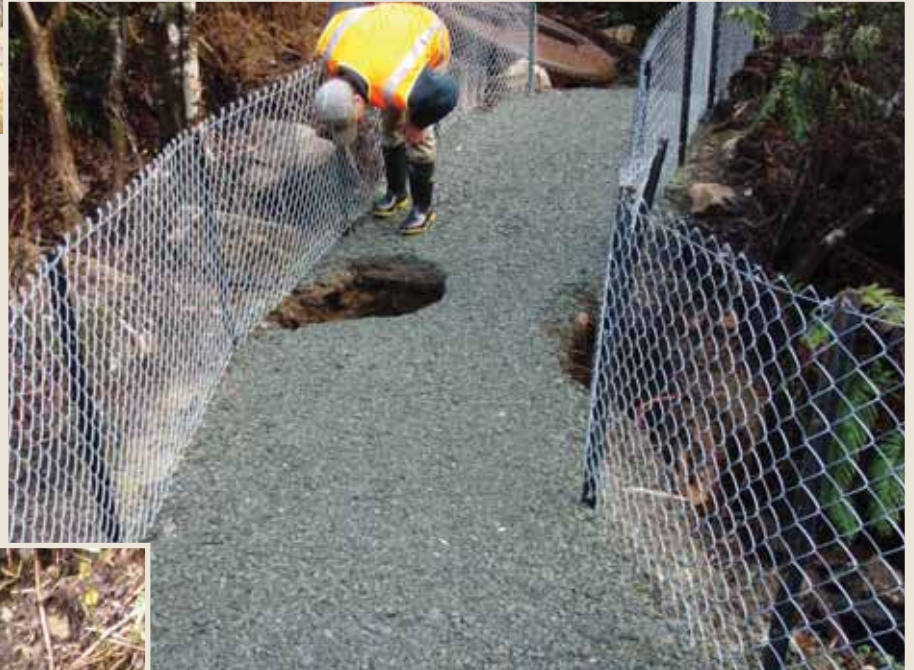
Right: The stone stacked drainage culvert collapsed after a major rain event prior to the Crib-Time Centennial in 2008. The track to the mine entrance was rerouted and the drainage culvert unblocked to prevent flooding and silting of the return airway and fanhouse sites. (Jim Brooks inspecting flood erosion damage).

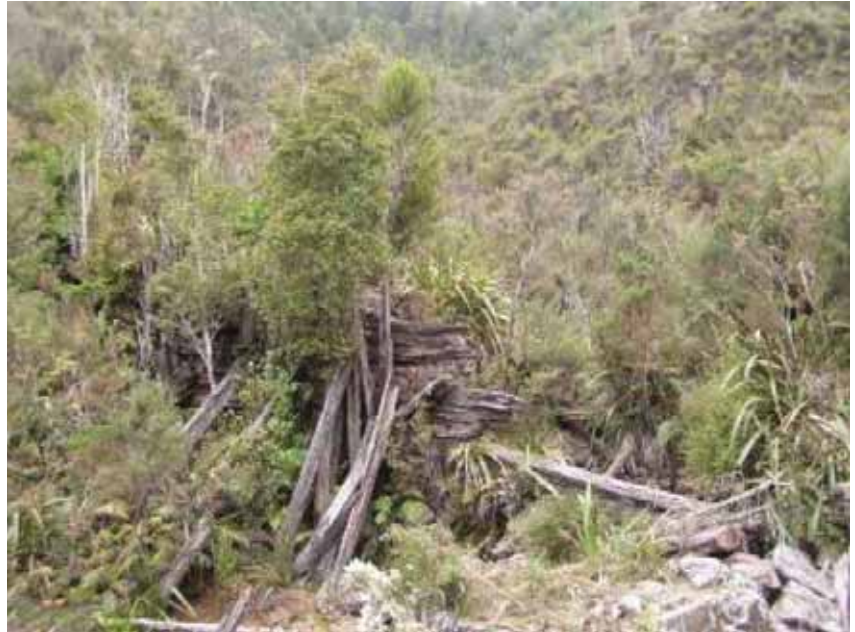
The dam supplied water to the mine boilers, for general site use and to the coal bins in the railway yards. Situated 100 m up the valley from the fanhouse structure its remnants consist of collapsed timber breastworks with beams lying in the creekbed along with associated bits of iron, rag bolts, wire rope and straps that presumably held the structure together.

SITE INSPECTION – THE DAM	WORK RECOMMENDATION Items marked * will require a work specification before work proceeds	HERITAGE IMPACT OF WORK Is this project complex ... and is a conservation plan required?
<p>Condition diagnosis</p> <ul style="list-style-type: none"> ▪ The existing timberwork is not sound ▪ It is structurally unstable ▪ The remains are in imminent danger of collapse ▪ Visitors who stray from the path could damage the dam and/or injure themselves ▪ The remains are susceptible to being swept down the creek into the drainage tunnels ▪ The remaining beams require treatment for long term viability 	<p>Remedial work</p> <ul style="list-style-type: none"> ▪ Stabilize the remaining dam structure ▪ Treatment of selected beams <p>Upgrade work</p> <ul style="list-style-type: none"> ▪ Make workplace safe* ▪ Select suitable beams to treat ▪ Measure up site and retain as much of the dam as is practical* ▪ Create a file record of old & new work. 	<p>Positive</p> <ul style="list-style-type: none"> ▪ The work involves no loss of heritage fabric ▪ The dam remains are made stable ▪ Adds life to the dam remnants ▪ Well within DOC Area Office capability to complete this project. <p>Negative</p> <ul style="list-style-type: none"> ▪ Nil

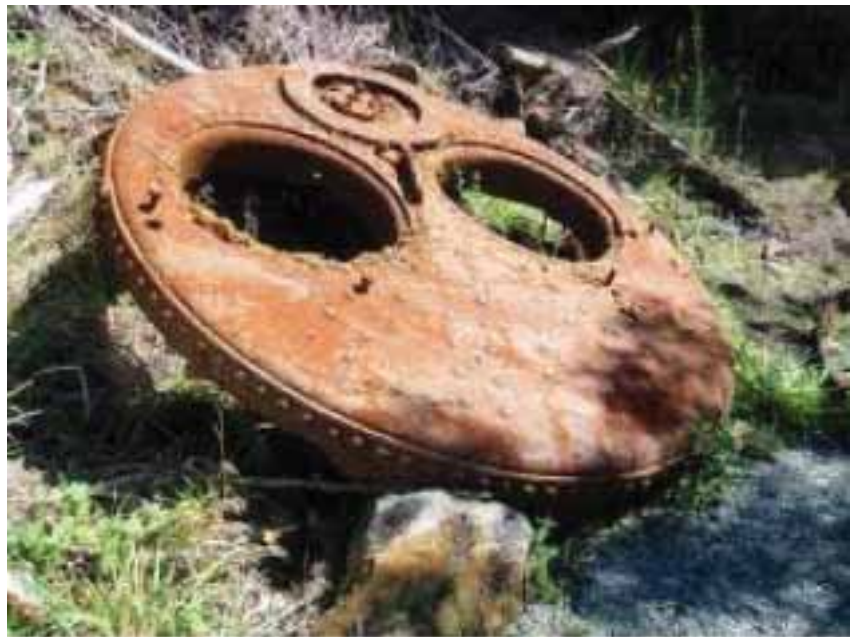
A Lancashire boiler endplate is all that remains of the boilers. As it is smaller than the usual 8' diameter for such a boiler it is believed to be the remains of 701/3977, the 20hp AW Smith of Glasgow boiler, first inspected at Blackball on the 22 February 1902.
