# Lessons Learnt 004

November 2019 V2

## Installation of a fish pass and baffles to promote trout passage through long perched culverts

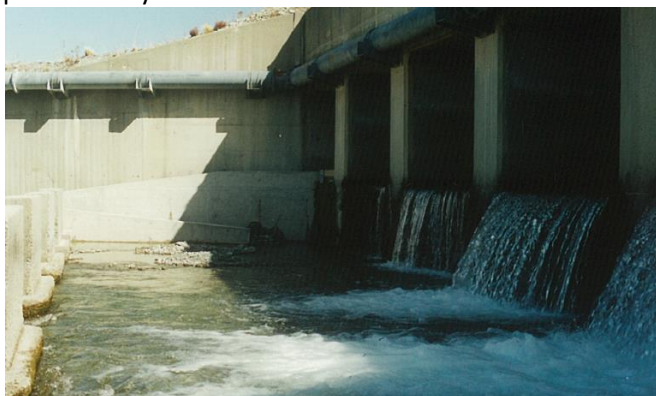
Six 120 m long, 2.6 m diameter barrel culverts (2% gradient; 2 cm average water depth) (Figure 1) pass the flow of Forks Stream under the Tekapo Hydro Canal, 1 km downstream from Lake Tekapo in the MacKenzie Basin. At this location this stream is subject to flows of between 1 and 50 m<sup>3</sup>s<sup>-1</sup>.

The outlets of these culverts are perched 2 m above the apron and are a barrier to adult trout. The perch is a result of the original design of the structure as fish passage was not taken into consideration. After passing under the canal, Forks Stream joins the Tekapo River about 100 m downstream of the culverts.

**Figure 1** Perched outlets of the six 120 m culverts running under the Tekapo Canal (1992. Photo: Mark Webb).

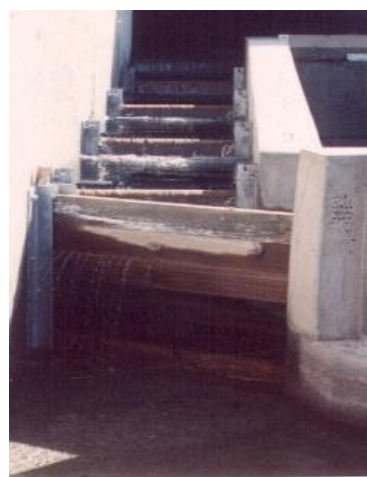
**Figure 2.** Pool/weir fish pass installed on the outlet of the Tekapo Canal. (April 1992; Source: Mark Webb)

Trout negotiated the fish pass below the culvert to the last jump. However, trout could not negotiate more than 3 m inside the culvert barrel due to high water velocities.

Partially. The pool / weir fish pass installed at the culvert outlet enabled trout to get past the 2 m vertical perch, however, attempts to get trout through the culvert failed. The length and gradient of the culvert was found to prevent trout passage. In addition, the fish pass structure could not pass flood debris and the concrete walls became damaged beyond repair.

In 1992, Electricorp Pty Ltd funded Fish and Game to install nine removable tanalised timber jump pool / weir fish passes (200 mm height; 900 mm width) in a 'U' formation in the last culvert barrel on the true right, to overcome perching (Figure 2).

The fish pass was designed for the median flows recorded in this culvert (about 20 l / s) and were considered adequate to provide upstream passage for adult trout. Monitoring showed the fish passes alone did not provide passage through the culvert length into the upper catchment.

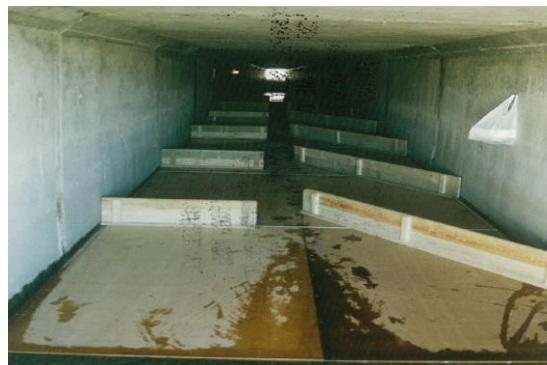
Figure 3. Baffles on a 5% gradient base overlying the culvert with a 2% gradient base. (Source: M Webb)

Monitoring of released trout in the section of prototype baffles within the culvert found that during a 36-hour period, 13 large trout (480 to 600 mm) only negotiated to the pool above the second baffle (approx. 5 m upstream). Pool depth was designed to be 0.5 m in flows of 90 l/s to 130 l/s, however in practice this became 0.65 m.

The 2% gradient of the culvert barrel required that the in-culvert baffle fish pass had an overall gradient of 5% in order to provide resting pools of 0.5 m depth between baffled units. This gradient exceeded the 3% gradient trialled by the designers of the fish pass. The extra gradient produced higher velocities and probably reduced the slower flow features produced by the lower gradient that are required for successful passage.

The marine ply prototype baffles trialled showed water pooled and flowed around baffles at flows of 90 l/s to 130 l/s so showed promise. But monitoring showed passage was not successful with baffling.

A further design was trialled using a 10.9 m prototype section of baffling within the culverts to accommodate the 2% culvert base gradient, plus an additional grade, to allow for provision of resting pools between baffled sections. The prototype consisted of four baffles on a 5% gradient and a pool (0.5 m depth x 4.2 m) at the upstream end (Figure 3). This represented one baffle unit plus pool that could be repeated throughout if successful.
