Lessons Learnt 008

June 2020 V1

Installation of Flexi-baffles to restore fish passage in a very long culvert

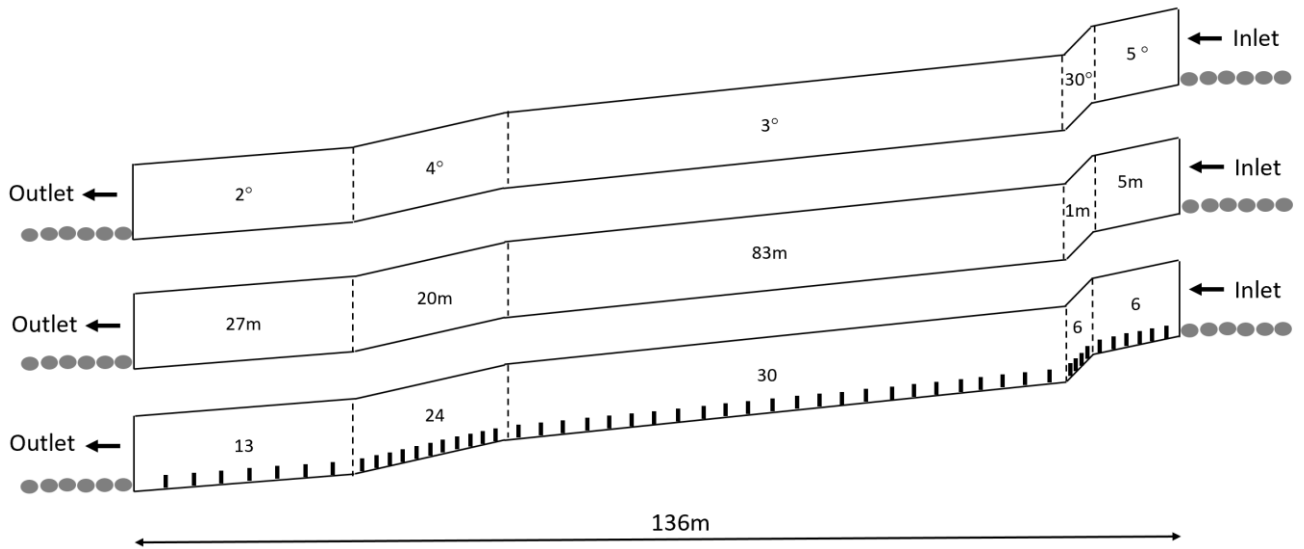
Reservoir Creek is a small, coastal stream that runs through urban Nelson. Approx. 1.5 km inland from the coast at an elevation of 31 m, the stream is piped through a complex culvert system. The culvert is 1.6 m diameter, 136 m long and has variable gradients ranging from 2° to 30° (Figure 1). The culvert is made up of different materials (concrete and metal) and changes direction numerous times. Fifteen previous fish records show that longfin and shortfin eels (*Anguilla dieffenbachii* and *A. australis*), banded kōkopu (*Galaxias fasciatus*), kōaro (*Galaxias brevipinnis*) and common bully (*Gobiomorphus cotidianus*) were found upstream and downstream of the culvert, while īnanga (*Galaxias maculatus*), and redfin bully (*Gobiomorphus huttoni*) were only found downstream (source NZ Freshwater Fish Database). It should be noted that there is only one record of common bully upstream of the culvert.

Figure 1. Cross section of Reservoir Creek culvert showing changes in gradient, length and number of baffles installed.

The spacing between baffles, and the number of baffles installed, was determined by the culvert gradients (i.e. more baffles were installed in shorter intervals where gradients were steeper) (Figure 1; Table 1).

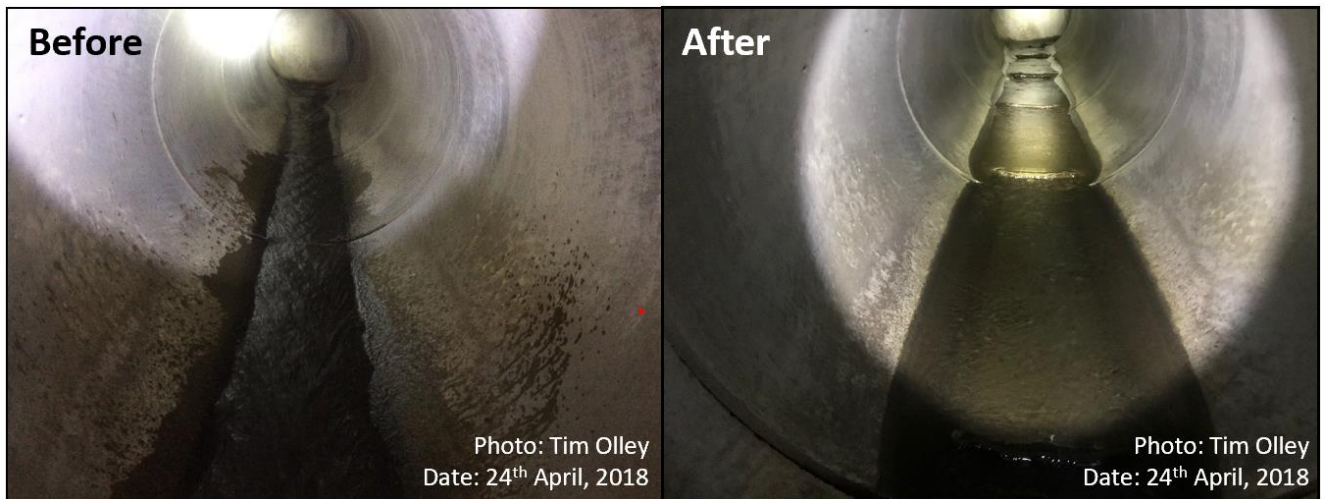
It was considered that high barrel water velocities due to the steepness of culvert gradients were impeding successful upstream passage of fish.

Figure 2. Lower section of the Reservoir Creek culvert before and after Flexi-baffle installation.

In April 2018, a total of 79 Flexi-baffles (ATS Environmental Ltd) were secured within the culvert to reduce water velocities and create resting pools within the culvert (Figure 2). Flexi-baffles are a type of flexible baffle made of a recycled polymer and were fabricated to suit the culvert (Table 1). All 79 baffles were 600 mm wide and 100 mm high with 50 mm slits and 45-degree cuts at both ends to allow fish passage around the baffle (Figure 2 and 3). The baffles were attached to the concrete culvert floor with stainless-steel sleeve anchors (M6.5 x 40 mm) and stainless-steel penny washers (32 mm). In the metal section of the culvert we used stainless steel tek-screws (14G x 25 mm) with stainless-steel penny washers (32mm).

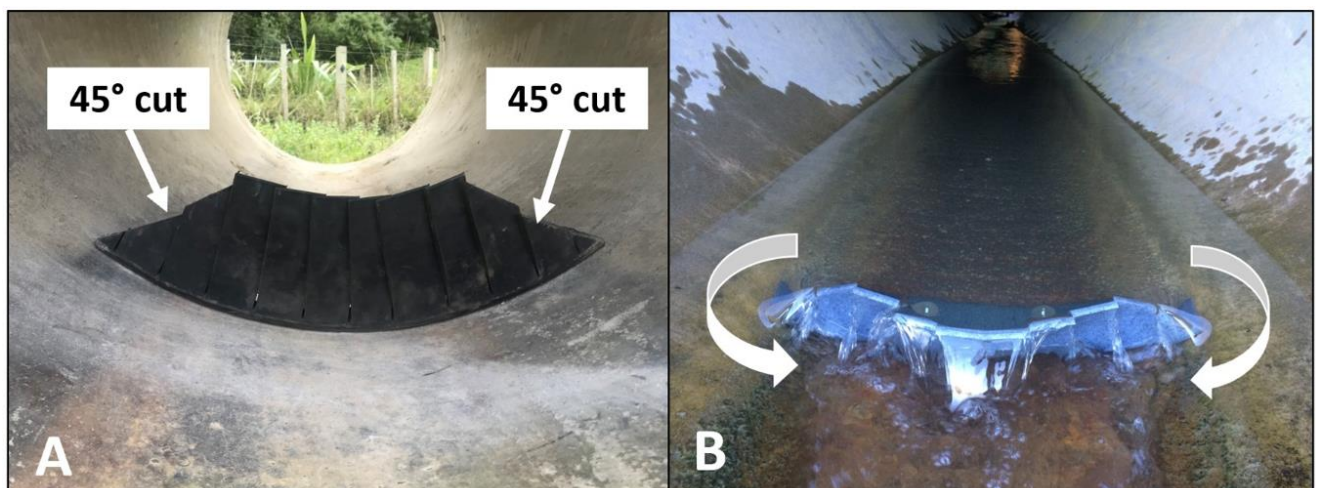
Figure 3. Each baffle is cut at 45° on either side (A) to allow water to spill around the baffle (B) enabling fish passage, even at low flows (Note: photographs are not from Reservoir Creek culvert).

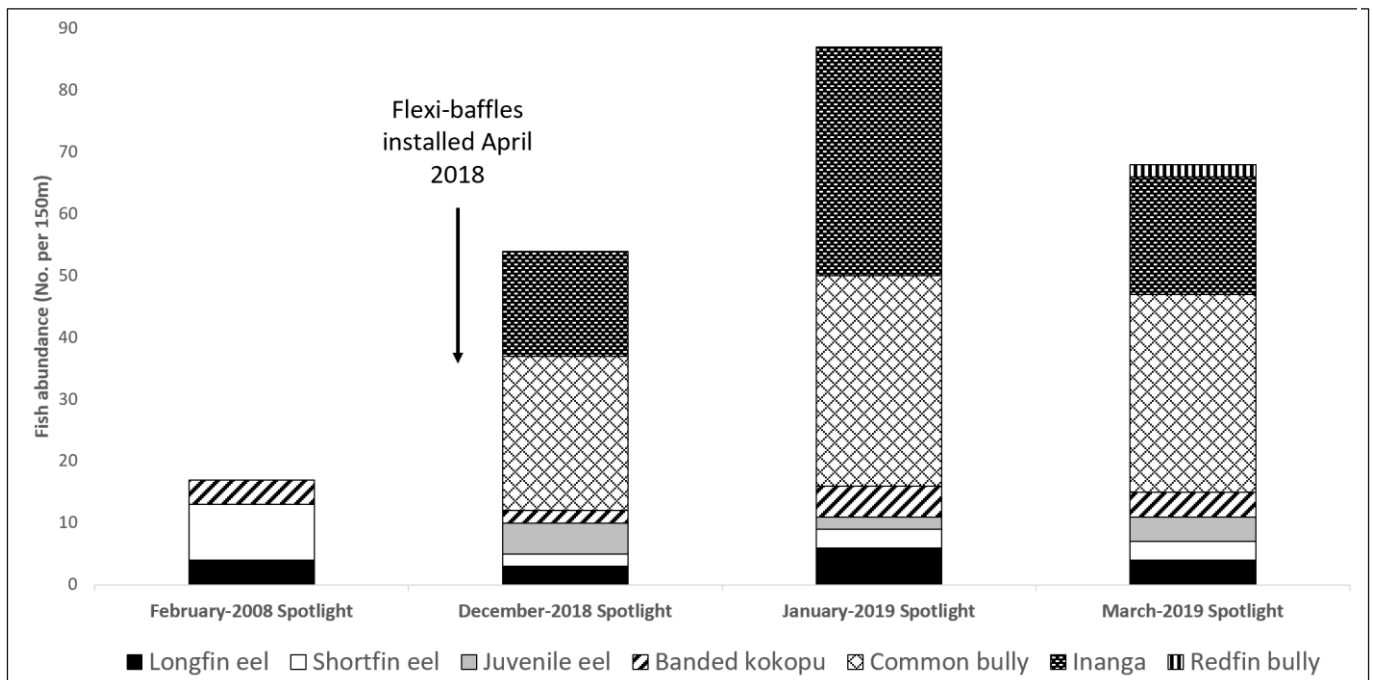
Fish communities within the 150 m reach directly upstream of the Reservoir Creek culvert were surveyed by TDC three times using single pass spotlighting over the 2018 / 19 summer, and once by single pass electric fishing in March 2020. These surveys can be compared to a single pass spotlight survey (February 2008), and two single pass electric fishing surveys (January 2012 and March 2016) of the same reach prior to any fish passage improvements (Figures 4 & 5). Results showed īnanga and redfin bully were found upstream of the culvert for the first time (Figures 4 & 5) and common bully numbers upstream of the culvert increased (Figures 4 & 5) following fish passage improvements. The minimum size of īnanga and common bullies was 50 mm and 40 mm, respectively, suggesting young fish are moving through the culvert.

Figure 4. Number of fish observed upstream of the culvert before (Feb 2008) and after (Dec 2018, Jan and Mar 2019) Flexi-baffles were installed.

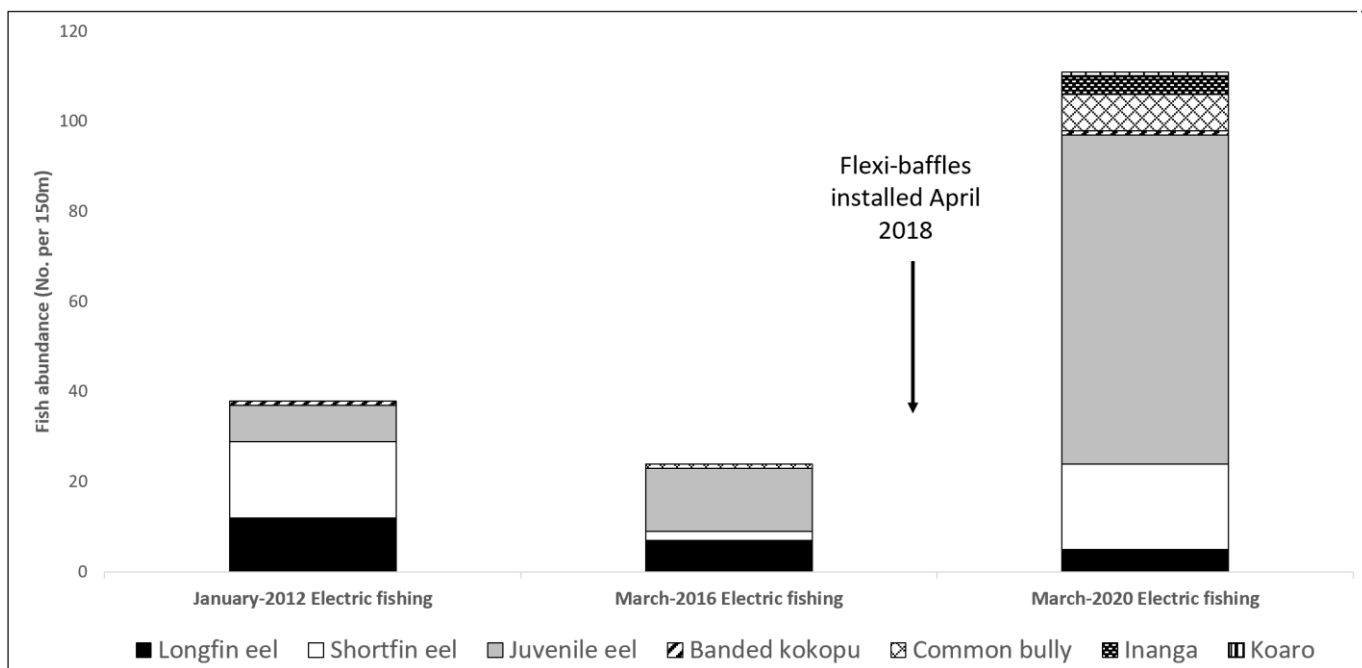
Figure 5. Number of fish observed upstream of the culvert before (Jan 2012 and Mar 2016) and after (Mar 2020) Flexi-baffles were installed.

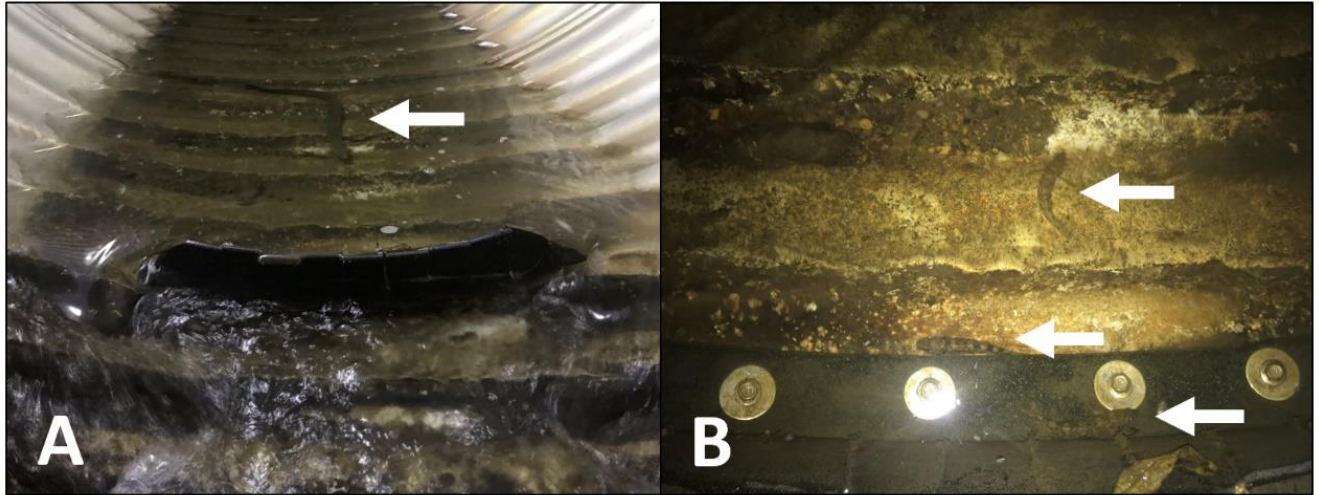
Several inspections within the culvert barrel have been carried out to assess baffle durability. During those inspections, anecdotal observations showed fish in pools between baffles and swimming upstream around the 45-degree cuts in the baffles and may be using baffles as refuge (Figure 6).

Figure 6. Photo A shows an eel in a pool upstream of a Flexi-baffle. Photo B shows three common bully in a pool upstream of a baffle near the top of the culvert.
