Report on Debris Flood Recovery and Rehabilitation of Matata Wildlife Refuge Reserve (Te Awa O Te Atua Lagoon)

Technical Report Series 3

Keith Owen, Ian Smith, Paul Cashmore, Sarah Crump, Brendon Christensen
and Chris Staite

Published by
Department of Conservation
East Coast Bay of Plenty Conservancy
PO Box 1146, Rotorua, New Zealand

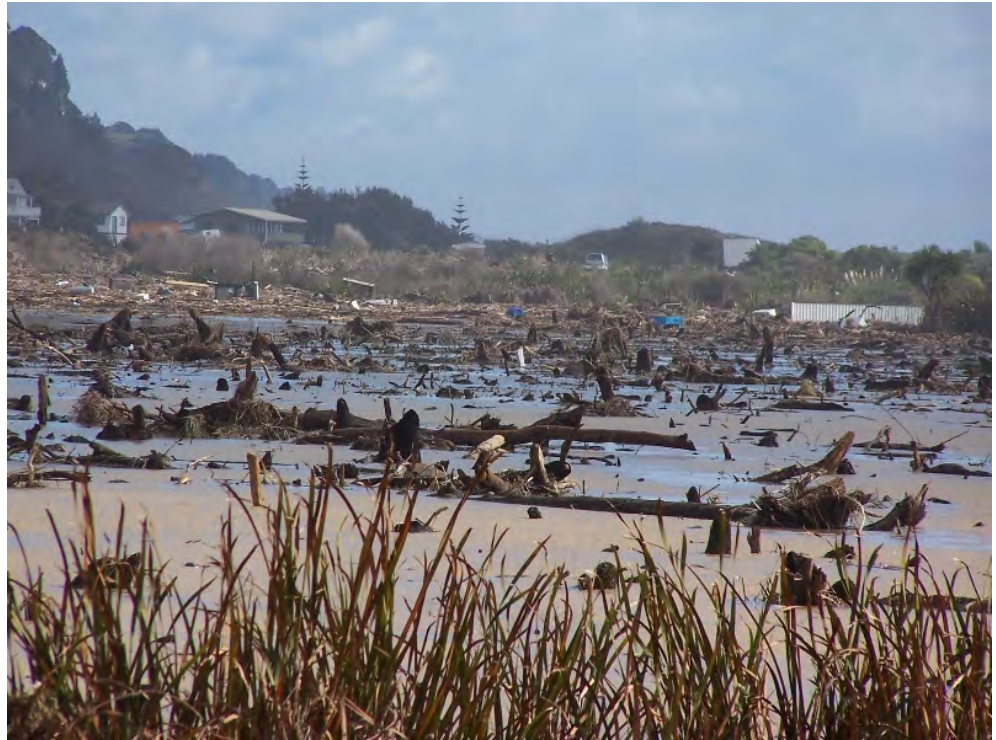
Figure 1. The result of the intensive May 2005 flood on the Reserve (western lagoon) is illustrated (Ian Smith, 31 May 2005).

Observations and comparison of the post flood aerial photos of the western lagoon, indicated infilling by up to 1 metre in the western part of the lagoon occurred. There was further encroachment of infilling into the western lagoon itself. Trees and debris accumulated over the full extent of the western lagoon. Timber from the surrounding forest catchment ended up there and protruded over much of the newly exposed western lagoon floor (See Figure 1).

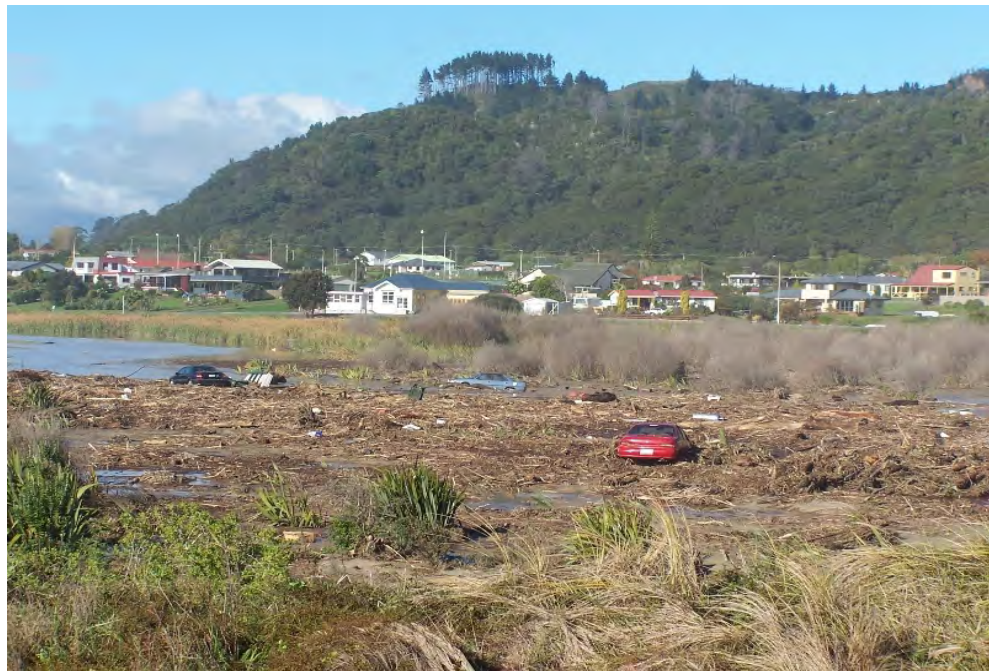
During the height of the storm more flood waters entered the Reserve than could disperse through the floodgate at the eastern end into the Tarawera River. An enormous amount of debris entered the western lagoon with the flood waters and backed up behind the road causeway to the Domain at the eastern end of the lagoon. The existing ecological processes within the western lagoon were seriously compromised by this huge influx of silt, logs, debris, pollutants and other foreign materials (See Figure 6).

Figure 6. Debris including silt, logs, cars, pollutants, and other foreign materials deposited at the west end of the western lagoon (Ian Smith, 31 July 2005).

Residential property such as cars, caravans, garden sheds, washing machines and other detritus had also ended up in the lagoon predominantly at the western end (see Figure 6). Emergency crews from the DOC removed the bulk of these items with the aid of a helicopter in June 2005.

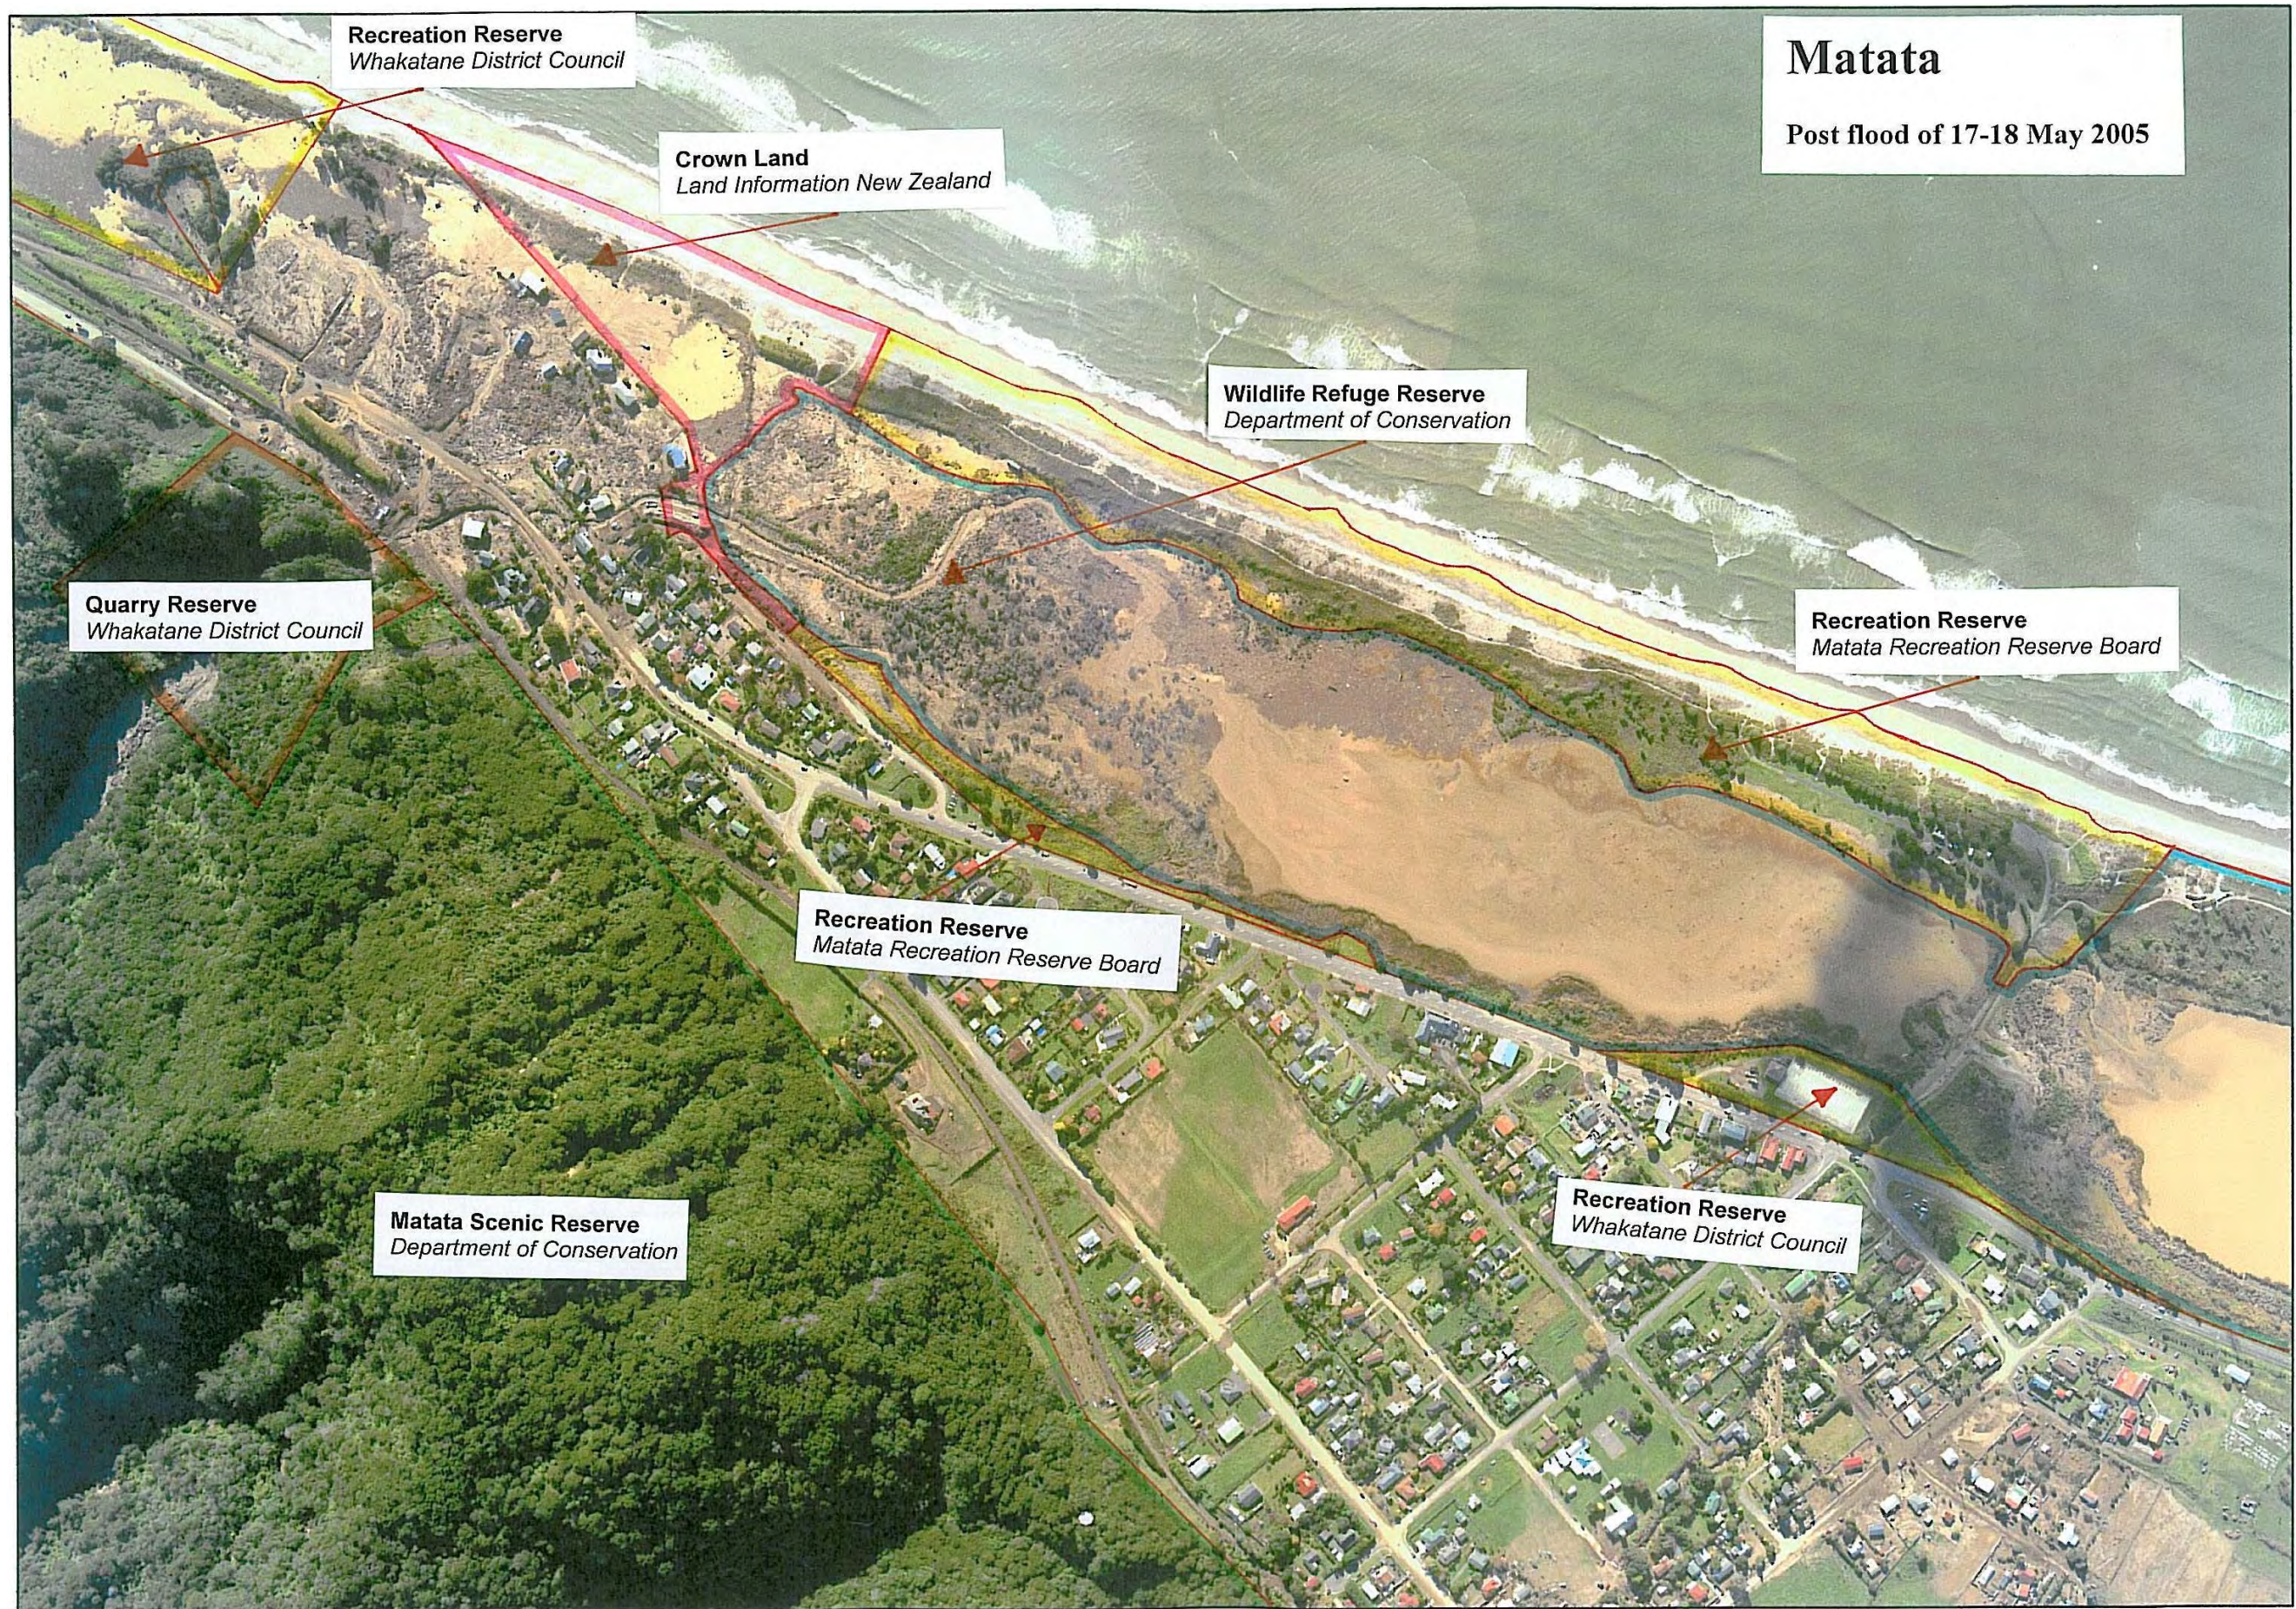
The road causeway effectively acted as a barrier to the spread of the flotsam from the western lagoon into the eastern lagoon (Figure 7). Significant sedimentation of very fine material occurred in the western part of the east lagoon as well. As the water level lowered within the western lagoon the residual silt was equal and in places higher than the pre-flood water levels.

Figure 7. Aerial photograph of western lagoon, Matata, immediate post flood of 17-18 May 2005.

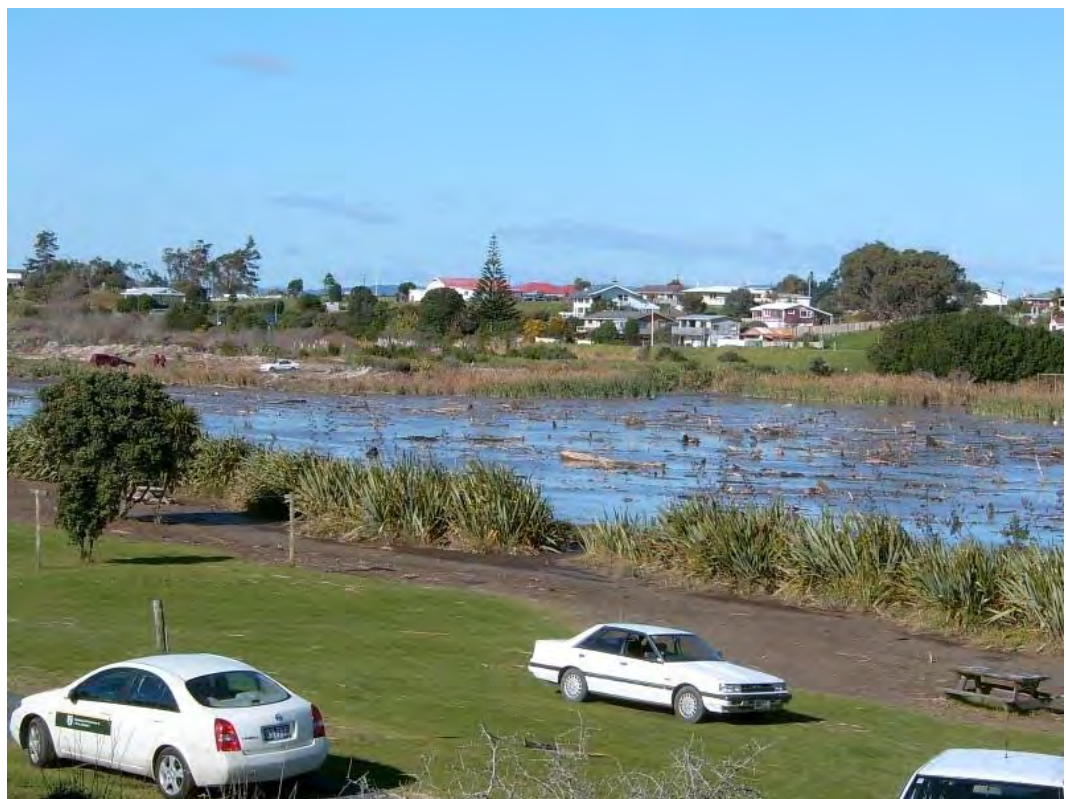
Part of the lawn in front of the Domain silted up to 150 mm deep, so it was likely the lagoon floor had also been raised by this amount (see Figure 8 below).

Figure 8. In front of the Domain at western lagoon. Lawn area silted up to 150 mm deep (Ian Smith, 31 May 2005).

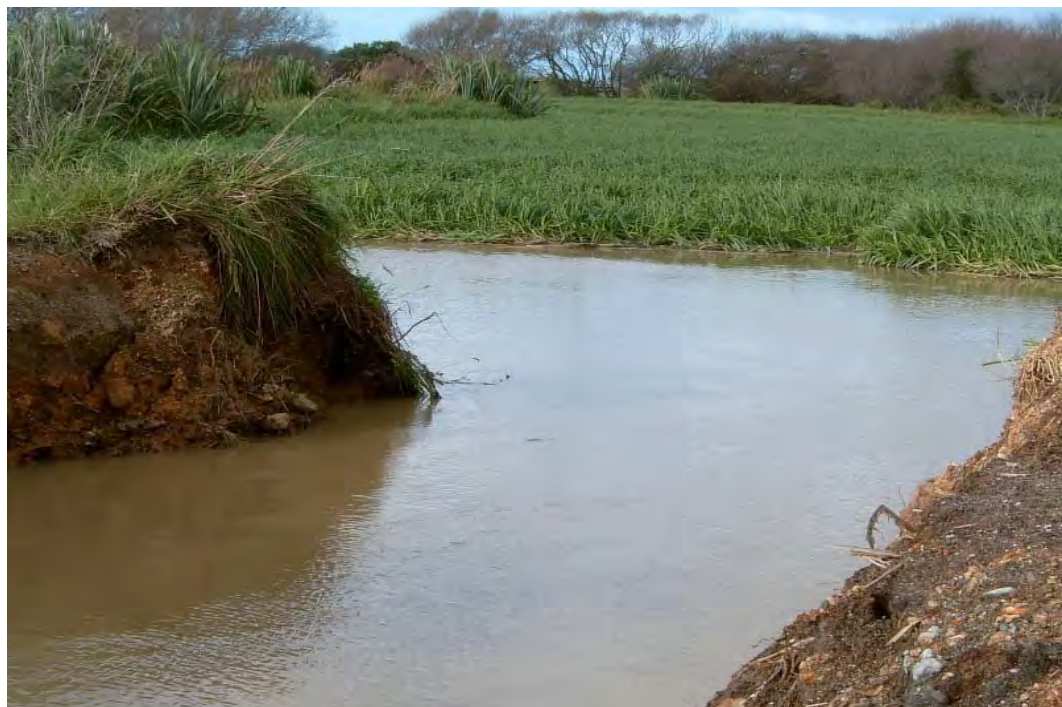
In the aftermath of May 2005 storm event, there was a fear of further flooding of the embankment at the Tarawera River end of the east lagoon. It was breached to allow flood water to escape (see Figure 9). It is possible that the tidal flap gate there had been stuck in a closed position. The breach was closed off soon after as a matter of urgency to stop sea water pollution of what is otherwise a fresh water lagoon system and to ensure that pest plants such as water sweetgrass (*Glyceria maxima*) would not invade the Reserve.

Figure 9. Embankment breached at eastern end of the eastern lagoon near Tarawera River. Water sweetgrass (*Glyceria maxima*) infestation beyond (Ian Smith, 31 May 2005).

Emergency work was implemented by breaching the stop bank and bypassing around the flood gate at the eastern end of the eastern lagoon (See Figure 9) to assist clean up operations, and ensure the continued drainage of storm water from both lagoons into the Tarawera River. There was a considerable amount of ground water within the silt which required draining.

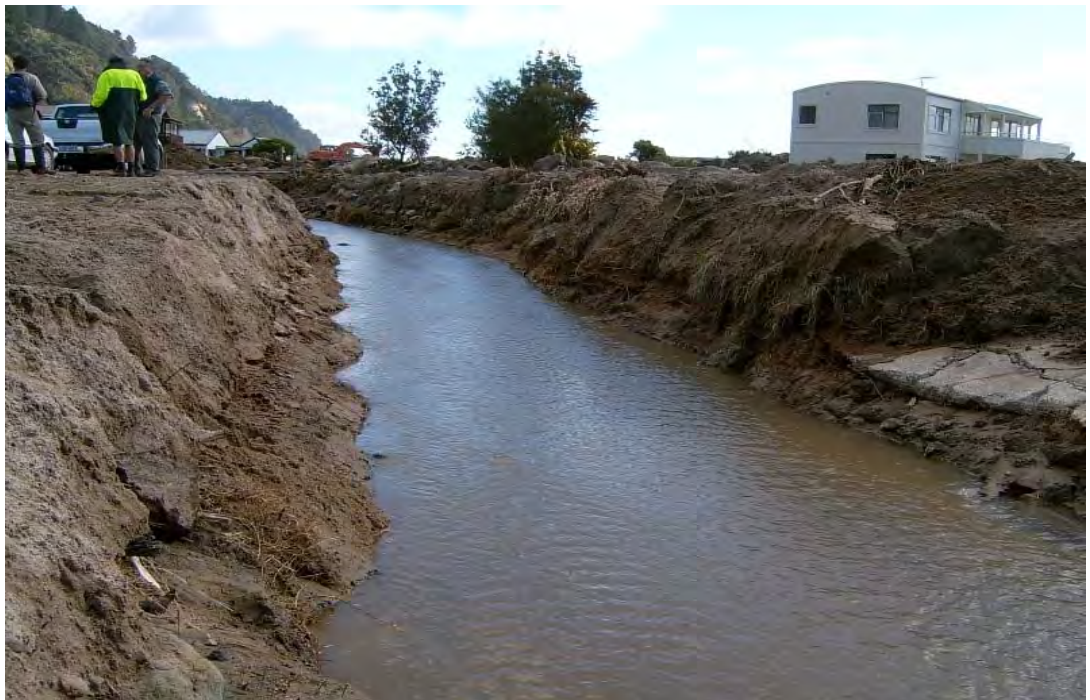
Considering management of water flows was not easy to achieve without significant input from both Regional and District Councils. It was noted that during the immediate cleanup after the storm, the sediment was cleared from around the houses at the Awatarariki Stream outlet and the stream was channeled into a narrow cut directly towards the remnant area of the western lagoon (See Figure10).

If no further work was done on modification here, then what was likely to happen in the next flood (even a normal fresh) was that the channel would soon block and the overflow sediment will then go directly to where the last lot has been removed i.e around the houses. Any reservoir for debris and sediment collection that pre-existed, has been largely in-filled in the areas adjacent to those houses during the flood and this adjacent infilling has not been removed.

Figure 10. Awatarariki Stream outlet looking upstream (Ian Smith, 31 May 2005). Note, the stream has been channeled into a narrow cut flowing directly towards the remnant area of the western lagoon.
