CONSERVATION ADVISORY SCIENCE NOTES

No. 61

**ACCELERATED LIFE ENVIRONMENTAL TESTS OF VARIOUS
OUTDOOR SIGNS**

TEST REPORT

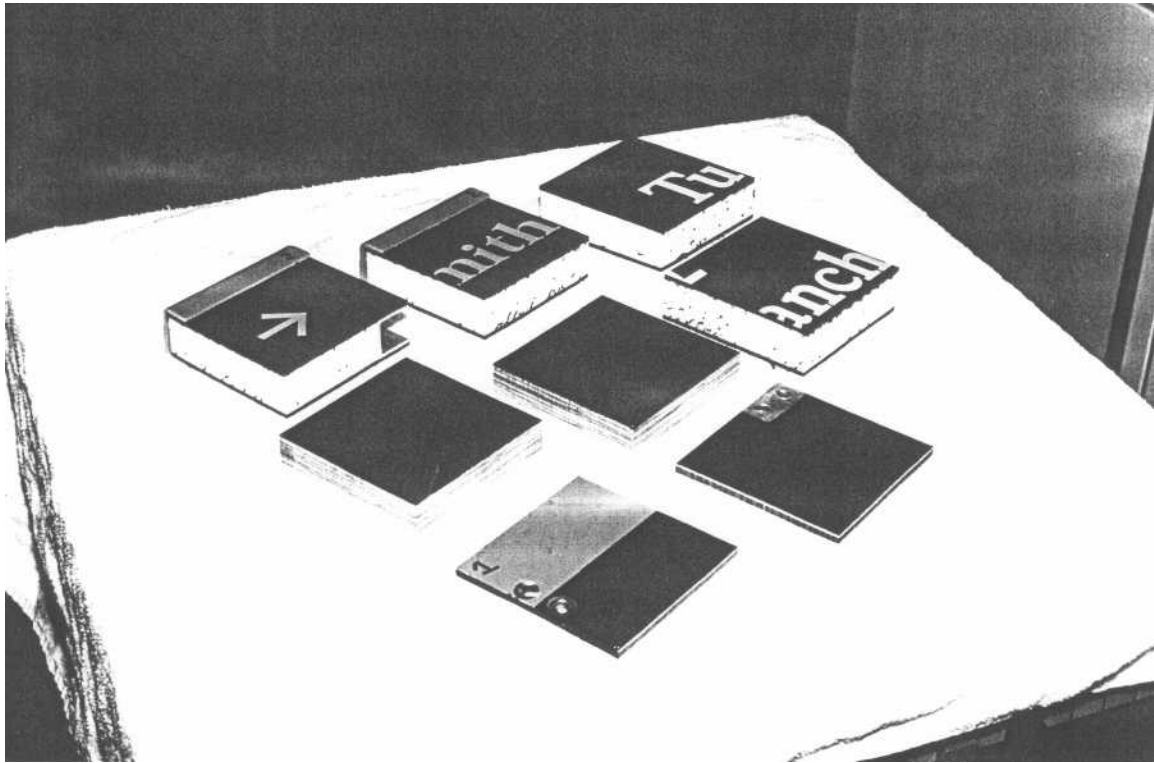
Figure 1 Test samples as received, before the salt/fog test

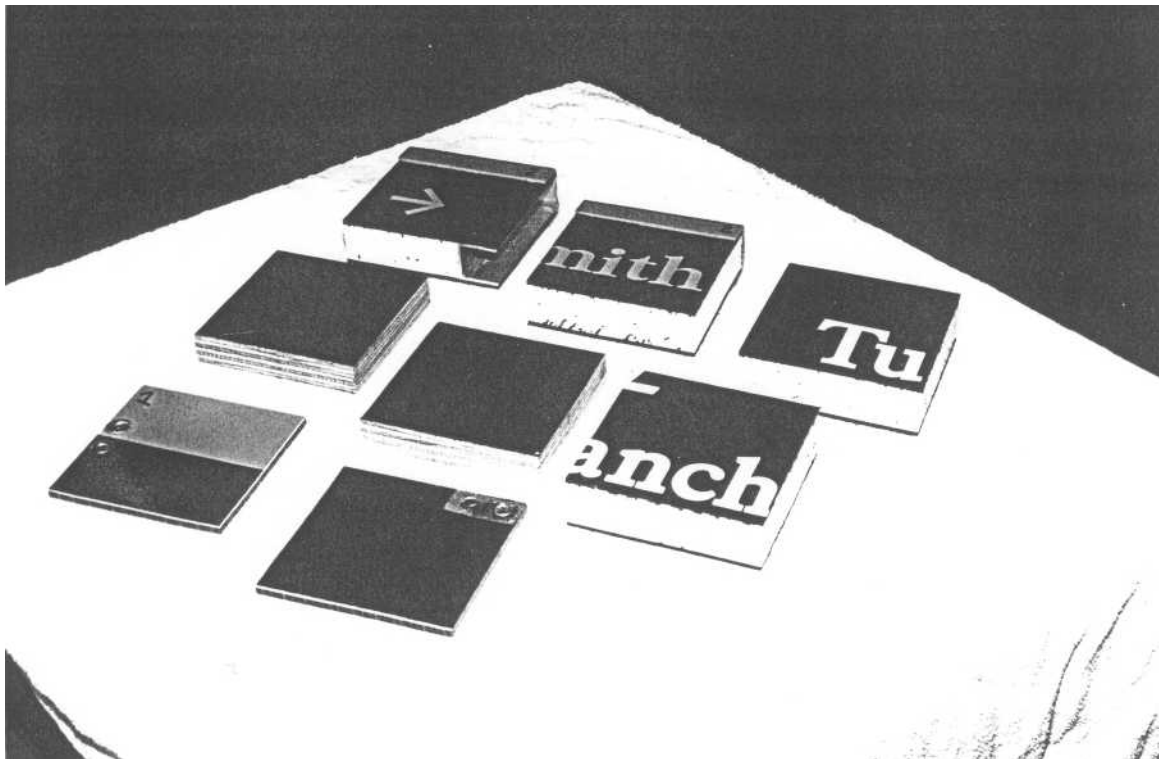
Figure 2 Test samples before the salt/fog test

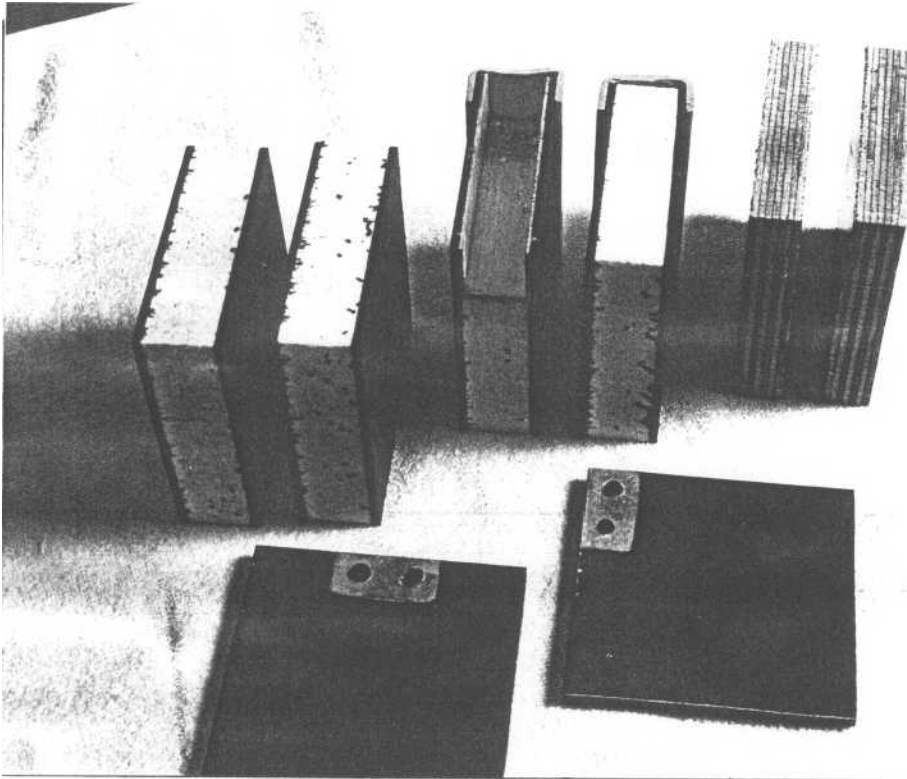
Sample 1 Both panels were beginning to show some oxidation of the unpainted aluminium around the bolt holes on the edge of the panel. No change to the painted surfaces or lettering.

Sample 2 Start of oxidation of the aluminium channel on the edges of the sample. No change to colour of panels or lettering.

Sample 3 No change to colour of panels or lettering.

Sample 4 On the edges where the samples were cut out corrosion was apparent on both samples, with lifting of the paint, but no change to the painted surface itself. See Figures 3 and 4.

Figure 3 Test samples AFTER the salt/fog tests

From the salt/fog evaluation it is apparent that the signs incorporating exposed aluminium, samples 2 and 1 (at bolt holes) may suffer in a coastal environment. While the coloursteel sample (4) may need protection on the edges depending on the method of fabrication.

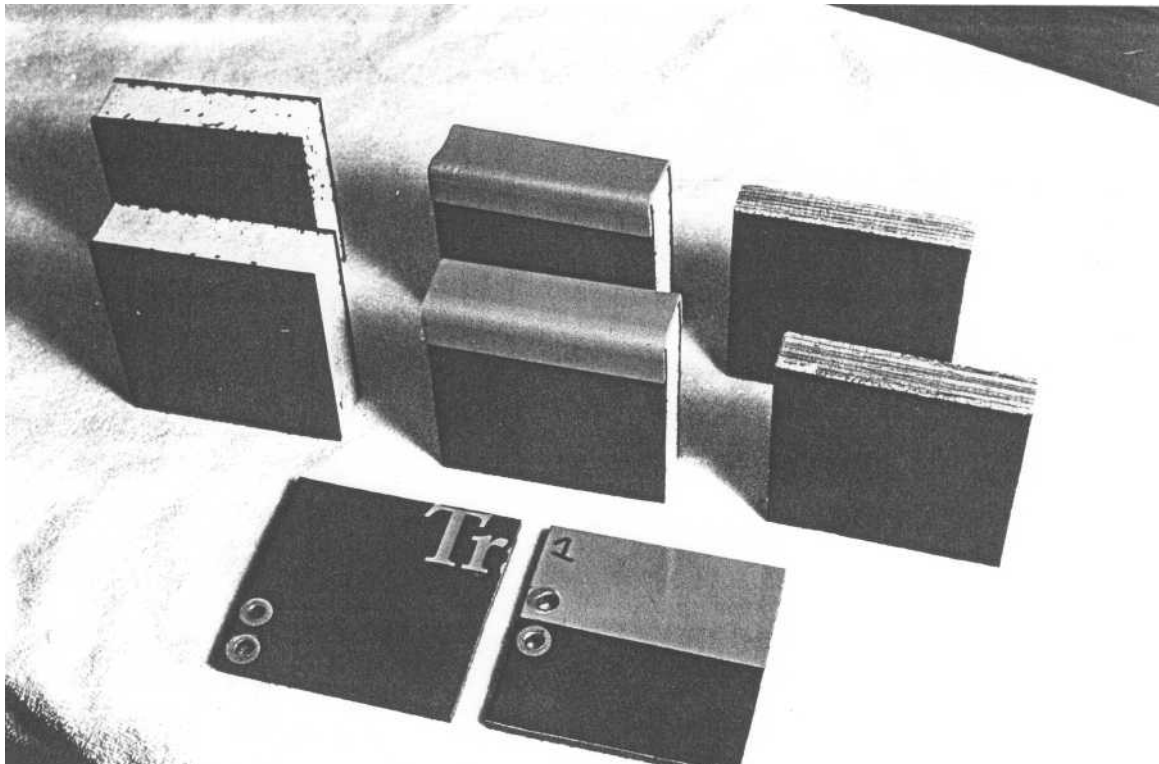
Figure 4 Test samples AFTER the salt/fog tests

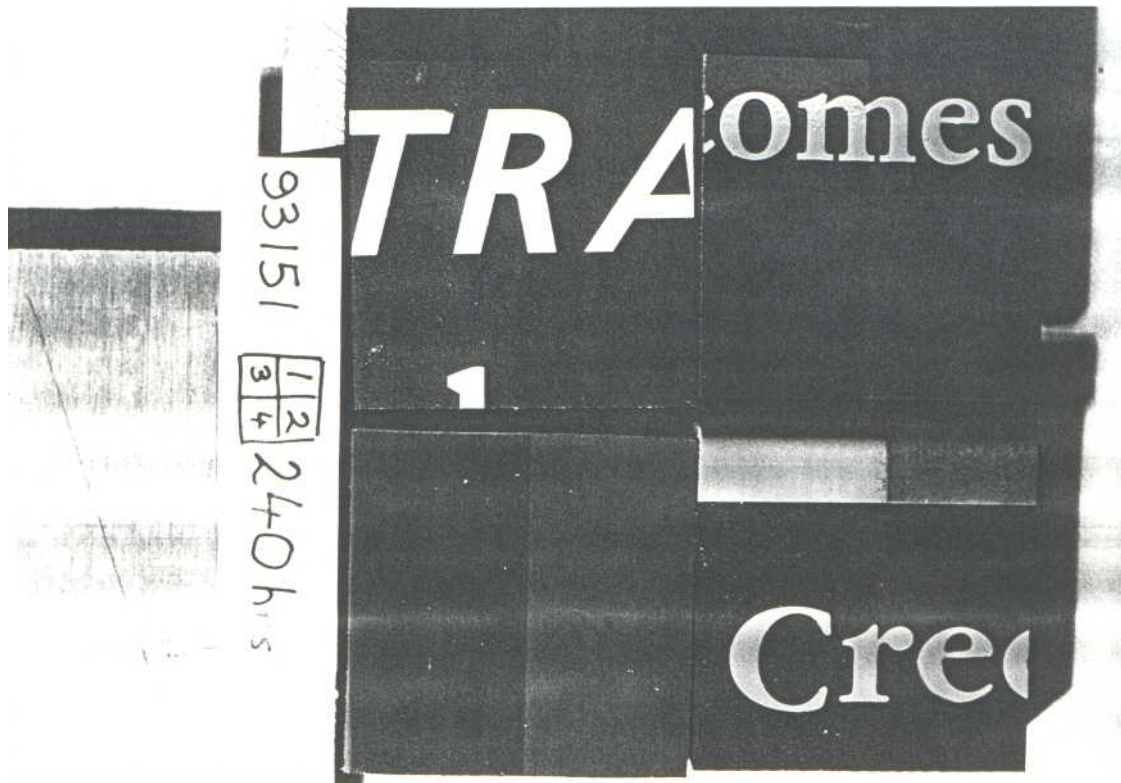
The most dramatic change was sample 1 with the high-gloss surface dulling and losing its green colour (after 240 hours). The lettering had dulled and paled in colour.

Sample 2, the yellow Trovicel frame had developed a strong brown colouration. The green surface had dulled slightly from its original matt finish and had darkened slightly in colour. The bright yellow letters had faded slightly, but one letter had started to lift at the edge (after 240 hours).

Sample 3 behaved similar to sample 2 except that the letters had dulled and had paled in colour.

Sample 4 without any lettering had dulled and paled from its original semi-gloss, though less pronounced than sample 1.

Figure 5 Samples after 240 hours UV exposure

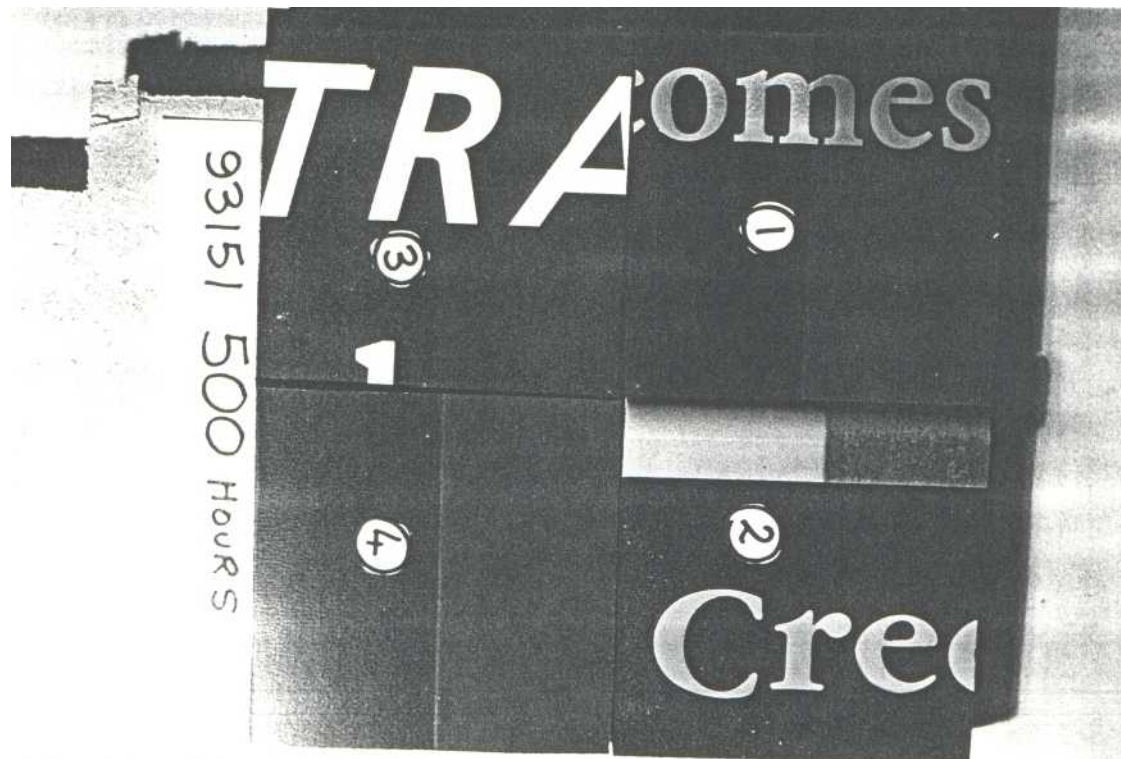
Figure 6 Samples after 500 hours UV exposure

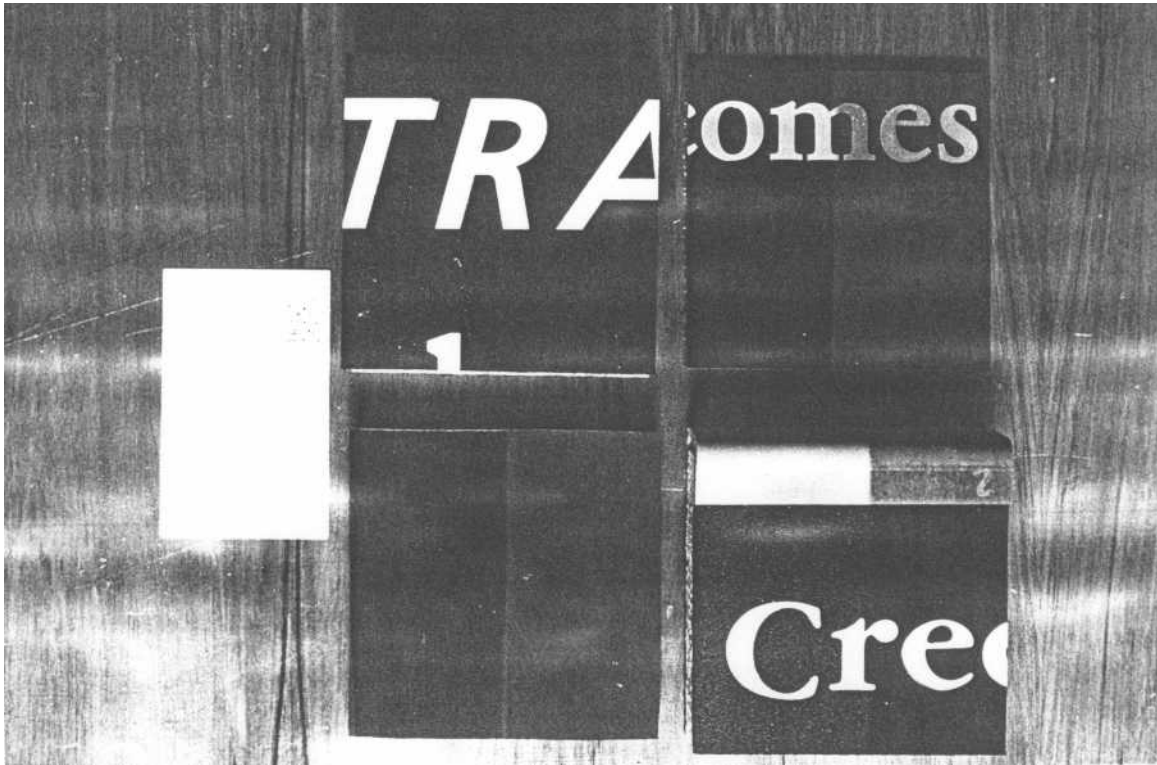
Figure 7 Samples after 1 000 hours, UV exposure

The UV accelerated tests for 1 000 hours are indicative of 5 - 10 years service, but are only valid as a comparative evaluation. Sample 1 showed the most dramatic change with significant darkening of the yellow lettering and green paint.

While sample 2 also showed darkening of the yellow top (Trovicel) cover, as well as indications that the self-adhesive lettering was lifting.

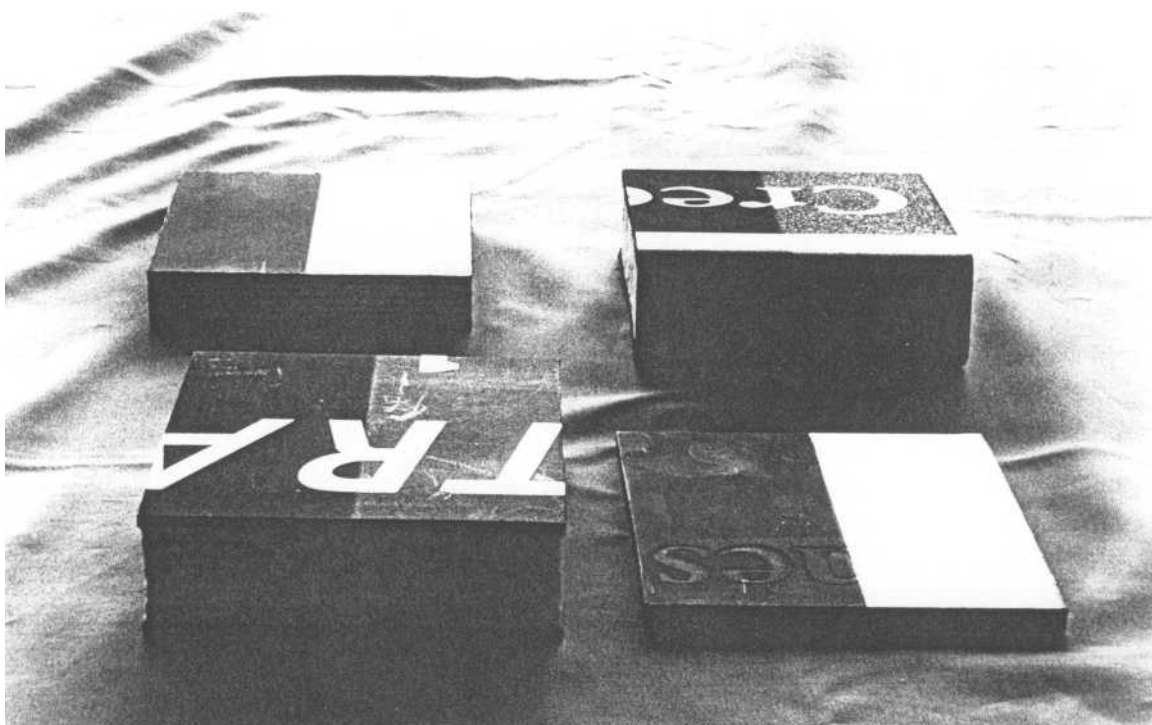
Figure 8 Samples after 1 000 hours, UV exposure showing change in surface gloss

The matt finish paints (samples 2 and 3) tended to show less change than the gloss and semi gloss finishes. The temperature shock tests indicated no apparent changes in the samples, though this may be an issue on a larger sign if hole clearances for thermal expansion and contraction are not taken into account in the sign attachment.
