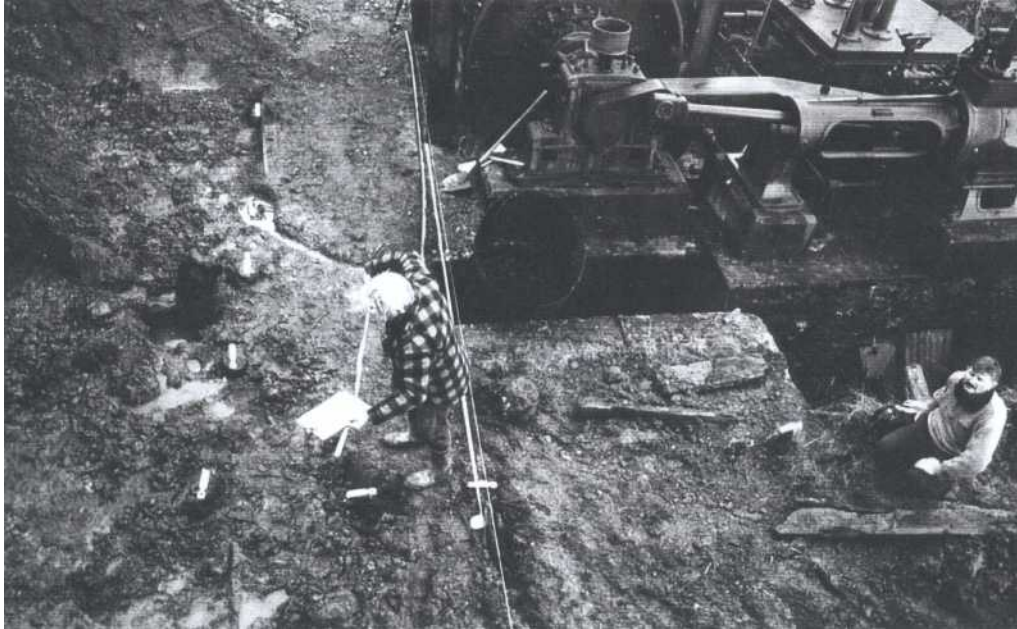
Photo 15: Alignment of piles (marked by white flashes) at the NW corner of the engine house.

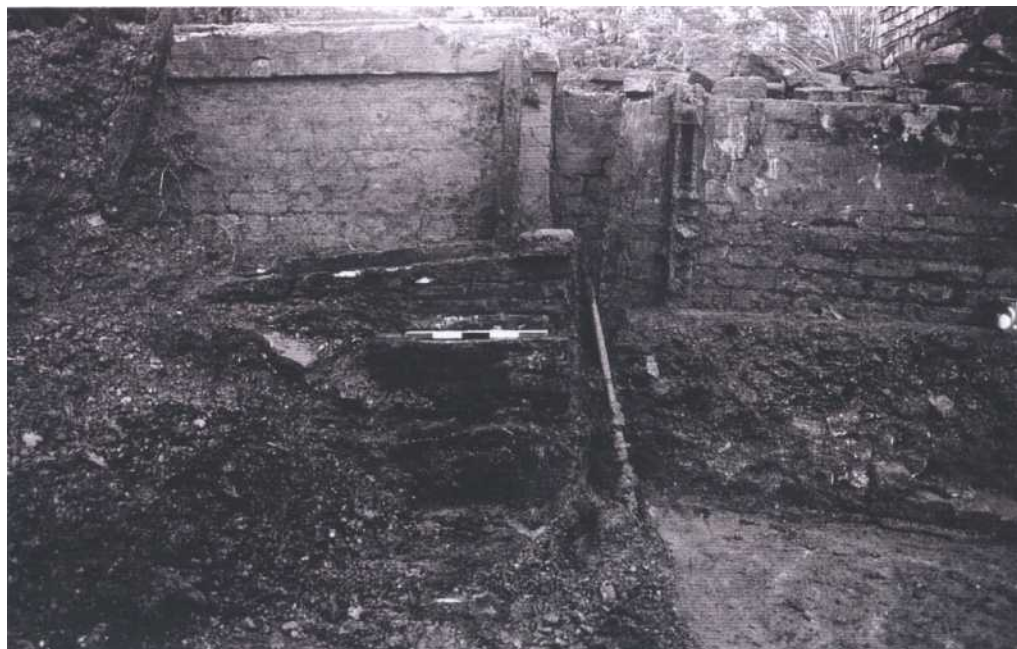
Photo 16: Brick wall and baulks of timber around chimney base.

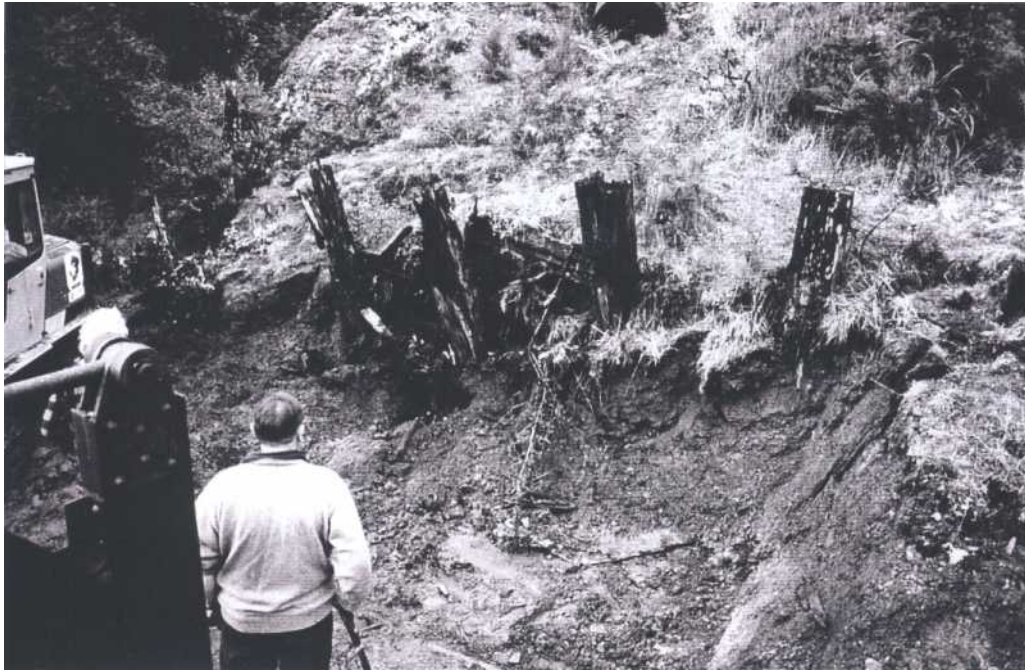
Photo 17: Remains of retaining wall.

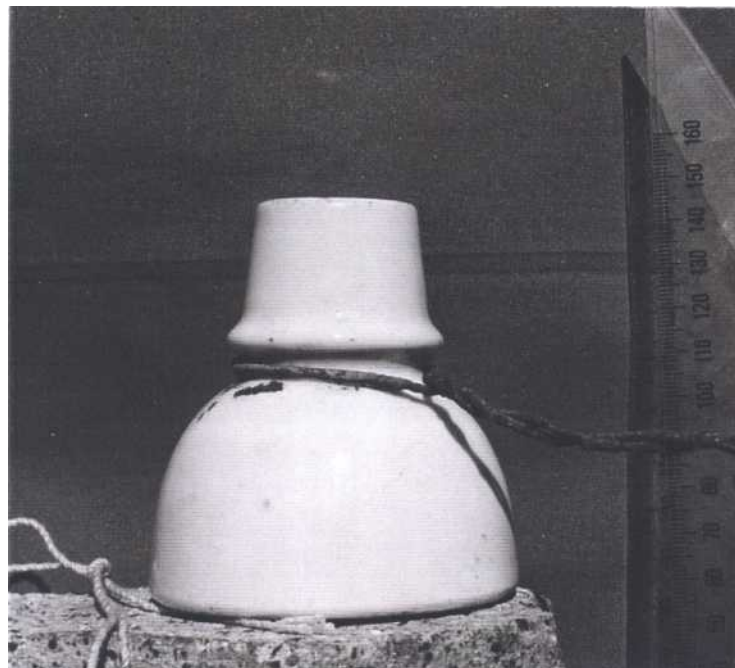
Photo 18: Ceramic insulator.

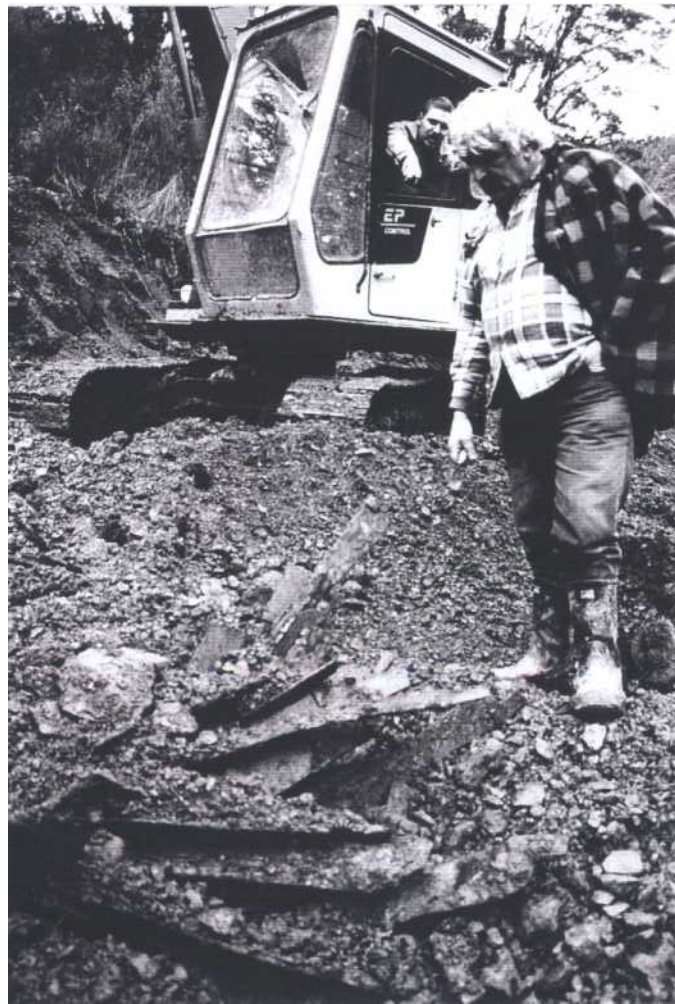
Photo 19:  
Fire irons  
cached  
outside rear  
of boiler  
room
