# First inspection of remedial treatments on the Howe Truss Railway Bridge, Waikino

Dave Page and Betty Patterson  
NZ Forest Research Institute Ltd  
Private Bag 3020  
Rotorua

First inspection of remedial treatments on the Howe Truss Railway Bridge, Waikino. *Conservation Advisory Science Notes No. 323*, Department of Conservation, Wellington.

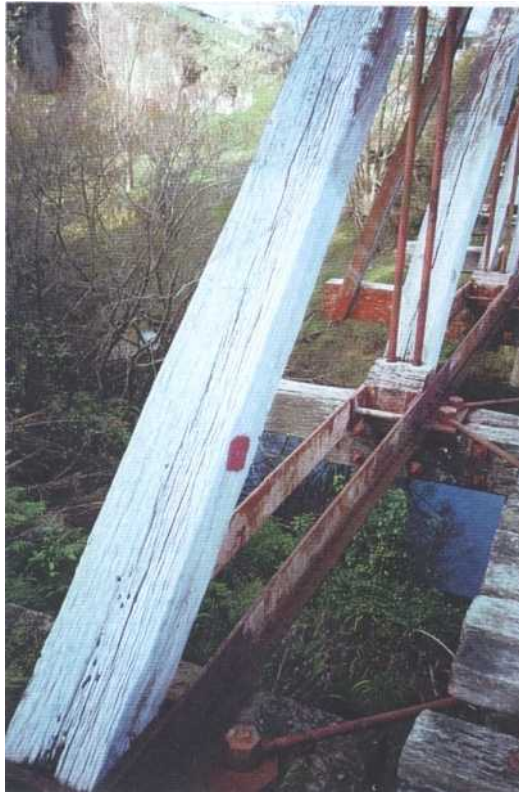
**Figure 1** (top left). The distinctively whitish colour of components treated with Busan 30L is evident on this king strut at the Waikino end (component 7). The lower part of the queen strut in the background (5), treated with Boracol, was pale in colour but not distinctively different from the untreated section of the strut.

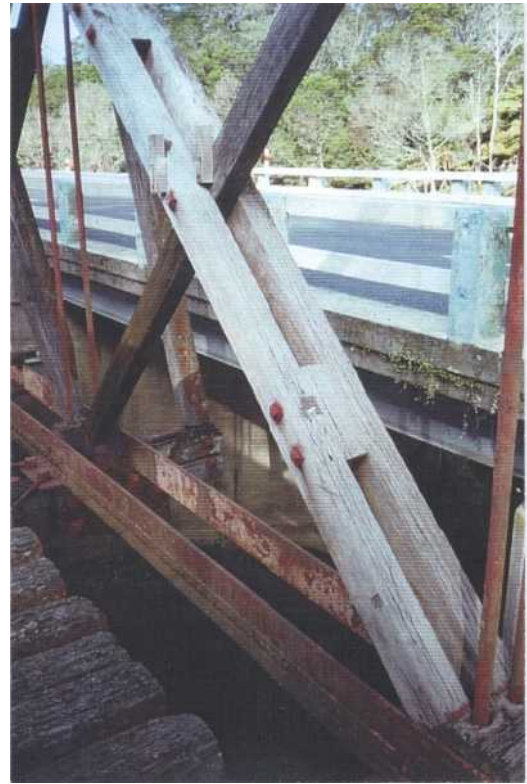
**Figure 2** (top right). The lower section of the double strut (12) was treated with CN emulsion and is much the same colour as the untreated section above the intersection with the single strut (14). The dark colour of the lower section of the single strut (14) is from the CD50 treatment.

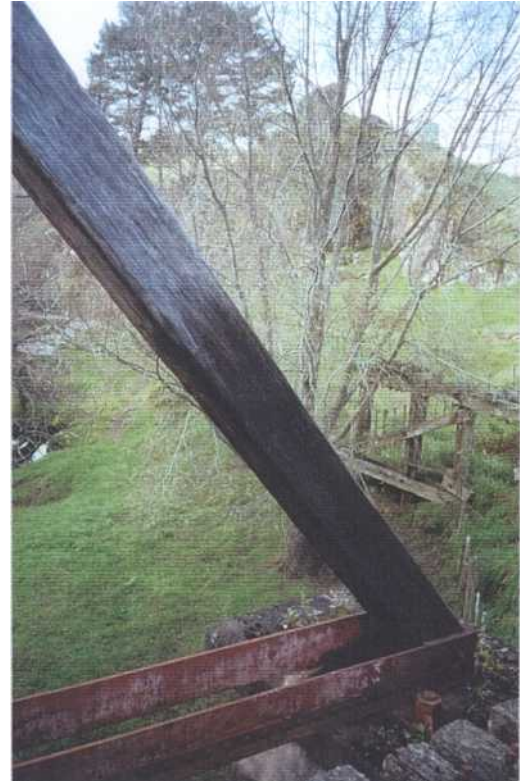
ably darker than other components treated with copper naphthenate in diesel, although there was no obvious reason why. The sections coated with CD50 were much darker than the untreated sections and components treated with other products. Both the oil carrier and the copper-based active ingredient in CD50 would have contributed to this darkening.

**Figure 3** (bottom right). King strut (1), showing the dark colour of the CD50 treatment.
