3.3.3 Exterior

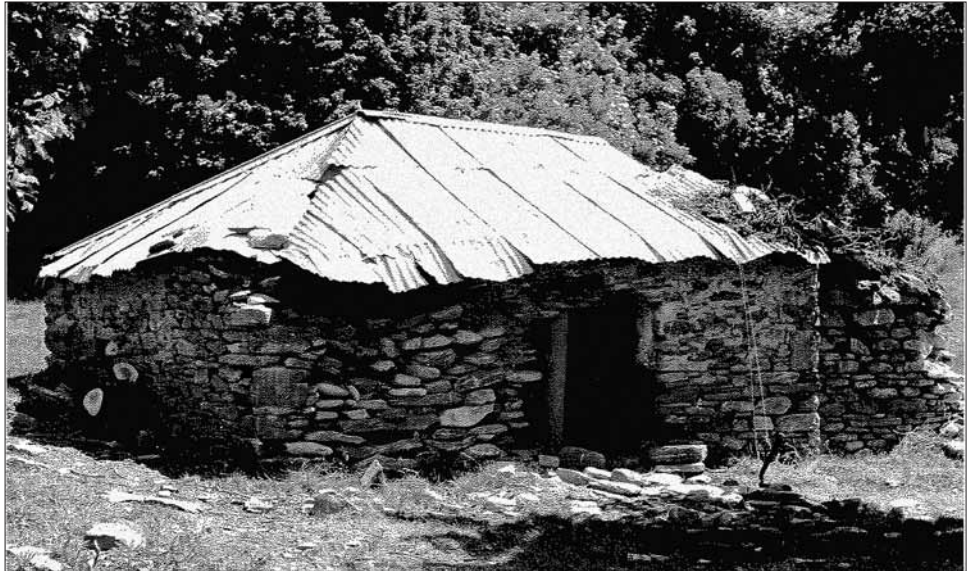
Figure 5. The Bakehouse from the northeast (front), prior to restoration in the late 1970s.

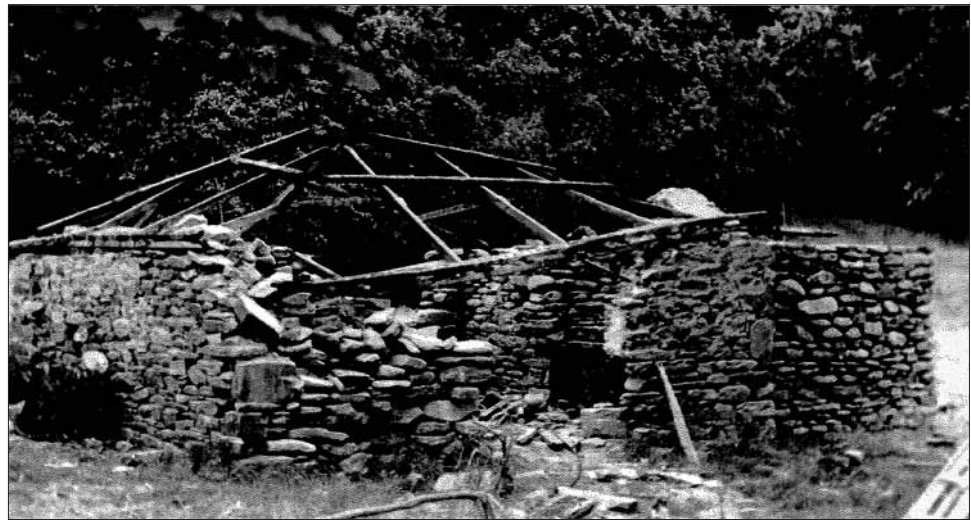
Figure 6. The Bakehouse during restoration, late 1970s. The right-hand (west) end of the building has been rebuilt and the front and back walls partially demolished awaiting rebuilding.

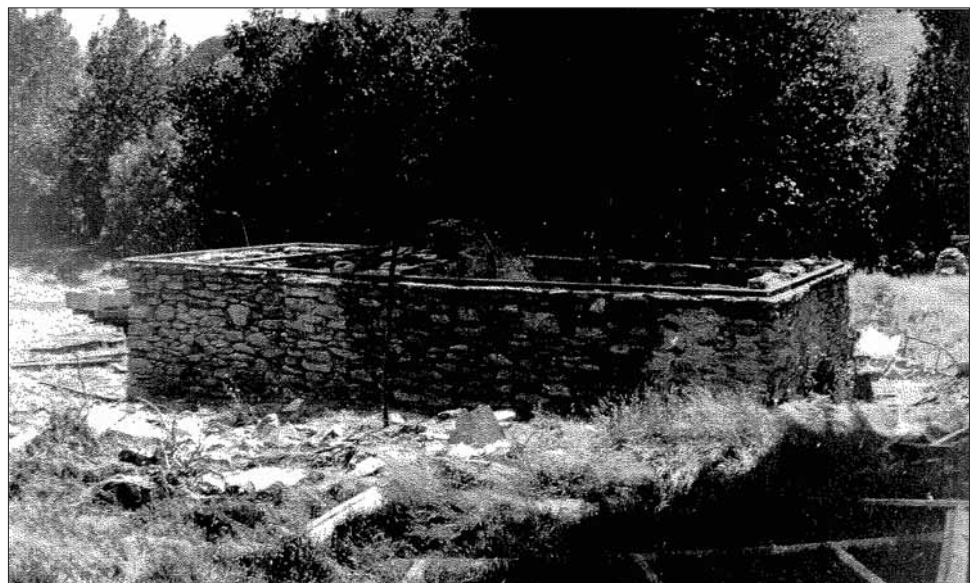
Figure 7. The Bakehouse (from south side) during restoration in the late 1970s. The front and back walls have been rebuilt.

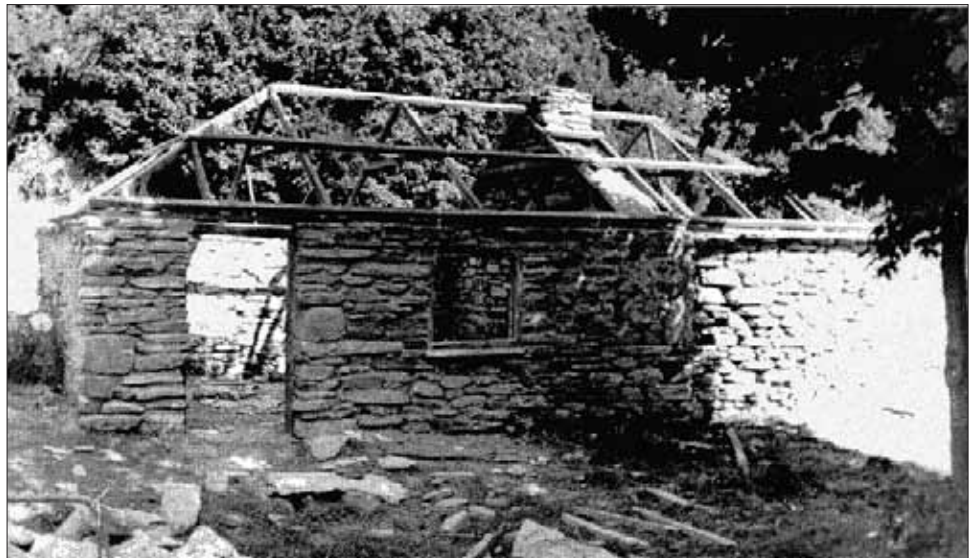
Figure 8. The Bakehouse from the north (front) with restoration well advanced in the late 1970s. Compare door opening with Fig. 5.
²Photo: L&S records from DOC files.

The stone wall between the east and west sections is constructed the full height of the gable, following the roof line (see Fig. 8). The walls are of exposed stonework and as noted for the exterior, the mortar jointing has eroded away or disappeared to varying degrees.

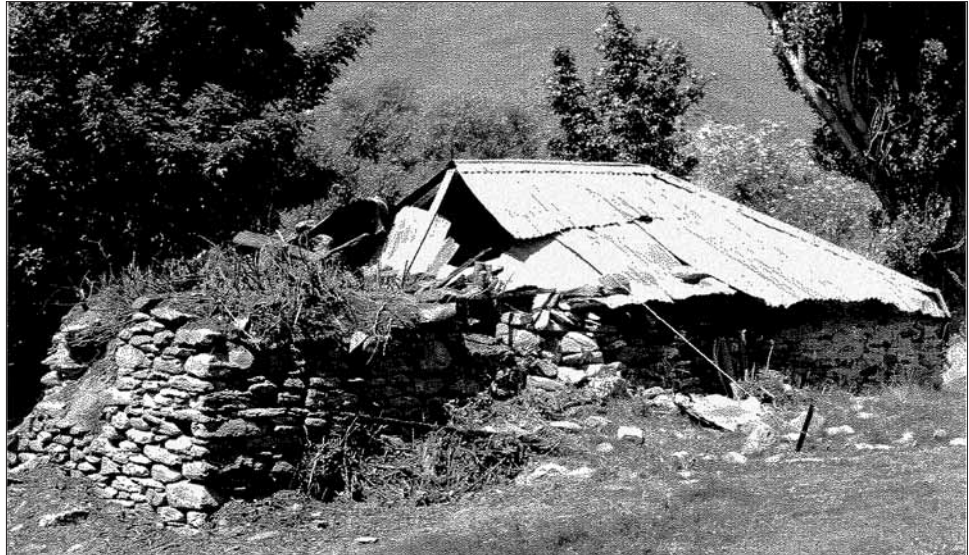
The earth mortar has become badly eroded from the stones forming the chimney, to the extent that these are now just sitting in place and in danger of total collapse. This is caused by the smaller stones falling out, leaving large gaps and little support for the larger stones. There are no flashings between the chimney and roofing iron and this situation has probably exacerbated the mortar erosion problem. Photographs of the 1979 rebuilding (Fig. 8) show that the chimney was fully rebuilt and re-pointed at that time. The photographs (Figs 4 and 9) also show that approximately half the roof framing timbers

Figure 9. The Bakehouse (southwest corner) prior to restoration, late 1970s.
²Photo: L&S records from DOC files.
