**RE-CONSTRUCTING EARTHWORK
FORTIFICATIONS: AN EXAMPLE FROM
THE WESTERN UREWERAS, NEW ZEALAND**

Kevin L Jones

Published by
Head Office,
Department of Conservation,
P.O. Box 10-420,
Wellington,
New Zealand

First published 1989

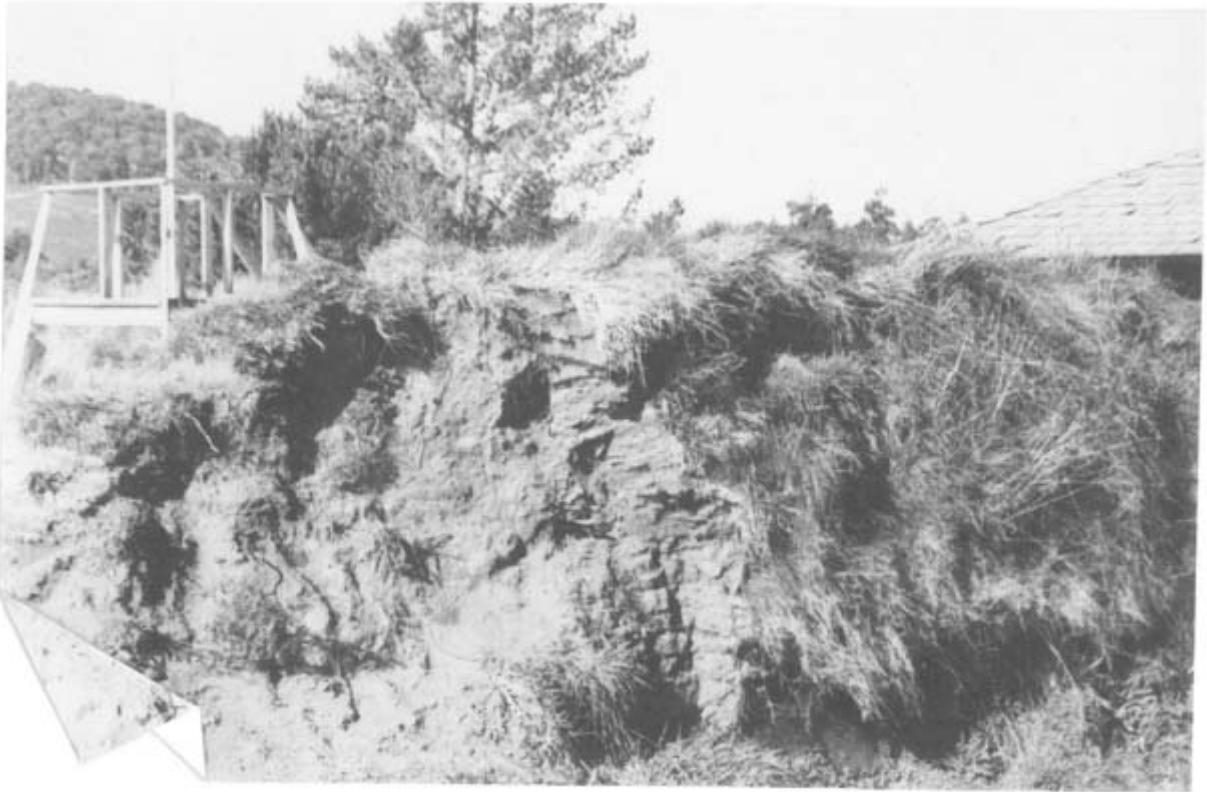
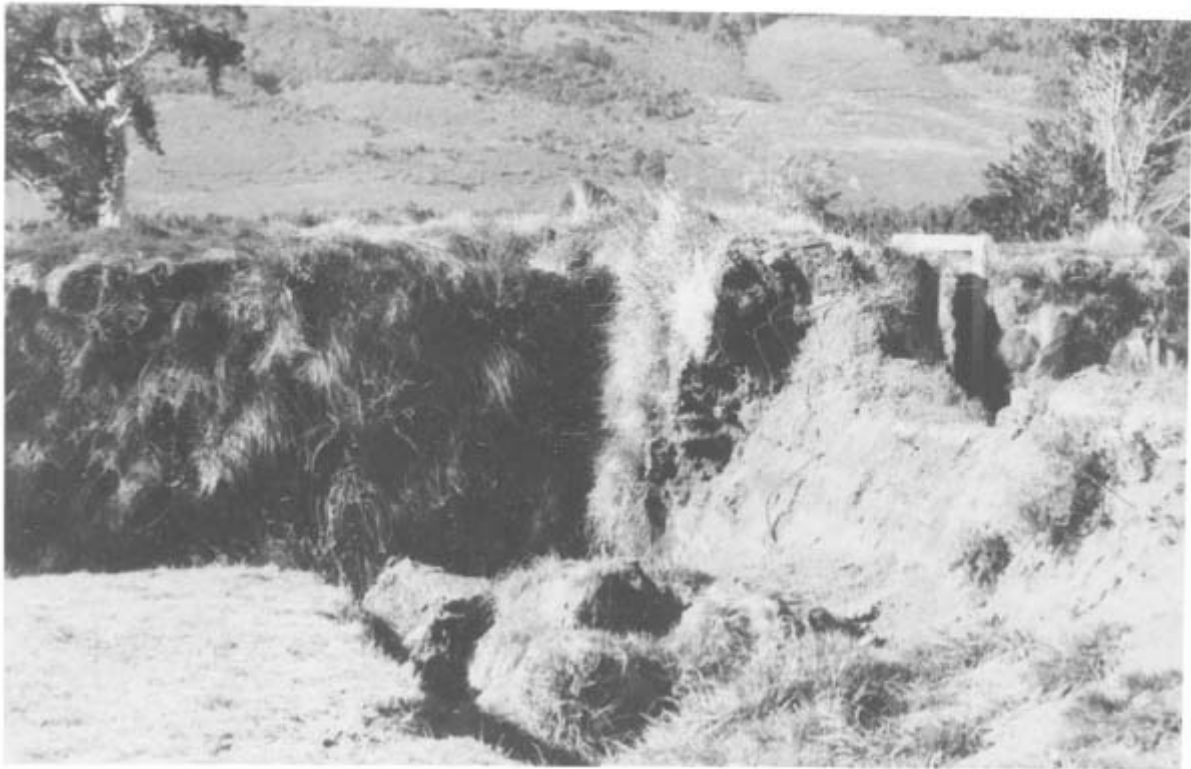
McDonnell's redoubt and blockhouse at Poutu (N112/113) was re-constructed in the course of the Tongariro Archaeological Project for public appreciation. The re-constructions were directed by T.R. Hosking, archaeologist in charge of the Tongariro Archaeological Project. The redoubt was originally built by Te Kooti and was subsequently occupied and altered by McDonnell, although at the time of re-construction Te Kooti's part in the building of the redoubt was not known. The plan of the redoubt, derived from archaeological survey of the surface features, was strictly followed. However, the above-ground features were not known and like the plan may have existed in various forms over time. Hosking adopted a known model of redoubts in widespread use in the 1860's. The height was based on a sketch and a description of contemporary earthworks. The walls were steep-sided and as much as 2.5 m high and began to collapse within two years –despite an attempt to reinforce them with steel rods (Fig. 1). The loose pumice soil did not stand up to people walking along the walls and the rods became exposed and a hazard. Maintenance costs were high, and it was left to J.R. McKinlay, then archaeologist for the New Zealand Historic Places Trust, to arrange to have the site reduced to the stable contour covered in broom and bracken in which it remains today. Part of another site, the Wehenegaiti rifle trenches (N102/45), was re-made in the course of the Tongariro Archaeological Project. These were basically excavated on the line of the surface-visible trenches of the site and survive today, some 20 years later, in good condition.

Figure 1 McDonnell's redoubt and blockhouse, Poutu, October 1976. Photograph J.R. McKinlay.

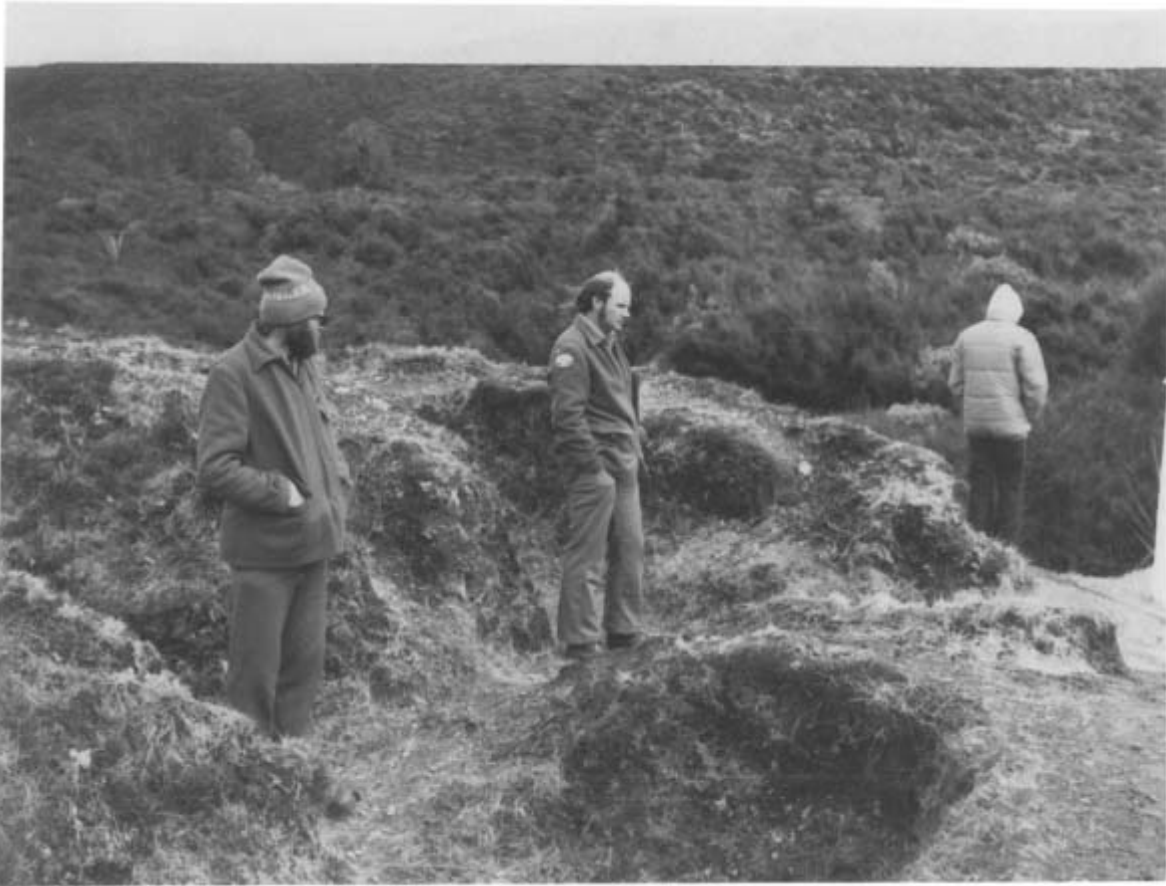
some 10 years. The long-term problem created by the desired visitor-viewing was eventually solved by placing an observation platform close by and outside the banks of the two fortifications which make up this complex. Figure 2 shows the lower rifle trenches with damage caused by visitors walking along the walls. Figure 3 is taken from the subsequently constructed viewing platform and shows the result of repairing the tops of the banks by the placing of turves. The grass seedheads demonstrate how little traffic has occurred along the walls.

Figure 2 The lower rifle trenches and breastwork at Te Porere in about 1980 prior to repair and the building of the viewing tower. This and subsequent photograph are by the author.

In the course of several years of visitor usage it was found that people had to get a view of the earthworks by walking on the breastwork banks. This caused the wearing of a channel in the grass on the top of the banks which eventually split open and had to be repaired. J.R. McKinlay removed the damaged portions and drove in iron fence standards lashing these across the line of the wall and then re-built the wall by filling in between with facings made of turves. This has remained stable over

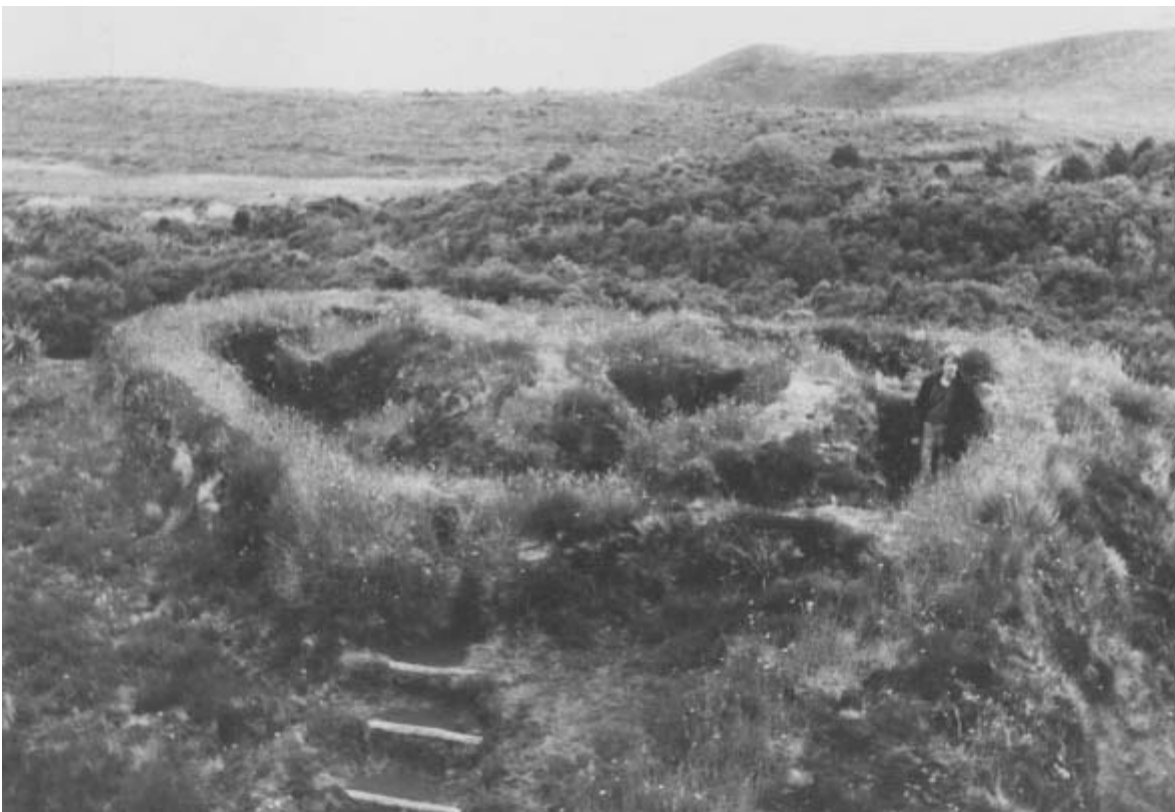
Figure 3. The same site from the viewing tower within a year of its construction.

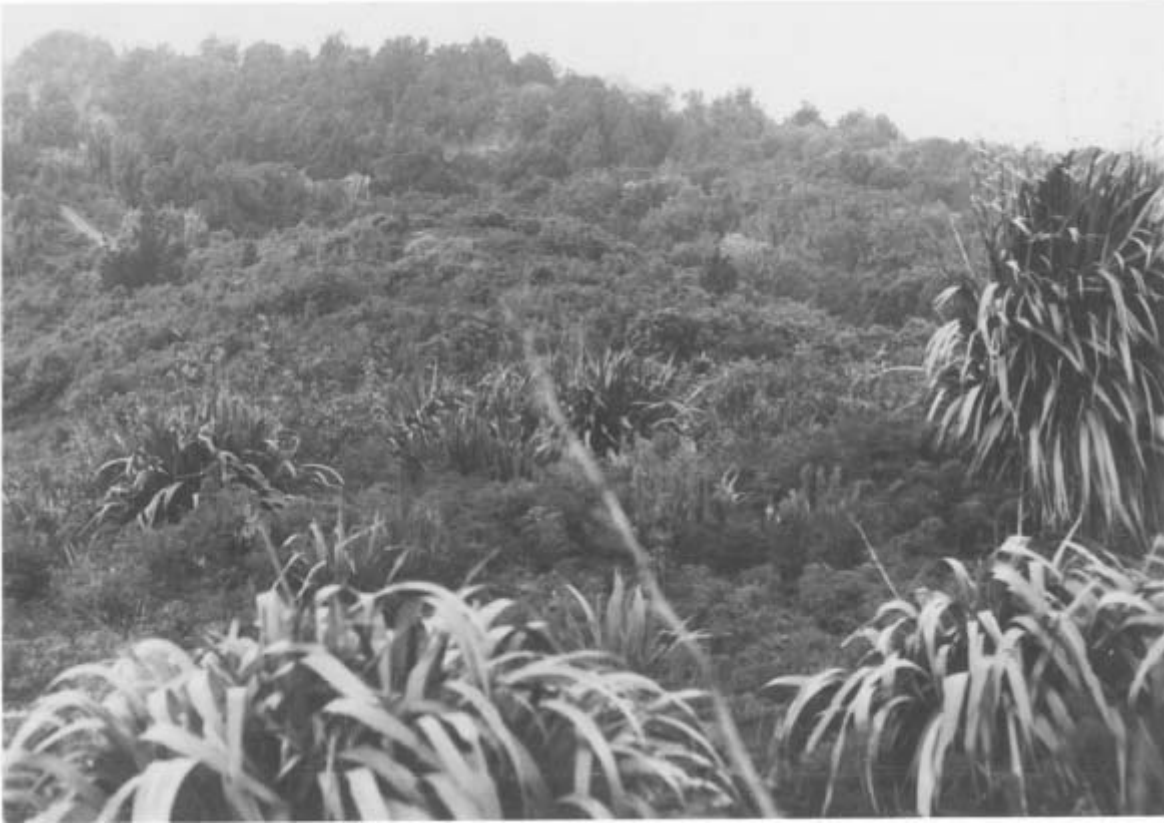
Figure 4 Te Tapiri the south in 1981. The site has reverted very quickly from its clearance some three years earlier.

Archaeological Association site record. A vertical aerial photograph flown at a low height had also been taken at this time but unfortunately not as a stereo pair. Figure 4 shows the Te Tapiri site as it looked three years after the scrub clearance carried out by the Nevins and five years before the bulldozing. The surface features of the site are invisible.

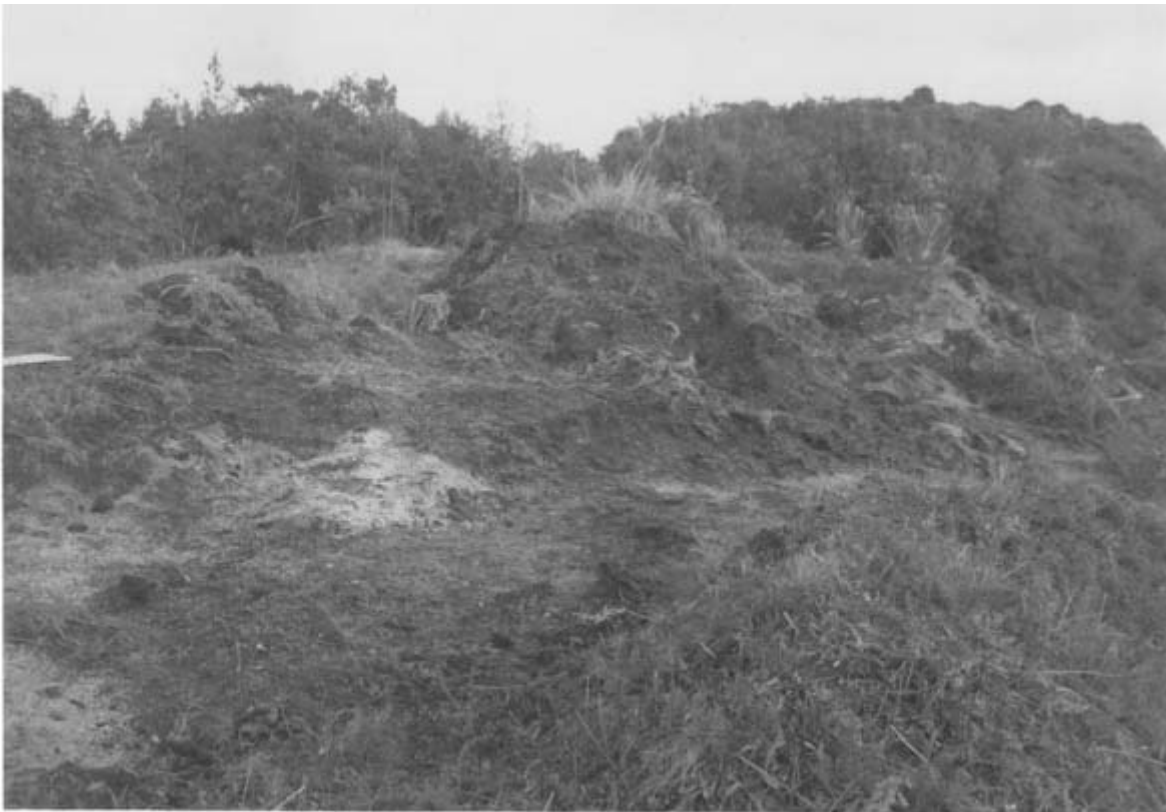
The result of this bulldozing was that some 20% of the defensive perimeter was destroyed in 4 separate places. The interior of the pa, in a lengthwise ribbon some 4 m wide, was some 30% modified on the surface (Fig. 5). This is somewhat less severe damage than noted in my preliminary report to the New Zealand Historic Places Trust, the discrepancy arising because the later record of damage was done from a plan and with the full area of the pa cleared of scrub. The bases of most of the whare (house floors manifested as rectangular depressions) and the perimeter rifle trench remained substantially intact. They were the lowest points of the site, had filled with substantial quantities of humus, and had been only lightly skimmed or in some places filled by the action of the bulldozer.

Figure 6 South end of Te Tapiri Pa following bulldozing. In the right foreground and at rear are remnants of the western perimeter bank and rifle trench.

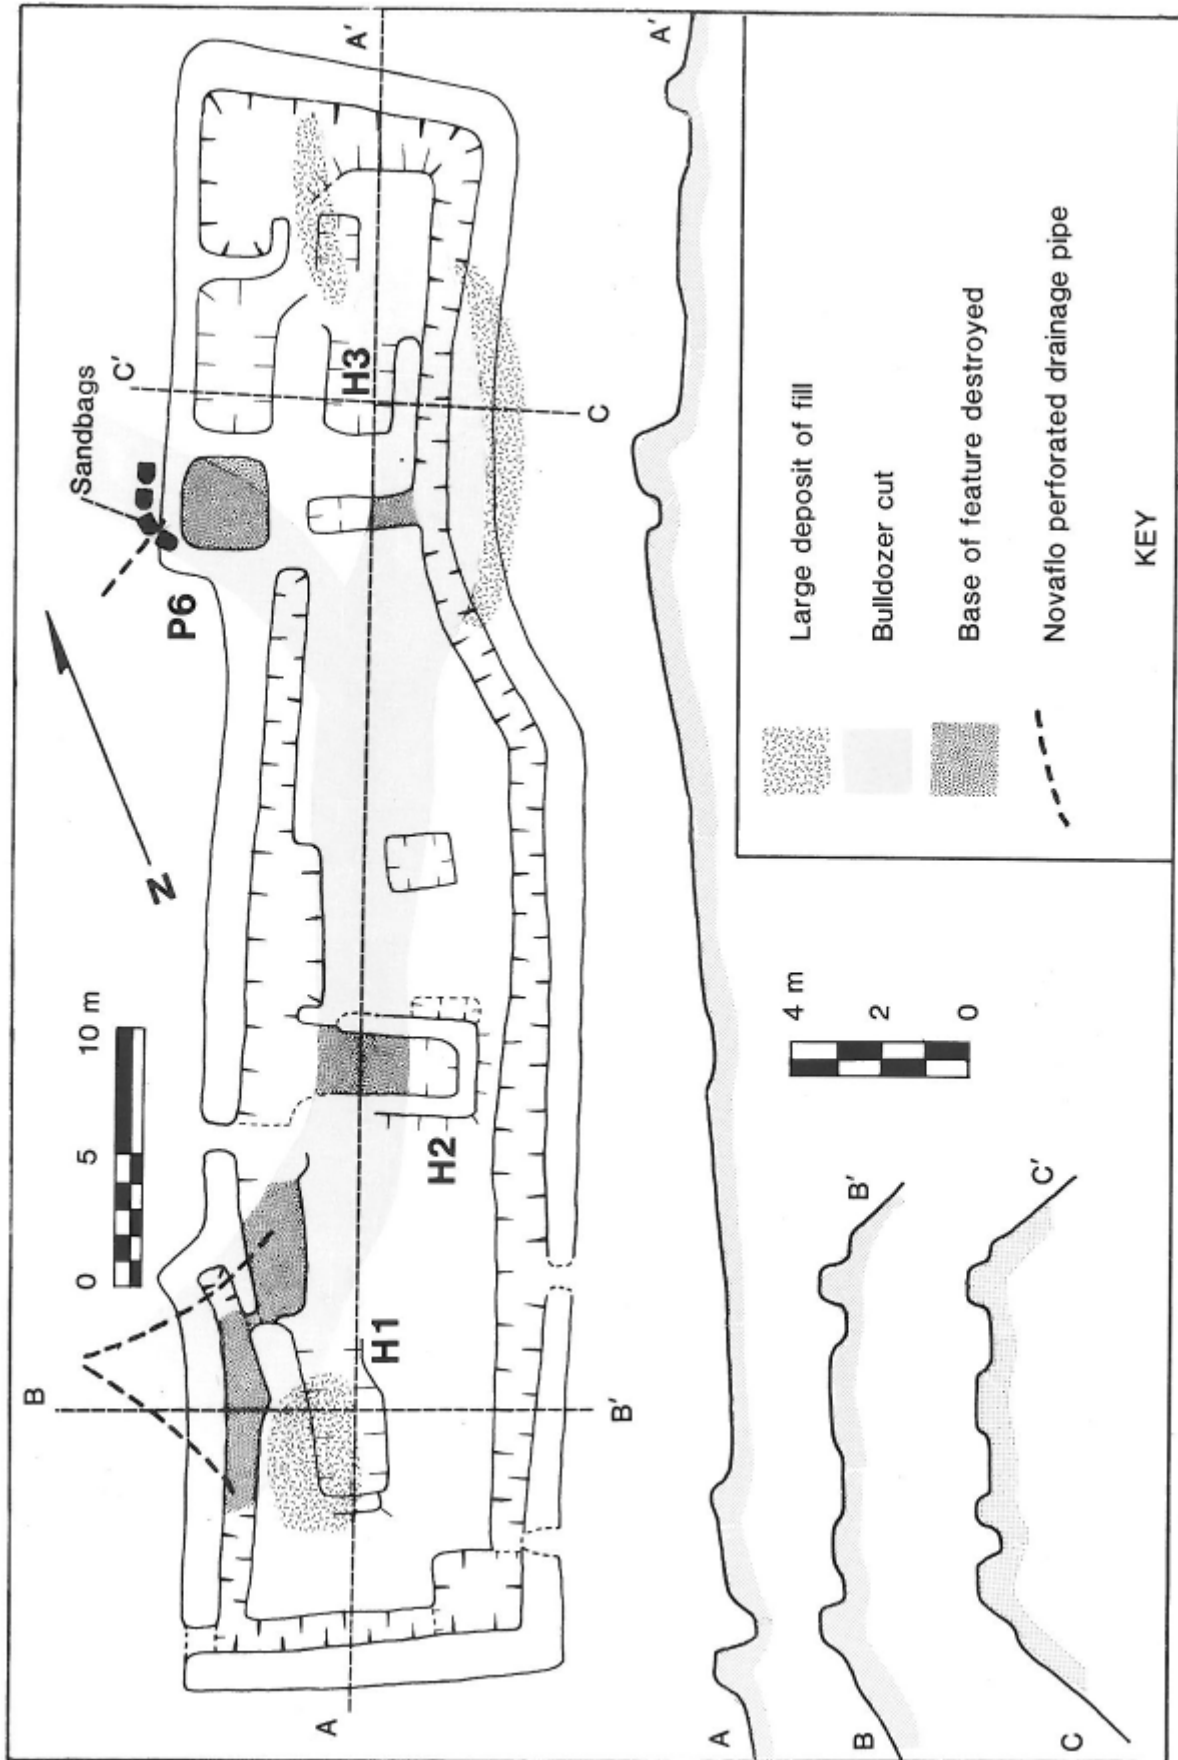
Figure 5. Plan of Te Tapiri Pa showing bulldozer track, and deposits of fill left on the site. The plan and feature numbers follow that of nevin's New Zealand Archaeological Association site record.

As a first step in the re-construction, a map record and notes were taken of the extent of the damage (Fig. 5-6). There had been extensive damage to the superficial stratigraphy of the site from pig-rooting. The site occurs in an area of fern and shrubland which has had periodically high numbers of pigs in the past. Their activities are noticeable because of a general "humpiness" of the surface of the site and undermining of the earthwalls of the whare within the pa. This action has probably done further damage in the richer soils in the base of whares or the perimeter ditch but it is not as noticeable on the surface in those areas.

In the two places where the bulldozer had left the western side of the pa, after entering from the north, a considerable quantity of fill had been left, as much as 15 m outside and 5 m below the pa. There were, however, two areas within the pa where a large deposit of fill occurred. These were at the southern end, where the whare site H1 had some 4 m³ of topsoil dumped on it (Fig. 6), and near the whare site H3 where the fill had been pushed over the eastern bank. The latter fill was derived from a slightly elevated platform which lay immediately south of the rifle trench inside the northern defences and may have been as much as 5 m³ volume. An attempt to retrieve some fill from the points outside the pa and to stockpile fill from the bulldozed track into the pa using a front-end loader was not possible because of the greasy surface conditions. The lack of access for anything other than tracked vehicles (which would have been unacceptable) also meant that turves to re-construct the banks could not be taken from a log-loading site nearby. In any event the turves that were tested for possible use on the site crumbled too easily to be of much use.

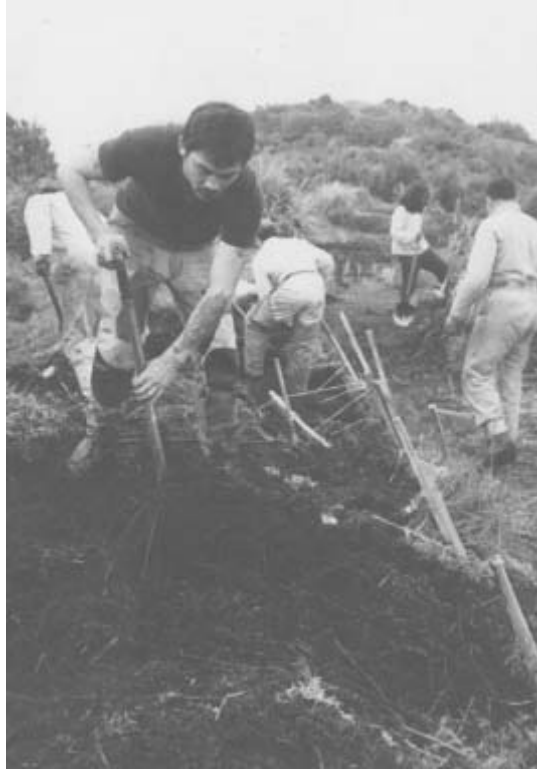
Figure 7 Filling behind the formwork of stakes and manuka brush on the eastern perimeter of the site.

The banks were laid out using untreated pine stakes 1.2 m long and 50x25 mm in section driven by mallet according to the layout of the original plan (Fig. 7, 8). The stakes would have a ground life of about 18 months. In most areas except where the cuts had been deepest, it was possible to detect the base of the original trenches, pits or house-floors, so that the plan of re-construction is accurate. In two places minor damage was done to extant features covered by fill: these were the inner side of the rifle trench adjacent to H1 where the bank may be too close in on the original line and the trench is rather too wide (actually cutting intact deposits), and the western bank adjacent to H3 where the outer side was inadvertently cut some 30 cm in the course of taking fill outside the bank to re-construct the inner features at this point.

The stakes were tied across to ensure rigidity and were driven at approximately 60 cm intervals along the length of the bank sloping in towards the centre (Fig. 7, 8). Where the bank still survived in part the stakes were tied in by small in the fill. The ties were made of synthetic twine so that they would retain their holding power until after the stakes had rotted. Any surface unsightliness will be able to be made good by judicious clipping. The twine will also clearly indicate the extent of re-construction in the event of future excavation. The fill was retained by brushwork of manuka laid inside the stakes, and was compacted by foot. Where the levels had been made up the walls were made relatively thinner than they should have been because of the shortage of fill. The topsoil fill was to make up the walls. It should hold its shape and take and grow grass very well.

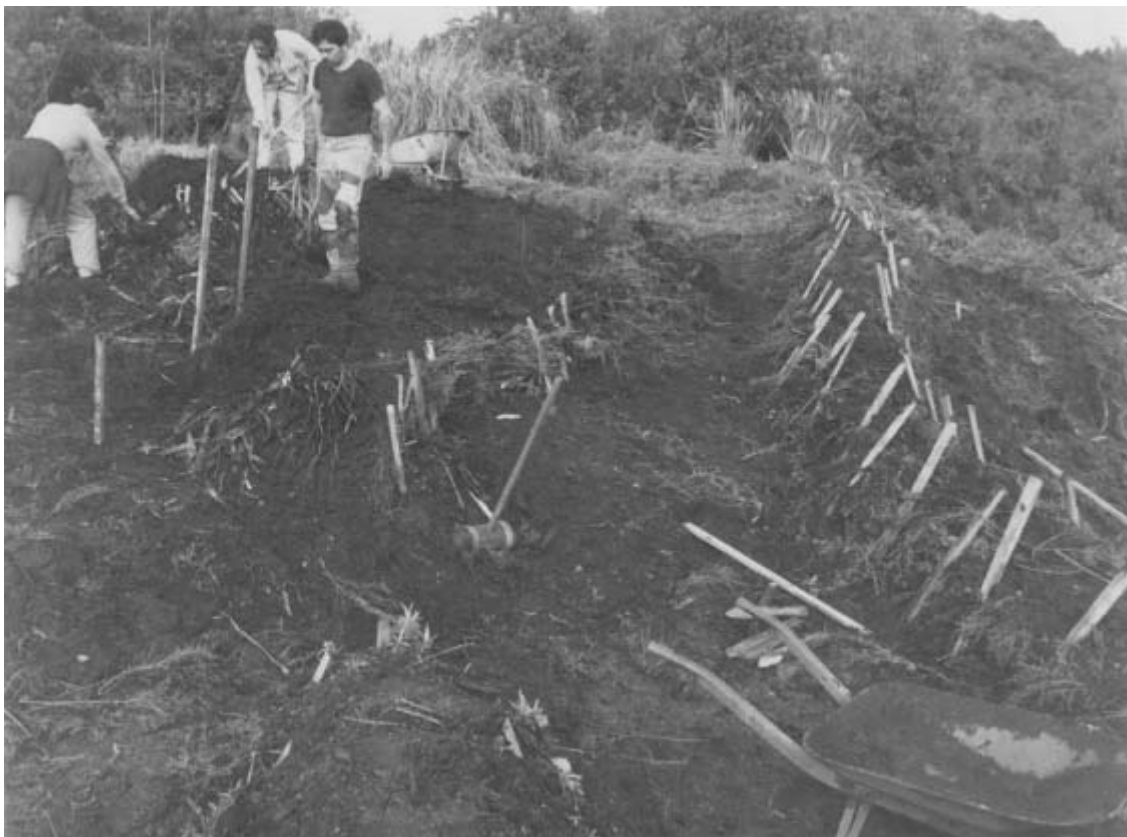
Figure 8 South-western perimeter after re-construction of the rifle trench and bank. This photo is detail of the area shown in Fig. 5. Whare site H1 is being cleared at left.

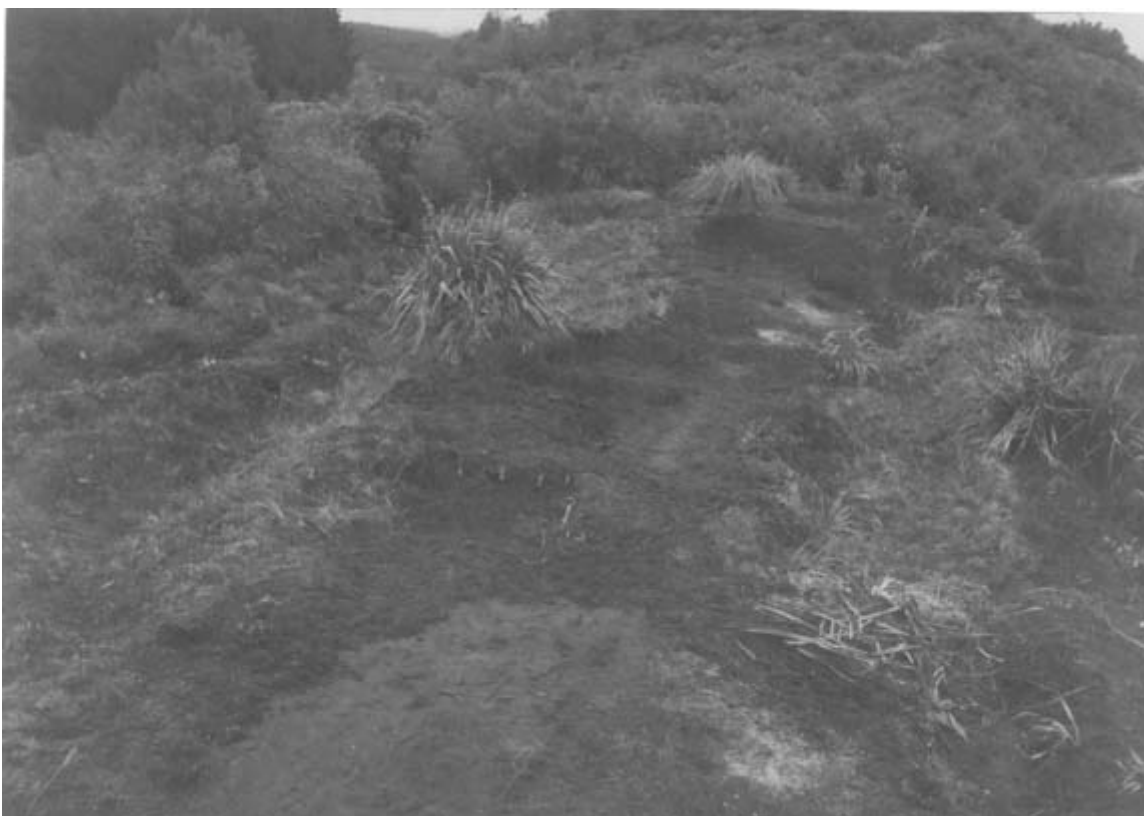
Figure 9 Southern half of the pa looking south after re-construction. Note where H2 is in centre, and bare patches of pumice subsoil in the cut.

Areas of bare pumice making up the levels outside the walls had flax planted on them and seed-rich manuka brush staked on to it. This will reduce the likelihood of erosion on these areas which are critical to the stability of the banks. Manuka brush with seed was also staked to several areas within the pa where there was exposed pumice subsoil (Fig. 9, 10) (for technical details of this method, see and Jones (1982)). Elsewhere, the exposed topsoil including the re-constructed tops of the banks and the bases of the trenches was grassed with 'Nui'. Relatively warm, wet conditions followed the re-construction and by mid-September the grass had struck well. Because of the presence of the rhizome, the topsoil will also continue to grow fern. Consideration was given to applying both short-and longer-term-acting fertilisers to the bare areas. However, fertility of the site is moderate, and experience of overnight rain showed that there was little need for very rapid stabilisation of surfaces. Furthermore, in the longer term, enhancing the growth of shrubs by the use of slow-acting fertiliser would obscure the features from visitors, increasing the risk of accidental bulldozing and damage to the archaeological stratigraphy from root growth.

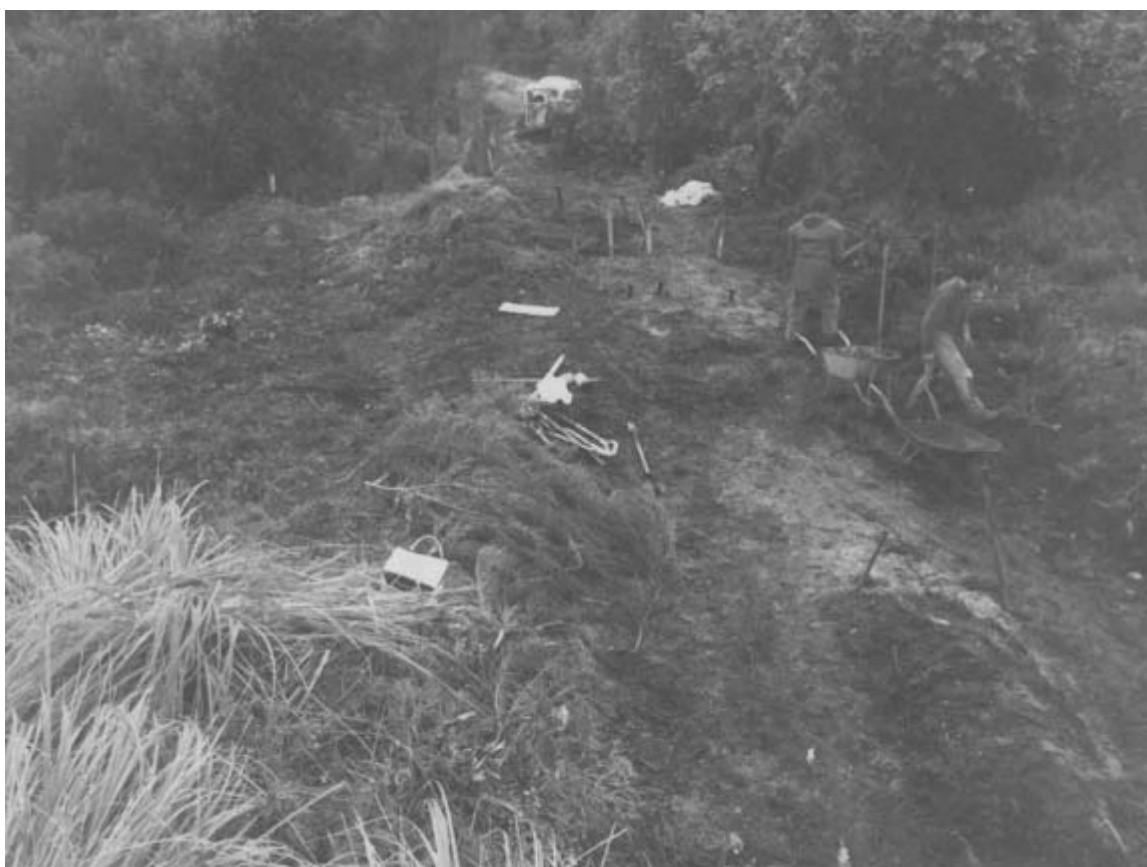
Figure 10 Northern end of the pa looking north. Whare H3 is right foreground, with manuka branches staked on to bare subsoil in centre. Stakes outline the destroyed breastwork which is in process of being re-constructed.

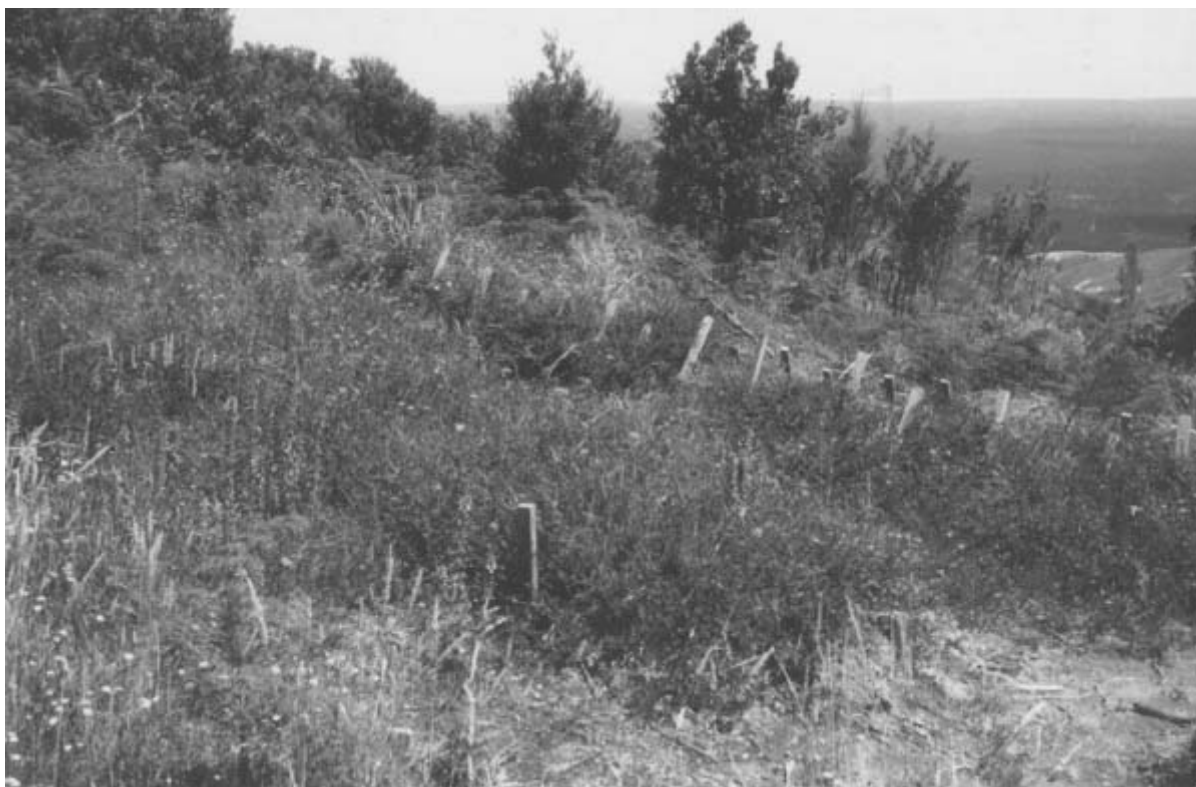
Figures 11 and 12 show two views of the site in February 1989. The vigorous fern growth is on undisturbed areas, while the stakes marking the re-constructed lines are almost obscured by a vigorous growth of grass and lotus (a broad-leaved weed with a scrambling habit similar to clover). This will provide a very stable cover for the banks in the short term. On the areas of bare mineral pumice, the manuka branchlets are still in place and should have released their seed. In the near future, decisions will need to be made about the most satisfactory way to keep the site open for prospective public visiting, since it is clear that the site will be invisible after a few years.

Figure 11 The southern end of the pa showing the western perimeter trench in February 1989. This is a similar view to that shown in Figure 8.

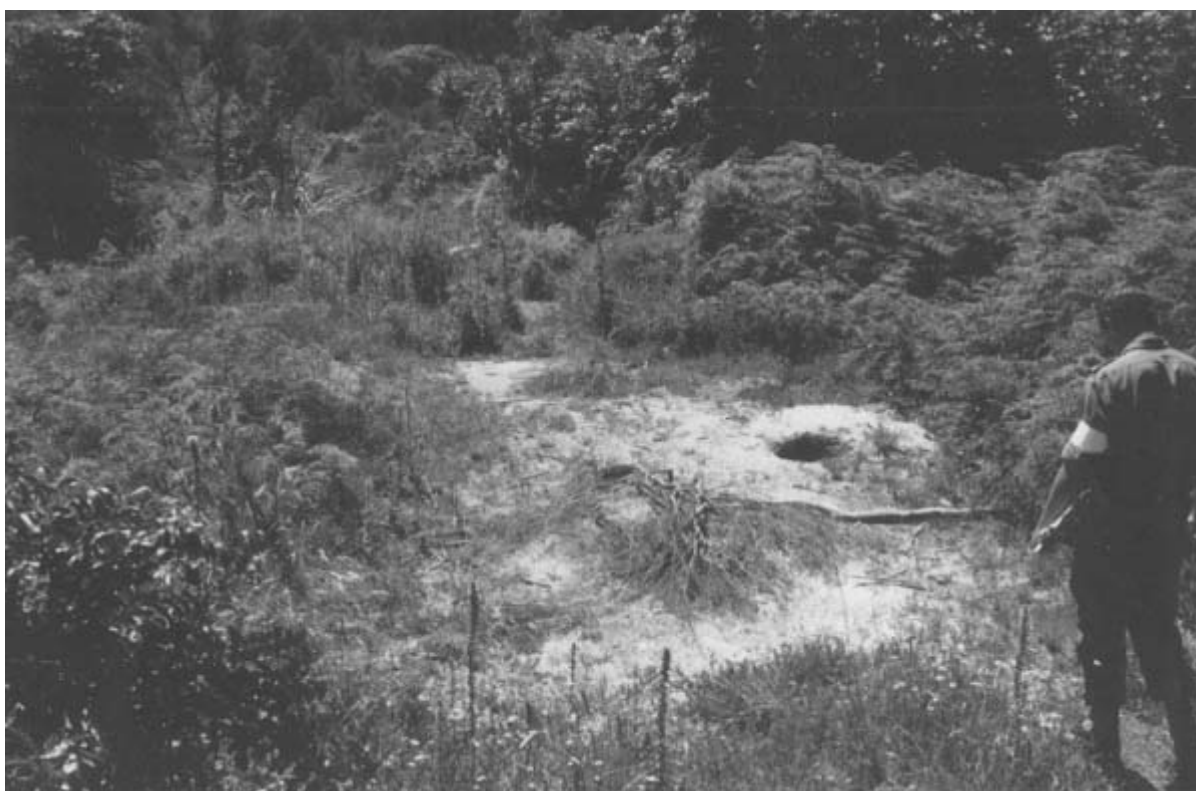
Figure 12 The northern end of the pa looking north in February 1989. This is a similar view to that shown in Figure 10.
