#### **4.5.2 Te Wahi o Moa, J39/1 GR 490398 (S110/1).**

#### 4.6 Oruaka, Wairewa (Lake Forsyth), M37/24 GR 868094 (594/9).

#### 4.7 Onāwe, Akaroa Harbour, N36/86 GR 041153 (S94/23).

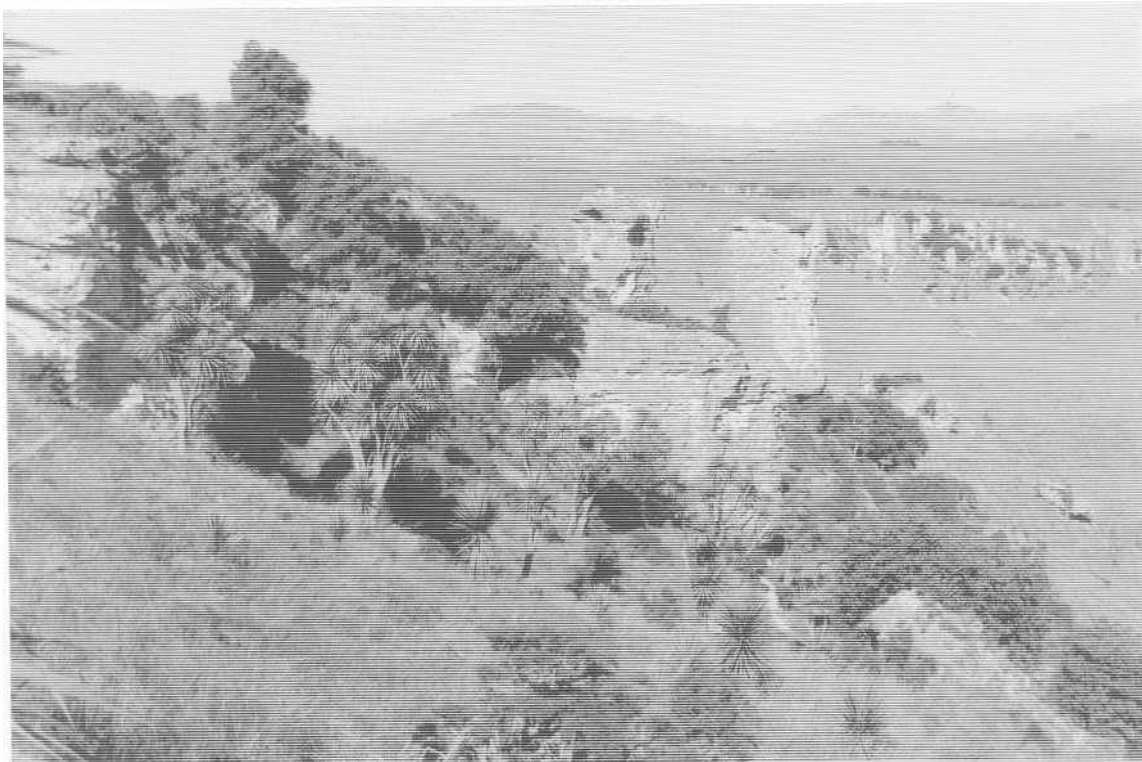
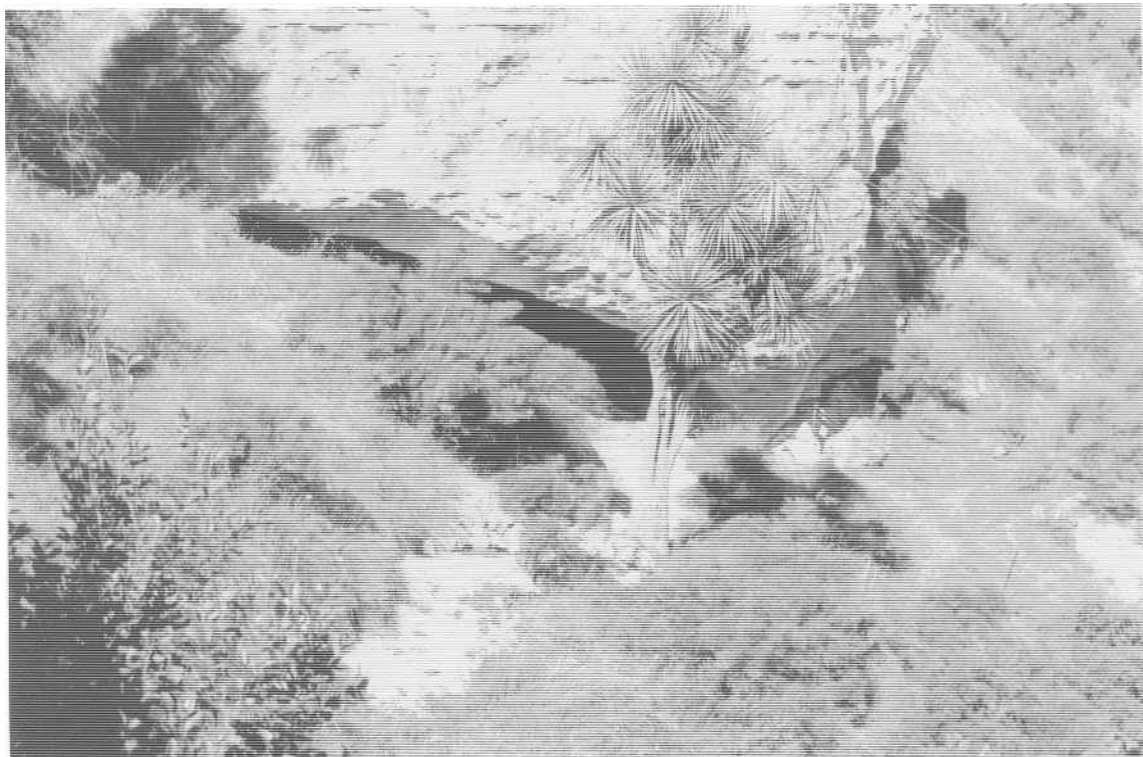
34(a)

**Figure 34(a), (b)** The gully reserve, Te Puke o Tahurua, Craigmore Station. (a) The fenced-out grassland is reverting to broadleaf, tī kouka (cabbage tree), matagouri, *Coprosma propinqua* and pohuehue (*Muehlenbeckia australis*). (b) A detail of the cave entrance. As the broadleaf (e.g., bottom left) grows, it may need to be reduced in height near the cave entrance to maintain the existing fairly dry environmental conditions in the cave. Nevertheless, a shrubland near the cave will assist in reducing diurnal and seasonal variations in temperature and humidity, and reduce the risk of dust.

Overall, this reserve area is regenerating in a most attractive fashion, but care will have to be taken to design openings into the eventual forest cover: (a) to maintain views to the surrounding landscape and (b) to ensure fairly dry and well lit conditions into the cave.

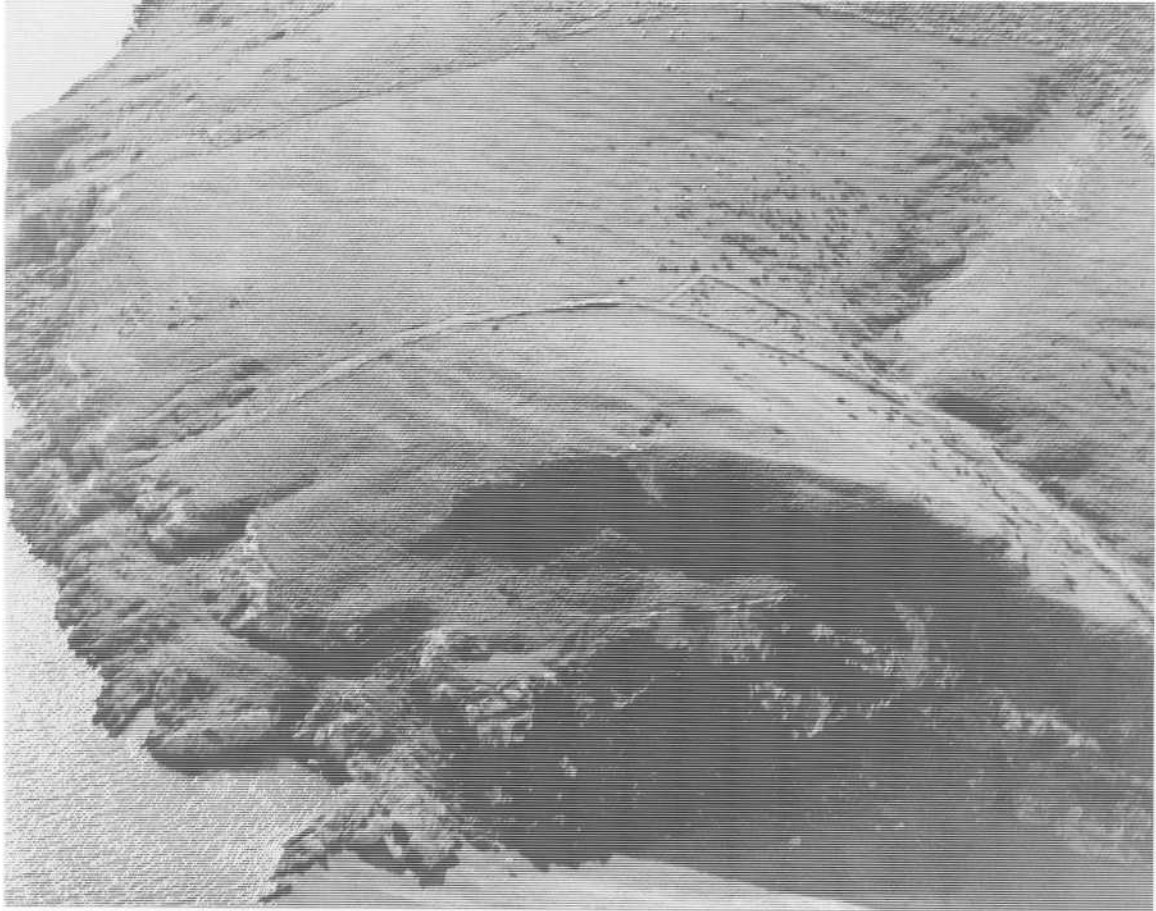
The dominant feature is a complex ditch and bank around the perimeter of the pa, while terraces and pits, much-rounded and in stable condition, lie on an east or south-east facing ridge (Fig. 35). The perimeter defence is a large ditch and bank varying between 1 to 2 m high and 3.5 m across running in a dogleg over some 120 m and enclosing the end of the ridge. The wave-cut cliff defends the southern and south-western edges. Exterior to the pre-European defences are two ditch and bank enclosures suggesting a period of early 19th century usage of the pā, either as a Māori settlement, or as stock yards. The association of ditch and bank fences with a pa is most unusual; unfortunately, the stratigraphic and surface linkage with the pre-European ditch and bank has been eroded by stock, but they evidently post-date by some time the major transverse defences.

The site lies in a grassland. The surrounding grassland is dominated by silver tussock (see top of Fig. 35), but the fenced historic reserve itself is completely devoid of tussock, which must have been deliberately removed or intensively grazed (see our notes on the grazing of tussock at Kawarau Goldmining Centre, above) at some point in time. The unimproved grassland of the pā contains *Rhytidosperra* sp. with sweet vernal, Yorkshire fog and ratstail. Scattered introduced rushes and *Muehlenbeckia complexa* occur.

Stock graze and trample the bank, but it is generally well vegetated. One section about 8 m long suffers from stock erosion and camping in the form of a bench into the outer slope of the bank. Here the characteristic subsoil fill of the bank is exposed and will probably resist re-vegetation or natural recovery of the grasses unless topsoil or turf is added. Being loess-based, the soil is prone to tunnel-gullying and a small incipient gully had formed in the ditch (Fig. 36). Collapse of a pit has occurred following recent unusually heavy rainfall, which suggests that it may also have been subject to tunnel-gullying.

**Figure 3-5** An oblique aerial view of Oruaka from the south-west (August 1991). Grazing at some point in time has reduced the population of silver tussock (compare with area outside the fence, top right). The pre-European pā and terraces are in the foreground; irregular ditch and bank enclosures adjoin the pre-European ditch and bank.

Close monitoring of the erosion features is warranted. Once it commences, tunnel erosion of the type that we believe may occur is very difficult to stop. Tunnelling sets in at interfaces between loess of varying densities, and any incipient movement will rapidly accelerate at points of weakness. It is not necessarily easy to discover a single

source of the water. Any backfilling or filling into holes must be of stiff clay and very well compacted in stages (packed every 10 cm or so). The few incipient tunnels identified should be packed with clay at the base, introducing it as far as possible into the voids and sealing it with a convex cap of topsoil. Shrubs such as *Muehlenbeckia complexa* or even coastal flax (*Phormium cookianum*) should be planted to shed water and spread roots down into the former cavity.

The pā is grazed intermittently with sheep. However, the grass was very short at the time of our visit, and it is possible that the current grazing regime is too intensive. In the low fertility regime imposed, the species present are not able to recover quickly from grazing. Assisted reversion to silver tussock may be the wisest management in the long term. Areas of erosion on the banks should be made good with added topsoil and grassed. The turfs could be taken from the base of the trench in its more level areas (to remove risk of erosion) under an archaeologist's supervision. Some shelter from sun and wind for sheep off the site area could be provided; this could be in the form of low, partly planked post and rail fences to form windbreaks. Post and rail enclosures with ecologically appropriate shrubs (kānuka, ngaio, five-finger, māhoe) and larger native grasses within could also be used.

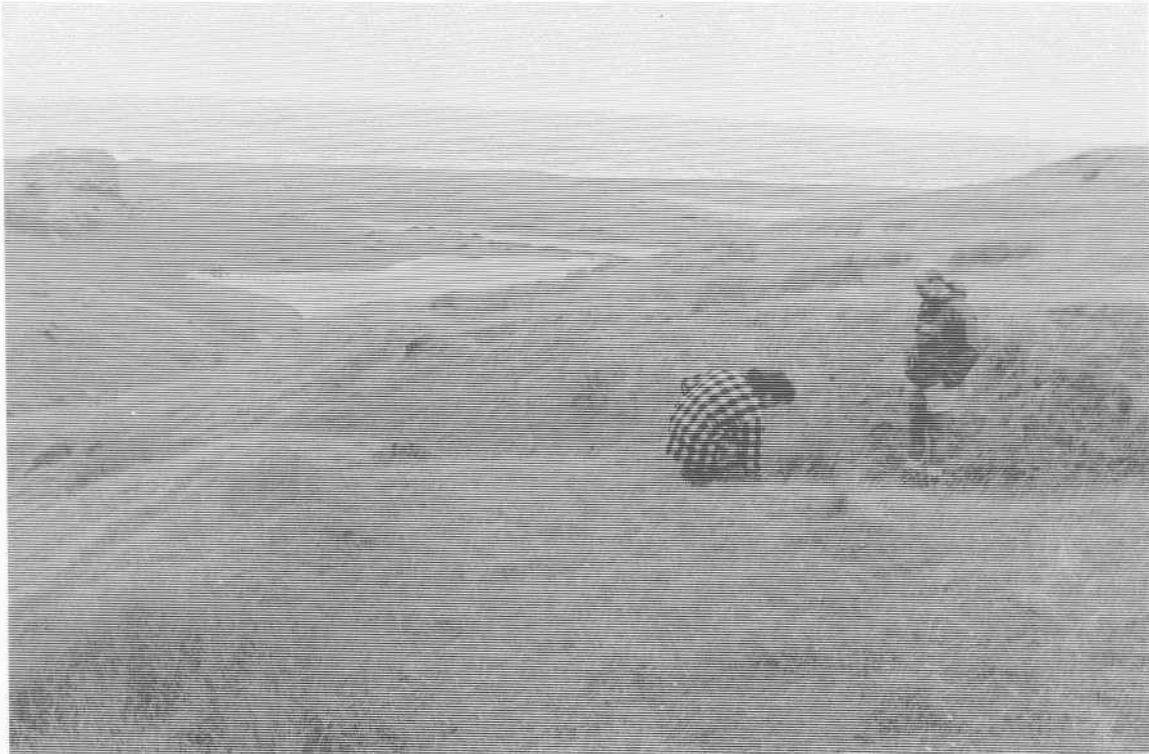
**Figure 36** A view to the south-east of Oruaka showing generally good condition of ditch and bank. The figures are inspecting incipient tunnel erosion on the counter scarps of the ditch.
