## Treble Cone ski area assessment of aquatic ecological values

**PREPARED FOR: CARDRONA ALPINE RESORTS LTD**

**DATE: JUNE 2020**

**REPORT NUMBER: 88-2020**

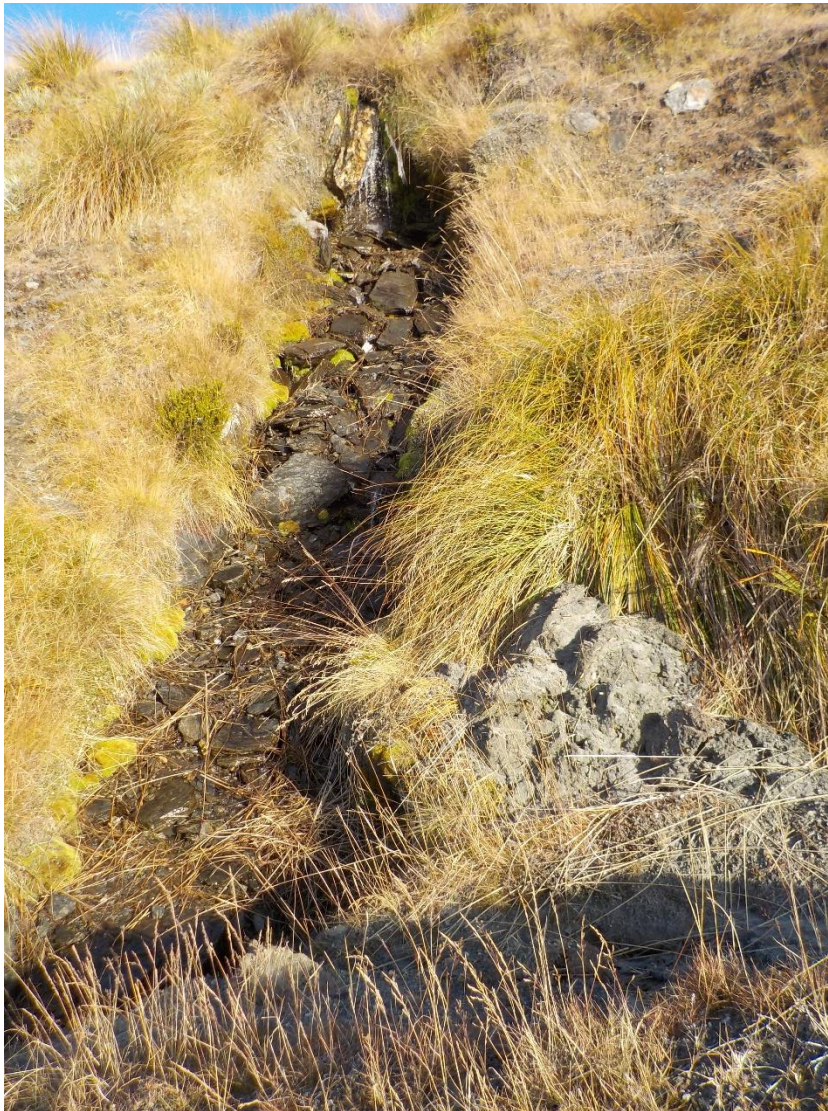
This site was a short section of modified stream channel flowing down the access track embankment (Figure 2). The channel was protected from erosion by the placement of flat schist slabs on the stream bed and by a well established riparian vegetation. Moss was present on the slabs indicating the channel is stable with little disturbance. *Deleatidium* mayfly nymphs were common on the rocks in this stream.

Figure 2: Site CONE1, a modified channel on the access track.

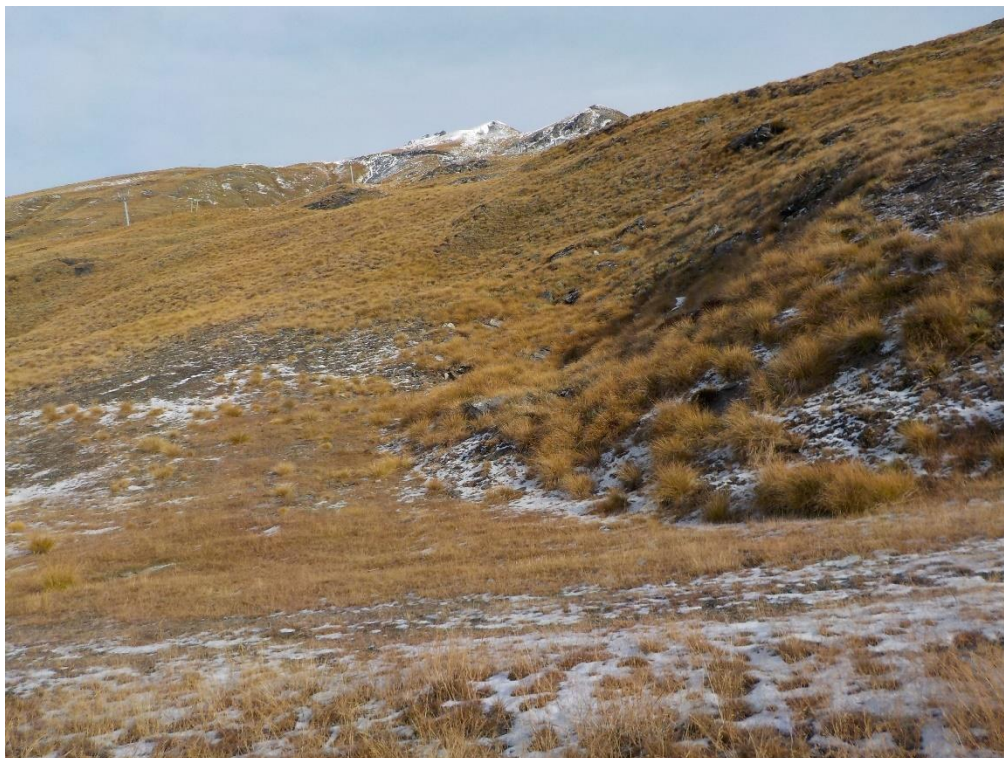
Site CONE2 was at the top of a modified slope on the northern edge of the ski area. No water courses were present at this site confirming no perennial streams are present on this part of the Basin (Figure 3).

*Figure 3: The view from Site CONE2 with no stream courses.*

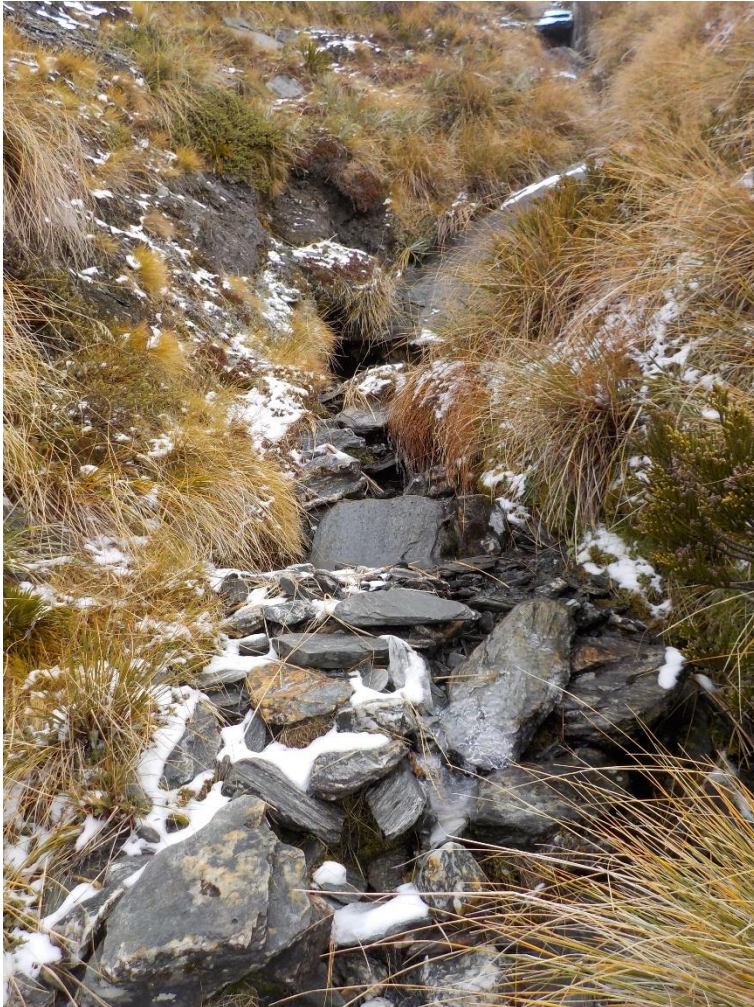
The stream at CONE3 was flowing at approximately 50 ml/s and it is possible this is an ephemeral stream, drying in the summer. It was in a steep V-shaped channel well incised into the hillside (Figure 4). The consisted of steep cascades and occasional very small pools with a maximum depth of 15 cm. No invertebrates were observed when the substrate, stream bed moss and riparian vegetation was searched. The stream channel appeared stable and had no modifications. The riparian vegetation was also intact along the stream edge restricting erosion.

Figure 4: The stream channel at Site CONE3.

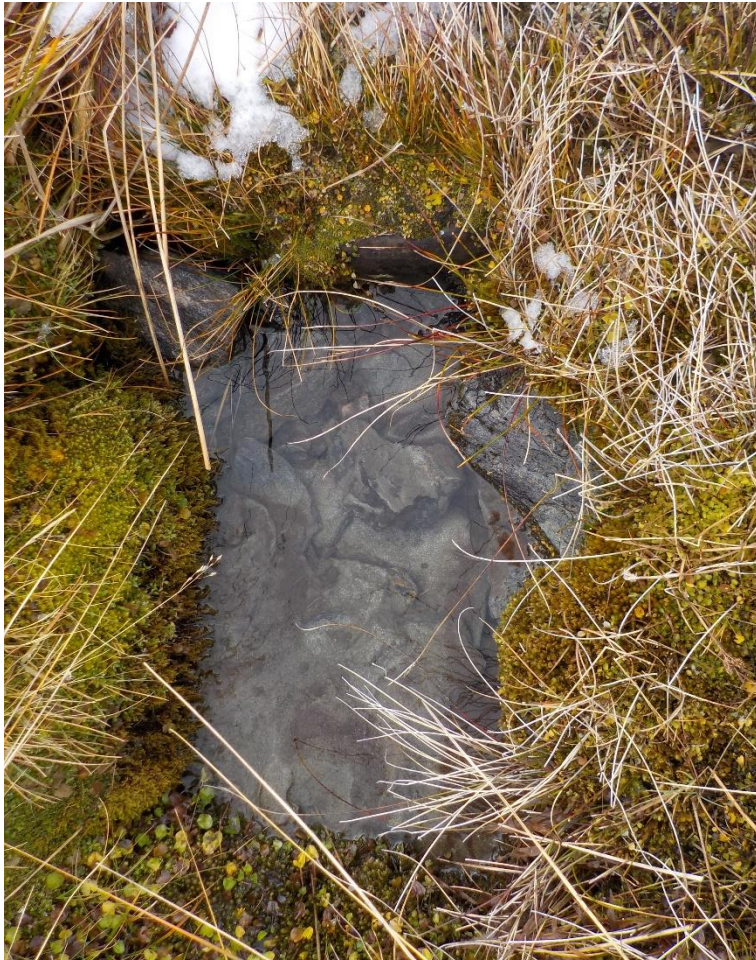
CONE4 was sited on another small steep channel with a good riparian margin and no erosion. The stream was almost complete enclosed by its banks and it had a maximum width of 40 cm and the flow was estimated to be 50 ml/s or less. A search of the stream bed substrate and bank edge vegetation found no invertebrates. Small pools were present and these had a maximum depth of 10 cm (Figure 5). It is likely that this stream is also ephemeral.

Figure 5: A small pool in the stream at site CONE4.

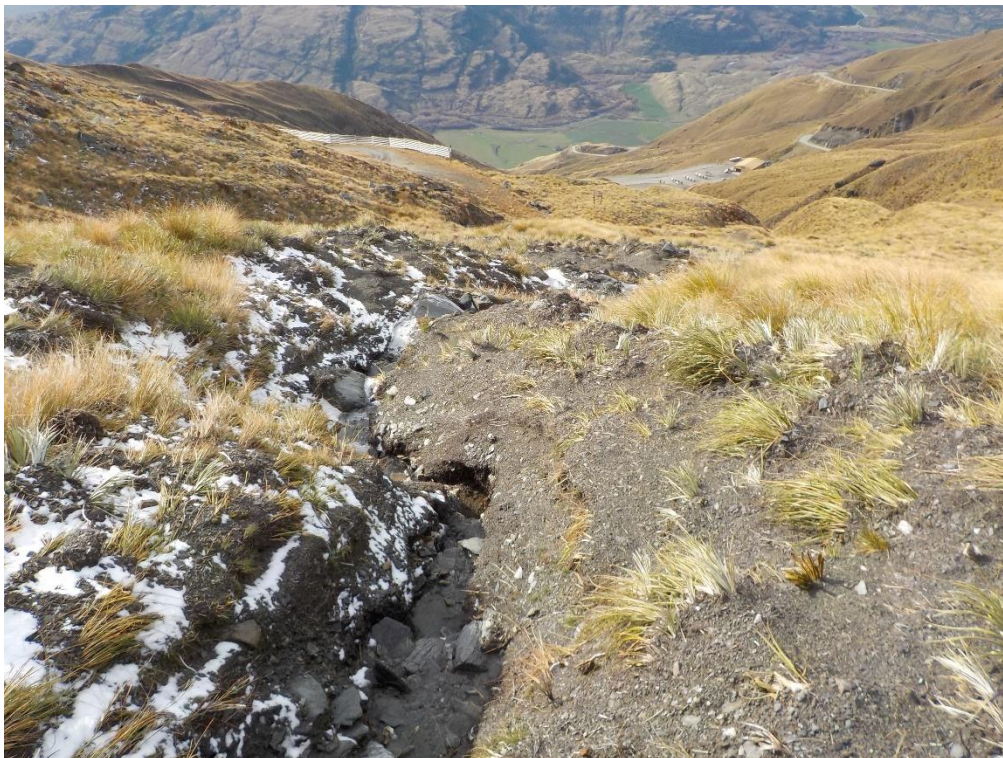
CONE5 was sited on a larger stream and has had large debris flows coming downstream from the mountain top in the channel. This stream drains the highest slopes in the Basin so has the largest catchment upstream of the survey site. There was sediment (silt to boulder sized particles) deposited along the stream edge and the riparian vegetation was partially buried. Some channel erosion was present but this was limited and appears to be due to the channel being over loaded

with sediment due to the upstream debris flow. The stream was up to 1 m wide and 20 cm deep. A search of the stream bed substrate found macroinvertebrates; *Austrosimulium* larvae were the common and other Diptera and caddisfly larvae were present. Given the presence of invertebrate life and the larger size of this stream it is expected that it is a perennial stream.

Figure 6: The stream channel at Site CONE5.

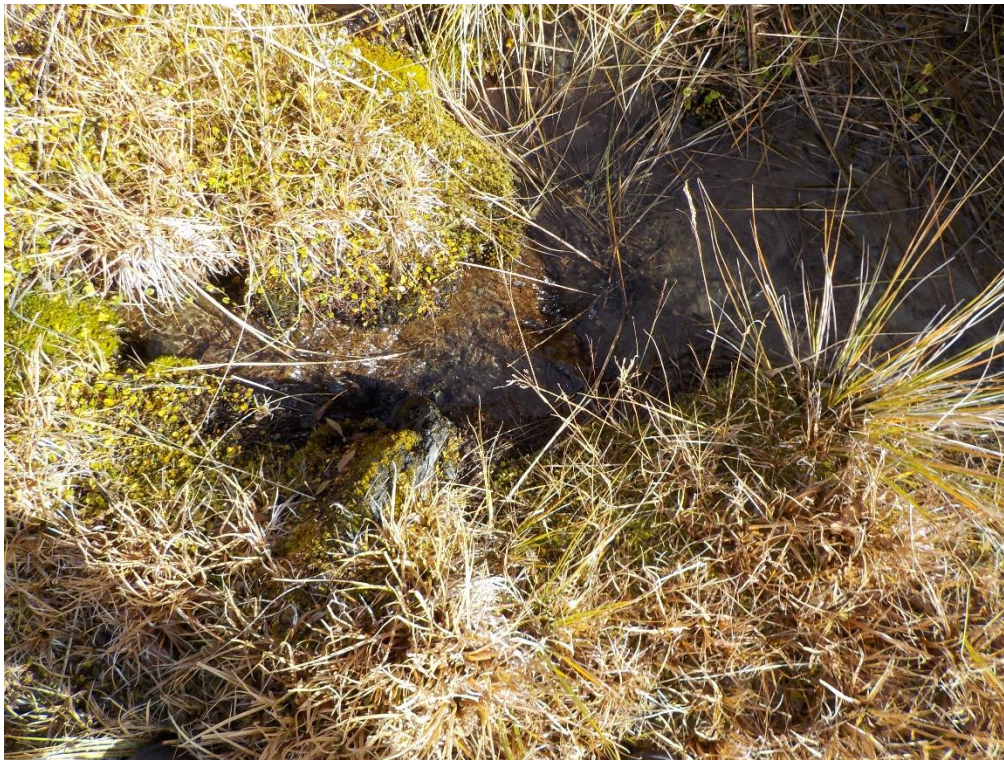
There were two small stable streams at CONE6 site. Both were narrow, 20 cm and 40 cm wide and had well vegetated riparian margins with saturated moss growth along the stream edges (Figure 7). The smaller stream had a fine sediment stream bed and the larger stream had some gravel and cobble on the stream bed. No invertebrates were found in the smaller stream while flatworms, *Deleatidium*, chironomid larvae and stoneflies (not identified) were present in the larger stream. Both streams had sections where the stream was completely underground or overgrown and not visible from above.

Figure 7: One of the small streams present at site CONE6.

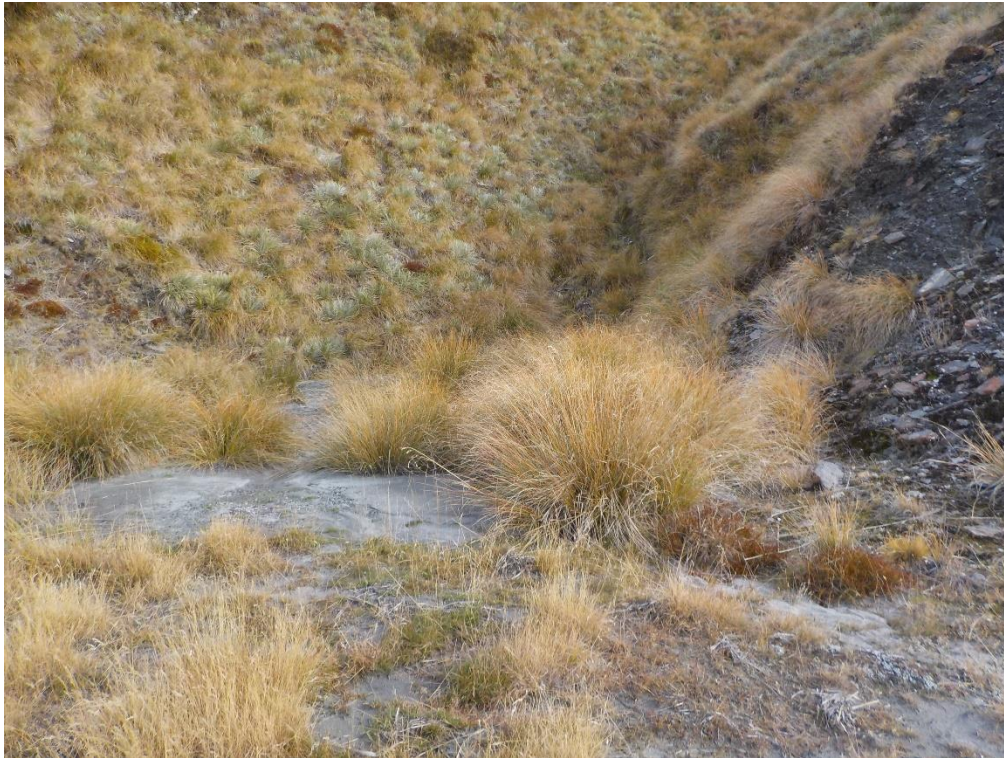
Sites CONE8 and 9 were located downstream of the previous sites near the confluences of the smaller streams. The streams at these two sites have undergone some very localised modification with a 4WD track crossing the streams using culverts. The stream at CONE8 downstream for site CONE5 and the 4WD track culvert is blocked by debris that has come down the stream. This culvert blockage has diverted the stream and it flows across to the stream at site CONE9. The CONE8 stream has a stream bed comprised of silt through to boulders. Invertebrates are present in the stream including flatworms and *Deleatidium* and stony cased caddisflies, although the abundance was low. No invertebrates were observed in the stream at CONE9.

*Figure 8: The stream at CONE8 looking upstream where sediment has accumulated upstream of the 4WD track.*

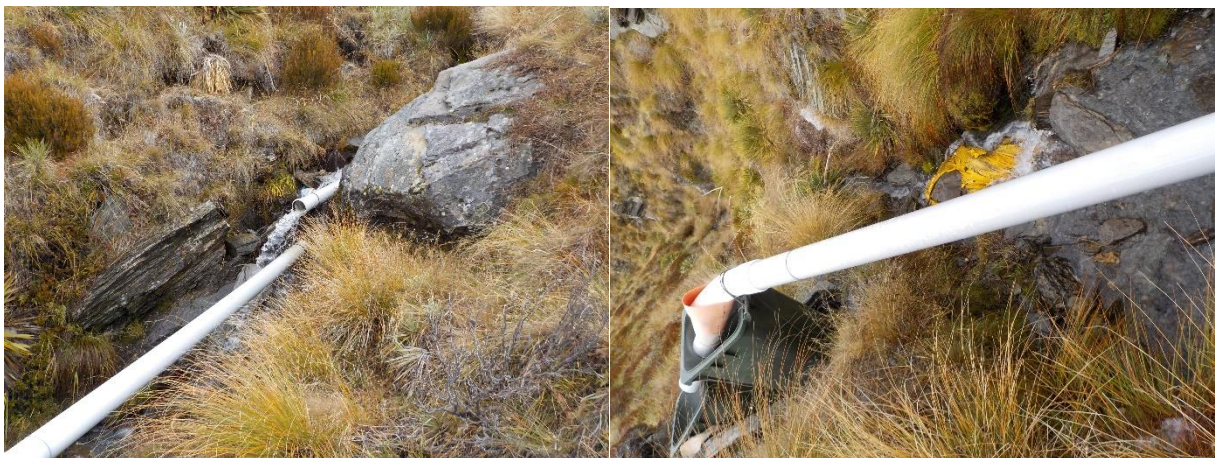
Site CONE10 was the water intake location for the Treble Cone base facility. At this location all the upstream tributaries sampled have joined to form this single stream channel. The channel is over 1 m wide and pools are up to 50 cm deep. The stream edge and bed is predominately bedrock and boulder with small areas of cobble, gravel and sand. The stream is incised in a narrow v shaped channel that has a well vegetated riparian zone. The steep is steep with the habitat generally a cascade with small plunge pools and runs. The water intake structure is the only modification and extends along about 10 m of stream.

*Figure 9: Site CONE10 with the water intake looking upstream (left) and downstream (right).*

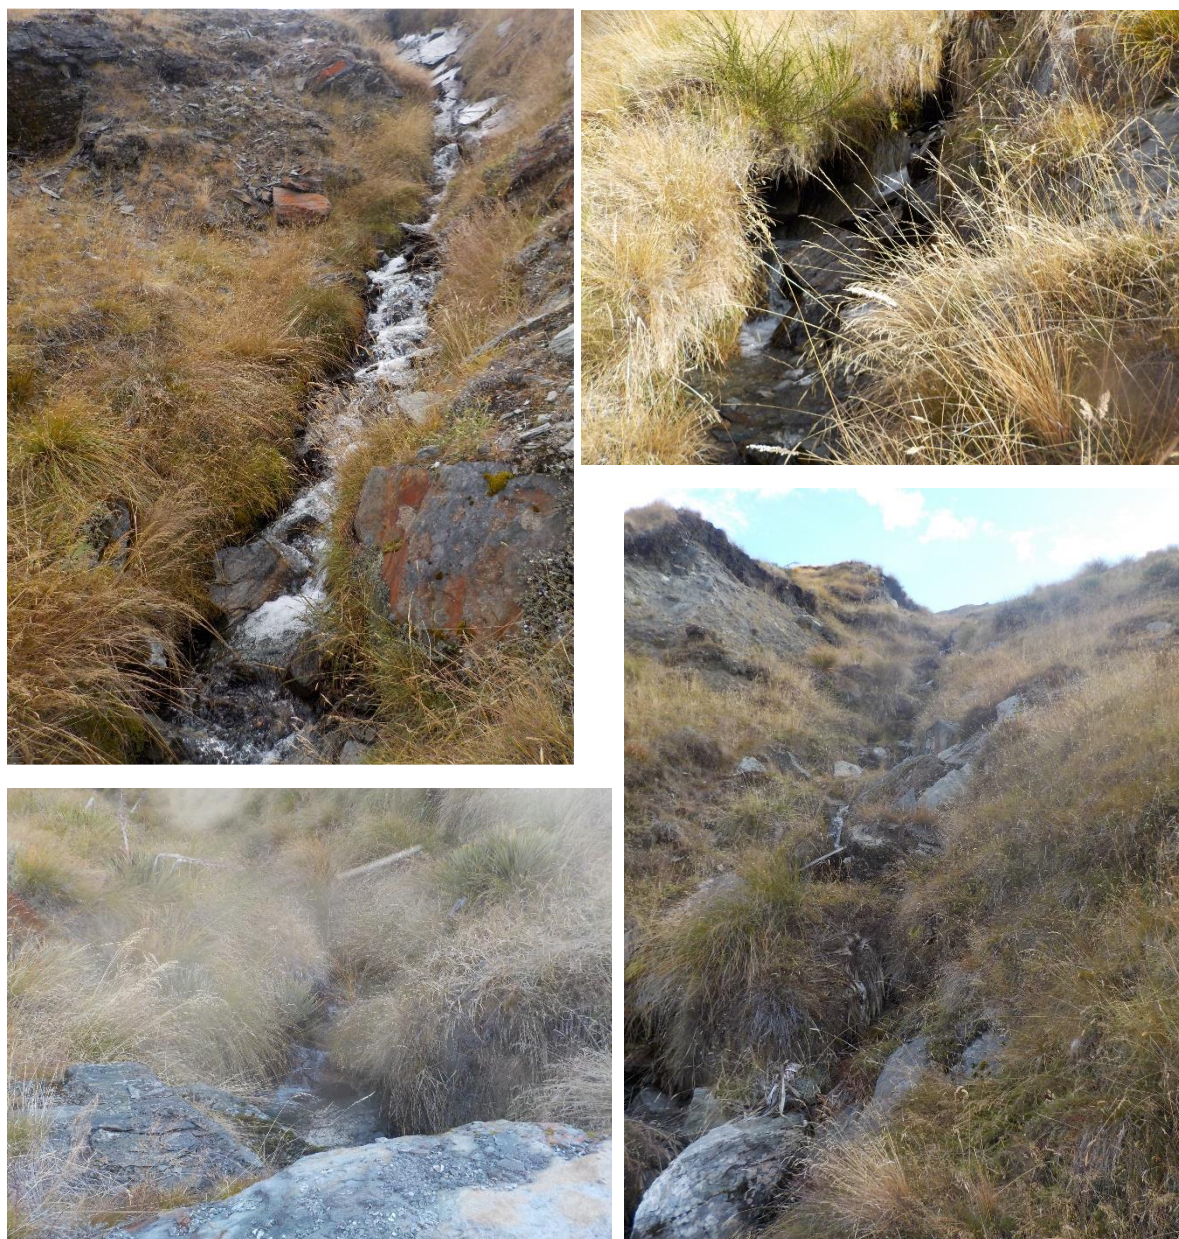
CONE11 is an artificial channel that flows alongside the learns slope and under the main chair lift before being culverted under the lower part of the Basin. The stream was sampled just upstream of the chairlift. At this site the stream has a stable boulder, cobble and gravel bed with some moss on the boulder and cobble. The riparian vegetation was intact and there was no erosion along the stream. Therefore, while an artificial channel this reach appears to be a natural channel aside from being straight.

Sites CONE12 and 13 are on the main stream located upstream (CONE13) and downstream (CONE12) of a long culvert section that flows under the ski area carpark. Both sites had a boulder, cobble and gravel stream bed that is stable with little erosion. The riparian zone is well vegetated at both sites with tall tussock grasses the most common vegetation. The stream width is approximately 1 m and the maximum channel depth is 25 cm.

Site CONE14 was on the upstream side of the access road on a stream just down the access road from the base buildings. This stream also steep cascading stream with a boulder, cobble bed stream and an intact tussock riparian zone.

*Figure 10: Invertebrate sample sites, CONE11 (top left), CONE12 (top right), CONE13 (bottom left) and CONE14 (bottom right).*

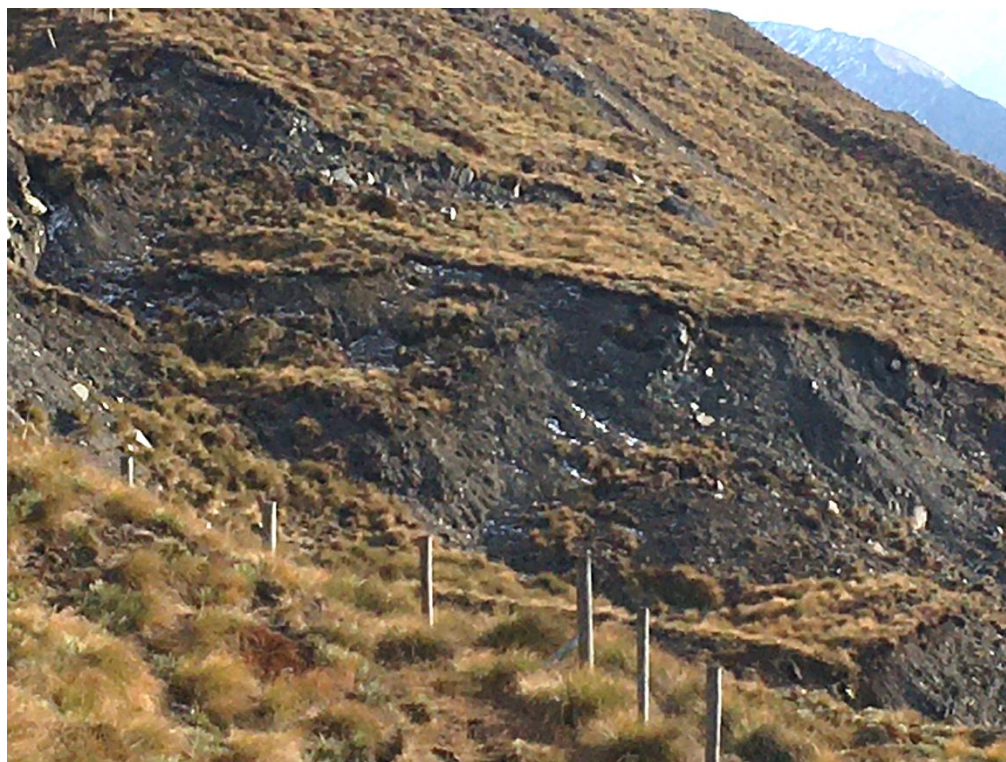
The stream habitats were generally unmodified and have been retained in a natural state. Most streams reaches have a natural stream bed and the riparian zones have intact native vegetation. Erosion is limited and one active slip at the top of the Basin is the only significant source of sediment in the streams. It is notable that the adjacent land area outside the ski Basin has a large active erosion area (Figure 11) indicating that these mountain slopes can be unstable. Small areas of stream alteration have occurred around vehicle tracks and there is a water take on the main stream. The streams are also culverted under the access road and base facility area. However, given the size of the ski area these alteration areas are small compared to its total area. The modified channels are all stable and support high quality macroinvertebrate communities (e.g., Site CONE11). The macroinvertebrate collections indicate that the water quality is excellent and therefore water draining from the Basin is of excellent quality and will have no detrimental effects on downstream ecosystems.

Figure 11: Erosion and landslip adjacent to Treble Cone.
