Te Kuha Mining Operation Geotechnical Concept Study for Stevenson Mining

Prepared For
Mike Coleman
CEO for Stevenson Mining

Document: Mine Geotechnical Feasibility Assessment

Date: 02 October 2015

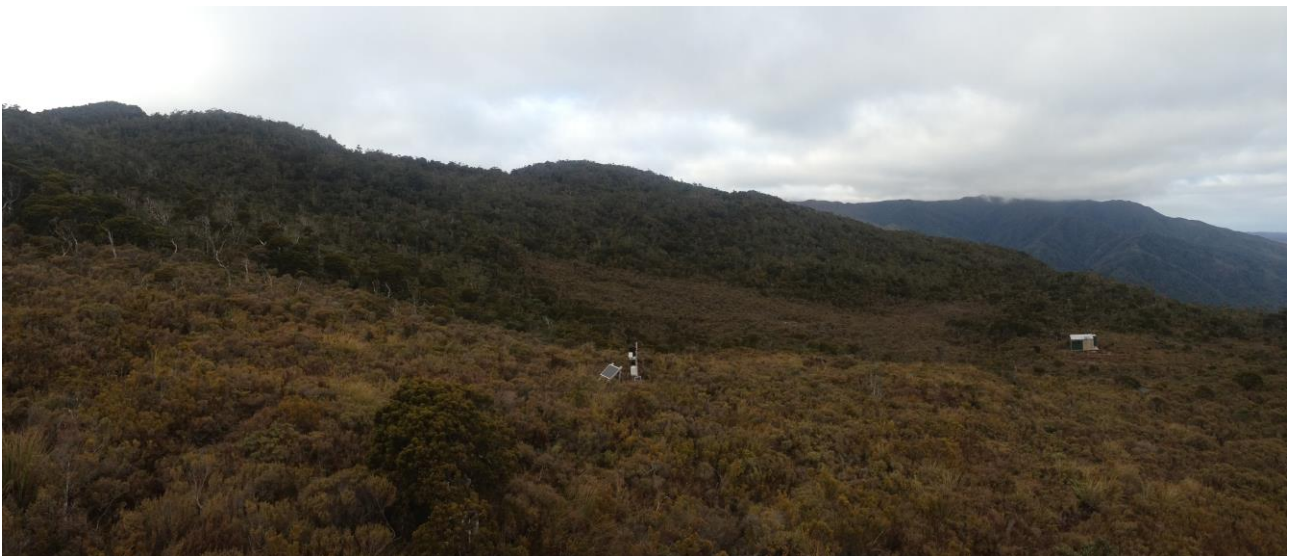
The site is densely vegetated and surface topography ranges in steepness from flat in areas to very steep (~45°), a couple of sheer cliff faces were identified on the western slope but generally limited to 10m height or less. Significant earth works will be required for mine access and haulage as part of operational preparation, initial surface excavation should not prove problematic with the weathered profile being fairly soft material and the more competent materials being blocky in nature.

Figure 6 - Photo of Western Hillside Looking South

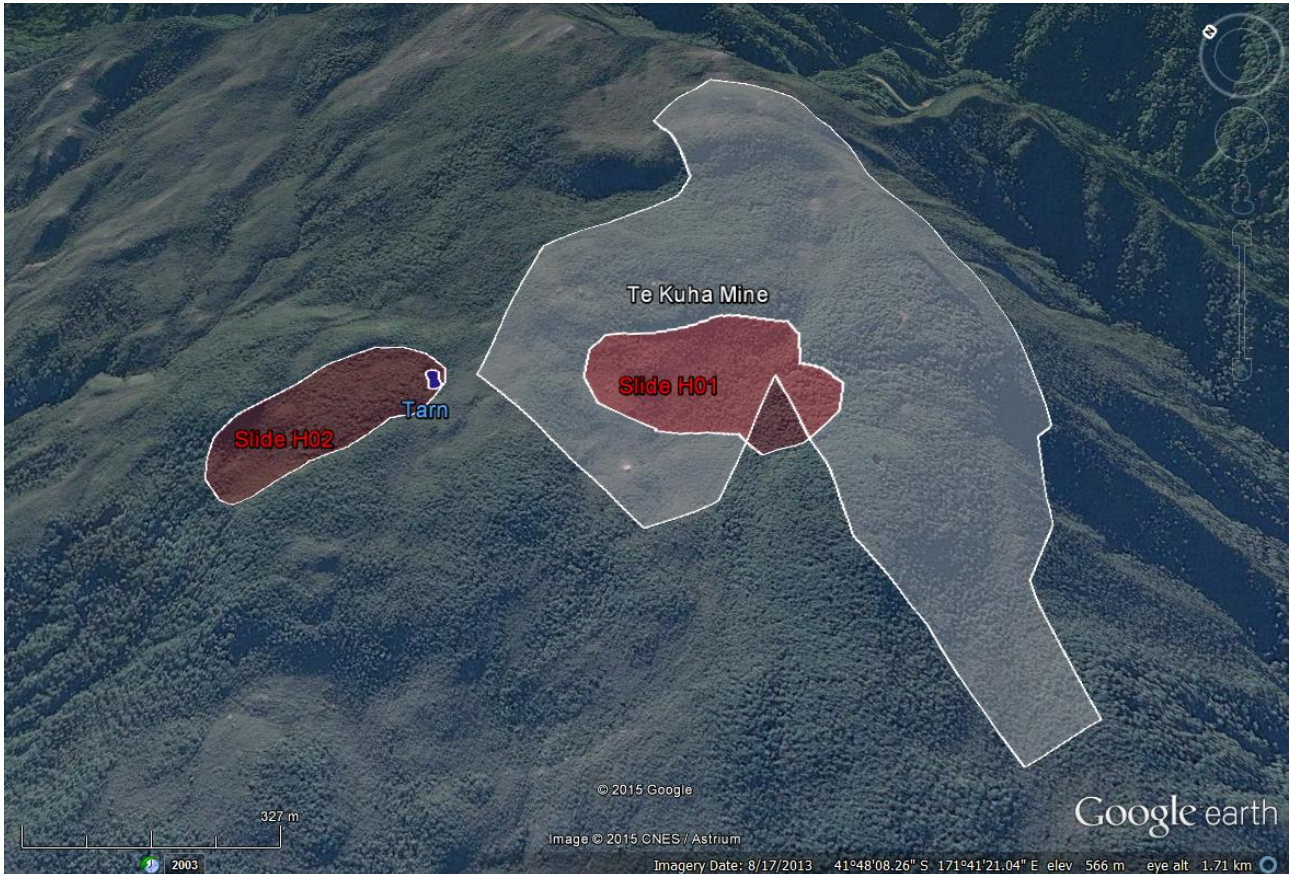
There appears to be two slides present on the Western slope which may impact on mining operations, these are designated H01 and H02. The slides are densely vegetated with minimal disturbance visible, some minor slippage of vegetation and muds can be seen but appears superficial and most likely associated with surface water. Exposed rock material within main body of slides is blocky in nature forming voids, exposed surfaces are planar and most likely due to the principal jointing structure. H01 intersects the mine footprint while H02 is located near the proposed material dump site.

Figure 7 - Landslides Proximal to Operation

The two slides discussed earlier do not appear active, it is difficult to make an accurate assessment of their condition or potential because of the inaccessibility of the area. The slides pose two different problems with regard to planned activities and as such management of the hazards should reflect this. The slides may be inactive or minimally active but they have created a subsurface water path, running water could be heard from the voids inspected in the main body of H01.

Slide H01 will interfere with mining activities as extraction takes place. Unconsolidated blocky material should be expected where pit walls overlap the slide, however, the majority of the slide will be removed during mining which would effectively remove the hazard. Excavation through and around H01 can be managed with appropriate buffers and sequencing until the slide is removed, the small remaining portion will be the toe and foot which should not present any risk once loading has been removed.

The initial material dump is planned in the area of the tarn which sits on the crown of slide H02, the presence of the tarn exacerbates any instability issues as the saturated materials and migrating water will reduce material friction angle and can lubricate the failure plane further. Filling in this area and promoting better water drainage is expected to reduce risk, in contrast, loading material onto the crown will increase risk (magnitude will be dependent on the volume of material, area applied over and moisture content). In general terms, moving water away from the slide failure plane is expected to have the more significant impact.

Mining sequence, particularly overburden stripping, has the potential to significantly reduce the geotechnical risks. Over-stripping adjacent to slide H01 and faults will reduce highwall exposures, introducing steeper benches or bunds to eliminate rock-fall risk. In extreme cases consolidation works or retaining structures may be required. The proposed up-dip mining sequence will enable most of slide H01 to be removed without exposing the pit floor to instability risks.

Water management is the critical aspect to control both the slides and general pit stability. The up-dip mining sequence has the added benefit of providing greater control over water management. Improved drainage and well thought out water diversion should decrease the volume of ground water, subsequently improving the stability of slide H02 and also reducing the overall likelihood of mass failure. Mining down-dip would allow for ponding at the toe of the highwall which will impact its stability, furthermore, seepage would most likely connect with slide H01 and possibly H02. All efforts should be made to reduce, or at the very least not increase, water ingress into either slide.

Detailed monitoring should be carried out for any new operation, in the case of Te Kuha, the geotechnical focus should include regular survey of slides H01 and H02 and the mass failure blocks interpreted by Johnson (2012). Remote tell-tale devices are relatively inexpensive and will assist to provide further assurance. The highest risk area is loading of dump material onto the crown of slide H02, monitoring frequency in this area should be high, at least initially, and alternative dump strategies should be available in the event that significant movement is detected.

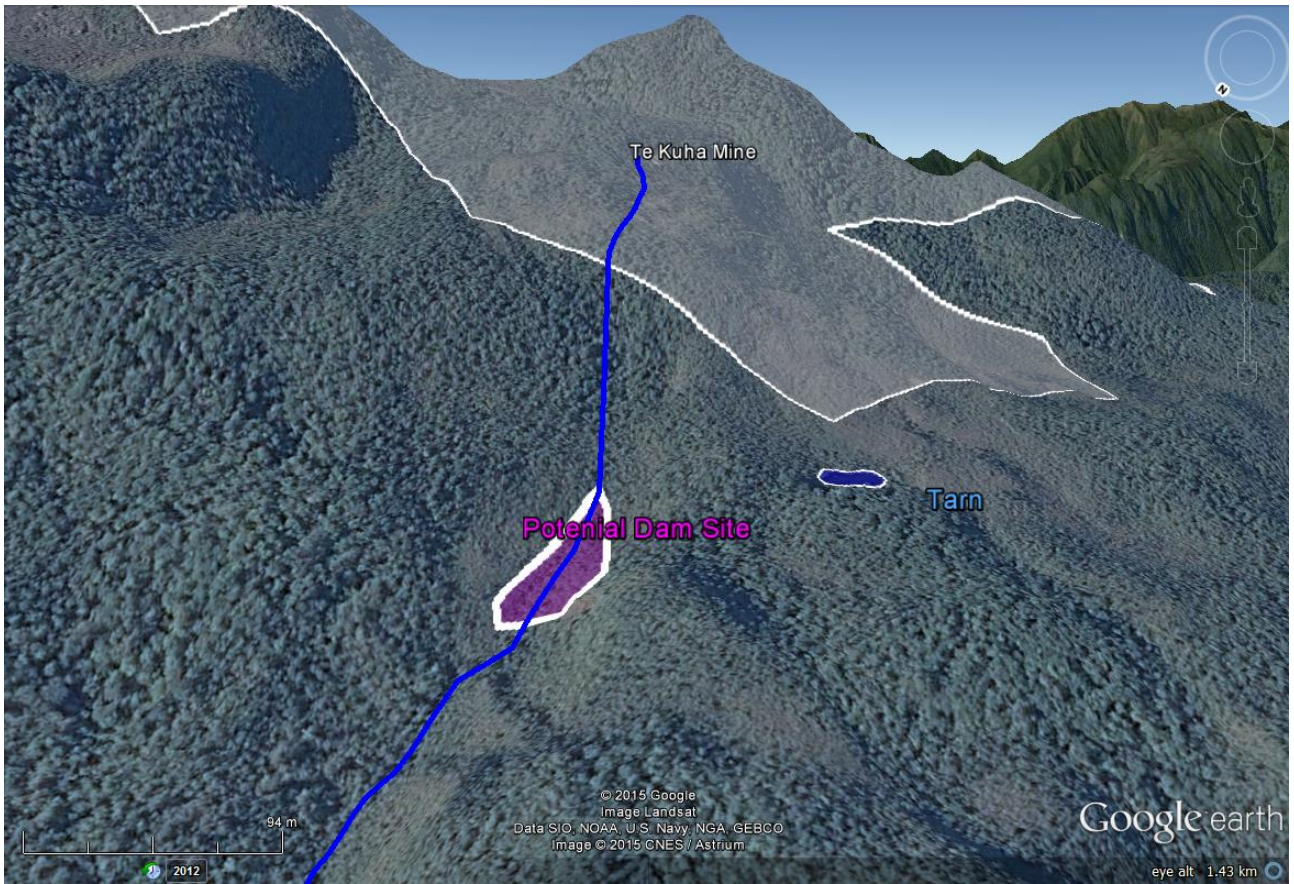
A small creek drains along the Northern gully (**Figure 8**) adjacent to the tarn, both slopes into the gully appear free of any obvious deformation and no evidence of sub-surface connectivity to the tarn could be found. This gully could be a suitable location for a dam.

Figure 8 - View of Northern Gully Looking Southeast, Showing Potential Dam Site (2:1 Exaggeration)

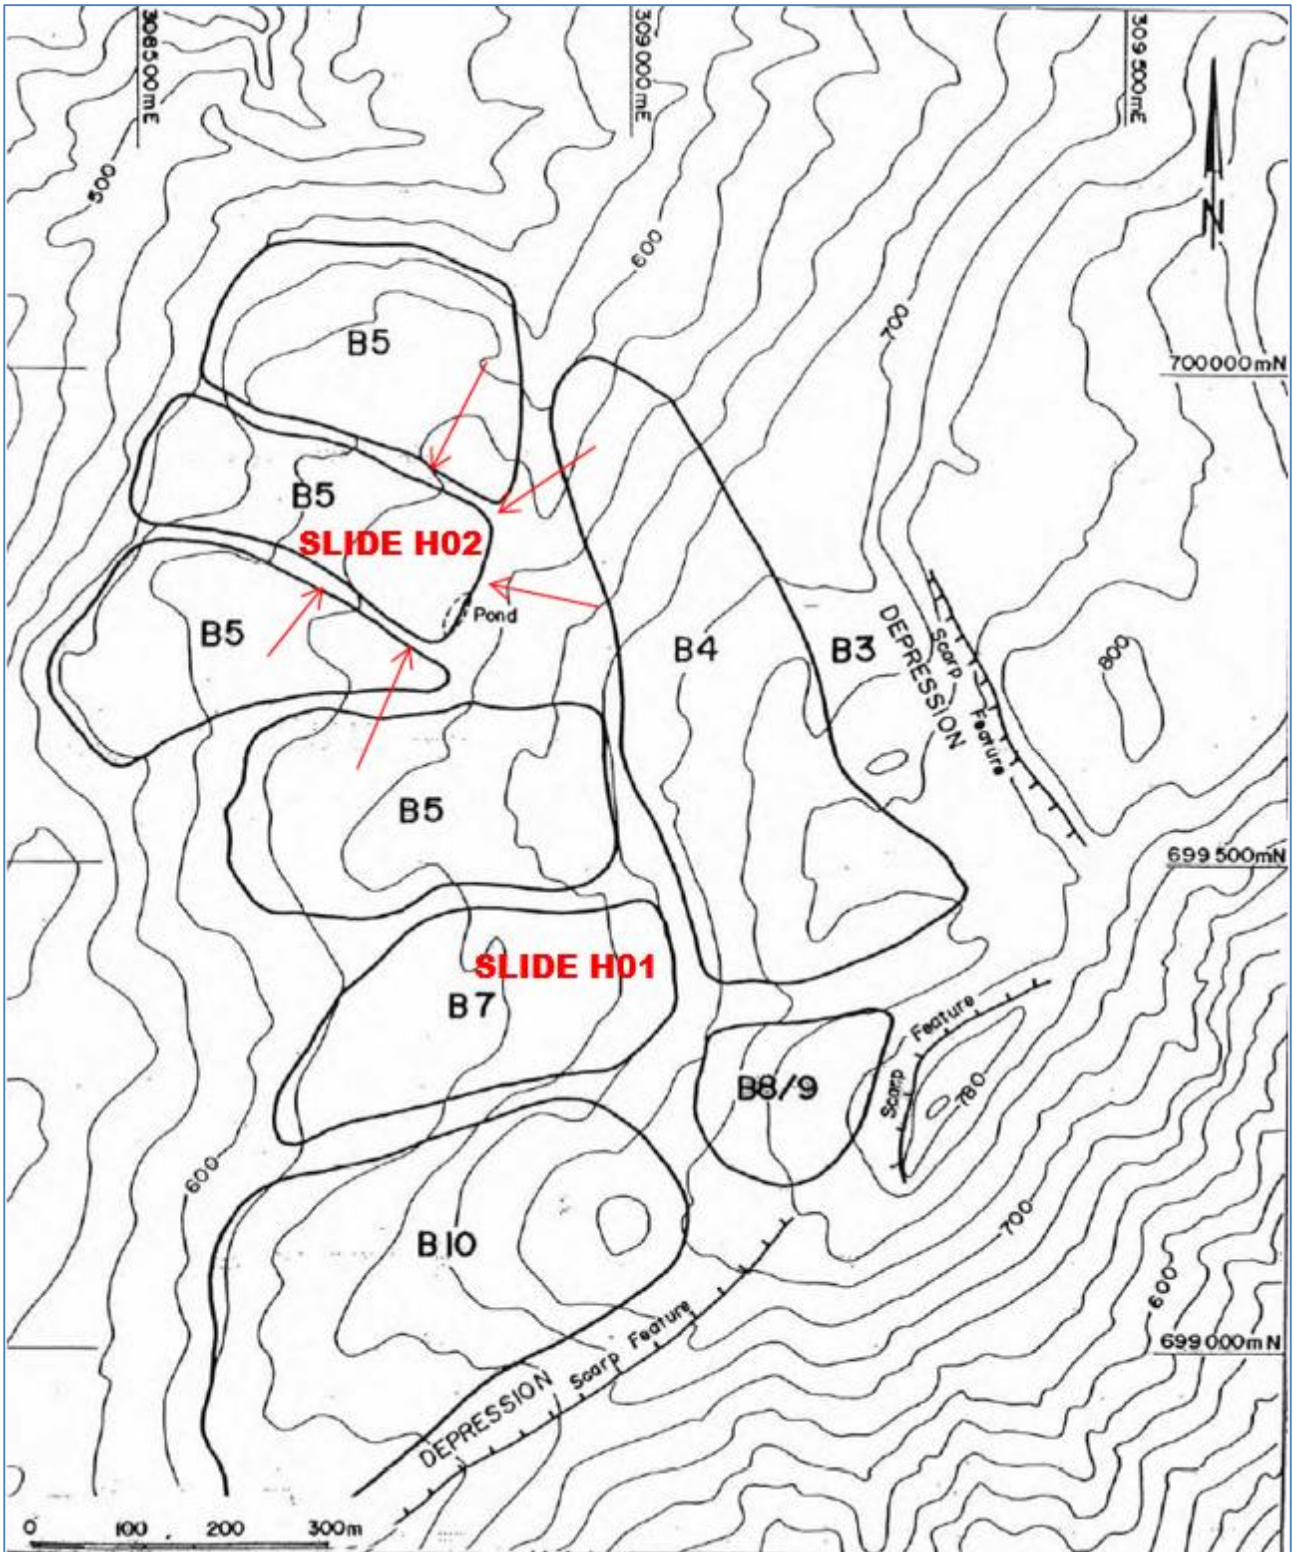
Johnson (2002) classified the site into multiple mass movement blocks from an ancient failure, the formation of voids appear consistent with strained zones as indicated in **Figure 12**, the interpretation also provides insight into how slides H01 and H02 are likely to have formed. The boundaries shown indicate the higher risk areas (more broken) and where monitoring activities should be concentrated.

Figure 12 - Te Kuha Mass Failure Interpretation from Johnson (2002)

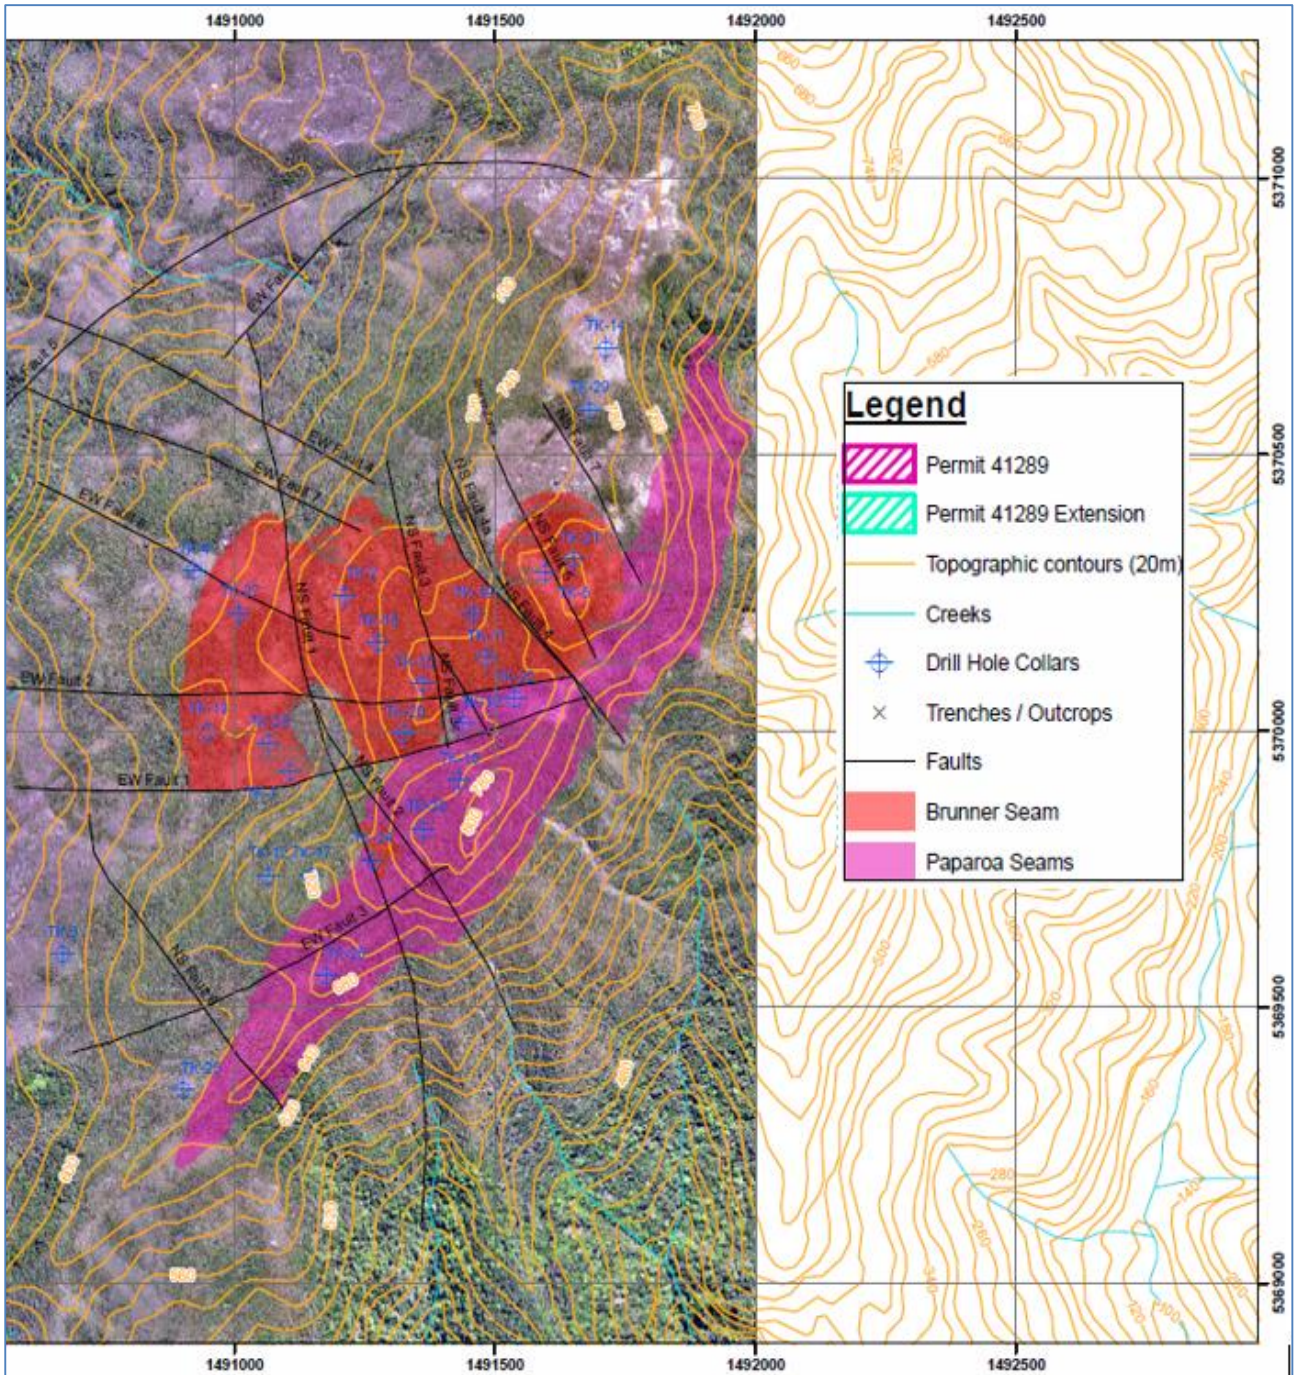
The principal faulting direction is North-Northwest (**Figure 13**) with the secondary set running East. The major structures are well aligned to the mass failure interpretation with displacements up to 50m predicted. Faulting of this magnitude is almost always accompanied by minor sets of associated faulting and shearing systems. Normal faulting (as opposed to thrust faulting) is expected to be the dominant type due to the nature of the mass failure.

Figure 13 - Te Kuha Fault as per Dutton (2013)

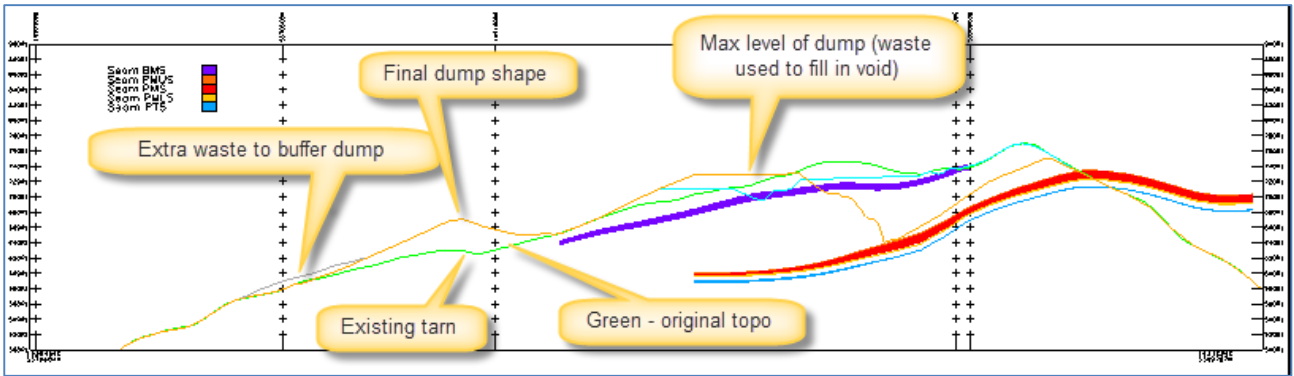
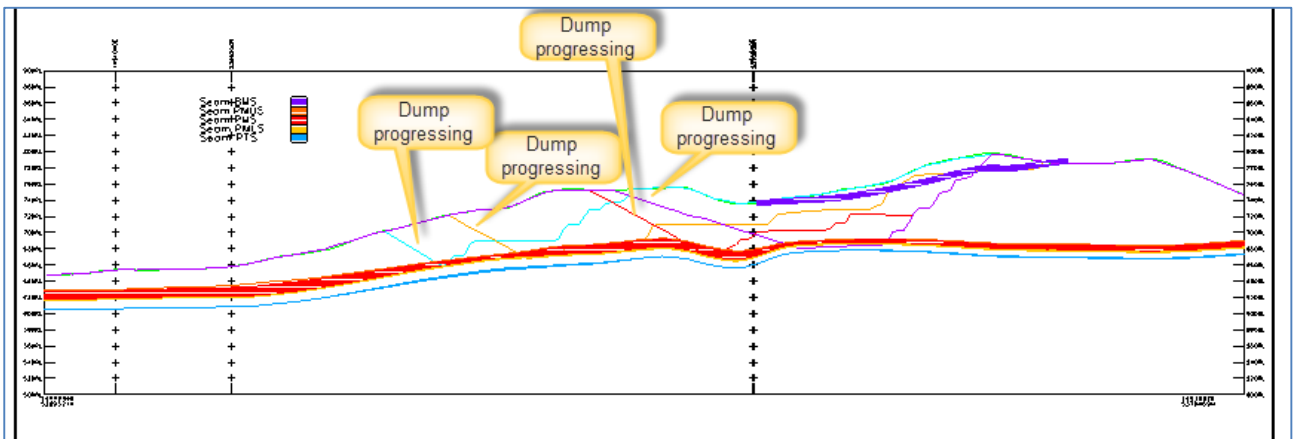
Figure 15 - Cross Pit Model (Section 1), Paparoa and Brunner Pit Overlapped

Figure 16 - Paparoa Pit Model (Section 4)

Factor of Safety (FoS) values returned by the model ranged from 0.9 up to 5.5 with the majority of outcomes over 1.2, these outcomes infer that the current pit design, generally speaking, is either stable or very near stable. As expected, the lower FoS values were associated with the Eastern wall and the steeply dipping stratigraphy, an adjustment of the Eastern wall angles to 50° (currently planned at ~60°) returned no FoS values <1.2.
