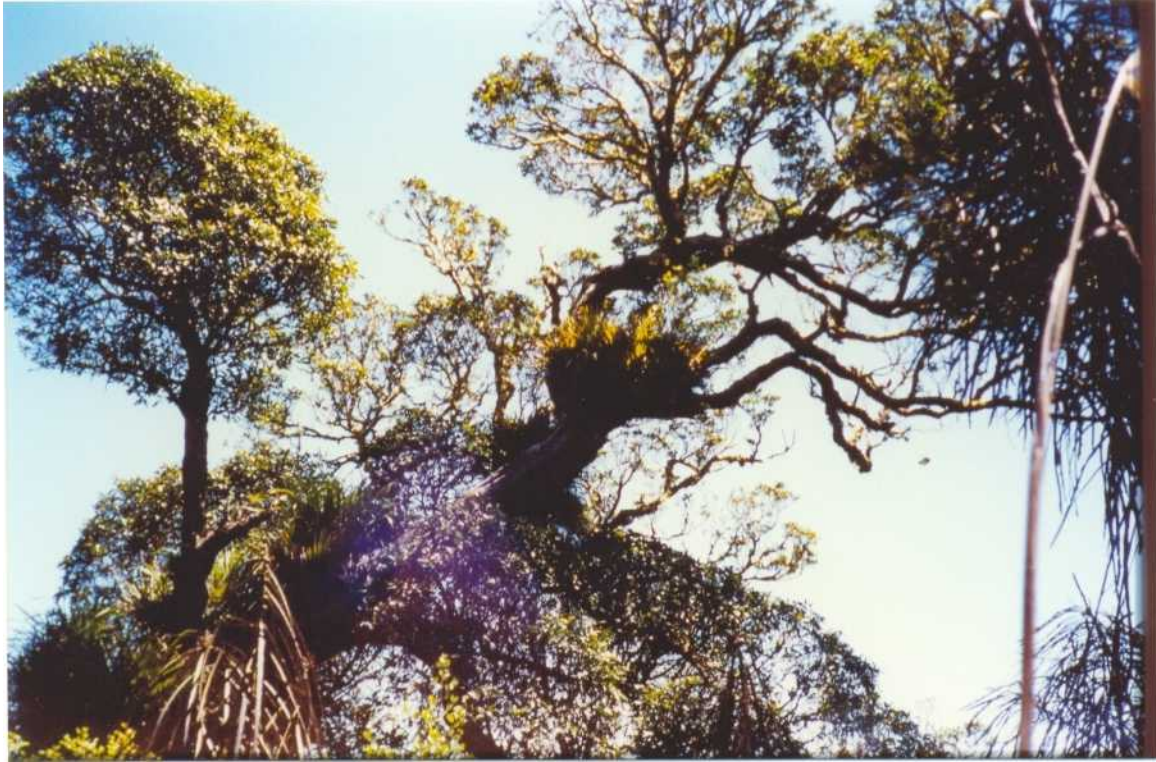
Figure 5: Lower crown regeneration on left is typical of the healthy condition 1 category. The contracting old crown represents condition 3.

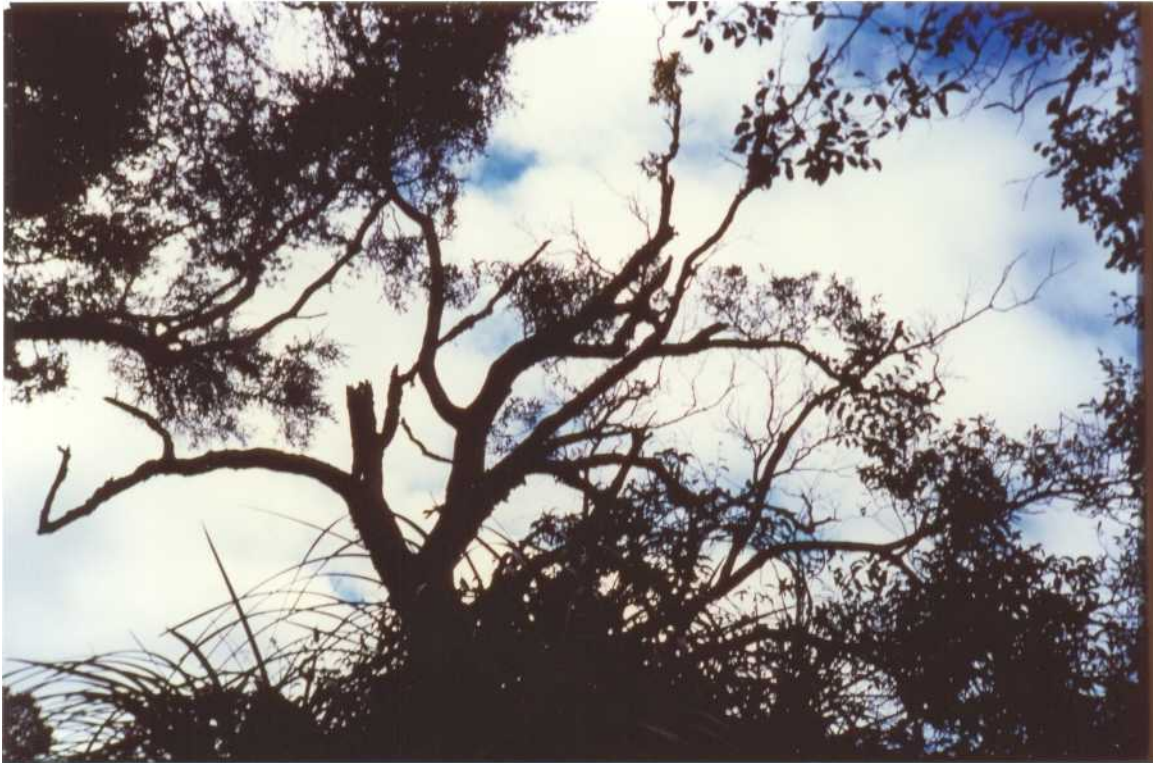
Figure 6: Severely contracted crown of a condition 4 tree although more commonly a greater proportion of dead fine branches were present.

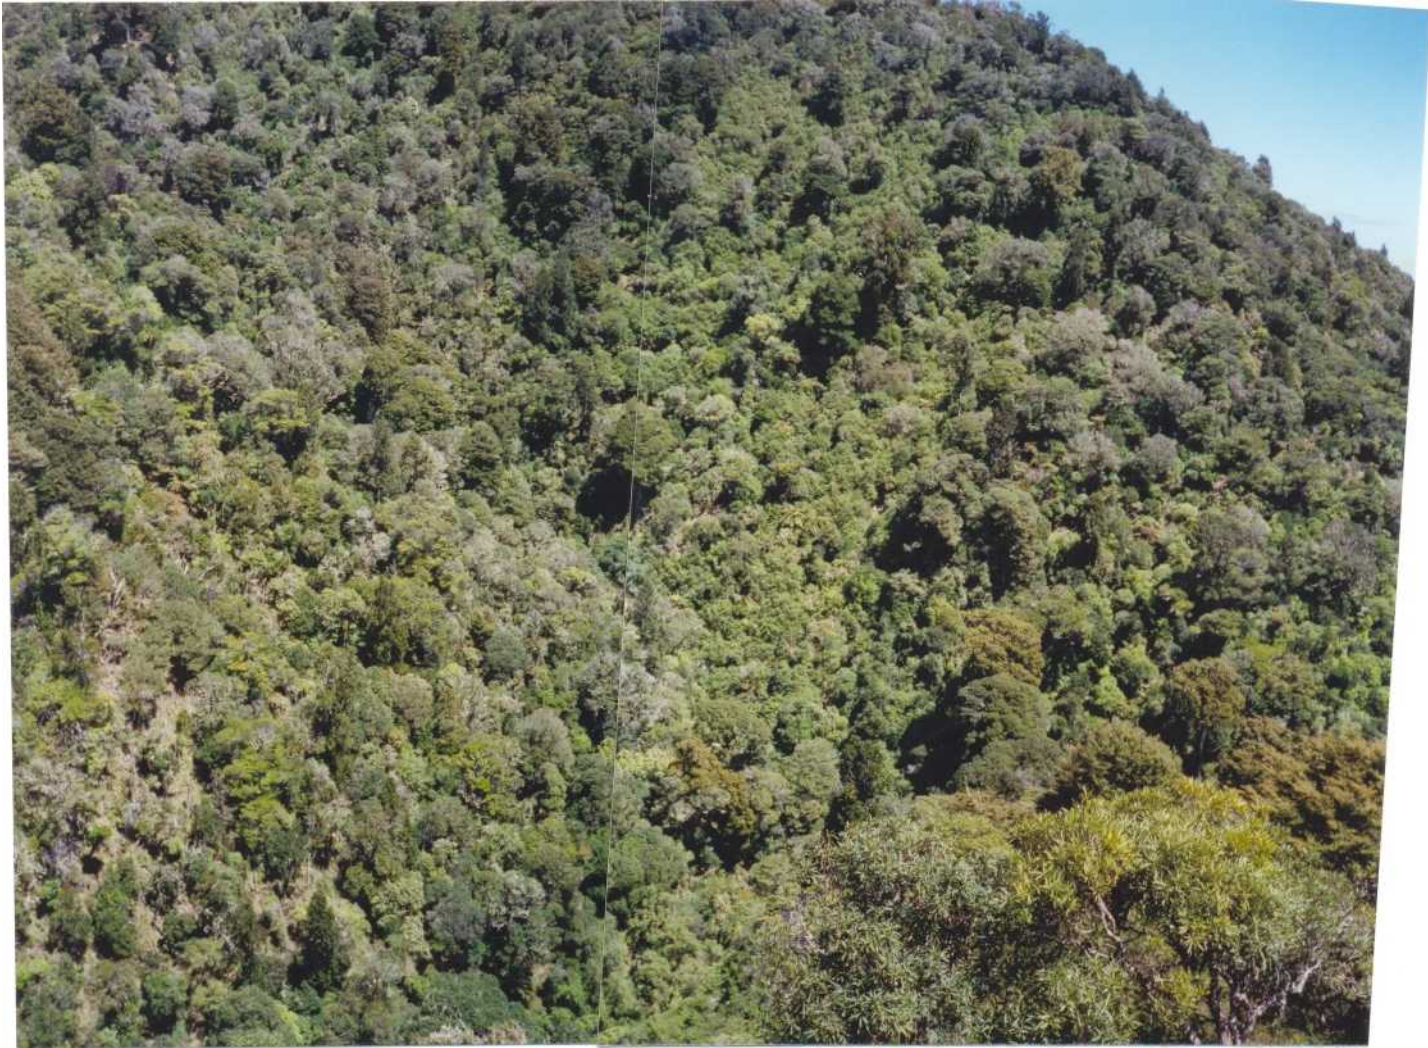
Figure 7: Typical open canopy forest with black maire dieback taken from track near site C.

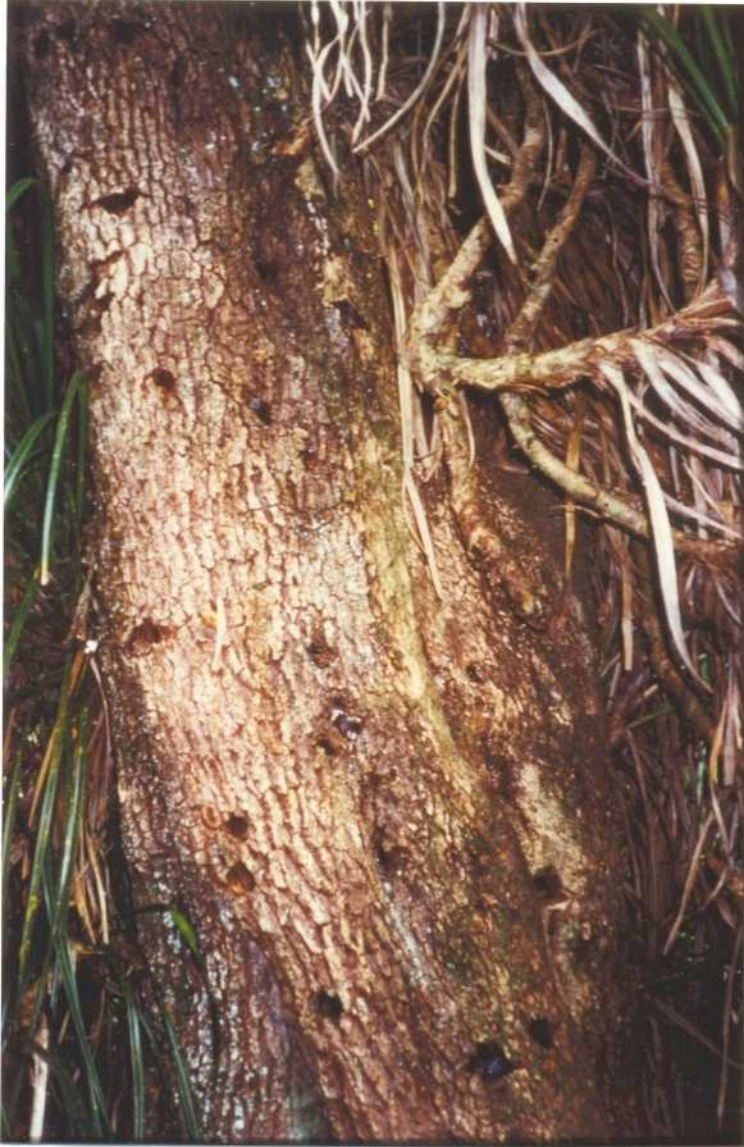
Figure 9: Heavy puriri moth attack on a 40cm DBH stem.
