Whanganui Catchment Ecological Health Assessment – Year One

DOCM-7529317

The purpose of this report is to present the results of the first year of survey work back to the hapū involved and to others interested in the health of the river. The prime consideration in selecting sites was the receptivity of hapū to the project and their capacity to be involved. As this took time and discussions to ensure we connected with the right people, only 10 of the original 53 sites were sampled in this first year.

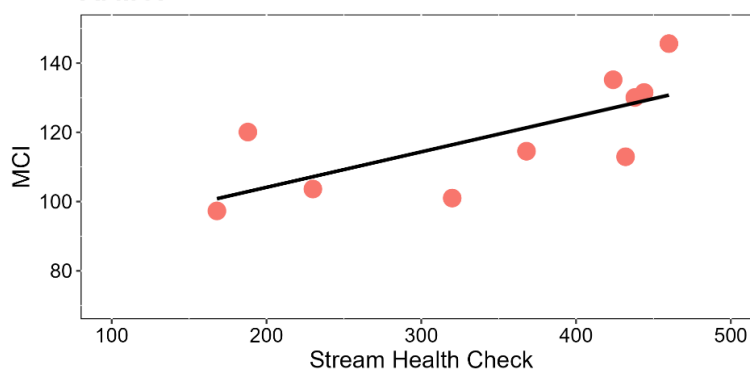
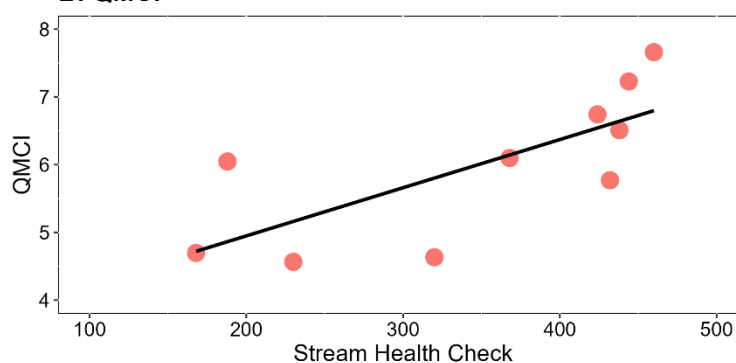
Figure 1: Stream health check scores compared with MCI and QMCI

There was a strong correlation between the MCI and the stream health check scores (Figure 1), indicating that the stream health check could be a useful, and less expensive or technical means for assessing and reporting on stream health (Death *et al*, in prep).

Seven of the sites scored over 250, indicating healthy conditions, and three sites scored between 120 and 250 indicating that these sites had potential but intermediate health (Table 1). No sites scored less than 120.

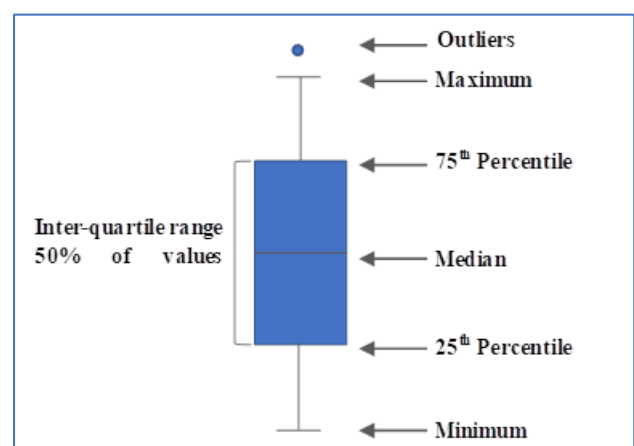
Figure 3: Box plots show the median (the middle line) and the range of data (the lines)

We followed the same methodology as in the Horrox study and collected five samples per site. This enabled us to calculate a median score per site and to graph that median along with the range to generate the following box plots. These are useful because where there is no overlap between the bars from the two surveys, then there

is a significant difference. For some sites, there was a drop in median value and the bars didn't overlap, although this didn't result in a drop in NPSFM band (e.g. the Pumice Creek site for MCI still remained in the A band even though the 2022 results were lower than the 1996/97 results).

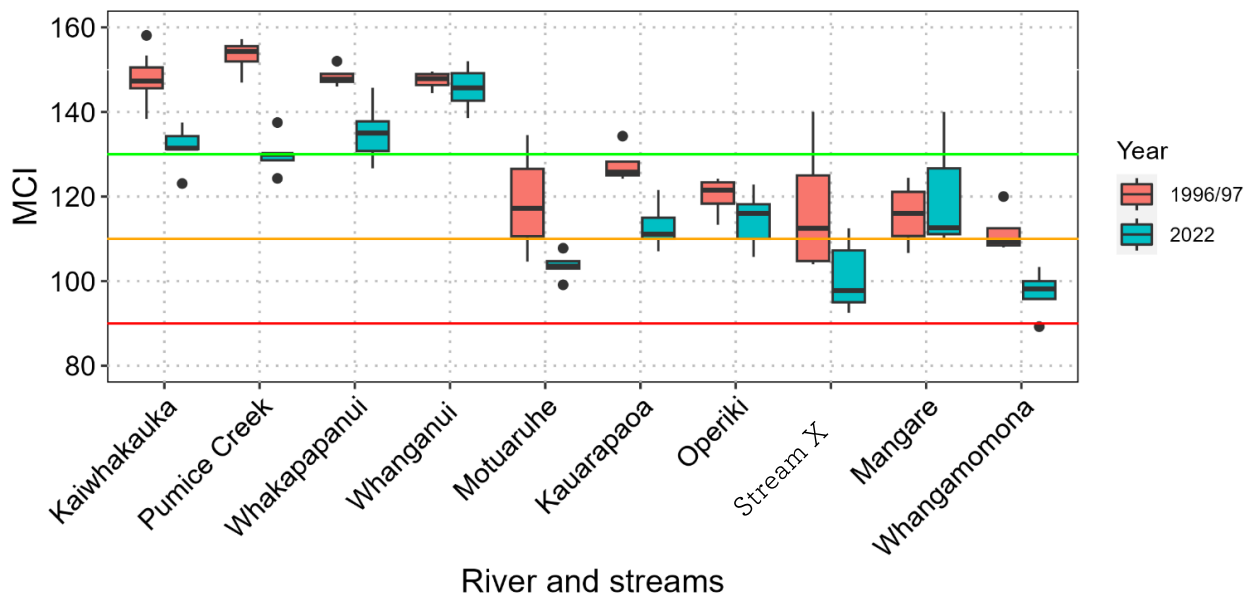
Figure 4: Change in MCI between 1996/97 and 2022. Above the green line is band A, above the orange line is band B, above the red line is band C and below the red line is D.

Figures 4-5 illustrate for each site, which sites were in the A, B, C or C band in each year for both MCI and QMCI. They illustrate whether there has been a change, and whether this has resulted in a drop in NPSFM band.

In summary, six sites demonstrated a decrease in MCI with two of those sites dropping down a band (from B to C). Five sites showed a decrease in QMCI, all large enough to result in a decrease in band – three sites dropping a band, one site dropping two bands, and one site dropping three bands (from an A to a D).

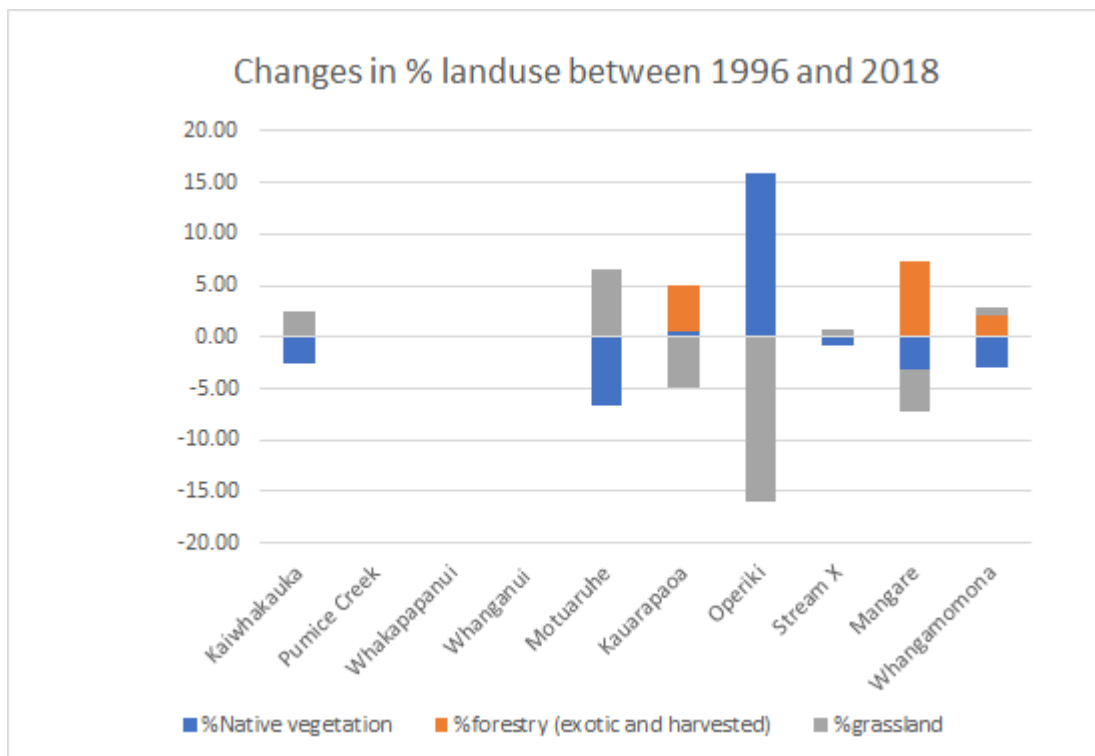
Figure 6: Changes in the proportion of each catchment between the 1996 and 2018.

The proportions of the catchments covered by the key land-uses of interest (native vegetation, forestry and grassland) were examined to see how these had changed between the landcover database in 1996 and the landcover database in 2018 (the most recent land cover database). For example, in the Operiki sub-catchment, 15% more of the catchment was in native vegetation in 2022 (using the 2018 landcover database information) than in 1996 and there was 15% less grassland (Figure 6). Four sub-catchments showed some change in land use: Motuaruhe (more grassland less native vegetation), Operiki (more native vegetation, less grassland), Kaurapaoa (more forestry, less grassland) and Mangare (more forestry and less grassland and native vegetation). This also illustrates the catchments where there has been little or no change in land use - Whakapapanui, Whanganui headwaters and Pumice Creek.

For example, Motuaruhe had more grassland and less native vegetation and showed drops in NPSFM band for both indices; Operiki had more native vegetation, less grassland yet still showed a drop in band for one index and Kaurapaoa had more forestry and less grassland and showed a drop in band for one index.

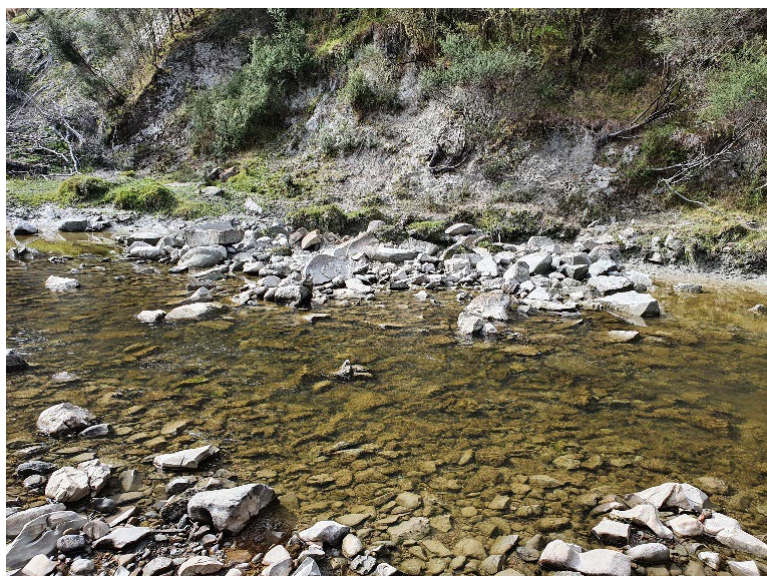
Photos and observations in the field highlighted that in some sites, particularly Whangamomona and Motuaruhe there was a considerable amount of deposited fine sediment. Large amounts of deposited sediment could be from landslides close to the river or land disturbance activities further up the catchment. These sites were characterised by low ecological health.

Sediment covered rocks at the Whangamomona site, a soft geology site

2. Recognising the likely role of deposited sediment in driving ecological change, it is recommended that future sampling should include a measure of deposited fine sediment at each site and a photo of the underwater conditions (Clapcott et al, 2011)

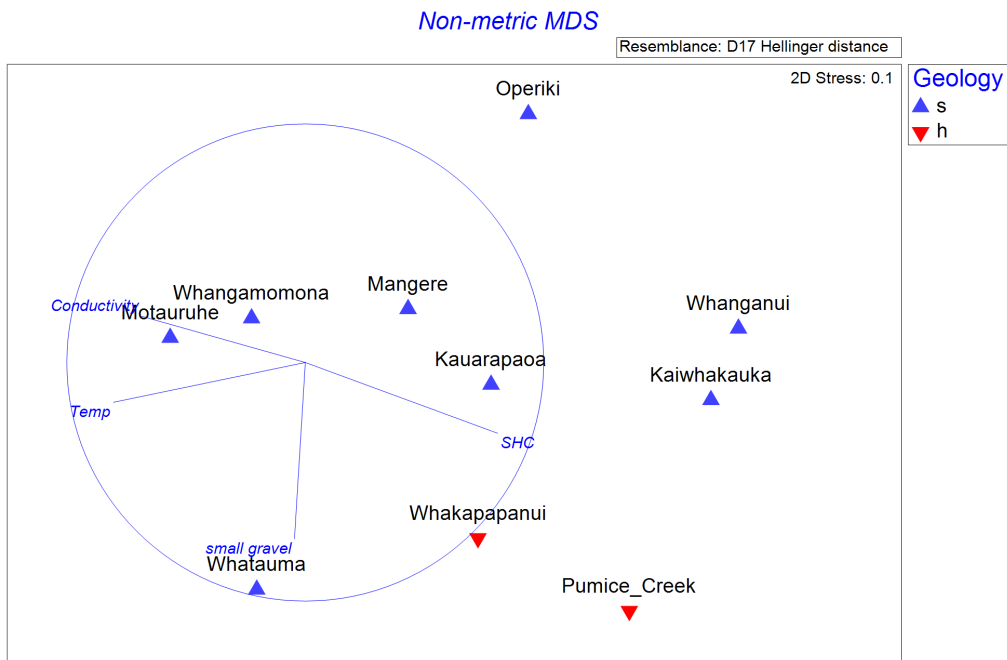
Figure 8: The invertebrate community data from the 2022 survey showing correlations between sites and water quality. Blue symbols are from hard substrate streams and red from mudstone streams.

In Figure 8, the sites to the left of axis one (Whangamomona, Motuaruhe and Whataumu) are identified as having high conductivity and temperature whereas sites to the right (Whanganui, Kaiwhakauka and Pumice Creek) have low conductivity, low temperature and high Stream Health Check scores. This seems to broadly correspond to sites with healthy ecological conditions on the right and more impaired conditions on the left.

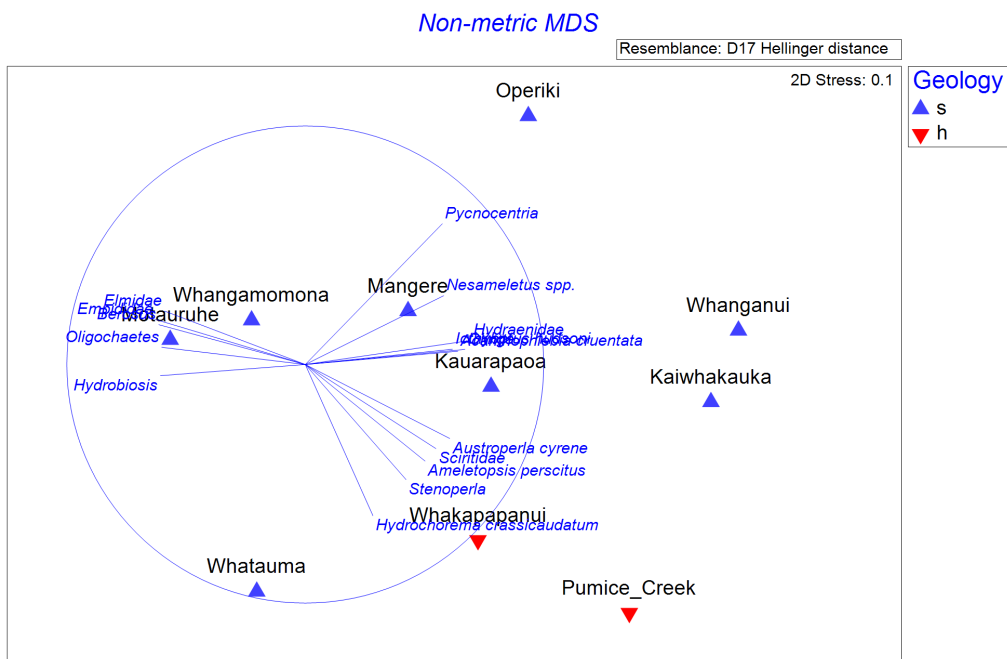
Figure 9: The invertebrate community data from the 2022 survey showing correlations between sites and individual taxa. Blue symbols are from hard substrate streams and red from mudstone streams.

We can also look at what particular taxa are associated with the patterns in the same way. Sites to the left of axis one of Figure 9 are characterised by *Elmidae*, *Berosus* (both beetle larvae), and *Oligochaetes* (worms) which often prefer habitats with high levels of fine sediment and/or lower water quality. Operiki in the top right probably had good water quality but reasonable levels of periphyton as the caddisfly *Pycnocentria* feed on algae in moderately good water quality sites (and was aligned with the top of axis 2). The stoneflies (*Stenoperla*, *Austroperla*), mayfly *Ameletopsis*, beetle *Scritidae* and caddis *Hydrochorema* all like high water quality forested streams and were aligned more to the right of axis 1.
