ASSESSMENT OF WETLANDS AT  
THE REMARKABLES SKI AREA,  
QUEENSTOWN

Report No. 2662

# SUGAR BOWL LIFT REPLACEMENT NATURAL HAZARDS ASSESSMENT

July 2018

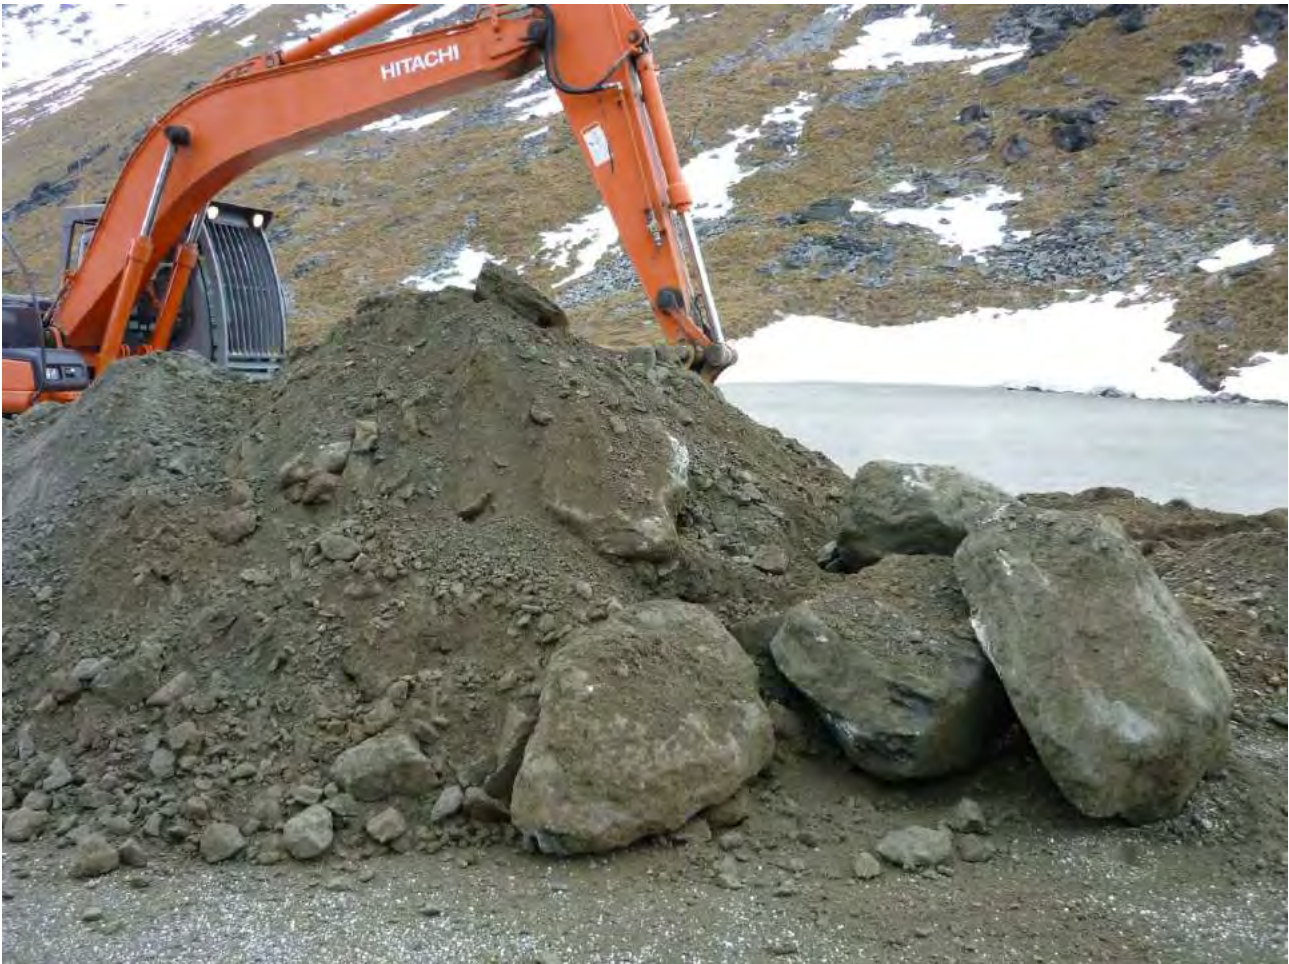
Figure 5-1: test pit excavation at the base building site in undisturbed dense glacial till

Areas of overlying colluvium consist of dense chaotic debris with numerous large boulders, many of these in excess of 1m maximum dimension. Very large erratic blocks may be present within this material. Test pit excavation for the base building, undertaken during 2013 in undisturbed natural ground, is shown in the figure below;

Our recommendations for foundations for both the base building and the Curvey Basin chair lift in both till and colluvium was that the material had an allowable bearing capacity of at least 300 kPa and an ultimate bearing capacity of 900 kPa. These are inferred values and the capacity of the foundation is likely to be governed by crushing of the aggregate rather than densification of the material. The actual confined capacity of the foundation platform before crushing occurs is likely to be greater than 900 kPa.

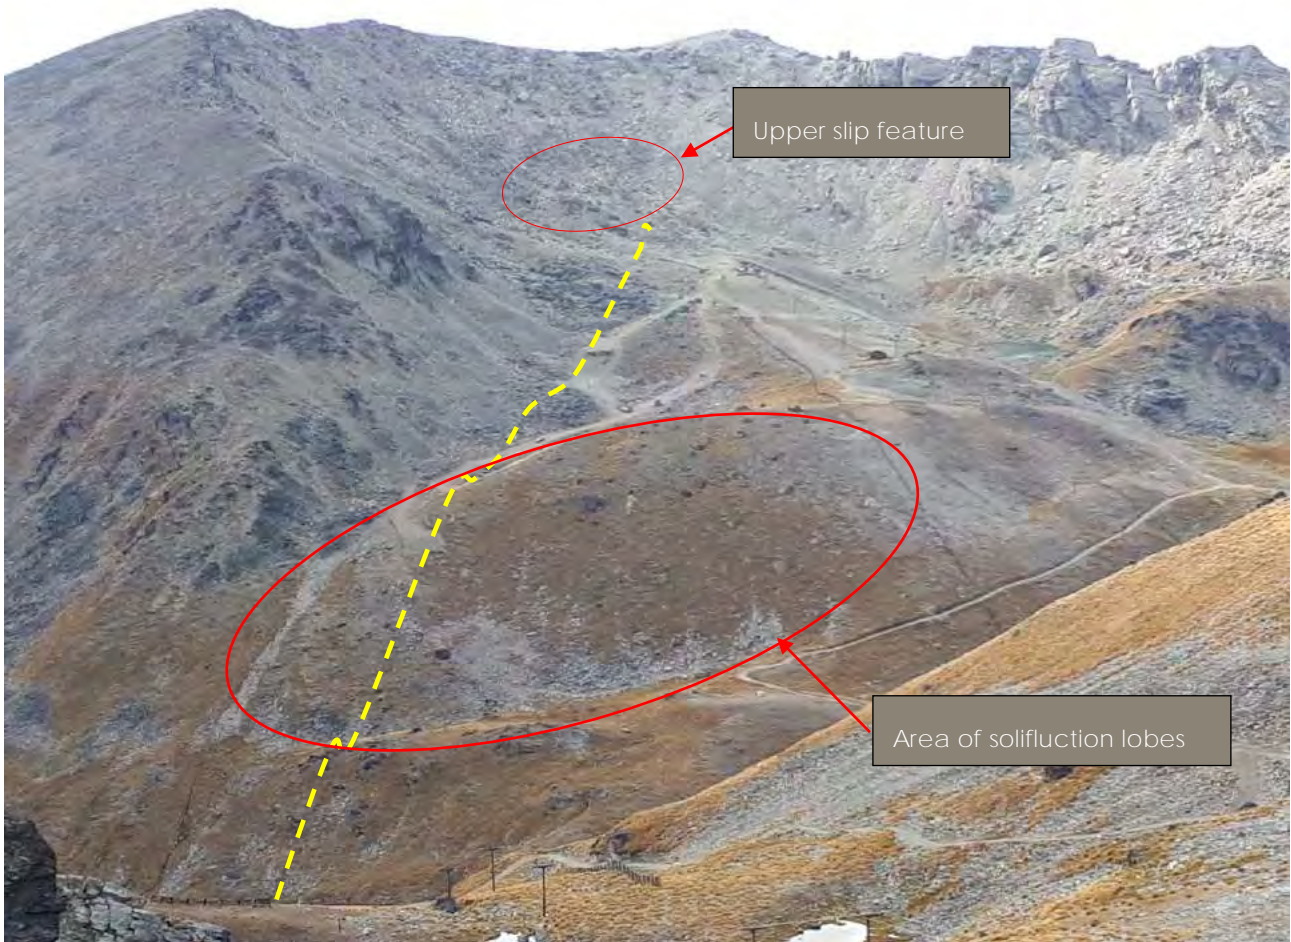
Figure 5-2: the proposed lift line marked with the area of slip marked in the circle

Because of the smooth landforms in the lower half of the structure any deep-seated instability and resulting movement would be expected to be evident. No such signs if circular slip movement are visible.

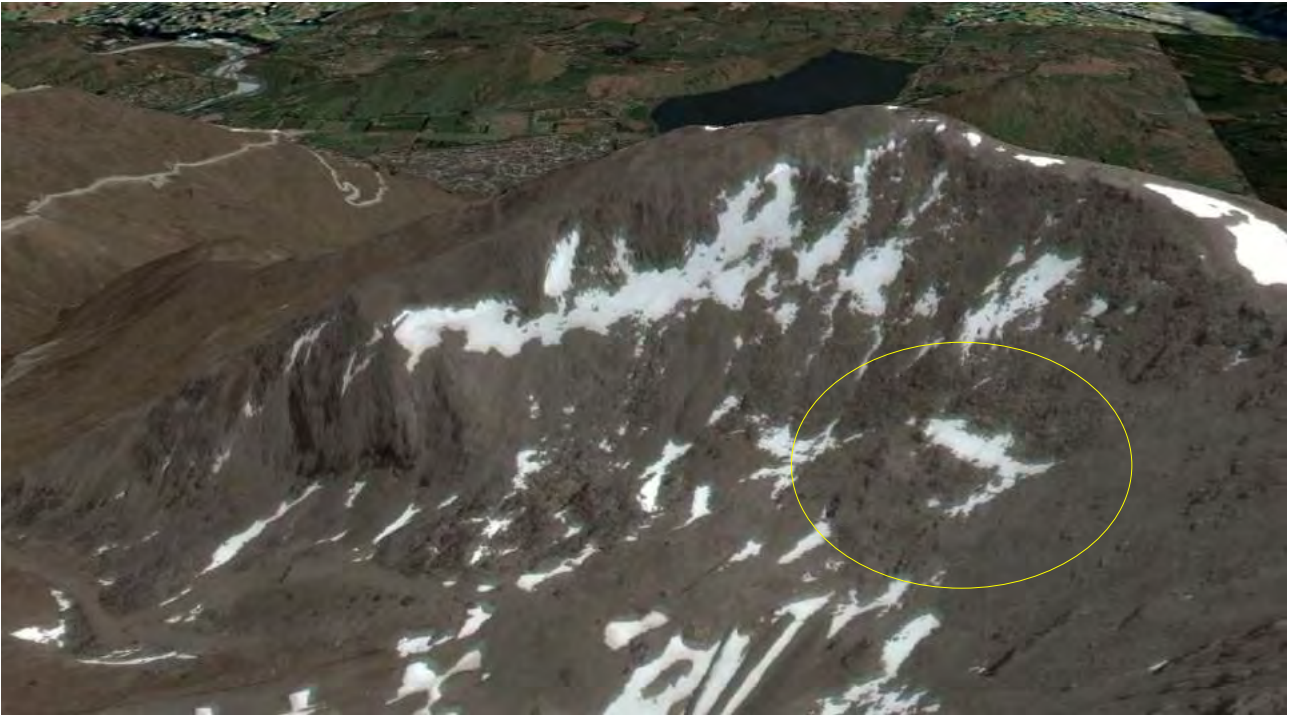
Figure 5-3: Google Earth view showing the slip above the top of the lift

Circular slip failures such as this are not generally associated with rapid or catastrophic failure. The movement of such features is often episodic in response to rainfall.

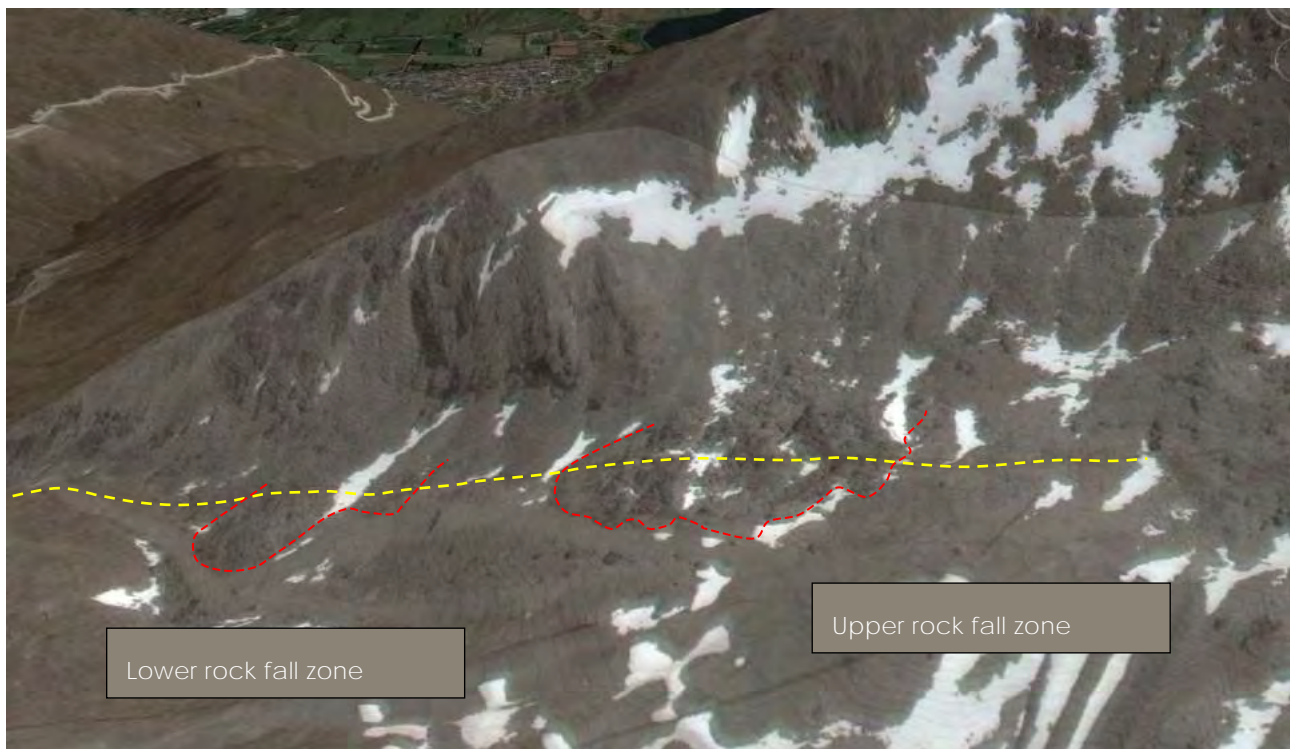
Figure 6-1: Lift Line and rock fall debris fans

The rock fall zones are shown in figure below:

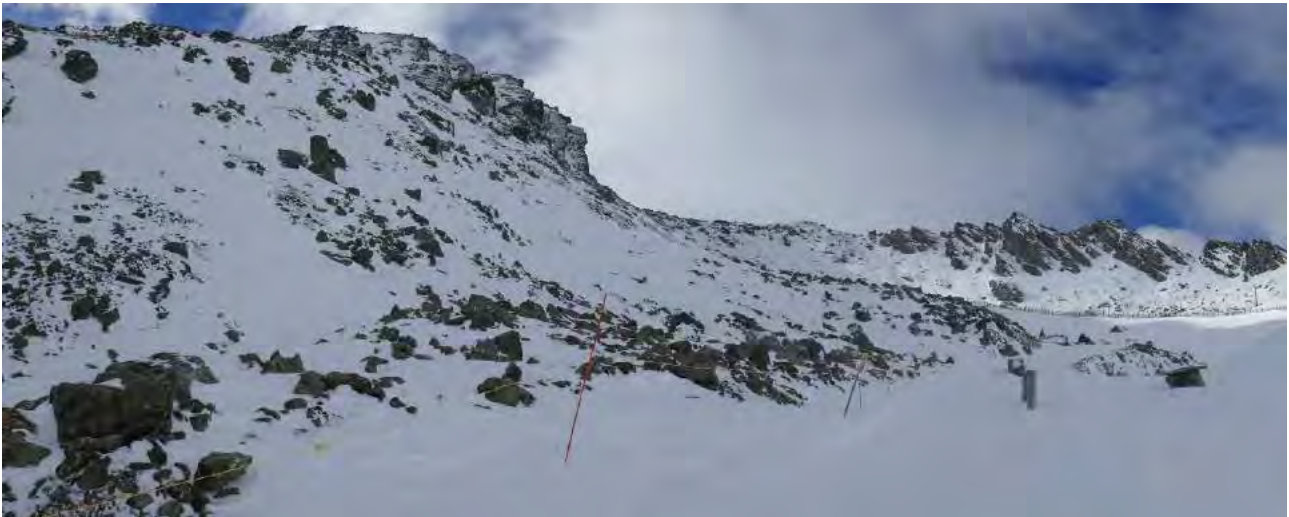
Figure 6-3: panoramic view of lower rock fall debris cone in the Little Witch and Snake Gully area

The lift crosses over rock fall debris in an area known as Little Witch and snake gully. This debris has originated from the bluffs above. This is shown in figure 6-2 below;

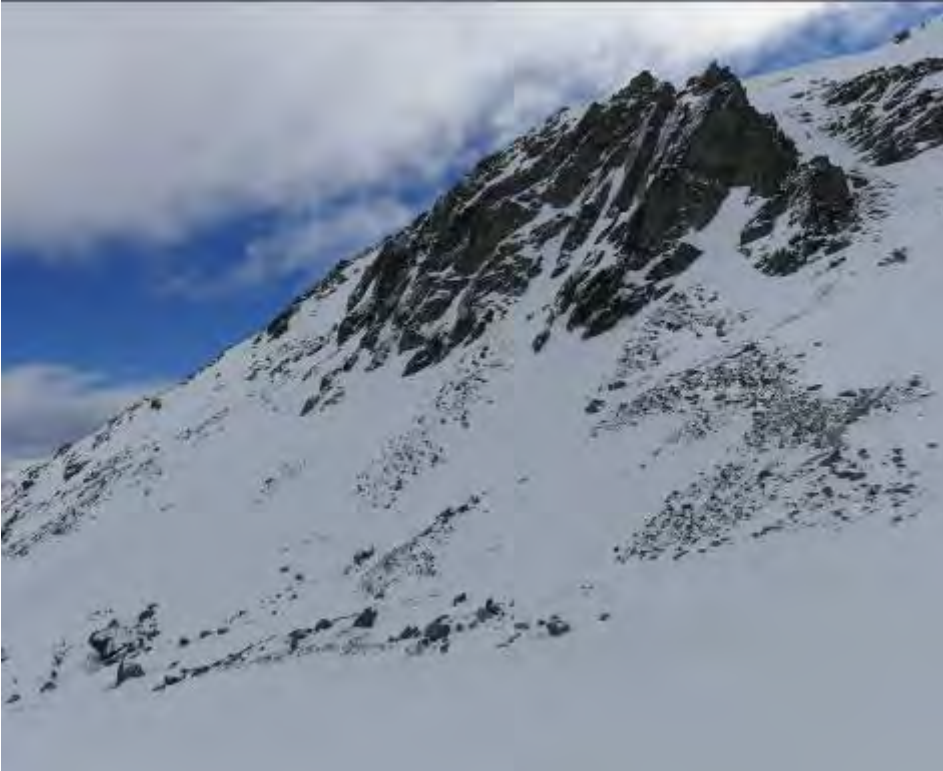
Figure 6-4: the feature where the little witch debris fan originated, adverse joint sets can be seen dipping to the west

Figure 6-3 shows a number of adverse joint sets which dip towards the west and the lift location. No specific significant hung blocks were detected during the inspection, but a rock fall risk remains. Rock fall in this area may be both seasonal and event related. Seismic events, heavy rainfall and seasonal freeze thaw action are likely to be the primary triggers of rock fall in this location.

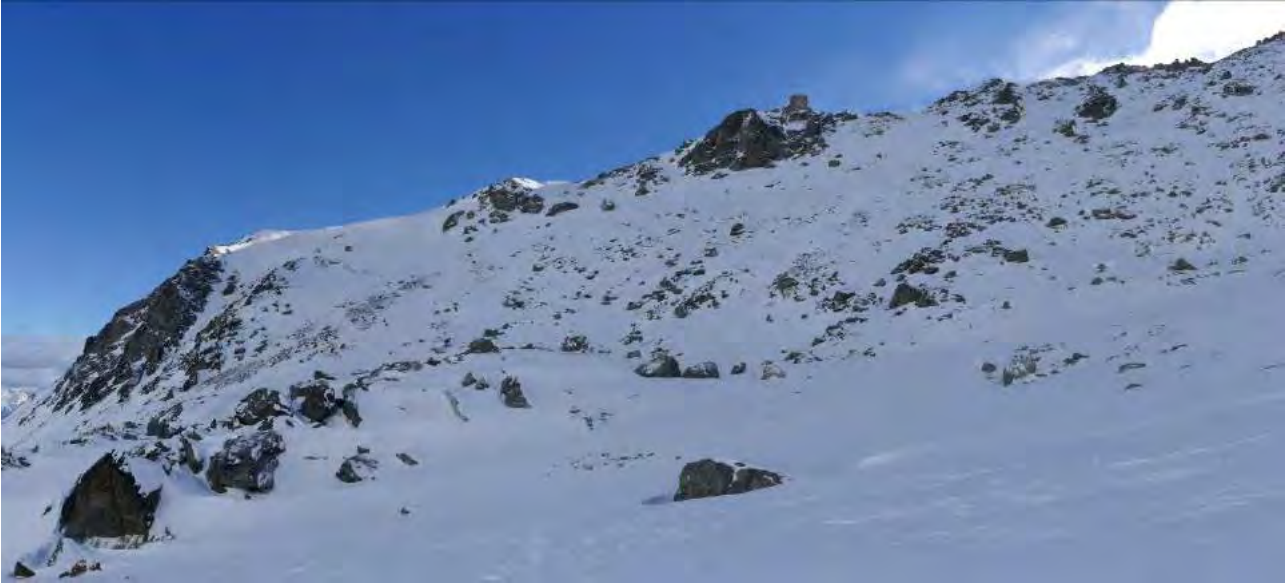
Figure 6-5: the upper rock fall area. The debris fan on the left and the margins of the rock fall are visible on the slope above

The upper rock fall fan is a significant feature. This was clearly a high energy event involving the collapse of a significant quantity of material from the ridgeline. This is evident in the two figures below;

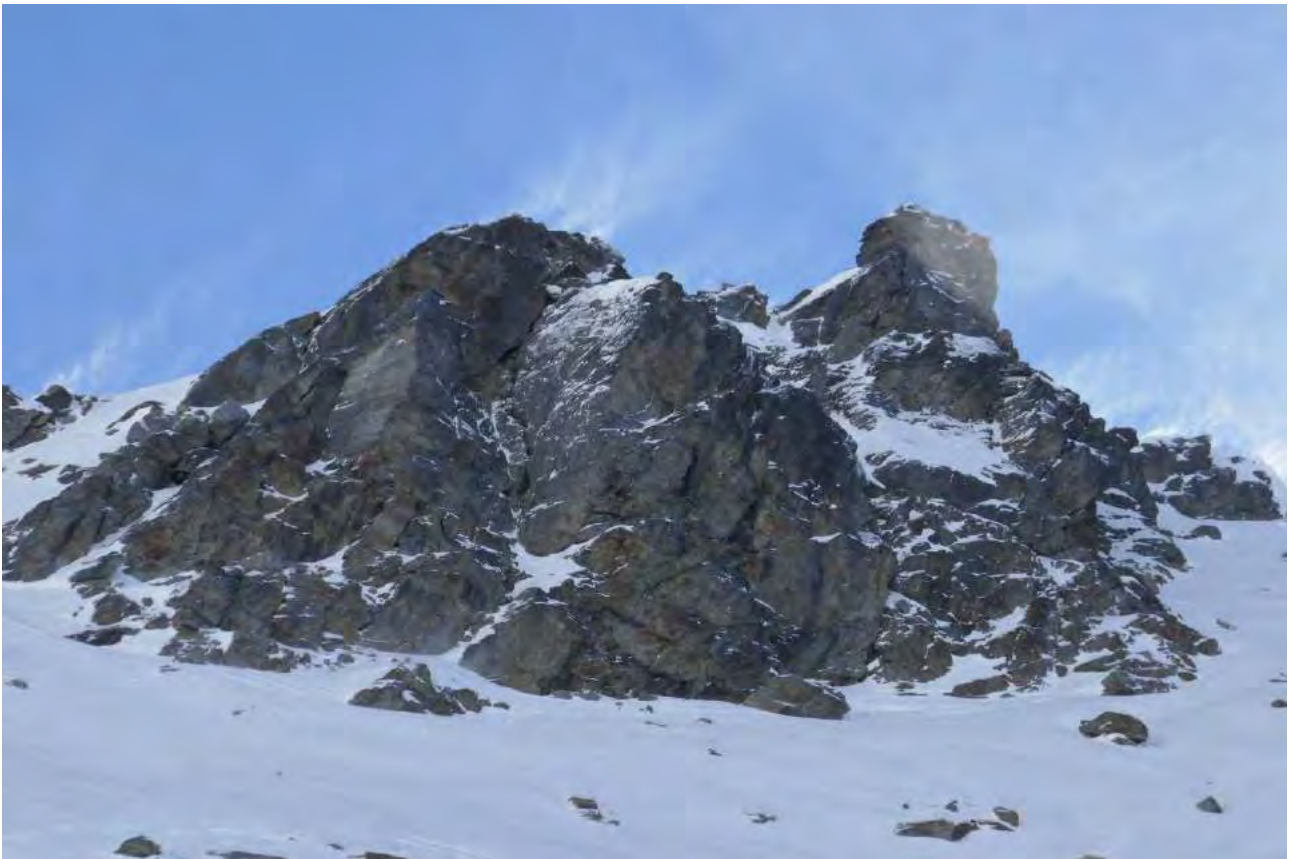
Figure 6-7: Remaining feature above the top rock fall debris fan

There remains a jagged feature on the ridgeline, which did not collapse with the earlier rock fall. This feature includes steep rock towers and this feature has not yet eroded to a stable condition. This feature is shown in the figure below;

Rock fall from this feature is likely to be precipitated by either a sufficiently large earthquake, heavy rainfall or seasonal freeze thaw action. This feature is sufficiently far from the debris run out zone that the debris may spread out in a wide area and thus it is not practical to move the towers sufficiently to defensibly reduce the risk. The fall from the feature is sufficiently high that rocks falling from this location may be travelling fast enough to cause damage to the towers.

- The upper rock fall debris fan covers a significant area. A potentially unstable rock tower remains in the source area. The return period of rock fall from this area appears to be in the order of hundreds of years and its return period is consistent with the design return period for other natural phenomena such as wind and earthquake loading given in the loadings standard NZS 1170.0. The most likely conditions for rock fall are earthquake, seasonal freeze/thaw or heavy rainfall. . This is a risk that will need to be understood and accepted with the proposed alignment

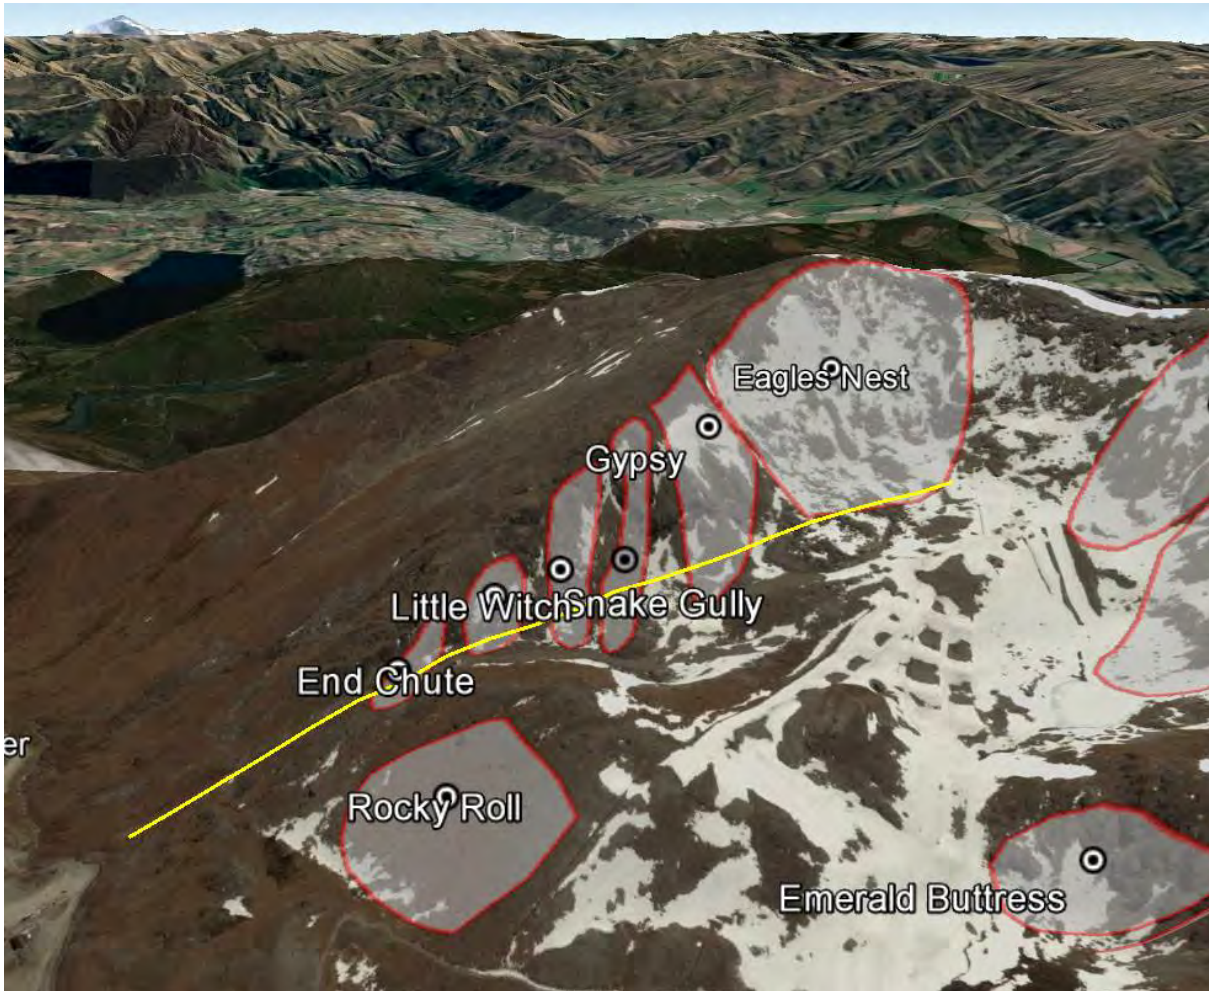
Figure 7-1: mapped avalanche paths and the lift route

The lift crosses a number of understood, named and managed avalanche paths. These paths are shown in the figure below:

The Remarkables maintain a robust avalanche control programme. We have discussed the avalanche control measures specifically relating to the new lift with the head of the Remarkables ski patrol. The avalanche control measures in place include the following:
