CLIFTON BEACH LANDSLIDE HAZARD ASSESSMENT

PREPARED FOR HASTINGS DISTRICT COUNCIL AND DEPARTMENT OF CONSERVATION

April 2020

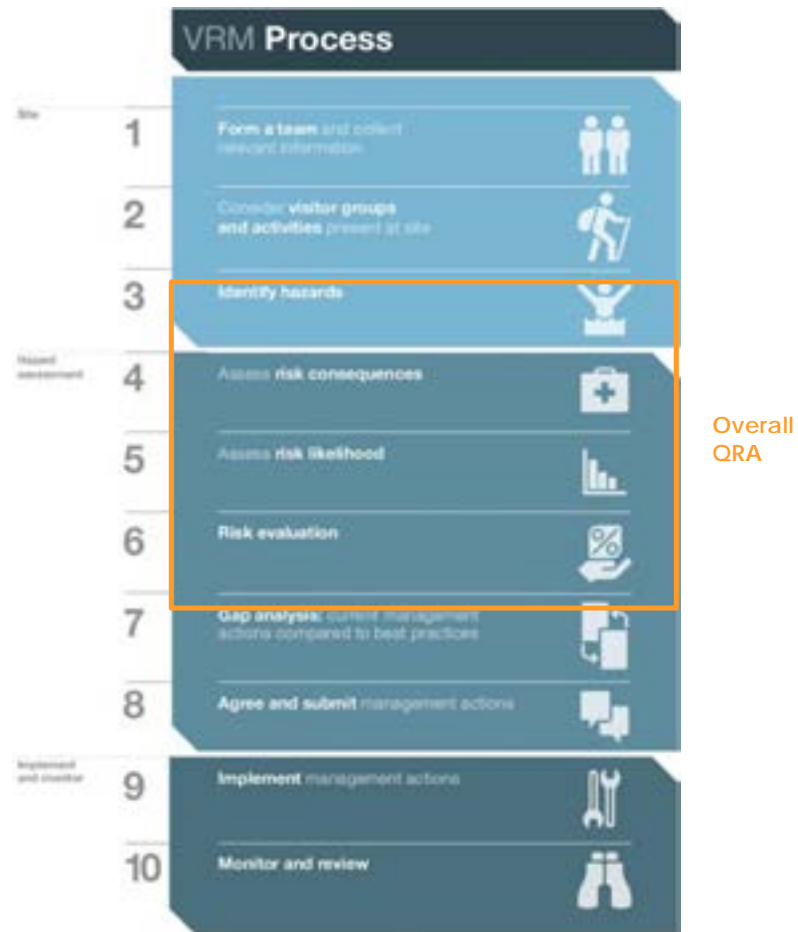
Figure 2-3: DOC framework for risk management

The QRA methodology is also judged consistent with the DOC framework for visitor risk management (VRM) on public conservation land, which is documented in SOP DOC-2852133 (Figure 2-3).

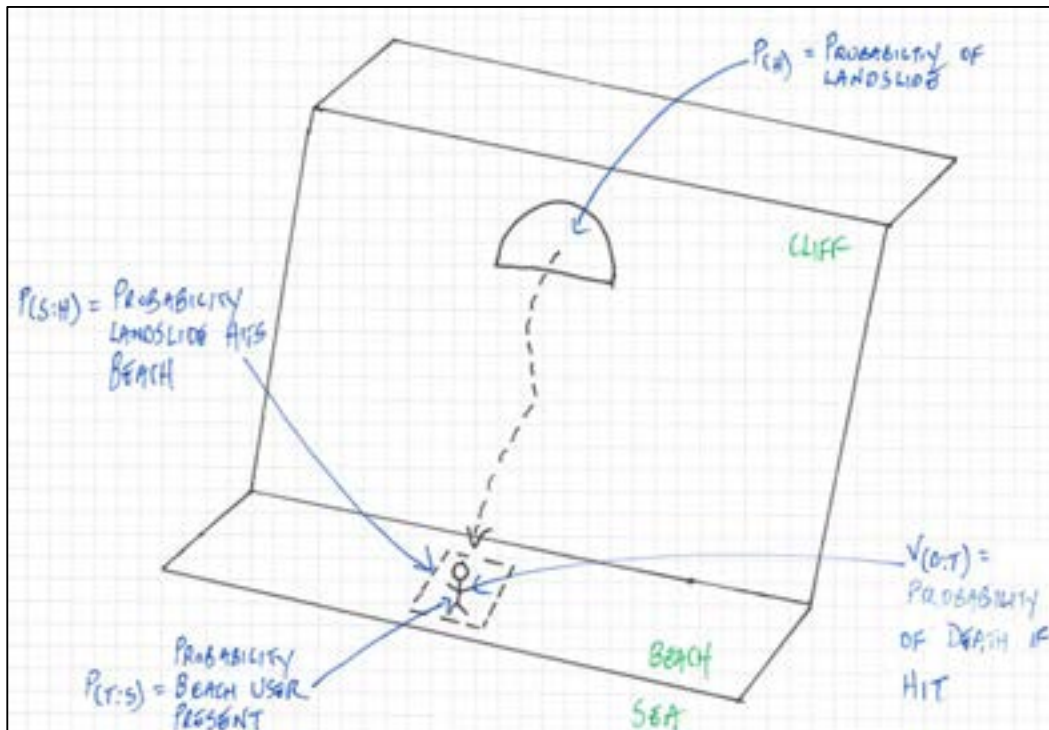
Figure 2-4: Graphical summary of risk calculation being used by the overall QRA

Each parameter in the risk calculation is assigned a value of between 0 and 1, a probability of 0 being impossible and 1 being certain. A value of 0.5 represents a neutral or an 'even chance'.

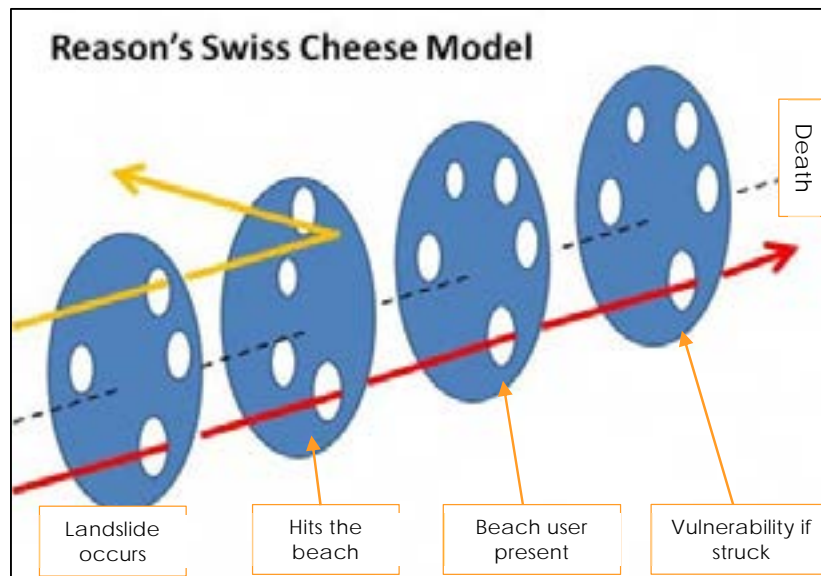
Figure 2-5: Reason's swiss cheese model for accident causation

As each step or parameter is not certain, each has a probability assigned to it. As you move through each of the steps, the cumulative probability reduces.

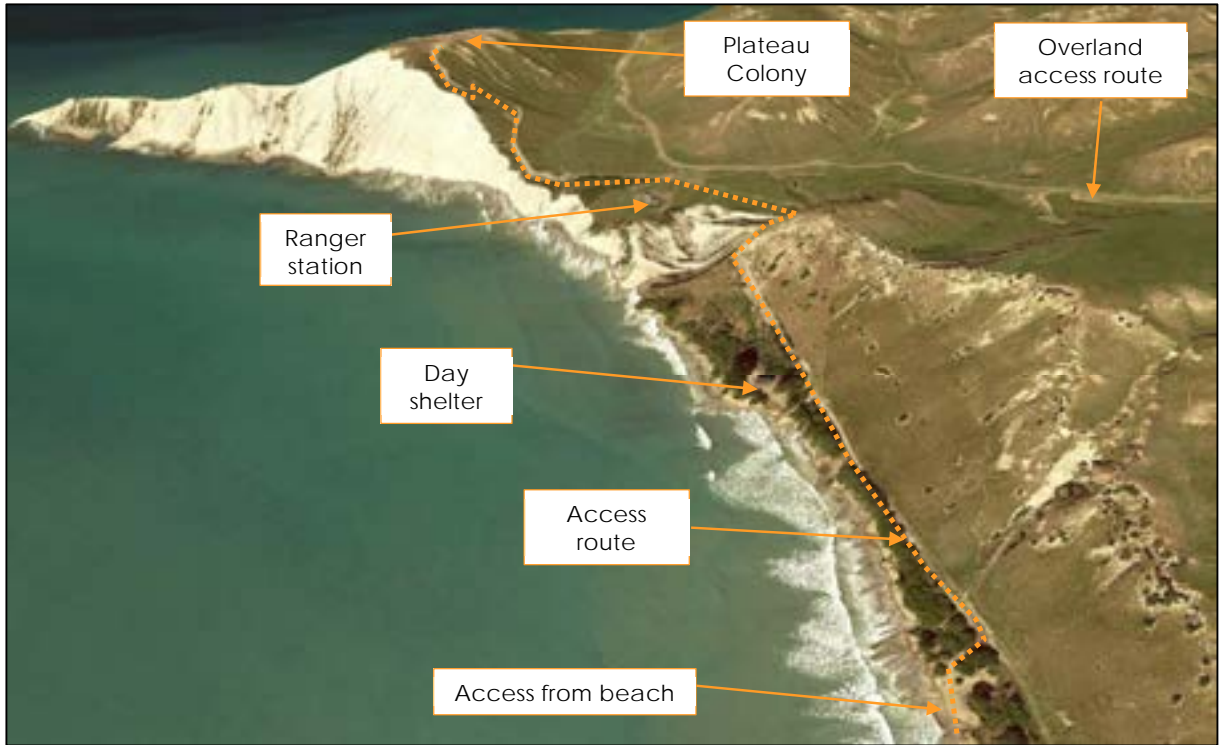
Figure 3-2: Oblique view of Cape Kidnappers looking SE

The location of the site is shown in Figure 3-1, together with key locations referenced in this report. Figure 3-2 shows the area around Cape Kidnappers in greater detail.

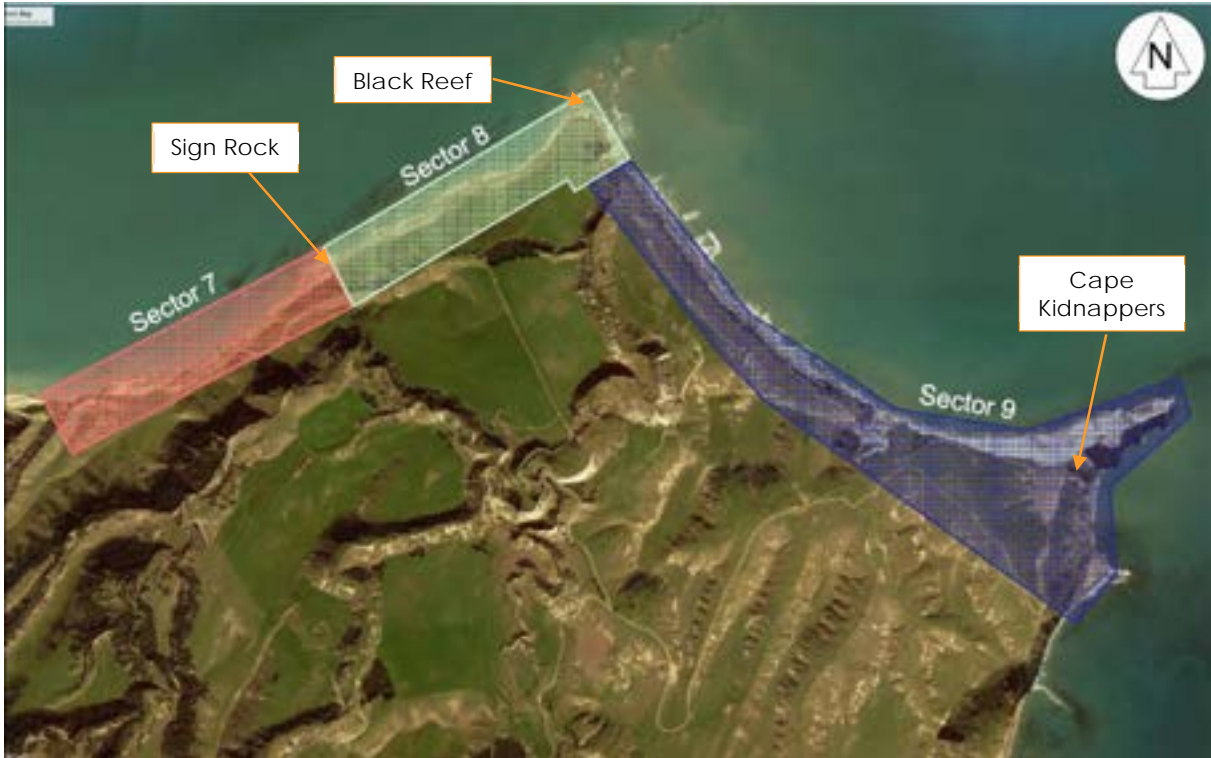
Figure 3-4: Surveying Sectors 7 to 9 locations

For the purposes of surveying during the hazard assessment, we have divided the beach into nine 'sectors'. These sectors were developed solely to aid the systematic survey of the beach. They do not represent sectors of varying hazards or risks. The location of the surveying sectors is shown in Figure 3-3 and Figure 3-4.

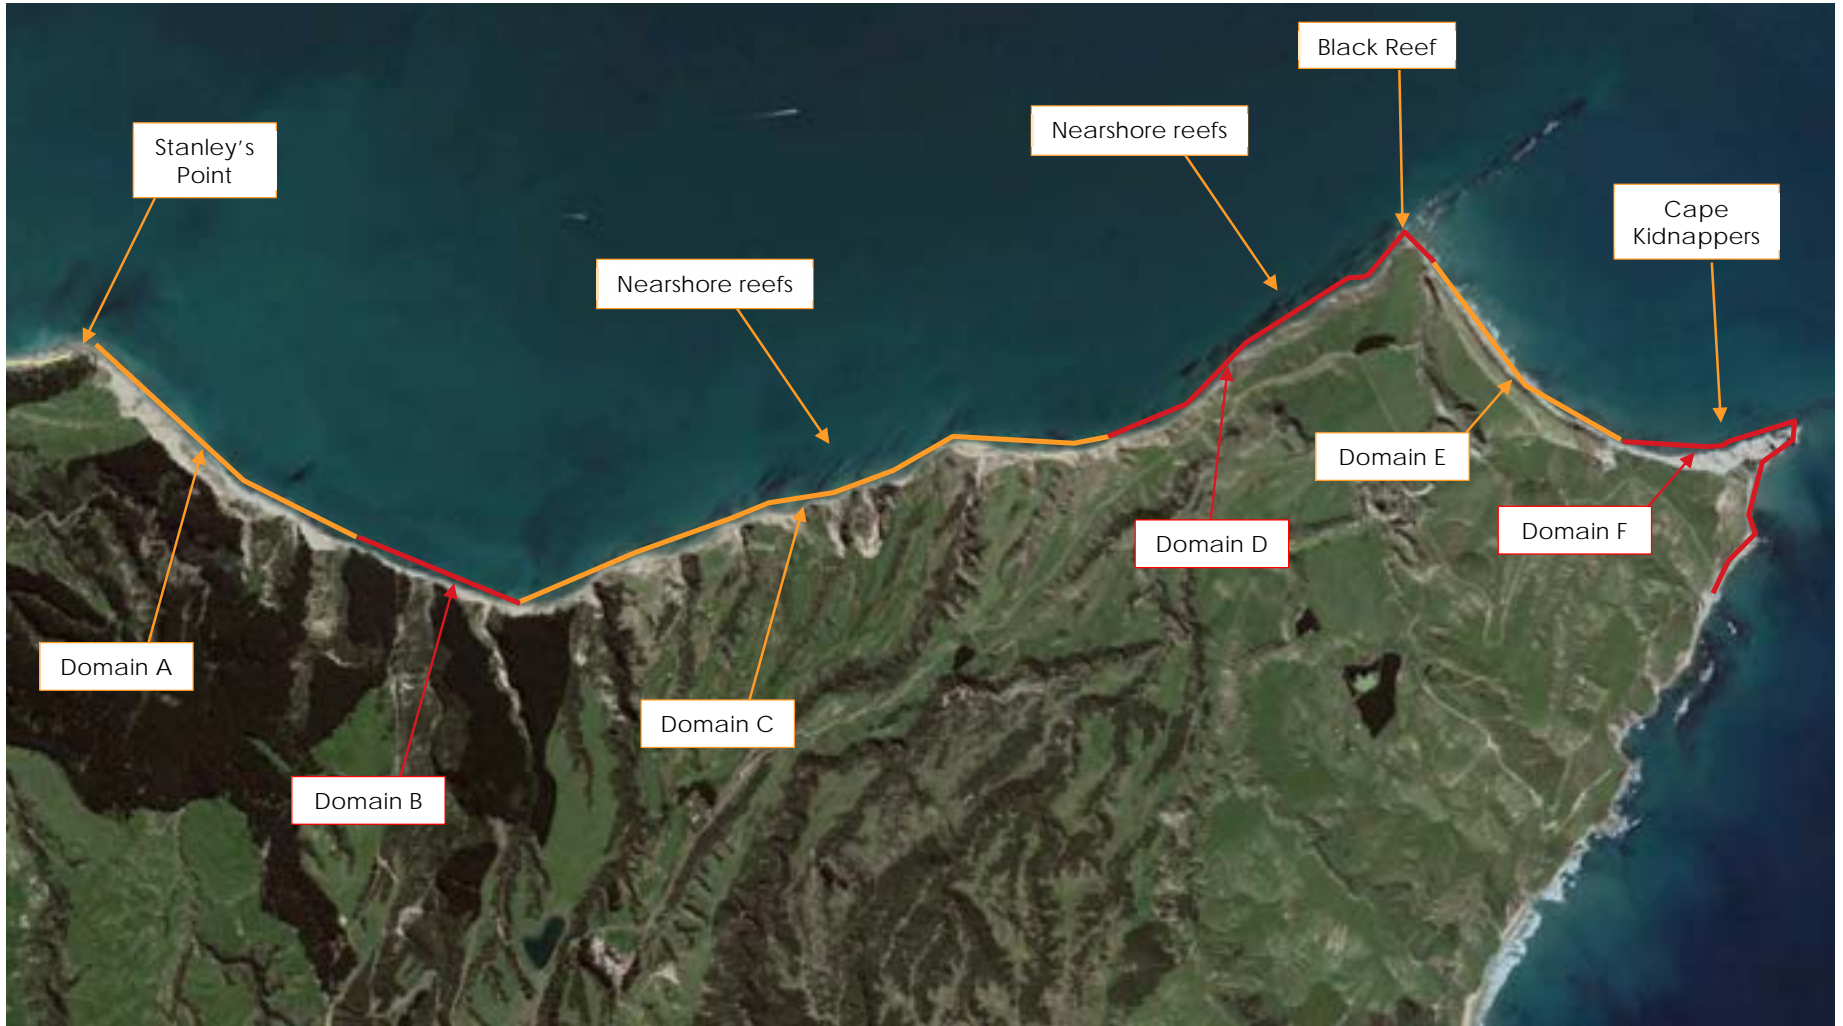
Figure 3-11: Physiographic 'domains' of the site

As the site comprises 9.5 km of coastline, the physiographic characteristics vary throughout the site. Understanding these changes is important for the hazard assessment. For this report, we have divided the site into several 'domains' of similar physiographic characteristics, as shown in Figure 3-11.

- The cliffs are typically high and largely continuous throughout the site, providing large potential source areas for landsliding.
- As the cliffs are typically very steep and the beach access is at the toe of the cliff, there is a limited travel distance for landsliding.
- The reefs are important for understanding the rate of erosion (and therefore landsliding). Sections of the cliffs which are free from vegetation and show evidence for historical landsliding, commonly have no nearshore reefs. The opposite of this also appears true.
- Sections of the cliffs where there is a distinct backshore or beach are not exposed to costal erosion as much as those where there is no backshore or beach.
- Swells from the N or NE are likely those most important for coastal erosion.

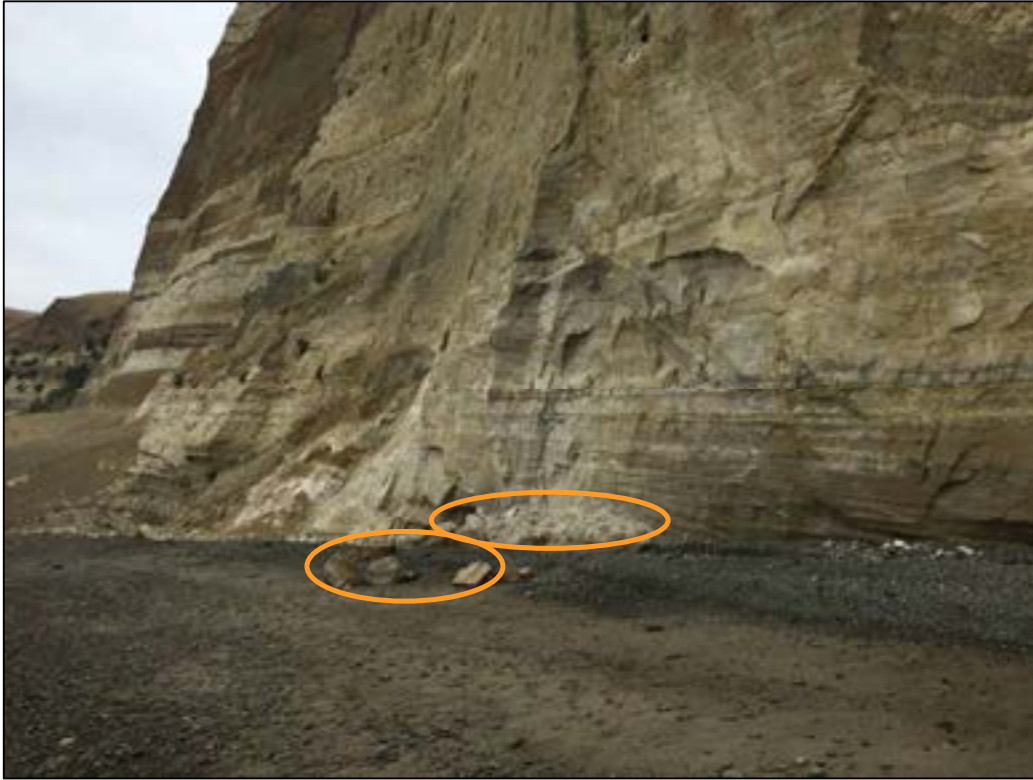
Figure 4-6: Sector 6 - example of rockfall deposits on the beach, west of the CKL

An example of a small and a moderate-sized rockfall is provided in Figure 4-6. A small rockfall spatially impacted the middle of the beach and this originated from high on the cliff. Behind this, a moderate-sized rockfall can be seen immediately against the base of the cliff, with the source area readily apparent above it.

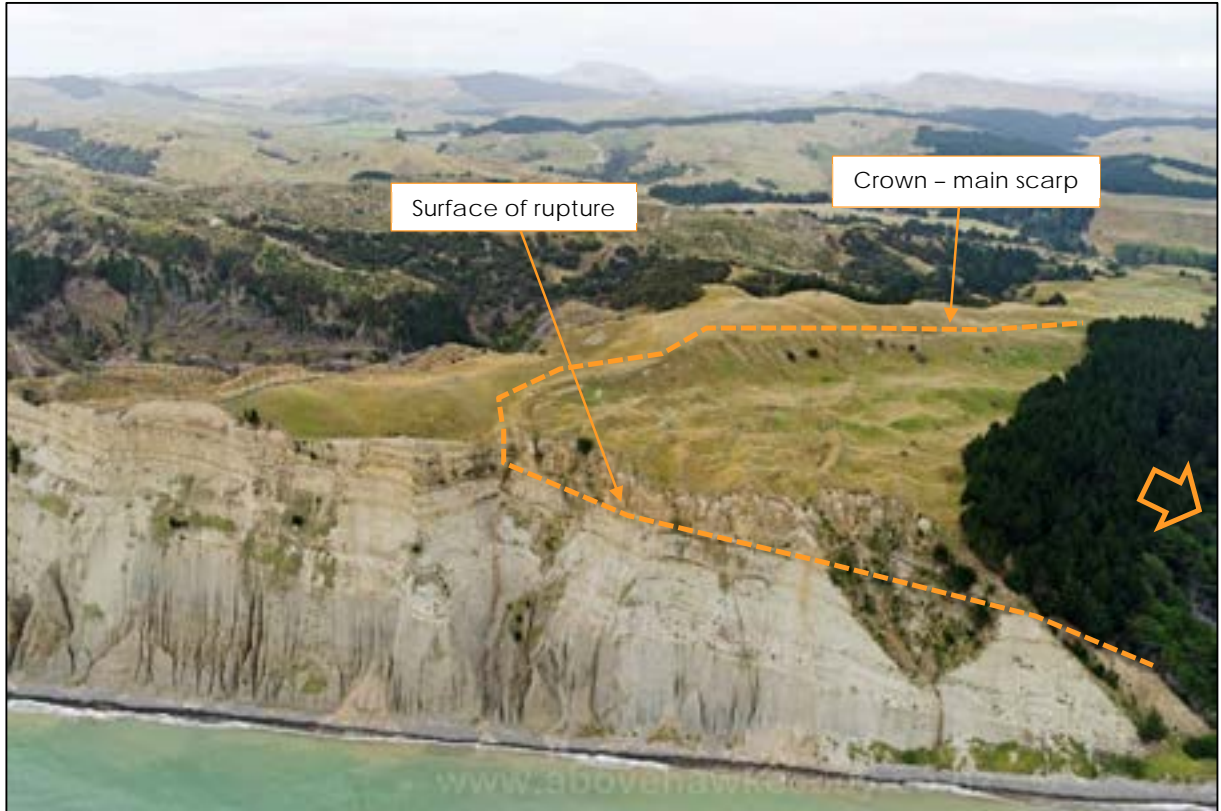
Figure 4-9: Sector 1 - A large deep-seated landslide, where the surface of rupture appears to be along bedding

The second most prevalent landslide failure mechanism along Clifton Beach appears to be 'slides'. A good example is the Clifton Motor Camp Landslide, located at Stanley's Point (Figure 4-9). This comprises a translational rockslide, with the surface of rupture occurring on bedding (i.e. a dipslope landslide). The landslide appears to have an area of around 0.3 km², with a failure surface around 20 m below ground level. It has a volume of around 7 MCM. The landslide is likely many thousands or tens of thousands of years old and extremely slowly moving. It is of limited importance for the hazard assessment for this reason.

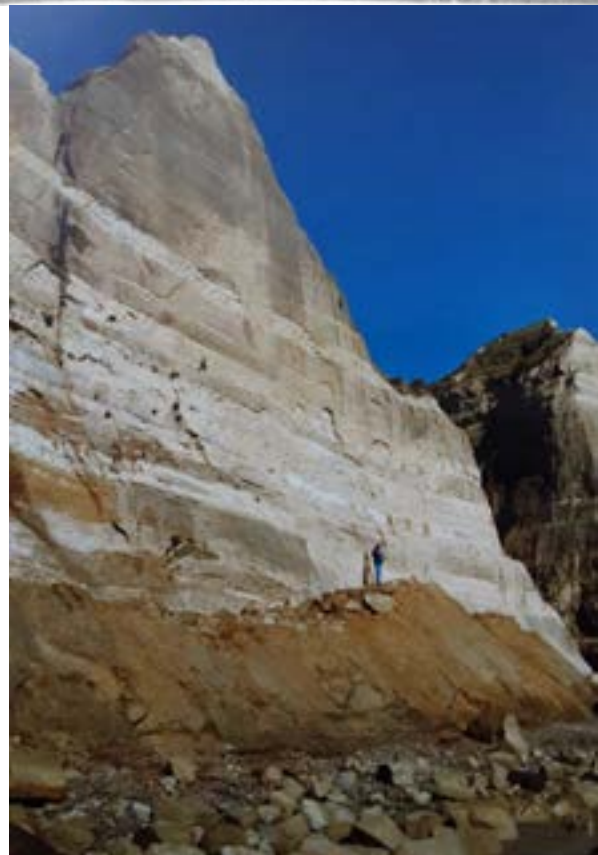
Figure 5-1: Newspaper articles from 5 March 1988 landslide

Excluding the January 2019 CKL and subsequent landsliding, two previous landslides are reported in the press where people were injured. These articles are presented in Figure 5-1 and

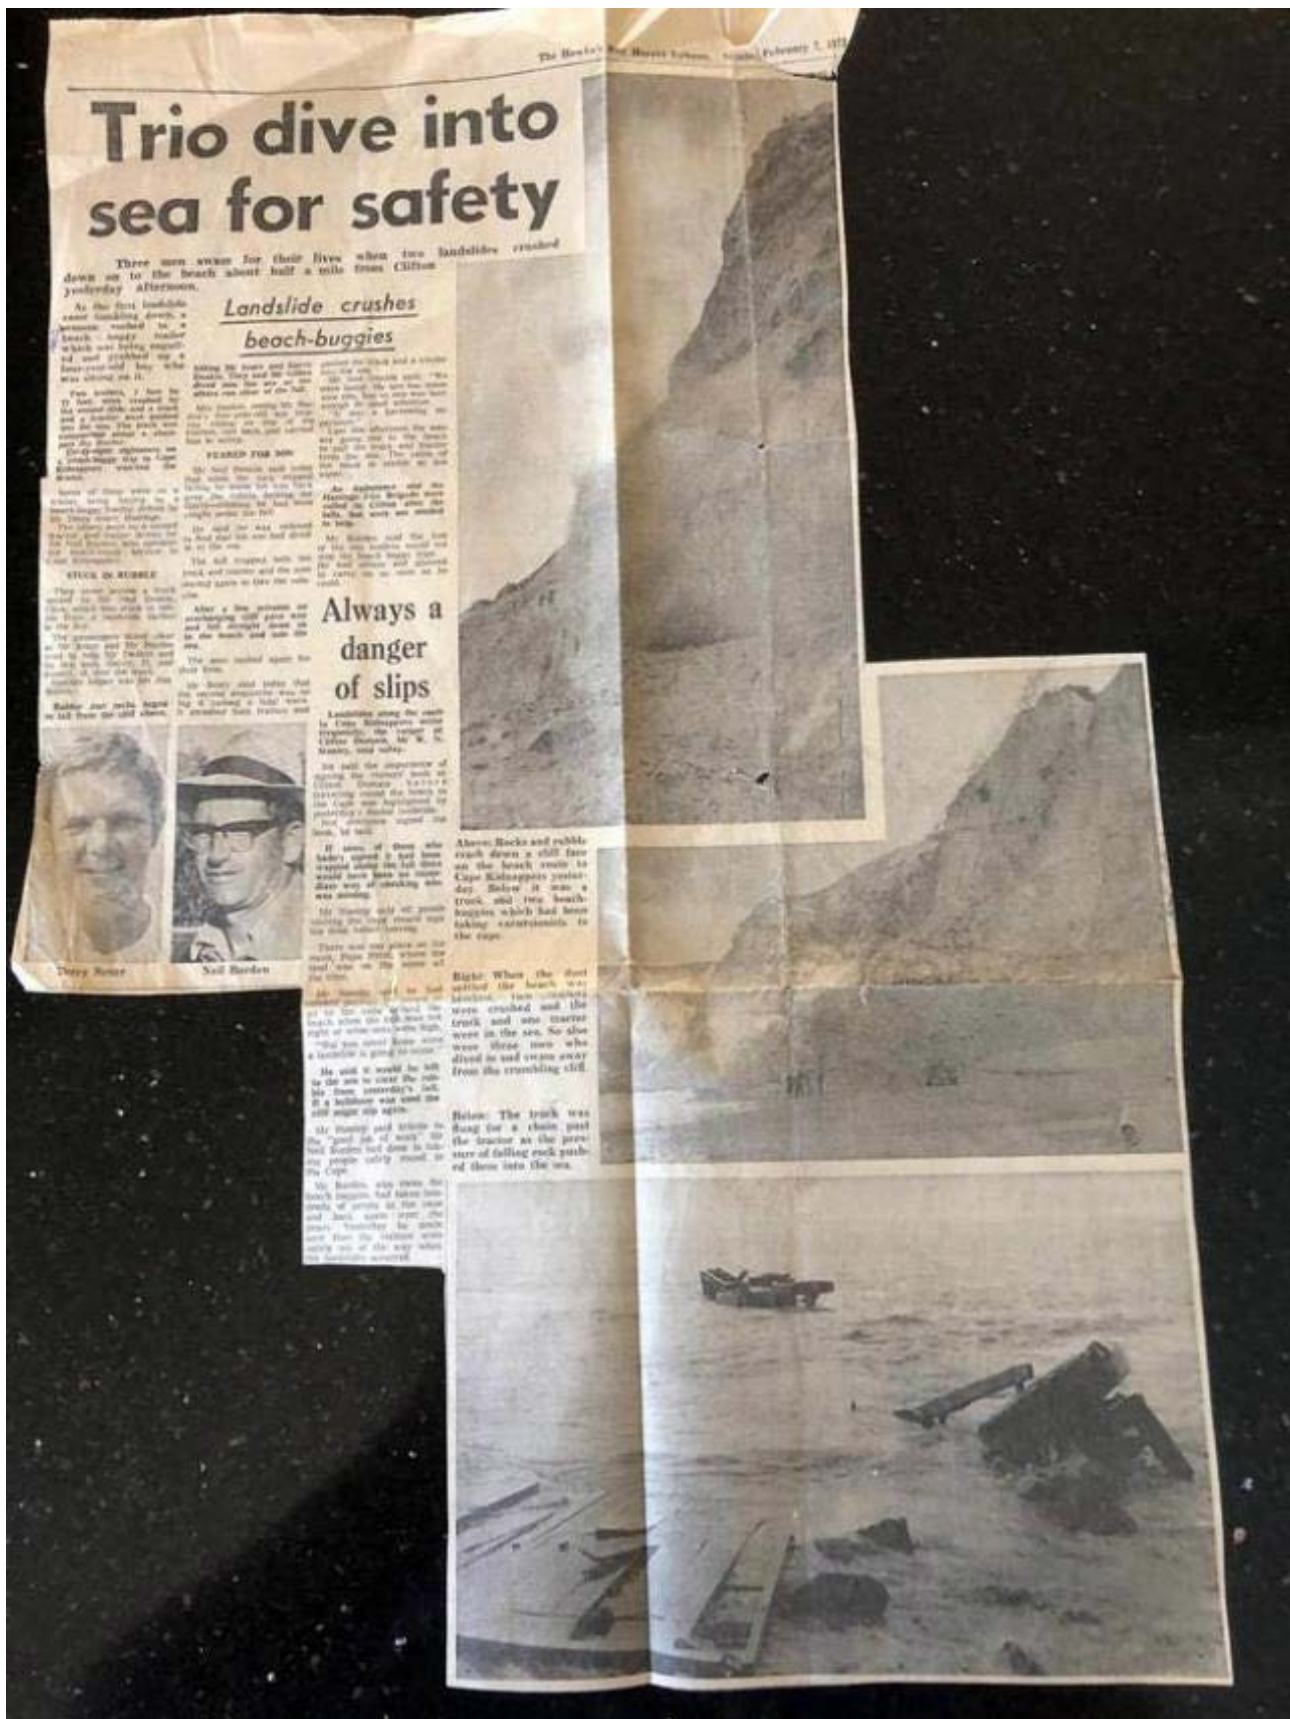
Figure 5-2: Newspaper article from 1 February 1973 landslide

Figure 5-2. These two landslides can be summarised as:

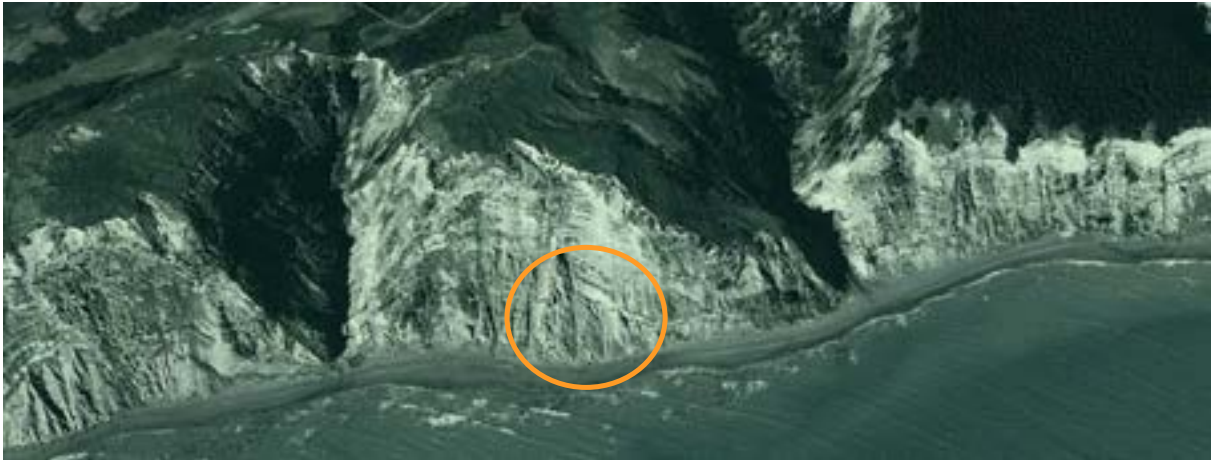
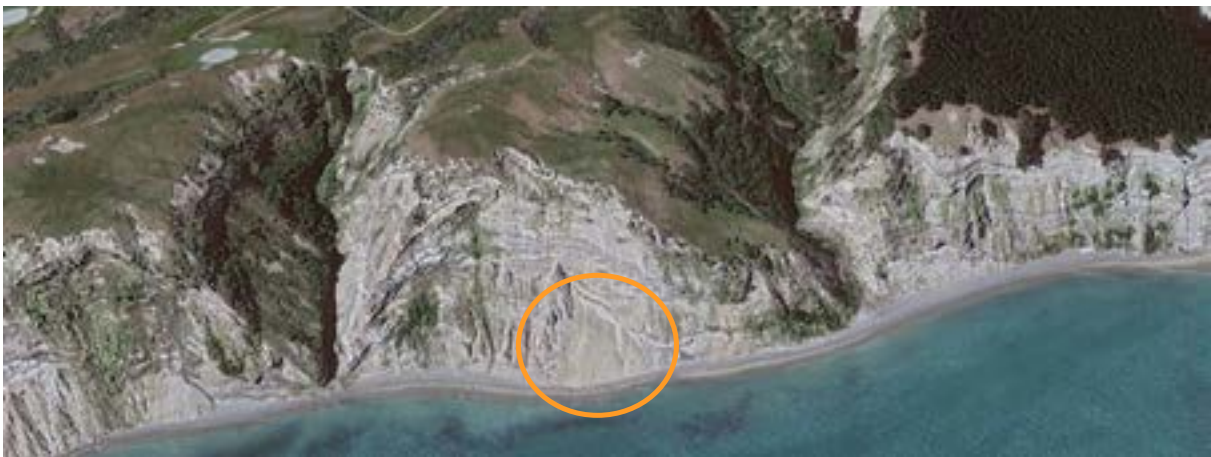
Figure 5-3: Sector 4 - example of a very large rock avalanche identified from historic imagery, Sept 2012 (top) and Nov 2012 (bottom)

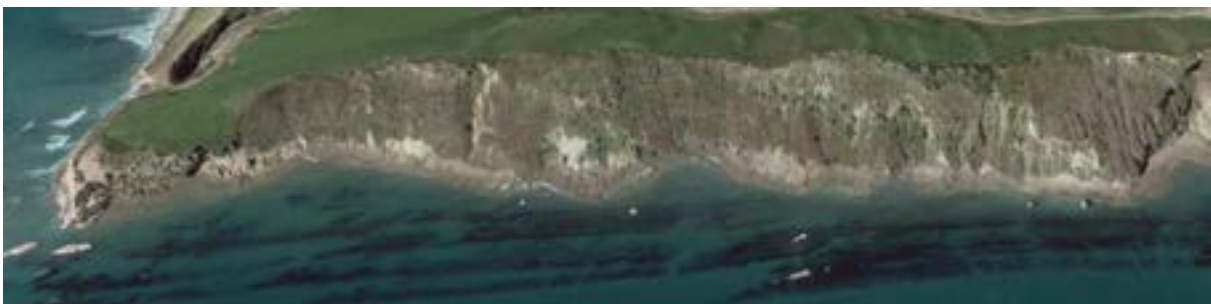
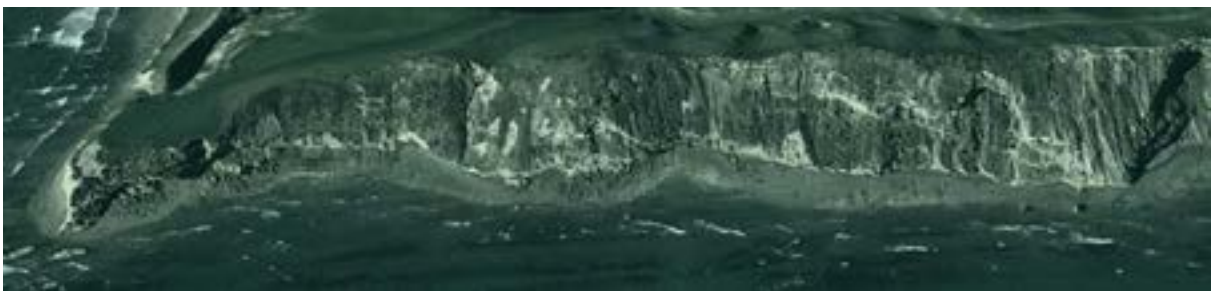
Figure 5-4: Sector 8 - Imagery from 2009 (above) and 2012 (bottom) - shallow landsliding between Jack's Camp and Black Reef due to the 2011 rainfall event

- Around 30 large to very large landslides appear to have occurred since 2008. This equates to around 1.5 a year on average
- Around 50% of these landslides have occurred in Sectors 1 and 2. The high rate of landslides at this location appears related to higher levels of coastal erosion, and the absence of nearshore reefs
- The remaining landslides are evenly distributed through Sectors 3 to 8. An example is shown in Figure 5-3
- Only one large to very large landslide appears to have occurred in Sector 9
- Many very small to moderate landslides have occurred since 2009. The 2011 rainfall event triggered significant shallow landsliding of the cliffs. This is particularly obvious in Sectors 7, 8 and 9. Figure 5-4 is an example of these small to moderate landslides.

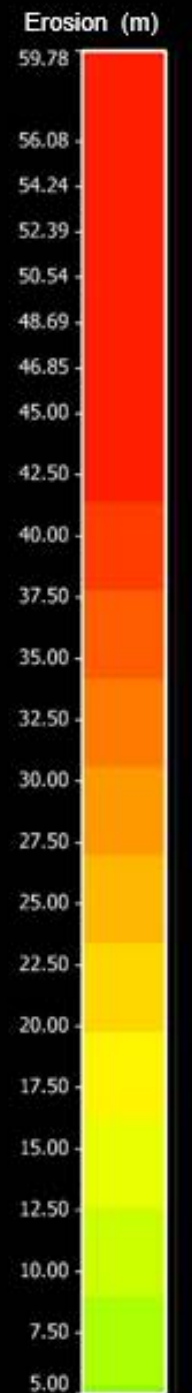
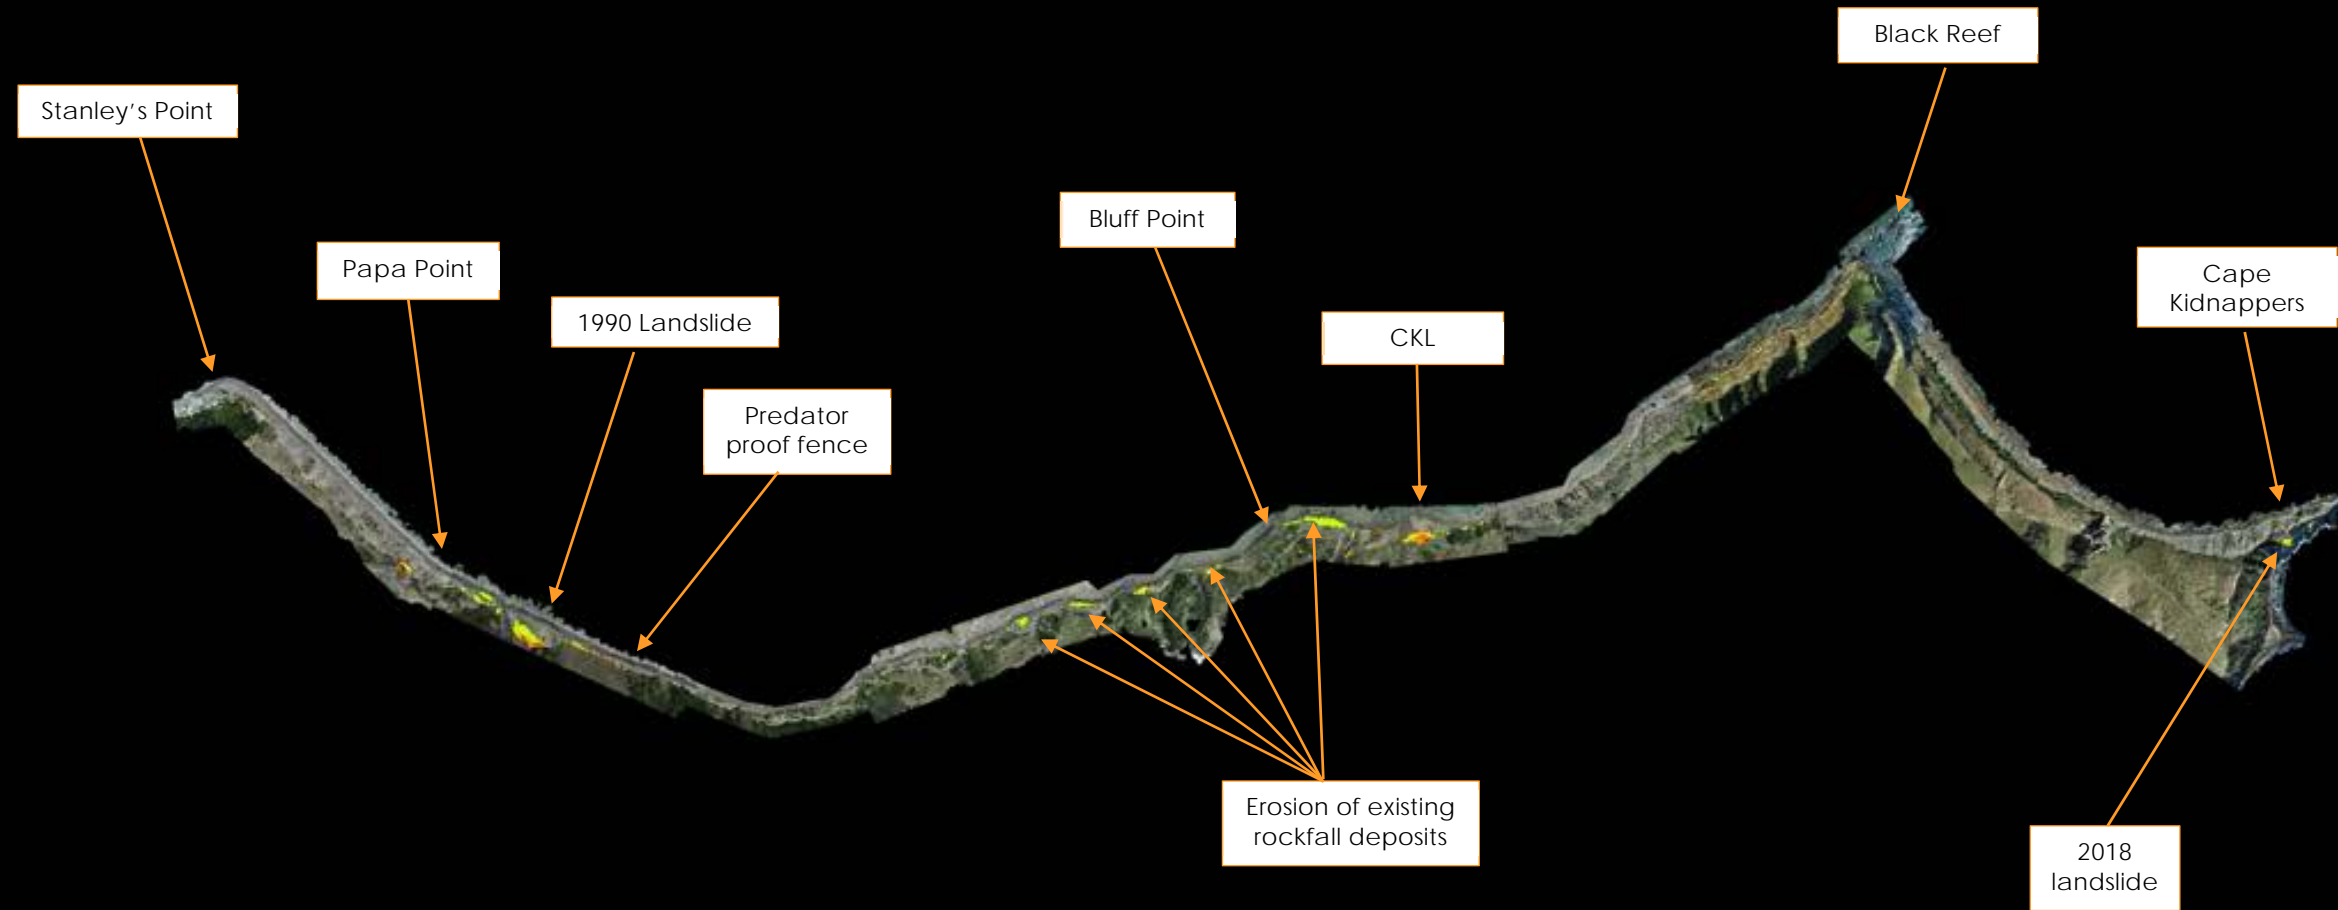
Plan View – Sectors 1-9

- Note: -
- 2012 LiDAR resolution nominally 0.5m plan grid
 - Coloured areas show changes at 1m plan grid
 - Highest points on both surveys used
 - i.e. Failures beneath overhangs not reported

Survey Dates Compared:
LiDAR 2012 – Drone Mar-Apr 2019

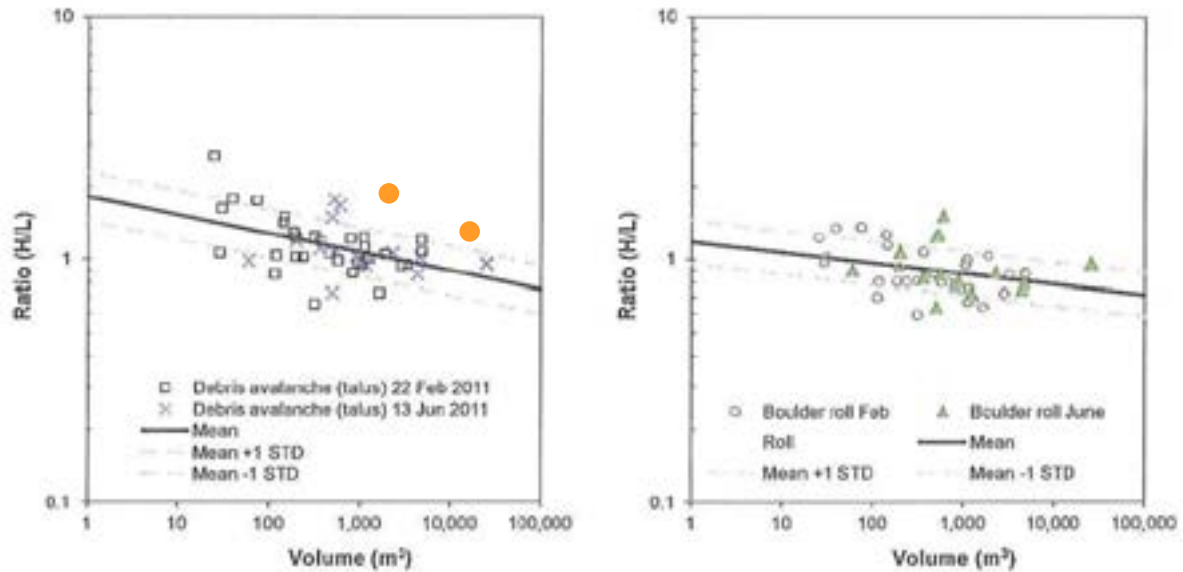
Figure 6-6: Relationship between Fahrboschung angle and rockfall volume (Massey et al 2012)

considered. The CKL had a failure volume of 25,000 and an H/L ratio of around 1.7¹⁰. The Pigeon Holes Landslide had a failure volume of 3,000 m³ and an H/L ratio of around 2. This data is generally consistent with that presented.

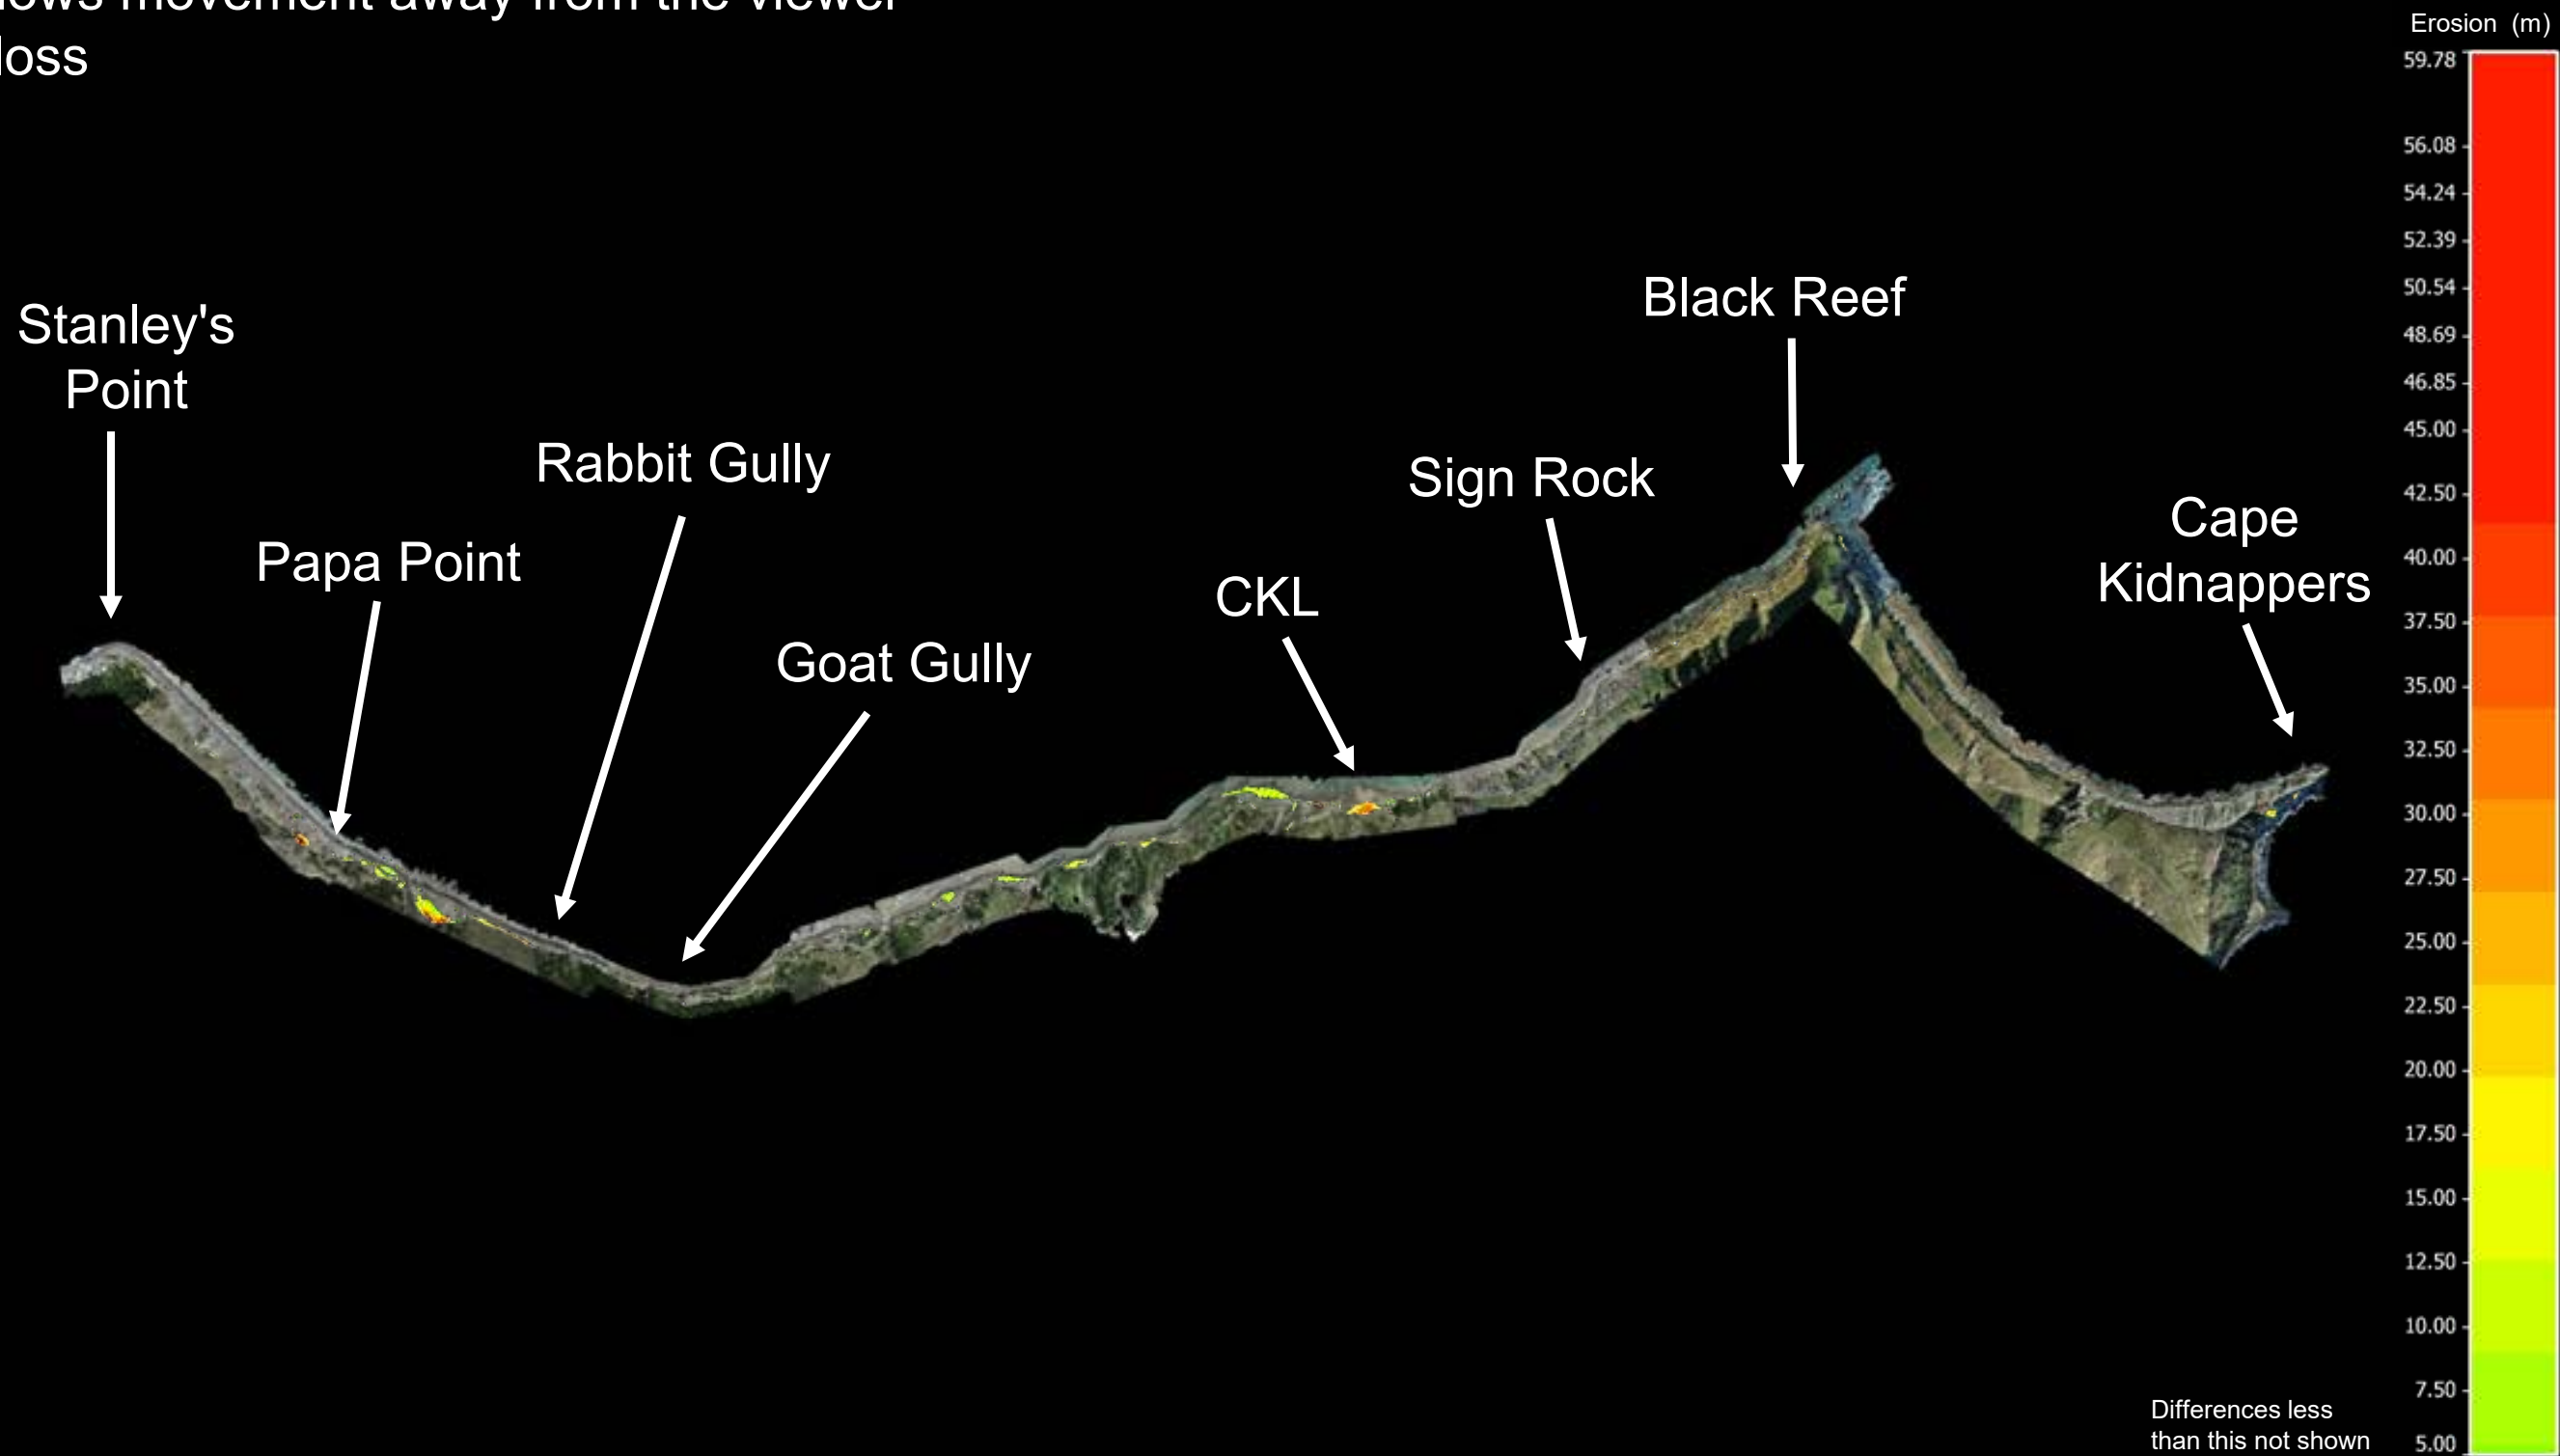
This figure shows movement away from the viewer
i.e. erosion / loss

Survey Dates Compared:
LiDAR 2012 – UAV Photogrammetry

Plan View – Sectors 1-9
