CLIFTON BEACH LANDSLIDE HAZARD ASSESSMENT

PREPARED FOR HASTINGS DISTRICT COUNCIL AND DEPARTMENT OF CONSERVATION

April 2020

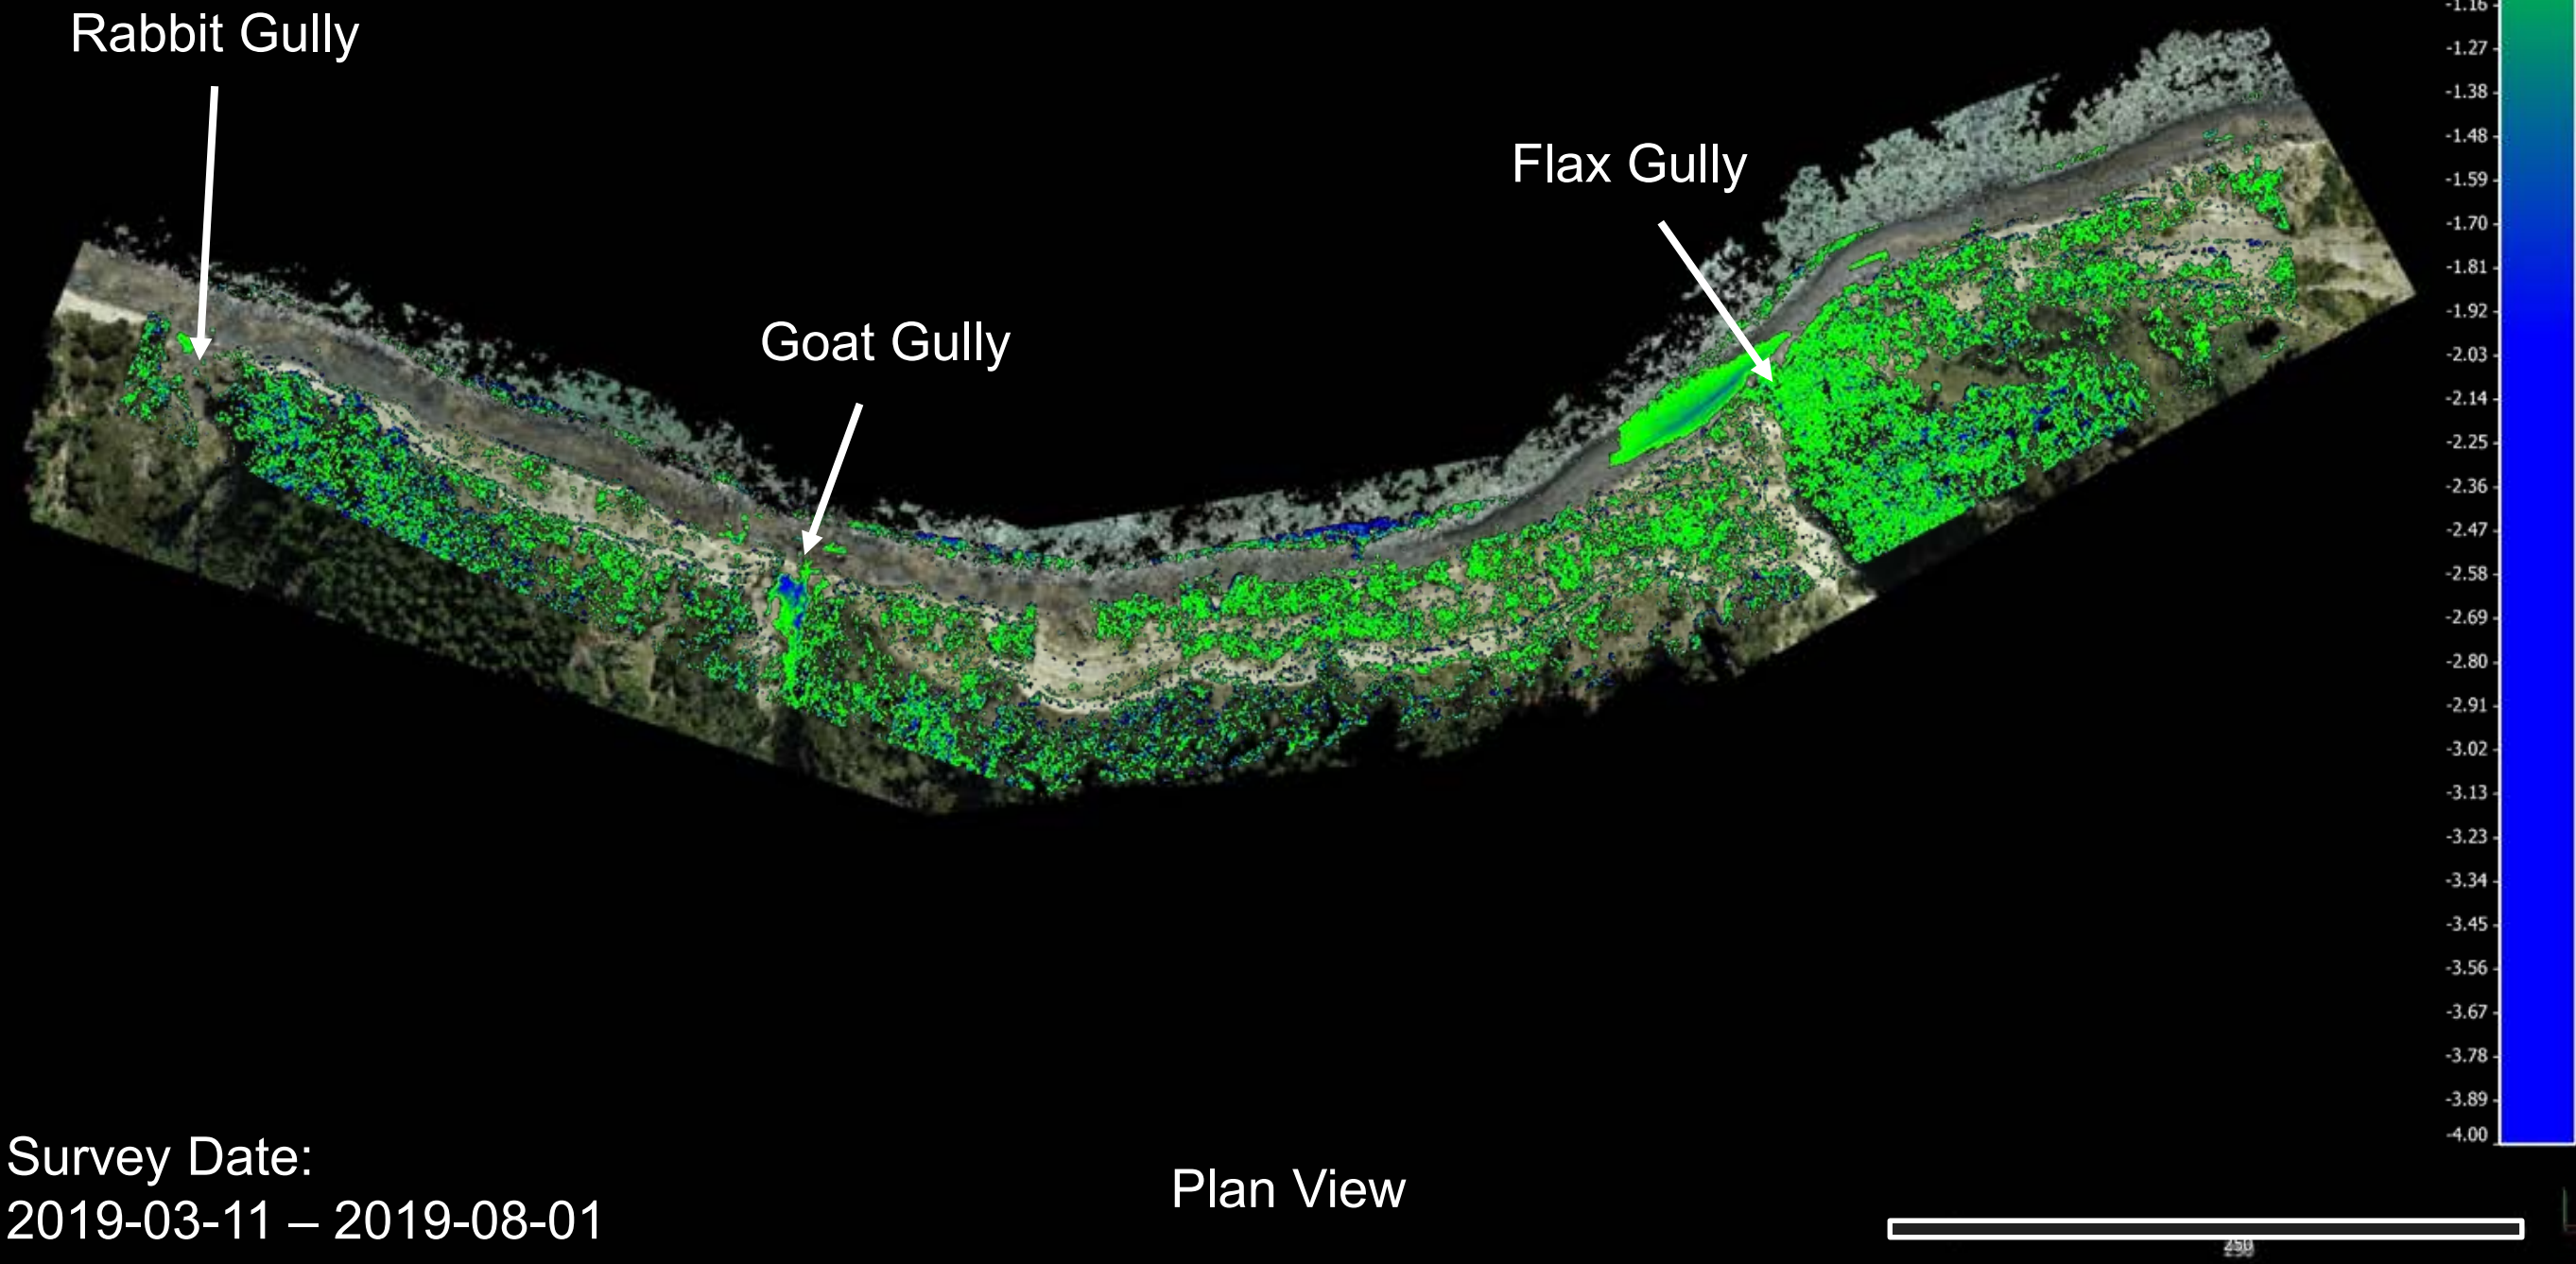
This figure shows movement towards the viewer
i.e. deposition / gain
