Estuarine systems in the lower North Island/Te Ika-a-Māui

Ranking of significance, current status and future management options

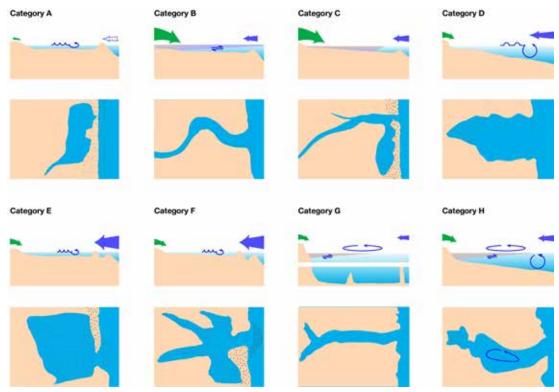
Figure 2. Schematic drawings of the eight hydrodynamic classes of estuarine systems showing their dominant morphometric and oceanographic properties (from Hume et al. 2007). See Appendix 1 for details of their characteristics.

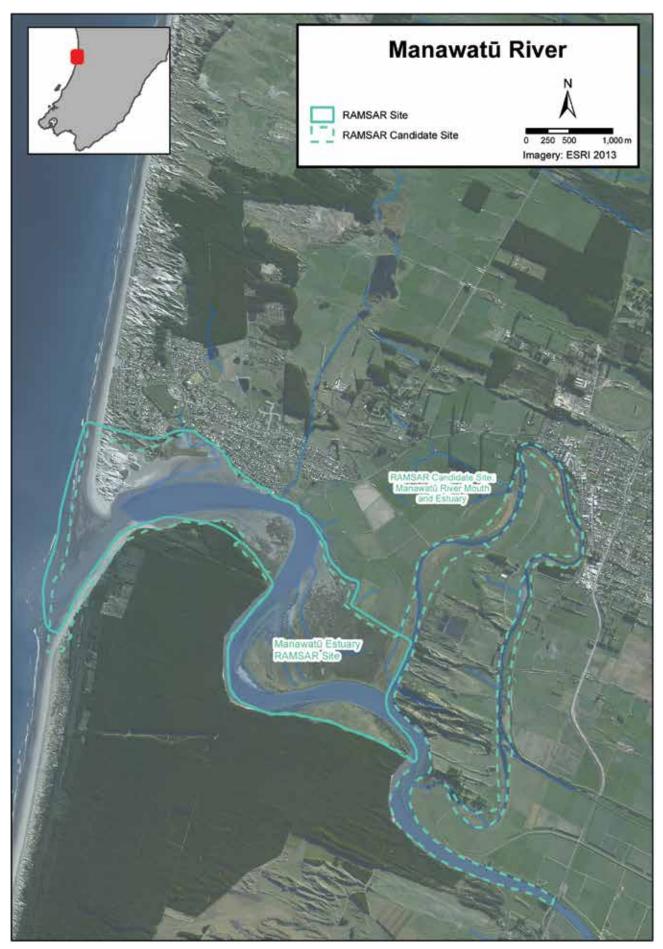
Figure 1.1. Manawatū River estuarine site showing the Ramsar site and candidate site boundaries.

Table 1A. Manawatū River site information (see also Figs 1.1 & 1.2).

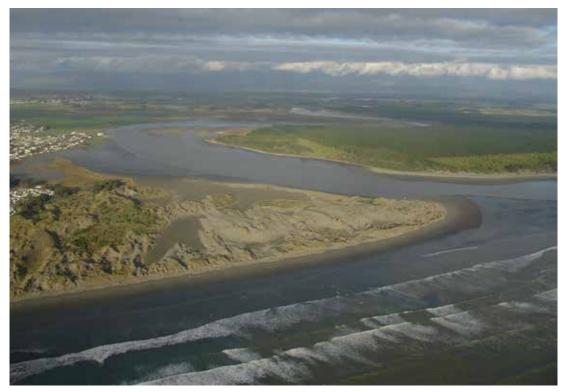
Figure 1.3. Aerial photograph of the Manawatū Estuary with extensive dunes at the river mouth (foreground), Foxton township and spit (left), S-bend and Fernbird flats (in the distance). *Photo: Don Ravine*.

The broad serpentine sweep of the river has led to the formation of large, nutrient-rich mudflats on either side of the channel. It is these that form the basis of the extensive saltmarshes, and support the invertebrate population. A narrow sandspit at the northern end of the estuarine site (Figs 1.3 & 1.4) separates the western saltmarsh area from the main channel. This spit has played a significant part in reducing the impact of the river channel on the marsh (Woods & Kennedy 2008).

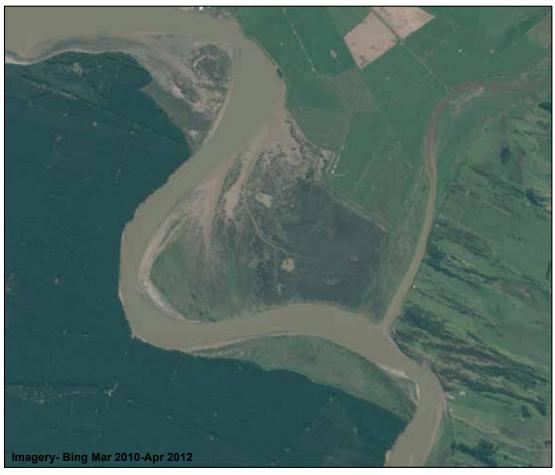
Figure 1.4. The 'Fernbird Flat' saltmarsh area in the Manawatū Estuary is habitat for a population of fernbirds.

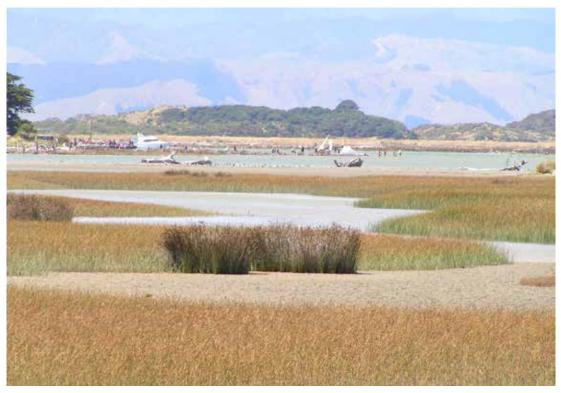
Figure 1.5. Manawatū River northern intertidal flats. In the foreground is three-square sedgeland, with clumps of sea rush. In the middle of the photo is the narrow sandspit area with a variety of birds present. *Photo: Helen Kettles*.

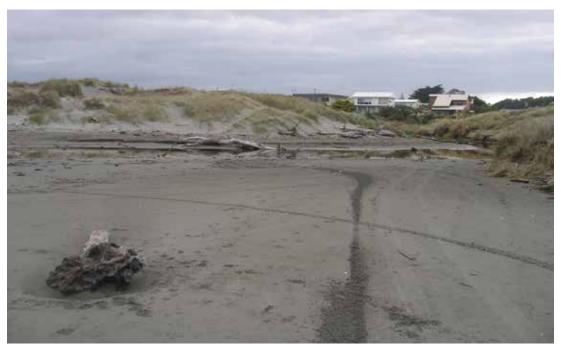
Figure 2.2. The mouth of the Wairarawa Stream flows across beach sandflats, with dunes on either side. Photo: Matt Todd.

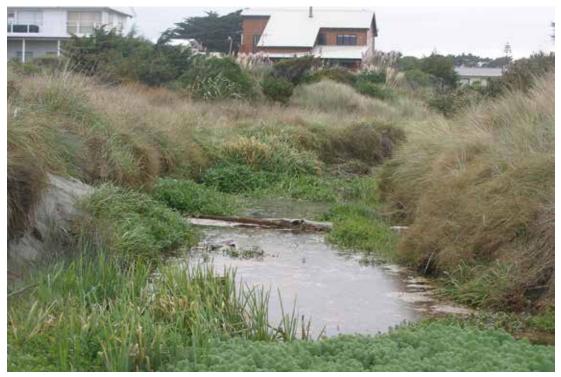
The abundance of filamentous brown algae (periphyton) and aquatic weeds indicate elevated nutrient levels, the result of contamination by nitrates and phosphates. The source of this is uncertain, but could be due to a combination of several factors, including diffuse agricultural runoff.

Figure 2.3. Ecological weeds (e.g. parrot's feather in the foreground) are abundant along the margins of Wairarawa Stream and in the waterway of the tidal area *Photo: Matt Todd.*

As the estuarine area runs through the domain and esplanade reserve, inclusion of the stream banks in the restoration programme would be appropriate. Rushes such as wīwī, oioi (both found elsewhere on the coast), and three-square (already present) could be planted along the margin, augmented by riparian planting of flax and toetoe. This would also assist in the enhancement of water quality by acting as a filter for nutrients.

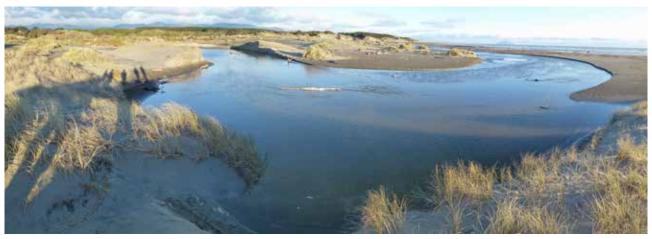
Figure 3.2. View of the Hōkio Stream mouth and 'Cut' in 2015 just after realignment for flood management. Photo: Helen Kettles.

The Hōkio Stream mouth is a small tidal river mouth type of estuarine system, spilling over the sandflats of the beach. (Table 3A, Figs 3.1, 3.2). The stream is tidal for perhaps a kilometre. The settlement of Hōkio Beach is immediately adjacent to the upper estuarine area, and the area has been modified and disturbed by housing and vehicles. A vehicle bridge crosses the upper tidal reaches and vehicle tracks run along both banks to the beach. The stream mouth is dynamic, and in storms can undercut the dunes to the south of the estuarine site. Due to its dynamic nature, and risk to flooding to the township, the stream mouth has been cut straight through to the sea a number of times in its history. The sandflats support herbfields, although tall fescue and other ecological weed species are abundant. The banks of the upper estuarine area are steep and dominated by grasses.

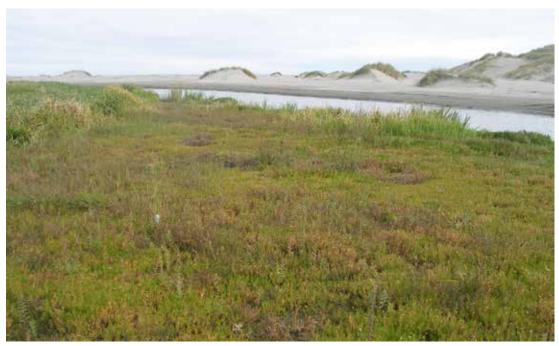
Figure 3.3. In 2009, prior to flood management operations, bachelor's button formed large swathes on the sandflats of the Hōkio Stream mouth. *Photo: Matt Todd.*

The beach at the mouth is devoid of vegetation, but the flats at the rear of the beach, where the stream forms two loops, have historically had herbfield areas dominated by bachelor's button (Figure 3.3). Although common in the region batchelor's button does not generally dominate large patches, as it has done here. Other species found in these areas include remuremu, sharp spike sedge, and mudwort, while three-square fringes the low water mark. Patches of wīwī,

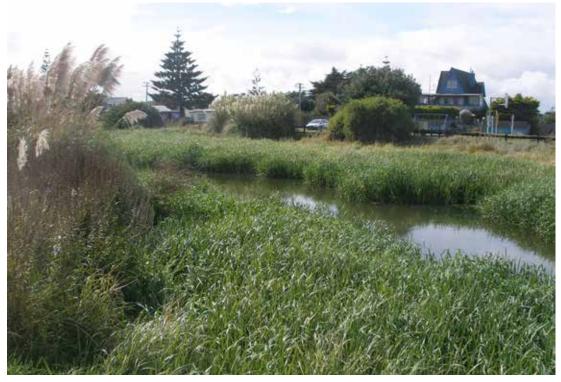
The upper tidal reaches have a severe ecological weed problem. The margins are inundated with an assortment of mat-forming weed species, particularly reed sweetgrass (Fig. 3.4), which have almost totally displaced any native species. Other weeds of particular concern include oxygen

Figure 3.4. Reed sweetgrass and riparian ecological weeds are abundant in the waterway of the Hōkio Stream. Photo: Matt Todd.

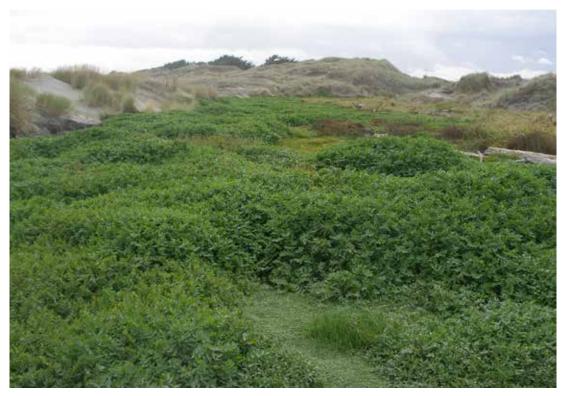
Figure 4.2. Water celery is dominant throughout the bed of the Waiwiri Stream. Photo: Matt Todd.

This braided stream mouth discharges across the beach between Ōhau and Hōkio. The tide penetrates about 300 m upstream, and the estuarine system is entirely within the coastal dune system (Table 4A, Figs 4.1 & 4.2). The area is isolated, with Hōkio Beach the nearest settlement, 4 km north along the beach. The stream is used as an access point for the beach; a vehicle track runs down the middle of the bed. Apart from small patches of saltmarsh vegetation, weeds dominate the environment (Fig. 4.2).

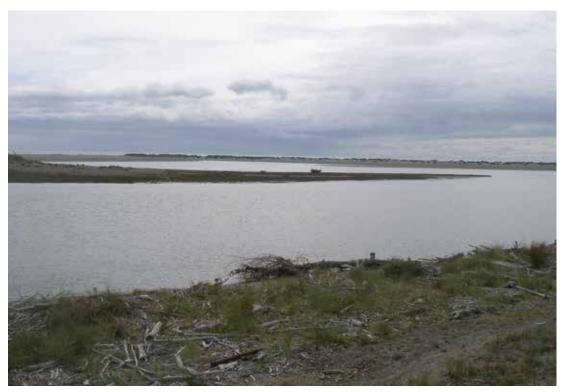
Figure 15.2. Glasswort and remuremu herbfields (centre) on the sandflats adjacent to Ōhau Lagoon. Photo: Matt Todd.

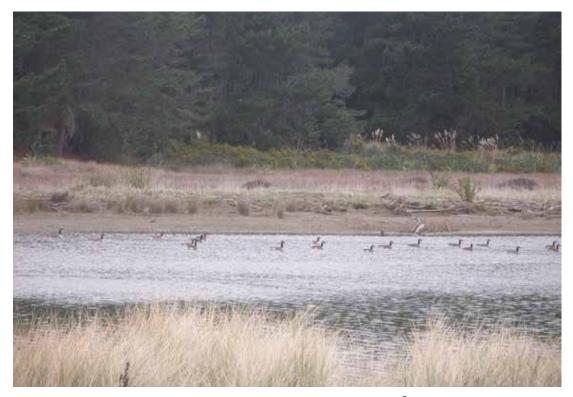
Figure 5.3. Saltmarsh (sea rush and saltmarsh ribbonwood) on the northern bank of the \bar{O} hau River is visible at the rear of a vegetated bank. *Photo: Matt Todd.*

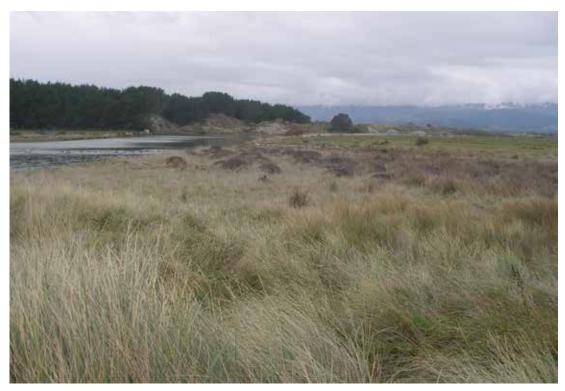
Figure 5.4. Saltmarsh ribbonwood and oioi in the saltmarsh on the southern bank of the Ōhau River. The farmed part of the Recommended Area for Protection is at the rear. *Photo: Matt Todd.*

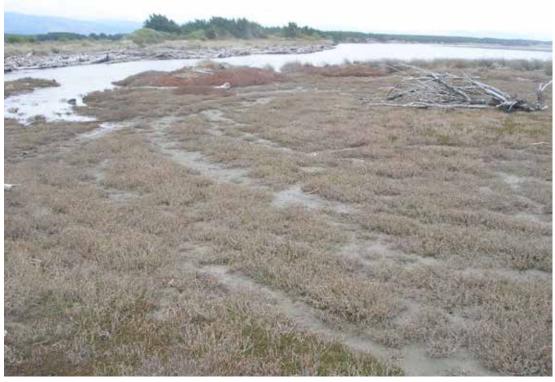
Figure 5.5. Vehicle damage in glasswort herbfields at Ōhau Estuary. Photo: Matt Todd.

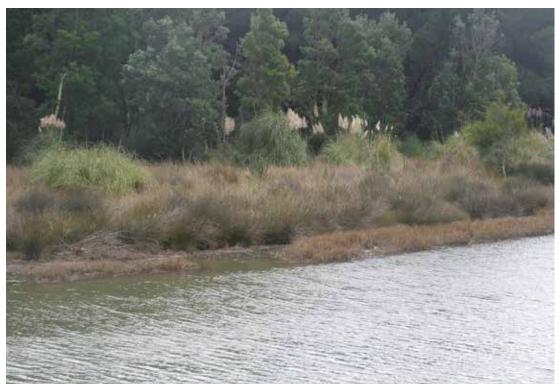
Figure 6.3. Saltmarsh (rushland and emergent sedgeland) adjacent to the pine plantation on the western bank of the Waikawa Stream. *Photo: Matt Todd*.

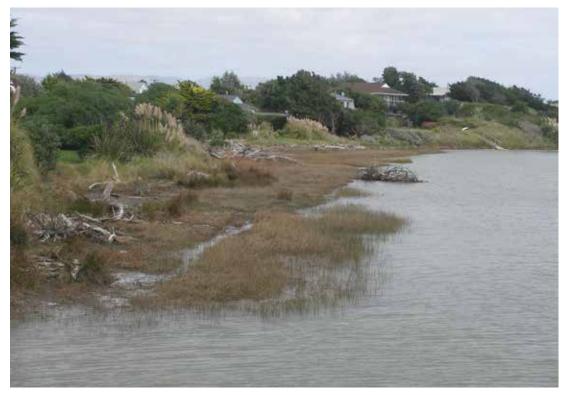
Figure 6.4. Saltmarsh (herbfield and emergent sedgeland) adjacent to the settlement on the eastern bank of the Waikawa Stream. *Photo: Matt Todd*.

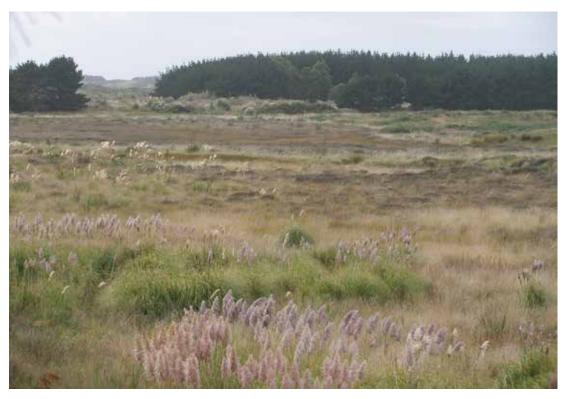
Figure 6.5. Saltmarsh fills a dune basin in the upper tidal reaches of the Waikawa Stream (centre). Pampas is dominant in the foreground. *Photo: Matt Todd*.

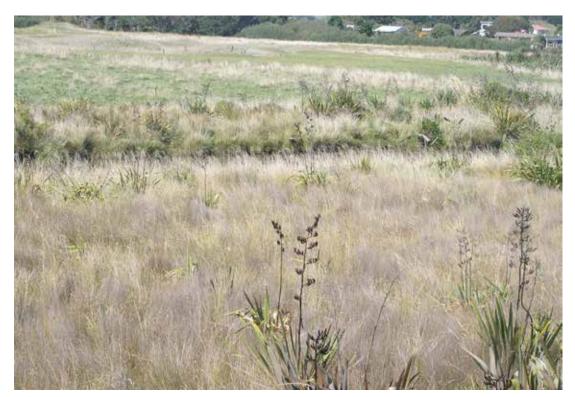
Figure 7.2. Restored wetland at the Waitohu Stream. Photo: Matt Todd.

Wetland continues along the bank from this area, following a historic path of the stream. Sea rush and oioi dominate here, along with patches of flax. Three-square is present on the water's edge. On the southern bank, near the Moana Street entrance, is the restored area of saltmarsh and riparian planting (Fig. 7.2). Sea rush is again the dominant species here, with patches of oioi and clubrush on the water's edge. Native shrubs here include flax, toetoe, taupata, tauhinu, small-

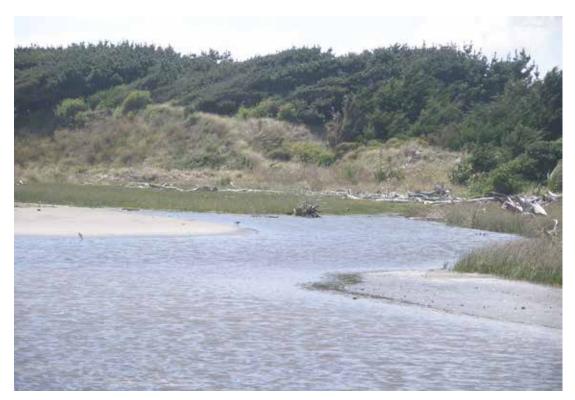
Figure 7.3. Emergent three-square sedgeland in a lateral arm of the Waitohu Stream, adjacent to the stream mouth. Pine forest dominates at rear. *Photo: Matt Todd.*

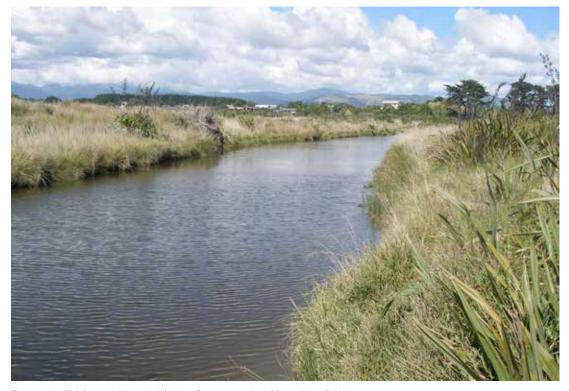
Figure 7.4. Tall fescue along the Waitohu Stream margins. Photo: Matt Todd.

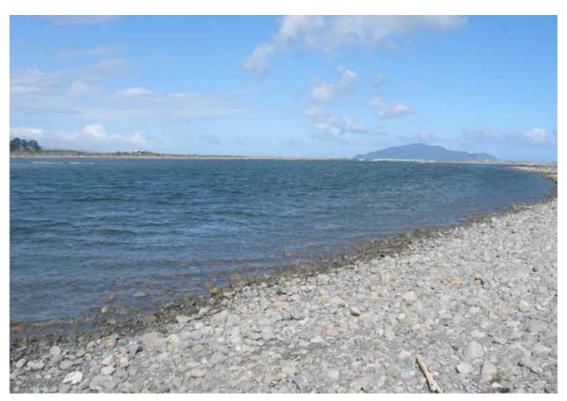
Figure 8.3. The main channel of the Ōtaki River mouth. Kāpiti Island is visible at rear. *Photo: Matt Todd*.

The main river bed is a gravel braided system fed from material from the Tararua mountain range via the fast-flowing Ōtaki River. This is unusual in the Kāpiti and Horowhenua Districts, where single channel systems with a heterogeneous range of habitats are the norm (Fig. 8.3). The lagoon on the northern side of the river mouth is subject to a large-scale restoration planting

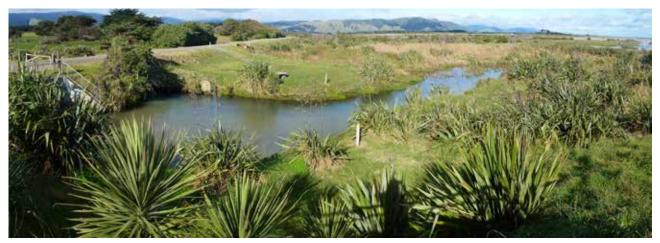
Figure 8.4. Outlet of the Rangiuru Stream towards Ōtaki Lagoon, in the restoration area. Photo: Helen Kettles.

Around the northern lagoon is an open environment dominated by flax, toetoe, and patches of regenerating coastal forest dominated by taupata (Fig. 8.4) and karamū. Significant areas of

herbfield are found in the intertidal zone; the dominant native species here are bachelor's button and slender clubrush. Shore primrose, remuremu and mudwort are also present in the intertidal zone. There are small patches of rushes, particularly wīwī and a large raupō swamp adjacent to the small tributary stream, Rangiuru (Fig. 8.4).

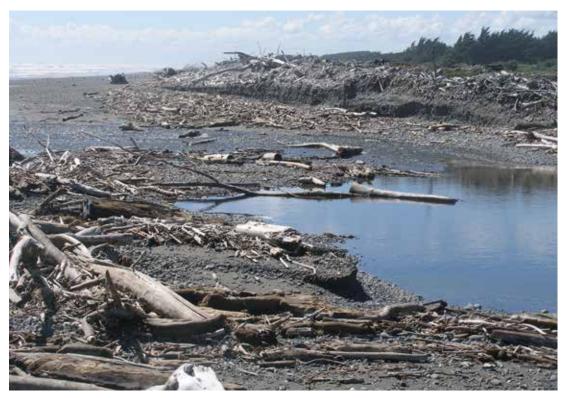
Figure 9.2. The mouth of Mangaone Stream is frequently blocked by gravel and debris. The outlet is maintained by mechanical means in such situations. *Photo: Matt Todd.*

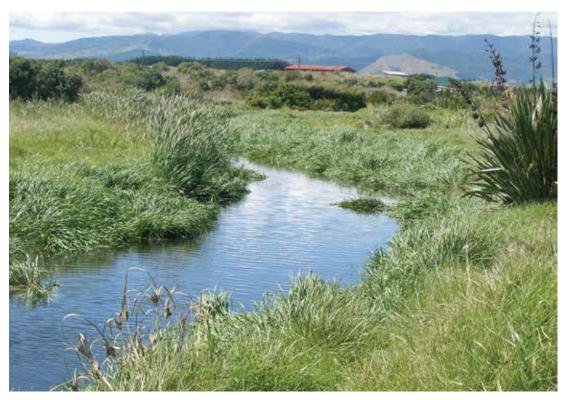
Figure 9.3. Reed sweetgrass lines both margins of the stream adjacent to the settlement of Te Horo Beach. *Photo: Matt Todd.*

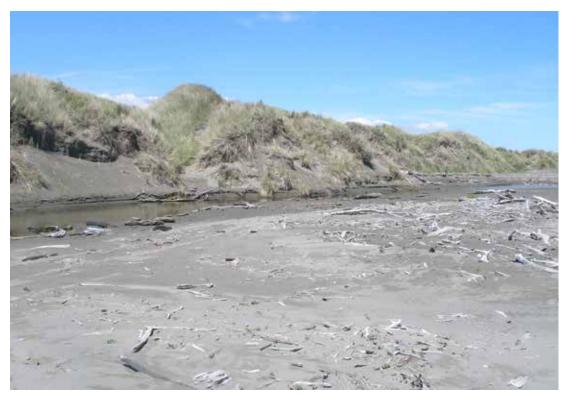
Figure 10.2. The mouth of the Kukutauaki Stream flows across beach sandflats, with dunes closely buffering the margins. Photo: Matt Todd.

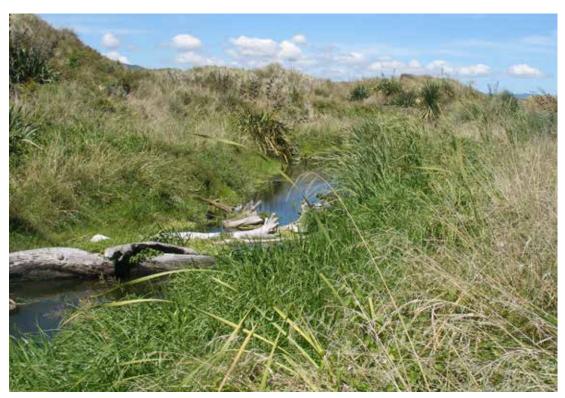
Figure 10.3. The tidal reach of the Kukutauaki Stream. Aquatic ecological weeds (reed sweetgrass and Mercer grass) are abundant in the margins. *Photo: Matt Todd*

There is a wide variety of invasive weed species including reed sweetgrass and Mercer grass, which form mats along the estuarine margin (Fig. 10.3); blackberry, great bindweed, monkey musk, tree lupin, gorse and tall fescue all have significant presences. Oxygen weed in the stream is particularly problematic as it is an aggressive coloniser and difficult to control.

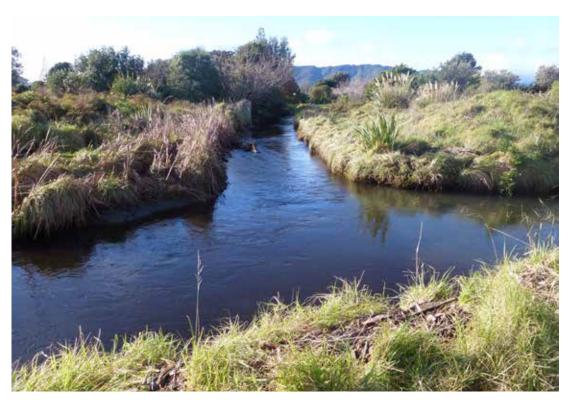
Figure 11.3. The junction of the Ngārara and Waimeha Streams, with a mix of tall fescue, taupata, harakeke and raupō lining the banks. *Photo: Helen Kettles*.

Patches of restored saltmarsh are present along the tidal stream margins, consisting of raupō, wīwī, oioi, and clubrush (Fig. 11.3). Bachelor's button is present, usually associated with clubrush. There are no threatened plant species known from this ecosystem.

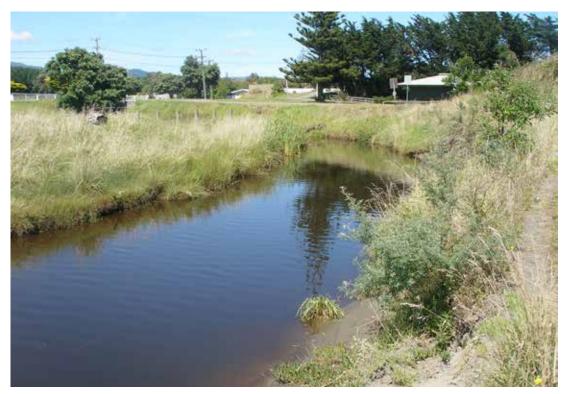
Figure 11.4. The lower tidal reaches of the Waimeha Stream. Note the discolouration of the water. Photo: Helen Kettles.

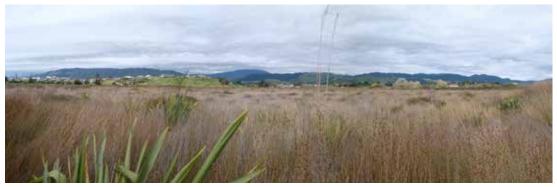
Figure 12.2. Intact saltmarsh along the margins of the Waikanae River, consisting of oioi/sea rush rushland. Photo: Helen Kettles.

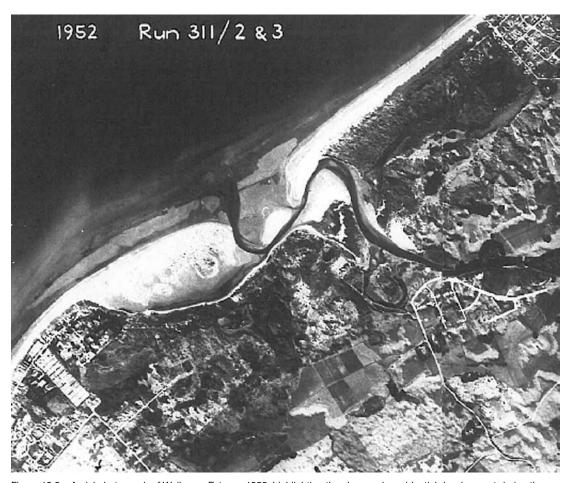
Figure 12.3. Aerial photograph of Waikanae Estuary, 1952, highlighting the changes in residential development during the subsequent years. The u-shaped Ōtaihanga Oxbow can be seen at the centre right.

Subdivision has had a big impact on the estuarine system and with dense residential areas on both sides, disturbance is an ongoing problem (Figs 12.3 & 12.6). A range of mammalian predators and browsers will be present but mostly their impacts have not been assessed at this site. The rabbit population in the area is significant, particularly in the Ōtaihanga oxbow, as they can do considerable damage to the habitat restoration efforts by destroying newly planted seedlings and attracting predators.

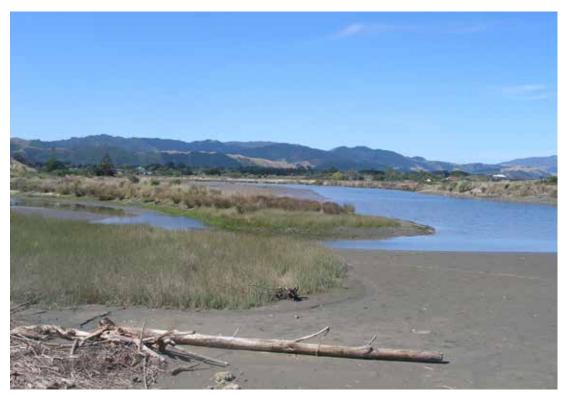
Figure 12.5. View upstream of the tidal reach and mudflats, from the northern margin. Dense swards of three-square sedgeland dominate at left. *Photo: Matt Todd.*

The estuarine system has extensive intertidal sandflats (Fig. 12.5) covering 50% of the total area (Stevens & Robertson 2006), and is an important habitat for a large variety of birds and native fish.

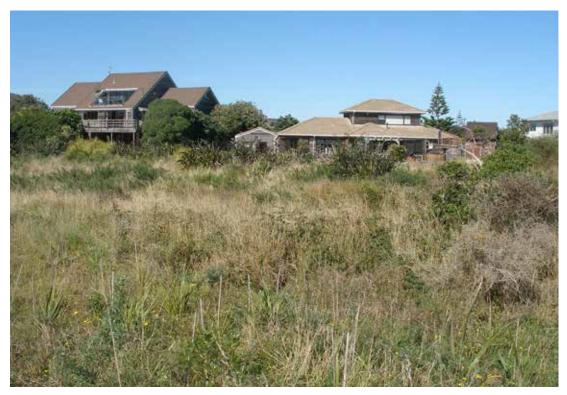
Figure 12.6. Urban development on the wetland margins of Waikanae Estuary. Restoration plantings are visible amidst the grass in the foreground. *Photo: Matt Todd.*

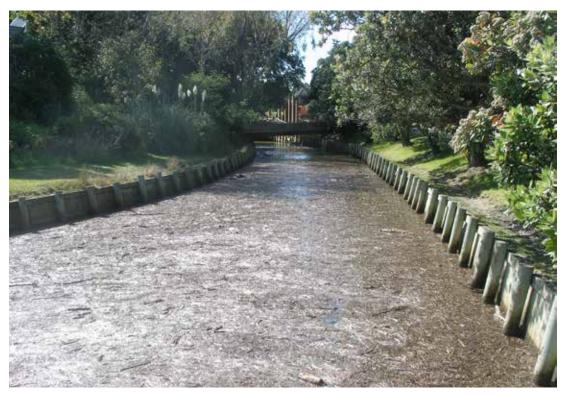
Figure 13.2. The tidal area of the Wharemauku Stream is entirely constrained by retaining walls on the margins. Photo: Matt Todd.

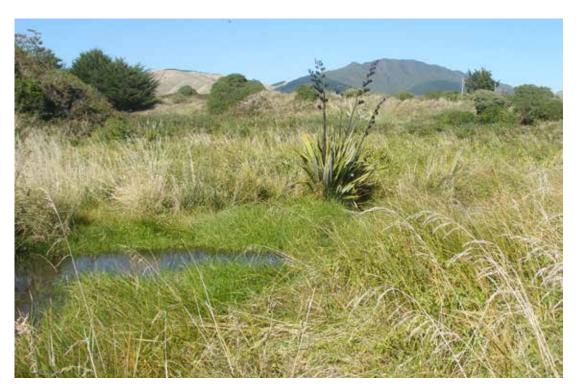
Figure 14.2. Saltmarsh in the upper tidal reach of the Whareroa Stream. Ecological weeds are abundant, and the margins of the waterway are lined with reed sweetgrass. *Photo: Matt Todd.*

The estuarine system has an ecological weed problem, particularly in the wetland above the footbridge (Fig. 14.2). Of particular concern are blackberry, brush wattle, and gorse. These species are difficult to control and will not decline by overtopping in the open saltmarsh. Tall fescue and kikuyu are prevalent grasses in the estuarine ecosystem; kikuyu in particular requires monitoring, as it forms dense mats that can crowd out native species in the estuarine margins. In the open water, water celery is starting to form thick patches and this species can clog a waterway if not managed properly.

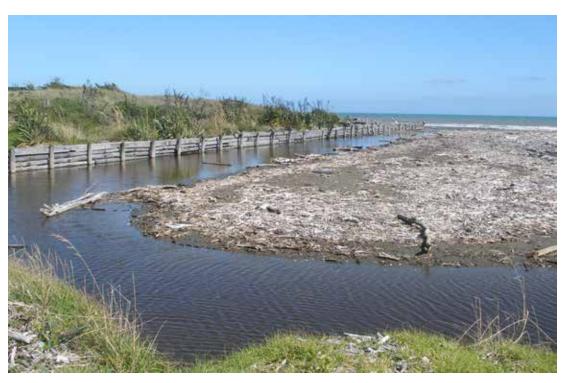
Figure 14.3. The mouth of the Whareroa Stream has been modified and constrained by a wall on the south bank. *Photo: Matt Todd.*

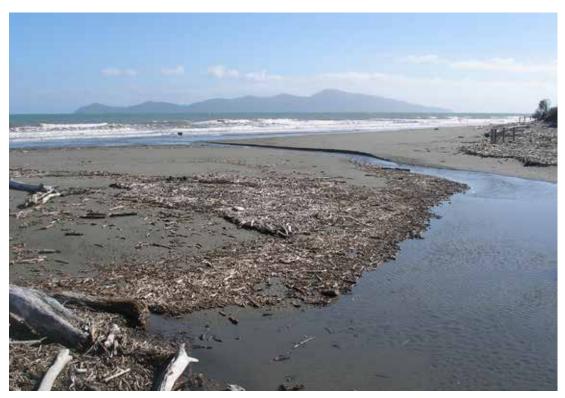
Figure 15.2. The outlet for the Wainui Stream mouth is dynamic, and changes its course and position frequently. *Photo: Matt Todd*

The mouth of the Wainui Stream forms a small tidal stream mouth estuarine system at the southern entrance to Queen Elizabeth Park (Table 15A; Fig. 15.1). The outlet drains across Paekākāriki Beach adjacent to the local surf-club, and it is likely that it is occasionally blocked (Fig. 15.2). A small tidal pool has formed behind the beach and passes through the coastal dunes, flanked on the south side by a steep bank (Fig. 15.3). On the true left bank, approximately 100 m upstream from the mouth, there is an area of saltmarsh wetland. A footbridge crosses the mouth at the rear of the beach, and connects the surf club to the walking tracks of the park, while a road bridge crosses the stream at the tidal limit. At times there can be large amounts of storm-tossed driftwood piled up in the lower tidal reaches.

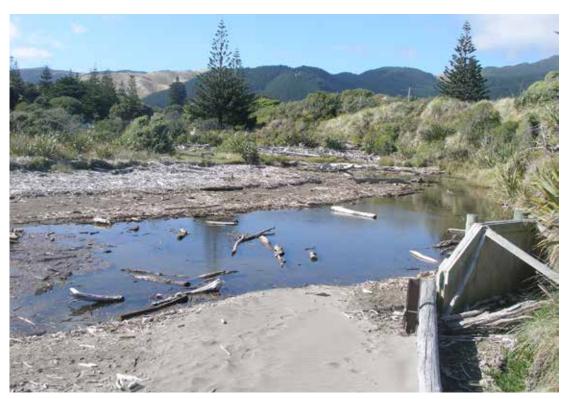
Figure 15.3. The partially blocked Wainui Stream mouth. The Norfolk Island pine in the saltmarsh wetland (centre rear) is stabilising the environment. *Photo: Matt Todd.*

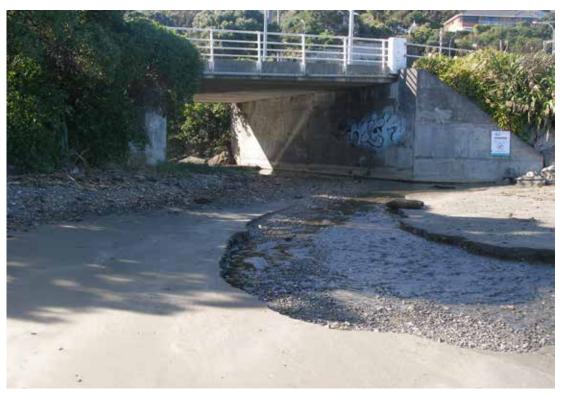
Figure 16.2. The mouth of the Taupō Stream passes underneath road and rail bridges. Photo: Matt Todd.

This is a small incised stream with a regionally significant flax swamp in it's middle reaches. The tide reaches no more than a few hundred metres up the narrow waterway. The mouth is greatly constrained by concrete bridge abutments underneath the road/rail corridor (Table 16A; Figs 16.1 & 16.2).

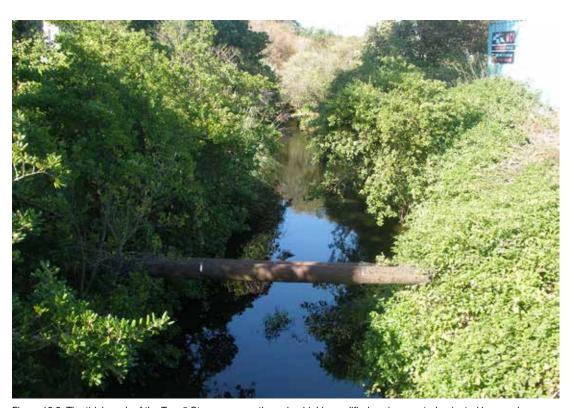
Figure 16.3. The tidal reach of the Taupō Stream passes through a highly modified environment, dominated by woody ecological weeds and vines. *Photo: Matt Todd.*

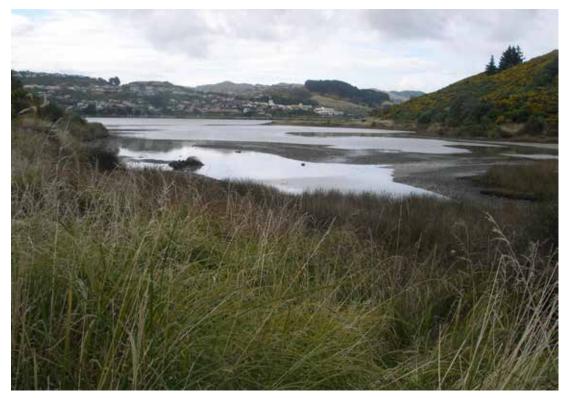
Figure 17.3. Te Onepoto Bay contains some of the most intact saltmarsh vegetation in the Onepoto Arm, fringing the margins of the bay. The submerged causeway lies across the mouth of the bay. *Photo: Matt Todd*.

There is a small area of saltmarsh in Te Onepoto Bay (Fig. 17.3) which is at the mouth of a small stream. The shore is lined with a band of herbfields, dominated by remuremu, glasswort, saltgrass and shore primrose. This quickly grades into rushland, mainly oioi and sea rush, with a small amount of wīwī and giant umbrella sedge present. The rear of the saltmarsh (Fig. 17.4) is dominated by saltmarsh ribbonwood and small-leaved pōhuehue. Other significant species around the bay include flax, toetoe, taupata, tauhinu and cabbage tree. A small but dense patch of raupō occupies a niche in the shoreline. There is a belt of kuāwa where the stream enters the bay, backed by ruatahi and giant umbrella sedge. Clubrush grows in the stream at the head of Te Onepoto Bay.

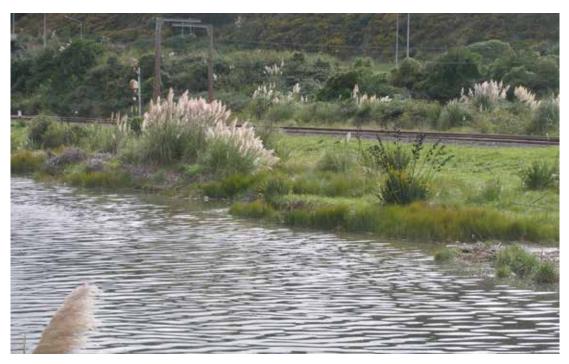
Figure 17.5. Patches of three-square and harekeke are all that remain of the original vegetation along the margin of the Porirua Stream. *Photo: Matt Todd.*

There is a small area of saltmarsh just inside the mouth of the Porirua Stream, consisting of oioi, saltmarsh ribbonwood, three-square, and flax (Fig. 17.5). Otherwise, the banks of the stream have been hugely modified, with plantings of native shrubs on the steep western bank, and a turf of exotic grasses in the railway reserve on the eastern. The Keneperu Stream, a tributary of the lower Porirua Stream, is also modified but patches of toetoe, flax and raupō still remain.

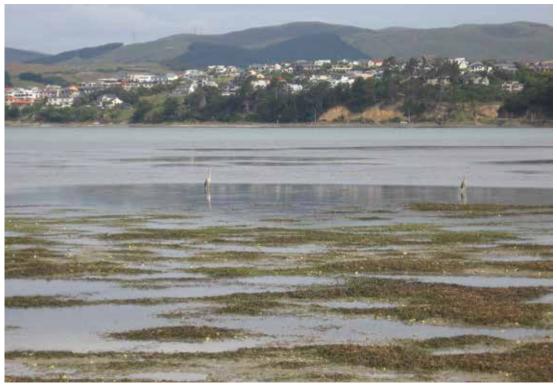
Figure. 17.7. Seagrass beds on the mudflats of Pāuatahanui Inlet. White-faced herons (and other birds) utilise the flats for feeding. Photo: Wriggle Coastal Management, © Greater Wellington Regional Council.

The intertidal area in the estuarine ecosystem largely consists of firm mudflats (Milne & Watts 2008; Stevens & Robertson 20013a). There are two large banks of seagrass in the estuarine area, both in the western part of the inlet, near the base of Moorehouse Point (Fig. 17.7) (Stevens & Robertson 20013a). With a few smaller patches along the southern shore, the seagrass beds in the inlet cover over 41 ha. Saltmarsh vegetation is similarly represented, with approximately 42 ha cover, or nearly 10% of the inlet.

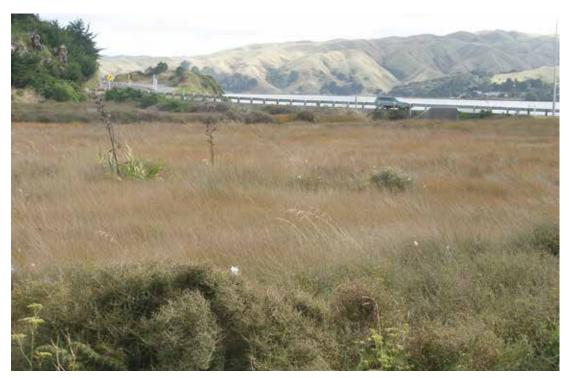
Figure 17.10. Oioi rushland in the lower tidal reach of Duck Creek. Note the road causeway across the mouth of the waterway. *Photo: Matt Todd.*

In the south, Duck Creek has a well-developed wetland, but this is isolated from the main inlet by the causeway of SH58 across the mouth of the stream but connected via a large culvert under the bridge (Fig. 17.10). Oioi is the dominant species in the rushland that takes up most of the basin, although sea rush has a significant presence further upstream and around the rear of the saltmarsh (Fig. 17.11). Along the true left of the stream, saltmarsh ribbonwood forms a thick band of shrubland, which blends into a more diverse area that also includes toetoe, flax, and tauhinu. Herb species grow amongst the rushes along the stream margins; these include remuremu, glasswort, shore primrose, and bachelor's button. In all, Wassilieff et al. (1986) listed 31 native species in the Duck Creek saltmarsh, none of which are threatened.

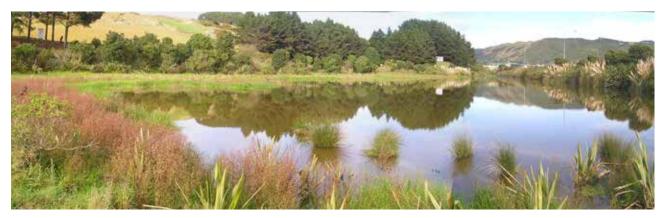
Figure 17.15. The southern part of Ōkowai Lagoon is currently being restored as a freshwater wetland. Photo: Helen Kettles.

In Onepoto Arm, the Ōkowai Lagoons have been the subject of a joint restoration project between Carrus Corporation, GWRC, Porirua City Council and DOC to transform the poorly functioning freshwater southern portion of these lagoons to an improved waterfowl wetland habitat (Figs 17.15 & 17.16). Substantial earthworks and restoration planting were undertaken in this area over 2010 and 2011 to assist with water quality and habitat enhancement (M. Parks, Boffa Miskell Limited 2013, pers. comm.). Carrus have now built a state-of-art three-tier sediment pond and wetland at the base of the subdivision, to receive stormwater/sediment, before discharging into the freshwater lagoon. They have also most recently extensively planted the slope faces leading to to the sediment pond/wetland.

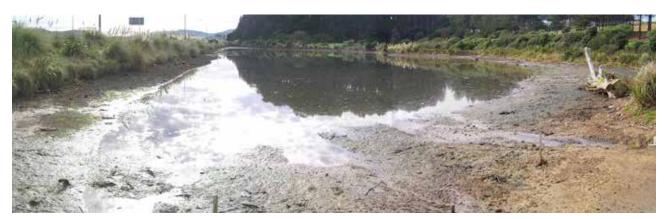
Figure 17.16. The northern part of Ōkowai Lagoon is degraded, but still retains saline function. This site will be restored in the future. Photo: Helen Kettles.

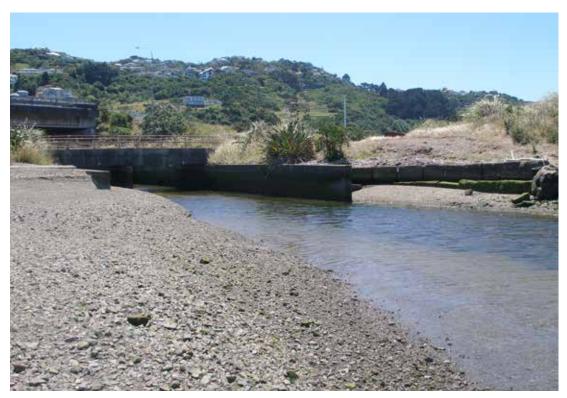
Figure 19.2. The mouth of the Kaiwharawhara Stream is highly modified as it passes underneath the transport corridor. *Photo: Matt Todd.*

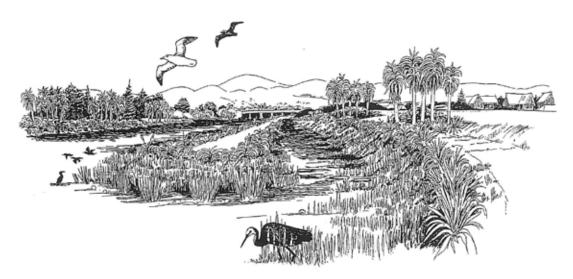
Figure 21.6. Concept design for Strand Park (Ōpahu Stream) restoration. Reproduced from Hutt River Environmental Strategy, Wellington Regional Council 2001a.

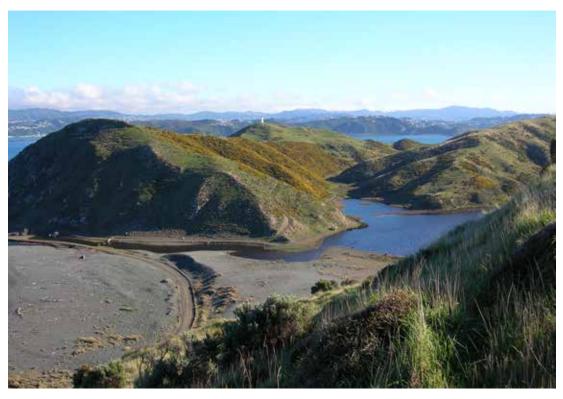
Figure 23.3. The entrance to Lake Kohangapiripiri with the roadway built across the outlet. Photo: DOC.

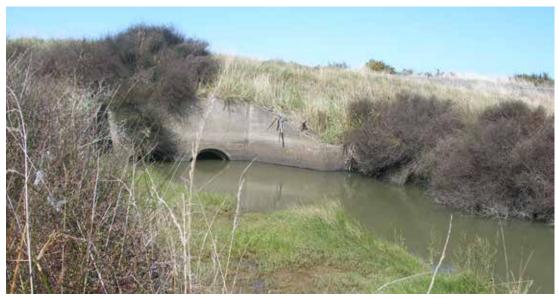
Figure 25.7. Connectivity is maintained between Pounui Lagoon and Lake Ōnoke by culverts. *Photo: Matt Todd.*

As the lagoon is directly linked to Lake Ōnoke, the flapgates remain closed during times when the lake outlet is blocked, causing a rising water level within the lake. This inhibits tidal flushing of Pounui Lagoon and creates a slow rise in water levels due to the upstream discharge into the lagoon. Correspondingly, the water quality drops, and the risk of algal bloom increases (Robertson & Stevens 2007b). This risk is augmented during southerly conditions by debris blockage of the culverts, often for extended periods (Mitchell 1996). The flapgates close on the incoming tide and fish passage through them is not effective (Mitchell 1996).

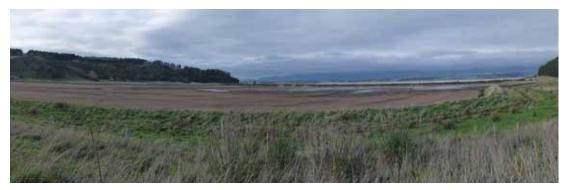
Figure 25.10. Saltwater intrusion to low-lying marginal farmland to the west of Pounui Lagoon is managed with stopbanks. Photo: Helen Kettles.

The lagoon and saltmarsh possess high conservation values. The grassland to the north within the conservation area could be planted in native plants or allowed to regenerate once an improved water regime is established. With projected sealevel rises lowlying marginal farmland to the west (Fig. 25.10) will become even more impacted by saltwater. Planning for a process to transition some of this land to restore naturally to coastal wetlands is worthy of investigation. Locating, documenting, and restoring potential inanga spawning sites would be valuable

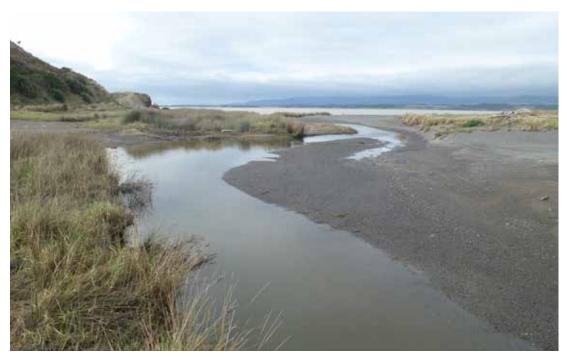
Figure 25.13. Outlet connecting Kiriwai Lagoon to Lake Ōnoke. Photo: Helen Kettles.

Kiriwai Lagoon (Table 25A.3; Figs 25.11, 25.12) is a small (10 ha) dune lake/wetland connected to Lake Ōnoke by a short channel and is regularly flushed by the high tide (Fig.25.13). The lagoon is surrounded by saltmarsh with a high biodiversity value and ranking, providing habitat for a variety of waterfowl. The saltmarsh is contiguous with Ōnoke Spit, and many of the species found there are also known in and around the lagoon.

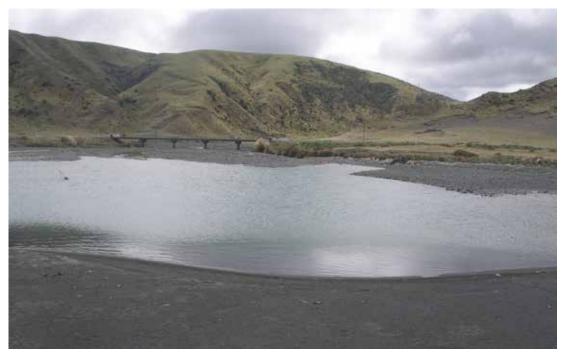
Figure 27.2. The Pararaki Stream displays the gravel basin and tidal pool typical of all three streams. Photo: Matt Todd.

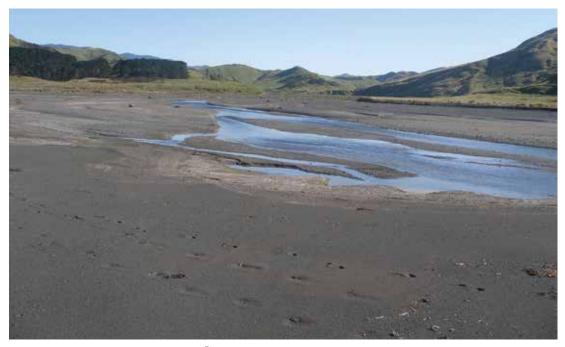
Figure 28.3. Sand and gravel flats form the Ōpouawe River mouth basin. Photo: Matt Todd.

A range of mammalian predators and browsers will be present but their impacts have not been assessed at this site. There is no specific fencing of the river margin (Figure 28.3), and stock (mainly sheep) have unfettered access to the river bed. As well as damaging terrestrial vegetation, trampling by stock also causes bank erosion and sedimentation, which in turn can reduce water quality, inhibit fish migration and smother habitat for aquatic animals. Sedimentation also exacerbates the effects of flooding.

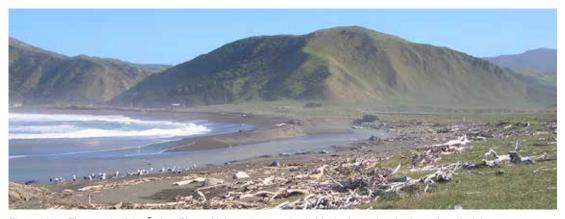
Figure 30.2. The mouth of the Āwhea River which can be completely blocked, causing the formation of a lake. *Photo: Helen Kettles.*

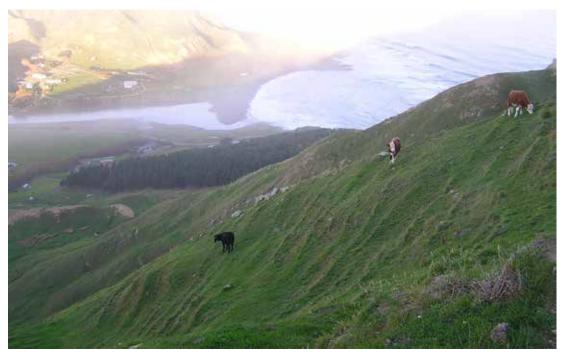
Figure 31.2. The mouth of the Ōterei River which is sometimes completely blocked by a sandbar, which then causes the formation of a lake. *Photo: Helen Kettles*.

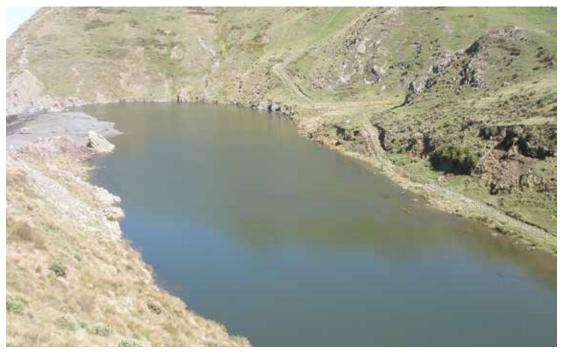
Figure 32.2. Overview of the brackish lake formed at the mouth of the Rerewhakaaitu River. *Photo: Matt Todd.*

The Rerewhakaaitu River discharges to the sea via a steep-sided, rocky valley (Table 32A; Fig. 32.1). The mouth is usually blocked by a substantial sandbar. Because of this sandbar, a broad brackish lake (5 ha) takes up the valley floor (Fig. 32.2), breaching the bar only at as a result of river flooding. The river is flanked by farmland, and the surrounding area is regularly grazed (Fig. 32.3). A small strip of saltmarsh is present along the gentler margins.

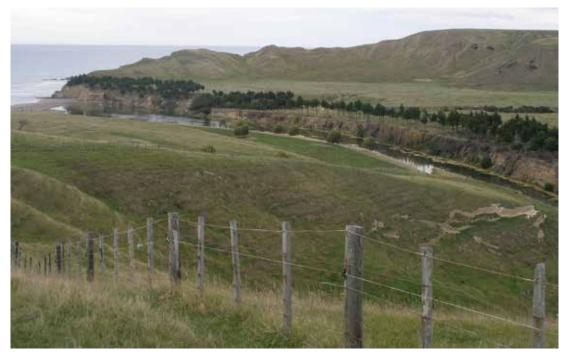
Figure 34.2. The mouth of the Kaiwhata River is completely blocked by a sandbar, causing the formation of a lake. *Photo: Matt Todd.*

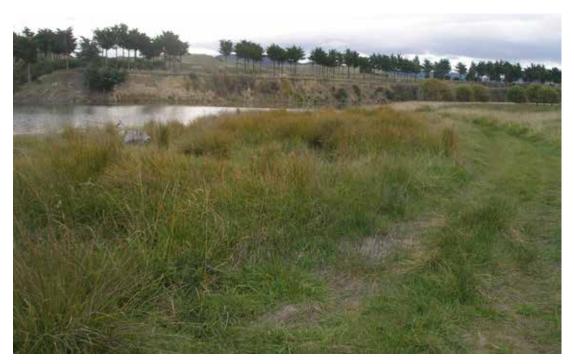
Figure 34.3. Wetland vegetation at the blocked mouth of the Kaiwhata River. The vehicle track passes through the wetland. *Photo: Matt Todd.*

The 4WD track that provides access to the beach passes through the middle of the wetland area at the mouth of the river (Fig. 34.3), although there was no evidence of vehicles on the beach at the time of visiting. Vehicles in wetlands damage the ecosystem by (a) doing direct damage to the wetland plants, aquatic habitats and native fish; (b) compacting the muddy substrate, modifying it in a way that makes it difficult for native plant species to re-establish; and (c) facilitating the invasion of mat-forming weeds such as buck's horn plantain.

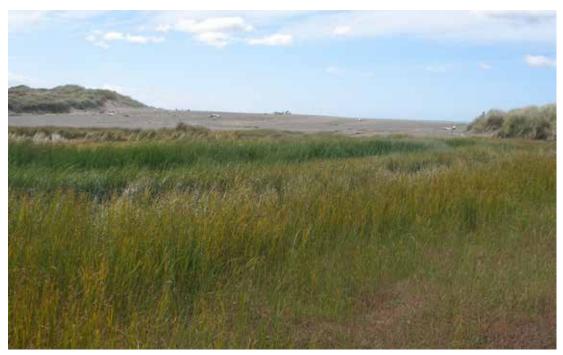
Figure 37.2. The waterway of the Waioronu Stream is obscured (foreground) by dense pūrua reedland. Note the large sandbar blocking the outlet. *Photo: Matt Todd*.

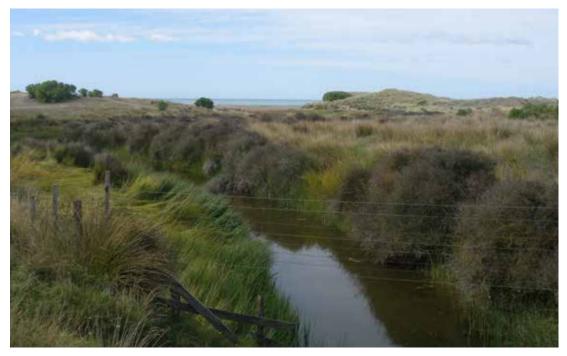
Figure 37.3. Shrubland is present on the southern bank (centre-right) of the upper tidal reach of the Waioronu Stream. *Photo: Matt Todd.*

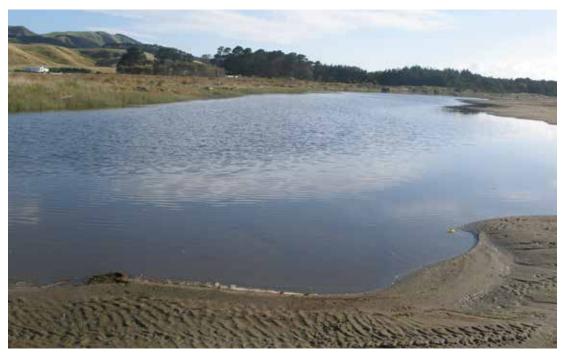
Figure 38.2. Sedgeland is visible along the left (inland) margin of the tidal pool at the mouth of the Motuwaireka Stream. Photo: Matt Todd.

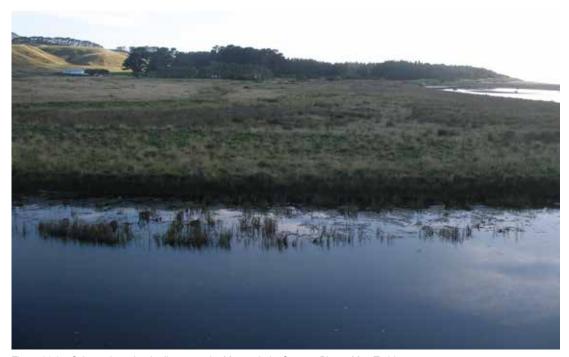
Figure 38.3. Saltmarsh wetland adjacent to the Motuwaireka Stream. Photo: Matt Todd.

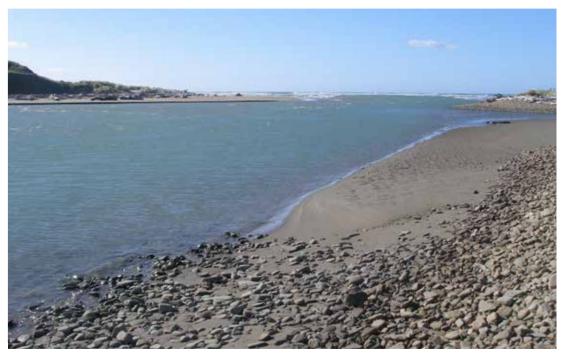
Figure 39.2. The mouth of the Whareama River, with flanking dunes. Photo: Matt Todd.

The Whareama River (Table 39A; Fig. 39.1) is a large, high volume river that, unusually for this coast, has no sandbar at the mouth and is always open to the sea (Fig. 39.2). For this reason it is classed as a Category B estuarine system, and the tidal influence can be observed up to 17 km upstream at times (Robertson & Stevens 2007). Its banks are steep, and the bed is given over to soft muddy sediments of a type not seen elsewhere in the Wairarapa; saltmarsh vegetation is negligible. The hills and terraces on either side of the river have been cleared and farmed for over 100 years. There is a sizeable pine plantation on the true left, around a kilometre upstream.

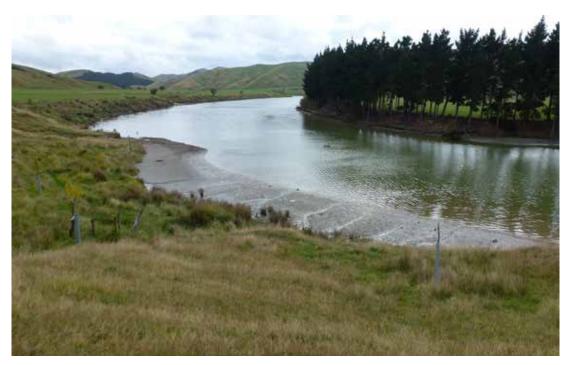
Figure 39.3. Saltmarsh vegetation is present (left) along the bank of the upper tidal reaches of the Whareama River. *Photo: Helen Kettles*.

The edges of the estuarine system have been greatly modified by farming. There is very little native vegetation remaining in the intertidal zone. The only sign of saltmarsh vegetation is a narrow strip of sea rush and wīwī (Fig. 39.3), some distance upstream (Robertson & Stevens 2007). An ephemeral wetland is present adjacent to the mouth of the river. Common species here include three-square, knobby clubrush, and giant umbrella sedge. Sand coprosma is also present. There are no threatened plant species in the estuarine site. A very small amount of seagrass has been noted near the entrance to the sea (Leigh Stevens, Wriggle Coastal Management 2012, pers. comm.)

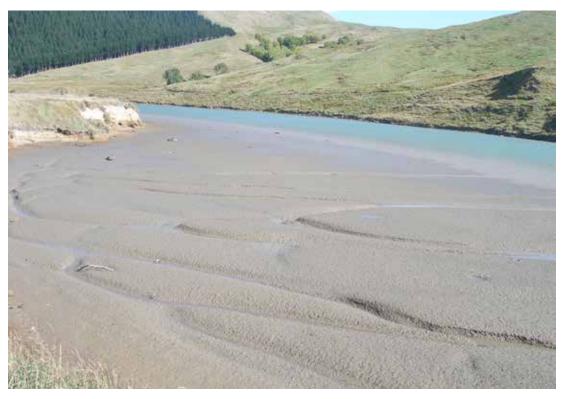
Figure 39.4. The soft sediment mudflats of the Whareama River are a rare ecosystem in the Wairarapa. Photo: Matt Todd.

The mudflats of the river (Fig. 39.4) are known to attract a number of birds to feed. The estuarine site was included in the OSNZ (2007) river mouth bird survey.

The mudflats of the site (Fig. 39.4) are an ecosystem unique in the ecological district; no other river on the Wairarapa coast has such an expanse, and the only other similar area in the Wellington region is Te Awa Kairangi/Hutt River estuarine system. Given its value as an uncommon environment and as a feeding site for birdlife, this part of the river requires at least reassessment of its legal status and could warrant protection as a Wildlife or Scenic Reserve.

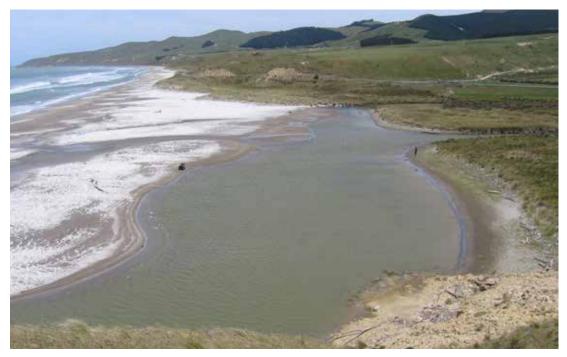
Figure 40.2. A tidal pool has formed at the mouth of the Otahome Stream. Saltmarsh ribbonwood shrubland can be seen at upper right. *Photo: Wriggle Coastal Management*, © *Greater Wellington Regional Council*.

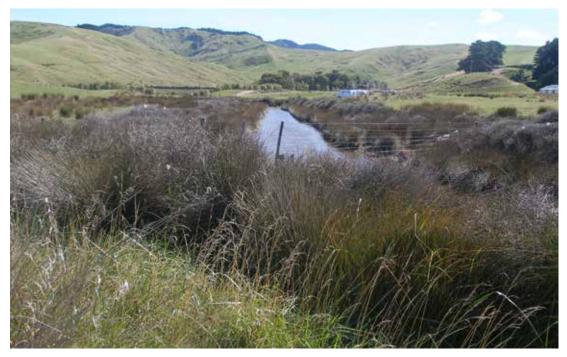
Figure 40.3. Saltmarsh ribbonwood shrubland lines the banks of Otahome Stream. Photo: Matt Todd.

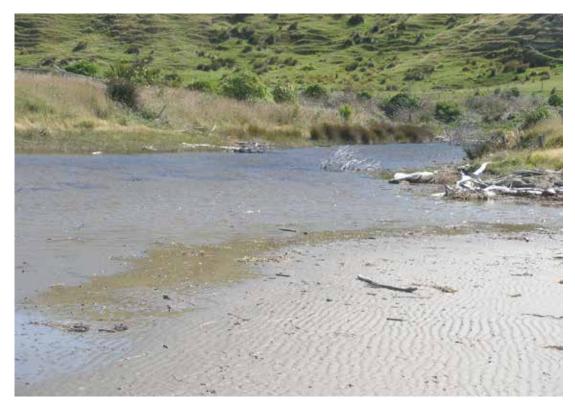
Figure 41.2. The mouth of the 'Humpy' Stream forms a tidal pool, with rushland and riparian shrubs visible on the banks of the waterway. *Photo: Matt Todd.*

This stream has a small Category B estuarine system; a rudimentary tidal pool constrained behind a sandbar (Table 41A; Fig. 41.1). The outlet is often blocked, and at such times saline influence is by seepage or wave splash. The banks of the tidal area of the stream cut through the coastal terrace, and there are narrow strips of saltmarsh vegetation on either side. The banks have been the subject of riparian planting since the 1990s (A. Crofoot, Castlepoint Station 2009, pers. comm.), and shrubs are beginning to dominate (Fig. 41.2).

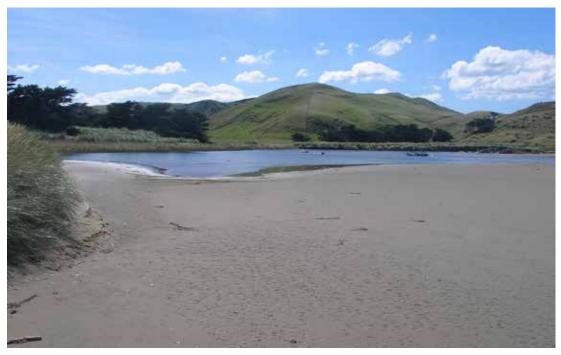
Figure 42.2. The tidal pool at the mouth of Ngākauau Stream. The main stream mouth is at the far left (obscured) while the smaller stream is visible at centre. *Photo: Matt Todd*.
