Estuarine systems in the lower North Island/Te Ika-a-Māui

Ranking of significance, current status and future management options

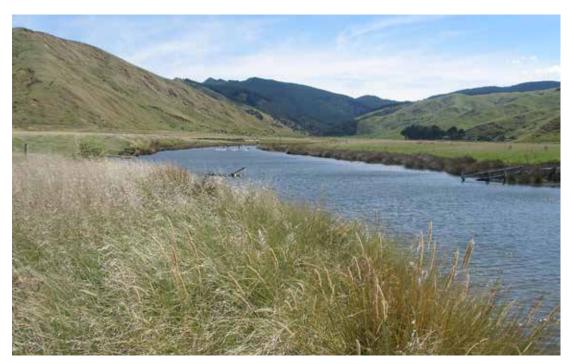
Figure 42.3. The tidal waterway of Ngākauau Stream is lined with narrow strips of searush rushland on both banks. The stream is utilised by waterfowl. *Photo: Matt Todd*.

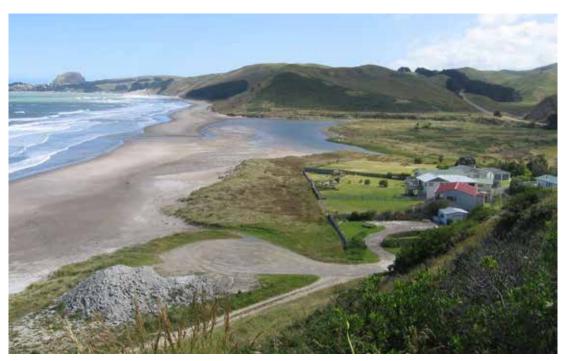
Figure 43.2. An overview of the mouth of the Whakataki River taken in 2009 when the outlet was blocked. The oxbow wetland can be seen occupying the terrace to the right of the large tidal pool. *Photo: Wriggle Coastal Management,* © *Greater Wellington Regional Council.*

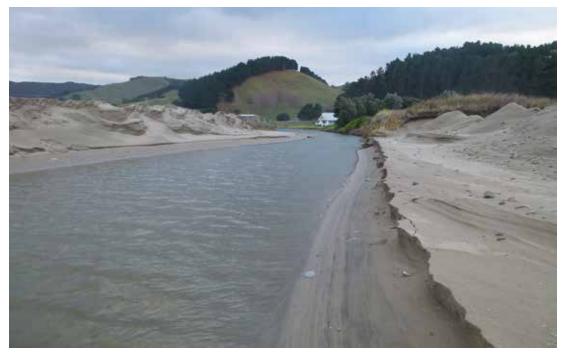
Figure 43.3. Mechnical opening of the river mouth was undertaken in 2015 to prevent flooding to neighbouring houses. Photo: Helen Kettles.

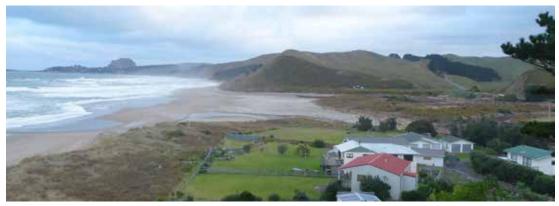
Figure 43.4 The new opening to the sea created in 2015 has diverted water flow from the owbow and tidal pool areas of the estuarine site. *Photo: Helen Kettles*.

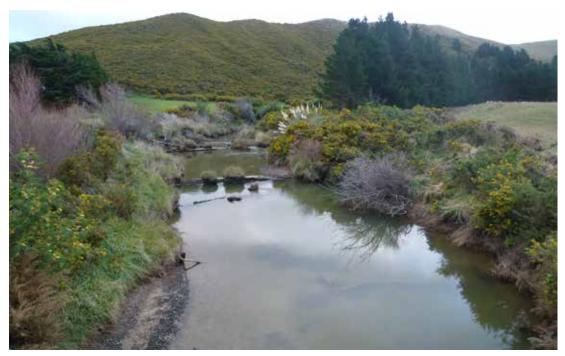
Figure 43.5. Gorse is very thick on the river banks and in the oxbow area of the site. Photo: Helen Kettles.

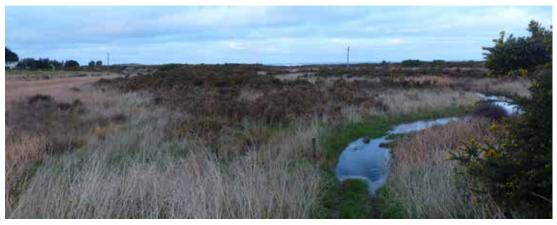
Figure 43.6. A track used to service powerlines dissects the oxbow wetland area. Photo: Helen Kettles.

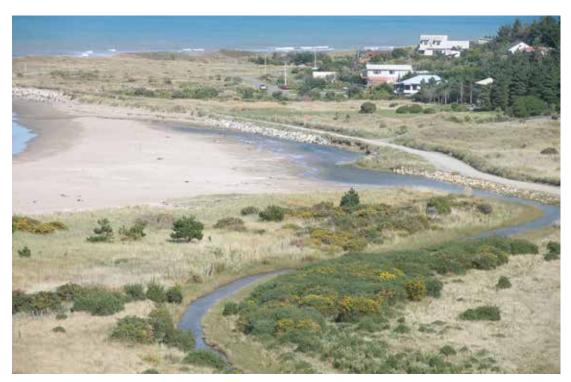
Figure 44.2. An overview of the tidal pool and associated wetland at the mouth of the Ōkau Stream, 2009. Photo: Matt Todd.

When the outlet is blocked (which occurs frequently), the narrow estuarine system of the Ōkau Stream sweeps across the shrubby coastal flat before forming a small tidal pool at the rear of the beach (Figs 44.1, 44.2). At times, the tide flushes over the bar and upstream. It is therefore a dynamic system. The coastal road skirts the estuarine site, constraining its southern end (Fig. 44.3). There are areas of saltmarsh vegetation along the fringes of the site, and an area of associated coastal wetland on the flat, marking a historical oxbow.

Three-square was the dominant species along the margin of the tidal area in 2009 (Figs 44.2 & 44.4), although tall fescue grew thickly along the bank further upstream. The tidal flats were converted into pasture and are now dominated by shrubland. Toetoe, giant umbrella sedge, tauhinu, and tarata were all present in 2009. Horse's mane grows in patches in the stream while knobby clubrush forms thick patches in the open pasture. There are no threatened plant species currently known to be present in the estuarine system, although sand pimelea was recorded in the adjacent dunes by Zotov (1945).

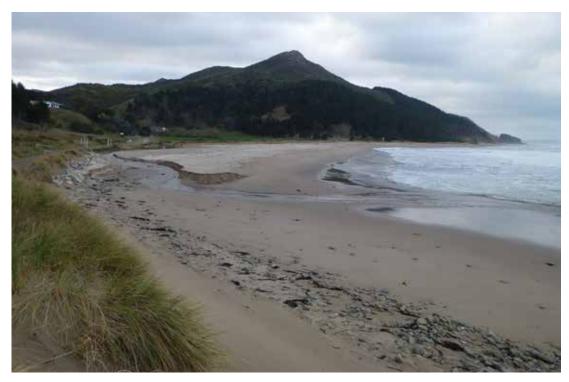
Figure 44.3. The stream mouth is at the southern end of the of the estuarine site and is constrained by the road and rock armouring. *Photo: Helen Kettles.*

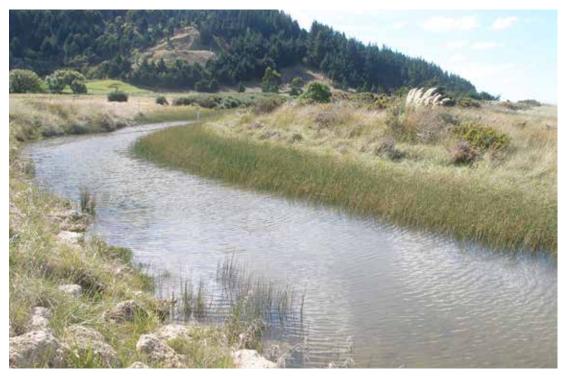
Figure 44.4. Three-square sedgeland lined the margins of the waterway in 2009. Gorse and other ecological weed species can be seen in the wetland further upstream. *Photo: Matt Todd.*

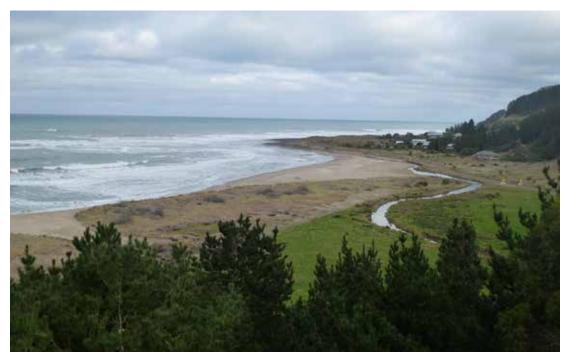
Figure 44.5. The Ōkau Stream now meanders through intensified farm land, 2016. Photo: Helen Kettles.

A range of mammalian predators and browsers will be present but their impacts have not been assessed at this site. Stock access to the waterway has damaged wetland vegetation at the margins (Figs 44.5 & 44.6) as pugging is likely to be exacerbated when tides penetrate into the wetland area.

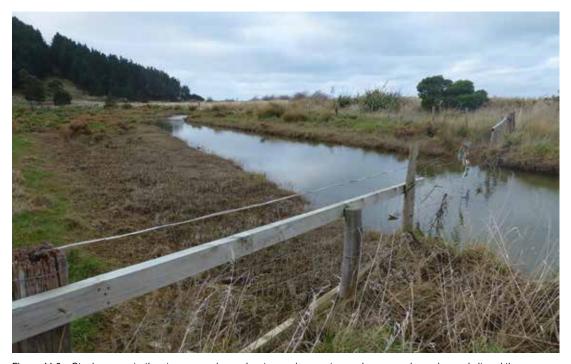
Figure 44.6. Stock access to the stream margins and waterway in recent years has caused pugging and altered the ecological values of the Ōkau Stream estuarine site. *Photo: Helen Kettles*.

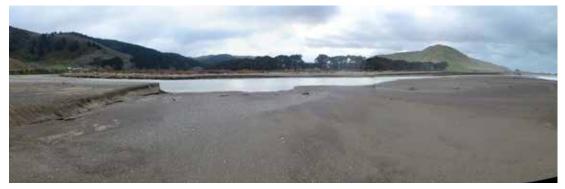
Figure 45.2. The Mātaikona River mouth is dynamic with step margins. Photo: Helen Kettles.

The mouth of the Māitaikona River is a Category B estuarine system constrained by a long sandspit (Table 45A; Fig. 45.1, 45.2). The river is tidal for around 2 km upstream. The estuarine sediments form an important feeding ground for birds that use the spit (Fig. 45.3). There is very little in the way of estuarine riparian vegetation, as the river margins are generally steep and the saltmarsh probably already occupies its maximum extent. There is a fringe of saltmarsh at the rear of the pool. The river drains through a narrow, rocky outlet and may occasionally be blocked.

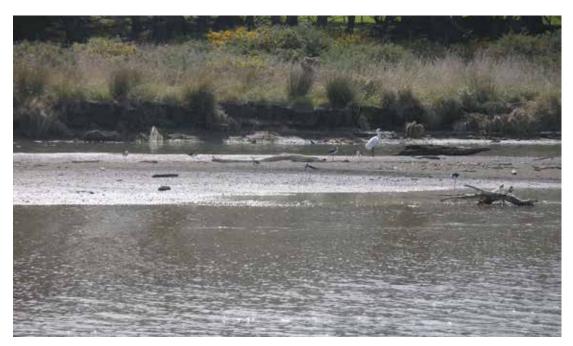
Figure 45.3. A number of shore and wading bird species visit the Mātaikona River mouth to feed in the mudflats. Note the steep, crumbly margins of the tidal pool. *Photo: Matt Todd.*

The mudflats of the shallow pool provide rich feeding grounds for a range of birds. White-faced herons, black shags, pied stilts, black swans and kingfishers are all present. Royal spoonbills (Fig. 45.3) and little shags are also sighted occasionally. On the sandspit, Caspian terns, banded dotterels, variable oystercatchers, southern black-backed gulls and red-billed gulls may be seen. The estuarine site was included in the OSNZ (2007) river mouth bird survey.

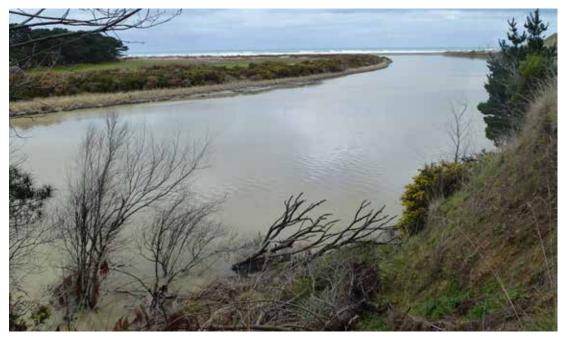
Figure 45.4. The southern side of the Mātaikona River is steep sided but a terrace on the northern side has the remanants of a wetland. *Photo: Helen Kettles*.

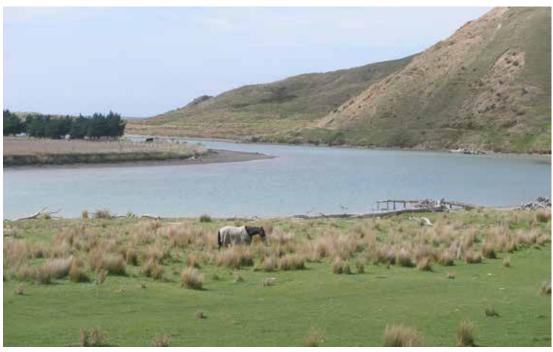
Figure 46.2. A part of the tidal reach of the Ōwāhanga River, looking towards the mouth (obscured at rear). The margins have been grazed for many years, but wading birds visit the mudflats to feed. *Photo: Matt Todd.*

The Ōwāhanga River reaches the sea in broad sweeps, with the river mouth constrained by a short sandbar (Table 46A; Fig. 46.1). The river is tidal for over 3 km, but the river valley has been modified during the early 20th century by drainage of the wetlands for pasture. At low tide, mudflats are exposed in the river bed, flanked by steep banks topped with pasture (Fig. 46.2). The most natural habitats remaining are found in the saltmarsh and mudflats of the river mouth.

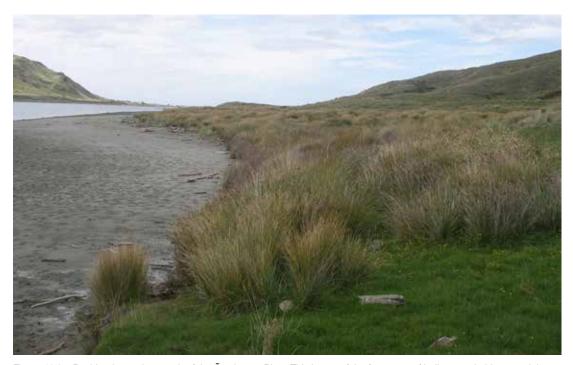
Figure 46.3. Rushland near the mouth of the Ōwāhanga River. This is one of the few areas of indigenous habitat remaining around the tidal area. *Photo: Matt Todd.*

Sea rush and knobby clubrush dominate the wetland areas (Fig. 46.3) on the margins of the tidal area, with wīwī, giant umbrella sedge, tauhinu, and small-leaved pōhuehue also present. Slender spike sedge is present amongst the rushes. There are no threatened plant species in the estuarine system.

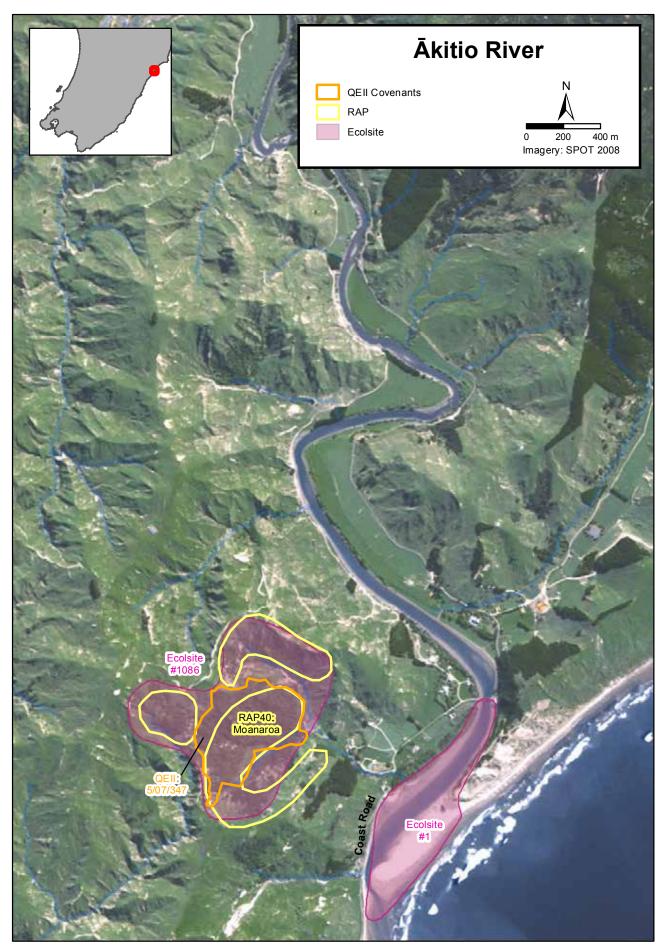
Figure 47.1. Ākitio River estuarine site showing areas and places mentioned in the text.

Table 47A. Ākitio River site information (see also Fig. 47.1).

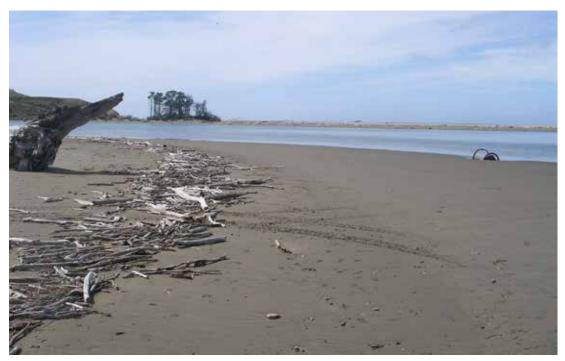
Figure 47.2. The dynamic mouth of the $\bar{\text{A}}$ kitio River mouth forms a large tidal pool amidst extensive sandflats. Photo: Matt Todd.

The Ākitio is a large Category B estuarine system, characterised by a dynamic sandspit at its outlet (Table 47A; Figs 47.2 & 47.2), backed by a large tidal pool. The river is tidal for nearly 5 km. The estuarine sediments form an important feeding ground for shorebirds. There is very little in the way of marginal estuarine vegetation, as the edges of the river are in pasture, and the river margins are generally steep, offering little opportunity for the development of saltmarsh (Fig. 47.3).

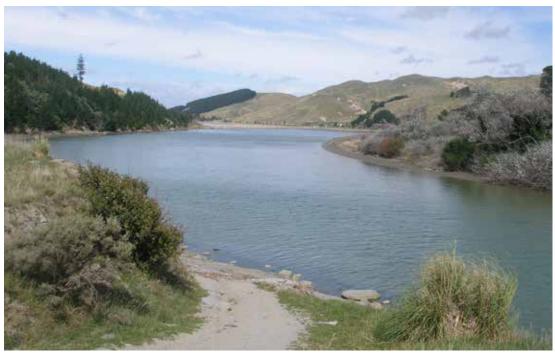
Figure 47.3. The lower tidal reach of the Ākitio River, looking towards the mouth. Exotic treeland occupies the margins of the river. *Photo: Matt Todd.*

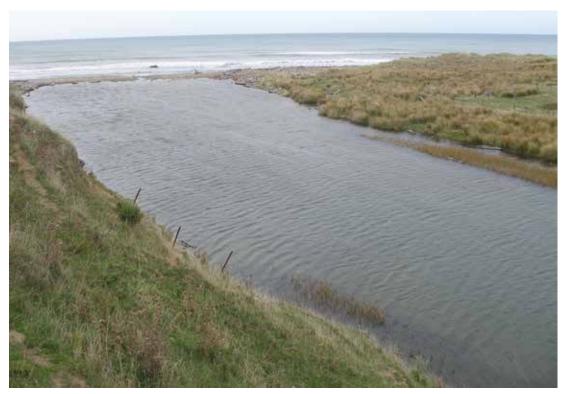
Figure 48.2. The mouth of the Waimata River is blocked, causing the formation of a small coastal lake. Patches of partially submerged three-square sedgeland may be seen, lining the lake margins. Other saltmarsh vegetation here has been grazed. *Photo: Matt Todd.*
