# OTATARA PA HISTORIC RESERVE NAPIER

## CONSERVATION PLAN

# Otatara Pa Historic Reserve Napier Conservation Plan

Including a specification  
for remedial work & regular maintenance

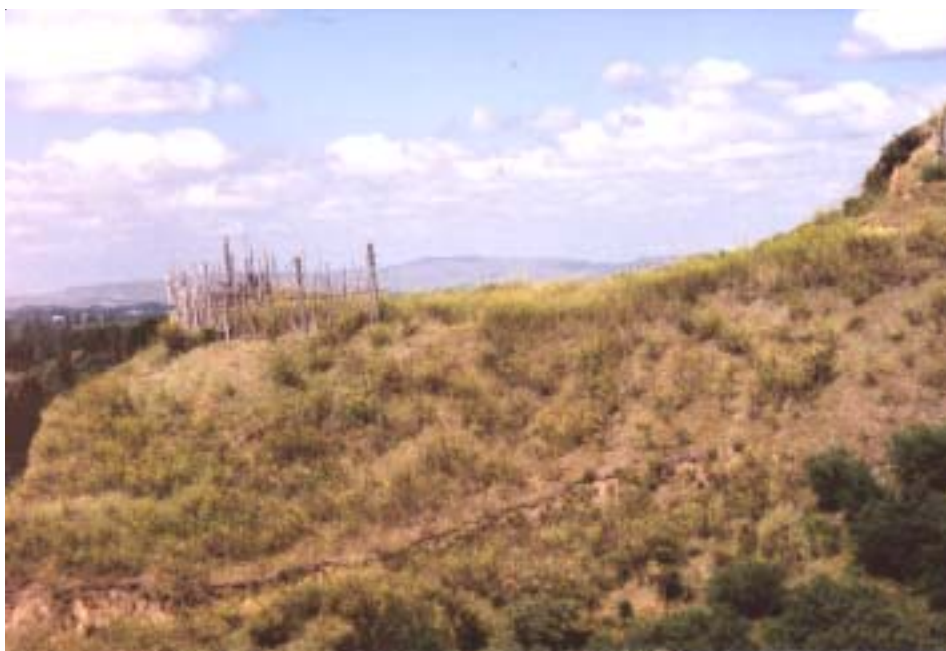
The on-going weed control programme is beginning to reduce the problems identified previously on Otatara Pa proper, but this programme will need to be maintained (Plate 1). Erosion is still occurring on this portion of the site, and the ground cover is sparse.

Plate 1: Otatara Pa proper, showing interpretive pallsades and erosion from quarry road.

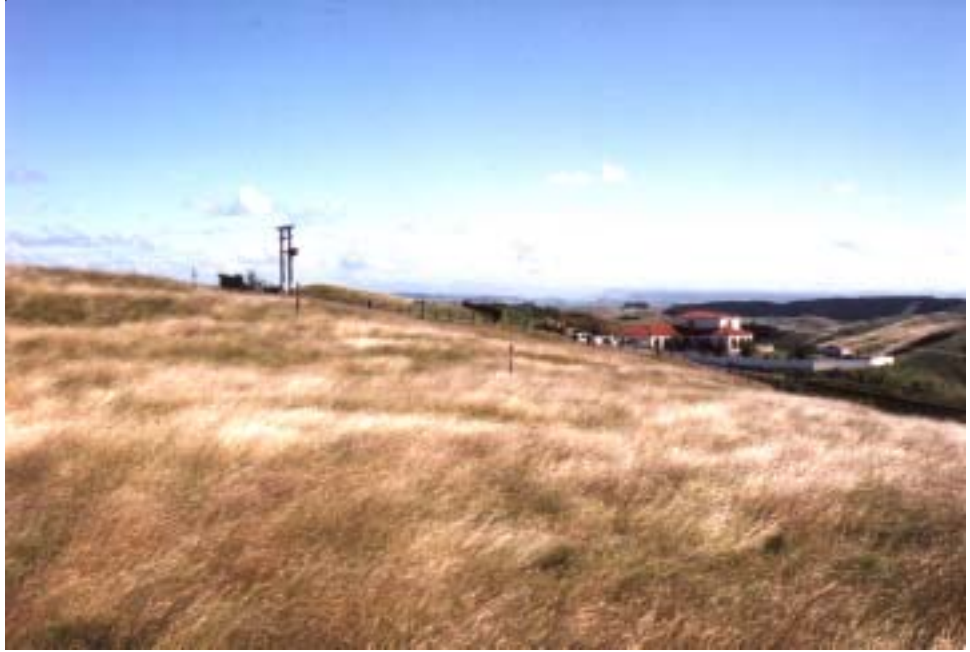
In February 2002 the main platforms and ridges of Hikurangi Pa had not been grazed since October 2001. The pasture sward was dense and well established (Plate 2). No recent damage to archaeological features was evident in these areas.

Plate 2: North-west platform, Hikurangi Pa, showing rank pasture.

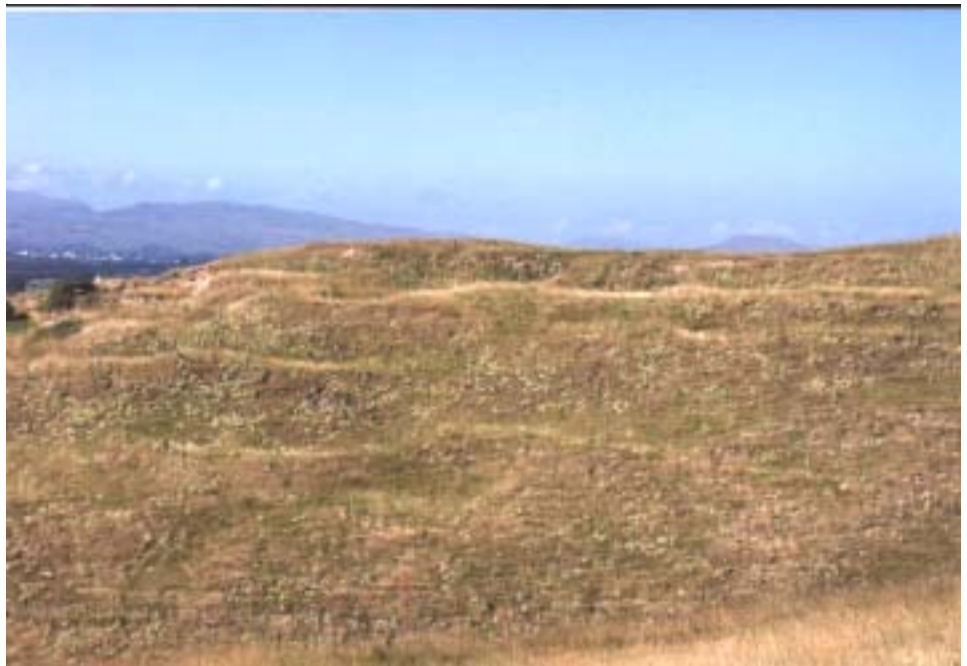
Severe stock tracking and camping was noted on the south east ridge in 1997. This damage is still apparent, however no new damage appears to be occurring (Plate 3). The pasture sward on the slopes is less dense than on the ridges, and these areas are vulnerable to livestock tracking. Damage occurs quickly once the pasture sward is broken, and areas of exposed earth caused by erosion or stock tracking are very slow to regain any vegetation cover (Plate 4).

Plate 3: South-east ridge of Hikurangi Pa, showing previous stock damage.

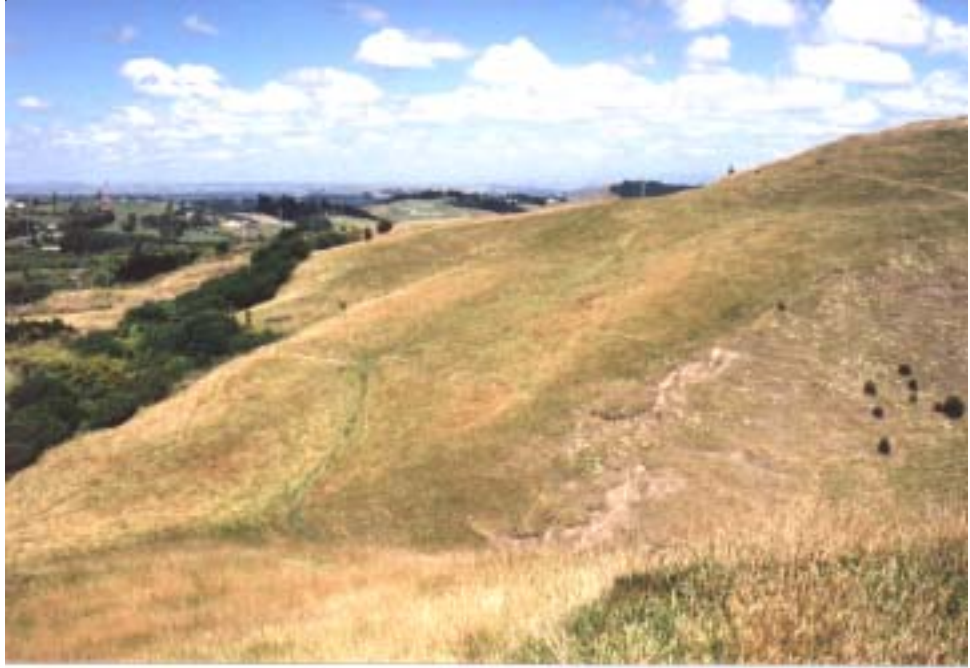
Plate 4: View of lower south-east ridge showing areas of exposed earth caused by erosion and stock tracking.

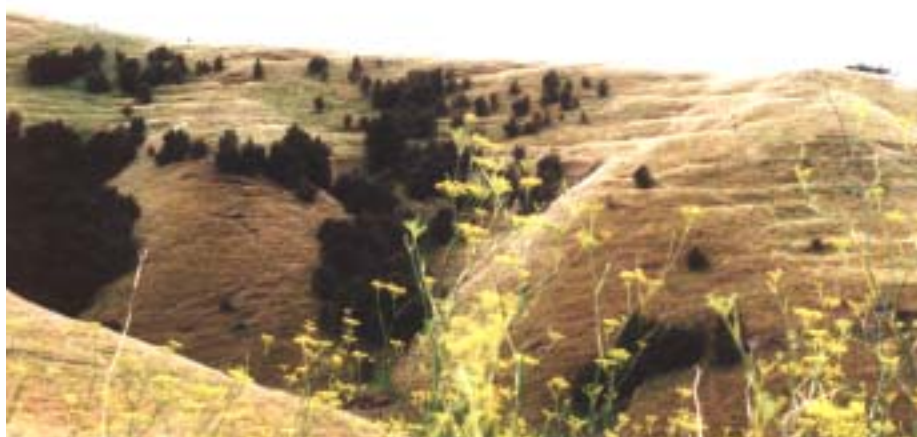
Provided a suitable grazing regime can be established, and weed control continues, it is unlikely that the site vegetation will markedly alter over the next decade. The kanuka tree land, left unchecked, is likely to continue to spread onto the eastern faces and ridges (Plate 5). It should be removed where it is encroaching on to archaeological features. Gorse, blackberry and potato vine will require ongoing control and it would be advisable to control the smilax (*Asparagus asparagoides*) and tradescantia (*Tradescantia fluminensis*) infestations before they displace pasture and become unmanageable.

Plate 5: Kanuka treeland on slopes of south-east ridge.

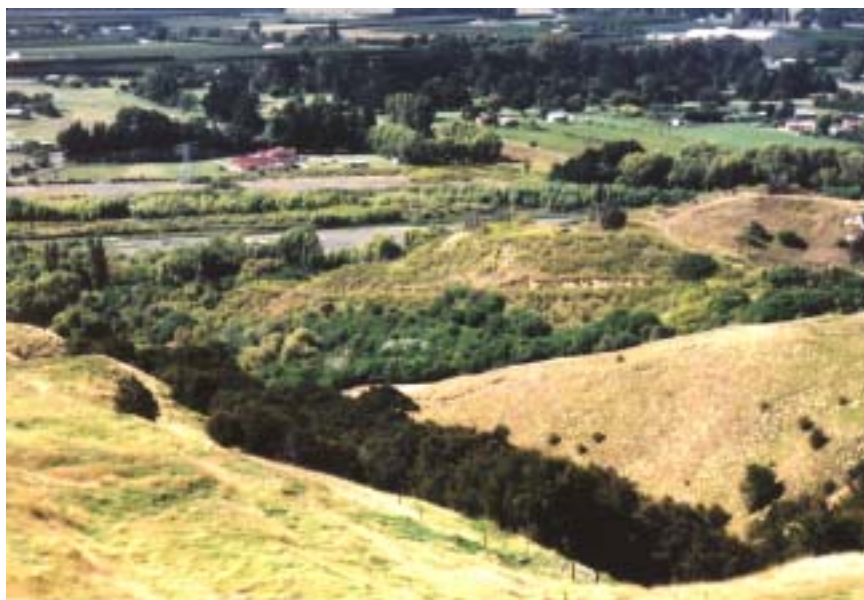
Plate 6: Look south-east to Otatara Pa with Waiohiki Marae in upper left of photo.

This vegetation type is variable. Ngaio, tree lucerne, kohuhu, and, in places, manuka (*Leptospermum scoparium*), kanuka and tutu (*Coriaria arborea*) form a low discontinuous canopy up to 3 m tall. Ti kouka and karamu (*Coprosma robusta*) are also present, and a small stand of poplar (*Populus* sp.) occurs below the pa. In the more open areas, fennel, blackberry, bracken (*Pteridium esculentum*), *Microlaena stipoides*, cocksfoot, Yorkshire fog, and paspalum (*Paspalum dilatatum*) are common, with occasional *Poa anceps*, *Calystegia silvatica* and potato vine. Pampas (*Cortaderia* spp.) is locally common. Firethorn (*Pyracantha angustifolia*) occurs in places. (Plate 6)
