Heritage Assessment: Gun Battery and Radar Station Bream Head

Maria Butcher
January 2011

Department of Conservation

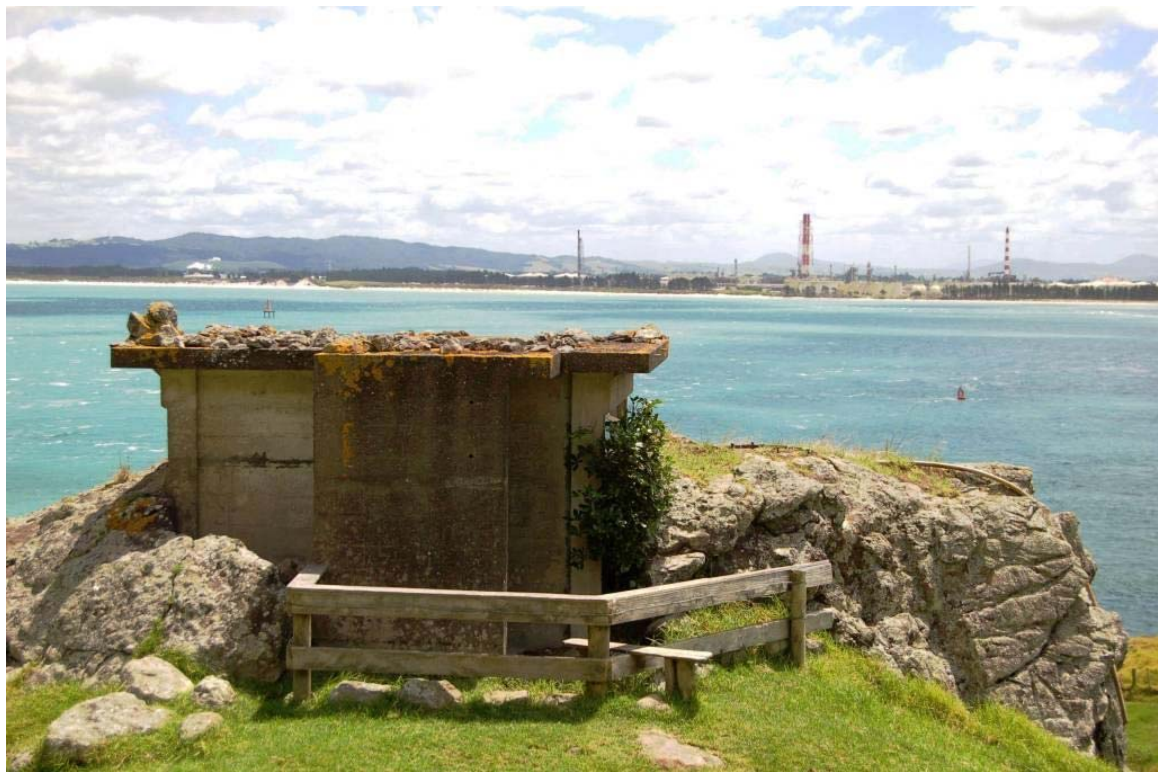
Figure 1: The rear of the B.O.P. Note the rocks cemented to the roof.

The B.O.P. is a small rectangular building measuring 8 by 10 feet (2.4 x 3.0m), with a narrow window around three sides of the building. It is sited above and to the south of the gun emplacement. As shown in figure 1, the B.O.P. is set into a rock cut; from the sea-ward side, only the narrow window and the roof of the building project above the rock. Small rocks have been cemented to the roof of the building, to improve the camouflage. Inside the building a mural has been painted onto the concrete wall immediately above the window. The painting is 0.28m high, 2.44m wide on the sides and 3.05m wide at the front of the building. S. Hillary, an art conservator, considers the painting “well-executed”.¹⁹ She describes the painting as follows –

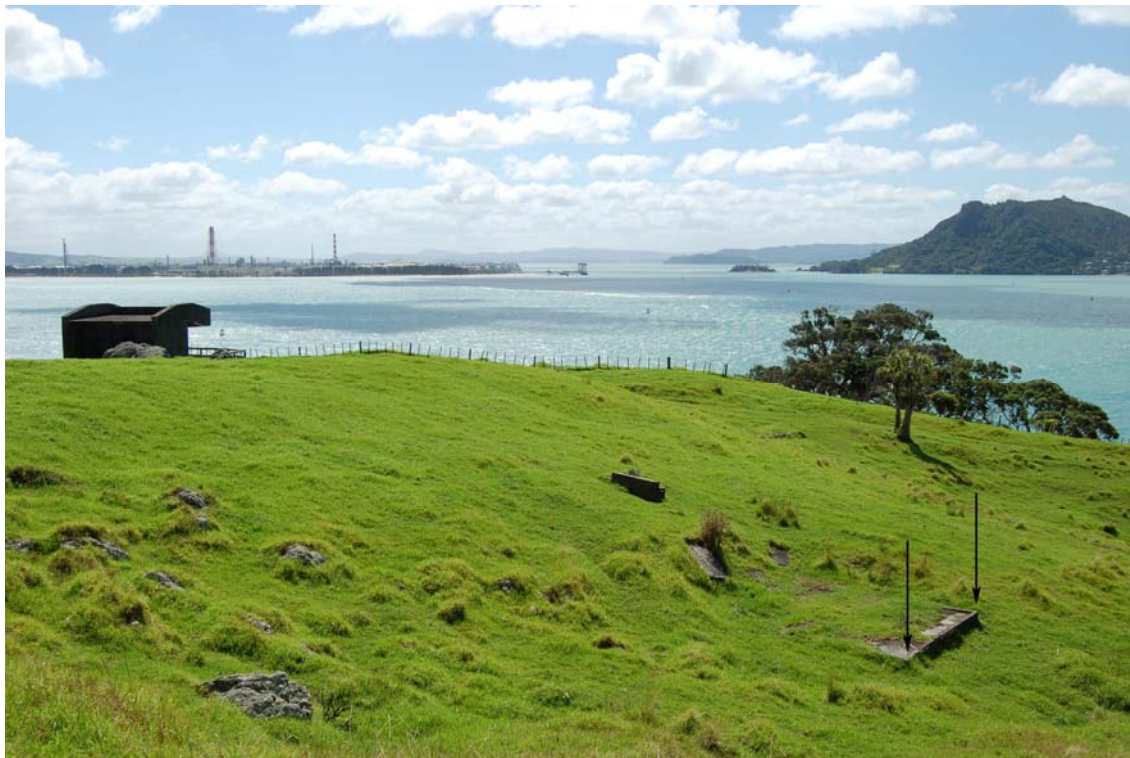
Figure 3: Site of accommodation building. Arrows mark corners of concrete platform.

Figure 3 is the site of the accommodation building taken from above. The photo suggests that there has been considerable soil movement since the building was demolished, partially covering the site.

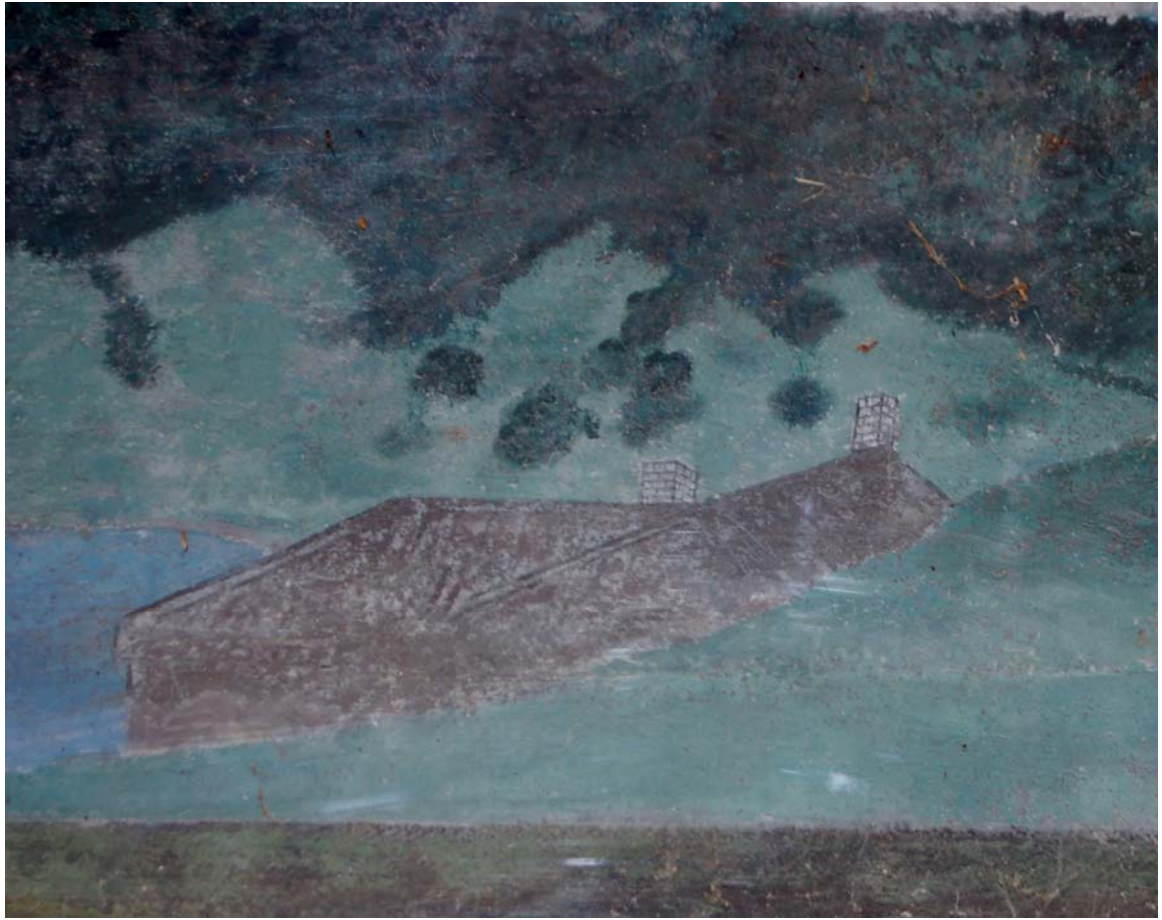
Figure 4: Part of the B.O.P. mural showing the accommodation building.

The accommodation building – which was disguised as a farmhouse – is no longer present. It is, however, depicted in the B.O.P. mural. The mural shows that the ‘farmhouse’ was sited to the north of the B.O.P. over a low ridge. The building depicted is either ‘L’ or ‘T’ shaped, with a rectangular hipped roof and two fireplaces. The site of the building is marked by an *in situ* concrete platform measuring 4.6 m across, displaced concrete slabs, and a set of displaced concrete stairs.

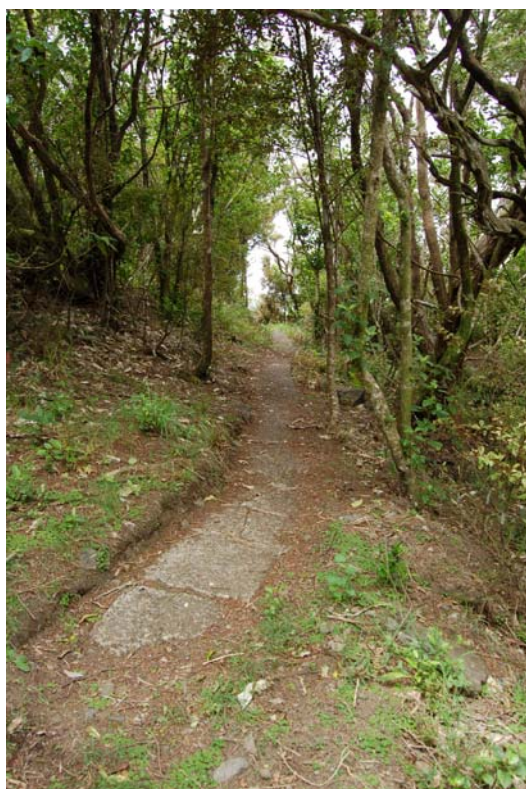
Figure 7: Path connecting radio hut to accommodation/laundry site.

The radio hut is connected to the site of the accommodation by a narrow concrete path which curves around the side of the knoll. The path is 0.45m wide and about 40m long. At the end of the path are concrete foundation slabs and a jumble of concrete rubble, shown in figure 10. There are two large concrete slabs measuring 3m x 5.15m and 3m x 3m. The dimensions of the slabs, and the presence of downpipes and drainage pipes, suggest that these are the ruins of the laundry/ablutions block.²¹

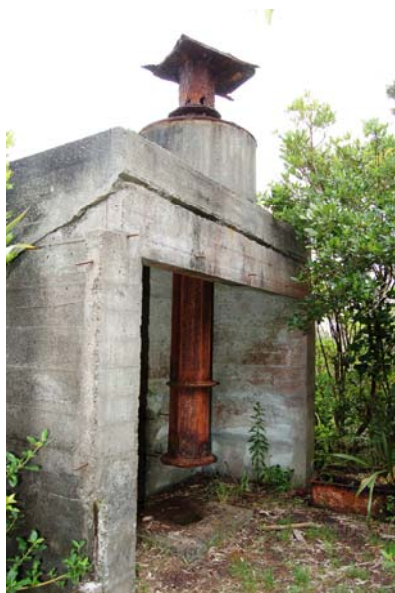
Figure 9: (left) The concrete tower and antenna shaft of the type C radio hut at Bream Head.

The concrete portion of the radio hut which housed the antenna is still standing, with the antenna shaft in place. It is an open-sided structure, measuring 3.35m x 1.5m x 3.2 metres high from the hut floor. There is a small compartment below floor level for access underneath the radar apparatus. Figure 8 is part of PWD 109653, the blueprint for “type C” radio huts. As shown, the concrete tower was attached to a hut measuring 16 x 14 ft, with a bench in the corner. As suggested in the archives, the flat area for the hut looks to have been blasted into the rock face.

Like the gun emplacement, the concrete radio hut has defects which include cracking and spalling. At present, the spalling is not severe. However, there is a wide crack with some displacement penetrating the width of the building.

It would be preferable for the defects to be stabilised or repaired. As with the gun emplacement, monitoring of the problem areas is recommended to determine the rate of deterioration.

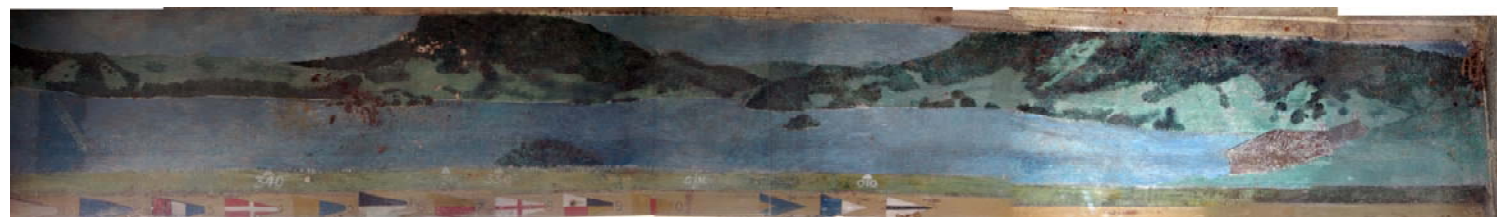
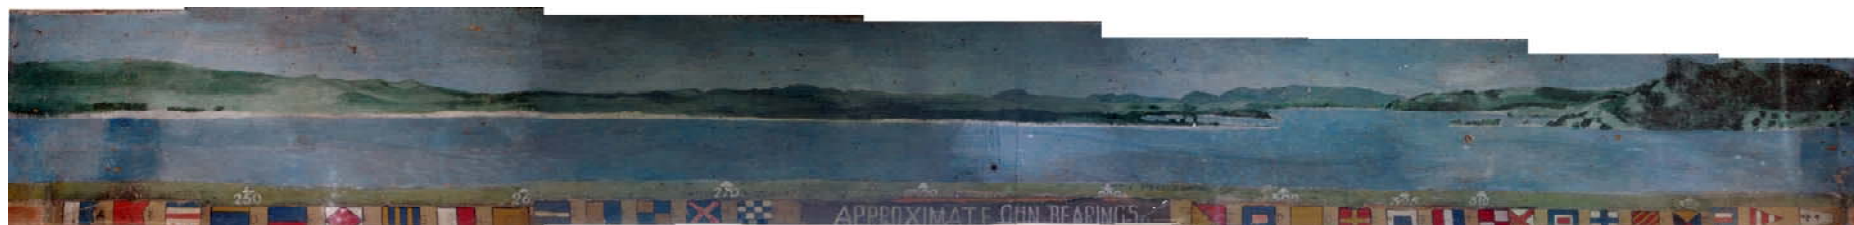
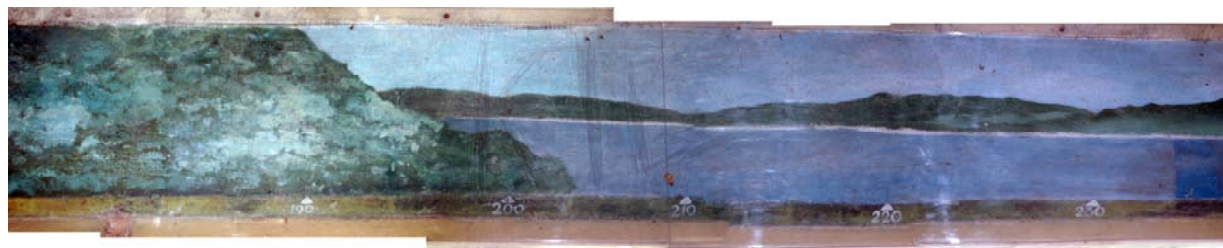
Appendix A: Panorama of B.O.P mural.

The subject of the painting is an accurate panorama of the landscape visible through the windows. The painting was measured off in degrees and its purpose was to assist in the quick identification of the location of a sighting. [...] Below the panorama is a green-painted strip with the degree positions painted on it and below that, in the upper window frame are the words APPROXIMATE GUN BEARINGS. Around these words on the front and right sides are flag symbols for letters in the alphabet and numbers to ten. This was no doubt intended as a prompt for semaphore interpretation. On the wall at the back of the room are two painted signs, the one of the left titled RANGES AND BEARINGS/TO DATUM POINTS and the other which is very damaged, titled APPROXIMATE RANGES & BEARINGS.²⁰

From top: looking north (side window), looking west (front window), looking south (side window)

Fifteen years after restoration, the B.O.P. mural requires some attention. Mason bees have invaded the gap between the mural and its perspex cover, and are building nests directly on the painted surface. The perspex needs to be removed, and the nests removed with great care. NB: Chemicals – such as fly spray – are not to be used on the painted surface. It is likely that the perspex cover has reached the end of its life, so a new cover should be manufactured before the old one is removed. A gap must be maintained around the edges of the cover, to prevent moisture accumulating on the surface of the mural.

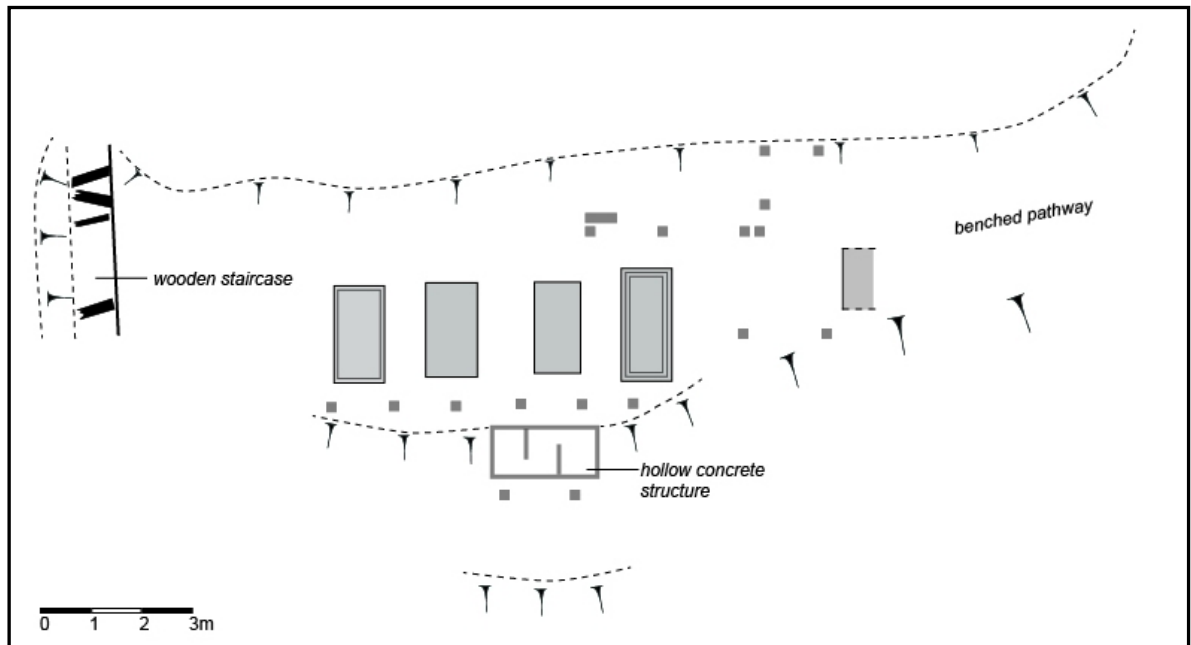
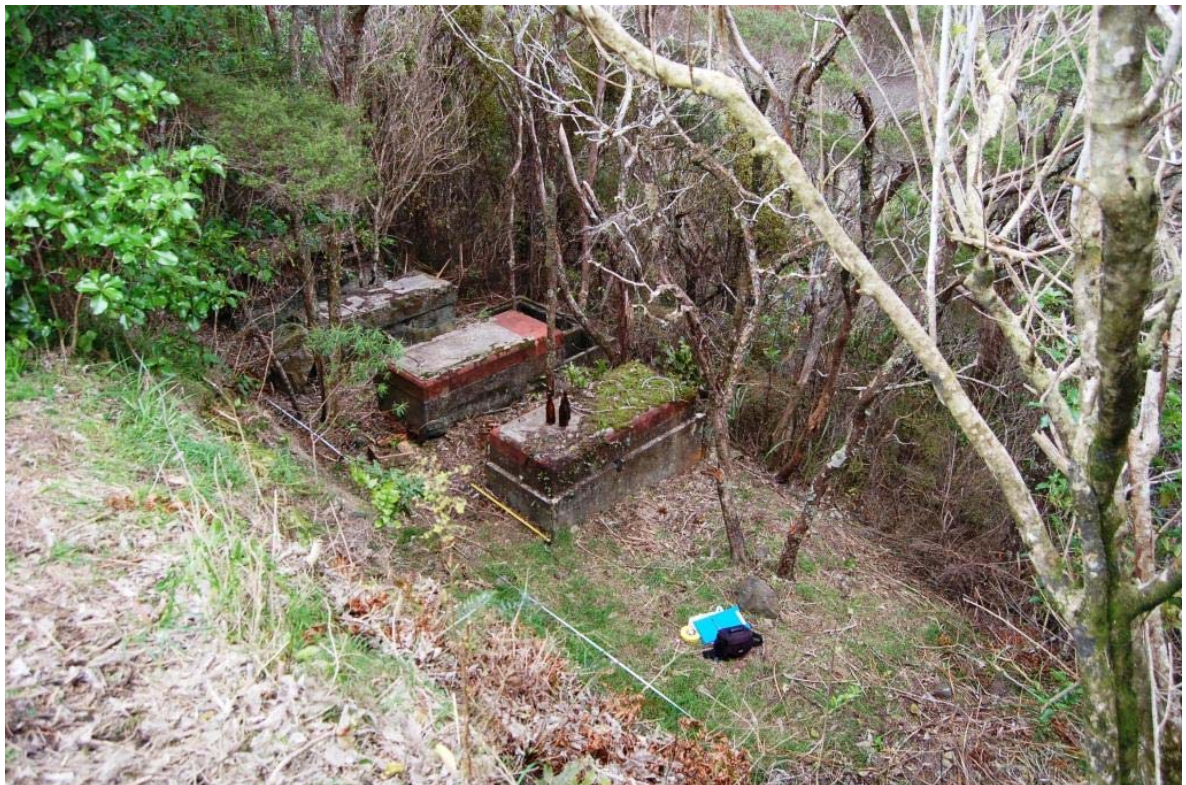
Appendix B: Plan and photograph of power house site. Compare with contemporary plans for power house in Appendix D.

On the other side of the knoll is the site of the power station. The four concrete plinths for the stations’ diesel generators are present. Each plinth is about 1.0 x 2.0m in plan. Their heights range from 0.65m to 1.0m, depending upon the level of the ground surface. Shown in Appendix B is a plan of the site today, along with the standardised P.W.D plan for the building. The building was designed to house three generators, but in mid-1943 it was altered to house a fourth²².
