WWII Mine Control Station Moturua Island

Historic Heritage Assessment

WWII Mine Control Station, Moturua Island: Historic Heritage Assessment

Melina Goddard, DoC, Bay of Islands Area Office 2010.

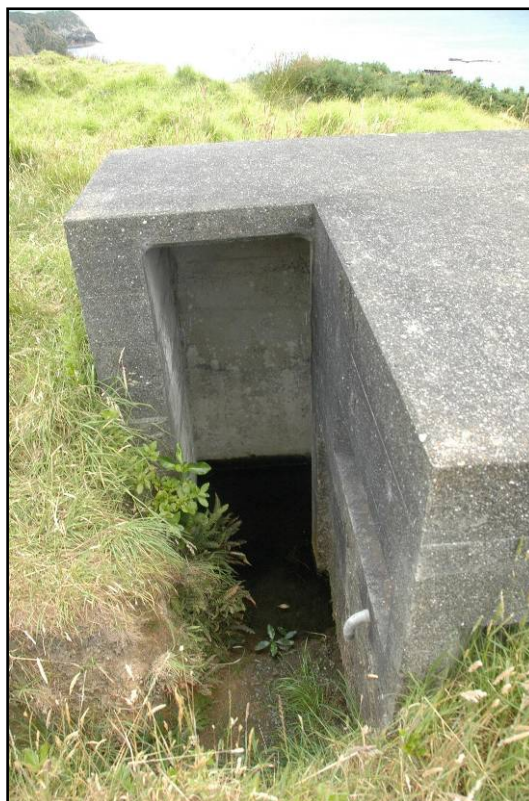
This post is located on the top of Hikurangi Pa on the northern headland of the Waiwhapuku Bay (fig 2). It is a reinforced concrete structure and has been excavated into the platform of the pa. The post is L shaped and measures 3.0m x 3.5m overall with a 1.5m x 1.2m entrance. The walls are concrete but may have been overlaid in timber during its operational life. A trench leading from the post's entrance to the end of the platform has been excavated to a depth of 2m and a width of 1m so that the lookouts could move in and out of the post unseen. A 4" clay pipe in the centre of the roof of the post served as an air vent, and a hole through the wall 1m below ground level acted as a cable duct. There are deep set windows on four of the five aboveground walls of the post. These still have their wooden frames and were once glazed (see appendix 11).⁷

Figure 2: Observation post on Hikurangi pa (DoC)

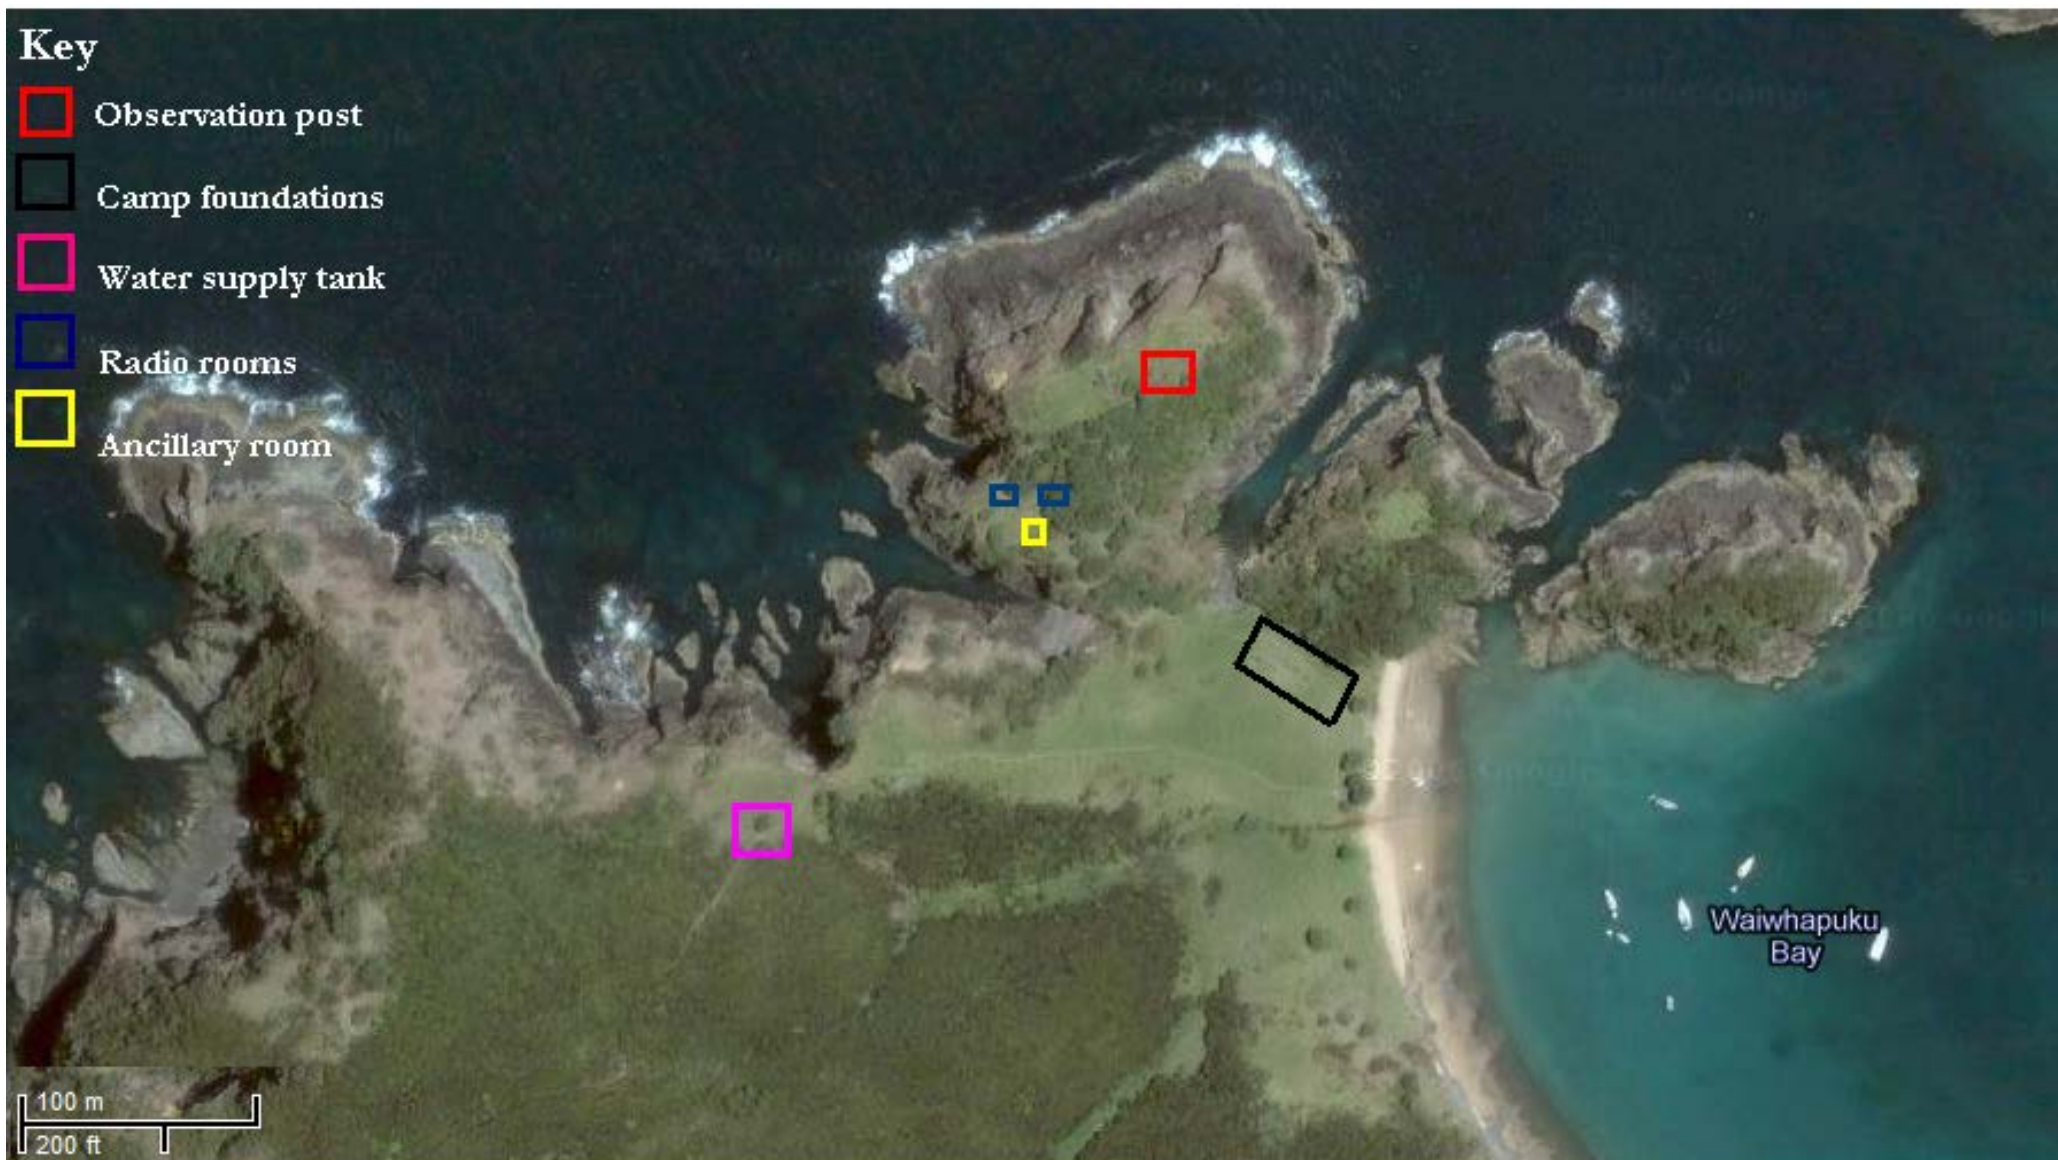
Appendix 2: The northern end of Waiwhapuku Bay showing the locations of the elements of Moturua Island station.

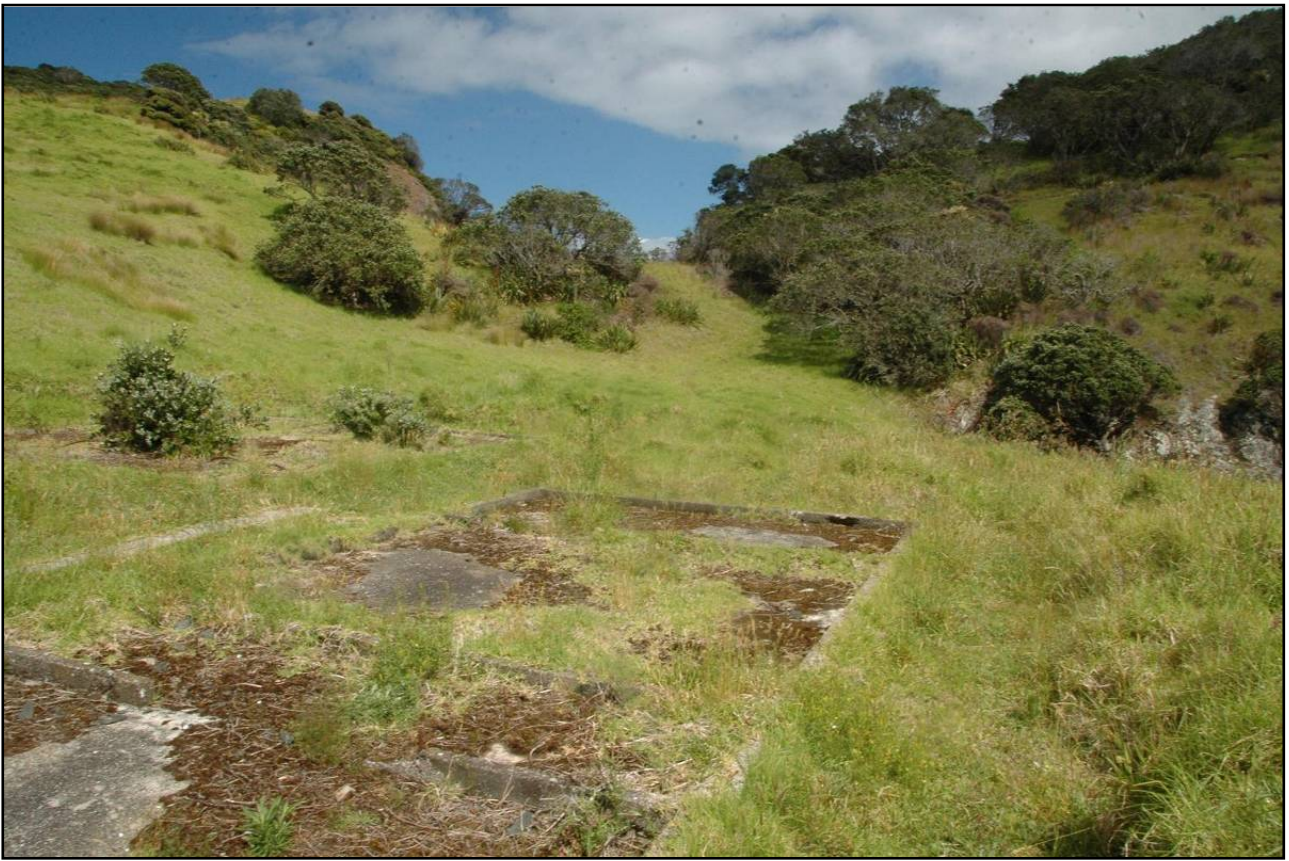
An early photograph of the camp with a handwritten layout plan describes the buildings that made up the camp (fig 1). These were 4 officer's cabins, an office, galley and mess, 5 four berth cabins, a recreation hut, and a joint toilet and engine room complex. The smaller buildings were wooden and the larger ones were built on concrete foundations. All of the structures were removed before the end of the war. Today the only visible remains are the concrete pads from the toilet block/engine shed, workshop and office (see appendix 3, 4). On the beach bank in front of the foundations are the remains of the minefield cable loop.

Appendix 3: A section of the campground foundations located on the bay flats (DoC).

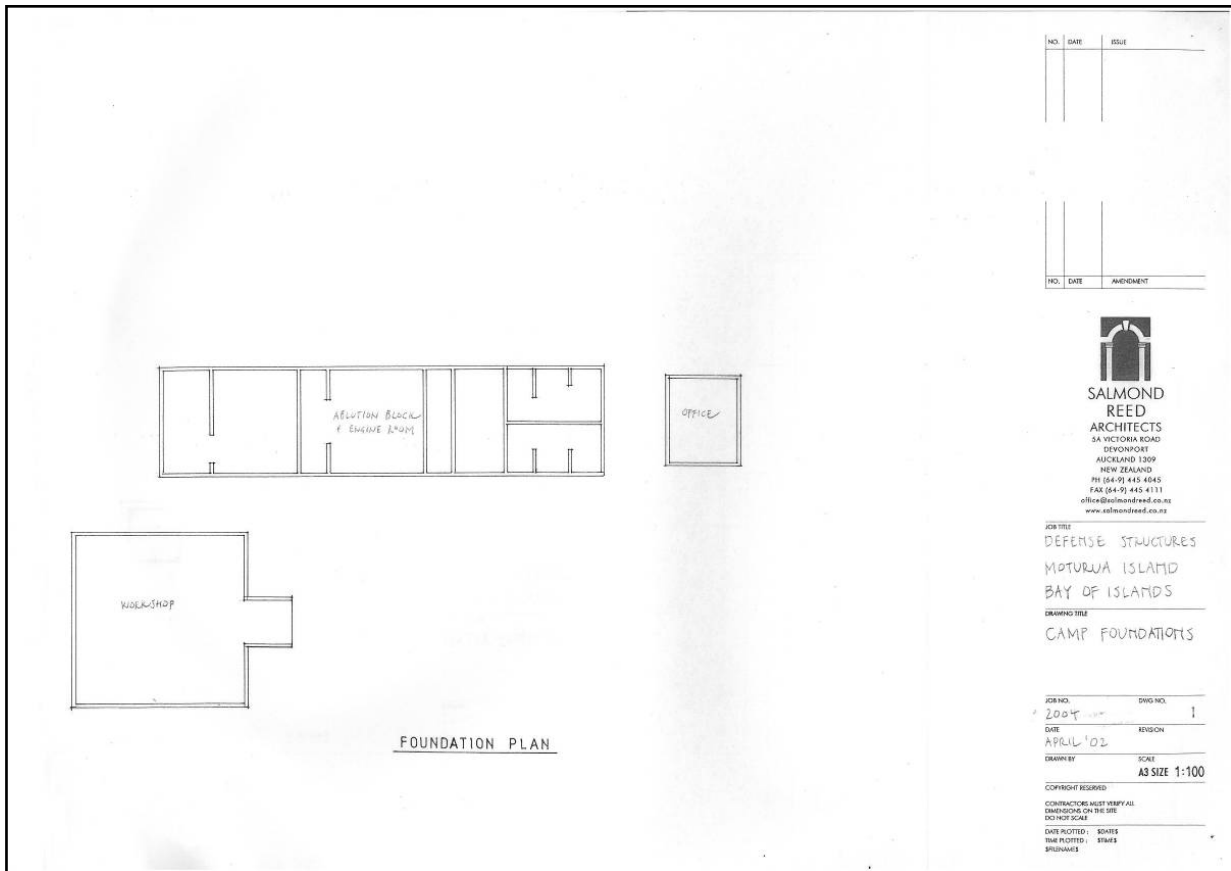
Appendix 4: Camp foundations plan by Salmond Reed 2002.

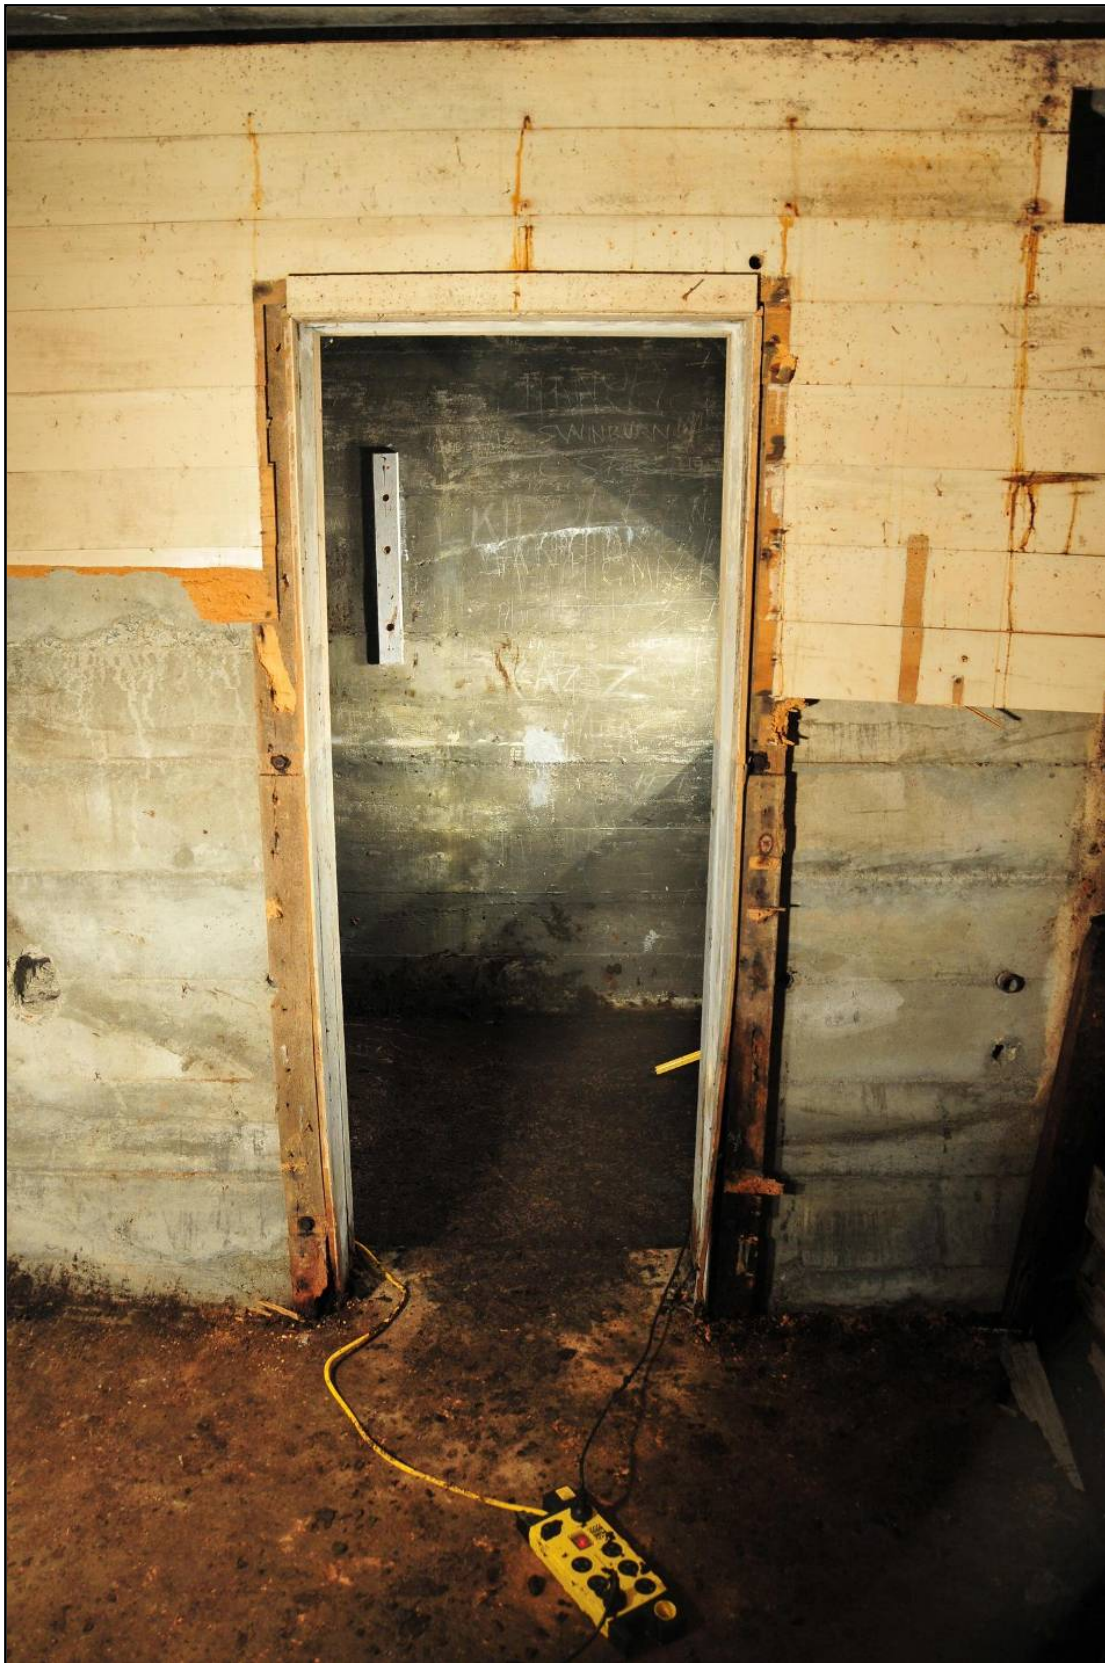
The power station consists of three under ground structures located on the southern flank of Hikurangi Pa. They are constructed of concrete and access is from three above ground 1m square shafts. The rooms are an L shaped and have connecting doorways to a larger room. One of rooms is plain concrete with the access shaft and circular vent hole

in the ceiling. The floor is concrete with the remains of a raised timber floor and the wooden door frame is still present (see appendix 5).⁵

Appendix 5: The doorway of the radio room. Shows the painted timber overlaid on concrete walls (DoC).

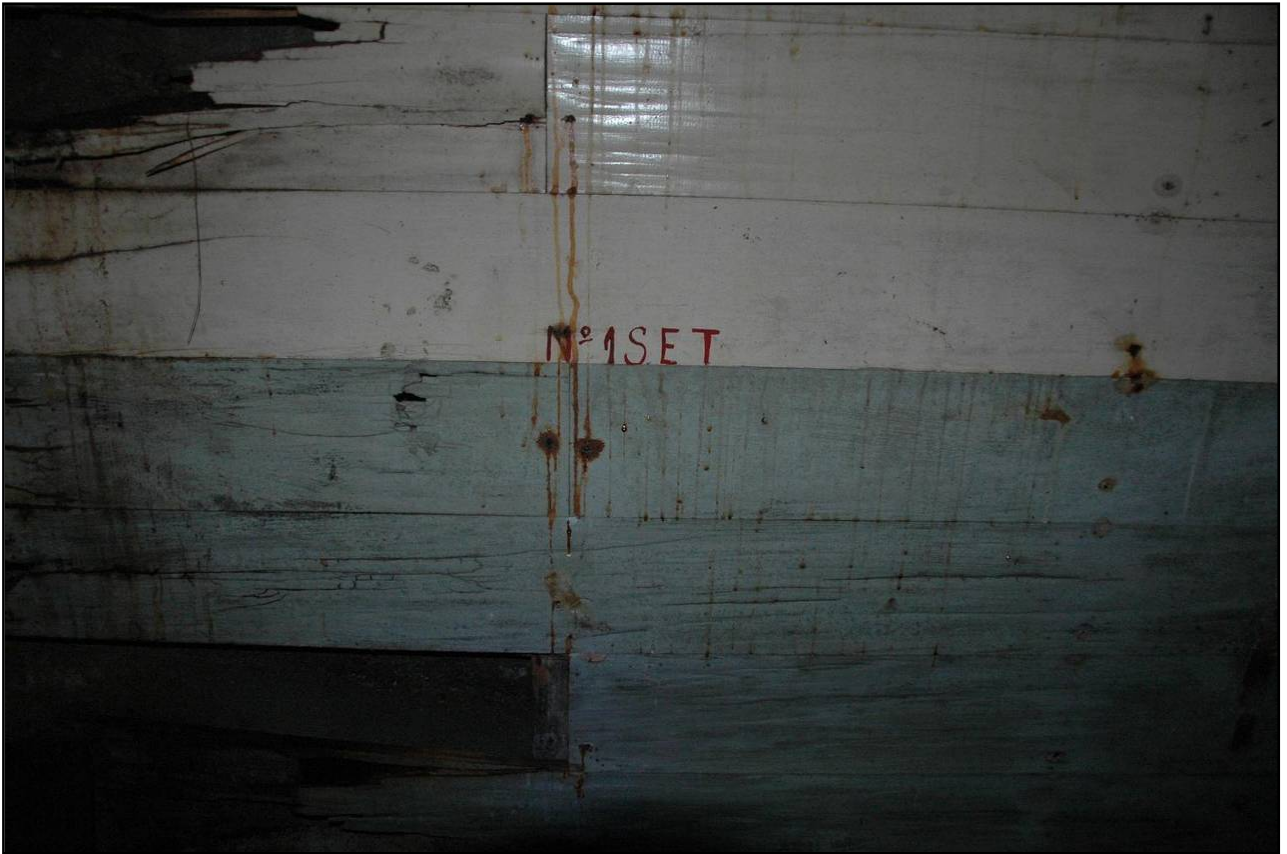
The second radio room is larger and the walls are lined with painted timber. Unlike the other radio room this does not have the remains of a raised timber floor over concrete (see appendix 6, 7, 8). There is however a raised bed of concrete located at the end of the room possibly where heavy equipment was placed. The ceiling has a circular vent hole and a single timber board that runs across the ceiling.⁶

Appendix 6: Wall of radio room showing “No. 1 set” indicating radio locations (DoC).

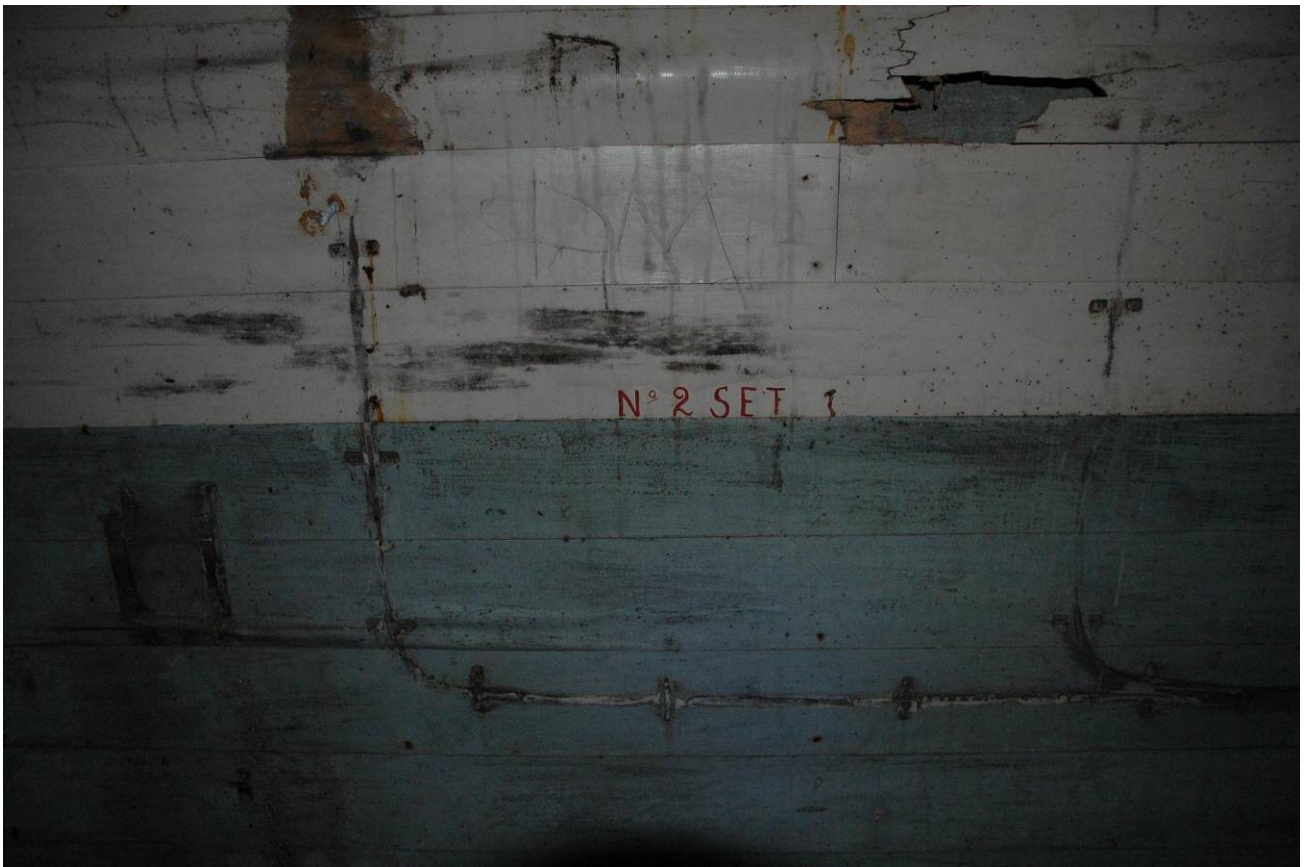
Appendix 7: “No. 2 set” location of 2nd radio (DoC).

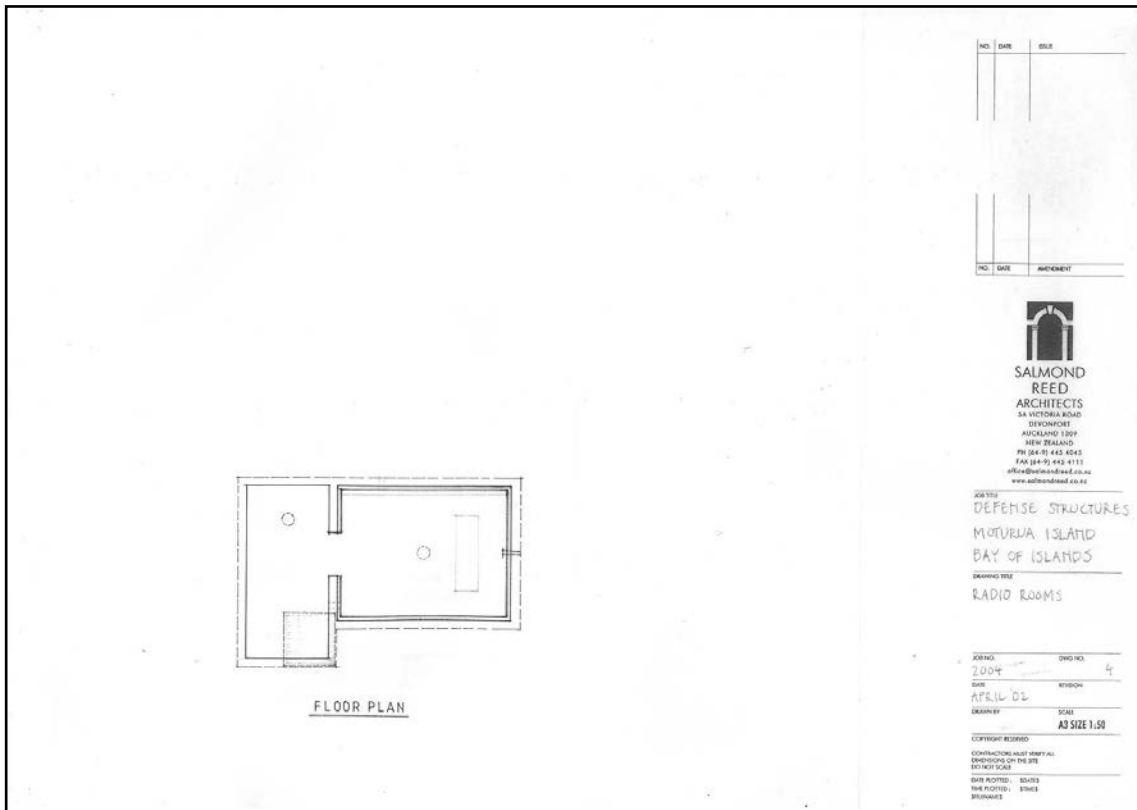
Appendix 8: Radio room plan by Salmond Reed 2002.

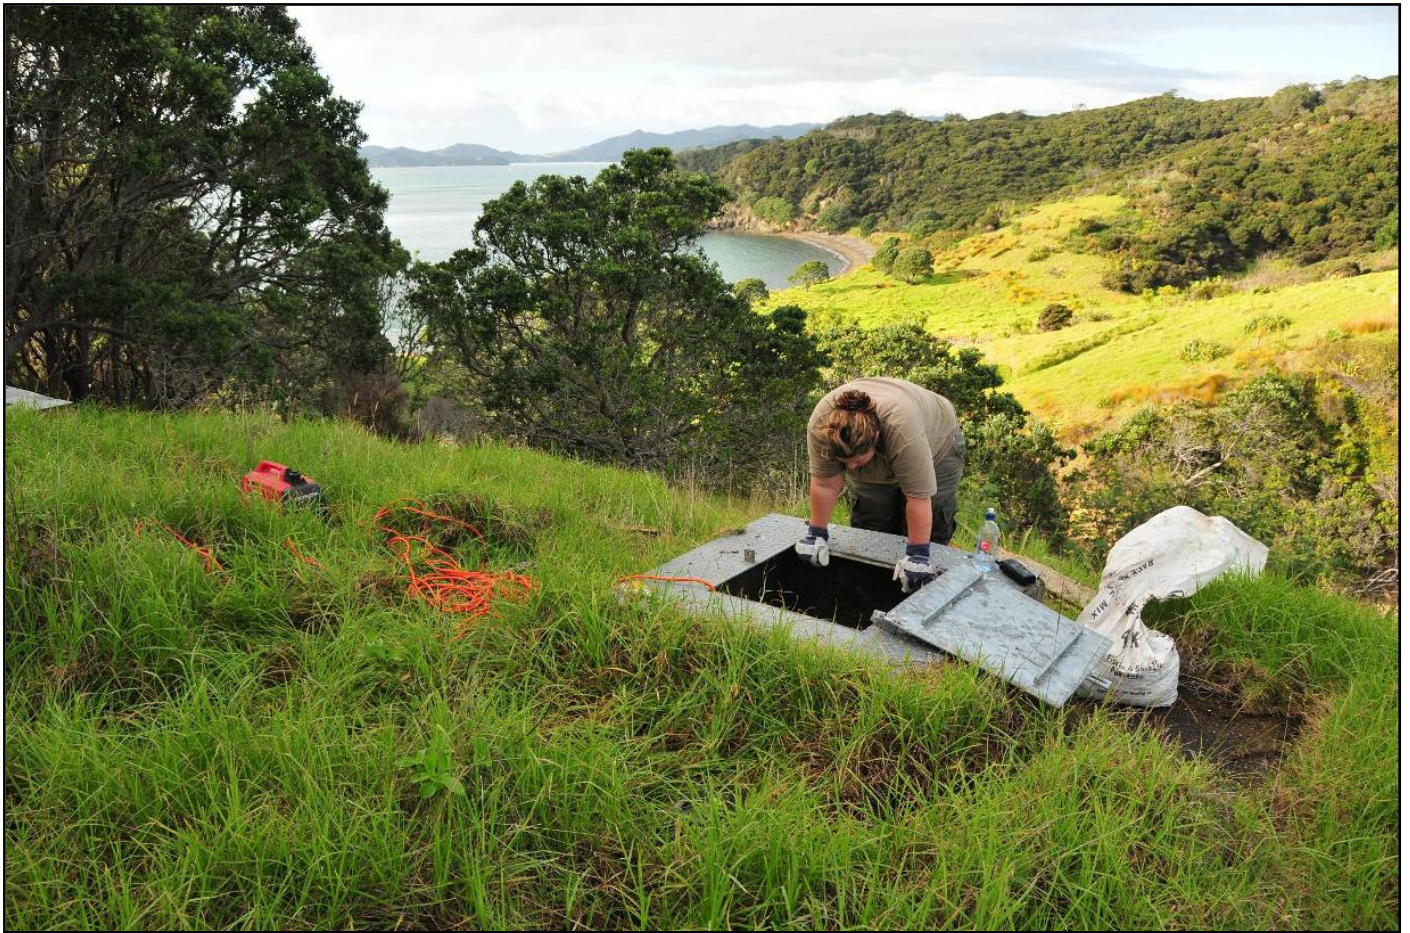
Originally the three shafts may have been entered via ladders and steel hatches. After the station was abandoned wooden security grills covered the shafts. Today they are covered with raised steel hatches that are padlocked (see appendix 10).

Appendix 10: The entry shaft to one of the radios taken during the 2010 clean up, facing south (DoC).
