## Macrophyte monitoring in Waituna Lagoon - Summer 2014

Prepared for Department of Conservation, Murihiku Area Office,  
Southland

NIWA Client Report No: DOC14206  
Report date: April 2014  
NIWA Project: CHC2014-037

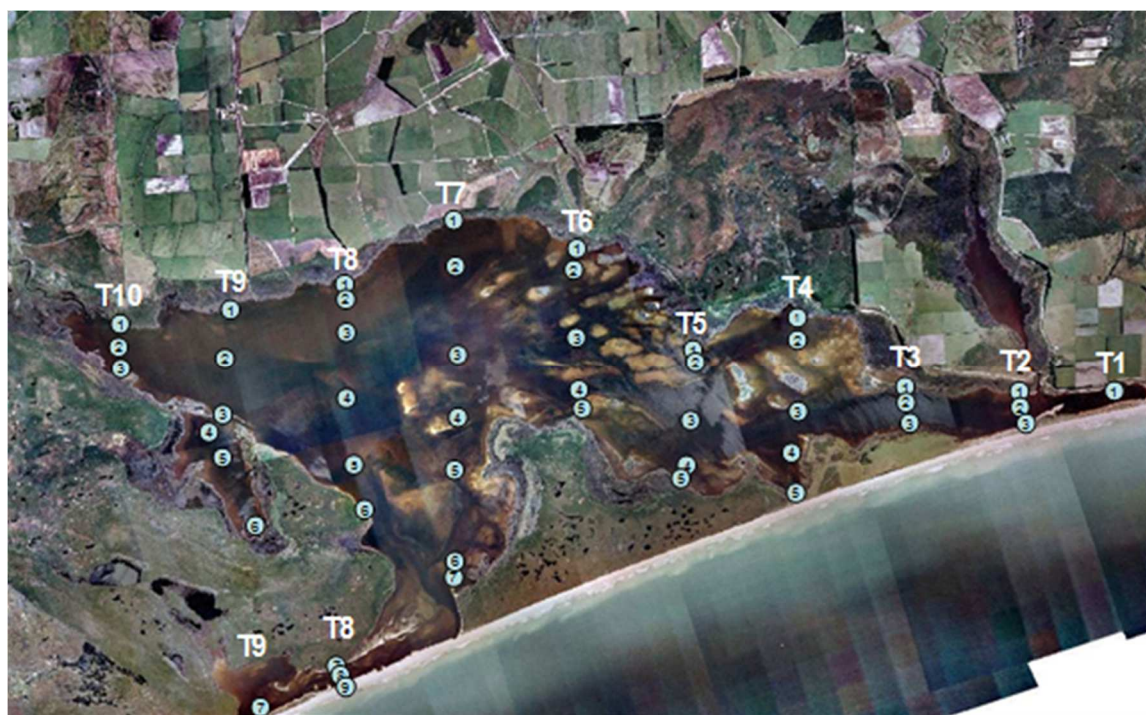
A total of forty eight sites situated on ten transects (orientated north-south) were surveyed across Waituna Lagoon (Figure 2-1). The sites were established in 2009 by Robertson and Stevens (2009) and are positioned in locations designed to represent both the shallow and deeper water habitats of the lagoon, with additional sites established on longer transects to improve spatial cover.

**Figure 2-1: Geo-referenced survey sites located in Waituna Lagoon.** Transects are numbered 1 to 10 from East to West and numbered on each transect in ascending order from North to South.

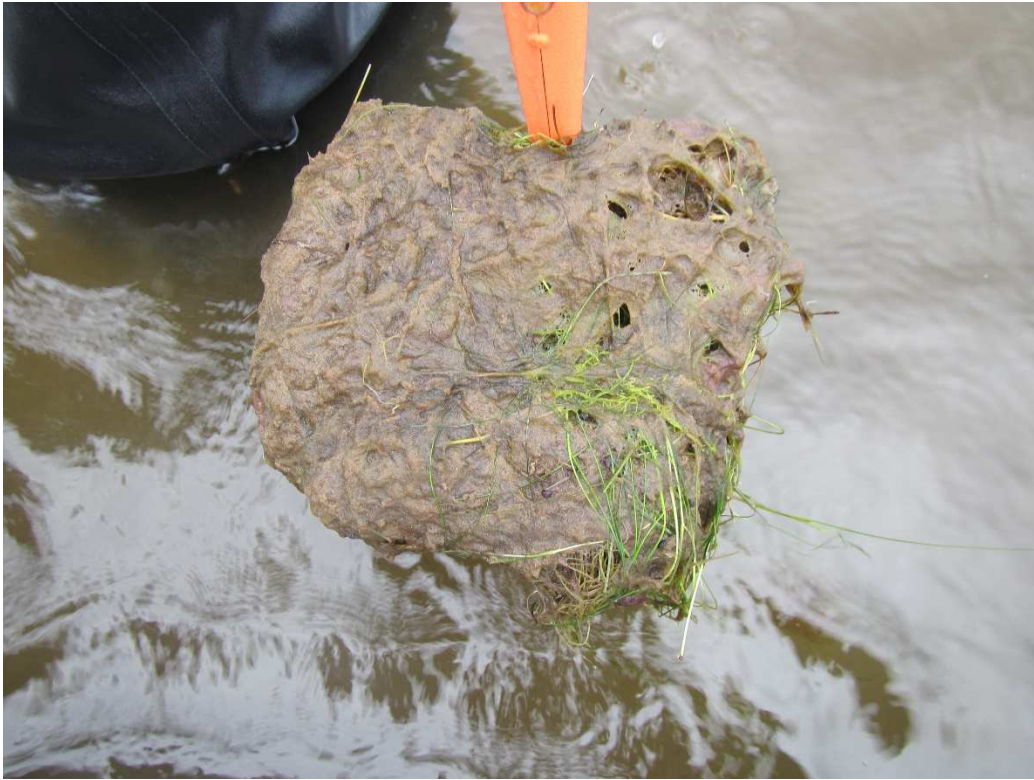
Figure 3-4: The marine macroalga *Bachelotia antillarum* smothering *Ruppia polycarpa*.

In addition to desiccation, the presence of marine macroalgae in the lagoon during open periods may negatively impact on *Ruppia* beds. The two macroalgal species recorded present during the 2014 survey are capable of smothering the *Ruppia* spp. beds as well as occupying habitat that would otherwise be available for *Ruppia* spp. growth. While this is likely to negatively impact on the growth of the *Ruppia* beds it is difficult to ascertain the degree of this effect as other major stressors, such as low water levels, increased salinity, increased wave action and desiccation, occur at the same time.

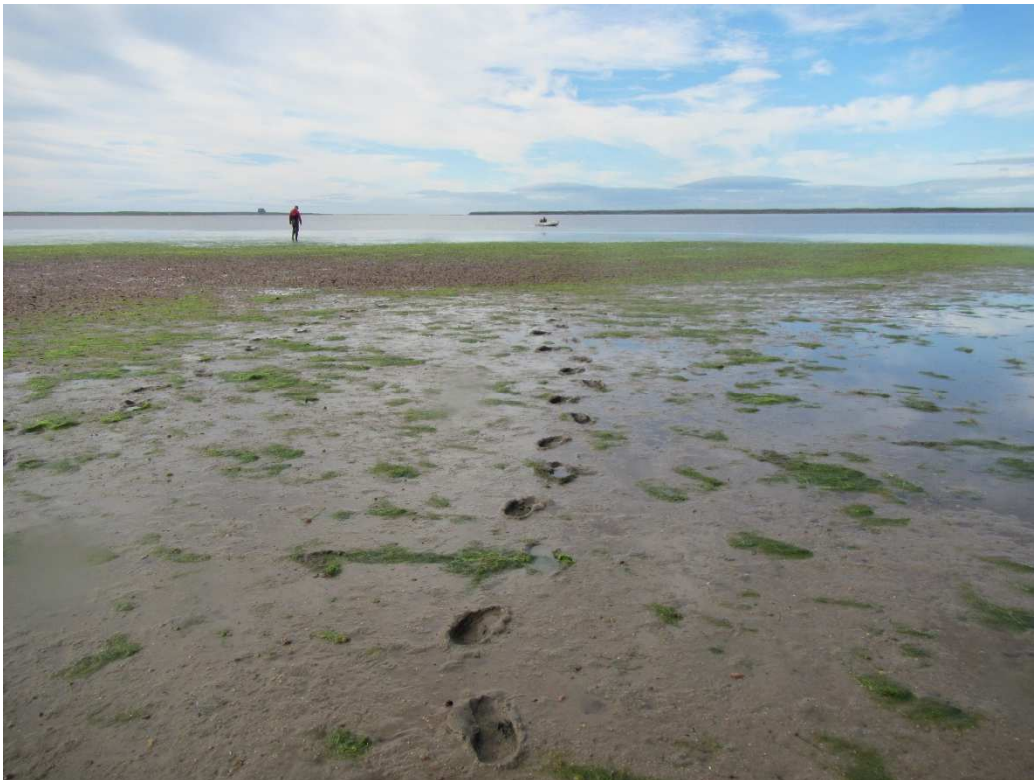
The frequency of occurrence of macroalgae was also low across the lagoon with only 27% of sites occupied by macroalgae (Figure 3-1). Only two species were recorded during the 2014 survey, the marine species *Bachelotia antillarum* and *Ulva intestinales*. The percent cover of *B. antillarum* ranged from < 1 – 100%, with an average cover of 20% and a median cover of 5% (Appendix B). The filamentous growth form of *B. antillarum* means that it is often found smothering plants in intertidal habitats (Figure 3-4). The percentage frequency and cover of *B. antillarum* has been variable since monitoring began. In 2009, it was considered to be widespread throughout the lagoon but had begun to decline in 2010 (see Robertson and Stevens 2009, Stevens and Robertson 2010 for details). *B. antillarum* was not recorded during the 2011 – 2013 surveys. The cover of *U. intestinales* recorded on the spot survey sites was typically < 5%, however, it was noted that cover was higher throughout the lagoon and large accumulations were present on the shoreline (Figure 3-5).

Figure 3-5: *Ulva intestinales* stranded on the shoreline of Waituna Lagoon.
