# Vegetation Status in Waituna Lagoon: Summer 2019

This report was commissioned by The Department of Conservation (DOC) and based on work under Project DOC18202.

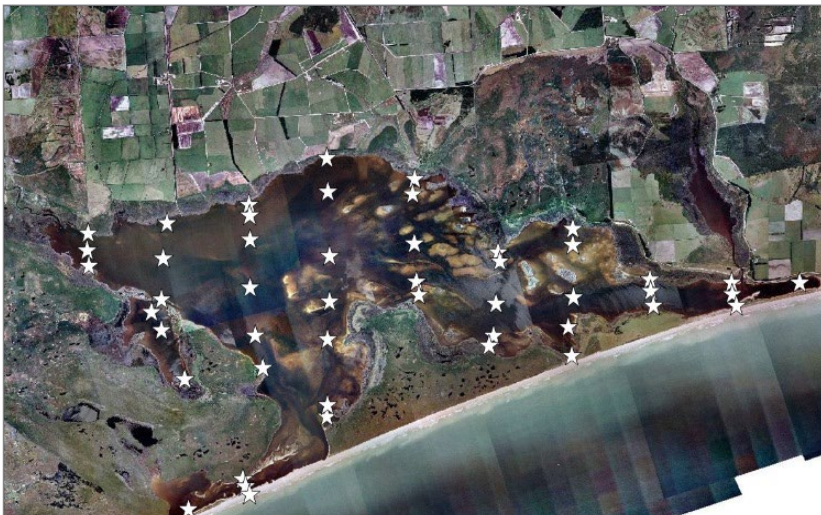
Figure 2a: Map showing the location of sampling sites (47-48).

The lagoon is monitored each year in late summer at 47-48 sites (Figure 2a). At each site an assessment of environmental quality includes depth and water quality measurements (Figure 2b). Substrate characteristics are measured in four samples of the lagoon bed retrieved using a garden hoe, and the composition and abundance of vegetation is also described, including *Ruppia* life-stage as flowering or vegetative. Submerged native plants can usually be identified directly (Figure 3), but the dominant macroalgae may only be described to type (Figure 3) based on appearance and samples.

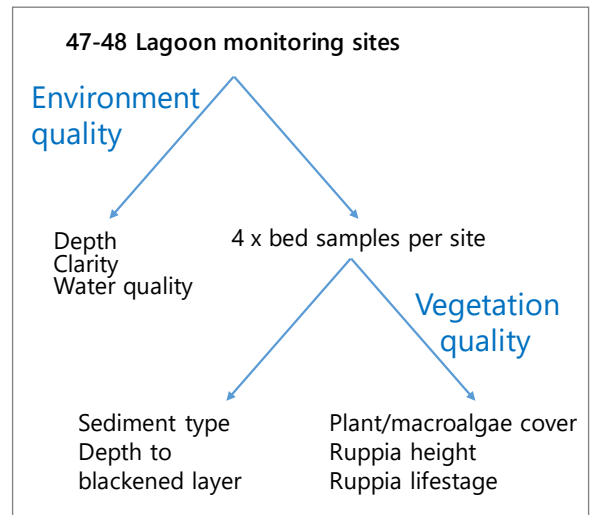
Figure 2b: Sampling design diagram.

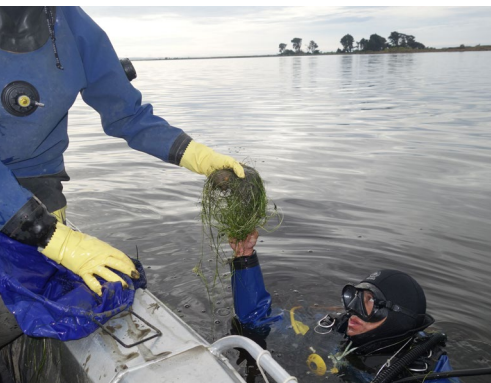
Figure 4: Lagoon-wide cover of *Ruppia* is shown as green bars and percentage of sites at which *Ruppia* was present as a blue line.

A healthy *Ruppia* community occupies a large habitat area in Waituna Lagoon. This is measured by calculating the percentage cover of *Ruppia* across all sites in the Lagoon. In 2019, the lagoon-wide average cover met the ecological target (Box 1) of >30–60% (Table 2, Figure 4).

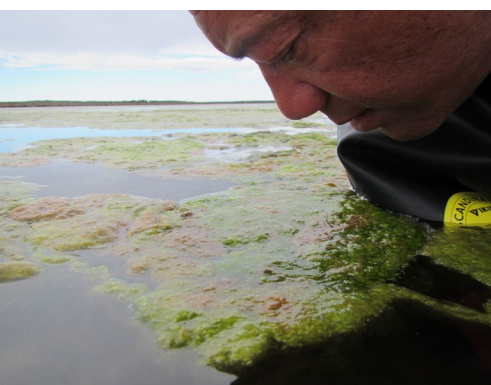
Figure 5: Lagoon-wide cover of macroalgae is shown as orange bars and percentage of sites at which macroalgae was present as a blue line.

Nutrient enrichment of waterbodies may result in excessive macroalgae growth that smothers the lake bed and shades *Ruppia* plants. One ecological target (Box 1) recognises that macroalgae on the lagoon bed (benthic), on plants (epiphytic) and floating mats should be no more than minor (<10% cover). Lagoon-wide average macroalgae cover in 2019 was the highest yet recorded (Table 4 and Figure 5) but macroalgae did not form floating mats that would shade-out *Ruppia*.

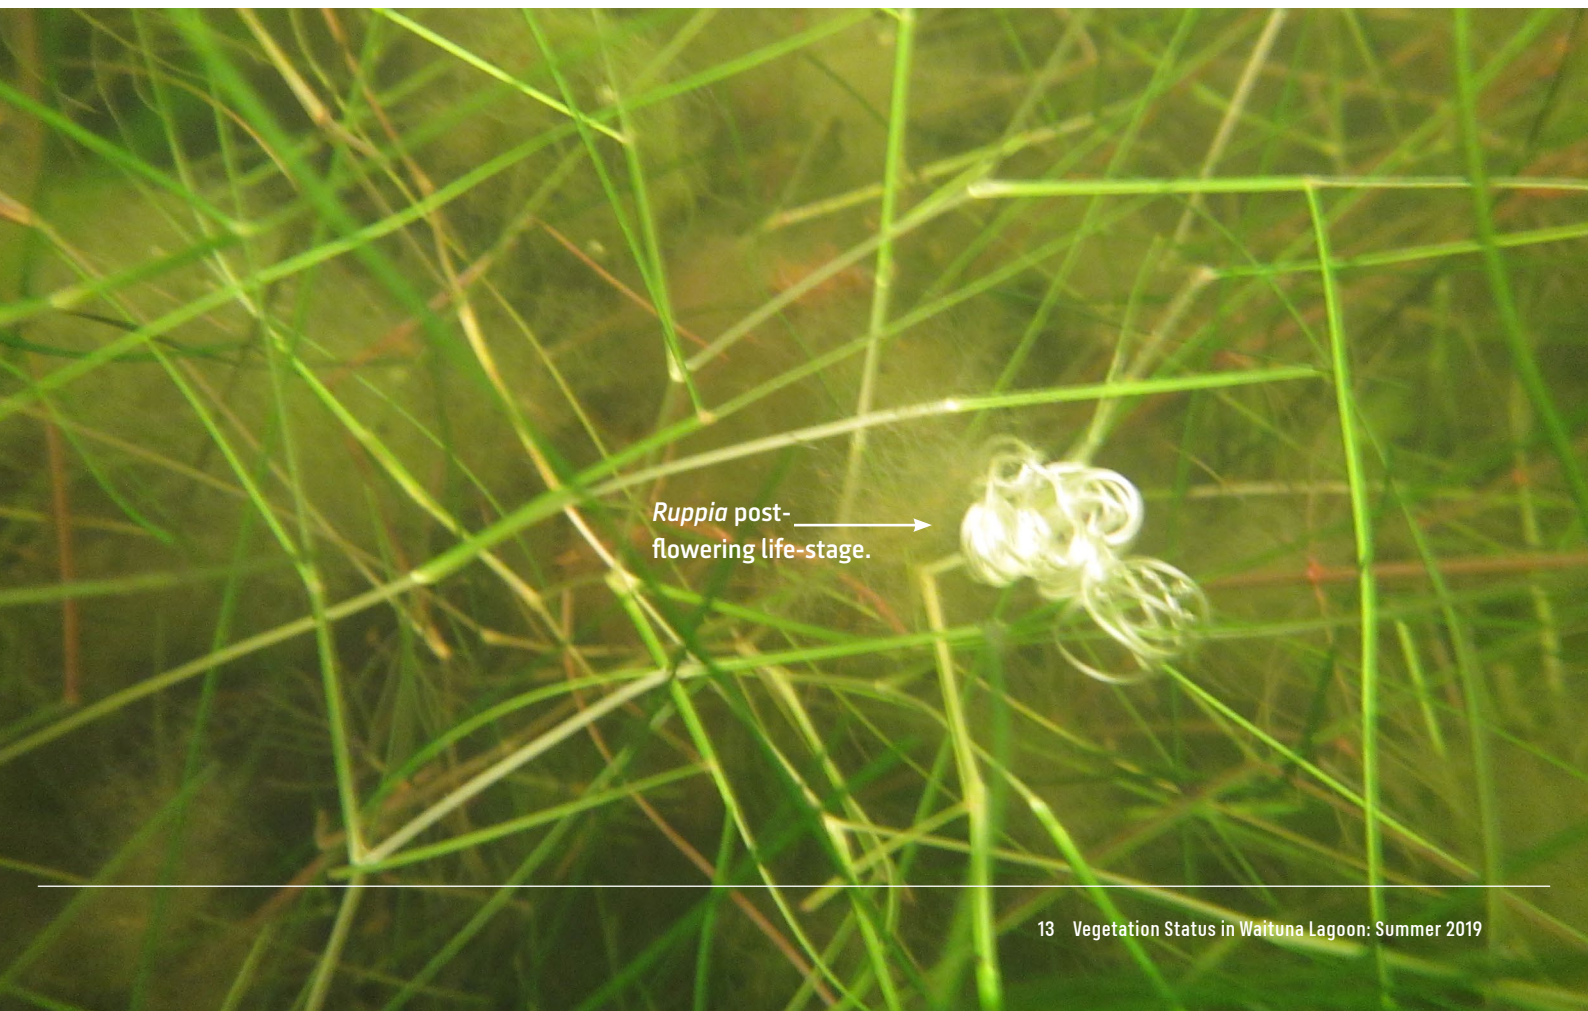
*Ruppia* post-flowering life-stage. →
