Vegetation Status in Waituna Lagoon: Summer 2023

This report was commissioned by The Department of Conservation (DOC) and based on work under Project DOC20203.

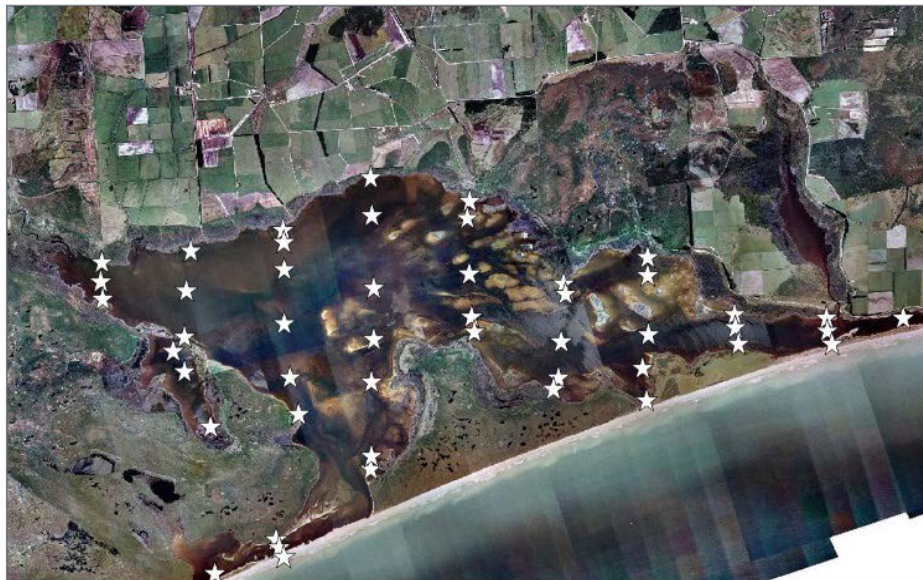
Figure 3a: Map showing the location of sampling sites (47-48).

The lagoon is monitored each year in late summer at 47-48 sites (Figure 3a). At each site, an assessment of environmental quality includes depth and water quality measurements (Figure 3b). Substrate characteristics are measured in four samples of the lagoon bed retrieved using a garden hoe, and the composition and abundance of vegetation is also described, including *Ruppia* life-stage as flowering or vegetative. Submerged native plants and dominant macroalgae are shown in Figure 4.

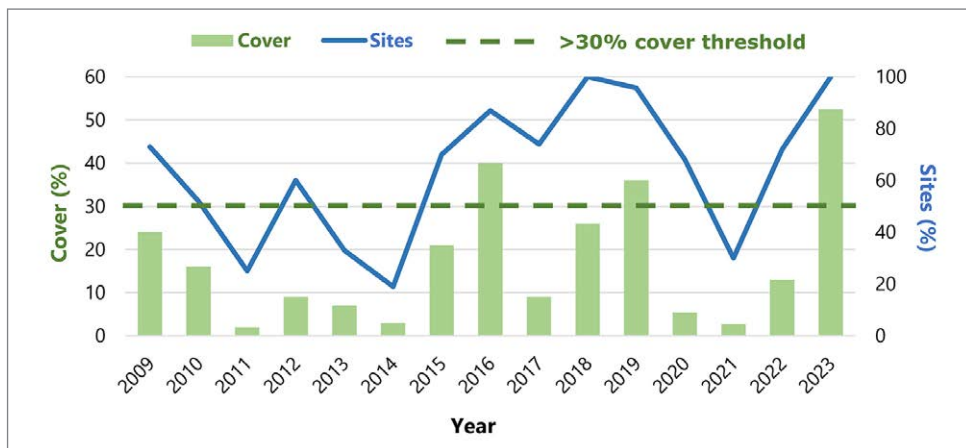
Figure 5: Lagoon-wide cover of *Ruppia* is shown as green bars and percentage of sites at which *Ruppia* was present as a blue line.

The ecological target of >30–60% cover for *Ruppia* across the whole lagoon (Box 1) was met in 2023 (Table 2). This is only the third time this target has been achieved since monitoring began in 2009 (Table 2, Figure 5). All three years that met this target were the second of two consecutive years of lagoon closure during the critical spring-summer growth period for *Ruppia*. *Ruppia* vegetation was recorded at all sites surveyed in 2023 (Table 2, Figure 5), with very high lagoon coverage by vegetation also recorded in 2018 and 2019.
