Technical Report on Vegetation Status in Waituna Lagoon: 2009–2023

This report was commissioned by the Department of Conservation (DOC) and based on work under Project DOC20203.

Introduction

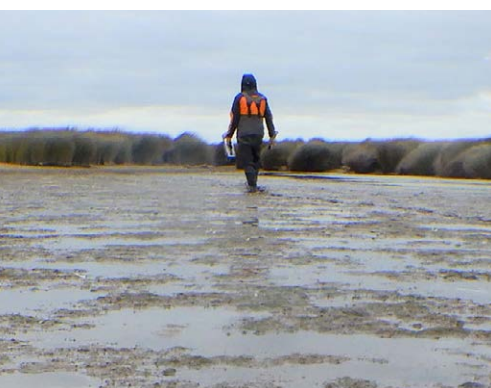
Figure 1: Diverging bar plot showing the number of months for which Waituna Lagoon was open or closed prior to monitoring (as indicated by the y axis). The dotted line indicates the ecological target of three months of lagoon closure before monitoring.

At the time of the annual monitoring of vegetation in 2023 (23–26 January 2023), the lagoon had been closed to the sea for 500 days (Figure 1, Figure 2). This closed period incorporated two consecutive spring-summer growth seasons for *Ruppia* and is the longest closed period in the 15-year dataset. Therefore, the target of three months of closed conditions prior to vegetation monitoring (Lagoon Technical Group 2013) was achieved in 2023. This target was also achieved in eight of the previous 14 monitoring years, including 2022 (Figure 1, Figure 2).

The previous lagoon opening before the 2023 monitoring was in September 2021, with this closing within days. Immediately before the 2023 monitoring, water level had mostly remained above normal level (average +0.5 m) for the previous 240 days. This followed a prolonged period (267 days) following the last lagoon opening when water levels were below normal levels (average -0.5 m) during closed lagoon conditions, with these low levels being a result of drought conditions in Southland. Water levels over the three months before the 2023 sampling dropped steadily from about 0.90 m from above normal to 0.3 m below normal. All monitoring sites were underwater at the time of the 2023 survey. This followed the 2022 year where drought conditions meant approximately 15% of monitored sites were dry or nearly dry.

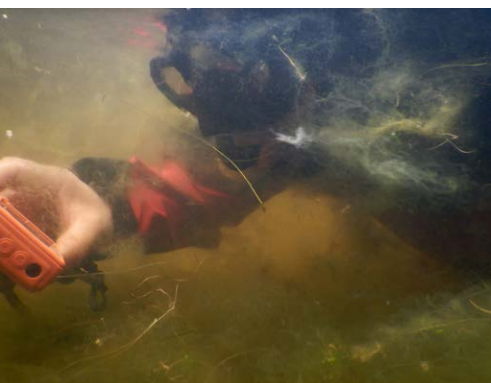
Figure 3: a) Timeseries of temperature and salinity, b) Chlorophyll-*a* (Chl-*a*), total phosphorus (TP), and total nitrogen (TN), and c) Total suspended solids (TSS) and turbidity at the lagoon centre sampled over 2009 to 2023.

Salinity levels in Waituna Lagoon are generally related to the opening regime. Salinity showed a steady drop over the nine months prior to the 2023 vegetation monitoring (late January), to a value of 0.9 PSU in early January (Figure 3a). Similar salinity declines are seen for extended closed periods, while after opening events salinity could approach the value of seawater (Figure 3a).

Water temperature increased by almost 15°C between August 2022 and early January 2023, to a value of 19.2°C prior to vegetation monitoring. Water temperature maxima prior to the 2023 monitoring were similar to 2018 to 2022 (>15°C), but warmer than temperature between 2016 to 2017 and 2013 to 2014, according to the Environment Southland data (Figure 3a).

In the 12 months before the vegetation monitoring in late January 2023, Chl-*a* concentration was low (<0.01 mg l⁻¹) without some of the higher peaks (>0.2 mg l⁻¹) seen in 2009, 2012, 2015 and 2018 to 2021. Although TN levels over the last year showed similar patterns to previous years with winter peaks, TP concentrations were constrained to a lower range of <0.05 g m⁻³ (Figure 3b). Both TSS and turbidity measurements in the lagoon had dropped in the 12 months before the 2023 vegetation monitoring to levels of c. 2 g m⁻³ TSS and 2.5 NTU (Figure 3c). This reduction is possibly related to increased sediment trapping capacity of *Ruppia* plants with the development of vegetation (Section 5).

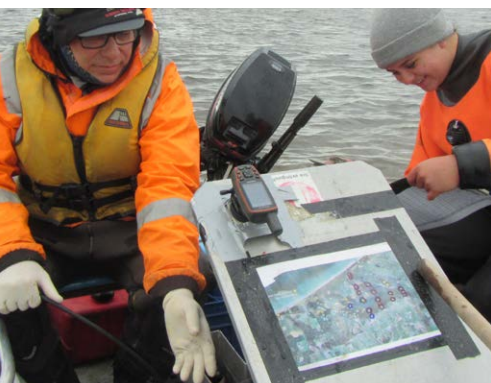
Figure 4: Monitoring sites in Waituna Lagoon. Transects are numbered from 1 to 10 from East to West. The numbers of each transect were allocated on ascending order from North to South.

The location of 47 monitoring sites are shown in Figure 4.

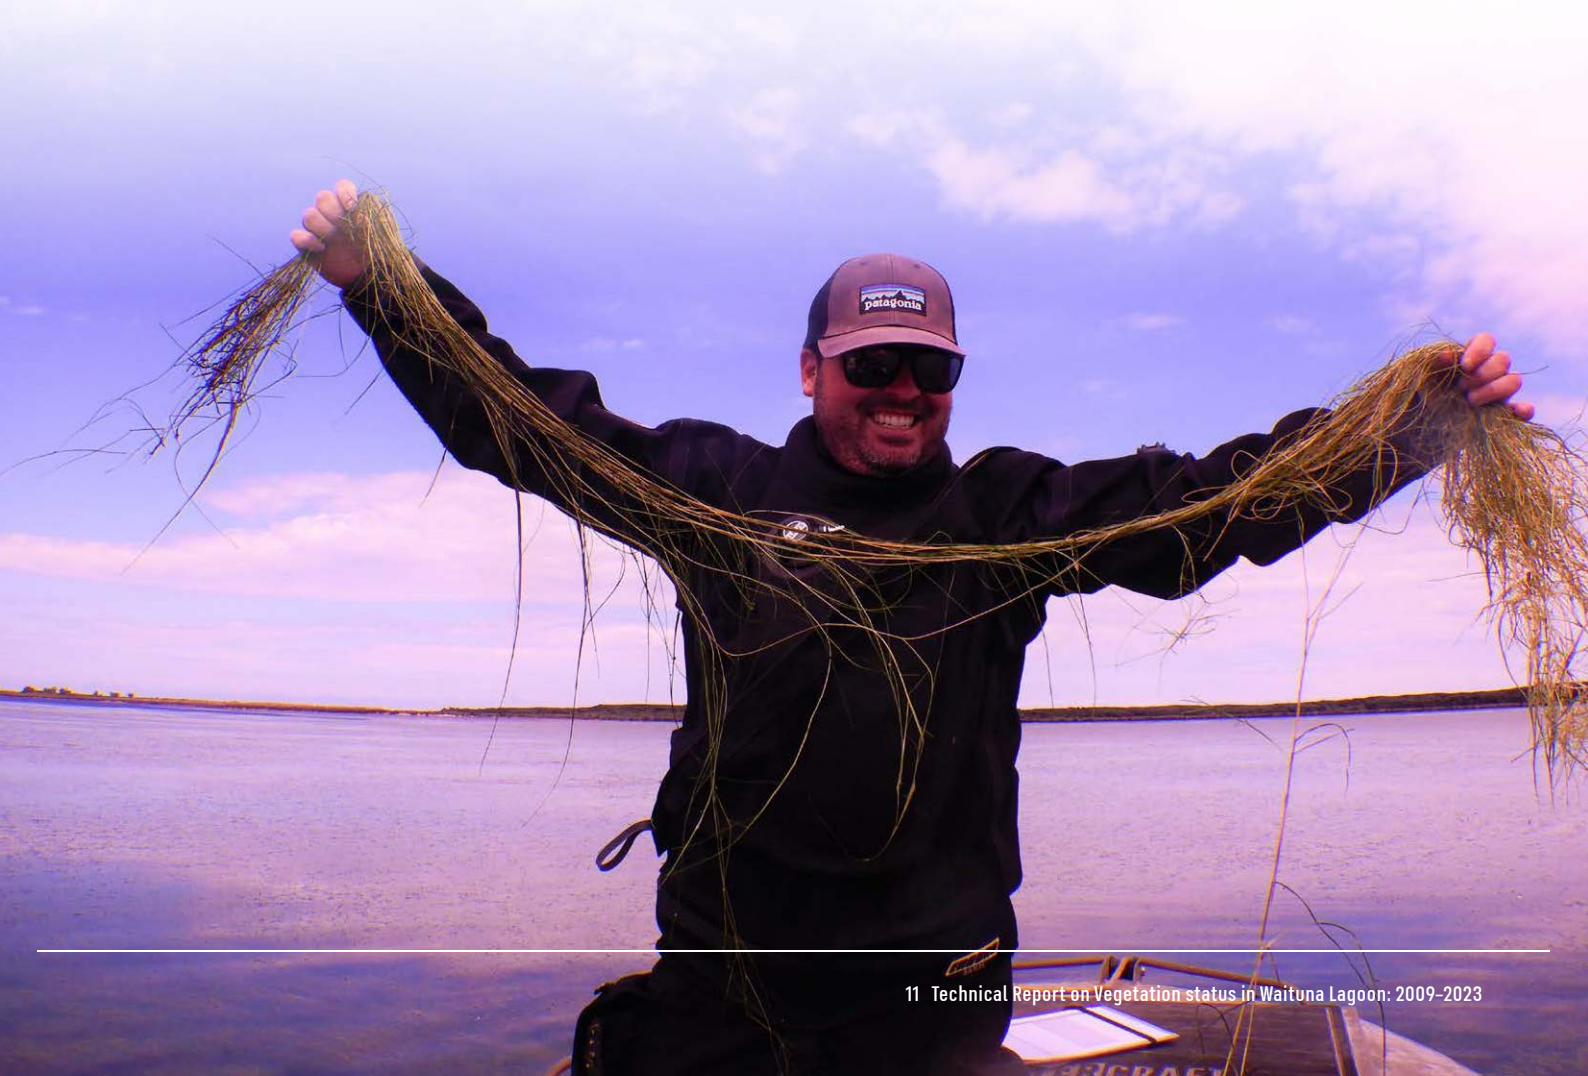
Figure 5: Box and whisker plots of salinity (top), depth (middle) and temperature (bottom) over all monitoring years. (n = 47).

The average water depth in 2023 was 0.76 m but ranged from 0.2 to 1.9 m at sites (Figure 5). Average water level in 2023 was higher than the monitoring occasions when the lagoon was open in 2011, 2013, 2014, 2020 and 2021, but was also higher than monitoring events in the drought years of 2018 and 2022 when the lagoon was closed at the time of monitoring. The average water temperature of 17.8°C in 2023 was similar to the 16°C to 18°C average for the majority of monitoring years (Figure 5). Most sampled sites were between 16.4 and 18.5°C, with outliers recorded along the shallow northern shore (Figure 4).

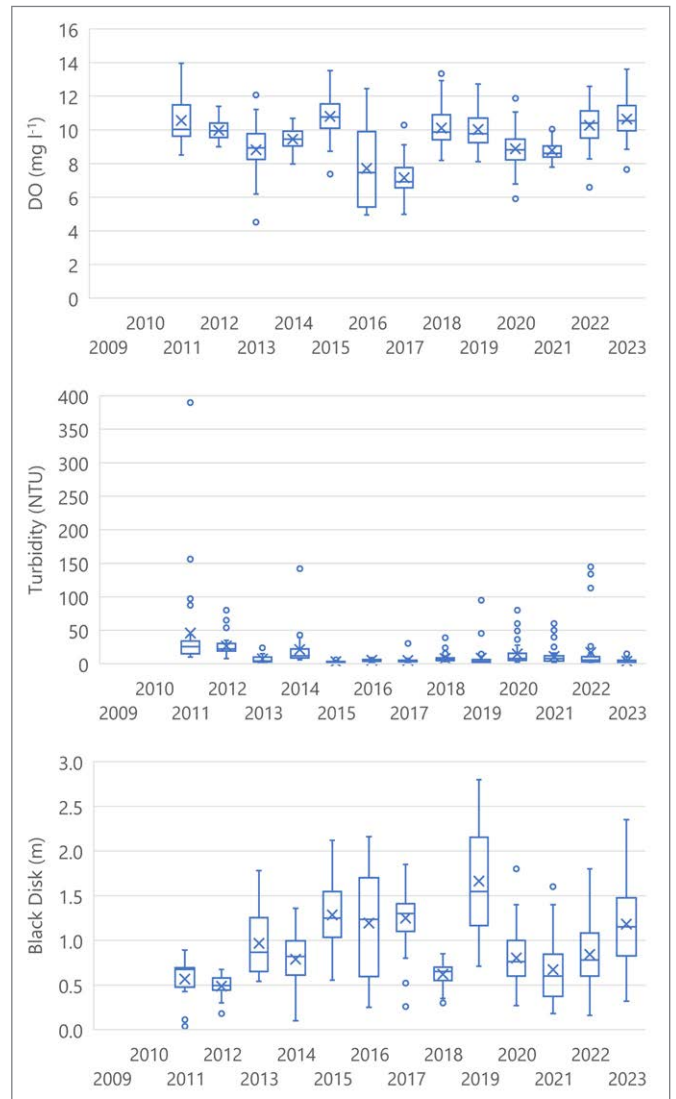
Figure 6: Box and whisker plots of DO (top), turbidity (middle) and black disk (bottom) at the monitoring sites (n = 47), from 2011 to 2023.

An average dissolved oxygen (DO) concentration of 10.6 mg l⁻¹ in 2023 was the second highest of all monitoring years (Figure 6). Dissolved oxygen levels were supersaturated at 83% of sites, likely due to very high *Ruppia* covers (Section 5) and only two sites recorded slightly less than 80% DO. The lowest recorded DO value was 7.6 mg l⁻¹ (Figure 6).

Average turbidity (NTU) was low in 2023 at a value of 3.9 (Figure 6). The highest turbidity measurements of c. 15 NTU were recorded in shallow water at two sites along the northern shoreline (Figure 4), possibly resulting from resuspension of bottom sediments by wind driven wave action.

Dense vegetation obscured black disc measurements at two sites in 2023. Elsewhere, the average black disc reading was 1.18 m (Figure 6). This value is similar to the monitoring years of 2015 to 2017, but lower than 2019 and higher than other years (Figure 6).

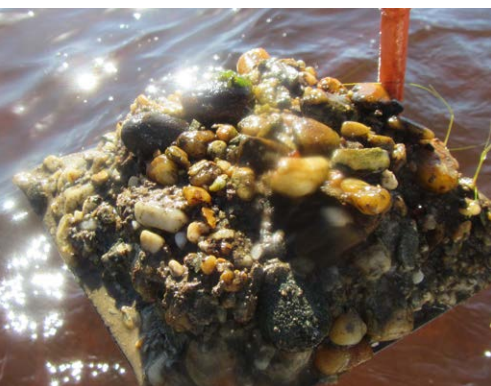
Figure 7: Bar plot illustrating the composition in substrate type (% occurrence), recorded during each of the annual monitoring surveys. Substrate types are numbered from softer to harder.

In 2023, the hoe substrates tended to be finer or softer (higher proportion of categories 1 to 3) than the previous year. The current monitoring year resembled the composition recorded in the monitoring years 2009–2011, 2015 and 2019, with a high proportion of soft mud/sand recorded (Figure 7). It also appeared that sand substrates had become muddier in 2023 than the previous year (Figure 7), potentially due to *Ruppia* capacity to trap suspended sediment and the increased vegetation development recently (Section 5).

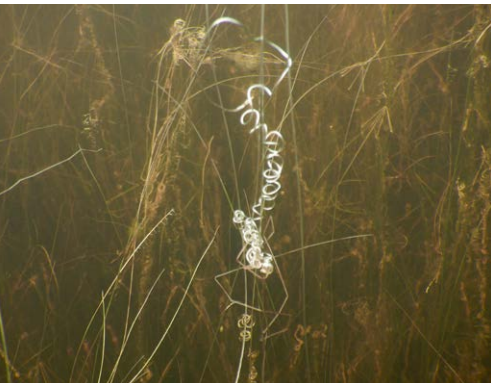
Figure 9: Vegetation composition shown as relative frequency of occurrence (sites recorded) for species or vegetation groups.

All sites surveyed in 2023 recorded vegetation (Figure 9). *Ruppia polycarpa* was the most widespread aquatic plant recorded, being present at 45 sites. *Ruppia megacarpa* was recorded from 18 sites and extended beyond its previous typical distribution in the eastern lagoon to sites on the northern half of transect 9 (Figure 4). *Ruppia megacarpa* occurred with *R. polycarpa* at all but two of these sites. *Ruppia* species occurrence in 2023 was similar to previous high occurrence records over 2018 and 2019 of 42-45 sites for *R. polycarpa* and 14-15 sites for *R. megacarpa* (Figure 9).

Lakeshore turf plants *Samolus repens* and *Lilaeopsis novae-zelandiae* were recorded at an increased occurrence in 2023 (Figure 9), possibly due to three previous years of low water level during summer (2020-2022) favouring these amphibious species.

By contrast to the higher plants, macroalgae were only seen at limited sites in the lagoon in 2023 (Figure 9). *Ulva intestinalis* was recorded at 10 sites, mostly in the central and western side of the lagoon. Occurrence of filamentous green algae was seen at just eight sites. Filamentous green algae were dominated by *Cladophora* species, but all algal samples collected had high numbers of sedimented diatoms (e.g., *Navicula* species). This reduction in macroalgae occurrence in 2023 contrasts with their frequency at sites over 2009 to 2022, and previously over 2015 to 2017 (Figure 9). Although hoe samples are known to incompletely sample macroalgae, wider in situ observations by divers (section 'Macroalgal cover') confirmed the limited nature of macroalgae in 2023.

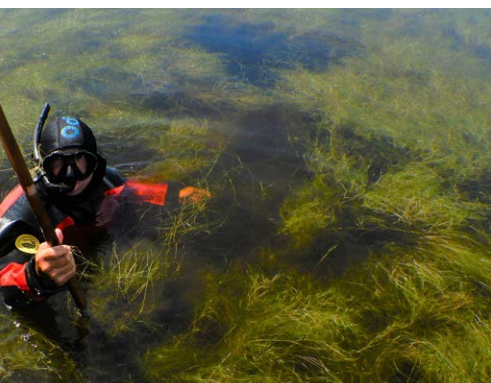
Figure 10: Box and whisker plots of *Ruppia* cover a), height b) and derived biomass index c) over monitoring years, as an average of measurements at monitoring sites ($n = 47$). Dotted line represents the lagoon-wide target for *Ruppia* cover of 30% identified by the Lagoon Technical Group (2013).

In 2023, *Ruppia* species had the highest yet recorded average cover out of the 15 monitoring years (Figure 10a). Average cover of *Ruppia* species from hoe samples was 52% lagoon-wide (Figure 10a), compared to the next highest average of 40% recorded in 2016 and 35.6% in 2019. Both of the *Ruppia* species exhibited similar average cover for the hoe samples in 2023.

The average height of *Ruppia* plants from hoe samples in 2023, at 0.61 m, was also greater than the <0.5 m values of all previous years (Figure 10b). Together, the heights and high covers recorded contributed to a record average biomass index of 4339 (Figure 10c). The next highest average biomass index values (1000 to 2000) occurred over 2015–2016 and 2018–2019 (Figure 10c), which also represented consecutive years of a closed lagoon in the three or more months before monitoring.

High outliers in Figure 10b and 10c represent sites were dominated by *R. megacarpa*. *Ruppia megacarpa* has been disproportionately represented amongst the taller height records and higher biomass index values in all monitoring events to date.

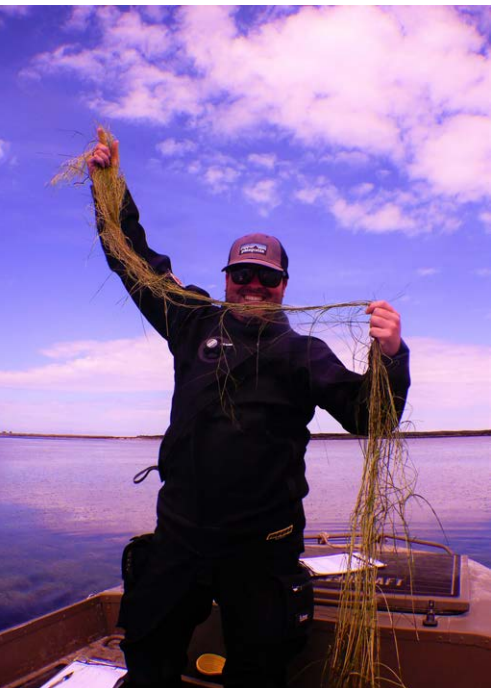
Figure 11: Relationship between *Ruppia* cover (top) and height (bottom) estimated from hoe samples and diver observations within a 10 m diameter area at each site.

In 2023, *Ruppia* was observed by divers within a 10 m diameter survey area at all sites. In previous years when *Ruppia* occurrence has been much less than 100% of sites, the diver observations were more likely to detect *Ruppia* than the hoe sampling method. Diver observations of *Ruppia* covers and heights show a correlation with the hoe method (Figure 11). Average *Ruppia* cover for each method per monitoring year showed a closer correlation ($R^2 = 0.94$, data not shown), although the diver observations gave higher estimates than hoe measurements for 10 out of 11 years.

Diver observations of *Ruppia* in 2023 averaged 63% cover (data not shown). Again, this value was higher than previous highest average cover values observed by divers of 37% in 2016 and 50% in 2019. Diver estimates of plant height at 0.83 m in 2023 were second highest to 2019 (0.95 m). The diver method has the tendency to report taller plants than the hoe method, probably because of the larger assessed area.

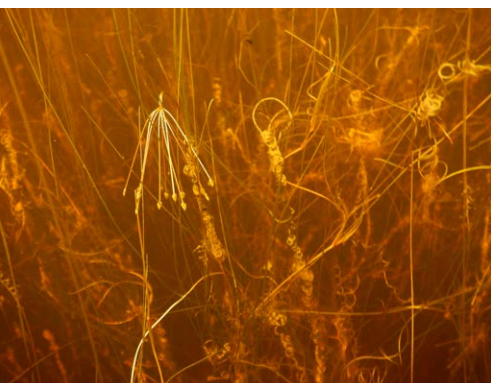
Figure 12: Life-stage category of *Ruppia* species across monitoring years as a proportion of records.

In 2023, 85% of hoe samples (96% of sites) recorded reproductive *Ruppia* plants with flowers or developing seeds (Figure 12, Table 1). This value is higher than all the previous measures of *Ruppia* reproductive success for monitoring years. Years when the lagoon has been closed for the three months over the main *Ruppia* spring-summer growth period recorded greater than 15% hoe samples as reproductive (Figure 12, Table 1). However, a higher reproductive success was associated with the second consecutive year of closed lagoon status, for example in 2016, 2019 and 2023 (Table 1). By contrast, years with $\leq 10\%$ of hoe samples recorded as reproductive were years when the lagoon was not closed for three months or more over the main growing season for *Ruppia* (2011, 2013–2014, 2017, 2020–2021, Figure 1, Table 1).

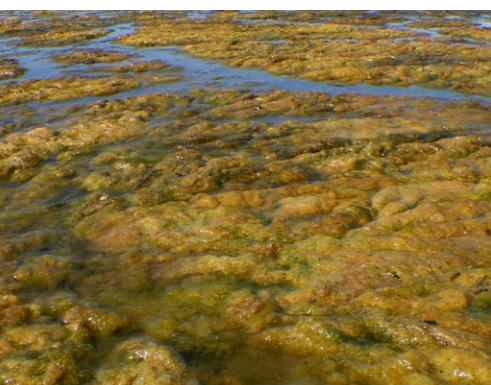
Figure 13: Box and whisker plots of macroalgae cover over monitoring years as an average of hoe measurements at monitoring sites (n = 47).

In 2023, the average macroalgae cover recorded from all hoe samples in the lagoon was low, at 5% (Figure 13). This value was low because macroalgae were only recorded at 32% of the hoe survey sites. Similar low average covers (<10%) for macroalgae cover have been recorded in 2009–2012, 2014 and 2018 (Figure 13).

Macroalgae formed covers of 100% at only one site in 2023 (Site 9.7, Figure 4). Previously in 2016, 2017, 2019 and 2022, macroalgae covers at individual sites have exceeded 100% where different macroalgae types formed overlying layers (e.g., benthic mats and surface mats).
