TE KUHA

Assessment of Aquatic Ecosystems for Access Agreement

Report Number: 1378205208-001-R-RevB

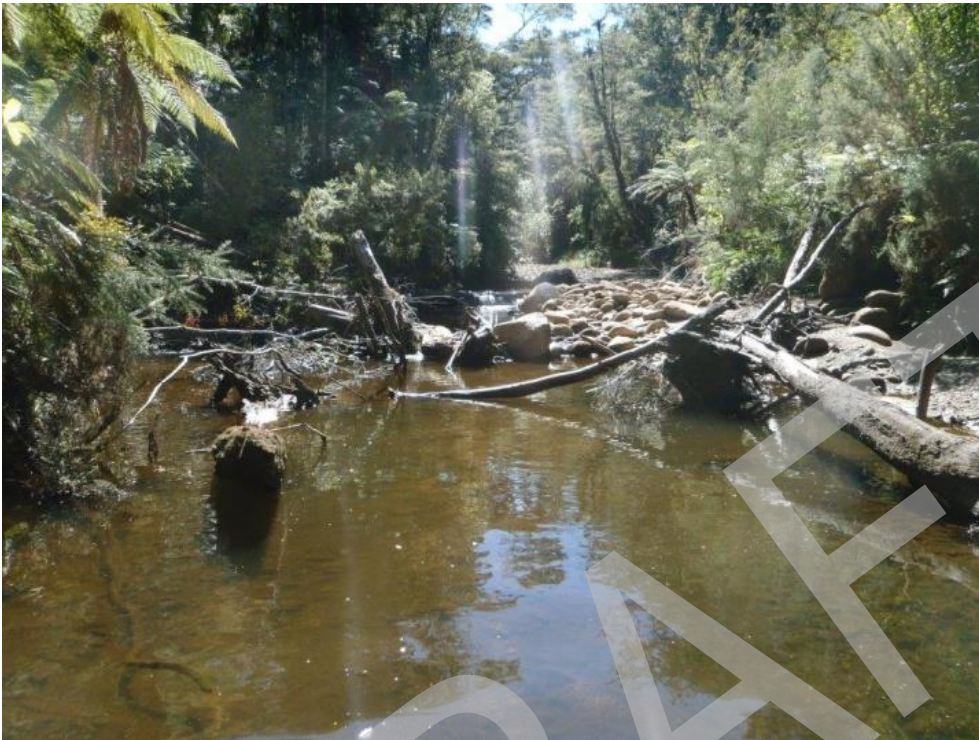
Figure 3: Coal Creek (Site 13) upstream of Nine Mile Road.

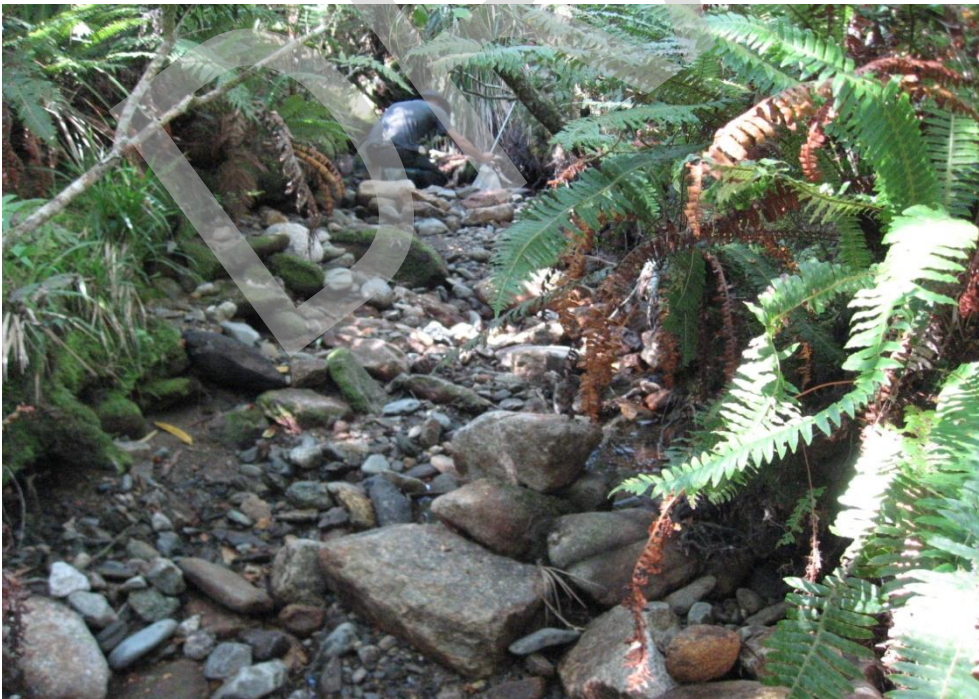
Figure 4: The nearly dry stream bed un-named Stream (Site 6), sampling in the background occurring in a remnant pool.

Below 200 m altitude the stream gradients decrease and the sites along the lower section of the Haul Road are in areas where pool, riffle and run habitats are present. Coal Creek (Site 11) was notable in that this site was still steep enough that the stream had step pool structures (Figure 2). Shading was variable with smaller streams (< 1 m wide) well shaded, but wider reaches with wide but not necessarily wet stream beds (> 4 m wide) being partially unshaded (e.g., lower Coal Creek, Site 13, (Figure 3). The un-named stream (Site 6) and other small streams draining the mountain front (as opposed to the mountain top) were all small (<1 m wide) and at the time of the survey dry or reduced to remnant pools and/or short intermittent flowing sections (Figure 4).

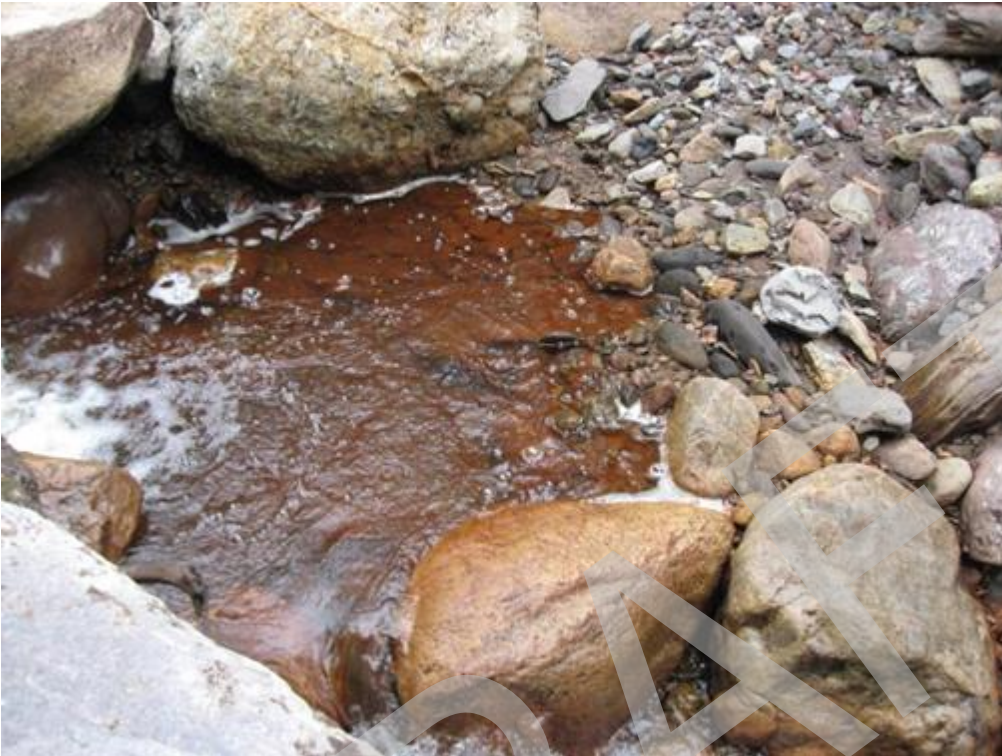
Figure 5: Coal Creek tributary, Site 10, with orange floc accumulation on stream bed.

The stream at Site 10 had large accumulations of orange coloured floc on the stream bed (Figure 5). Given the low flow conditions in the months prior to the survey, this may have accumulated over some time. However, no other stream had this orange floc so it was considered a stream specific issue. It was also noted that the water at Site 9 was a grey colour that the survey team also noted as unusual.

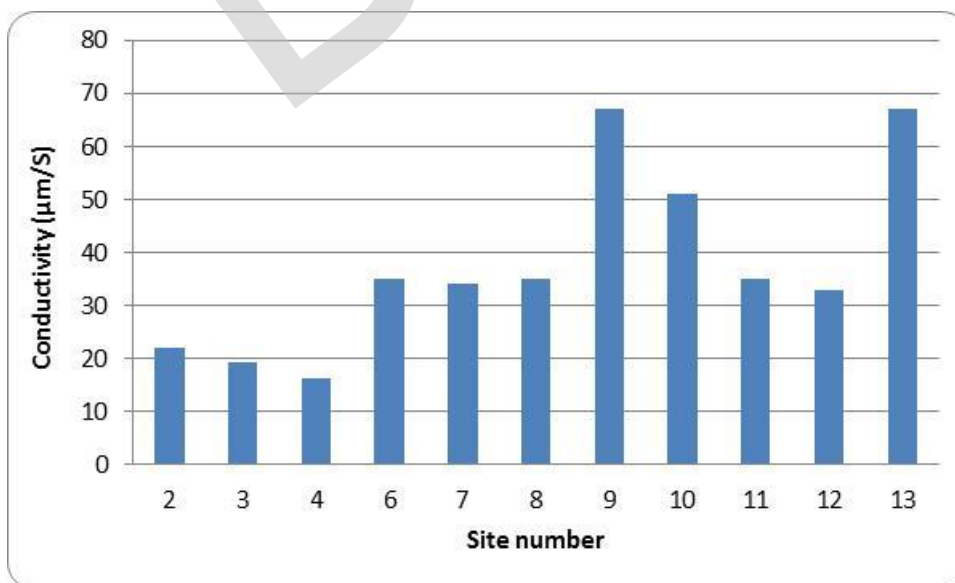
Figure 7: Conductivity at samples sites at Te Kuha with flowing water, March 2013.

Conductivity in the flowing streams on the mountain top was low in the order of 10 -25 $\mu\text{S}/\text{cm}$. Conductivity increased downstream with conductivity at the majority of the sites in the lower reaches being between 30-40 $\mu\text{S}/\text{cm}$ (Figure 7). Three sites, Sites 9, 10, and 13, had relatively high conductivity and these first two sites, as noted above, had water colour or stream bed anomalies

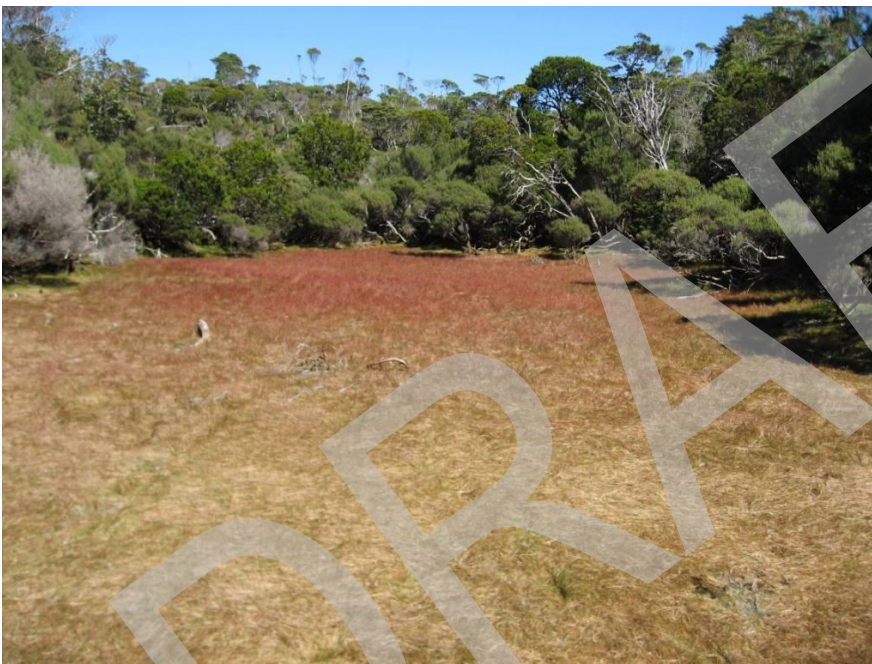
Figure 8: The dry tarn (Site 5) on the upper mountain slopes, Te Kuha, March 2013.

No macrophytes were observed at any of the stream survey sites. Bryophytes were present at the upper mountain sites (Sites 1-3). Stream bed coverage was low with 2 - 10 % of the bed covered by bryophytes. At the time of the site visit the dry bed of the tarn was covered in an introduced rush (*Juncus bulbosus*) (Figure 8).

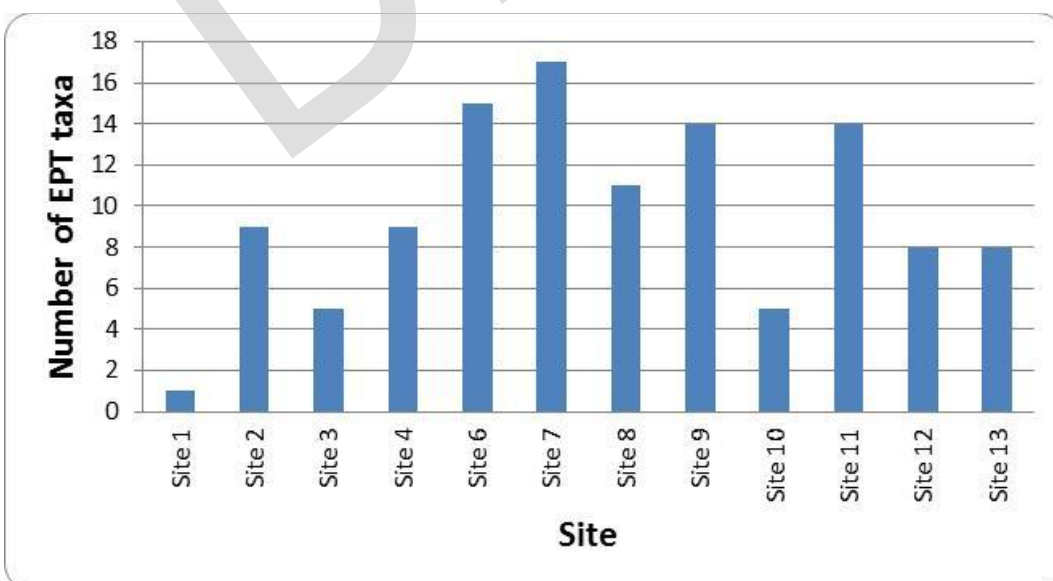
Figure 11: EPT macroinvertebrate taxa richness at sample sites at Te Kuha, March 2013.

Site 1 and Site 10 had lower numbers of EPT taxa than other adjacent sites (Figure 11) whilst %EPT was lowest at sites 1, 12 and 13 (Figure 12).

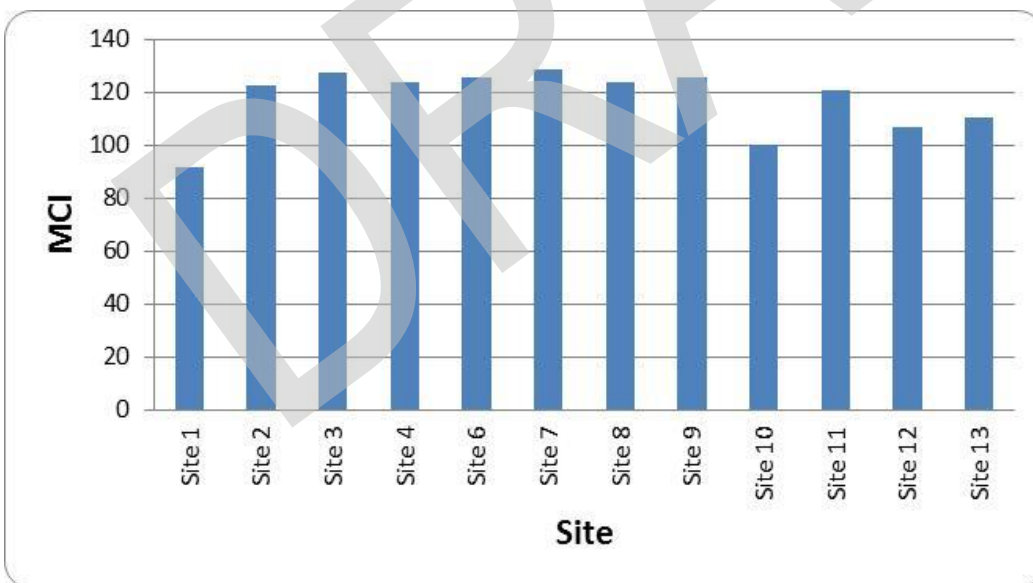
Figure 13: MCI at sample sites at Te Kuha, March 2013.

The MCI scores for the majority of sites indicate excellent water and/or habitat quality (Figure 13). Site 1 has a low MCI score that is due to the limited number of taxa surviving in the remnant pools. The MCI for Site 10 indicated lowered water quality and Site 12 and 13 are also lower possibly due to the effects of agricultural runoff.

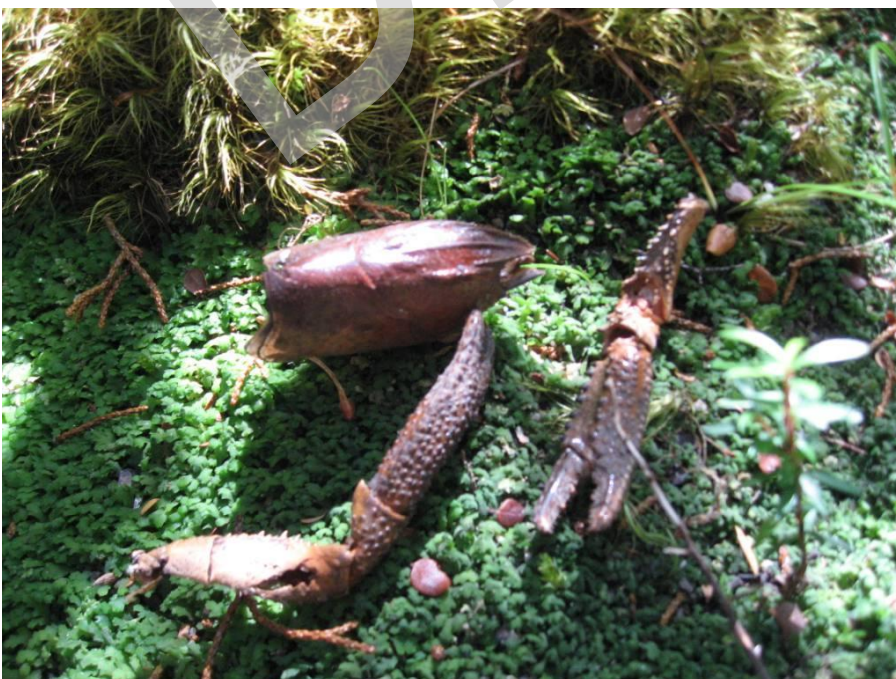
Figure 15: Koura remains found in the dry bed of a small stream (Site 4, March 2013).

Smaller streams on the upper mountain were commonly dry. Searches of the stream bed at these sites did locate koura bodies (Figure 15). The tarn on the upper mountain was also dry (Figure 8); however numerous burrows were observed around the margin of the tarn at or about what would most likely be the normal water level (Figure 16). Excavation of the one of these burrows located a live koura (total length 50 mm, (Figure 17) at the bottom of the burrow amongst damp sand/fine gravel material. Further burrows were not excavated to avoid promoting more rapid desiccation of koura that had retreated to these damp refuges. The densities of burrows around the tarn edge indicated that a reasonably abundant population of koura was present at the tarn.

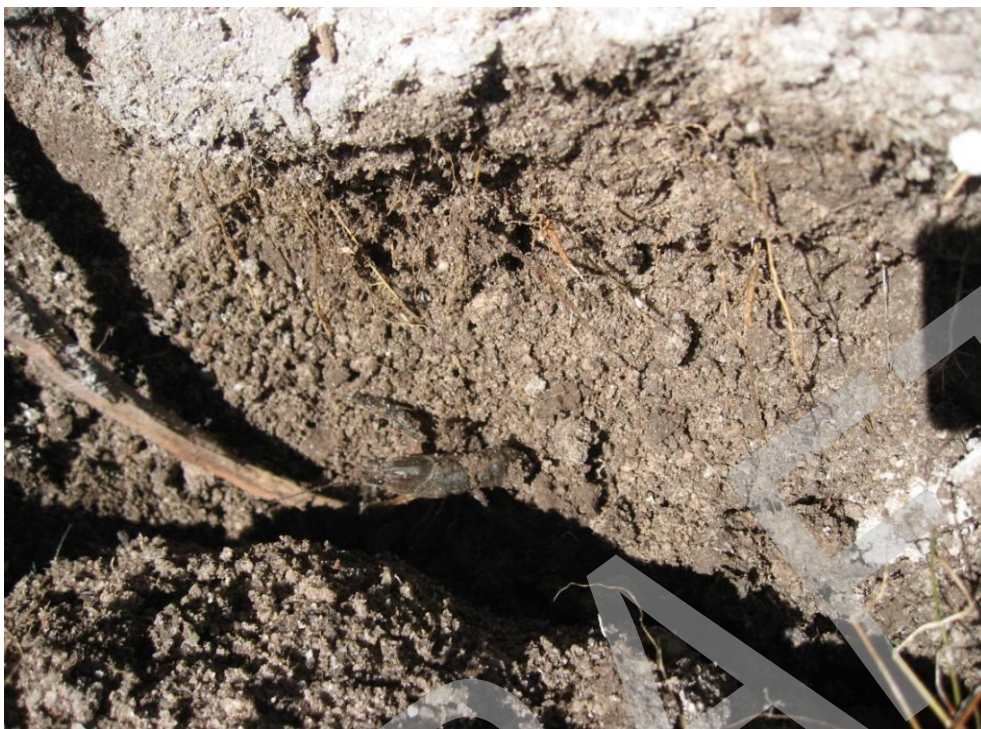
Figure 16: Koura found at the bottom of a burrow at the tarn edge, March 2013.

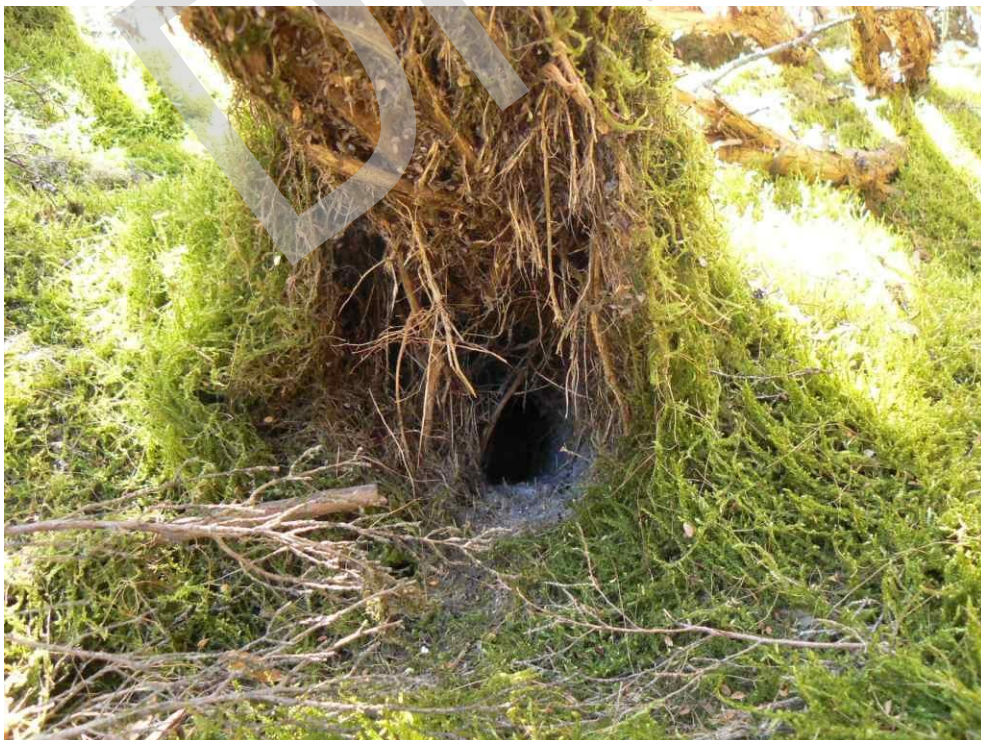
Figure 17: A burrow at the edge of the dry tarn, March 2013.

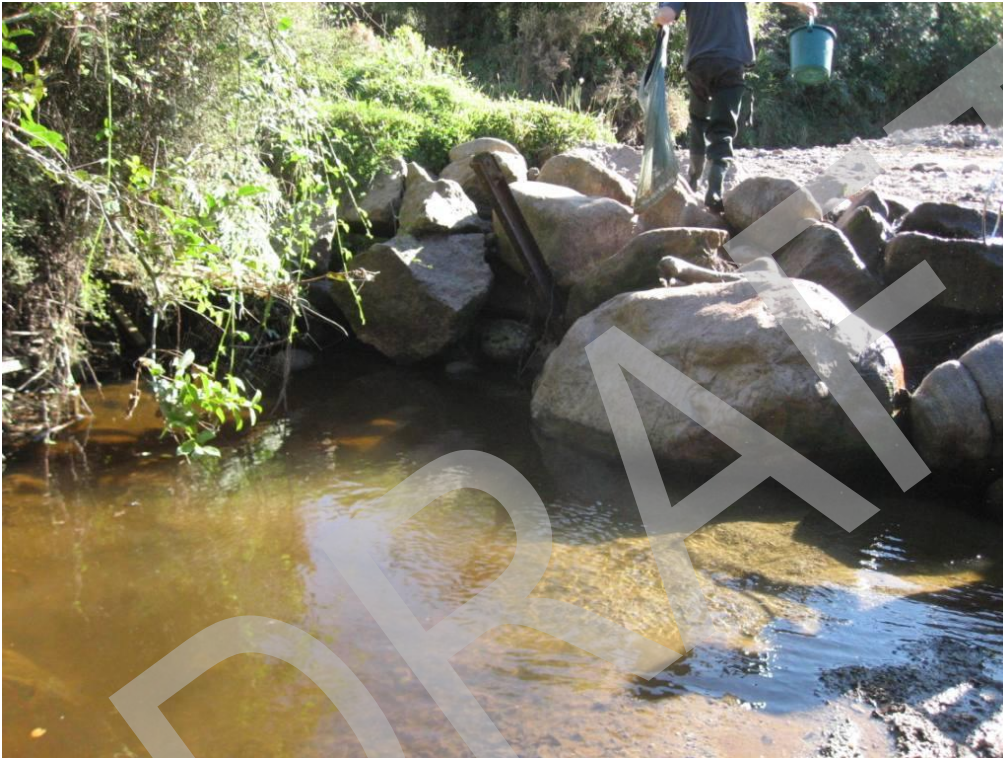
Figure 18: Partial fish passage barrier on West Creek at the Nine Mile Road ford.

A partial fish passage barrier was present in West Creek at Nine Mile Road and most likely further downstream as well. The road crossing is a ford with a vertical fall on the downstream side of the road (Figure 18). Erosion of the road is prevented by the placement of large boulders along the downstream side of the road ford at the base of the drop. When the site was fished, juvenile redbfin bullies were very common downstream of the road, but noticeable rarer on the upstream side. Furthermore, all of the fish species encountered up and downstream of Nine Mile Road in West Creek are known as climbing species, that can ascend steep slopes and vertical surfaces. No poor climbing or swimming only native fish were present at this site indicating that a further barrier exists on West Creek between Nine Mile Road and the Buller River.

Downstream of the Haul Road, West Creek has a partial fish passage barrier and stock had access to the stream and stream banks at crossing sites. The impact of this passage barrier is unclear as the extent to which it restricts whitebait and elver passage is unknown and the age of the barrier is also uncertain. Upstream fish communities are less abundant than that observed in some areas of the West Coast, but the low fish densities may also be the result of flood disturbances as the steep mid-reaches of West Creek have an unstable stream bed and eroding stream banks and riparian zone. In addition, stock access was possible to areas of West Creek from the ford on Nine Mile Road and from a farm track crossing. Storm water runoff from Nine Mile Road (a gravel road) and the farm tracks is also expected to add suspended sediments to the stream reducing the downstream habitat quality. Therefore, the decline in QMCI observed in West Creek at Nine Mile Road is expected to be related to the impacts of agriculture and roading.
