### Draft Aquatic Ecology Report

TE KUHA MINE

# Assessment of Aquatic Ecosystems for Access Agreement

Report Number. 1378205-093

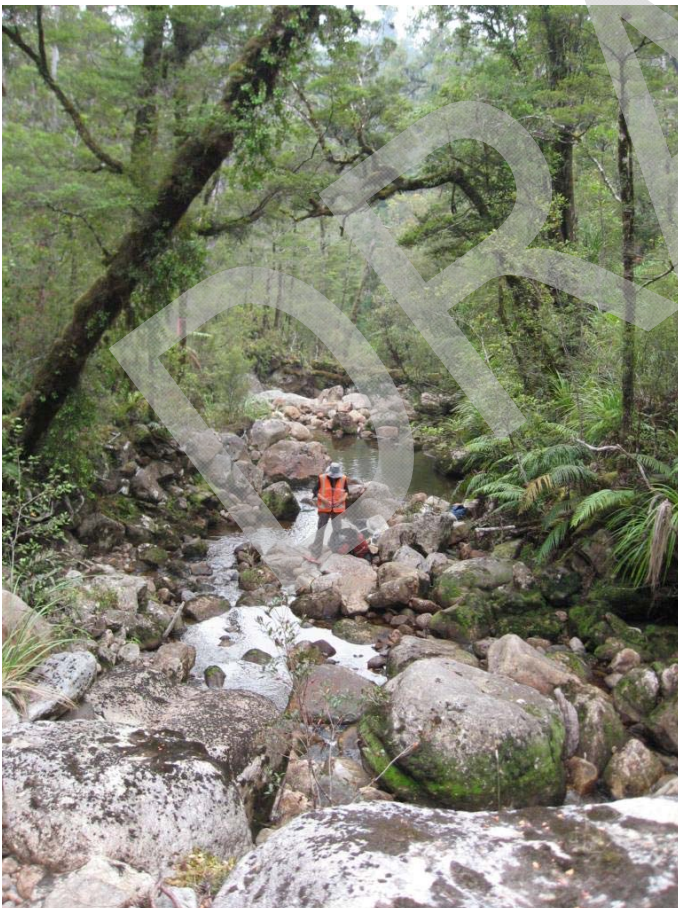
*Figure 2: Coal Creek (Site 11) at the lower Haul Road crossing point.*

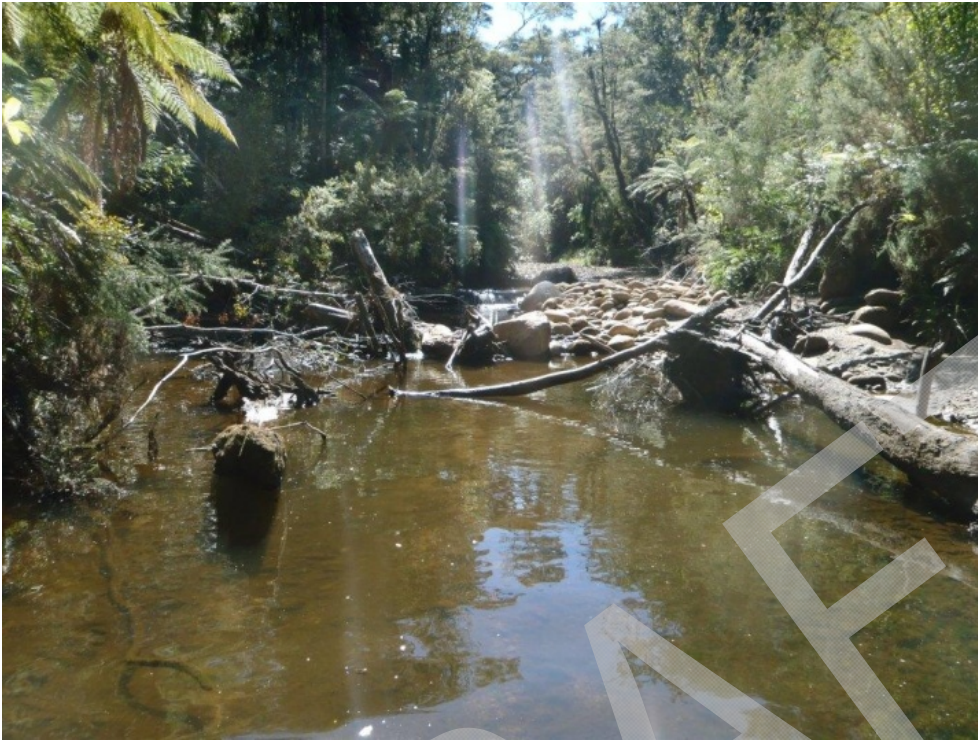
The lower reaches of Coal Creek appeared fenced from stock at Site 13 and the riparian zone was well protected. Stock access was possible to West Creek at the Nine Mile Road ford and at a farm track crossing between Site 7 and 12.

Figure 3: Coal Creek (Site 13) upstream of Nine Mile Road.

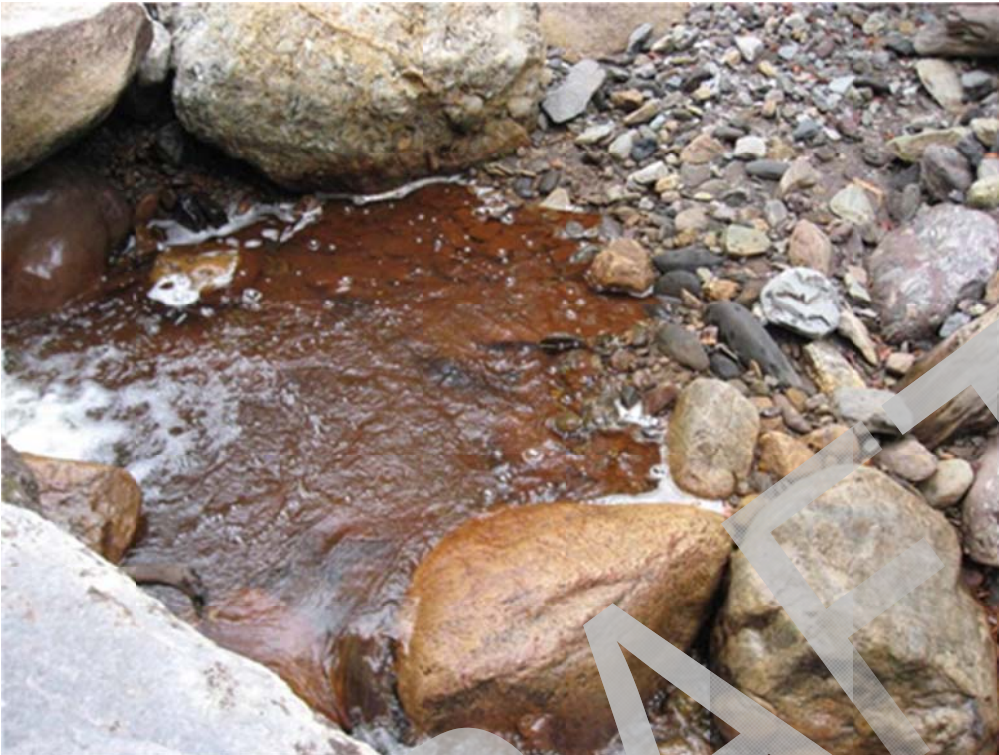
The stream at Site 10 had large accumulations of orange coloured floc on the stream bed (Figure 5). Given the low flow conditions in the months prior to the survey this may have accumulated over some time. However, no other stream had this orange floc so it was considered a stream specific issue. It was also noted that the water at Site 9 was a grey colour that the survey team also noted as unusual.

Figure 5: Coal Creek tributary, Site 10, with orange floc accumulation on stream bed.

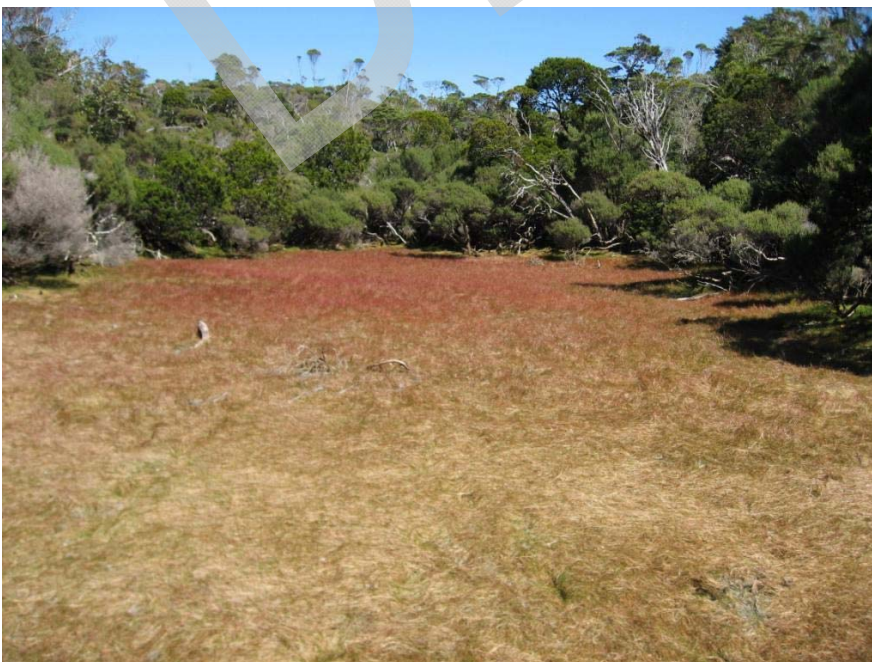
No macrophytes were observed at any of the stream survey sites. Bryophytes were present at the upper mountain sites (Sites 1-3). Stream bed coverage was low with 2-10 % of the bed covered by bryophytes. At the time of the site visit the dry bed of the tarn was covered in an introduced rush (*Juncus bulbosus*). (Figure 8).

Figure 8: The dry tarn (Site 5) on the upper mountain slopes.

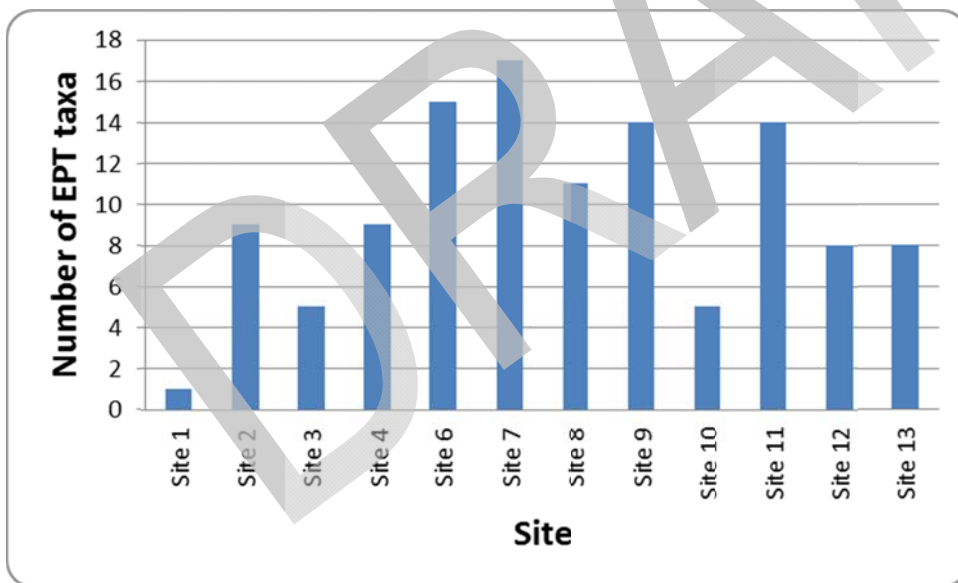
Site 1 and Site 10 had lower numbers of EPT taxa than other adjacent sites (Figure 11) whilst %EPT was lowest at sites 1, 12 and 13 (Figure 12).

Figure 11: EPT macroinvertebrate taxa richness at sample sites at Te Kahu.

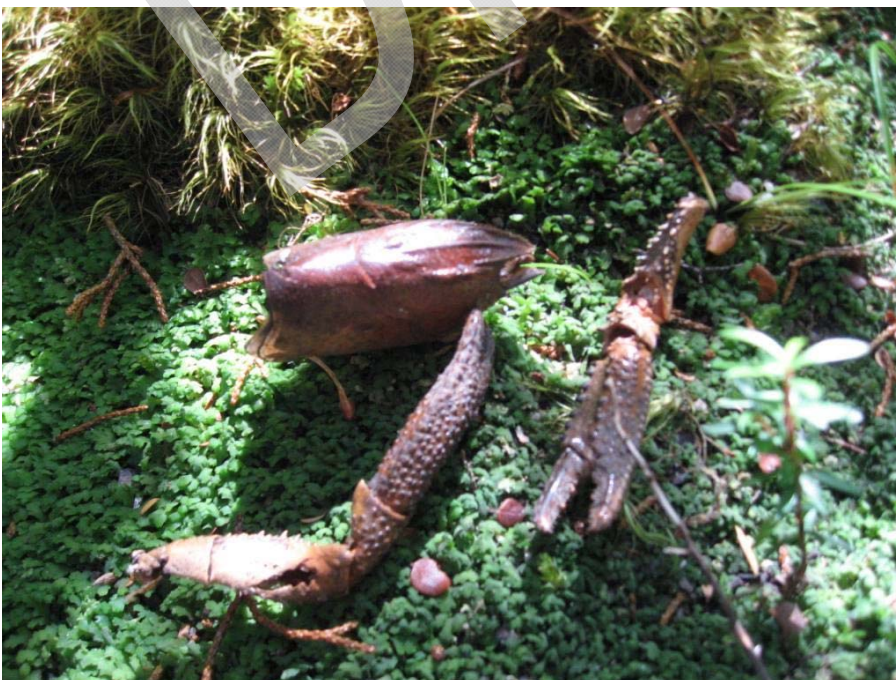
Smaller streams on the upper mountain were commonly dry. Searches of the stream bed at these sites did locate koura bodies (Figure 15). The tarn on the upper mountain was also dry (Figure 8); however numerous burrows were observed around the margin of the tarn at or about what would most likely be the normal water level (Figure 16). Excavation of the one of these burrows located a live koura (total length 50 mm, Figure 17) at the bottom of the burrow amongst damp sand/fine gravel material. Further burrows were not excavated to avoid promoting more rapid desiccation of koura that had retreated to these damp refuges. The densities of burrows around the tarn edge indicated that a reasonably abundant population of koura was present at the tarn.

Figure 15: Koura remains found in the dry bed of a small stream (Site 4).

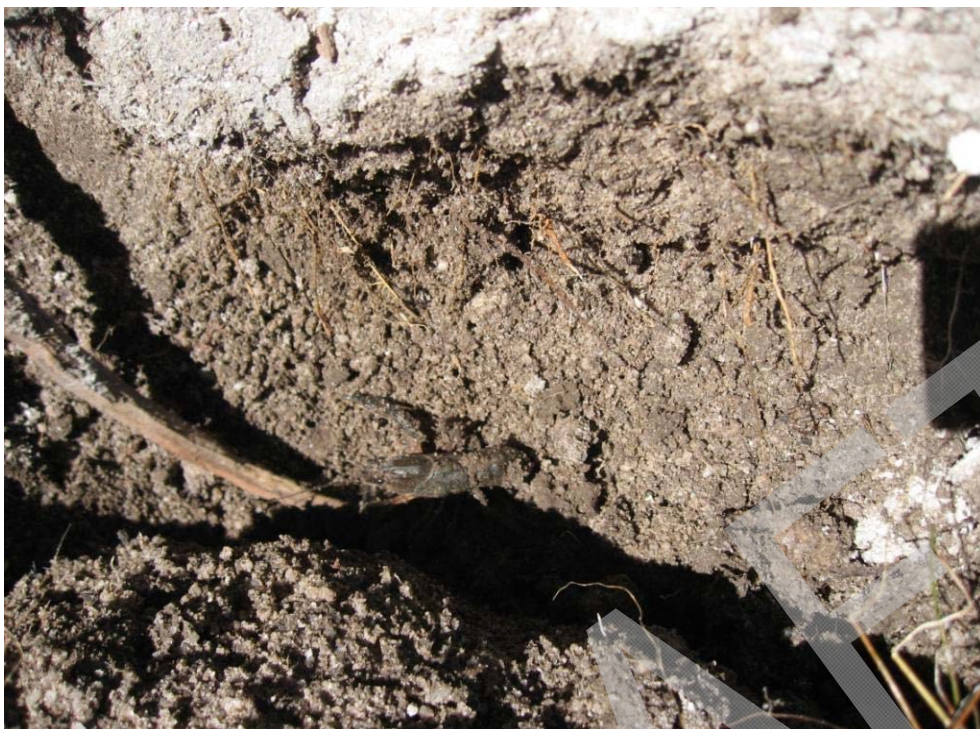
Figure 16: Koura found at the bottom of a burrow at the tarn edge.

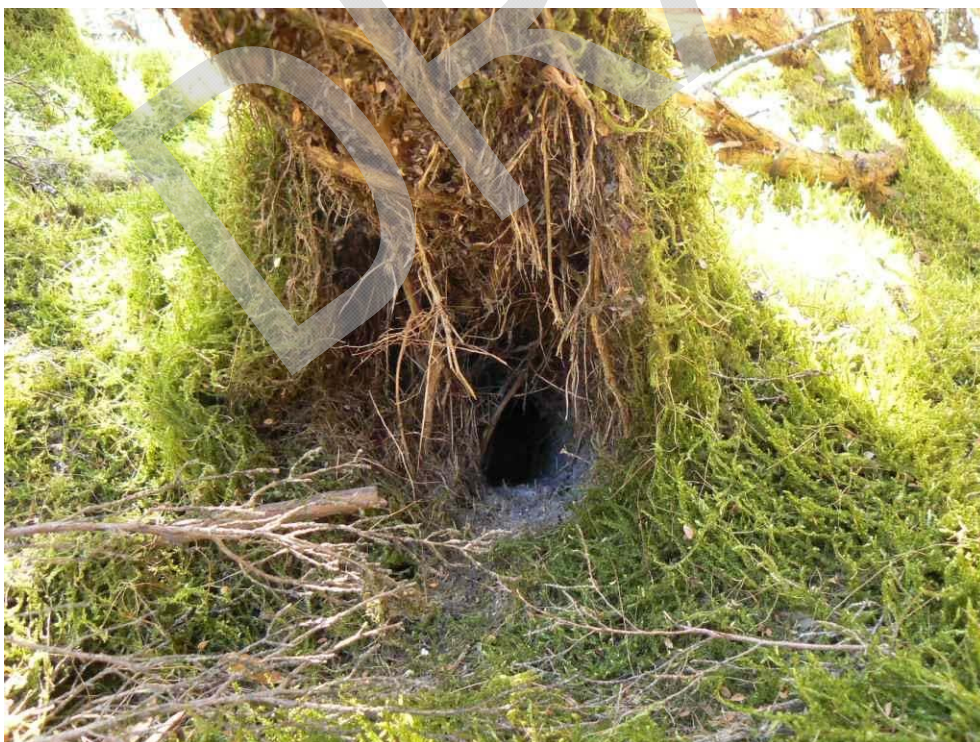
Figure 17: A burrow at the edge of the dry tarn.

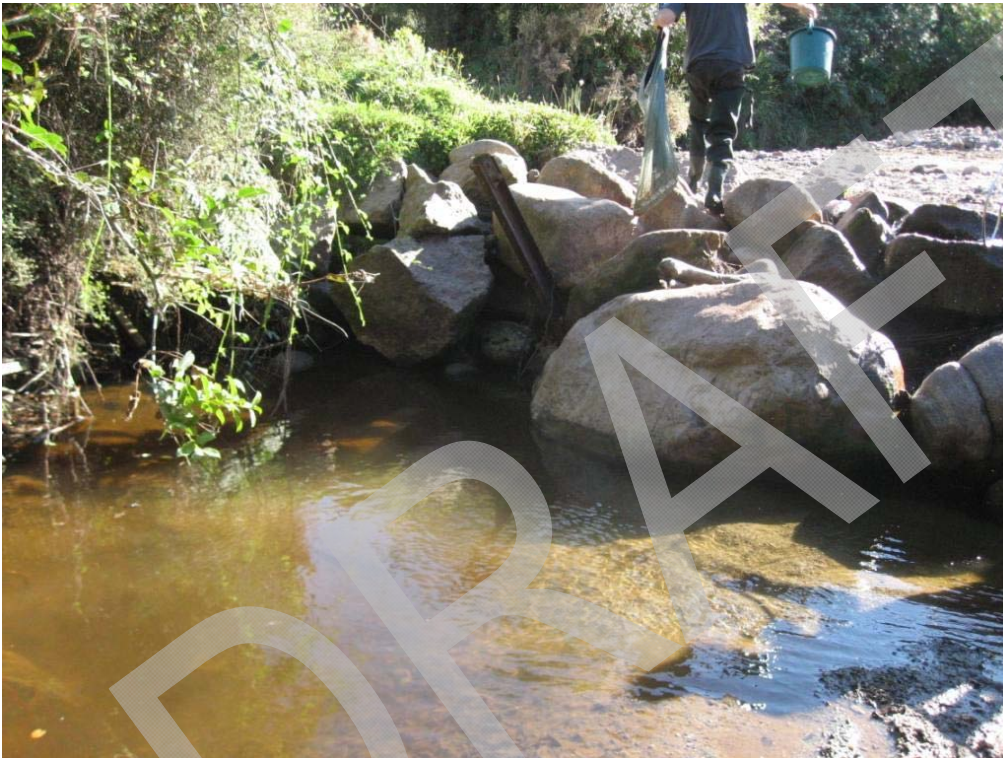
A partial fish passage barrier was present in West Creek at Nine Mile Road and most likely further downstream as well. The road crossing is a ford with a vertical fall on the downstream side of the road (Figure 18). Erosion of the road is prevented by the placement of large boulders along the downstream side of the road ford at the base of the drop. When the site was fished juvenile redfin bullies were very common downstream of the road, but noticeable rarer on the upstream side. Furthermore, all of the fish species encountered up and downstream of Nine Mile Road in West Creek are known as climbing species, that can ascend steep slopes and vertical surfaces. No poor climbing or swimming only native fish were present at this site indicating that a further barrier exists on West Creek between Nine Mile Road and the Buller River.

Figure 18: Partial fish passage barrier on West Creek at the Nine Mile Road ford.

Downstream of the Haul Road, West Creek has a partial fish passage barrier and stock had access to the stream and stream banks at crossing sites. The impact of this passage barrier is unclear as the extent to which it restricts whitebait and elver passage is unknown and the age of the barrier is also uncertain.
