MAHINGA KAI AND ECOLOGICAL RESTORATION PLAN FOR RANGITATA HĀPUA, RANGITATA RIVER, SOUTH CANTERBURY

Contract Report No. 5920e

March 2022

Department of Conservation
Raukapuka/Geraldine Office
PO Box 33
Geraldine 7956

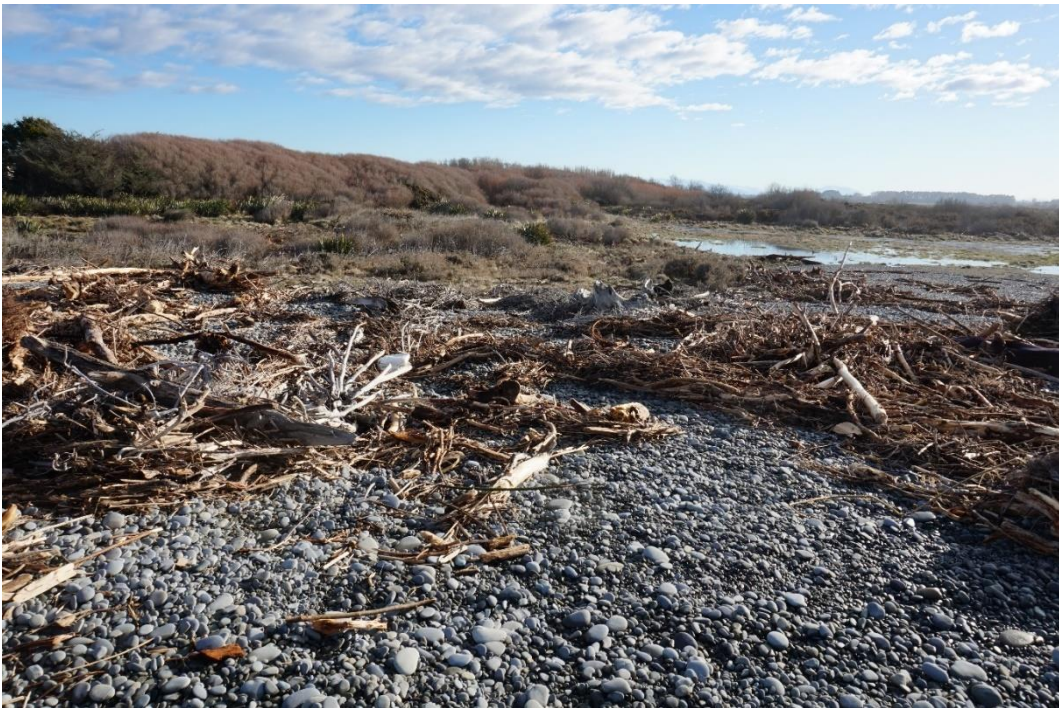
Plate 2: The southwestern margin of the hāpua within Management Unit A. Areas of wetland within this part of Management Unit A could be a useful site for the restoration of mahinga kai plant species. 8 July 2021.

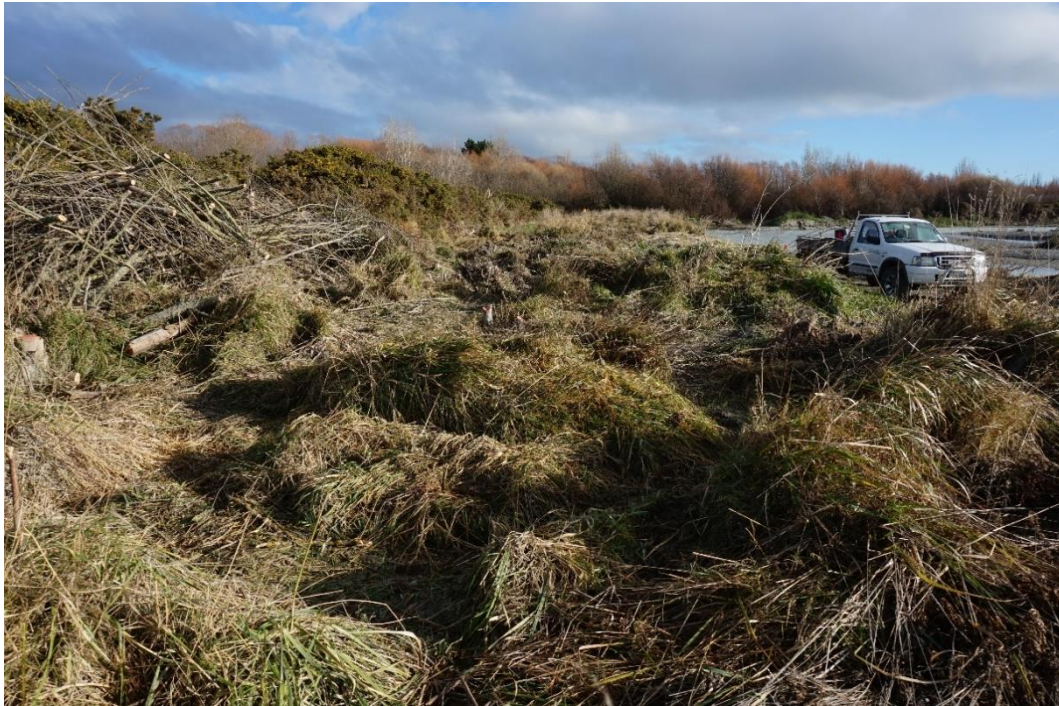
Plate 3: Potential īnanga spawning habitat along the margins of side braids within Management Unit A are being restored through the control of pest plants and the planting of indigenous vegetation. The margins of the smaller spring-fed streams within the site should also be restored in this manner. 8 July 2021.

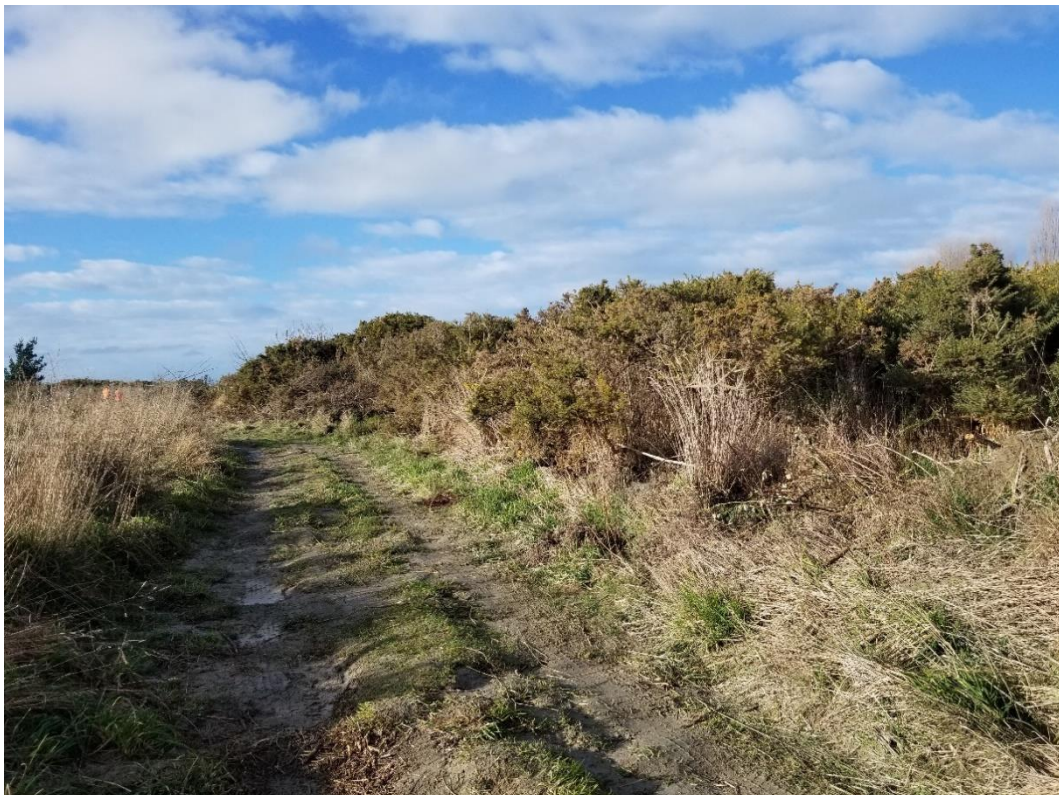
Plate 4: Areas of gorse and Scotch broom shrubland within Management Unit A could potentially be cleared to improve habitat for indigenous fauna. 8 July 2021.

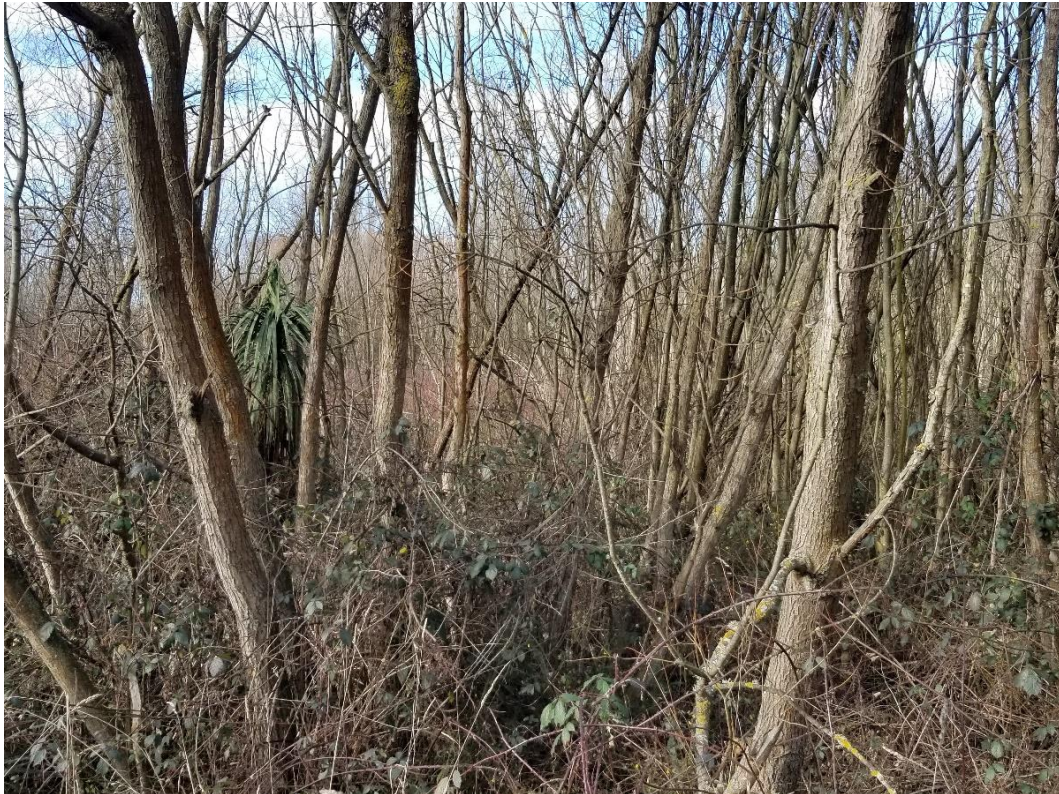
Plate 5: The area of poplar and crack willow forest within Management Unit A could act as an area to trial restoration treatments to be deployed across the wider catchment. 8 July 2021.

8.11 Selectively restore indigenous vegetation in areas of poplar and crack willow forest

Areas of poplar and crack willow (*Salix ×fragilis*) forest in Management Unit A could be selected to trial restoration methods for use across the wider catchment. Ideally, the area of control would extend beyond the footprint of the project area to the wider margin of the wetland to the southwest of the management unit. Several restoration treatments could be applied to sections of the area that are controlled (e.g. underplanting existing canopy with and without prior canopy thinning, followed by strategic canopy removal; no planting but sustained pest plant control, no control) to better understand how management achieve restoration of indigenous vegetation within these exotic forests. The existing willow nurseries within this area should be retained.
