Figure 1 **SCHEMATIC DIAGRAM OF WAIKINO RAIL BRIDGE**
 (not to scale)

Figure 2
SCHEMATIC DIAGRAM OF WAIKINO RAIL BRIDGE
Cross Section (not to scale)

Figure 3
SCHEMATIC DIAGRAM OF WAIKINO RAIL BRIDGE
Layout of Preservative Treatments

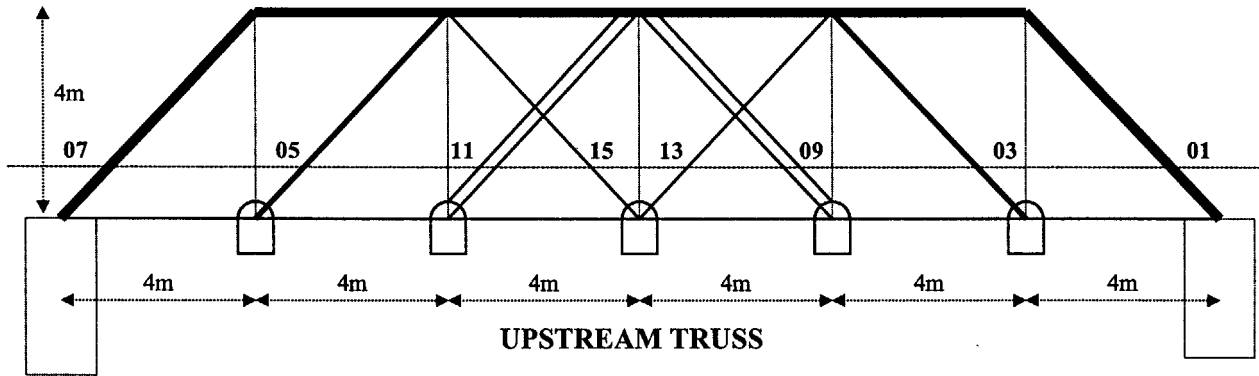
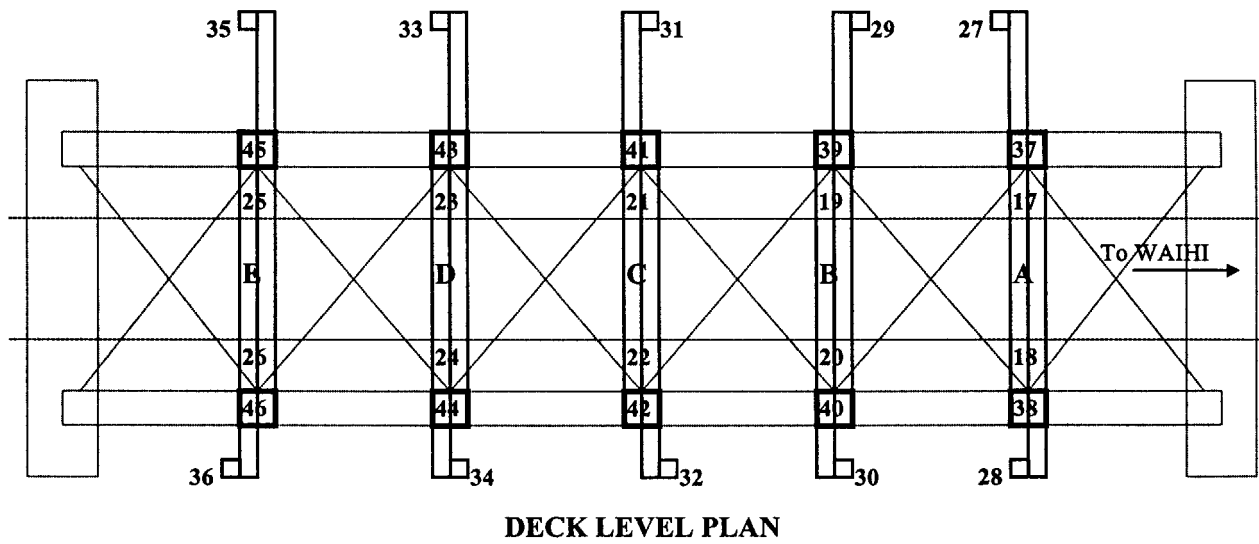
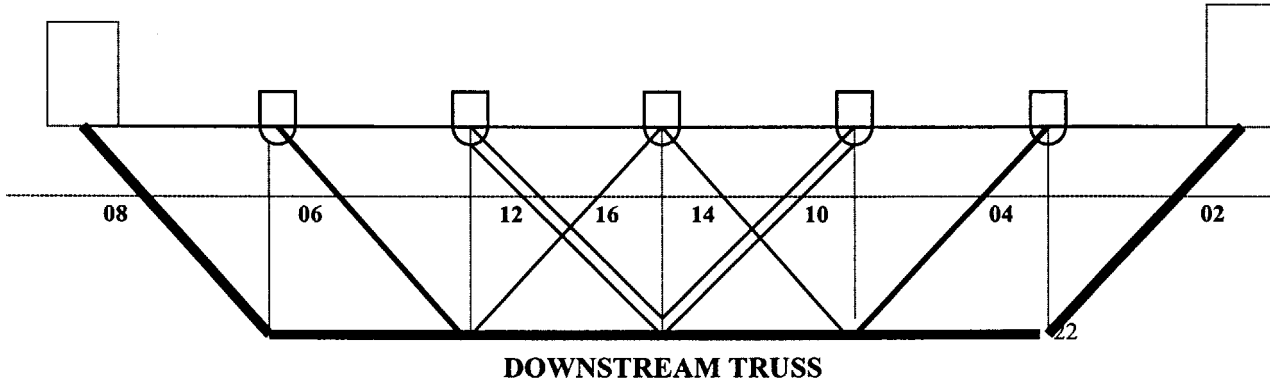
Key to component numbers/treatment areas

Numbers 01, 02, 07, 08; 45° king struts (300x400mm)

Numbers 03 - 06 45° queen struts (350x250mm)

Numbers 09-12; Double 45° struts (2/200x130mm)

Numbers 13-16; Single 45° struts (200x130mm)

Numbers 17-26; Upper surfaces of transoms between stringers and sway braces

Numbers 27-36; Semi vertical sway braces (200x130mm)

Numbers 37-46; Compression blocks at the base of the 45° struts

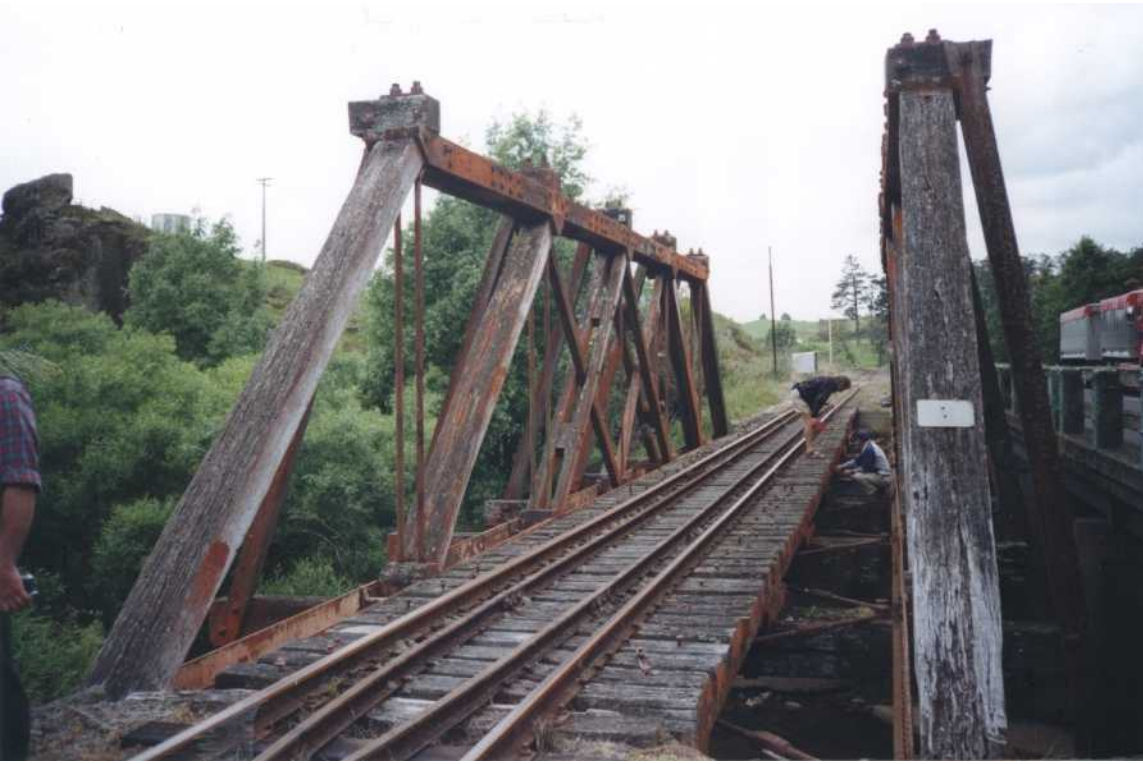
Figure 4. General view of the bridge from the Waikino end, before water-blasting and treatment started. There was extensive orange algae and lichen on many of the components as well as deep fissures and occasional deeper decay.

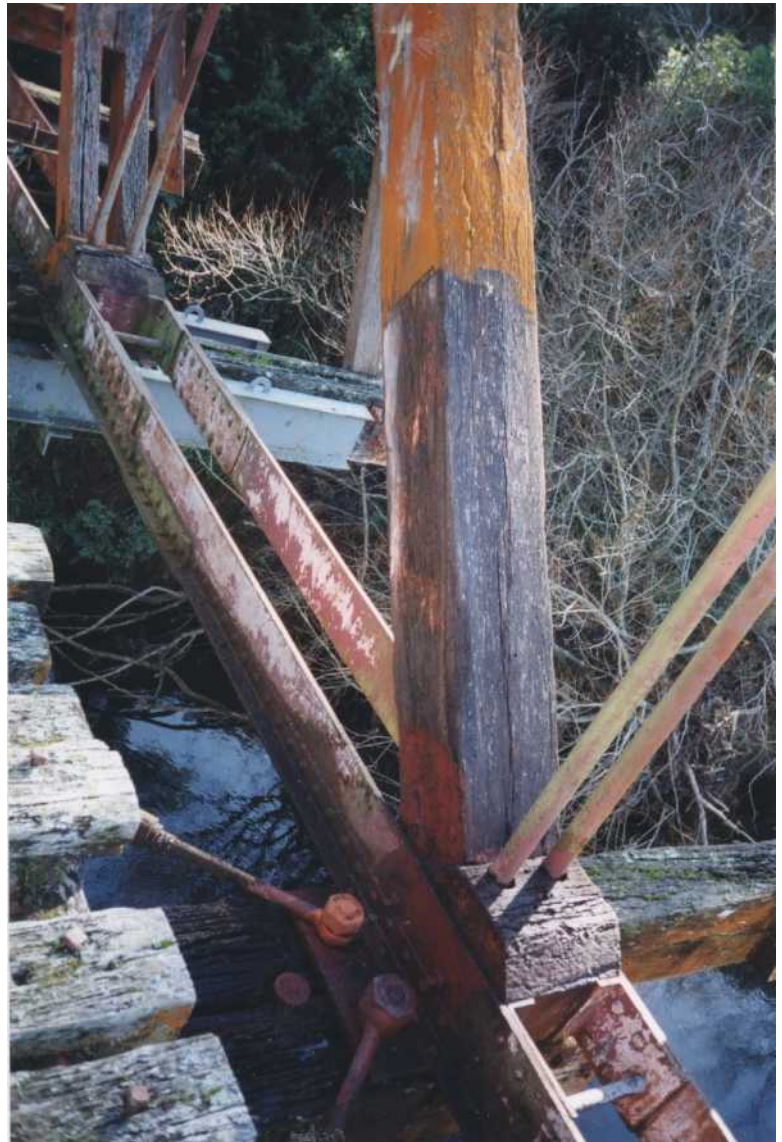
Figure 5. Initial water-blasting test on queen strut 3 and compression block 37. Water-blasting removed the orange algae, lichen, debris and most of the moss and vegetation growing in fissures in the beams. The original red primer on both the metal and wooden components was not all removed.

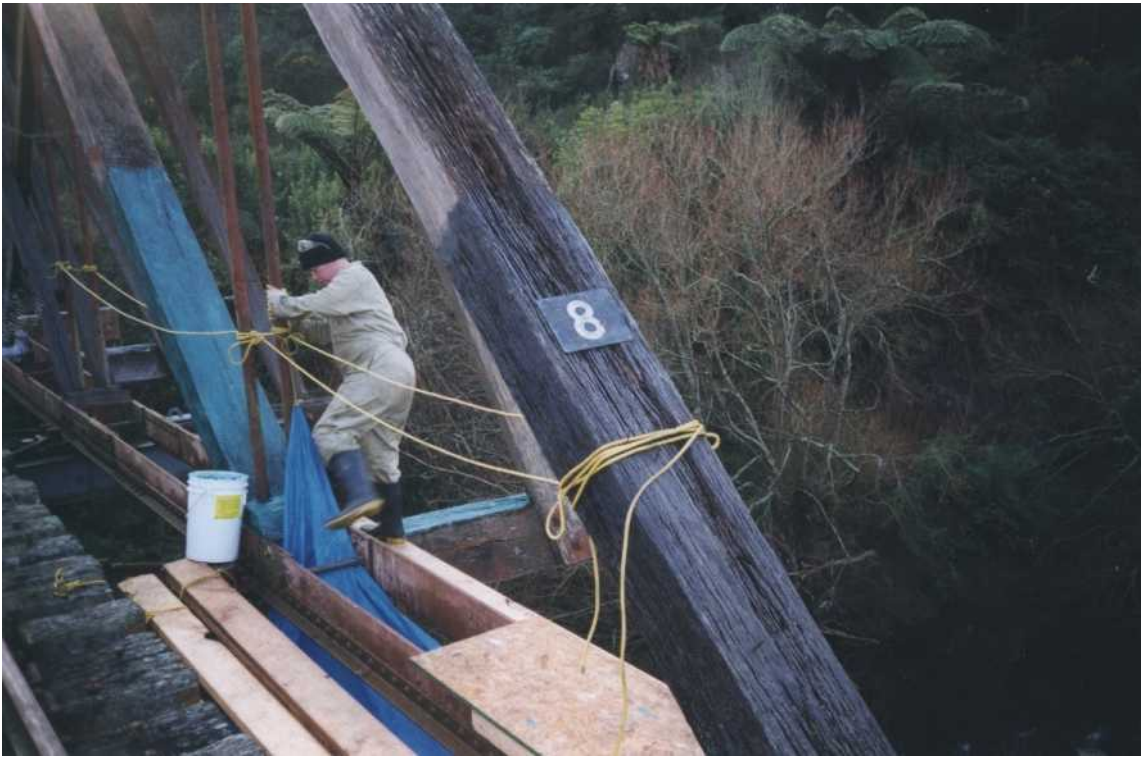
Figure 6. Components at the time of treatment. King strut 1 in the foreground has just been coated with CD50 and the tarpaulin installed to prevent spillage into the creek is being removed. Queen strut 3 and the top of transom 17, coated with CN Emulsion earlier in the day, are in the background.

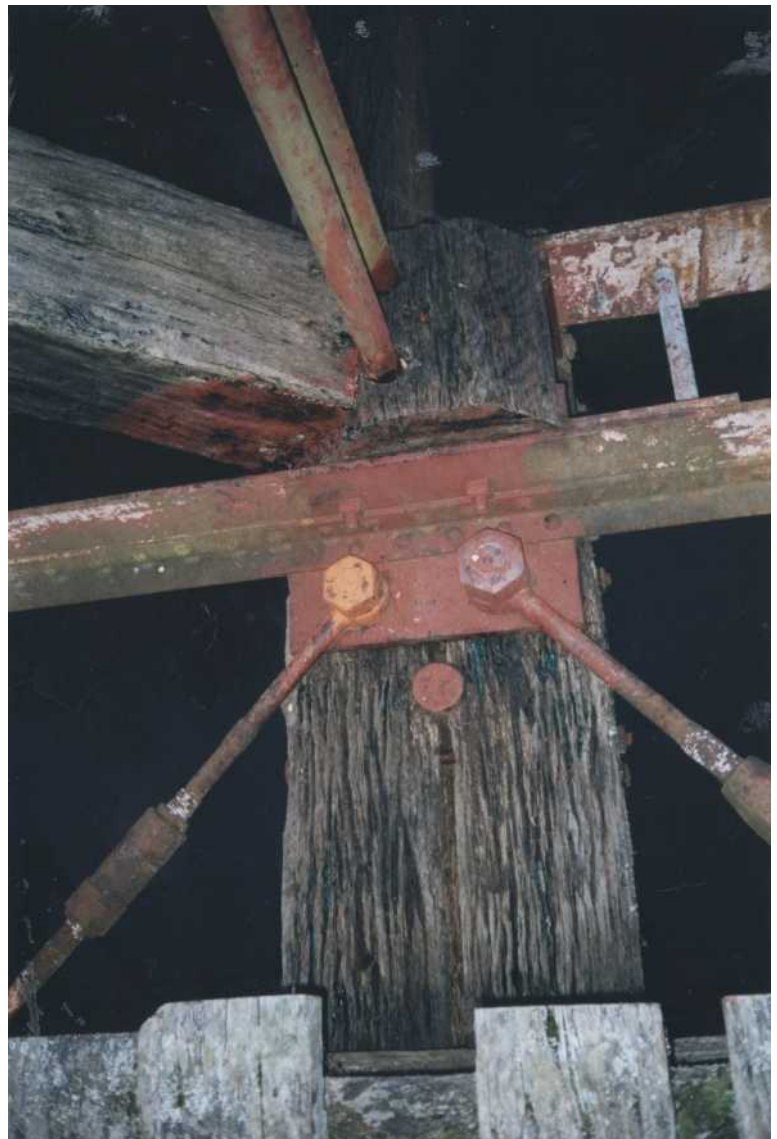
Figure 7. The upper surface of transom 17, compression block 37 and the lower end of queen strut 3, six days after application of CN Emulsion. The surface has almost returned to its original grey colour; there is some darkening and traces of CN Emulsion in the fissures.

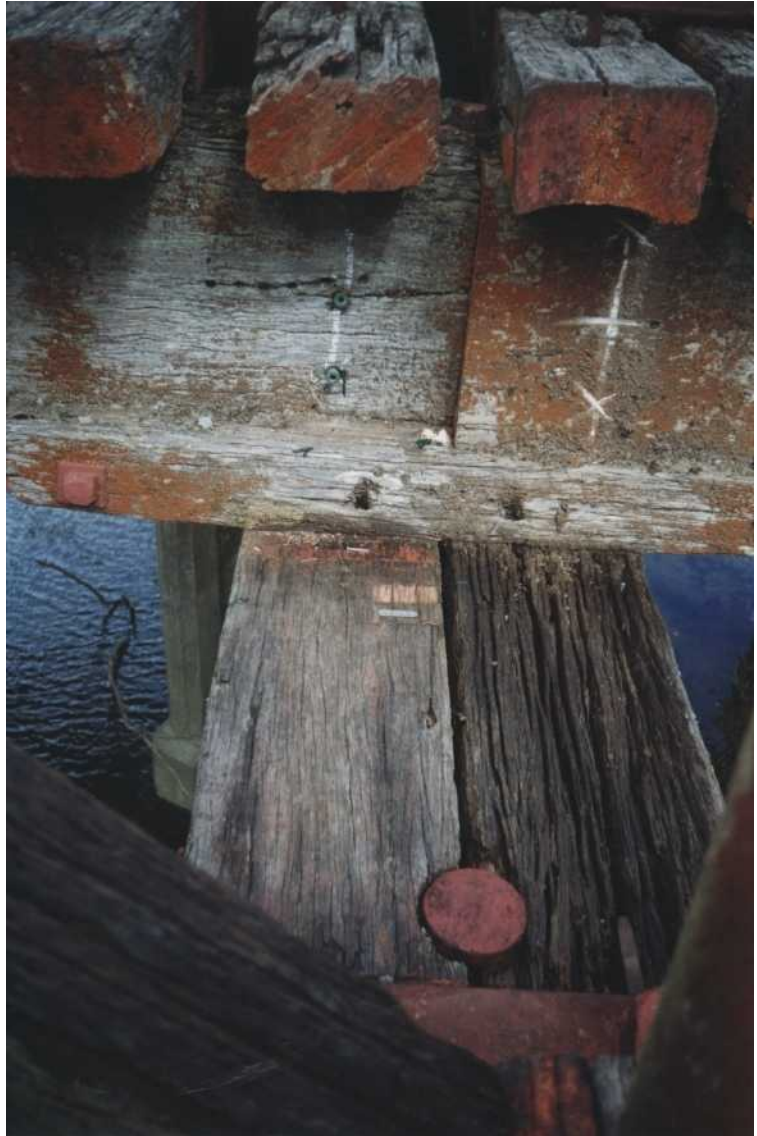
Figure 8. Green plastic plugs in the end of the stringer resting on the transom '23' are just visible. These are plugging the holes filled with CN Emulsion preservative at 'C', immediately above the surface sampling point 0375 (aluminium tag) The upper surface of the transoms had just been recoated with copper naphthenate in diesel, but the green preservative colour disappeared immediately after application.
