Map of archaeological sites on Pukekura Pa

Map of archaeological sites on Pukekura Pa. *Conservation A dvisory Science Notes No. 57*, Department of Conservation, Wellington. 22p.

Map of archaeological sites on Pukekura Pa Jill Hamel, June 1993.

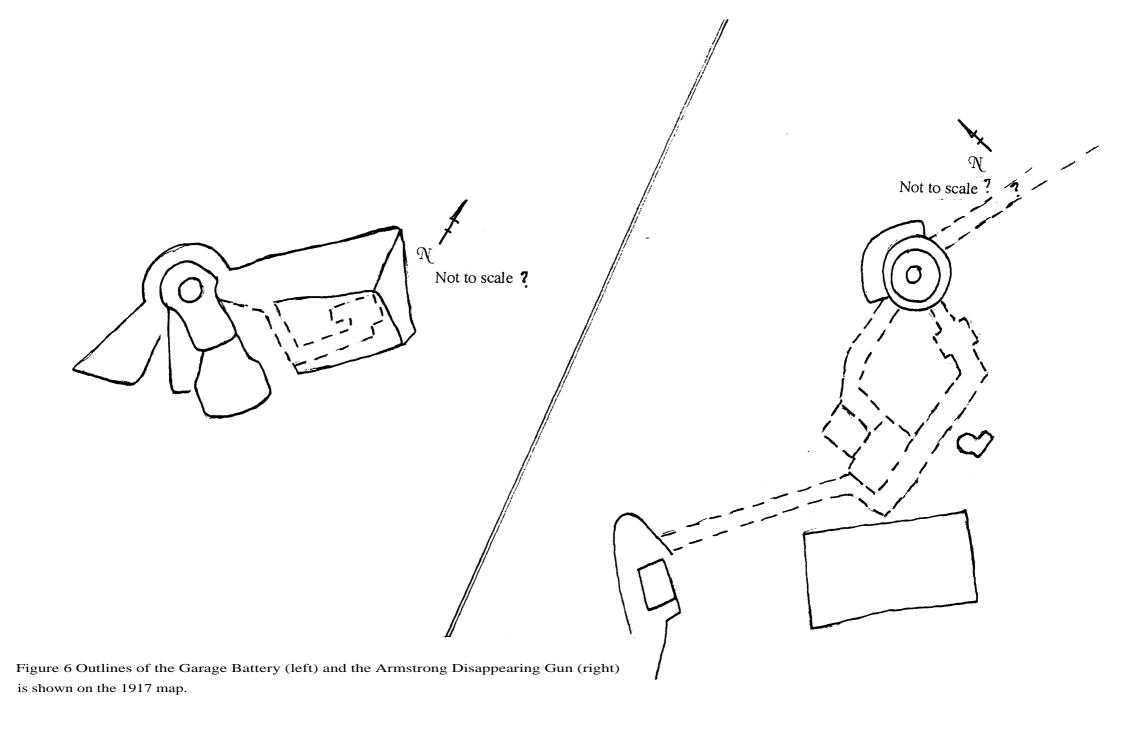
Figure 5a Plan of the Saddle Battery showing the gun platform and underground rooms for ammunition. A central corridor between the ammunition rooms has four small viewing hatches.

Figures 5 and 6. Four of the older batteries shown on the 1917 map have been expanded by 150%. The battery under the modern observatory is so simple it was not worth expanding. The drawings do not seem very accurate and are probably meant to be diagrammatic. The Disappearing Gun has only part of its concrete apron shown but it probably extended all the way round even in 1917. There is a roadway marked running eastward from the gun which I have not checked on the ground. The water tank at the entrance to the Tunnel Gate is shown, but it is not apparent what the big oblong to the south east of the gun is meant to represent. Underground rooms are represented by broken lines.
