Electronic monitoring in the New Zealand inshore trawl fishery

A pilot study

DOC MARINE CONSERVATION SERVICES SERIES 9

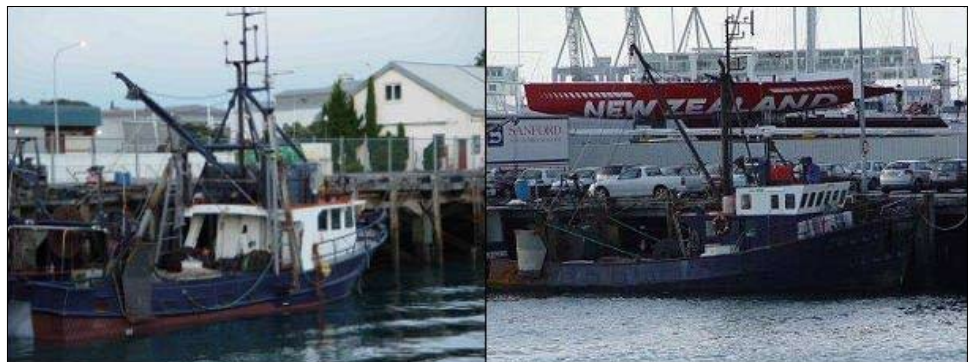
Figure 1. The two inshore trawl vessels that participated in the study shown alongside each other in Auckland (vessel identifiers have been removed).

Two inshore trawl vessels of similar tonnage were selected by vessel managers at Sanford to participate on this study. The two vessels are referred to as V1 and V2 in order to protect their identity (Fig. 1).

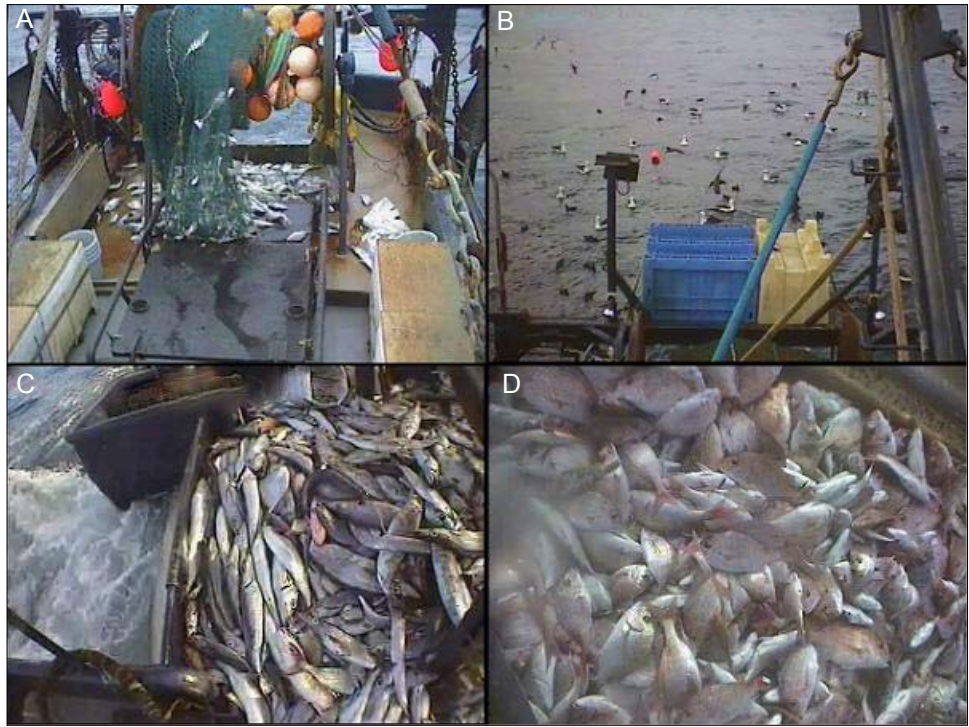
Figure 3. Sample images from V1. A. Overall view of the complete deck area. B. View used for assessing seabird abundance and for the detection of mitigation devices. C. and D. views were used for quantifying and identifying protected species bycatch, offal discharge and discarded bycatch.

Particular camera angles (see Figs 3 & 4) were used to enable protected species abundances around the stern of the vessel to be assessed during EM review. All observed daylight tows were reviewed and abundance estimates were made for recorded gear shooting and hauling intervals. Seabirds were the main protected species regularly detected during the EM review process, although dolphins were also seen. Imagery was typically viewed at 1-2 times speed to assess seabird abundances. The EM viewer's estimates were always for distances of less than 100 m from the vessel, and more likely within 25 m of the vessel. This range limitation likely explains some of the differences seen when comparing EM-based estimates with observer data. Seabird abundance was assessed both during gear shooting and hauling. Exact seabird counts were not possible, and abundance estimates were classified into the following six abundance categories:

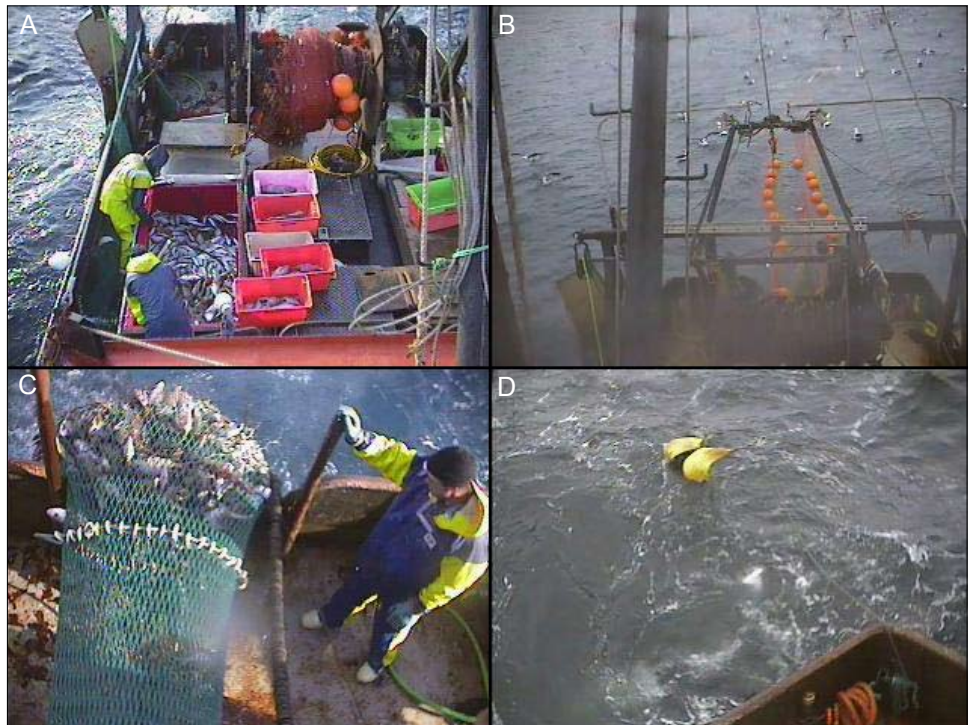
Figure 4. Sample images from V2. A. View used for analysis of offal discharge, discarded bycatch and protected species bycatch. B. View used for assessing seabird abundance and mitigation device deployment. C. View used to detect protected species bycatch when the codend was hauled over the stern. D. View initially set up to detect warp strikes. This view was eventually used to detect deployment of the warp scarer that was clipped to the main warp.

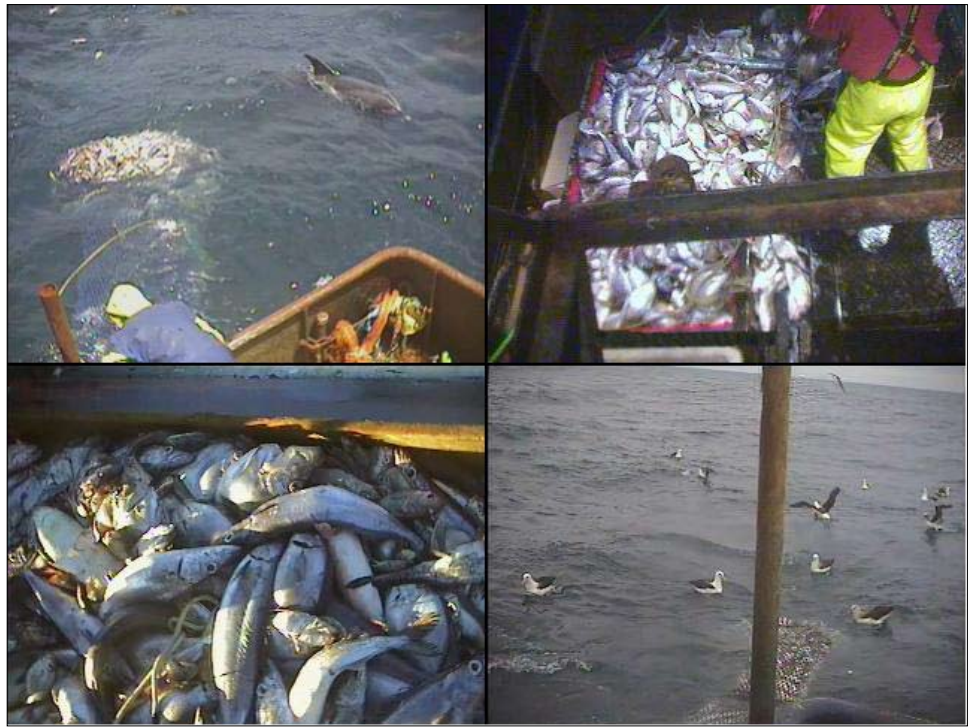
Figure 7. Port stern camera views that were changed. V2 (top) was changed from showing the stern quarter (left) to capturing catch processing that sometimes occurred on the port side (right). This camera view on V1 (bottom) was changed from describing the catch on deck (left) to capturing action (seabirds, warp) off the stern quarter (right).

Changes were made to the camera angles throughout the duration of the project in an effort to better capture all the events of interest (see Fig. 7 for examples). Sometimes these changes to camera configurations diminished the system's ability to monitor for other objectives. The changes in camera views made in an effort to capture all events made subsequent analysis of the image data for this project difficult for the EM reviewer.

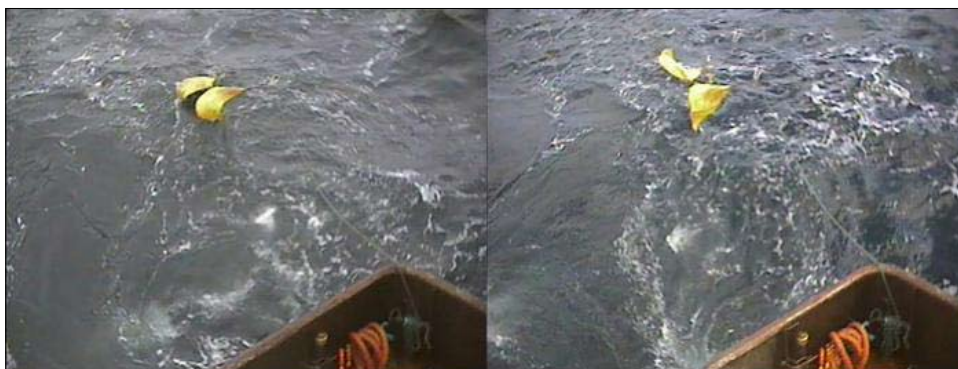
Figure 9. Two images showing the camera view that was set up on V2 for assessing seabird interactions with the warp.

EM imagery was recorded from the time when trawl doors were deployed to 30 minutes after gear was on the bottom fishing, and again when gear was retrieved until 30 minutes after the gear was stowed aboard the vessel. Image data could be reviewed for seabird strikes on warps or mitigation devices during these periods. Following the same definitions used by the observer for heavy contacts and light contacts, and small or large seabirds, the EM reviewer attempted to record counts of any interactions of seabirds. Figure 9 shows the camera view from V2 that was set up to assess seabird interactions with the warp.

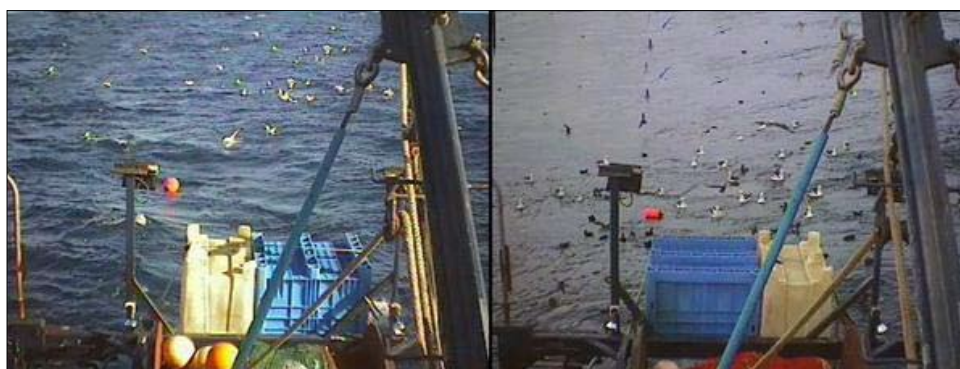
Figure 10. Example images of seabirds around the stern of V1 during hauling operations.

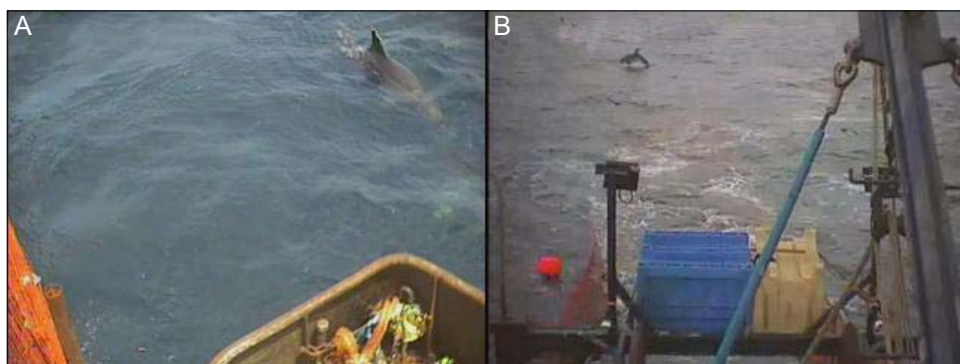
Figure 11. Example images of marine mammal activity from A. V2, and B. V1 during hauling operations.

During review of the non-observed tows, dolphins around the vessels' sterns could be detected and rough abundance estimates made (see Fig. 11). The EM reviewer was able to identify marine mammals to a general species level such as dolphins (*Delphinus* spp.). Additional full resolution images are shown in Appendix 3.

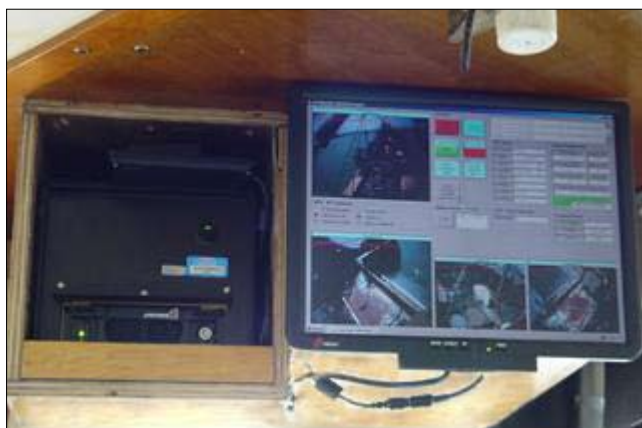
Figure A1.1. EM control box and user interface installation on V1 (ceiling mounted).

The heart of the electronic monitoring system is a tamper-resistant metal control box (approx. 38 × 25 × 20 cm) that houses computer circuitry and data storage devices (Fig. A1.1). The control box receives inputs from several

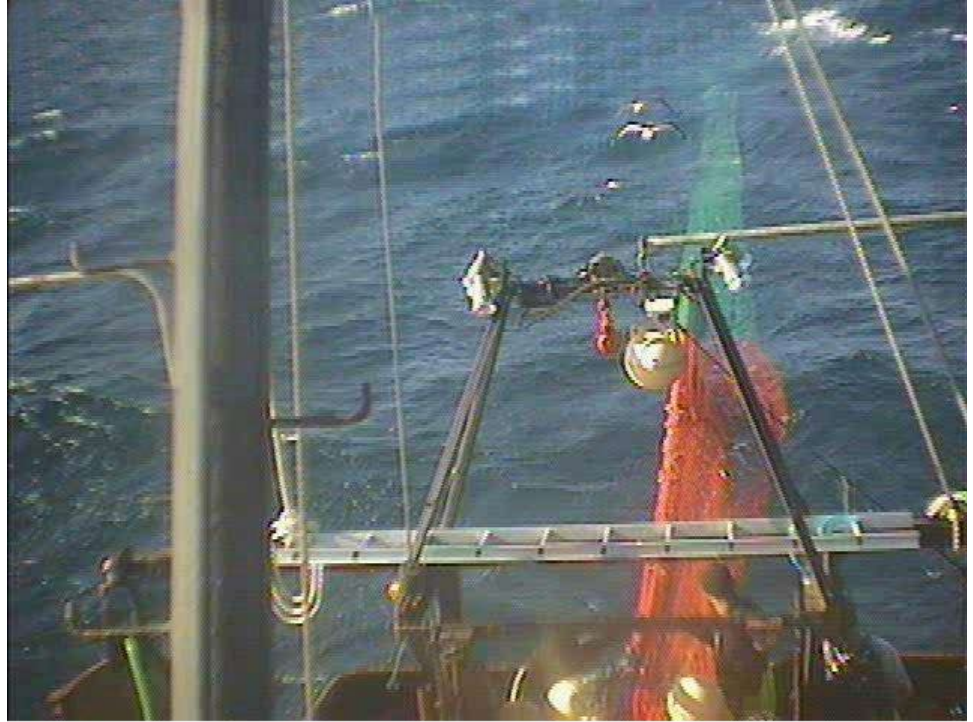
Figure A3.1. Sample image from V2 during hauling of fishing gear, seabird abundance category 1 (0-10 seabirds).

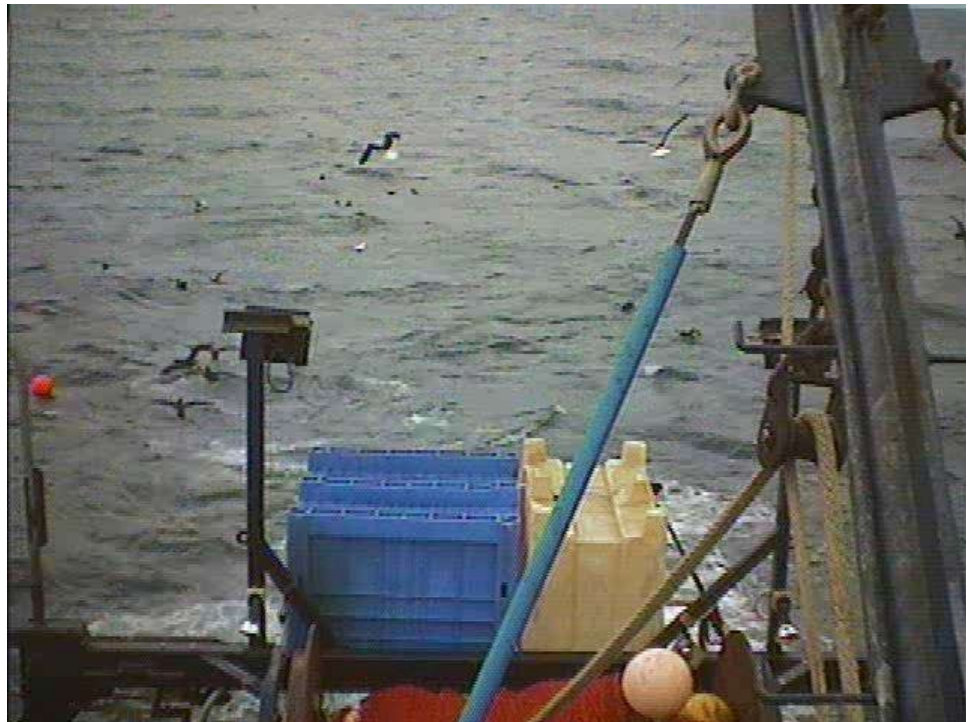
Figure A3.2. Sample image from V1 during hauling of fishing gear for seabird abundance category 2 (11-15 seabirds).

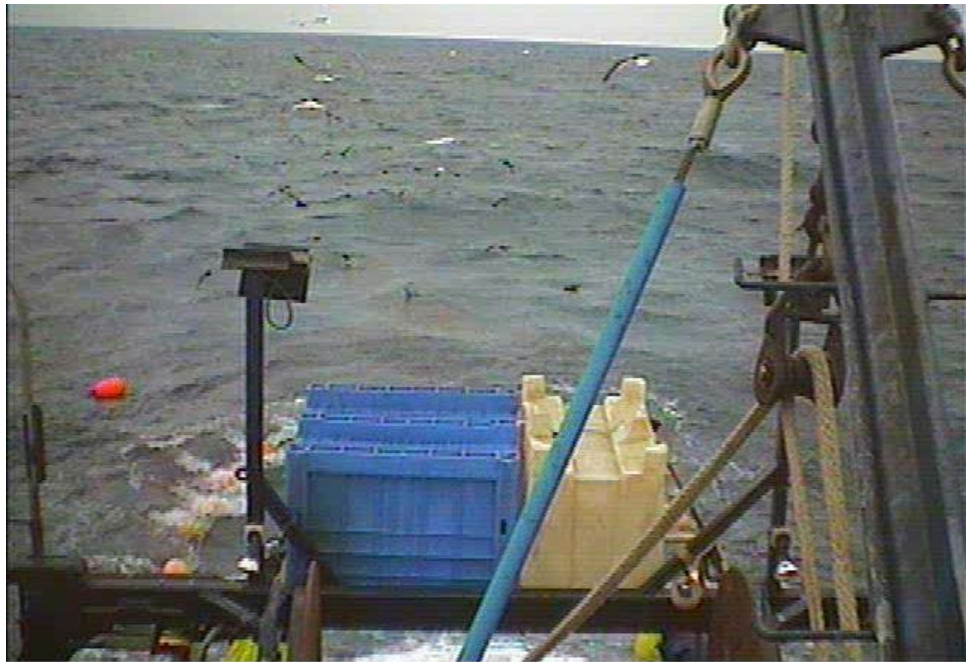
Figure A3.3. Sample image from V1 during hauling of fishing gear, for seabird abundance category 3 (16-25 seabirds).
