Mt Harper ice rink

Baseline inspection and historic values assessment

Katharine Watson

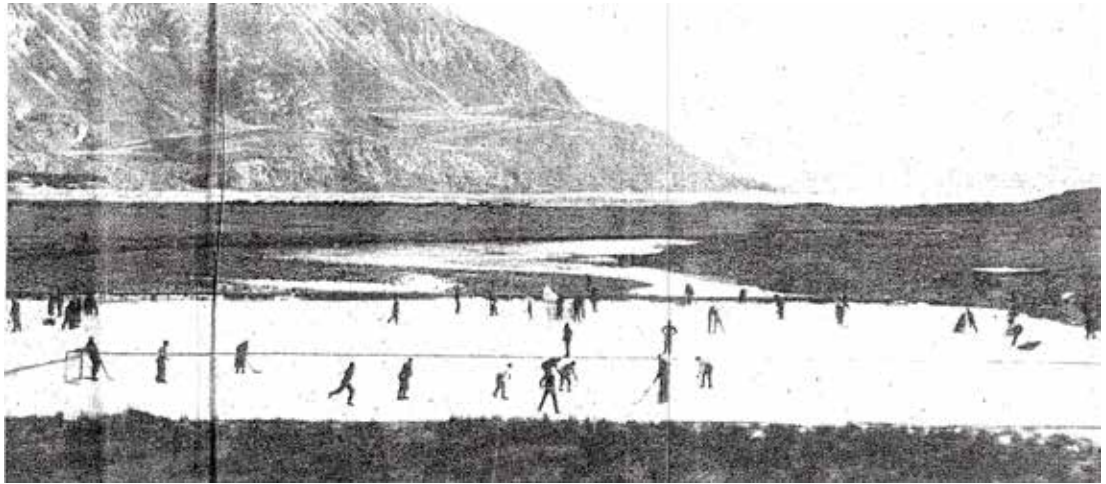
The first dated photograph of the ice rink is from 1936 (Fig. 2). Here, the rink area has been divided in two (this may have been an original division) and hockey is being played on the rink in the foreground. The rink in the distance (to the west) is only partly frozen, if at all. The skate shed can be seen at the end of the bund (earth mound) that separates the two rinks, but no other buildings are visible.

Figure 2. The Mt Harper ice rink in 1936, looking west. Source: *The Press*, 20 July 1984.

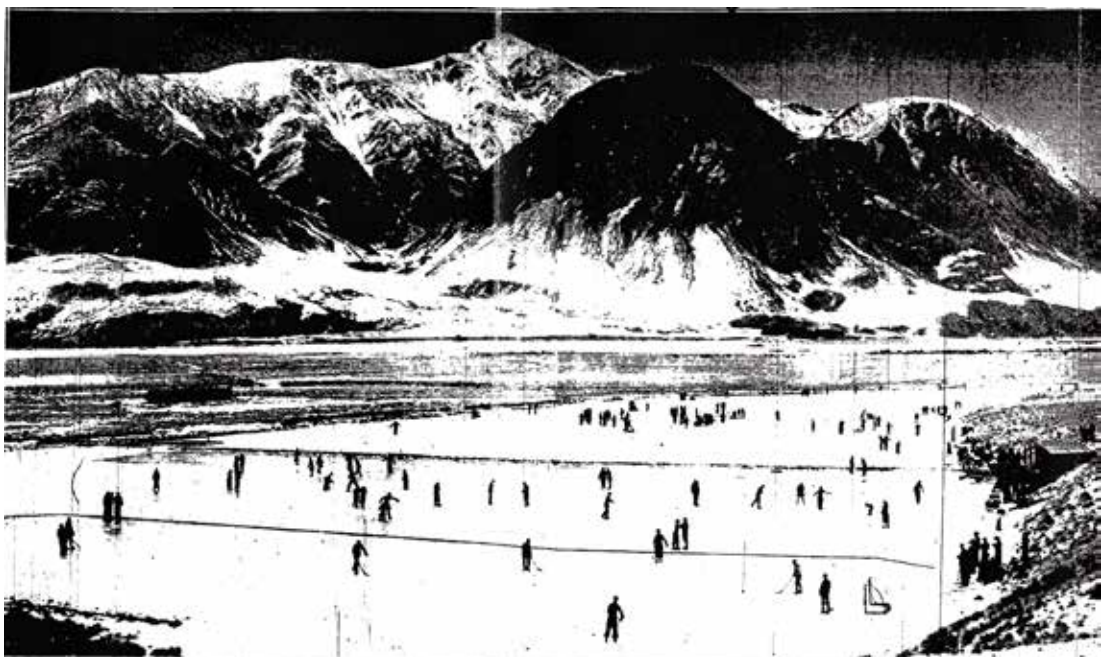
The area of ice was not increased from the early years of the rink's operation, but was later subdivided into smaller rinks and some areas were abandoned due to poor ice. No further division of the rinks had occurred by 1937 (Fig. 3), but at least one small rink had been subdivided off the main eastern rink by 1940; however, this may have been part of the original design (Fig. 4)—other available photographs do not show the relevant area. At some stage, a second, slightly larger rink was formed to the east of this small rink, but this was never used as there was a spring beneath it and so the area never froze (B. Allan, pers. comm.)—which may have been why the area was subdivided off from the main rink.

Figure 3. The Mt Harper ice rink in 1937, looking southwest towards Ben McLeod. Source: *The Press*, 6 July 1937.

Photographs of the skate shed show a long, low, rectangular building built into the face of the terrace on the north side of the rink (Fig. 3). There were three windows across the south elevation of the building and several doors, some of which were 'half' doors (Fig. 10).

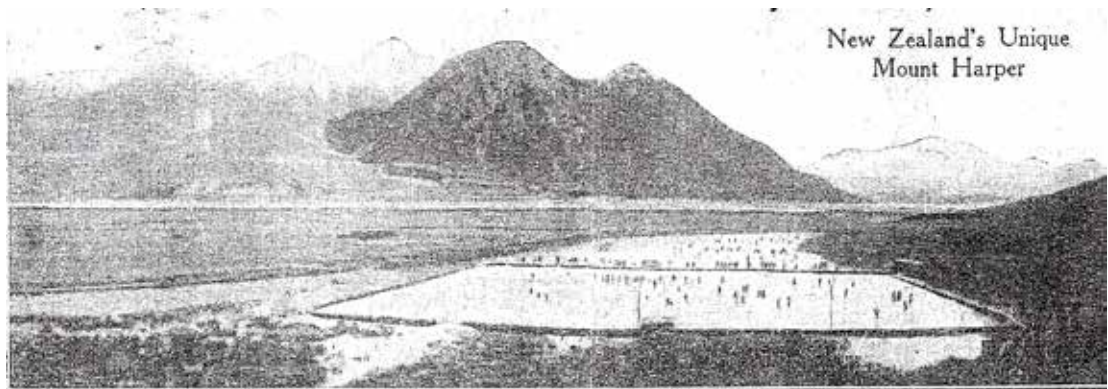
Figure 4. The Mt Harper ice rink in 1940, looking west. Source: *The Press*, 2 July 1940.

Bruce Allan indicated that Rink 3 contained a spring and never froze, and thus was never used for skating. Furthermore, Rinks 4 and 8 seem too small to have ever been used for skating, although Rink 4 had ice on it in 1940 (Fig. 4) but not in 1947 (Fig. 5). Rink 7 had a row of poplars (deliberately planted, not wildings) growing in it, immediately west of the hockey rink, indicating that it was not used for all of the rink's lifespan. This rink was frozen in 1947 (Fig. 5), and it is possible that the trees were planted at the time the refrigeration unit was installed or even after

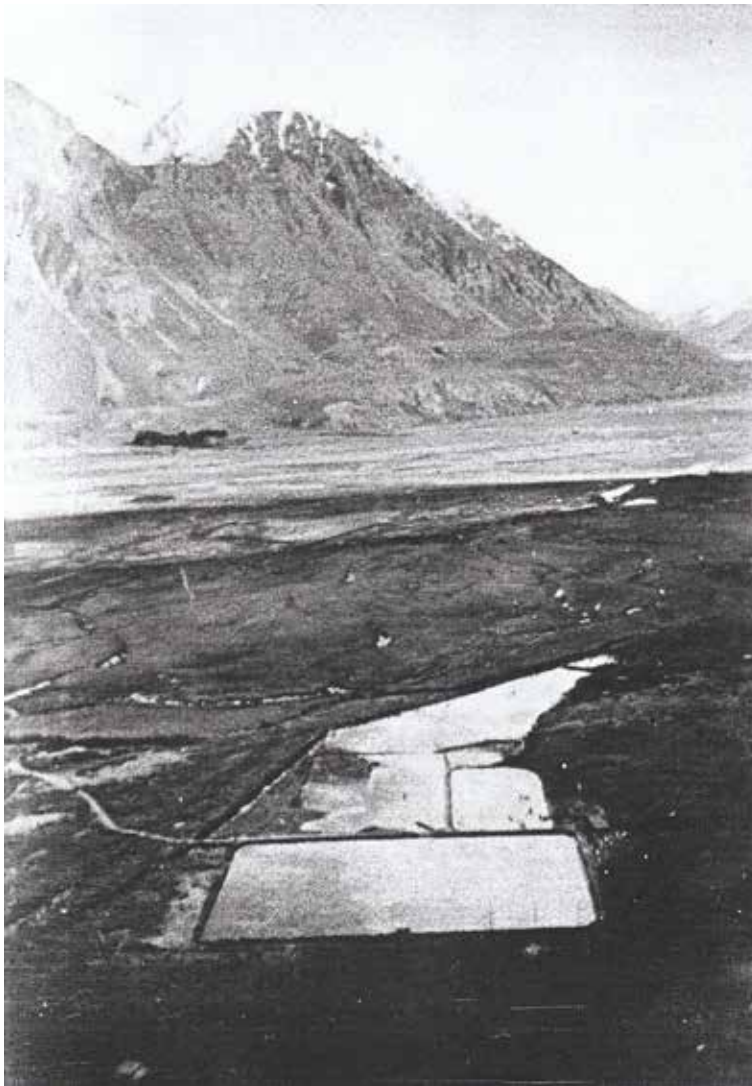
By 1947, the western area had been divided into three rinks, one of which was to become the hockey rink (Fig. 5; Wright 2007). During the later years of the rink's operation, the westernmost rink ceased to be used, as the ice did not freeze well (R. Taylor, pers. comm.).

Figure 5. The Mt Harper ice rink in 1947, looking west. Rink 2 is in the foreground, with Rinks 5 (right) and 6 (left) in the middle, and Rinks 7 and 8 beyond. (Note: These rink numbers were designated during the archaeological survey.) Source: *Ashburton Museum*.

of this bund that separated Rinks 2 and 5 was no doubt removed to create a suitable sized hockey pitch in Rink 5, which had been completed by 1947 (Fig. 5). The reason for the broader nature of the bund along the south side of Rink 6 is not clear, but it may have been to provide space for people to watch the skating.

A notable feature of Rink 6 is the presence of a wing wall next to the gap in the bund between this rink and Rink 2, which was present in 1947 (Fig. 5). The purpose of the wing wall is not clear. It is possible that it was used to channel the flow of water or it may have been used to slow skaters down as they moved between rinks. It should be noted that this gap in the bund was the only one that would have been big enough to skate through. This gap was not visible in the 1947 photograph and so may post-date this—although this may also be due to the quality of the image. The gap is unlikely to have been an original feature as it would not have been possible to walk all the way along the central embankment to the refreshment house with this gap in the central embankment. This gap may have been one of the reasons why the ticket office was built.

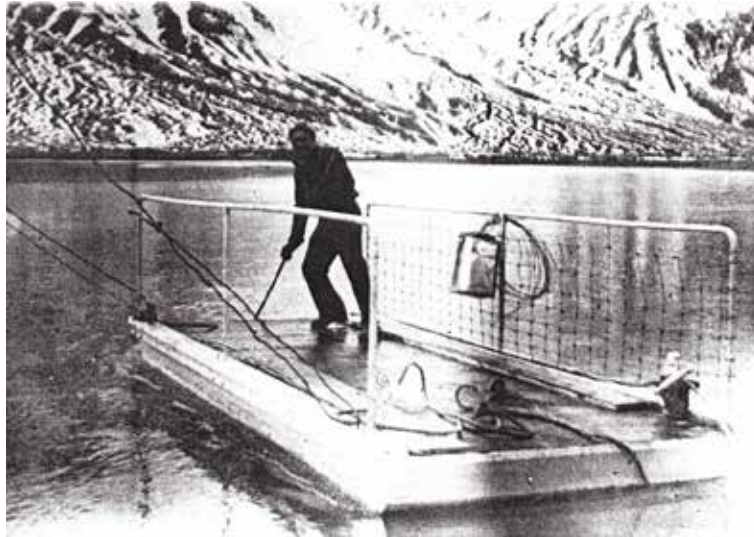
Some of the means of accessing the rink have already been described. During the first years of rink construction, the Barkers (and their helpers) used a boat to reach the rink. The first method that the public used to cross the river was to take the Erewhon punt across the main stream and a cradle across the second stream. The punt was a raft built from drums (Fig. 6) that was

Figure 6. The punt on the Rangitata River. Source: Geraldine Museum 1829.

pulled across the river by wires attached to towers in the riverbed (Kerr-North 1984). The punt and cradle were removed at the end of the winter, before the spring floods could damage them (Wright 2007). Nonetheless, there were still problems with the punt, and it was swept away (bearing passengers) on more than one occasion (Kerr-North 1984; *Timaru Herald* 1934).

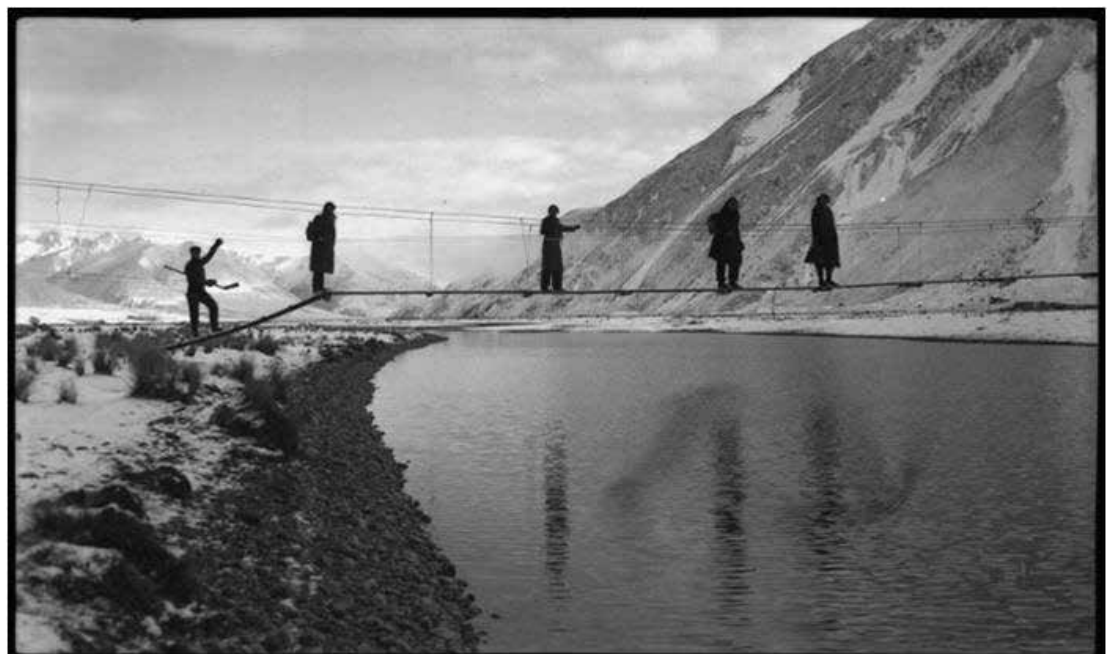
Aside from the potential risk of being swept away, the punt also posed limitations because it could only carry 20–30 people, leaving others waiting on the cold, frozen riverbed. Consequently, a swing bridge was installed in later years (Fig. 7). During the Kirkpatrick's tenure (1948–49), a pontoon bridge was used (Fig. 8). However, this was found to be unsatisfactory and so was subsequently replaced by another swing bridge (Wright 2007).

Figure 7. Crossing the swing bridge, c. 1940. Source: Alexander Turnbull Library, PAColl-3052, Box 17.

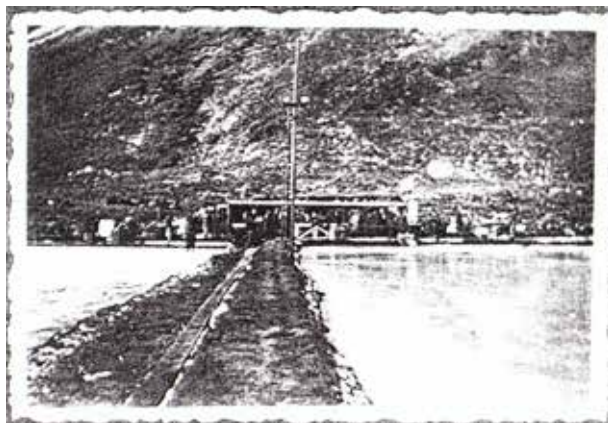
Figure 9. The central embankment leading to the skate shed. Note the power pole/lamppost on the embankment in the middle distance. Source: *Geraldine Museum 4332*.

house could have been used for these functions; *Timaru Herald* 1934). The shed was definitely in place by 1936 (Fig. 2). The shed was reached by a broad bund between the two main rinks (Fig. 9; Wilding 1940; Wright 2007). The following description of the shed appeared in the *Timaru journal*, published in 1940: 'There are two heated rest rooms, a restaurant, skating library, and a library of skating pictures, beside the ice, where skates, curling and other equipment can be hired'. Some 300 pairs of skates were available for hire here (Anon. n.d.a), which cost tuppence

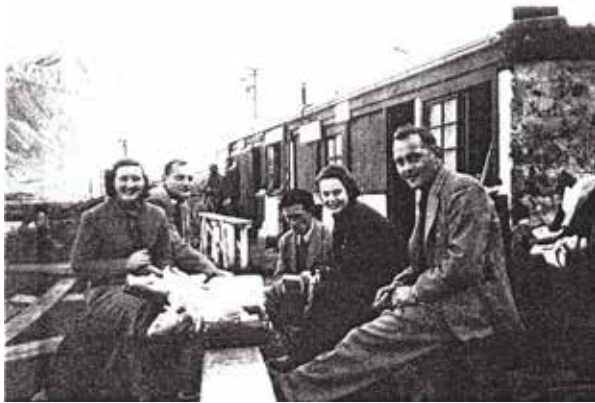
Figure 10. A group of people outside the skate shed. Source: Geraldine Museum 4734.

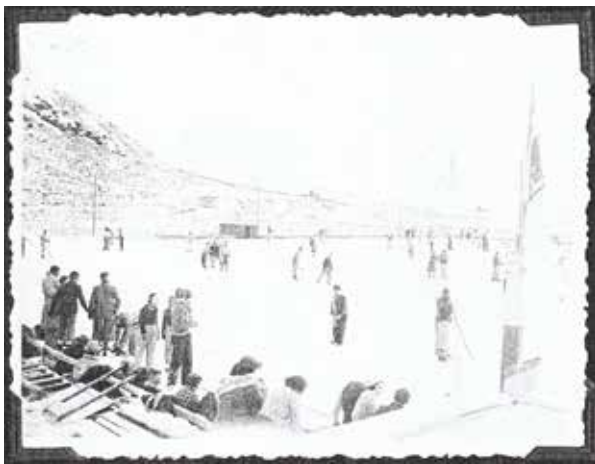
Figure 11. The men's toilets can be seen in the background of this 1938 photograph. Source: Ashburton Museum, Jordan album.

The date of the construction of the men's toilets is not known, but they can be seen in the rear of a 1938 photograph of the rink (Fig. 11). Given the extent of the other facilities that Barker took the trouble to provide, it would not be surprising if there were toilets at the rink from the time of its first major public season (1934), particularly as there was no vegetation to shelter behind to relieve oneself.

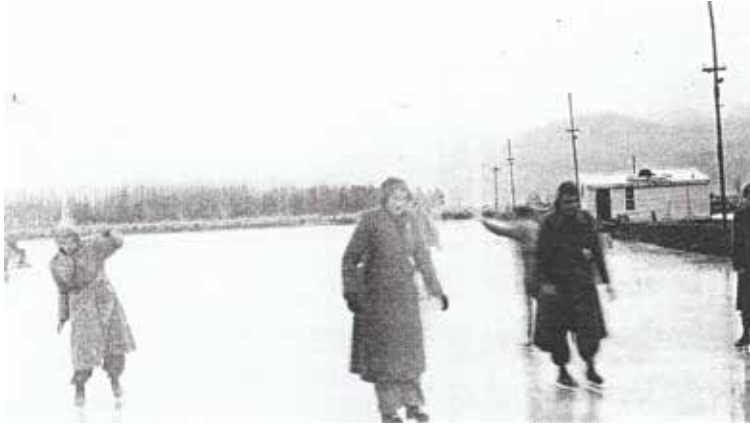
The ticket office was built in the mid- to late 1940s, either by the Mt Harper Ice Skating Club or the Kirkpatricks, and was used to sell tickets for entry to the rink (Wright 2007). This was a weatherboard building, with a door and window in the north elevation, and was positioned on the central bund (Fig. 12). The building blew down in the late 1960s or early 1970s (Wright 2007).

Figure 12. People skating, with the ticket office in the background. *Source: Ashburton Museum clippings file.*

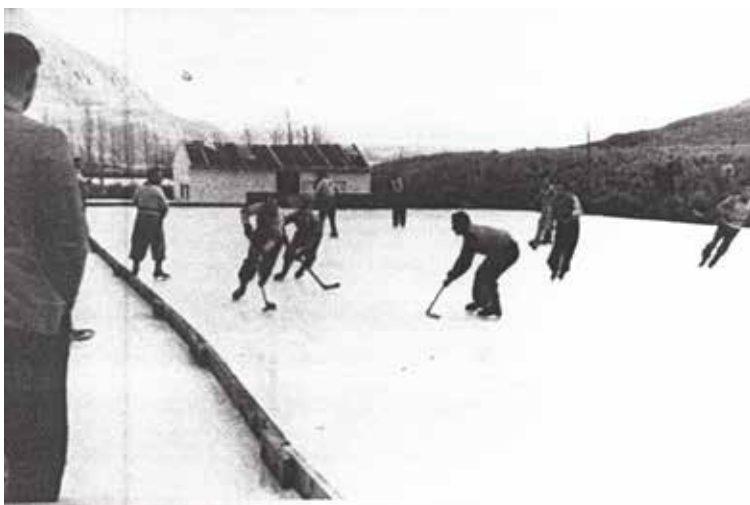
Figure 13. The hockey rink with the refrigeration unit in the background, c. 1949. *Source: Geraldine Museum 1830.*

there may have been some modifications to the rink's size and shape (Fig. 13). It may have been at around this time that the westernmost rink ceased to be used. The road into the rink, which passed through Mt Possession Station, was completed by 19 October 1948 (MHVB 1934-1954), and it is likely that the refrigeration equipment was brought in after this.

would have been visible through it. Figure 13 shows timber boards set into the ice around the edge of the hockey pitch, and regulations passed by the NZISA in June 1939 required that all ice hockey matches for the Erewhon Cup be played on rinks with at least 2-inch-high boarded edges (NZISA 1987: 13). These may have been wedged up against the concrete and then held in place by the frozen ice, or the concrete may only have been poured when the refrigeration unit was installed (after the bulldozer carried out work at the rink).

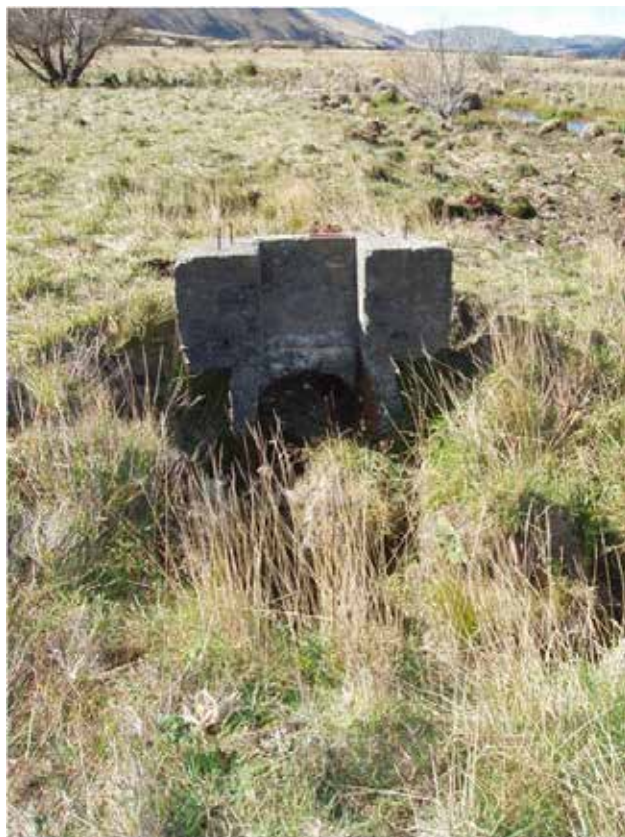
Figure 15. The concrete culvert and control structure. Photo: Katharine Watson.

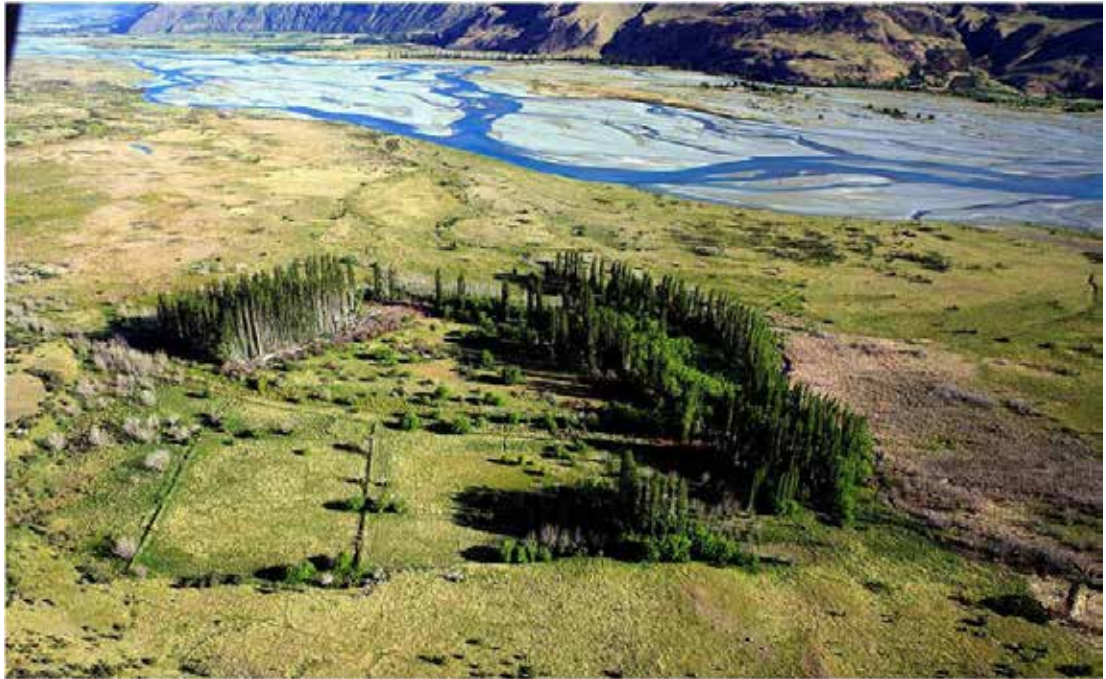
Figure 17. An aerial view of the rink, showing the bunds that surrounded the ice rinks, as well as the vegetation growing in the rinks. *Photo: Ian Hill.*

The layout of the rink is still clearly visible and is formed by a number of bunds (Figs 14, 16 & 17). These bunds were probably formed using the materials that were excavated when the rinks were levelled, as there is no evidence for any borrow pits nearby. The southernmost bund is presumably the 4-ft-high sod wall referred to in the 1934 Timaru Herald article, which formed the southern boundary of the rinks (although it does not reach the terrace at its eastern end). This enclosed an area that had been subdivided into eight areas. Historical evidence suggests that not all of these areas were used for skating. In particular, no historic photographs show ice on the eastern area (Rink 1), the ground of which was not as level as that in other areas and was

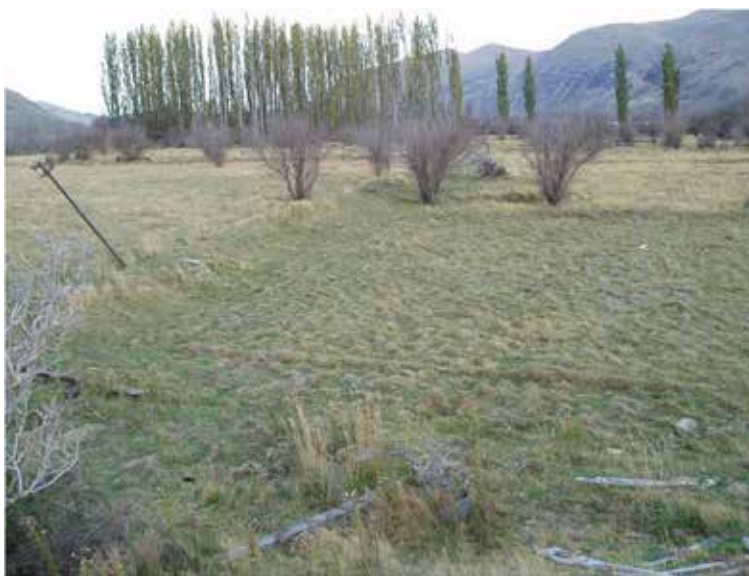
Figure 18. Looking into the ice hockey rink, where the concrete outlines of the pitch can just be made out in the grass. *Photo: Katharine Watson.*

Rink 5—the hockey rink—is notable because it contains the remains of the refrigeration unit (discussed in more detail below) and the concrete outline of a rectangular ice hockey pitch (Figs 18 & 19). Since the ice was clear, the concrete

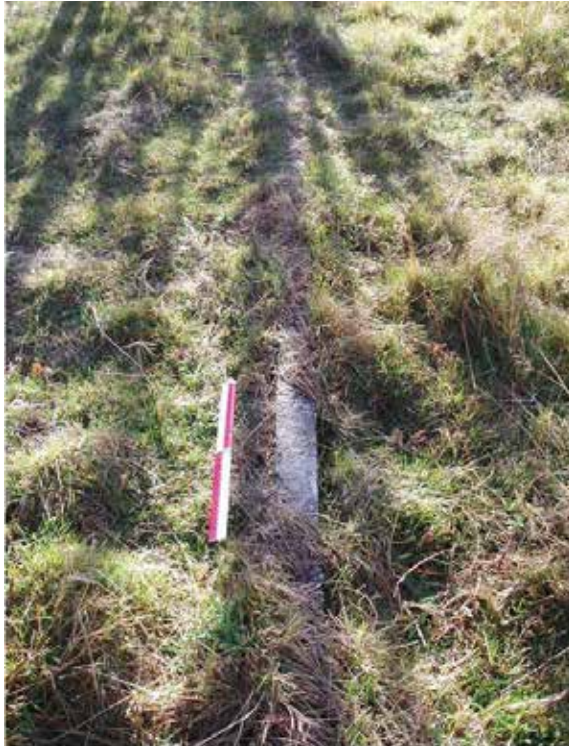
Figure 19. Part of the concrete ice hockey pitch outline. Photo: Katharine Watson.

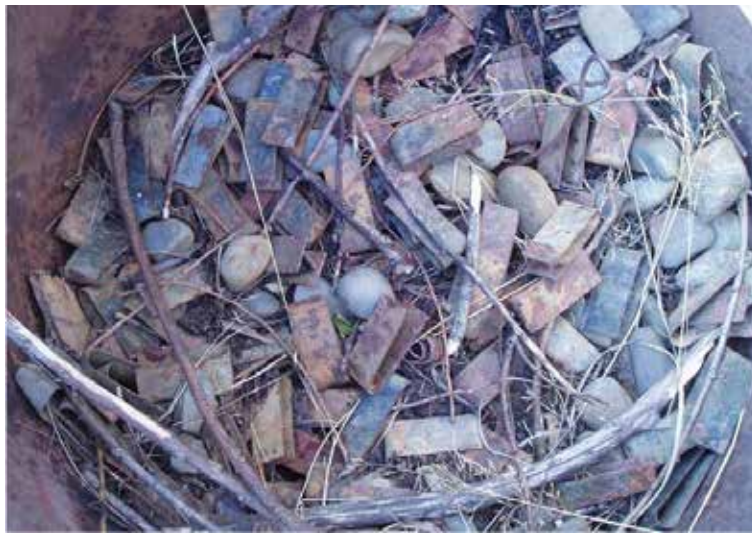
Figure 20. Metal clips in a 44 gallon drum adjacent to the hockey rink. It has been suggested that these were related to the pipes used to freeze the ice. Photo: Katharine Watson.

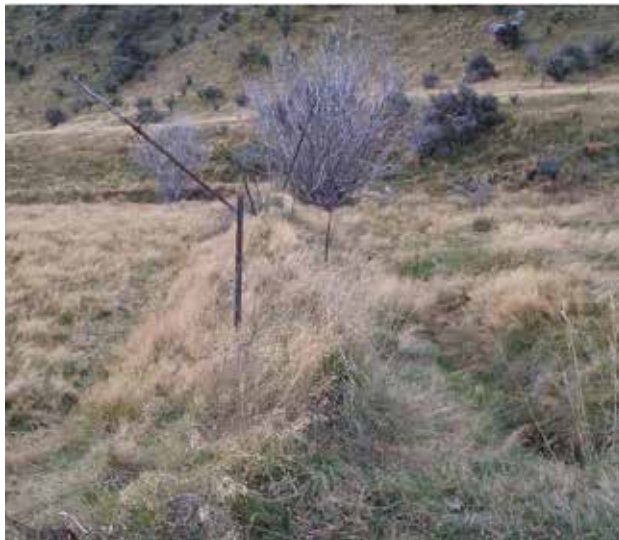
Figure 21. Power poles/lampposts along the bund on the east side of Rink 2. *Photo: Katharine Watson.*

Power poles/lampposts were found along the bunds on the east, south and west sides of Rink 2 (Figs 18 & 21). This was the only rink with poles around it, suggesting

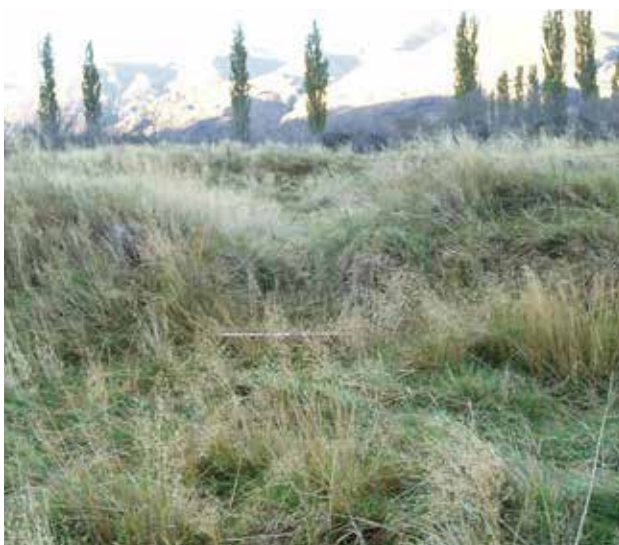
Figure 22. A gap in a bund to enable the flow of water between rinks. *Photo: Katharine Watson.*

the spring (in Rink 3 and possibly from Rink 1; see below) to the rinks. Gaps in the bunds around each rink would have ensured the flow of water (Fig. 22). No evidence of how the water was controlled was found, although there was a concrete control structure towards the east end of the south bund (i.e. on the exterior of the rink; Fig. 23). The presence of a channel on the south side of this structure would have suggested that it was used to control the flow of water into the rinks. However, in the absence of such a channel, alternative theories must be considered. The structure (which is associated with Rink 1) was presumably used to dam the eastern area of the rinks and may have only been used during the 1933 season. Alternatively, the structure may have dammed the swampy eastern area and the water that pooled in this area may have been used to flood the other rinks.

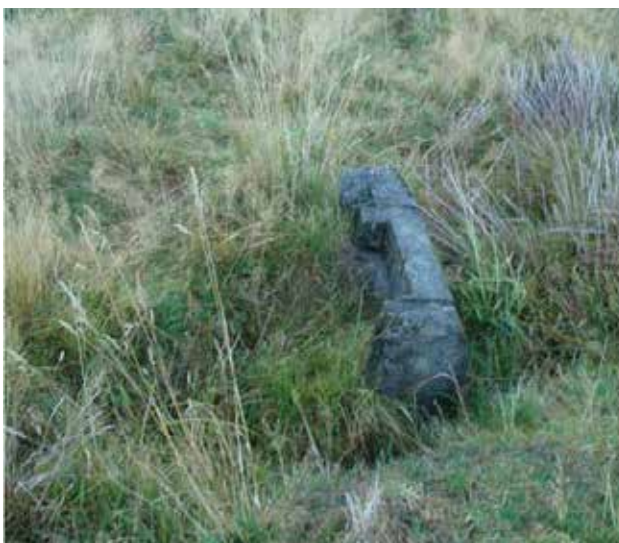
Figure 23. The control structure in the southwest corner of Rink 1. *Photo: Katharine Watson.*

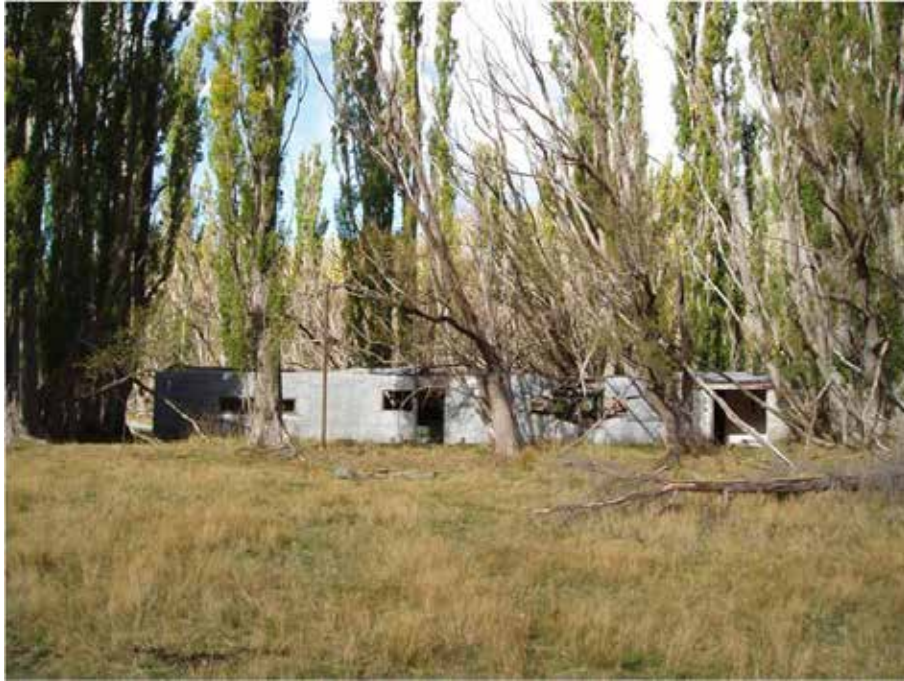
The Barkers' house was built in at least three stages (Fig. 24). Phase 1 was the central block, which was a long, low, rectangular building that comprised Rooms 1–5. Work on this started in the summer of 1931/32 (Fig. 25). The next two phases were essentially wings that were added to Phase 1, and it is not clear what sequence they were added in or when they were added. Therefore, here, for the sake of simplicity, the western wing will be referred to as Phase 2 and the eastern wing as Phase 3. Phase 2 cannot be seen in the 1937 photograph of the building (Fig. 3; Phase 3 would have been out of the camera shot). Both of Phases 2 and 3 were concrete, with a corrugated iron roof.

Figure 25. The south elevation of the Barkers' house. *Photo: Katharine Watson.*

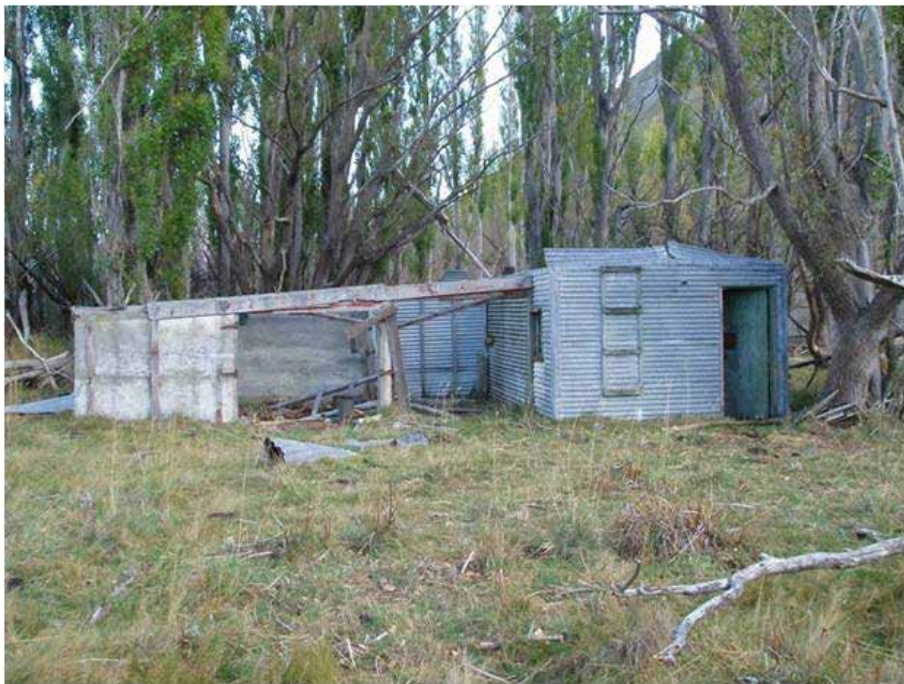
Phase 1 was timber-framed, clad and roofed with corrugated iron, and timber-lined, with a concrete floor. Two brands were found on the corrugated iron—'BRETONA' and 'TITAN BEST/ TRADEMARK'. No information was found about the former, but the latter was available in New Zealand from at least 30 June 1912 (Evening Post 1912). The pitch of the roof was surprisingly shallow, given the possibility of snow in the area (Fig. 26). A wooden ladder had been built onto

Figure 26. The east elevation of Phase 1 of the Barkers' house, showing the shallow pitch of the roof and the ladder for roof access. The concrete section to the left is Phase 3 of the house. *Photo: Katharine Watson.*

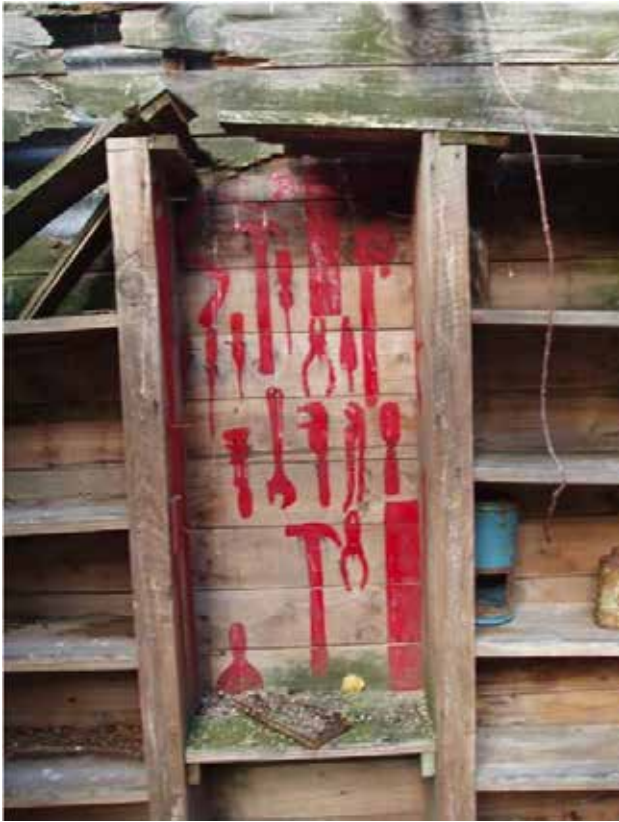
There were five rooms in Phase 1. Room 1 was probably a workshop, and contained boxes that may have stored skates (Fig. 27), space for hanging up tools (Fig. 28), and other shelves and cupboards. One of the flues from the central heating ran up the wall at the western end of the room (Fig. 29).

Figure 28. Spaces for tools to hang in Room 1 of the Barkers' house. Photo: Katharine Watson.

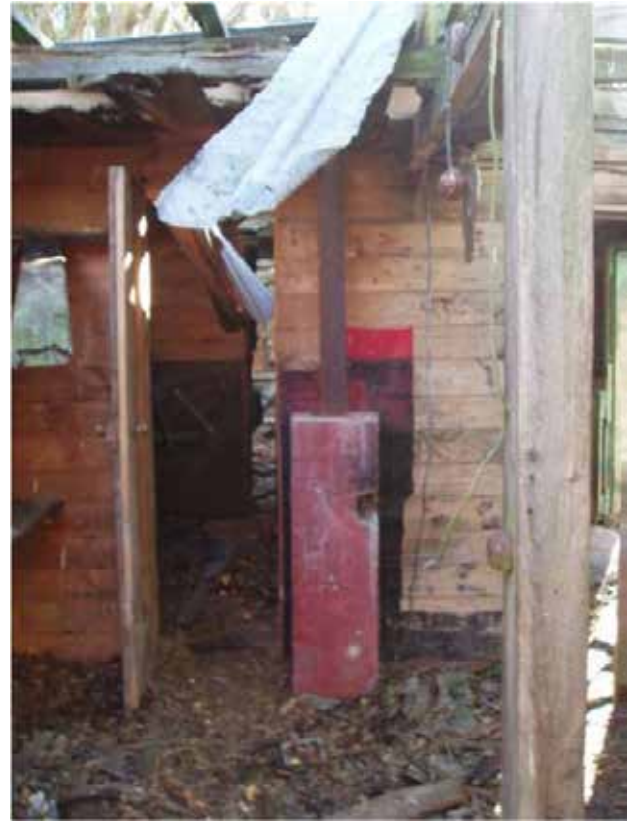
Figure 29. A flue associated with the central heating in Room 1 of the Barkers' house. Photo: Katharine Watson.

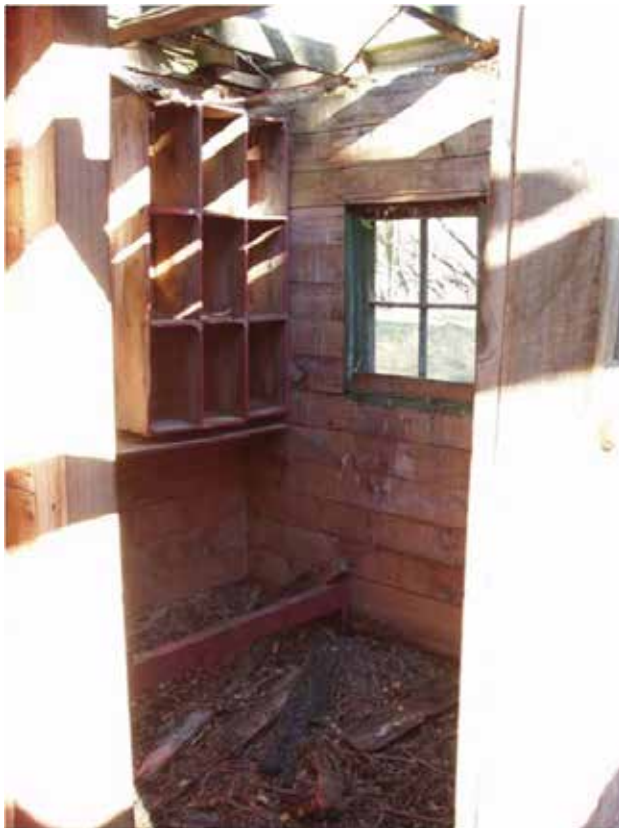
Figure 30. Storage space in Room 2 of the Barkers' house. Photo: Katharine Watson.

Room 2 was a small room in the southeast corner of Room 1. No evidence indicated that there had ever been a door between the two rooms. Room 2 contained more storage space, in the form of shelves and cupboards (Fig. 30).

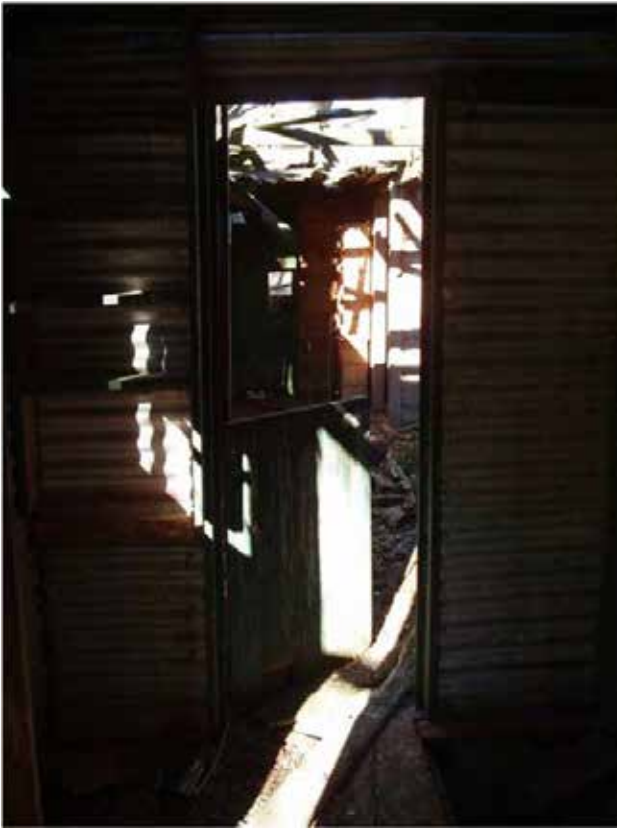
Room 3 may have been the main entrance to the house. It was a relatively small space, entered by a stable door in the north elevation of the building, and connecting to Rooms 1 and 4 via more stable doors (Fig. 31). This room was home to the fire that fed the central heating system (Fig. 32). Some of the walls in Room 3 were lined with corrugated iron, possibly due to the risk posed by the fire—although there were timber boards immediately behind the fireplace. The timber-lined walls were painted green on the lower half and white on the upper half (Fig. 32). While many of the timber details in the house were painted green, the wall timbers in other rooms were not painted.

Figure 31. A stable door in Room 3 of the Barkers' house. Photo: Katharine Watson.

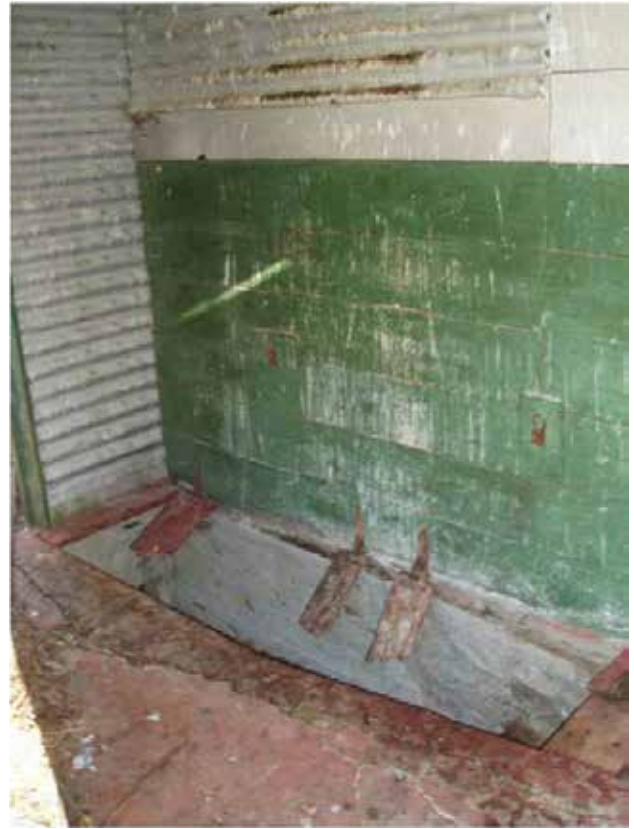
Figure 32. The location of the fire that fed the central heating in Room 3 of the Barkers' house. Photo: Katharine Watson.

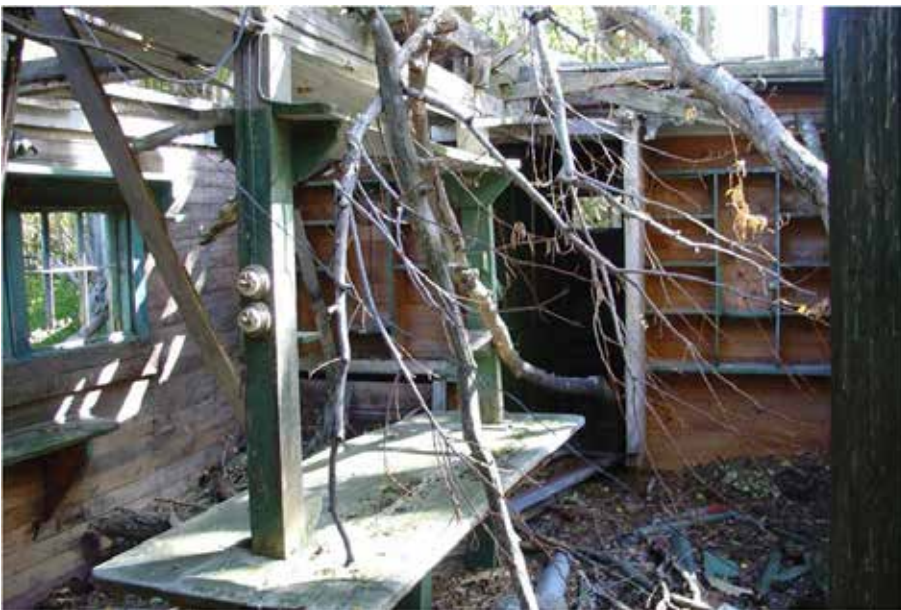
Room 4 was the kitchen, and contained a meat safe, two hot water cylinders, a built-in table, and a kitchen bench with sink and storage space (Fig. 33). Much

Figure 33. Room 4 of the Barkers' house. Photo: I. Hill. Photo: Katharine Watson.

of the shelving and other features (such as the window frames, benches and table) in this room had been painted green. Richie Taylor (pers. comm.) indicated that there had once been beds that pulled down from the west wall in this room. Doors opened off this room to Phase 2 and Rooms 3 and 5. Room 5 was the toilet, which was a can (Fig. 34).

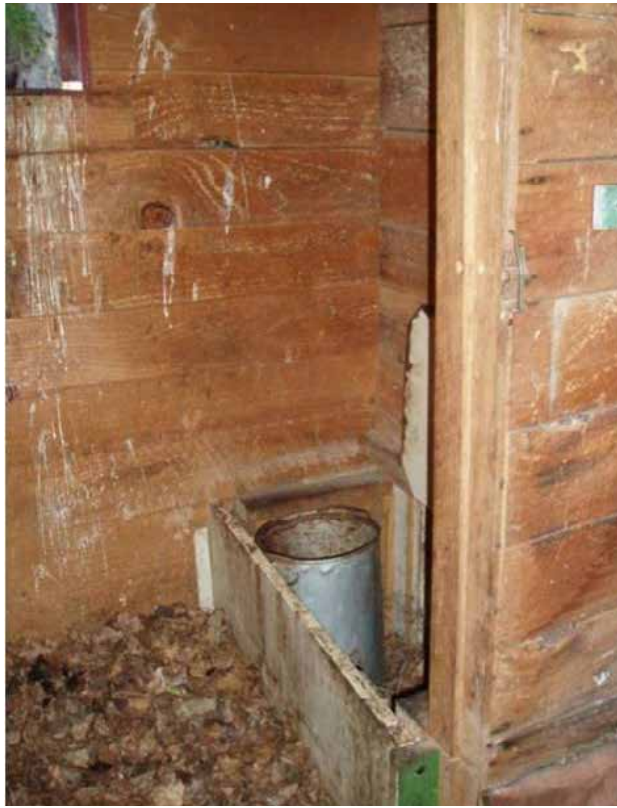
Figure 34. The can toilet in Room 5 of the Barkers' house. *Photo: Katharine Watson.*

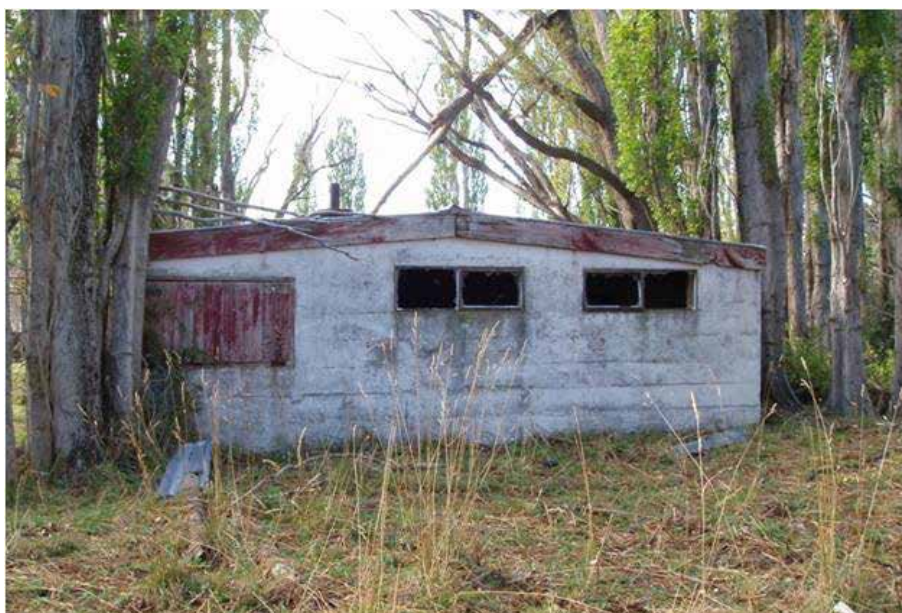
cobbles. There were three windows in the west elevation, one of which was boarded up (Fig. 35), and what appeared to be double doors in the north elevation. There was also a small window in the east elevation. Phase 2 comprised two rooms.

Figure 35. The west elevation of Phase 2 of the Barkers' house. *Photo: Katharine Watson.*

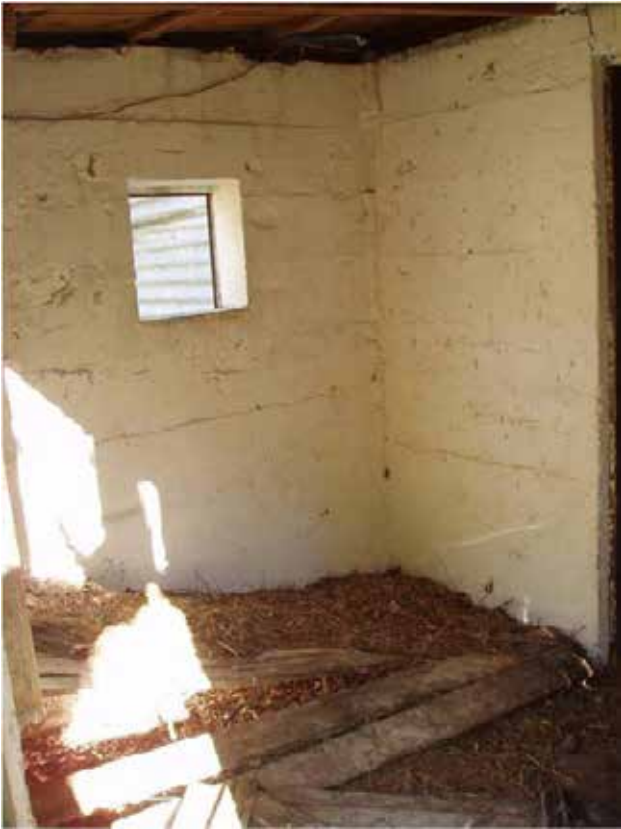
Room 6 contained the exterior entrance to this wing. It had a possible bench in it, two windows (one each in the east and west walls) and a flue from the central heating system (Fig. 36). There was a door from this room into Room 7, which could also be entered from Room 5.

Figure 36. Room 6 in Phase 2 of the Barkers' house. Photo: Katharine Watson.

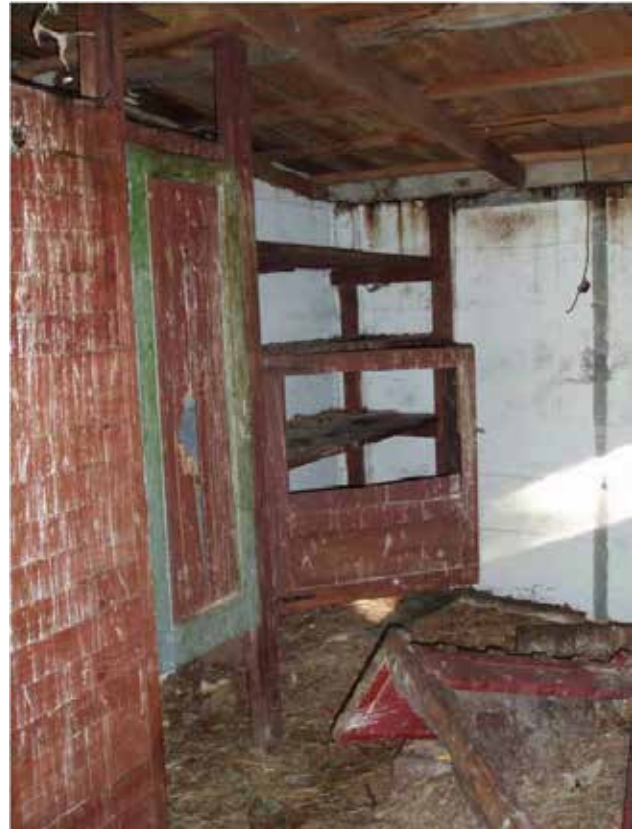
Room 7 contained a bed frame from a single bed and a significant amount of built-in timber storage space (Fig. 37). It is likely that this room was the bedroom, although it is not certain if the bed is original.

Figure 37. Room 7 of the Barkers' house, showing the built-in storage space. Photo: Katharine Watson.

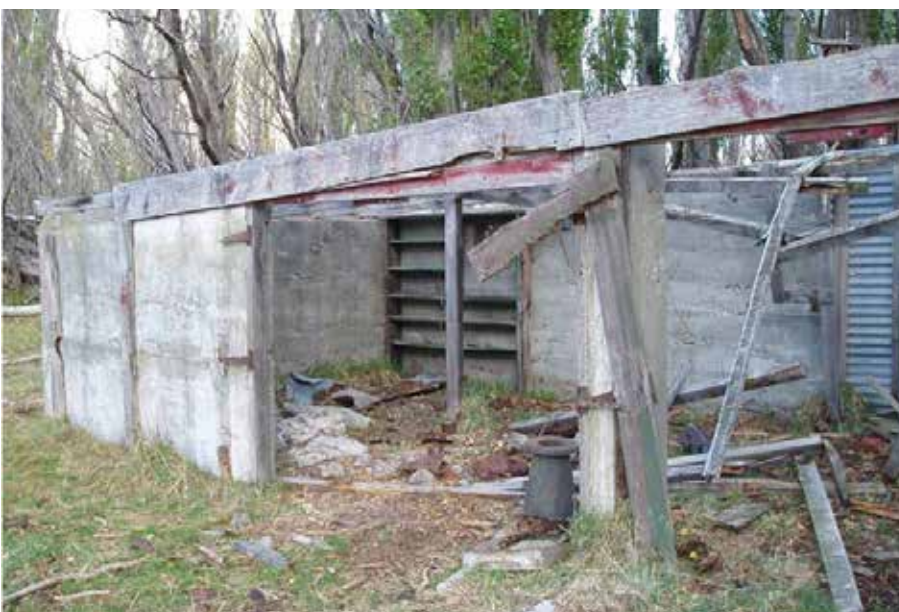
Figure 38. Room 9 (the garage; left) and Room 8 (right) in Phase 3 of the Barkers' house. Photo: Katharine Watson.

The Barkers' house is in only reasonable condition. A tree has fallen on the house, damaging the roof and allowing the weather and animals in. As noted above, there has also been damage to Phase 3, which is missing its roof. There is a considerable build-up of straw and grass in some parts of the house.

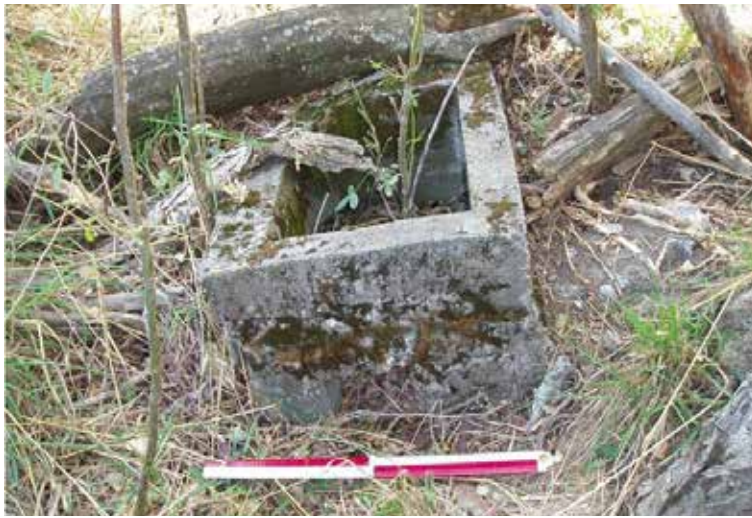
the house, a piece of concrete boxing (with holes in the base) was found and there were stones in what remains of the channel downstream of this, as if to direct the flow of water (Fig. 39).

Figure 39. Concrete boxing associated with the house water race. Photo: Katharine Watson.

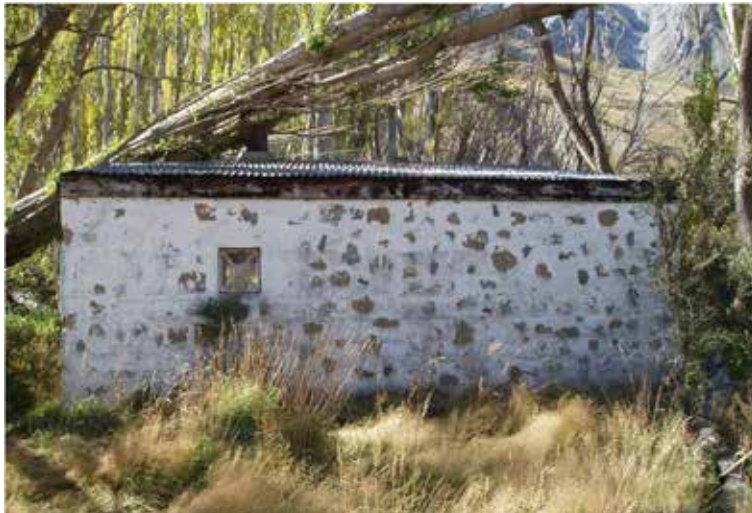
Figure 40. South elevation of the White Hut. Photo: Katharine Watson.

(Fig. 40). The concrete for the hut was made using river cobbles, and the walls of the hut were subsequently painted white on the interior and exterior. At 450 mm thick, the walls of the hut are substantial and were no doubt designed to keep the occupants warm in the chill of winter. This may also explain why the hut has only four windows, two of which are relatively small—or this may reflect its original function as a cow byre (Fig. 40). An insulator on the exterior of this building indicates that it once had electricity.

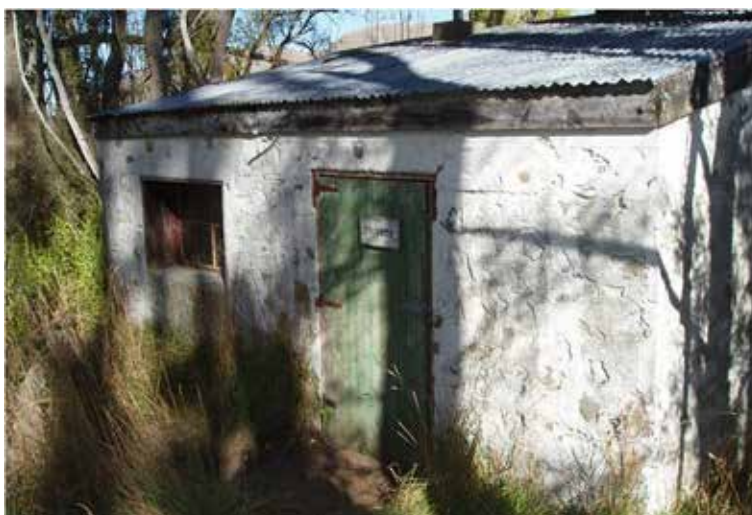
Figure 41. North elevation of the White Hut. Photo: Katharine Watson.

The hut was entered via a timber door in its north elevation, which was painted green and labelled ‘Private’ (Fig. 41). It had two rooms, separated by a timber partition (possibly not original), and a mezzanine floor above most of Room 1 (Fig. 42). Room 1 had a drain set into the floor against the wall on the north side of the building, which extended into the doorway and is likely to have been associated with the building’s original function as a cow byre. This room also contained

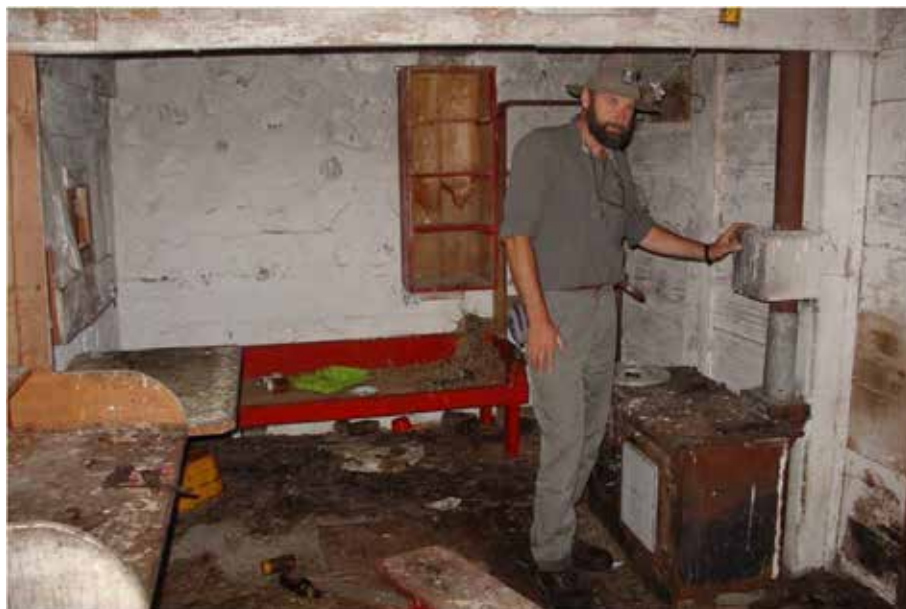
two benches, shelving, a Champion stove with an exposed flue and a single bed (Fig. 43). Presumably a ladder was used to access the mezzanine floor.

Figure 43. Room 1 of the White Hut. Photo: Ian Hill.
