Mt Harper ice rink

Baseline inspection and historic values assessment

Katharine Watson

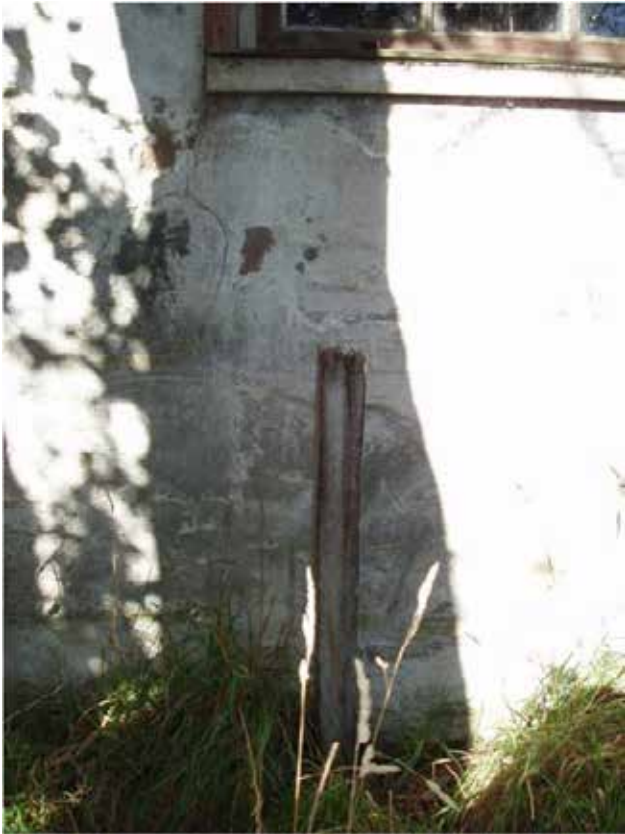
Figure 44. The single gate or fence post that remains next to the White Hut. *Photo: Katharine Watson.*

have been deliberately planted, but not all of it. Other features around the hut include the remains of a gate or fence, which consist of a single post (Fig. 44), and a hen house. The gate/fence was on the hut's west elevation and was presumably associated with keeping the cow in. Two timber beams appear to have been set into the exterior west wall on either side of the window above the gate/fence remains (Fig. 45), the original function of which is not clear. The collapsed remains of the hen house lie to the north of the White Hut (Fig. 46), which was evidently a corrugated iron structure. A plough and roller were found to the south of the hut when fallen trees were cleared away, which were no doubt used in preparing the rinks (Figs 47 & 48).

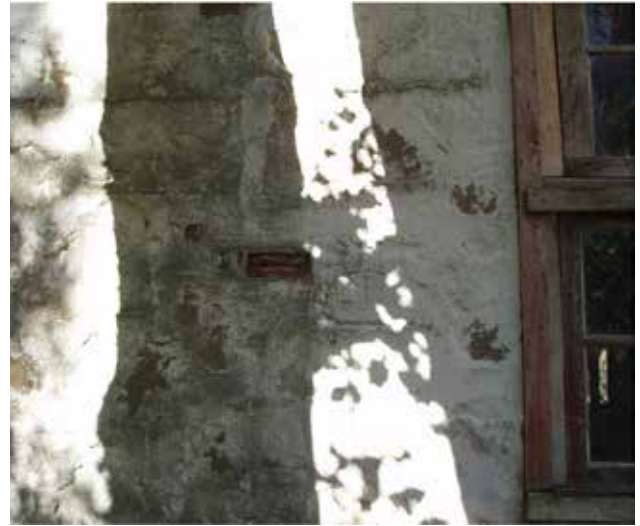
Figure 45. One of the beams set into the exterior west wall of the White Hut. *Photo: Katharine Watson.*

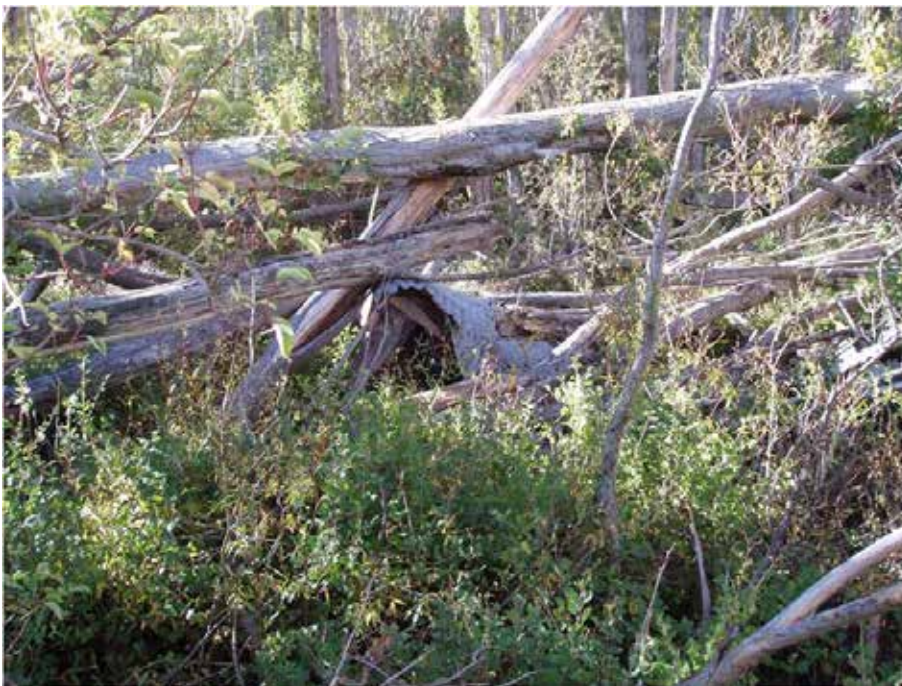
Figure 46. The collapsed remains of the hen house, near the White Hut. *Photo: Katharine Watson.*

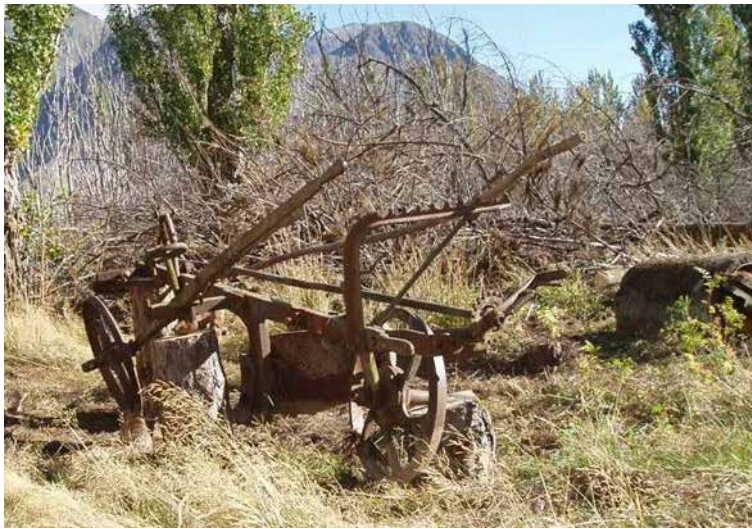
Figure 47. A plough found near the White Hut, no doubt used for preparing and/or maintaining the rinks. *Photo: Katharine Watson.*

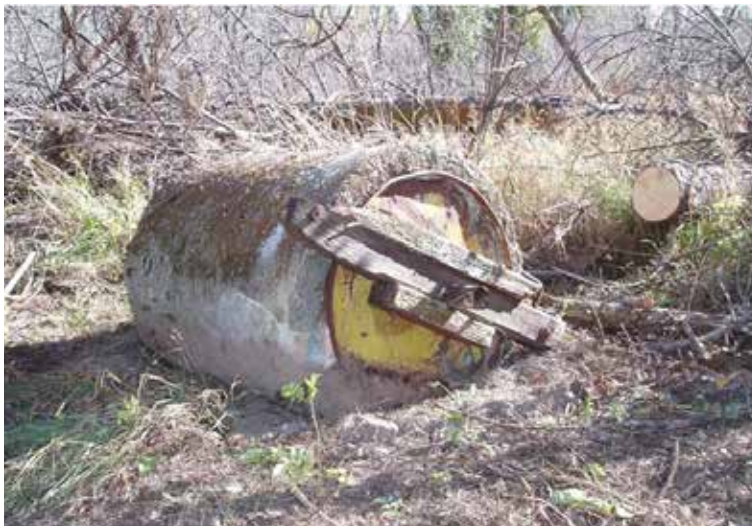
Figure 48. A roller found near the White Hut, no doubt also used for preparing and/or maintaining the rinks. *Photo: Katharine Watson.*

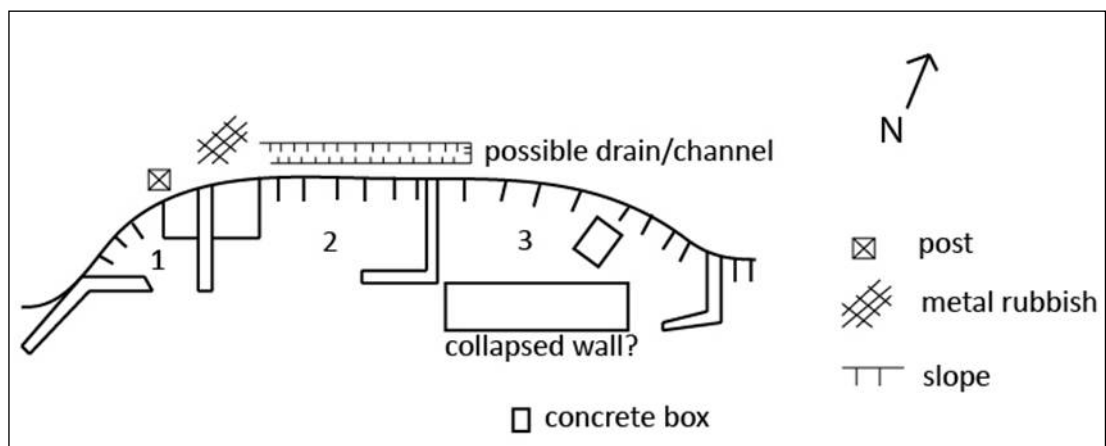
Figure 49. Sketch plan showing the remains of the skate shed.

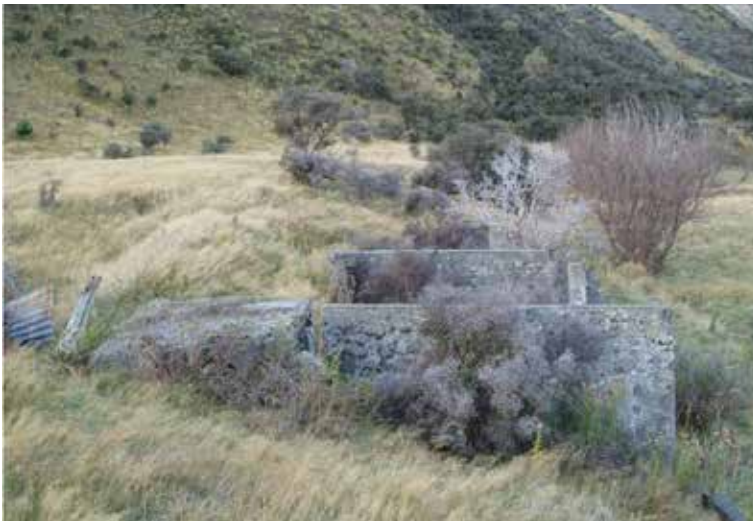
The skate shed was set back into the face of the terrace on the north side of the rinks. Its remains comprise a series of concrete walls (Figs 49 & 50). As with the cow byre and part of the Barkers' house, the concrete was made using river cobbles. There appear to have been at least three rooms in the hut—it is possible that the area under the concrete roof may have been two separate rooms, rather than part of Rooms 1 and 2. Room 1 was the smallest of the rooms and its original function is not known. Room 2 was where food was served and Room 3 was the skate hire area (R. Taylor, pers. comm.), and possibly also the location of the 'skating library' and the 'library of skating pictures'. One of the concrete walls of this room has collapsed, and vegetation is growing throughout the structure.

Figure 50. The skate shed, looking northeast. *Photo: Katharine Watson.*

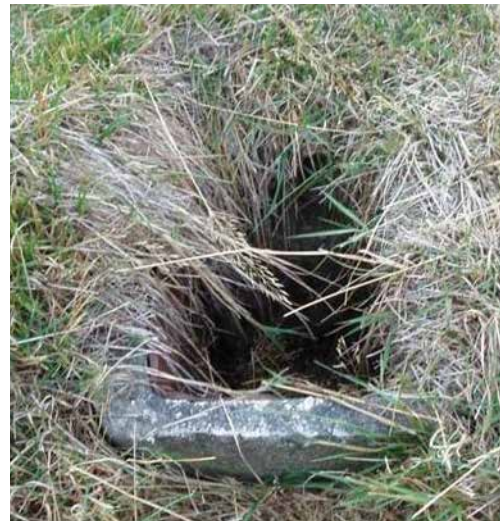
Other features in the area include what is essentially a concrete curb that continues along the base of the terrace to the west of Room 1, a small concrete box lined with metal (Fig. 51), and a wooden post, ditch and scattered rubbish on the terrace above the shed. The ditch is probably natural.

Figure 51. A small concrete box lined with metal, near the skate shed. *Photo: Katharine Watson.*

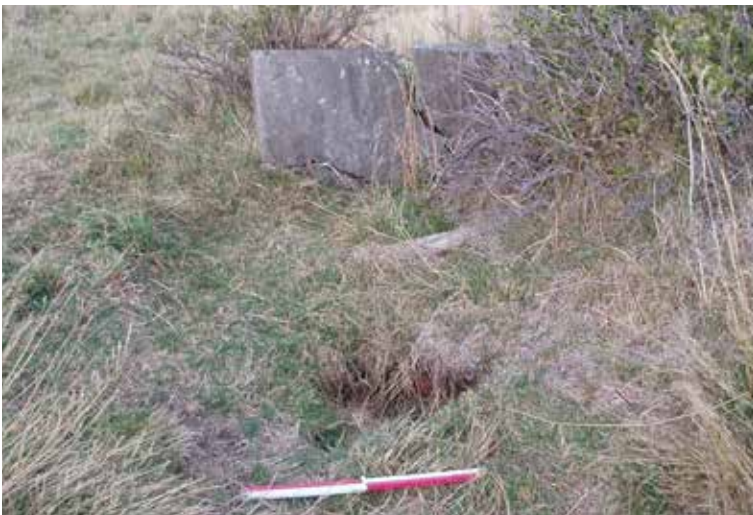
Figure 52. The remains of the men's toilets—the concrete wall in the background and the barrel in the foreground. *Photo: Katharine Watson.*

The remains of the men's toilets are on the bund between Rinks 1 and 2. These remains comprise a 40-gallon drum set into the ground (i.e. the toilet was a long drop), a concrete wall and the remains of a timber structure (Fig. 52). There are cracks in the concrete and vegetation growing around the remains of the structure.

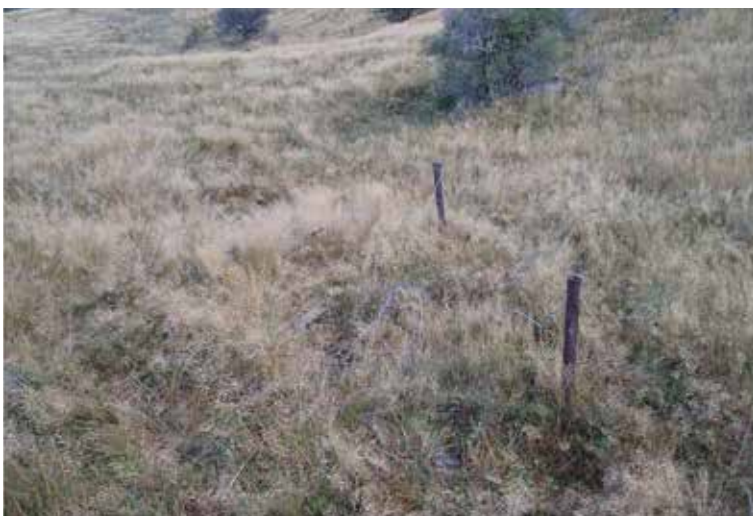
Figure 53. The remains of the toilet block—some waratahs and fencing wire. *Photo: Katharine Watson.*

The toilet block was situated on top of the terrace to the north of the rinks (and must have been difficult to reach with skates on). The remains comprise a hole in the ground (another long drop toilet), standards with wires attached to them (possibly anchors for the building), waratahs, metal pipes (some of which also had wire attached to them), and scattered timber and corrugated iron (Fig. 53).

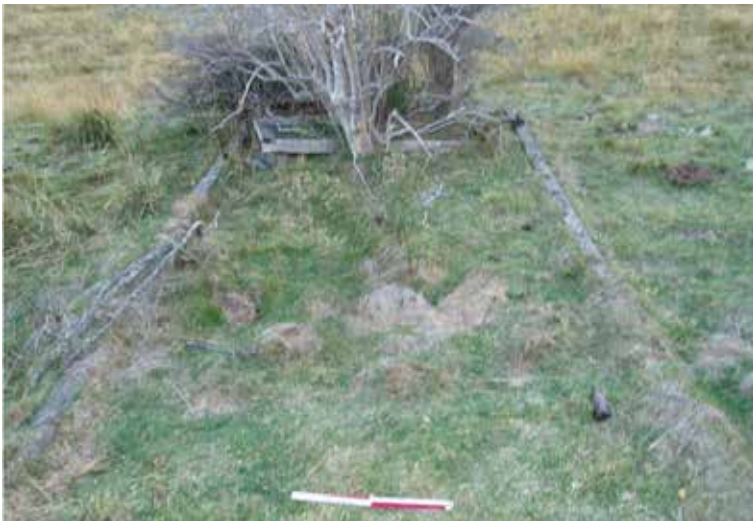
The remains of the ticket office are on the bund to the east of Rink 6. All that remains of the office are the rectangular concrete foundation and some scattered timbers (Fig. 54). Some vegetation is growing at the east end of the building remains.

Figure 54. The foundations of the ticket office. *Photo: Katharine Watson.*

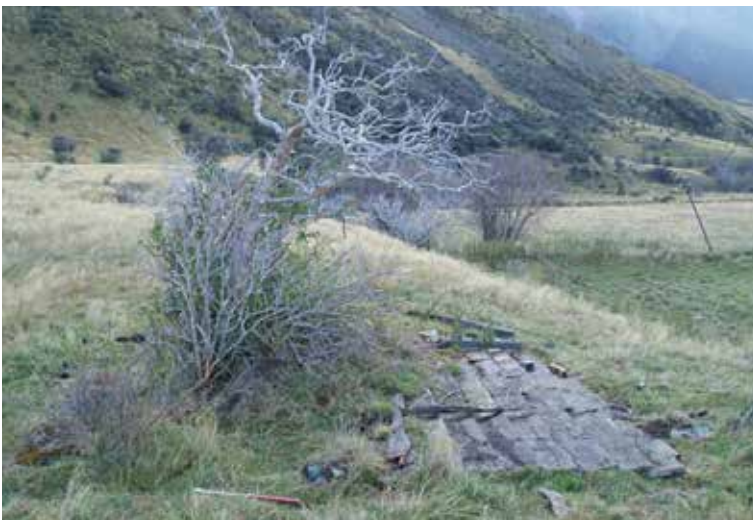
Figure 55. The collapsed remains of the hockey rink shelter on the bank above the hockey rink, looking northeast. *Photo: Katharine Watson.*

The hockey shelter was on the same terrace as the toilet block, but to the west, looking out over the hockey rink. The remains of the building comprise the concrete foundations and a collapsed weatherboard wall (Fig. 55). There is vegetation growing within the remains.

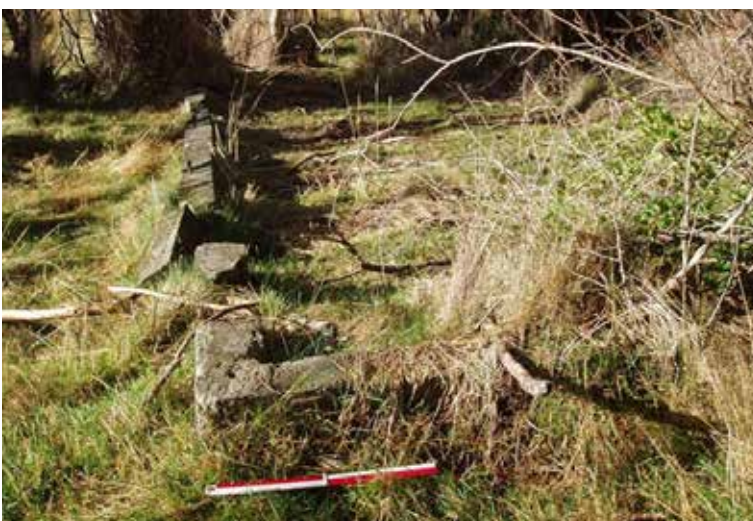
Figure 56. The concrete foundations of the refrigeration unit at the hockey rink. *Photo: Katharine Watson.*

The remains of the refrigeration unit are at the west end of the hockey rink and are now overgrown. As for a number of the other buildings, the remains comprise the concrete foundations (Fig. 56). These foundations have metal bolts protruding from them. There are four small concrete blocks within the foundations at the south end, which are likely to have been machine supports.

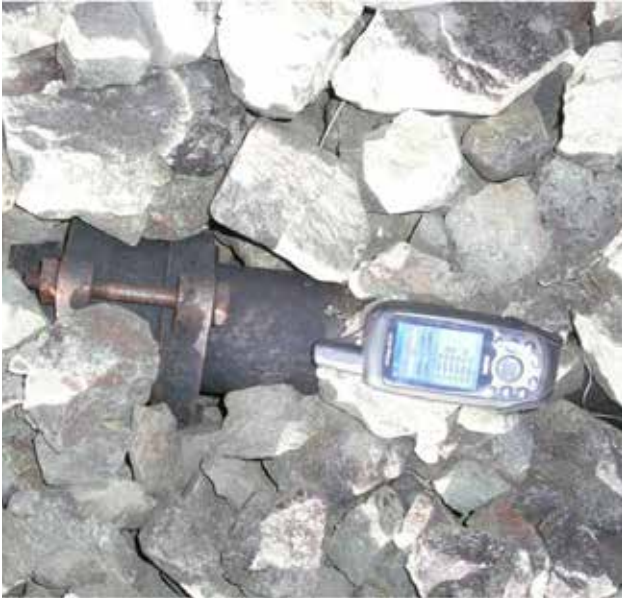
Figure 57. The penstock buried in the scree. *Photo: Ian Hill.*

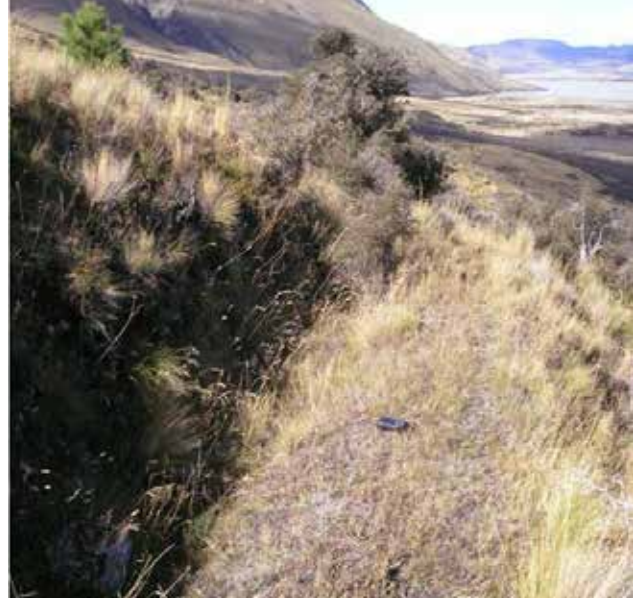
The remains of the power scheme are reasonably complete, and comprise the power house and its associated infrastructure—the penstock and water race. It has not been possible to examine the water intake structure. The water race was flumed, piped and carried in an open ditch from the intake to the head of the penstock (Figs 57 & 58). The penstock is buried in scree for most of

Figure 58. The water race ditch on the slopes of Mt Harper/Mahaanui above the ice rink. *Photo: Katharine Watson.*

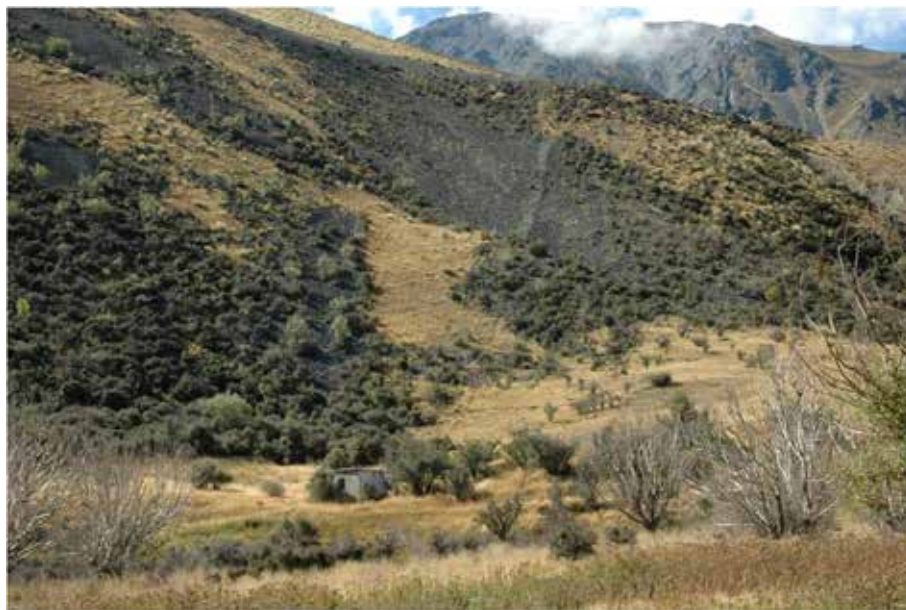
Figure 59. The power house (the concrete structure in the middle distance), clearly showing the route of the penstock down through the scree. The zig-zag track can just be made out to the left of this. *Photo: Katharine Watson.*

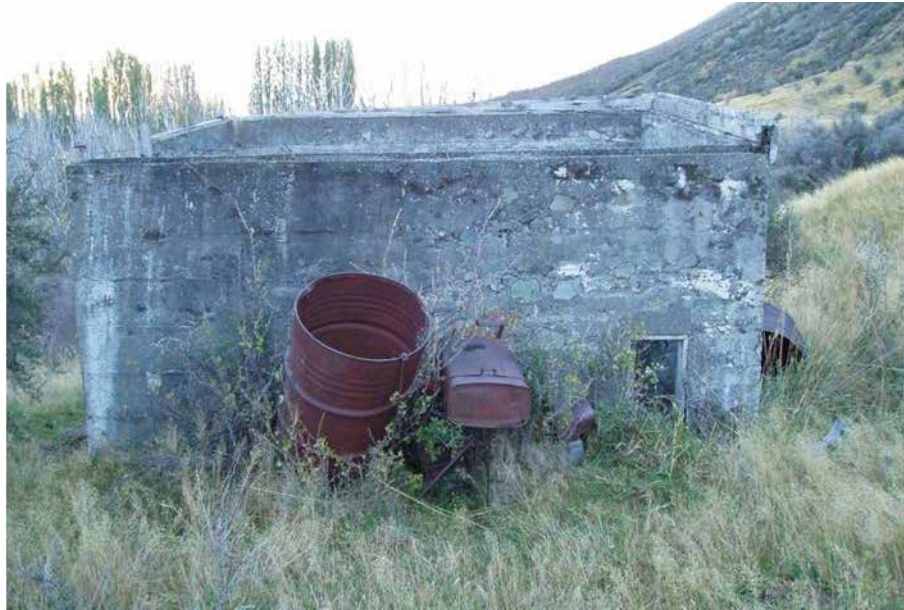
The power house is a rectangular concrete structure that has lost its roof (Fig. 60). The door is in the south elevation of the building and there is a window in the west elevation (Fig. 61). Water entered the building through an opening at ground level in the northeast corner and flowed through a channel to the Pelton wheel. There was also an overflow pipe to carry excess water out

Figure 60. The power house. Photo: Katharine Watson.

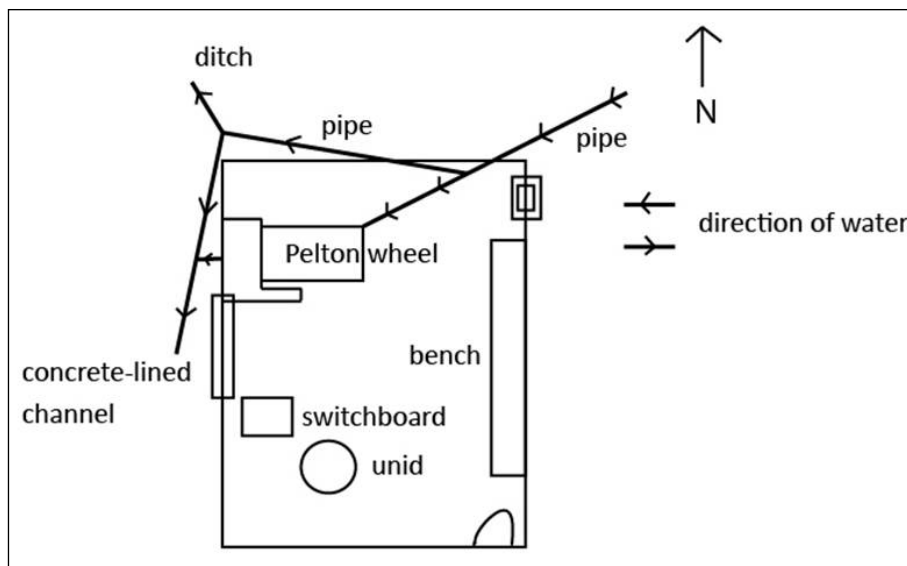
Figure 61. Sketch plan showing the layout of the power house.

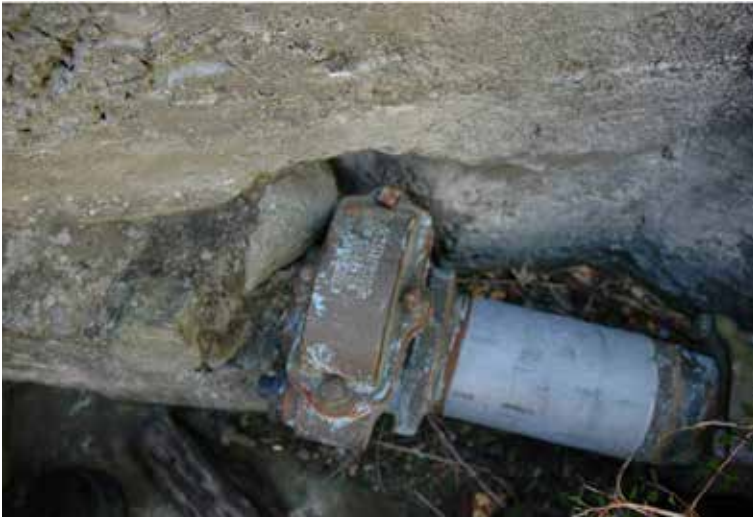
of the building before it reached the Pelton wheel. This excess water could then be diverted to one of two drains (Fig. 62), one of which had been dug into the dirt and petered out after a short distance, while the other was concrete-lined for a short distance and also collected the water that powered the Pelton wheel (Fig. 63). This latter drain continued around the terrace edge for some distance, but has suffered some damage through being used as a cattle track.

Figure 62. The overflow pipe from the power house. *Photo: Katharine Watson.*

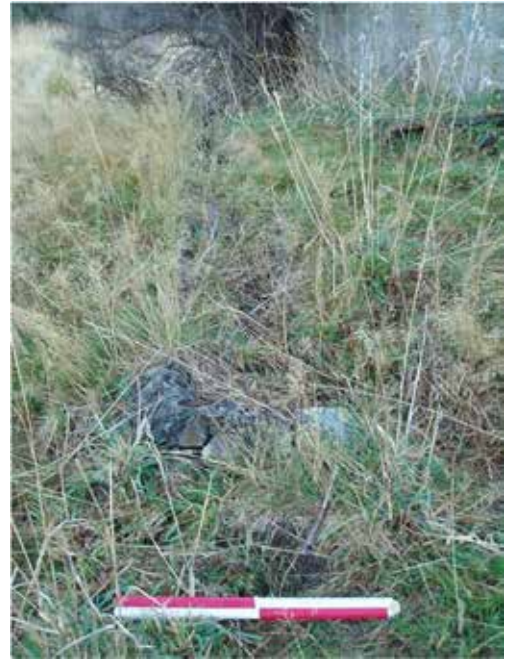
Figure 63. The concrete-lined drain that collected excess water from the power house. *Photo: Katharine Watson.*

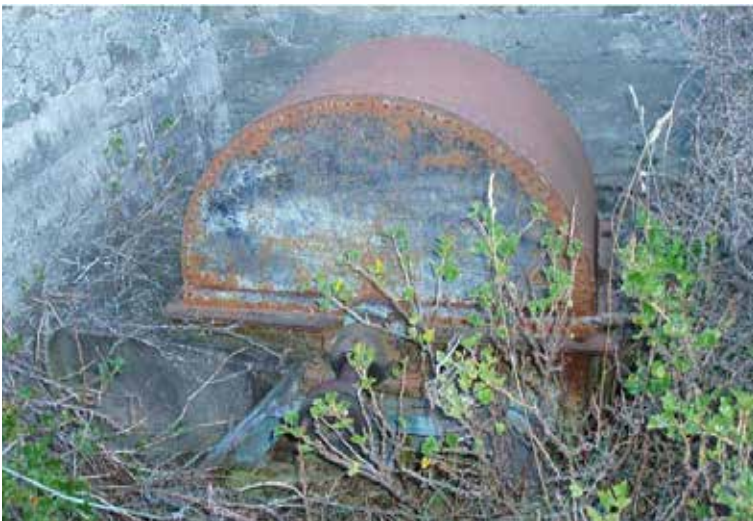
Figure 64. The Pelton wheel and its cover in the power house. *Photo: Katharine Watson.*

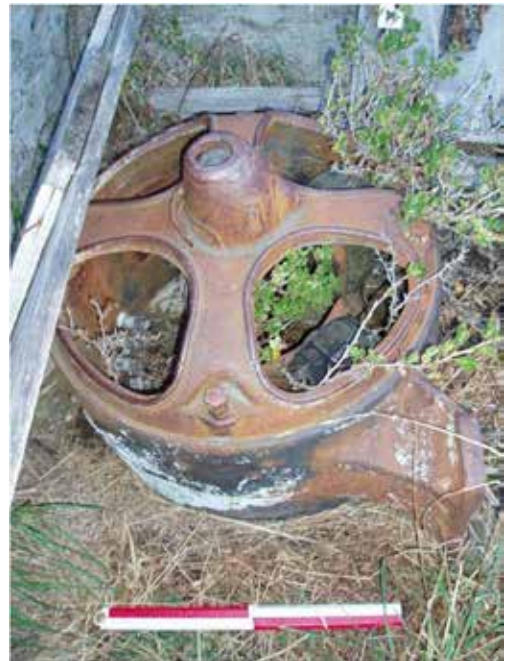
The remains in the power house consist of the aforementioned drains, the Pelton wheel and its cover (Fig. 64), a switch board, an unidentified metal artefact (Fig. 65), and an in situ work bench (Fig. 66). There is vegetation growing in and around the power house.

Figure 65. An unidentified metal artefact in the power house. *Photo: Katharine Watson.*

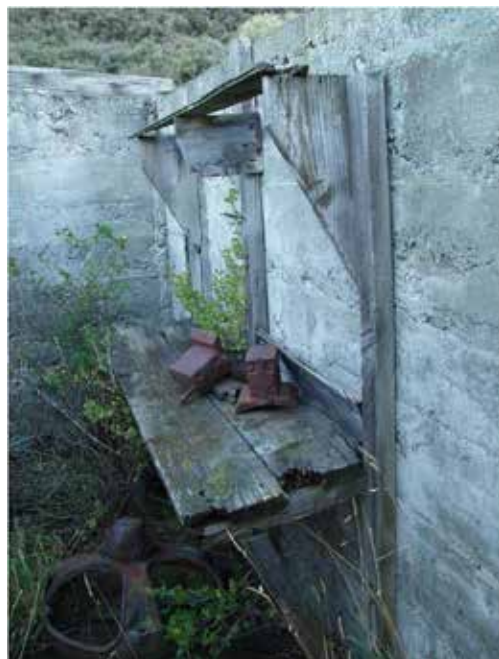
Figure 66. The in situ work bench in the power house. *Photo: Katharine Watson.*
