## 12. Wellington and district

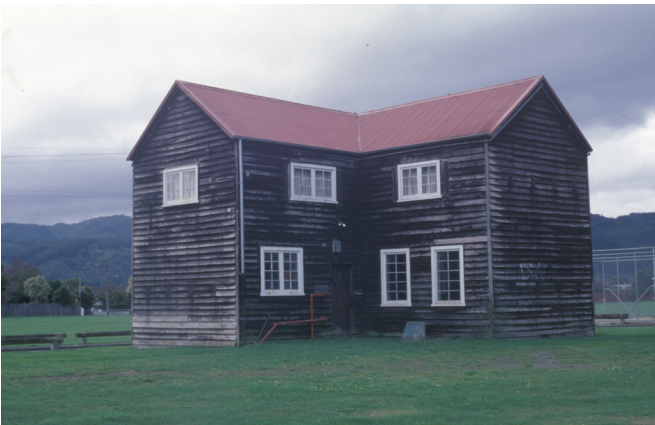
Figure 124. Corner blockhouse of Upper Hutt Stockade. *Photo N. Prickett, 1990.*

Cowan (1983 I: 25–27) describes a near-square 9 ft (2.7 m) high stockade, 30 yards (27 m) east–west and slightly more north–south, with a low parapet outside a firing trench. There was a two-storey, loopholed, L-plan blockhouse at the north angle and stockade bastion at the south angle.

The unique blockhouse survives, with stockade earthworks easily visible under mown grass on adjacent ground.

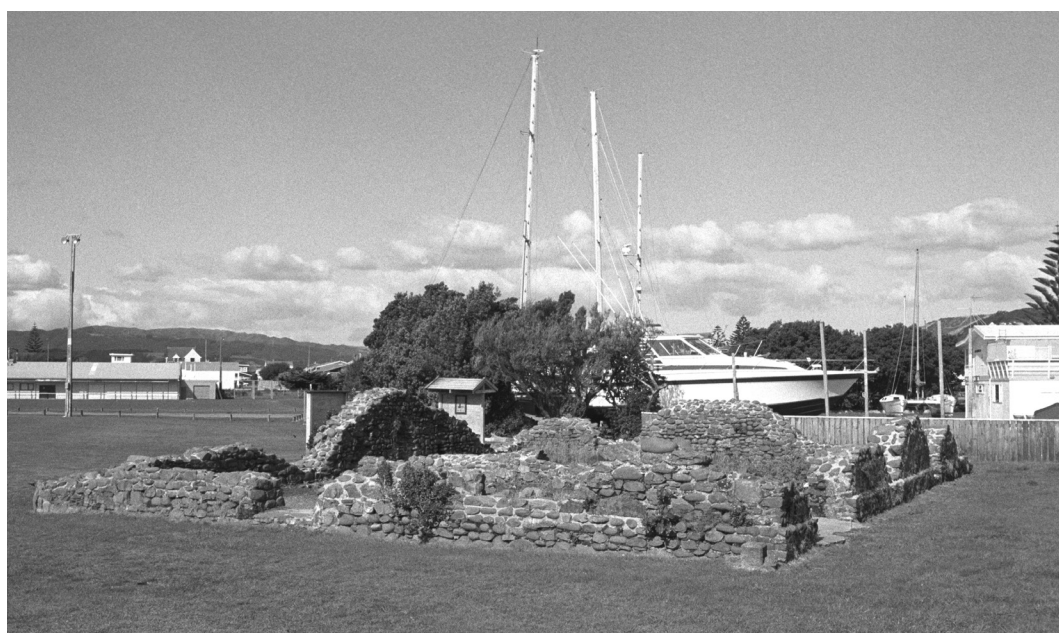
Figure 127. Paremata Barracks. Photo: N. Prickett, 1990.

There are important surviving remains despite continued deterioration of the walls. A protective fence was put up in 2004. There is no reported evidence of the associated preliminary earthwork or stockade.
