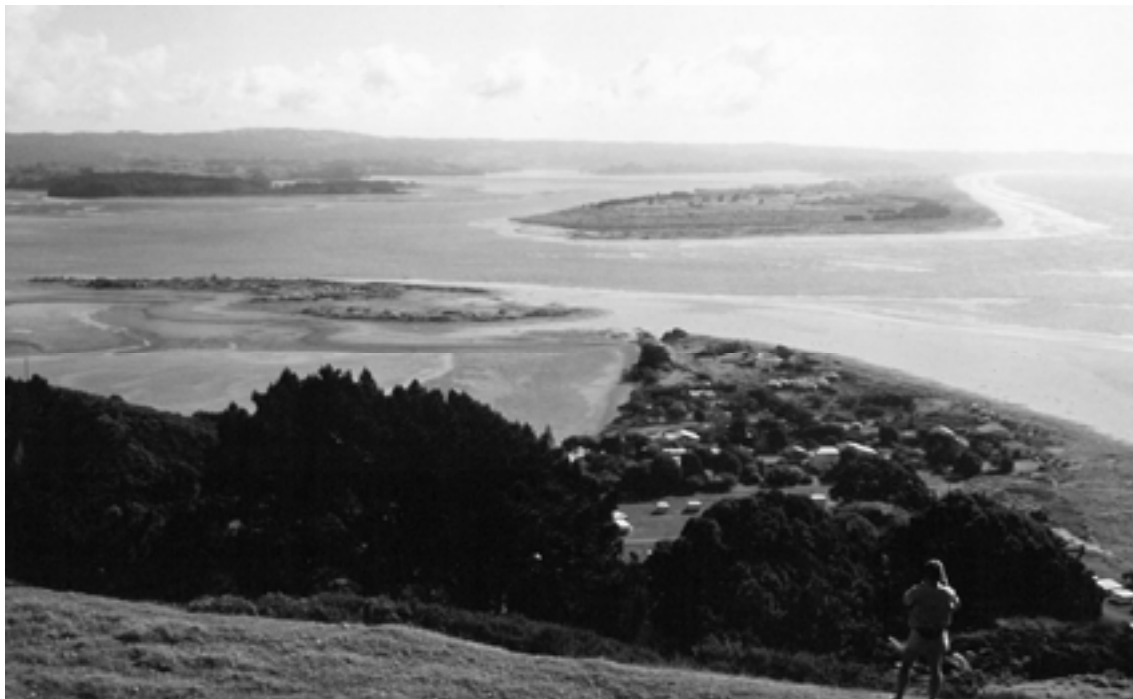
Plate 8 Ohiwa spit (foreground), Bay of Plenty, looking west to Ohope spit, 2 April 1992, rated 36. Characterised by its low-lying nature (4.7 m), high storm wave run-up (5 m), and low gradient behind the foredune. It suffers from erosion (3.15 m/yr) and high fluctuations due to the repositioning of the spit tip. On Ohiwa Spit two subdivisions have been lost to erosion this century.

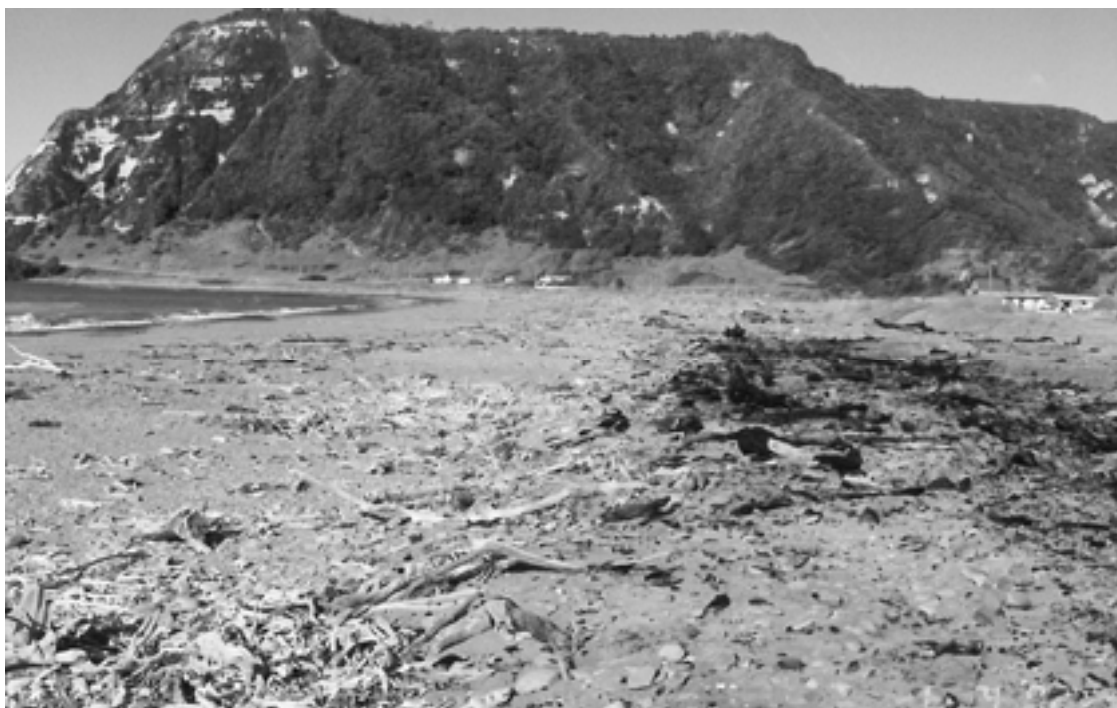
Plate 9 Eastern Te Araroa beach (Site 63), East Cape, 1 April 1992, rated 36. This low-lying sand/gravel beach (1.5 m above MHWS) suffers from inundation from storm events, high fluctuations (50 m) and a high rate of erosion.

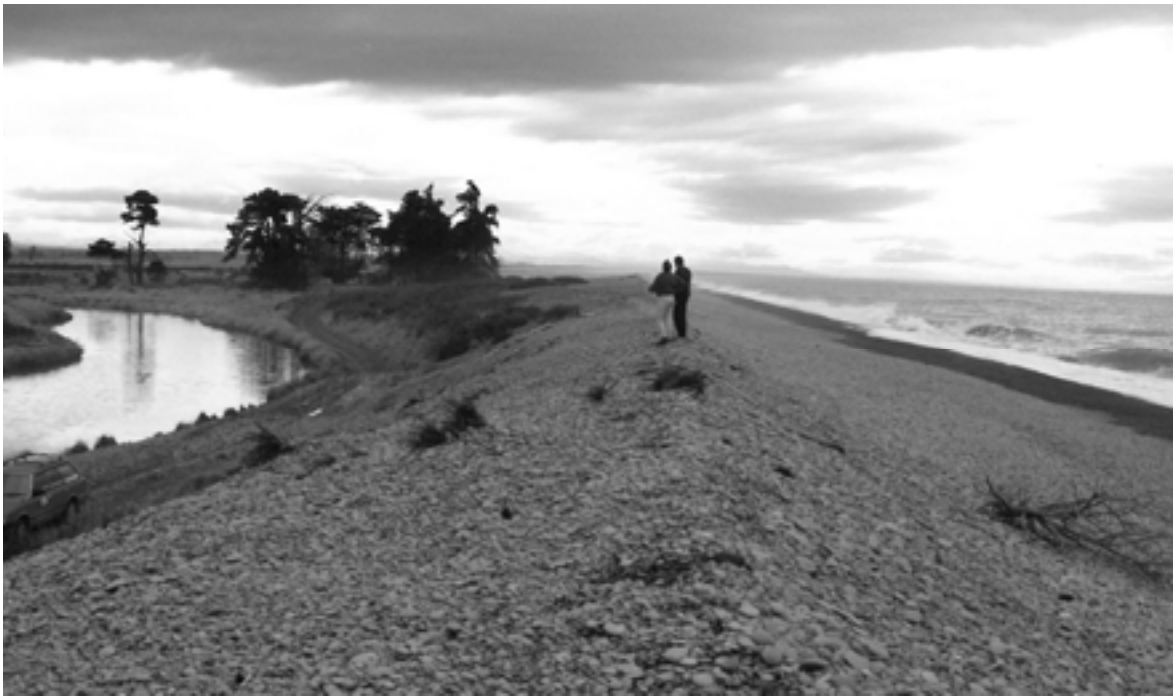
Plate 10 Looking north at Site 100, Wainono Lagoon, Waimate Creek, Canterbury, 14 May 1992, rated 35. Gravel beach ridge has a medium elevation (6 m), but it is eroding and is regularly overtopped, inundating the lagoon behind. It also from high fluctuations and cut-back during storms.

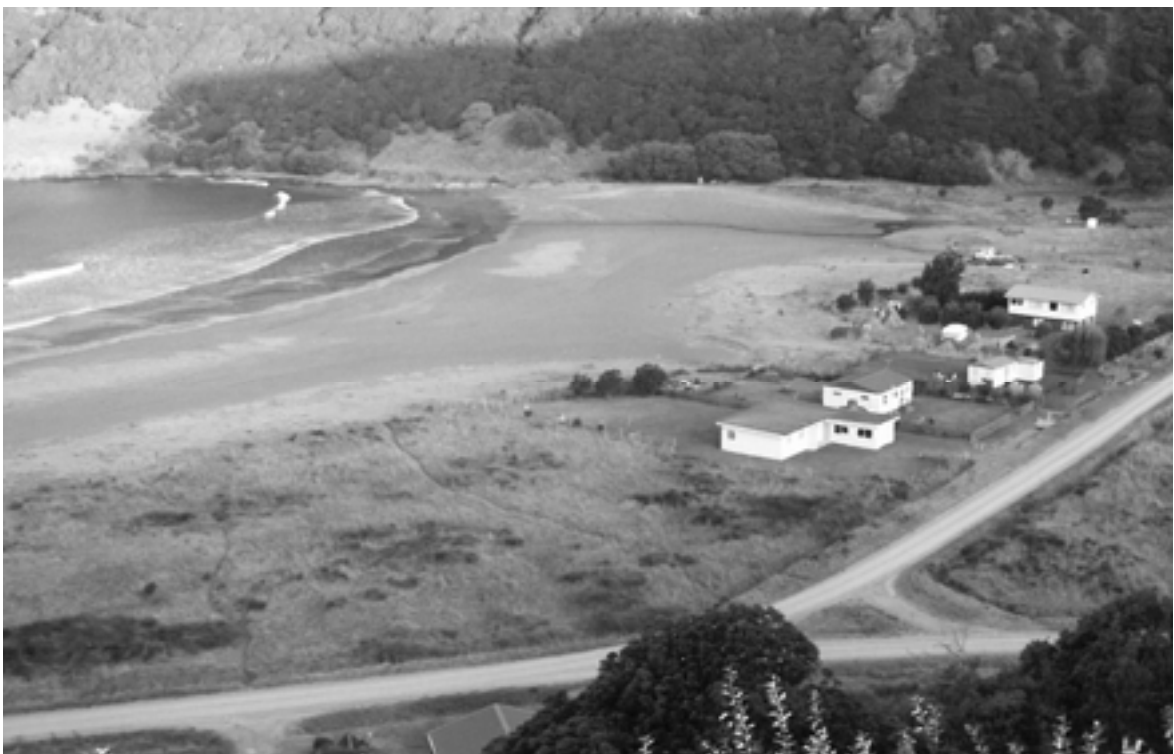
Plate 11 Site 67, Onepoto, Horseshoe Bay, East Cape, 1 April 1992, rated 33. This accreting (0.5 m/yr) sandy beach has a very lowland elevation and gradient, and experiences high storm wave run-up levels which frequently extend inland through the houses to the road paralleling the beach.

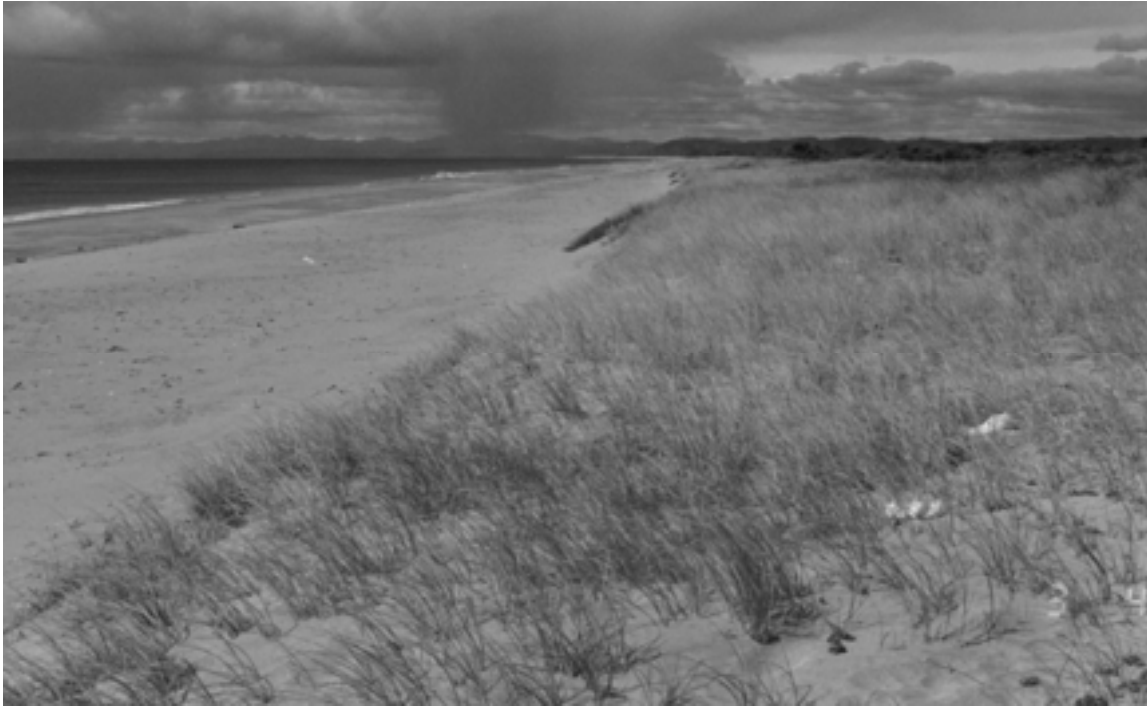
Plate 12 Looking east, Site 83, midway between the Rangataiki and Tarawera rivers on the Bay of Plenty coast, 3 April 1992, rated 32. This sand beach has a low elevation which is overtopped by storm wave run-up. While experiencing very high short-term fluctuations it is accreting at the rate of 1.4 m/yr.

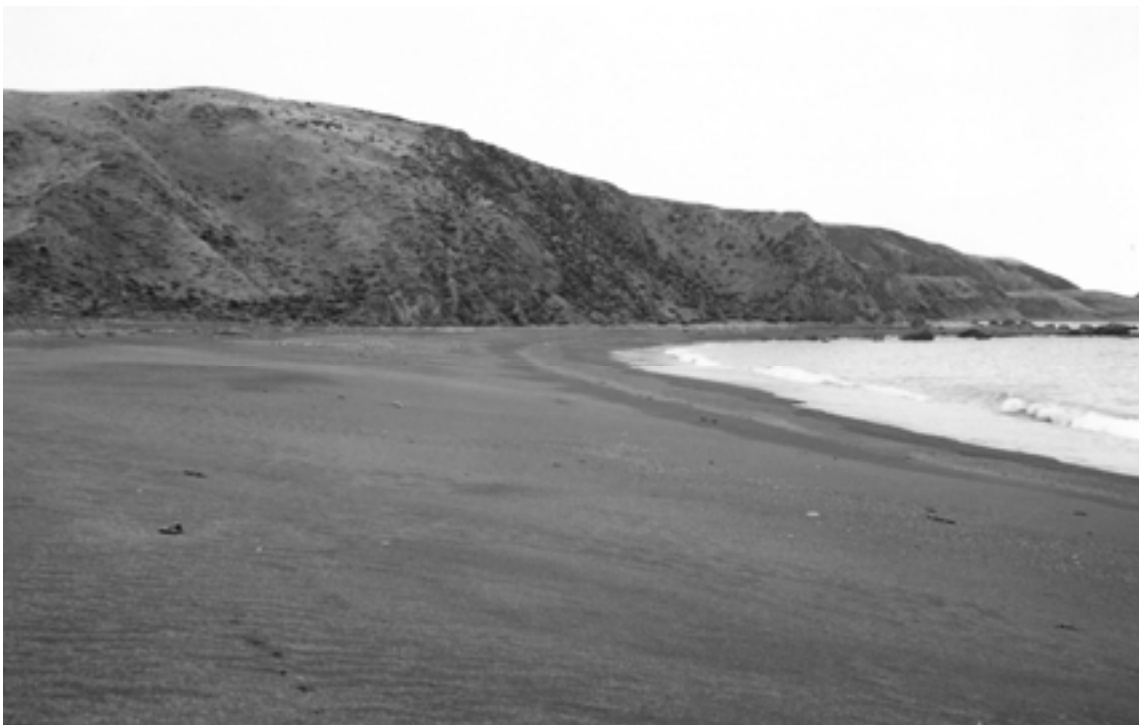
Plate 13 Looking east, Site 33, Bluff Point, Wellington, 19 March 1992, rated 31. This gravel beach site is characterised by a medium elevation (6 m), but is overtopped by very high storm wave run-up (m). While the long-term trend remains approximately static, it experiences very high fluctuations as a result of pulses of gravel entering and leaving the bay from longshore drift.
