SCIENCE & RESEARCH SERIES NO.69

**WHITEBAIT
SPAWNING GROUND MANAGEMENT**

C.P. Mitchell

Published by
Head Office,
Department of Conservation,
P O Box 10-420,
Wellington,
New Zealand

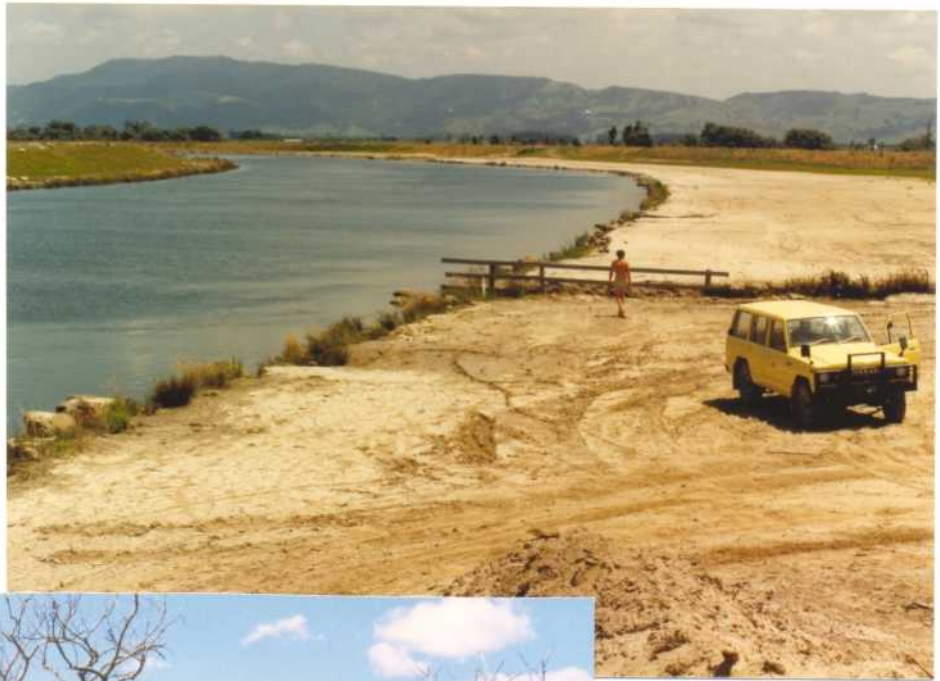
Figure 4 Vegetation outside enclosure before grazing, April 1993.

One instructive feature of autumn 1993 was there had been no grazing of stock on the surrounding land for six months. The area was used to grow a maize crop over summer. After no grazing for this period, creeping bent (*Agrostis stolonifera*) and Festuca had reached a length of 15-30 cm along the river bank. In April, whitebait spawning was found in this grass only, straddling the fenced spawning ground (Fig. 2 & 4). Unfortunately cattle were returned to the paddock before these eggs would have had time to hatch (Fig. 5). In May a small patch of spawning was found on the edge of the fenced area, where cattle reaching through the fence had shortened the grass.

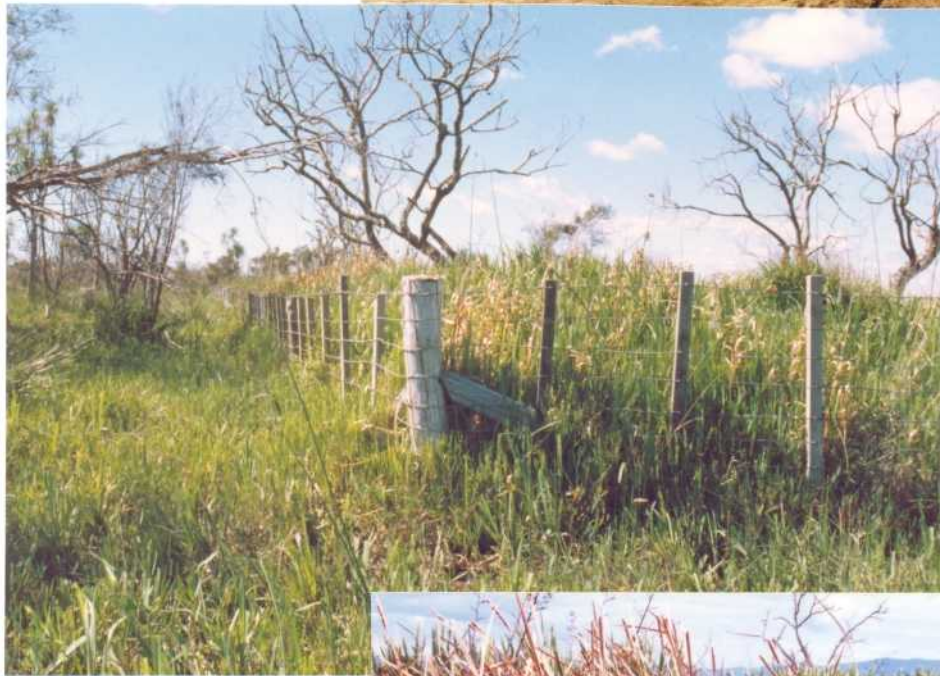
Figure 5 Vegetation outside enclosure after grazing, May 1993.
