NORTHLAND

3.4 Ruapekapeka, Q06/139 GR 144377 (N16/185) (Fig. 15).

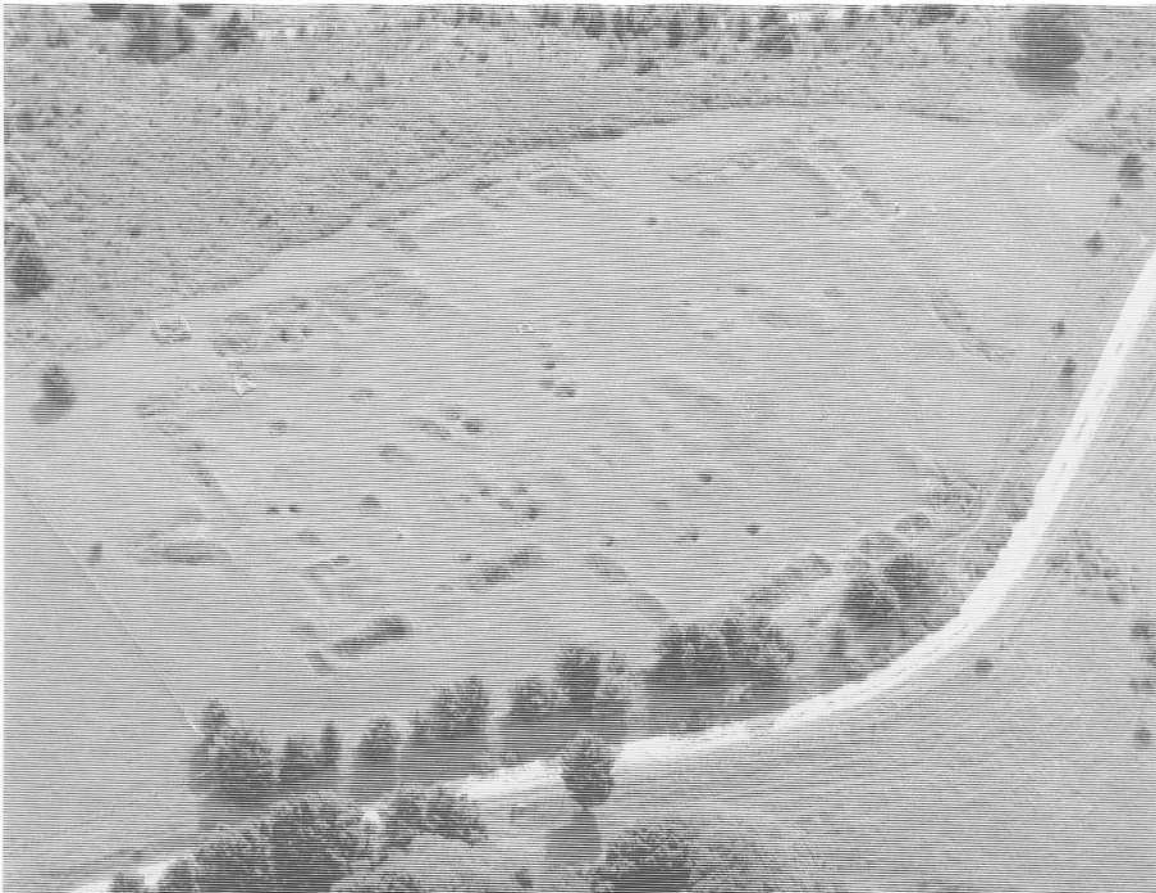
Figure 15 Oblique aerial view of Ruapekapeka, February 1992. The surviving perimeter of ditch and bank provides unique insights into the earlier phases of Maori gunfighter pa. The ditches lay inside a screen or palisade of puriri logs; the interior pits were roofed over with earth to avoid the effects of exploding rocket fire. Totara trees line the fence in the foreground and manuka-dominated scrubland dominates the background.

Generally, the conservation status today, as marked by the general lack of patches of progressively eroding soil, is good. Some tracks formed by visitors are causing spots of failed grass cover but the impacts on the historic fabric are not pronounced. On our visit we saw very limited signs of people getting access to the underground pits, wearing a path into only one pit near the northern perimeter. Stepping of cattle or people to reach fodder or blackberries had made minor collapses on one or two other pits near the southern perimeter.

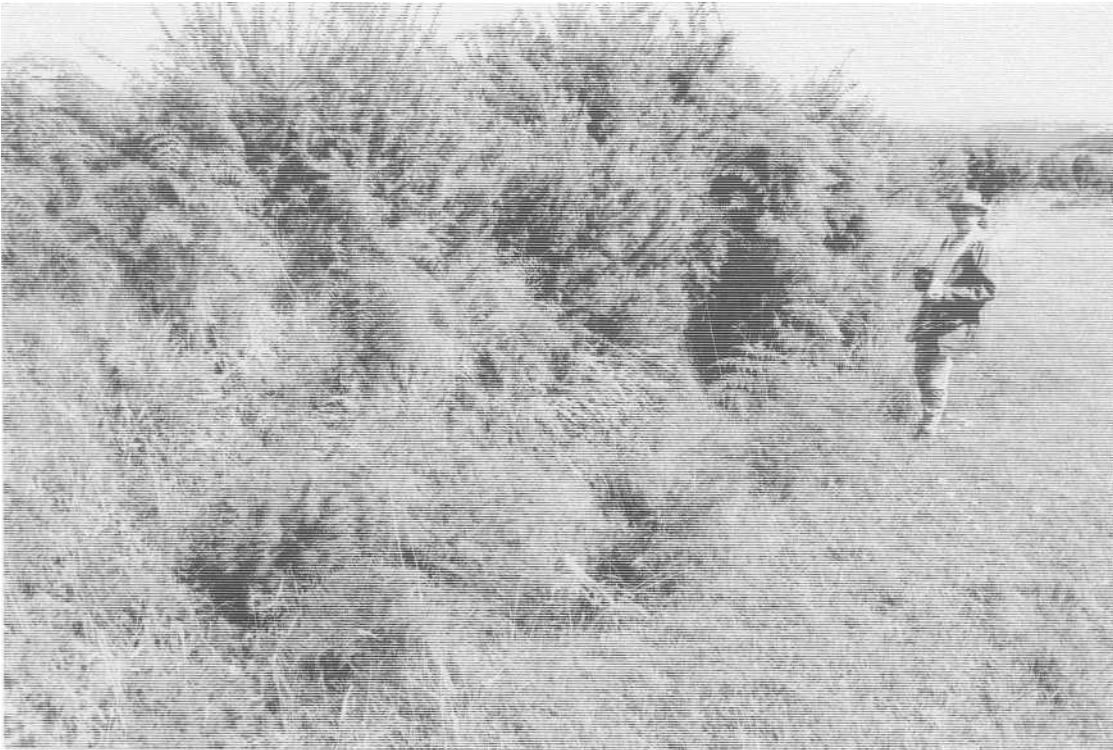
16(a)

The pits and trenches contain a variety of herbs and shrubs, because they are not maintained in grass (Fig. 16). Some areas of grass described by Woods (1993: 4) include Yorkshire fog, cocksfoot; there are also a potentially useful sedge (*Cyperus eragrostis*) and rushes (*Juncus* spp.). Ferns include bracken, ponga, mamuku, *Paesia* (ring fern), *Doodia media* and *Blechnum* "black spot", all of which are significant in protecting soil features. One observer considered that the underground rhizomes of bracken formed conduits for water when they died and thus contributed to soil erosion, but we have not seen examples of this. We are more impressed by the ability of bracken to hold friable soil together and protect sensitive pā features from raindrop impact. Gorse and blackberry also occupy pits and trenches, and people seeking blackberry fruit have unwittingly caused some minor bank erosion. In the few cases where pits are maintained in grass, there is erosion caused by people crawling in to explore the underground galleries.

Figure 16(a), (b) Ruapekapeka: (a) the pits and ditches, protected from grazing and mowing, have become colonised by gorse, bracken, blackberry, koromiko and tree ferns with a wide variety of herbaceous ground plants. (b) a dense cover of indigenous fern *Doodia media* covers the shaded surface of a ditch on Ruapekapeka.

are very moist and contain introduced rushes and sedges. There has been local but significant erosion of the rims of pits and trenches by stock seeking to eat the diverse shrubs and other plants growing within.

Key management measures are needed. Mowing should be set at a greater height, especially for work on the perimeter bank, allowing for a minimum clearance on the bank of 15 cm. Elsewhere a minimum clearance of 10 cm should also be set. This will still reveal the features. Some scrub-cutting and weed-eating of shrubs, including gorse and bracken fern, is needed in the perimeter trenches, to take these back to within

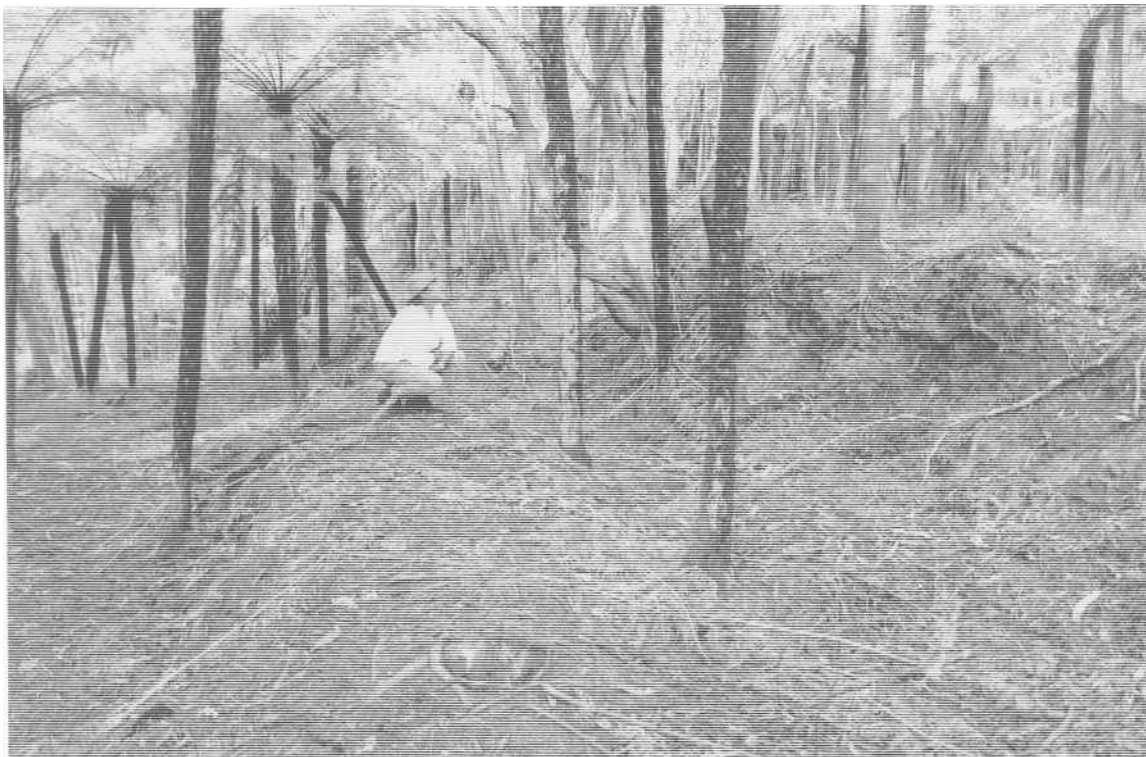
Figure 17 Ditch and bank surfaces of Okuratope colonised by trees/ferns, tanekaha and other forest species which provide some protection from rain-induced erosion.
