Blackball Coal Mine

Historic Site Assessment and Workplan

Jim Staton | West Coast *Tai Poutini* Conservancy

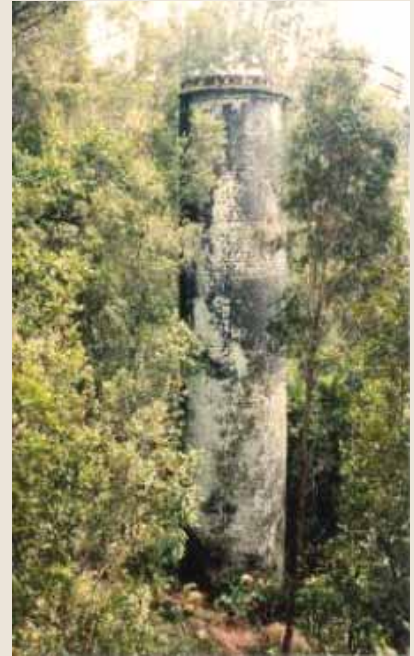
Top: 1892 wooden chimney site, rebuilt in 1897 in brick. Below :second chimney base, built in 1895, extended in 1896—dark lines represent the original height.
JIM STATON COLOUR PRINTS

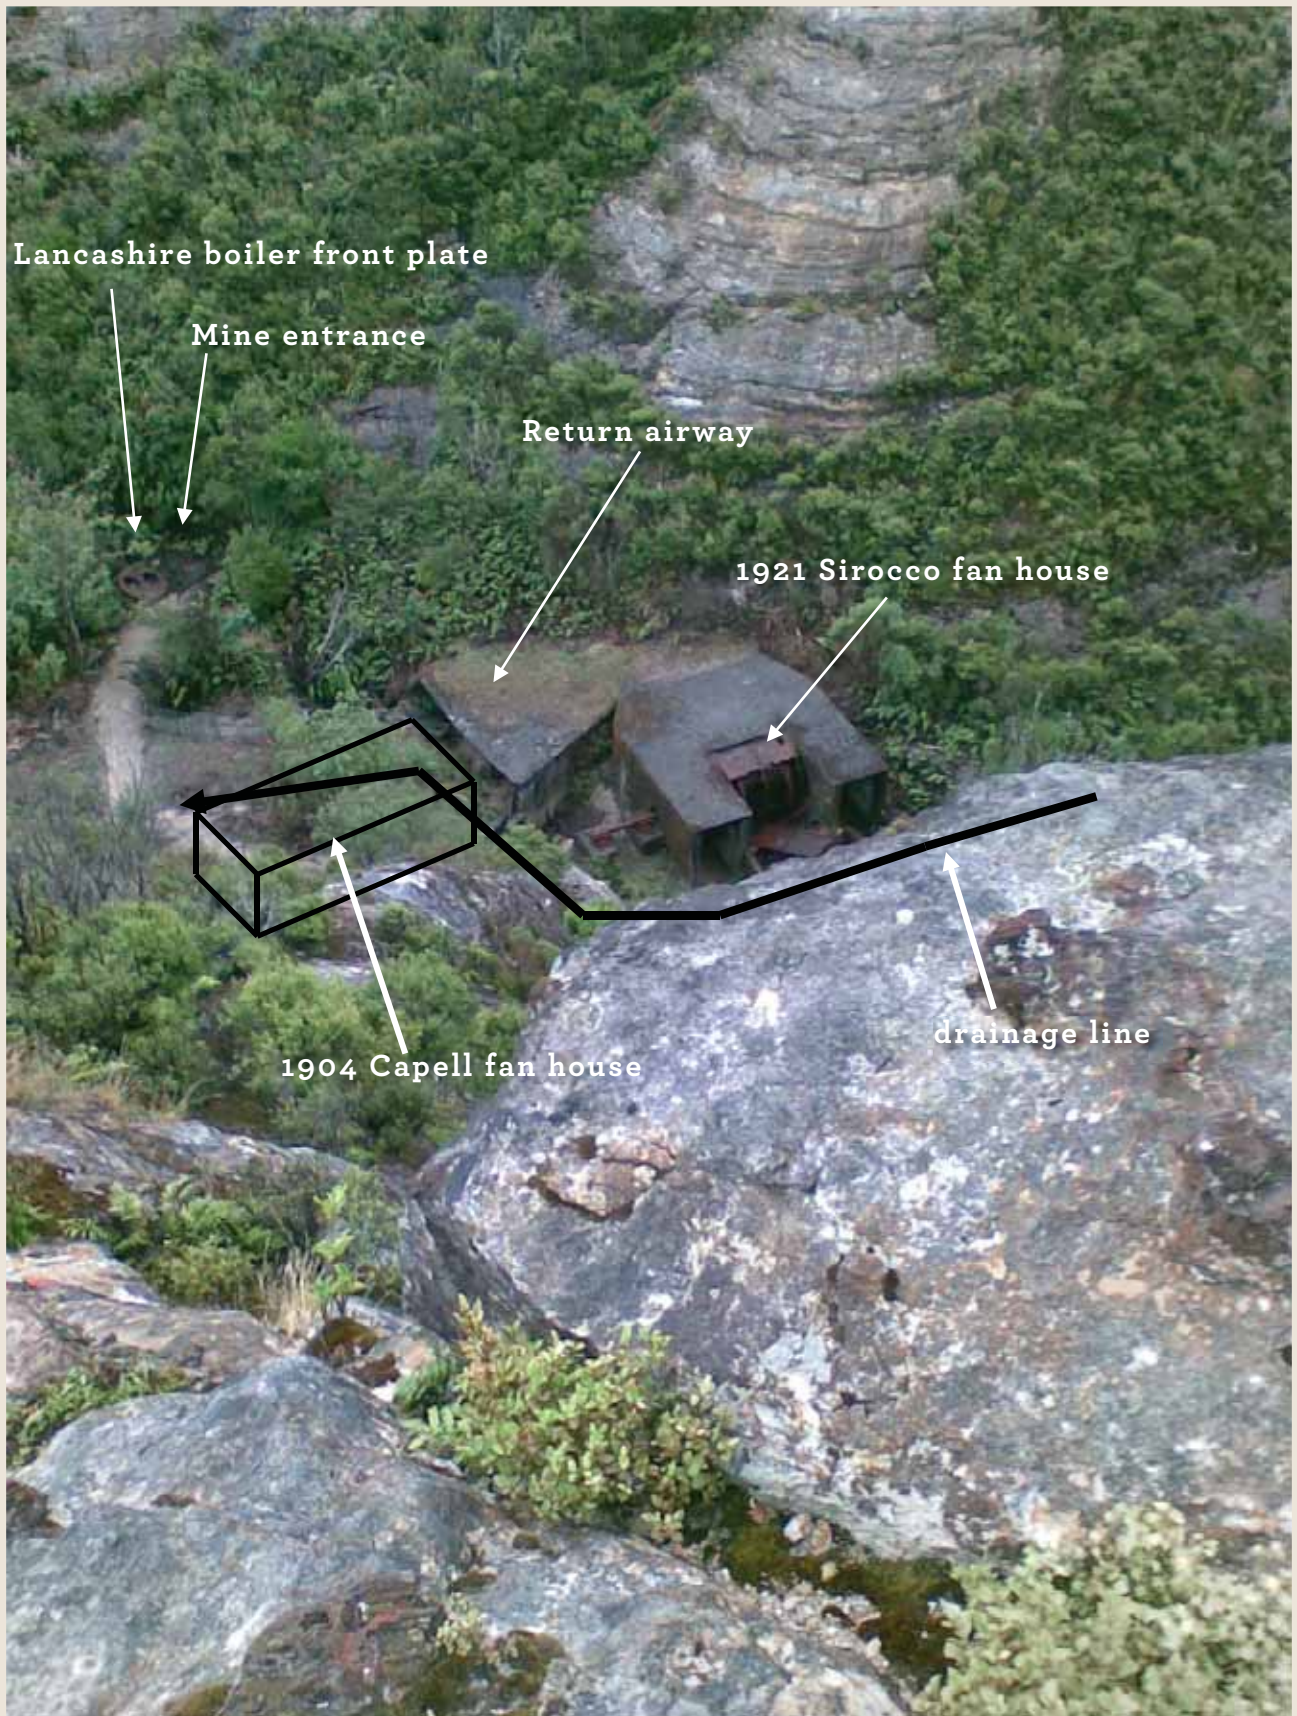
View over the mine area, return airway and fanhouse from above the tall chimney on the ridge to the south east showing approximate line of the drainage channel and most probable site of the 1904 Capell fan house. JIM STATON, MARCH 2008

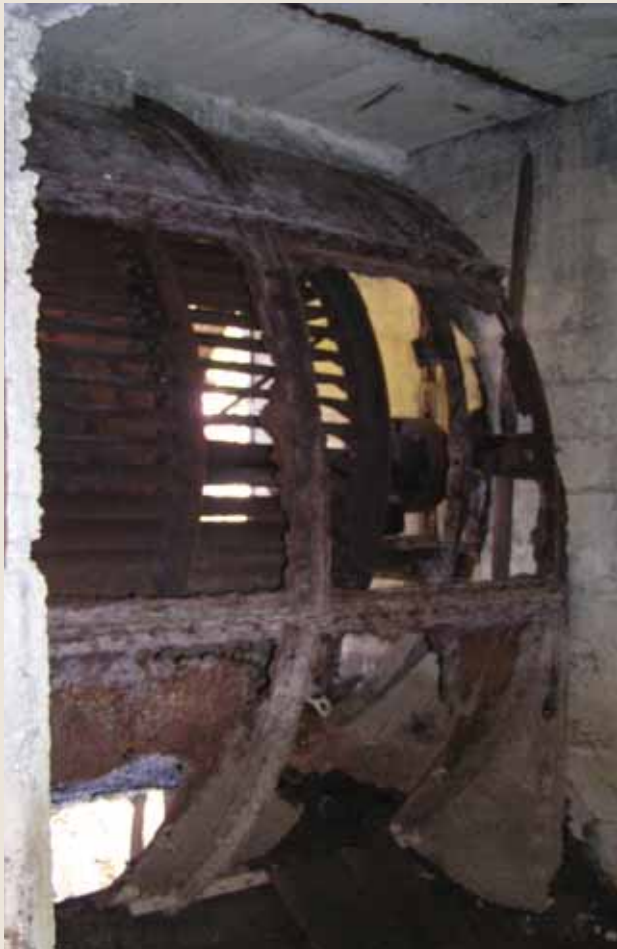
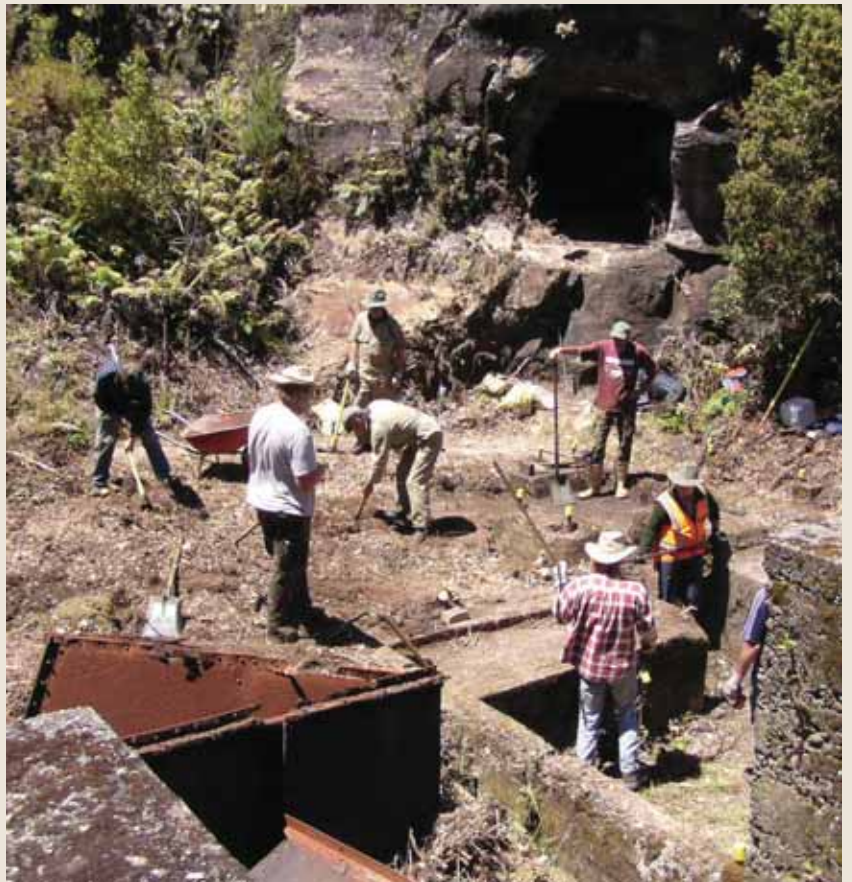
Blackball community helping DOC staff clean up the fanhouse engine house foundations. Note the explosives store in cliff face. JIM STATON, DECEMBER 2007

The Sirocco fan drive engine and control room foundations are in good condition. Several bricks are lying around loose, with some smashed after being thrown against the fanhouse structure. The foundations have been cleared of vegetation with assistance from the Blackball community.
