Te Kuha Mining Operation Geotechnical Concept Study for Stevenson Mining

Prepared For
Mike Coleman
CEO for Stevenson Mining

Document: Mine Geotechnical Feasibility Assessment

Date: 02 October 2015

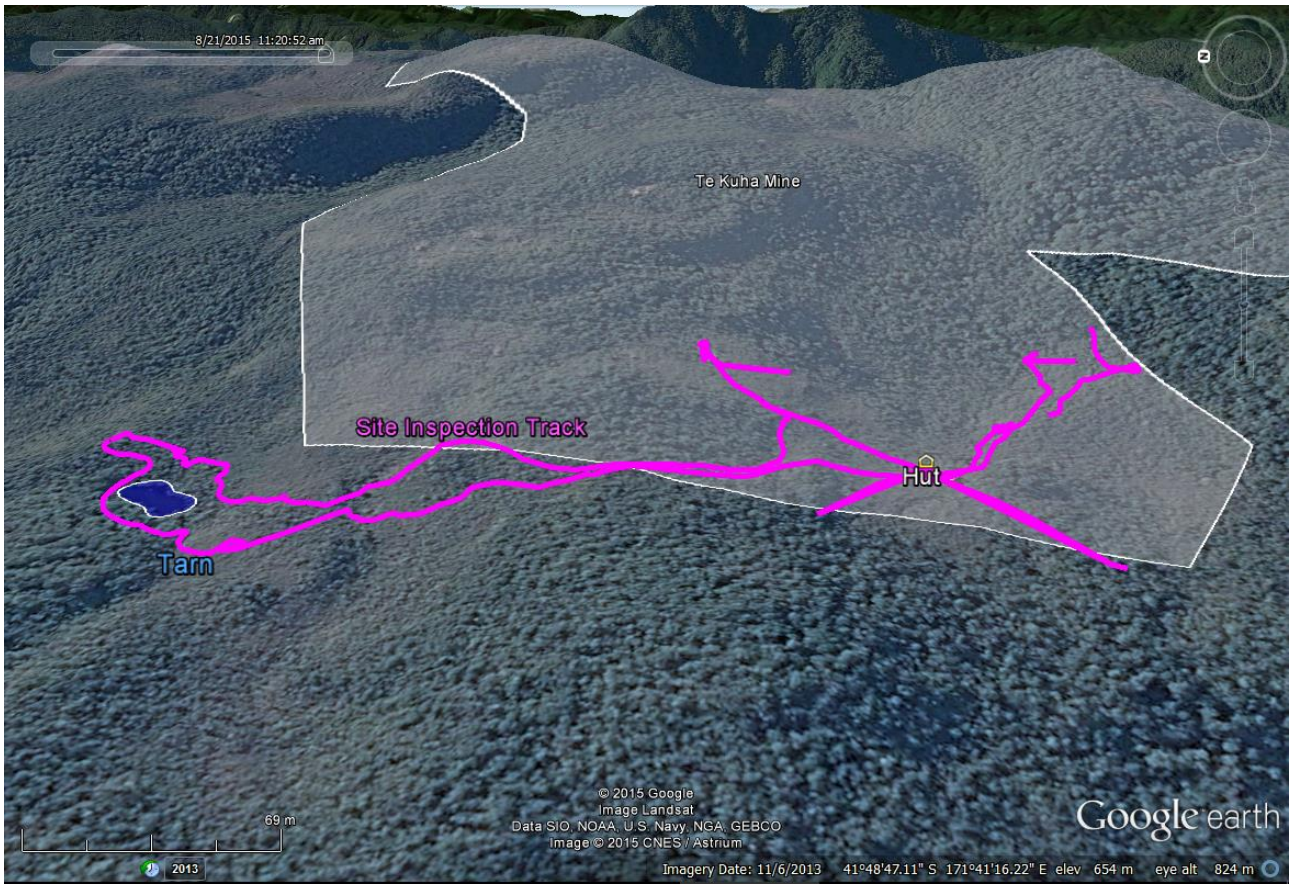
Figure 5 - Site Inspection Track from 28/08/2015 Showing Mine Footprint and Tarn

A site inspection was carried out on 28 August 2015 by Geologist A. Dutton and Geotechnical Engineer C. Mans to make a general assessment of the site, look at the identified slides, inspect reported voids in outcrops, investigate surface water around the planned dump sites (particularly the tarn) and assess if a suitable dam location exists towards the Northern boundary.

The site is densely vegetated and surface topography ranges in steepness from flat in areas to very steep (~45°), a couple of sheer cliff faces were identified on the western slope but generally limited to 10m height or less. Significant earth works will be required for mine access and haulage as part of operational preparation, initial surface excavation should not prove problematic with the weathered profile being fairly soft material and the more competent materials being blocky in nature.

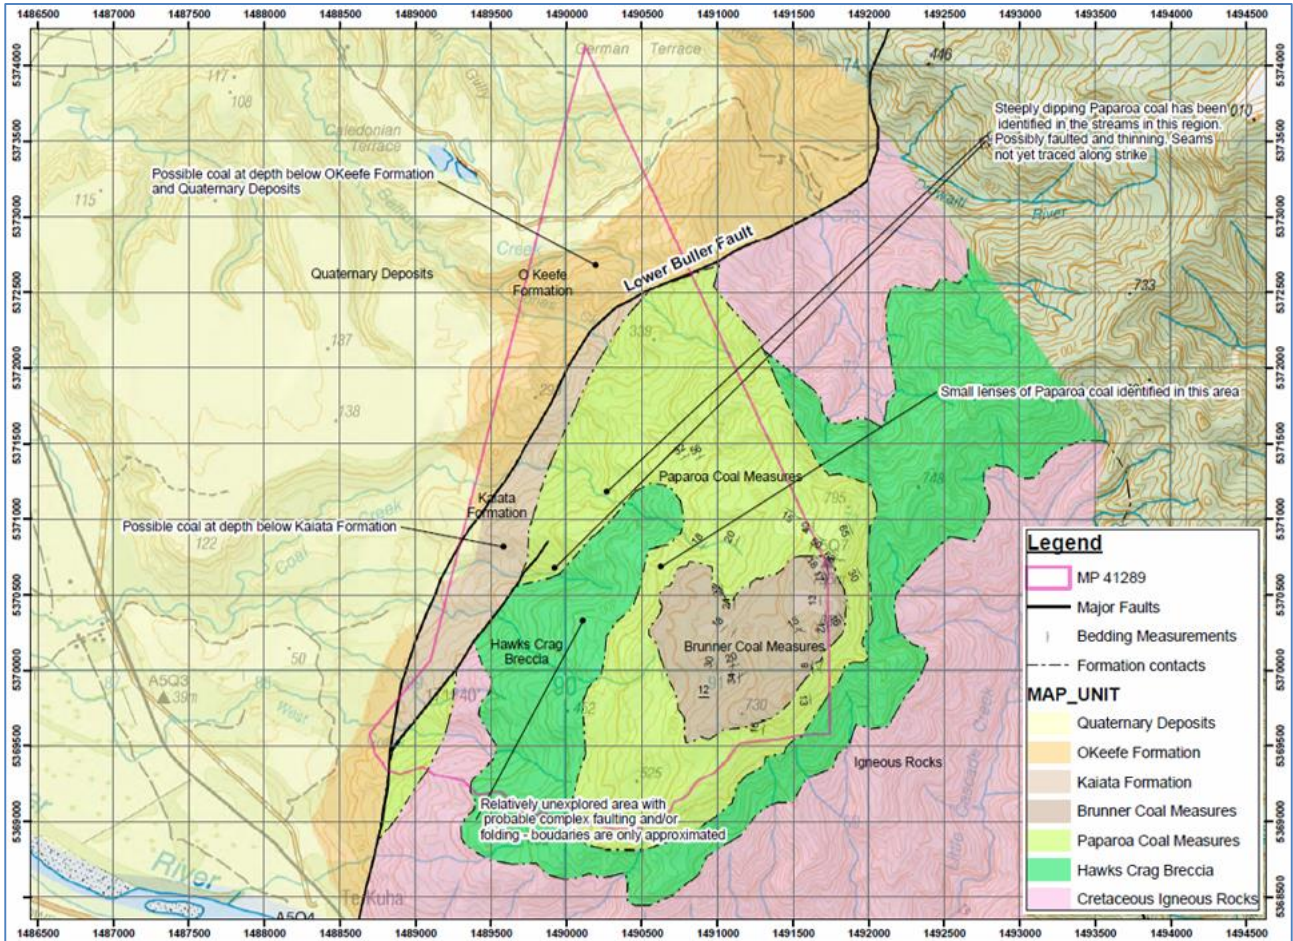
Figure 9 - Te Kuha Regional Geology Map as per Dutton (2013)

The Paparao and Brunner formations are typical coal deposition environment consisting largely of sandstones and siltstones with some minor gravel conglomerate and mudstone components. The weathered profile in the planned mining areas is generally limited to ~5m above the Paparao seam with the upper ~10m consisting of highly weathered material, decreasing to slightly weathered, lower in the profile.

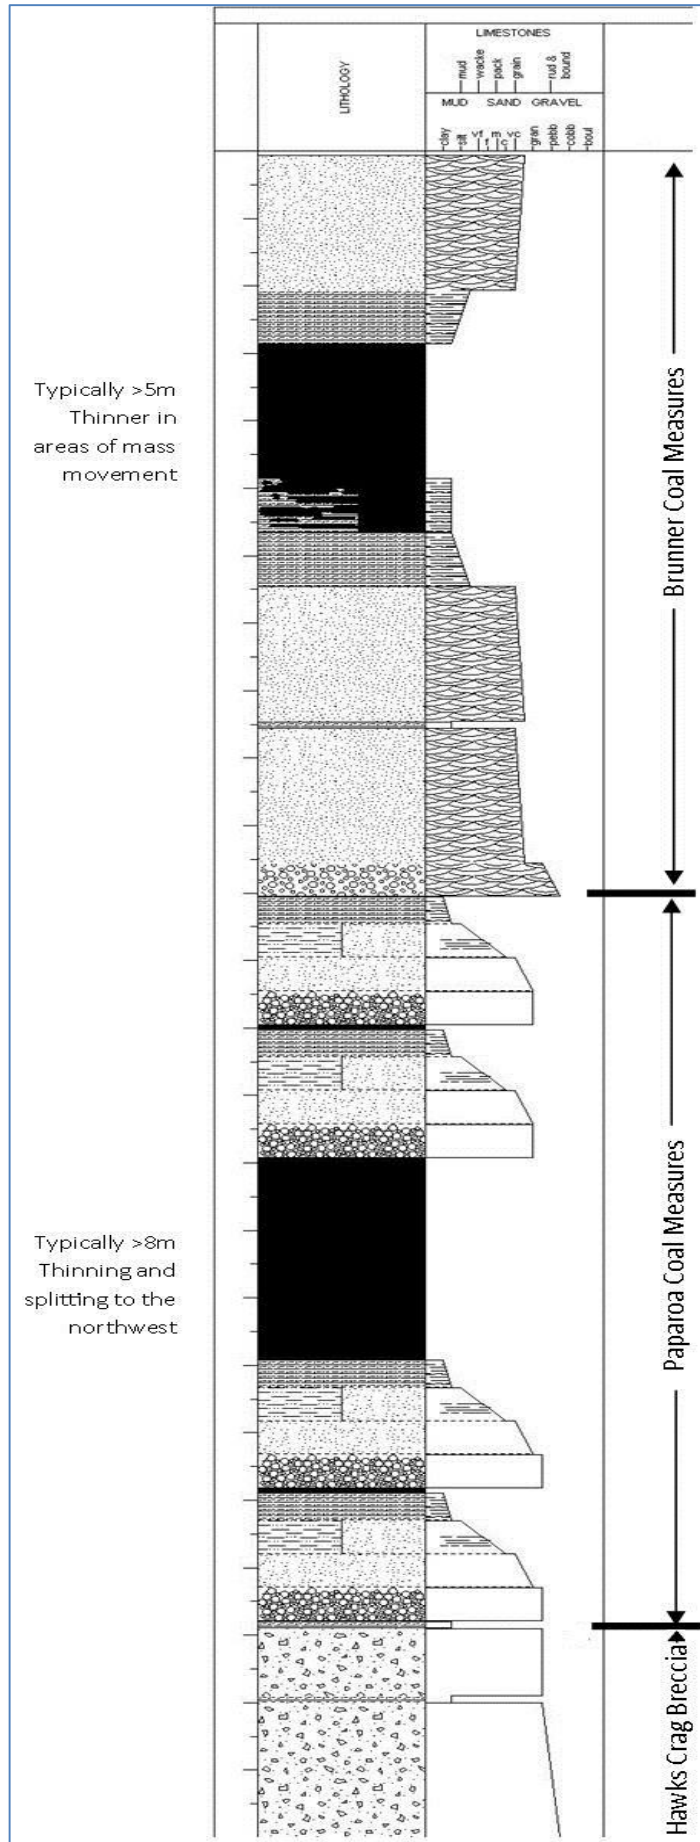
Figure 11 - Te Kuha Generalised Stratigraphic Column with Lithology as per Dutton (2013)

The generalised lithology (**Figure 11**) has been used for construction of the stability models, generic cohesion and friction angle values for coal measure lithologies have been used for purposes of assessment. The slightly weathered and fresh materials have been down-rated via GSI (Geological Strength Index) to account for the moderately spaced jointing pattern (~1m).

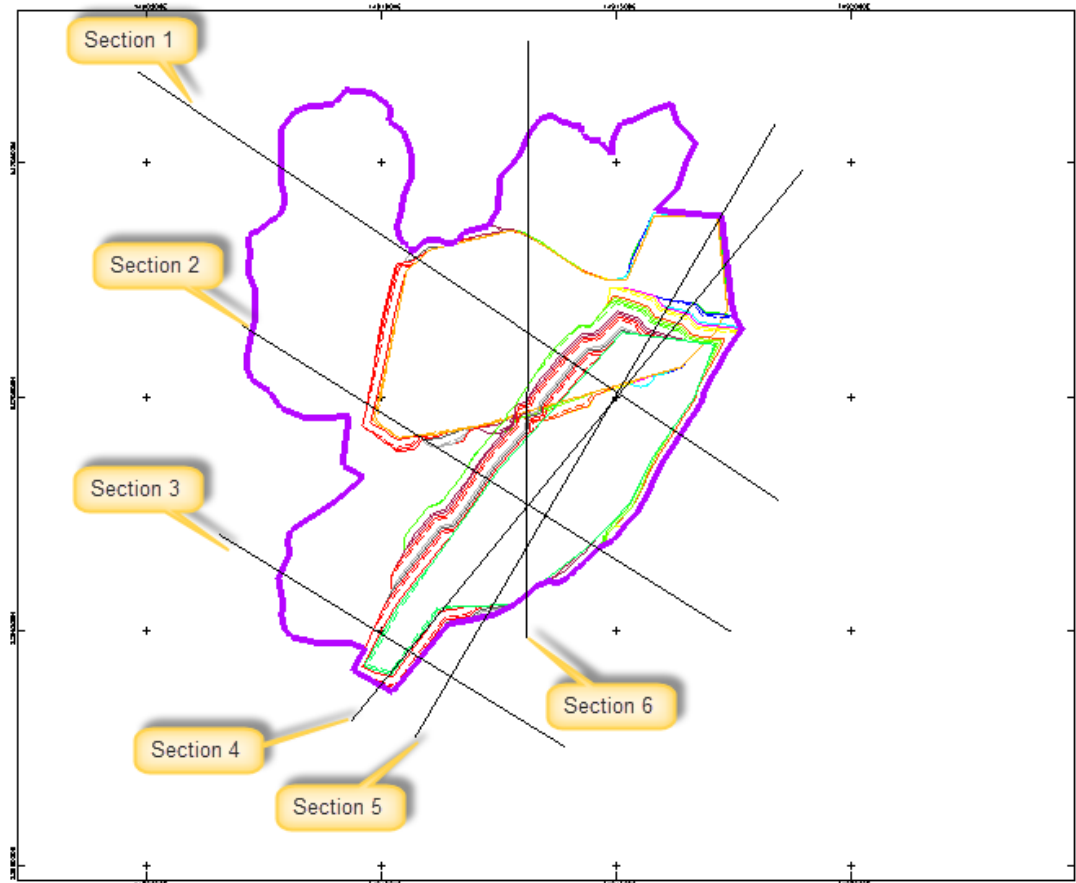
Figure 14 - Section Summary

Analyses were carried out in the form of a sensitivity study with circular and non-circular failure planes incremented along the model beginning at first benches and extending to include entire walls. The parameters used in the model are considered conservative for general operation, assuming geotechnical testing reasonably corroborates the model inputs, there is likely to be opportunity for optimisation.

Some rough sensitivity checks of faults were carried out by introducing shear planes in close proximity to the walls / benches. FoS results indicate that localised instability can be generated but is limited to individual benches, this type of failure is most likely to be generated by the interaction of the major structures and jointed blocky materials.

The exposed sections of the slide were also replicated by conservatively treating the wall material as spoil, the affected zones are minimal (and limited to the Western walls) but will be prone to instability, adjustment of wall angles at these locations should stabilise these sections and increasing bench widths will effectively eliminate rock-fall hazards.
