**EDMOND'S RUINS, KERIKERI INLET,  
BAY OF ISLANDS:  
THE STONE STRUCTURE AND  
THE ARTEFACT ASSEMBLAGE**

Aidan J. Challis

Published by  
Head Office,  
Department of Conservation,  
P O Box 10-420,  
Wellington,  
New Zealand

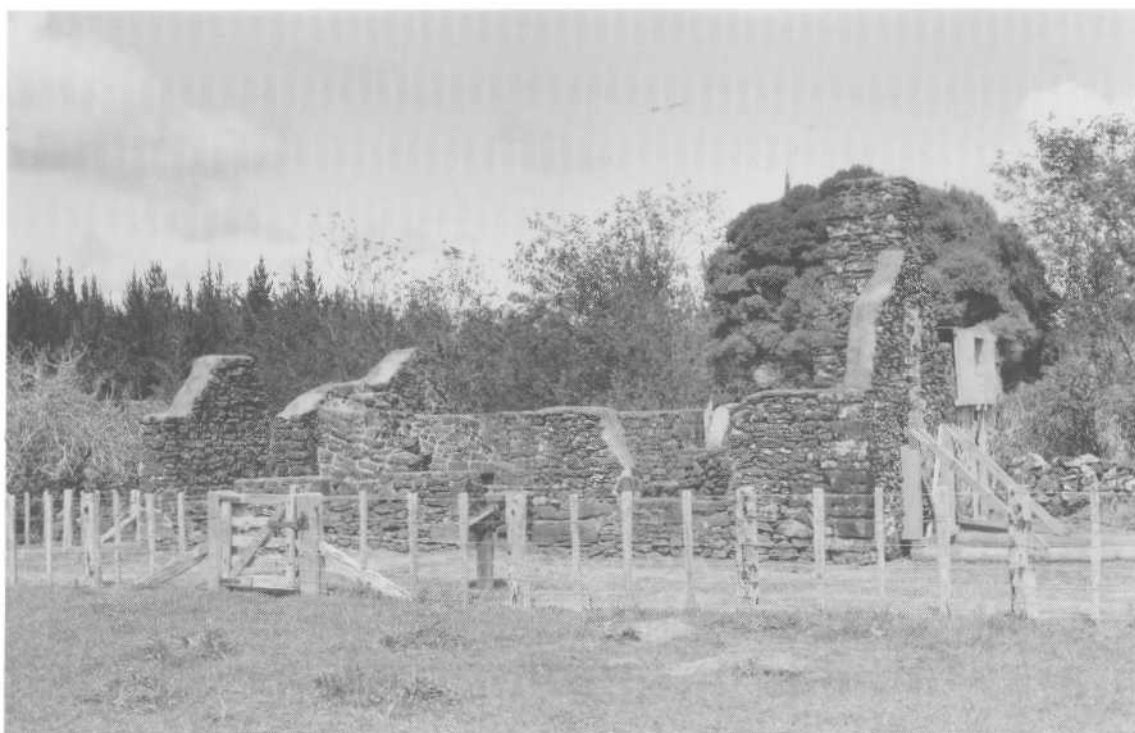
**Figure 3 Edmonds Ruins, east front, 1992.**

The main house ruins stand to an average wall height of 2 m (see Figures 3, 9, and 10). Immediately to the west of them are the remains of an outbuilding known as the annexe (see Figures 8 and 12). Other stone structures, perhaps the remains of a shed, garden edging and an approach track, exist on the western side, and immediately to the east are other alignments of stone kerbing which probably defined gardens. In a swampy freshwater hollow to the west is a stone-lined well. (For these and other details, see Figure 2.) Also in the vicinity of the ruins are remnants of orchard and garden plantings (e.g., citrus, stone fruit, fig, gladioli, lilies and roses).

The house is built of vesiculated basalt field stone. Large blocks were available. Some quoins (external corners) have been dressed to sizes up to 1 m across, but the majority of the structure is of undressed field stones as small as 60 mm across. Cockle shell may have been burnt for use in mortar at the tidewater site 750 m to the north-west (site number P5/512, mentioned previously). None of the walls has any apparent formal foundation. The bottom stones appear to have been placed on the top of ground soil, with no built basal or lateral support. There has been an accumulation adjacent to the walls of around 250 mm on the outside and around 360 mm on the inside, of loose mortar, rubble, and other environmental material. All walls show a lack of deliberate bonding. That is, the stones were generally laid in stacks, not in horizontal layers and not with the mortared joints between the stones of one layer covered by the stones of the next (Harris 1975: 60). Dressed quoins, where they exist, are not bonded with adjacent masonry. Field stones have been stacked, heaped and tacked on to build the structure. The lack of bonding produced a relatively weak structure from which losses have occurred. Comparison of Figures 3 and 4 indicates some of the losses of the past thirty years.

- (1) 750 mm thick exterior walls (shown as phase 1 on Figure 8; see also Figure 9). These stand to their original eaves height of 2.2 m on the west side of the house. The upper parts of the gable ends to the north and south were higher but have partially collapsed (see Figures 3 and 4). There are massive well dressed quoins. Most other stone has been subject to some dressing at least on the exposed side. Parts of these walls retain exterior plastering (seen in Figure 4).

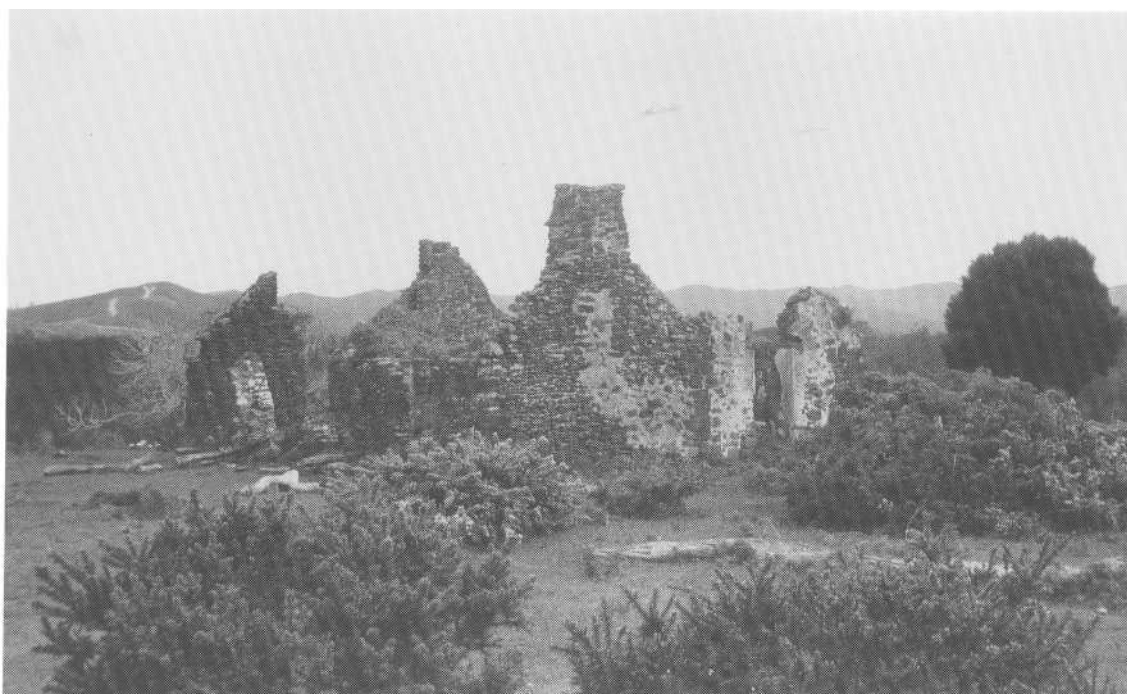
**Figure 4 Edmonds Ruins from the north east, 1964 (R.I.M. Burnett; Historic Places Trust photograph collection No. 1381).**

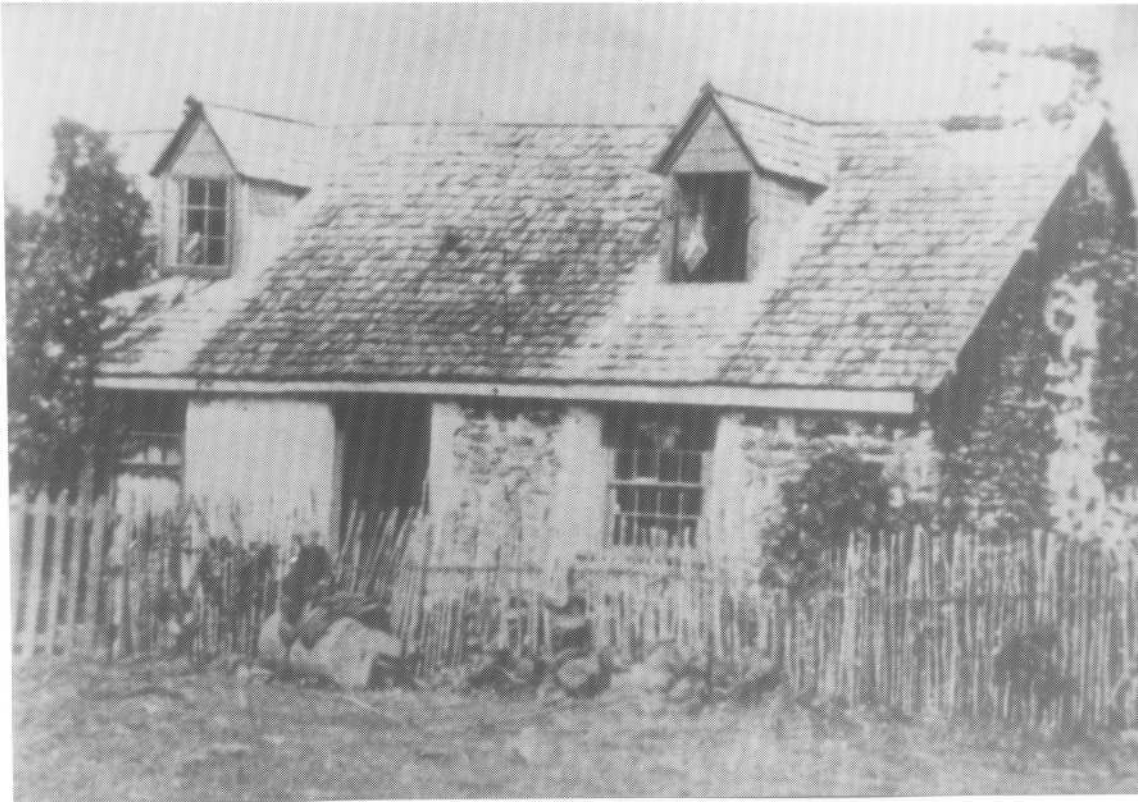
**Figure 7 Photograph of the Edmonds home before the fire of 1885-1886.**

A historic photograph of the house (Figure 7) shows the east front. Details still identifiable on the ruins, including the string-coursed stonework of the chimney top (horizontal bands of masonry, Harris 1975: 480) and the door and window placings, prove it to be Edmonds Ruins. The house appears to be in need of maintenance. The north dormer window casement is missing and some glazing seems absent elsewhere. Additional exterior mortar applied to the outside of the north wall, seen in the photograph, is still present (compare Figures 4 and 7). Concern about structural problems such as slumping, and their effects such as draughts or leaks, could have prompted its application. There is no evidence in the historic photograph of the
