Development of a Template for Vessel Hull Inspections and Assessment of Biosecurity Risks to the Kermadec and sub-Antarctic Islands Regions

National Institute of Water & Atmospheric Research Ltd

Department Conservation (DOC)

NIWA report no. CHC2010-086

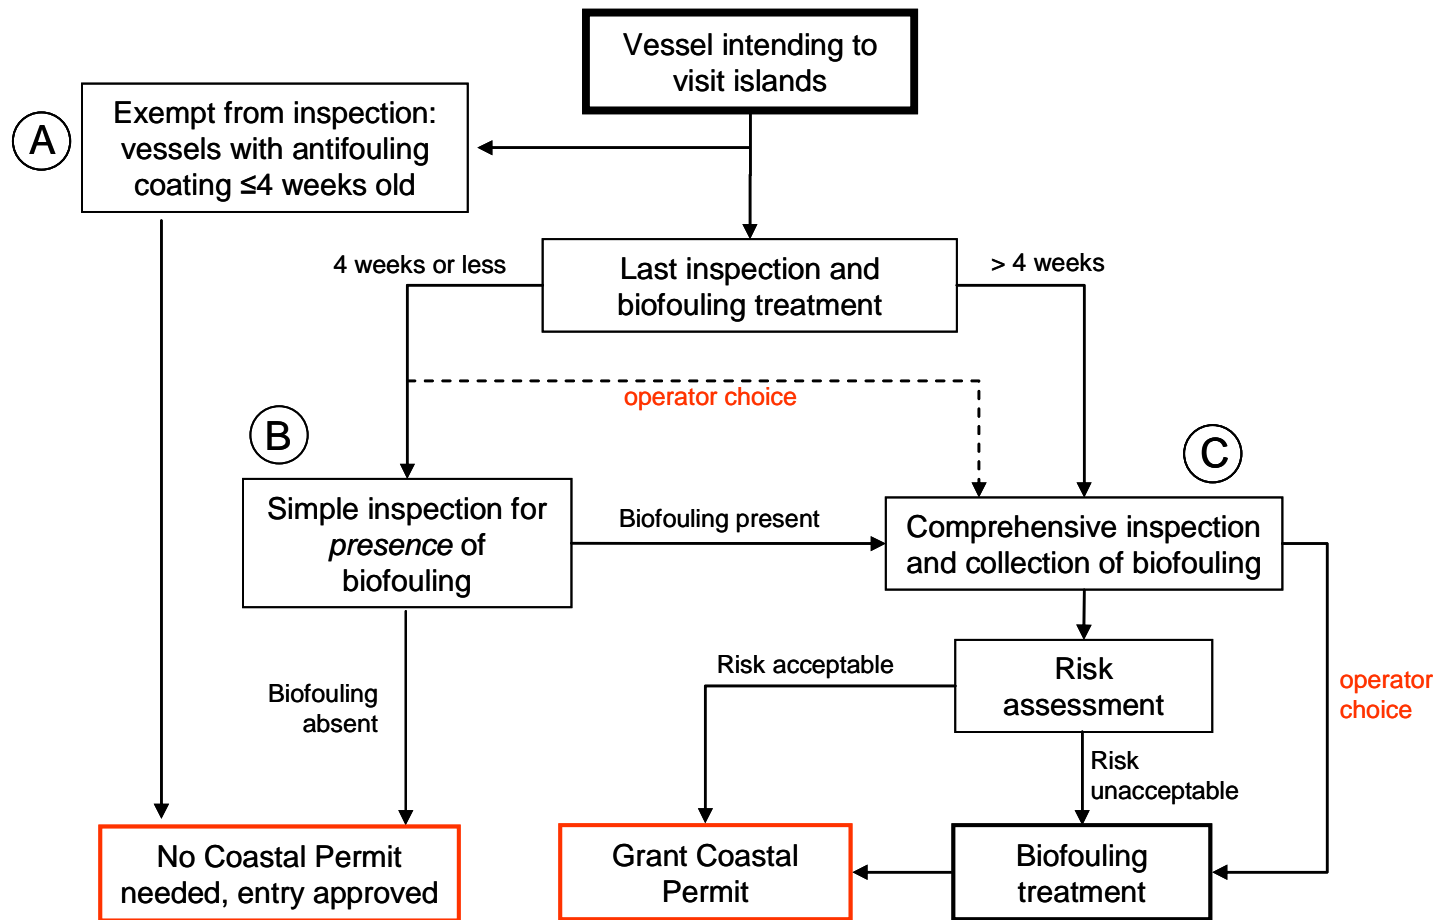
Figure 1: Decision framework for the requirement for vessel biofouling inspections. Simple (biofouling presence/absence) inspections or comprehensive inspections (biofouling collection and risk assessment) are required depending on the maintenance history the vessel is able to document evidence for. Situations A, B and C correspond to descriptions in the main text.

Framework for biosecurity inspections

We recommend that all vessels, including privately owned craft such as yachts, are subject to a biofouling inspection unless they can demonstrate that their last antifouling paint renewal occurred *4 weeks or less* prior to the time they intend to visit New Zealand's offshore islands. Vessels antifouled within the previous 4 weeks should be exempt from an inspection because they are likely to be either free of biofouling or any organisms present are unlikely to have attained sexual maturity (Figure 1 - A). Vessels applying for an exemption must present appropriate documentation of their recent antifouling paint renewal. This could be in the form of a receipt and description of services from a maintenance operation.

The suggested framework incorporates two types of inspections for vessels that do not qualify for an exemption: (1) simple inspections for the presence of biofouling, and (2) comprehensive inspections to enable assessment of the biosecurity risk to the islands. The type of inspection required will be determined by whether or not the vessel operator can supply evidence that the vessel has recently (within the last 4 weeks) been inspected elsewhere and found to be free of biofouling or if it has been cleaned by an approved method, such as dry-docking or in-water cleaning. The framework would require DOC to develop a list of technical dive companies and hull maintenance facilities, in New Zealand and overseas, that it has "approved" to conduct biofouling inspections using the sampling protocols prescribed in this report and which are able to remove biofouling assemblages to a satisfactory standard. The acceptance of approved hull inspections and treatment if needed may provide incentives for pro-active maintenance measures to avoid delays that would be caused by more detailed inspections, a risk assessment and the need to obtain a Coastal Permit.

If a vessel has not undergone a hull inspection or approved cleaning activity within the 4 weeks of the intended date of travel to the islands, it will be required to undergo a comprehensive biofouling inspection (Figure 1 - C). This inspection must be carried out by an approved dive

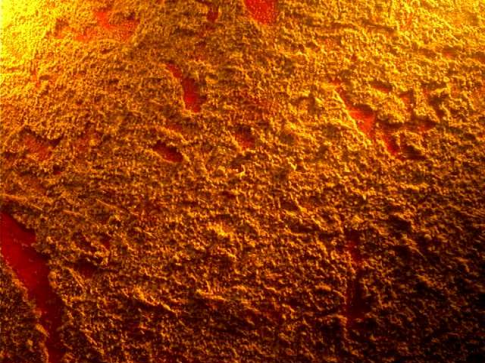
</div>
1	Hull partially or completely covered in slime fouling (biofilm). <u>Absence of any macrofouling.</u>
	<div style="display: flex; justify-content: space-around;">

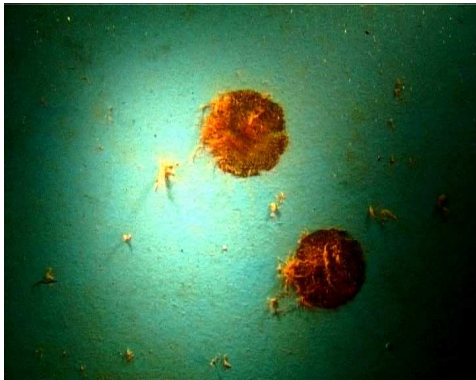
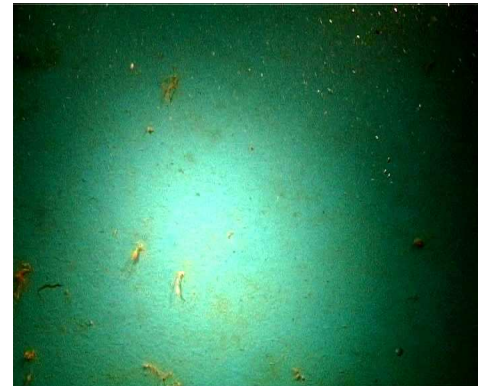
LOF rank	Criteria
2	<u>Light biofouling</u> . 1 – 5 % of visible surface covered by very patchy macrofouling. Remaining area often covered in slime. Examples below show presence vs. absence of fouling in two adjacent areas of a vessel hull.

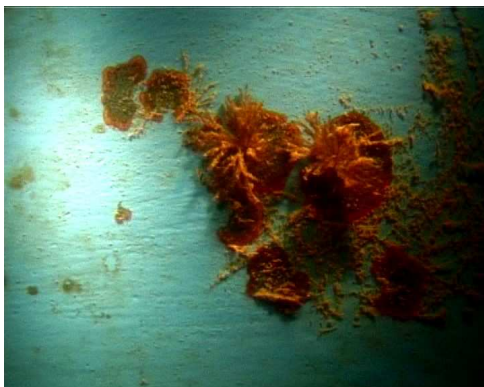
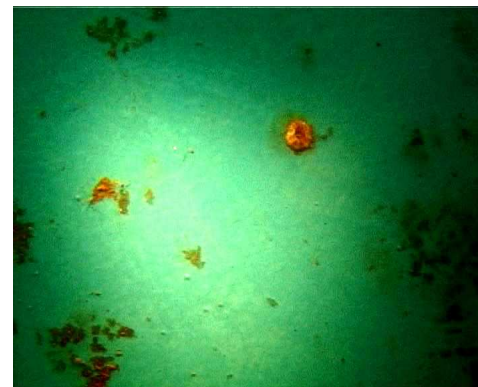
3	<u>Moderate biofouling</u> . Macrofouling clearly visible (usually > 1 species) but still patchy. 6 – 15 % of visible hull surface covered by macrofouling. Remaining area often covered in slime.
---	--

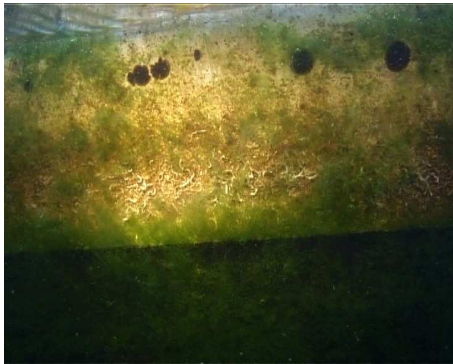
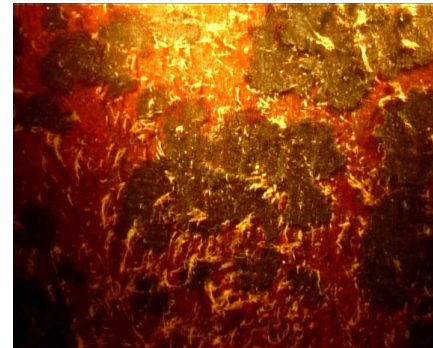
LOF rank	Criteria
4	<u>Extensive fouling</u> . 16 – 40 % of visible hull surface covered by macrofouling, generally several distinct types of organisms. Remaining area often covered in slime.

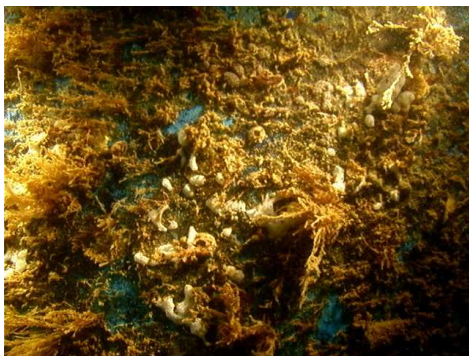
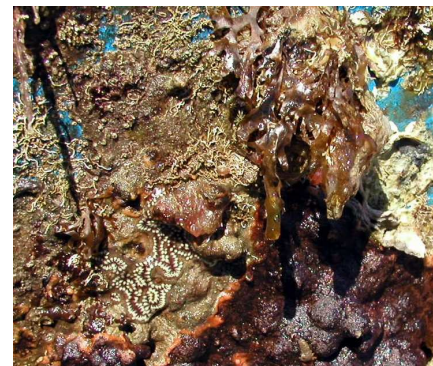
5	<u>Very heavy fouling</u> . 41 – 100 % of visible hull surface covered by macrofouling, often many distinct types of organisms. Remaining area often covered in slime.
---	--
